CLOSEBOURNE VILLAGE TANK STREET COTTAGES

TREE ASSESSMENT REPORT

MAY 2023

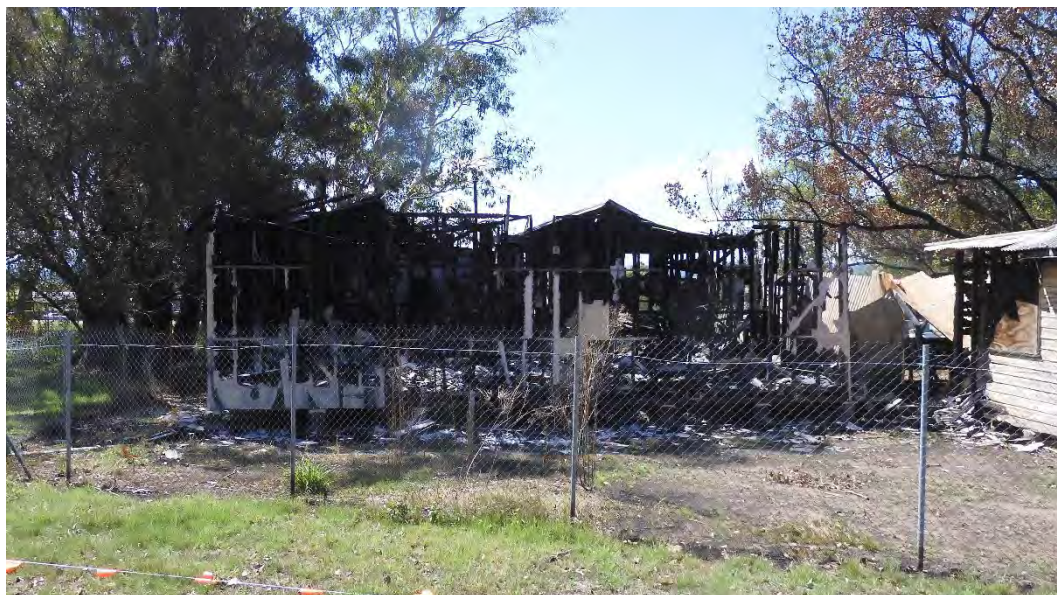
FIGURE 3: VIEW OF FIRE RAVAGED WESTERN COTTAGE

On the night of 16th February 2023 a fire broke out in the western section of the disused buildings. These buildings were proposed to be demolished late February/early March. The fire destroyed the first (western) building and affected approximately 25% of the second (eastern) building. The effect of the fire was that friable asbestos fibres were dispersed into the air and spread around nearby grounds and into the vegetation, therefore contaminating the area. A Licensed Asbestos Assessor (LAA) from Trinitas Group, was promptly engaged to undertake a PVA makesafe of the fire affected structures, this included spraying PVA over fire affected materials and to commence a site investigation. Trinitas Group also prepared report that detailed the required remediation works (Trinitas Group, 2023).

- Stage 1: Demolition of the fire-affected buildings and associated structures with the safe removal of debris to an approved receiving facility.
- Stage 2: The felling and removal to an approved receiving facility of 11 trees that may contain asbestos fibres etc. within their canopies. (This is required as it is not possible to thoroughly inspect the canopies of trees, to guarantee that there is no risk to humans of being exposed to asbestos fibre. The option of hosing down the trees was considered; however, there could still be no way of confirming that the asbestos had been eliminated. Failure to remove the trees would result in a qualified Clearance Certificate and the need for the trees to be placed on the site's Asbestos Register.)

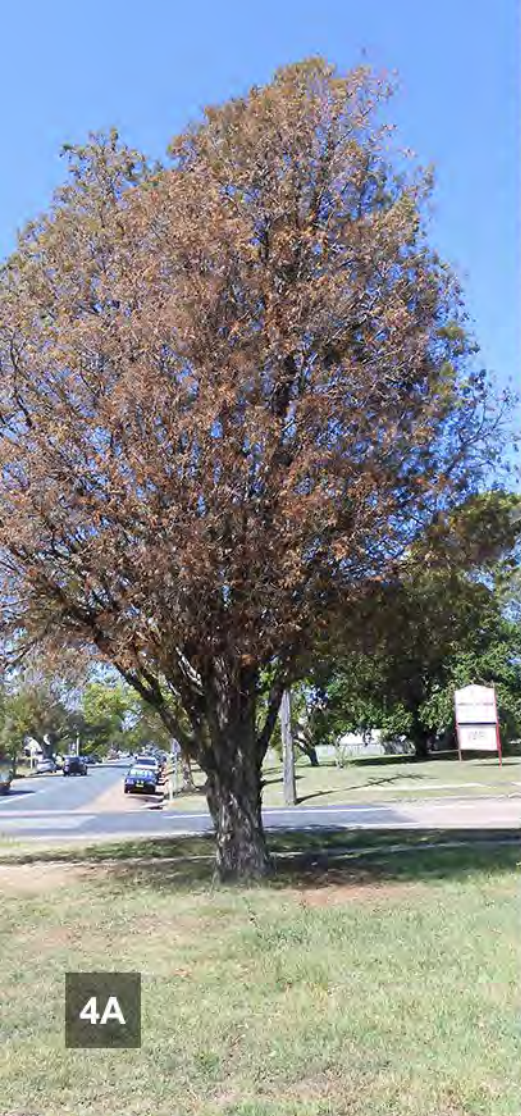
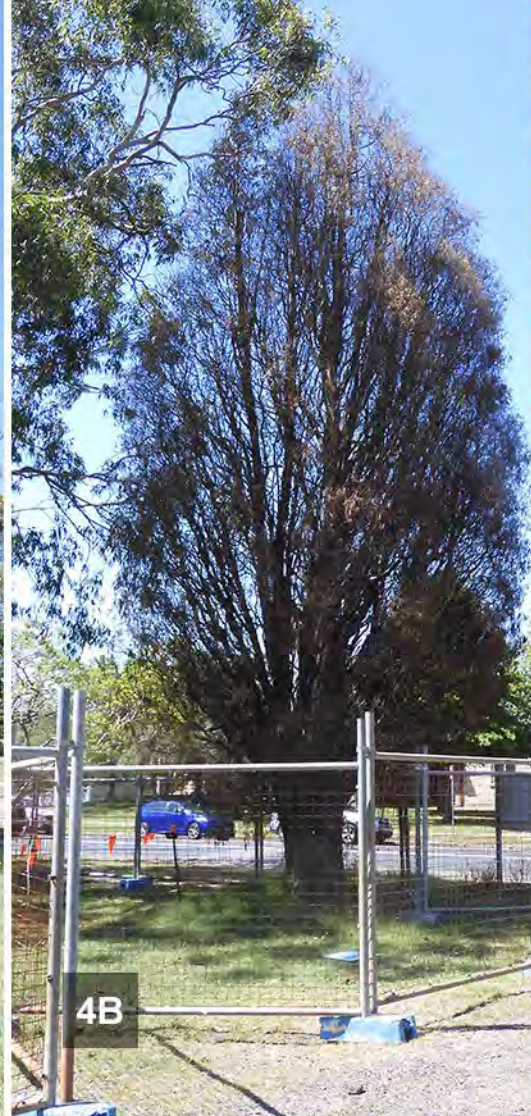
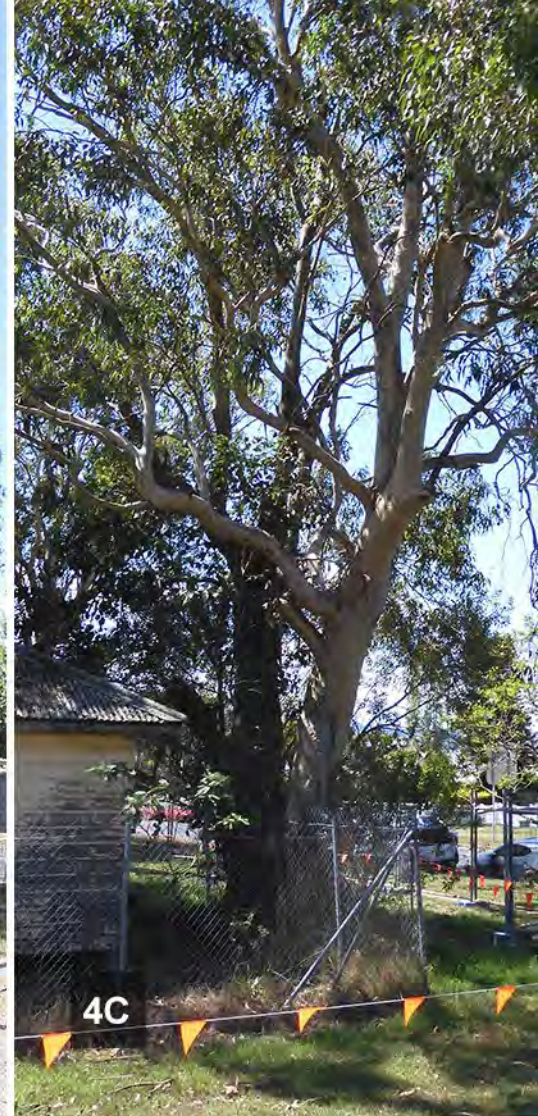
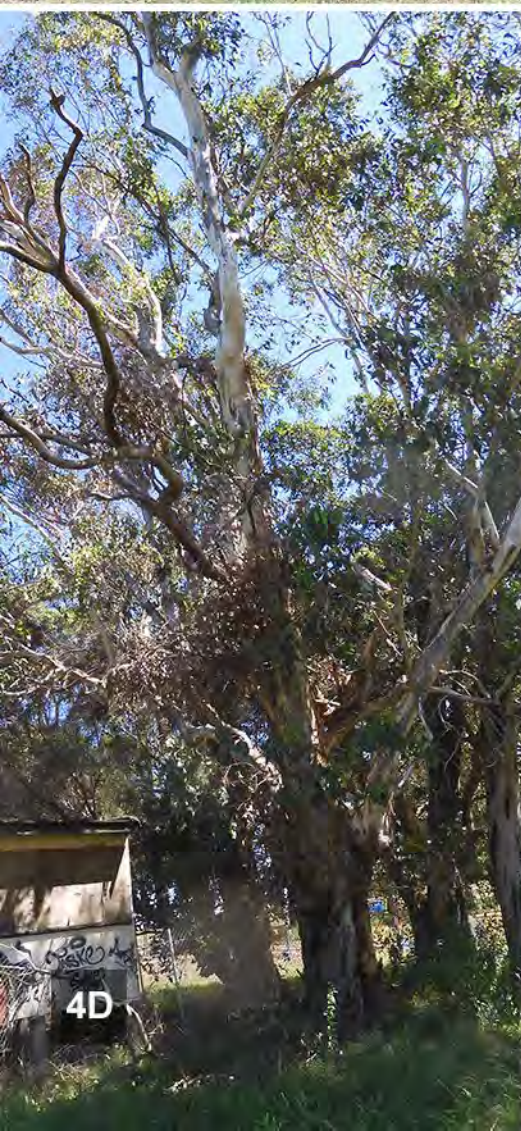
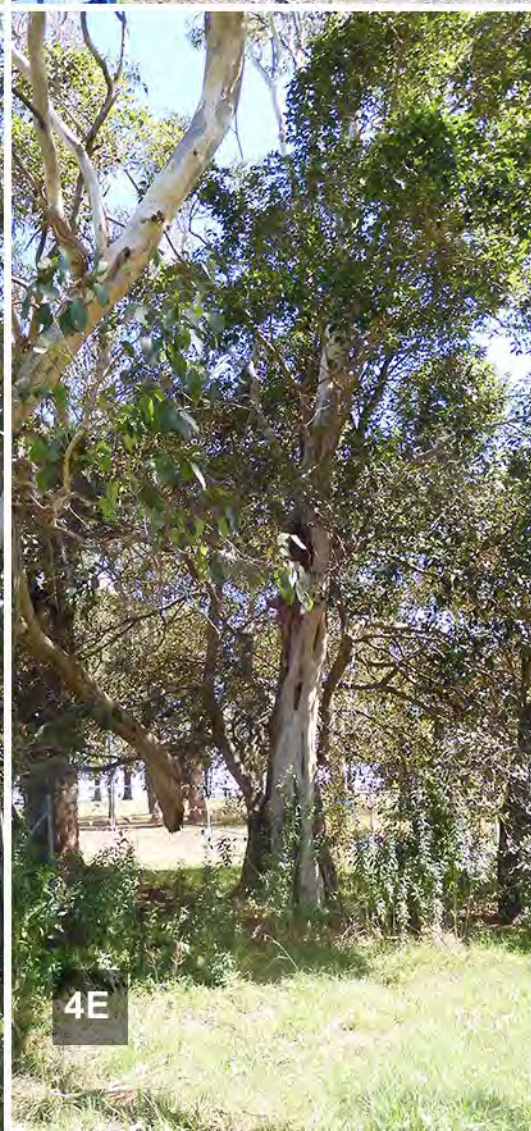
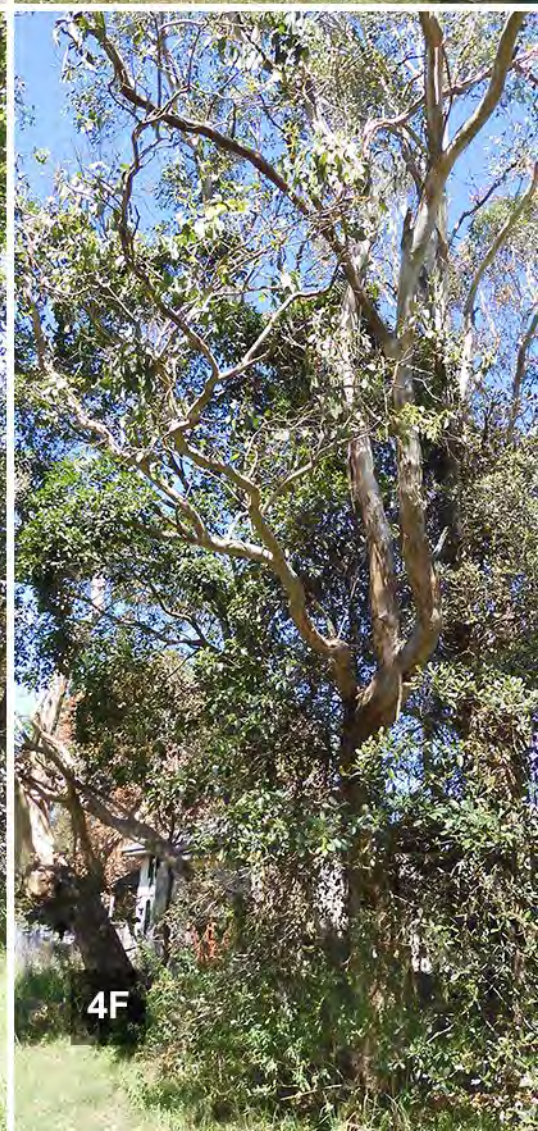
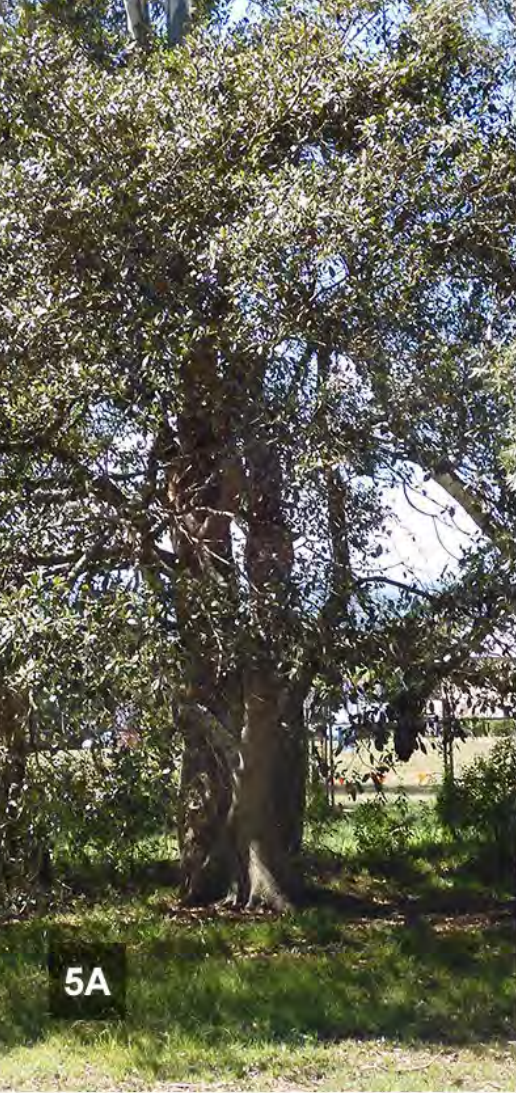
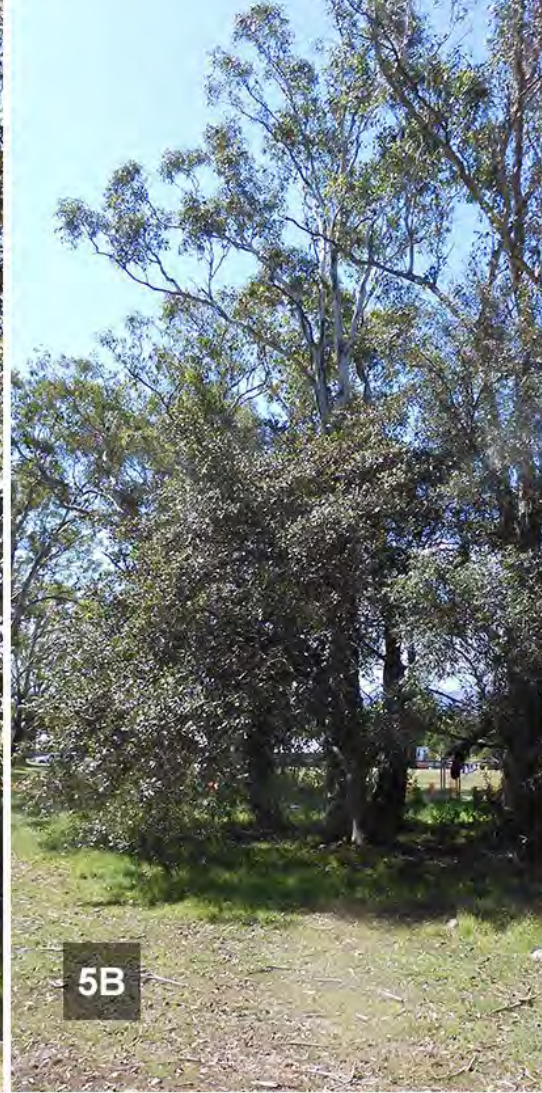
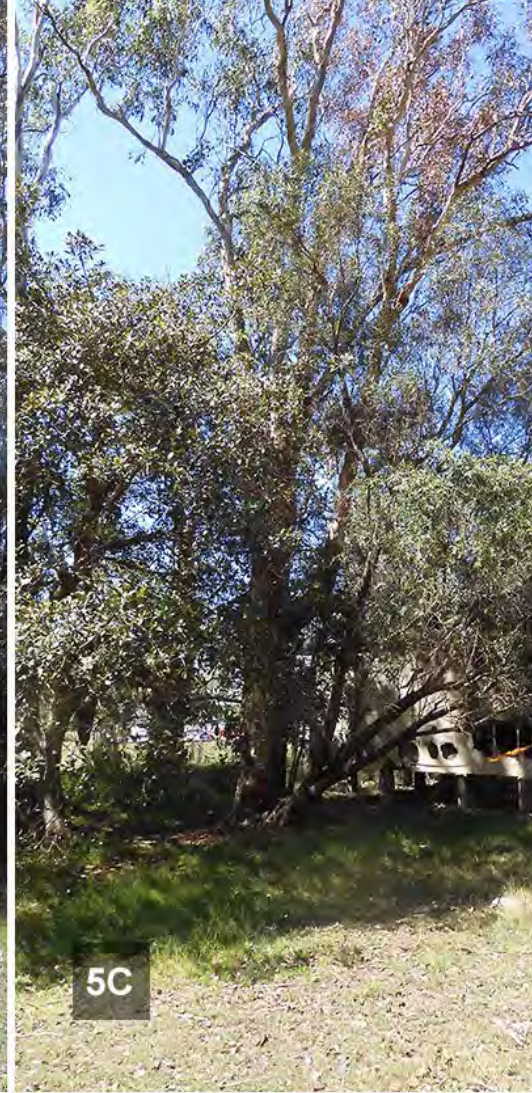
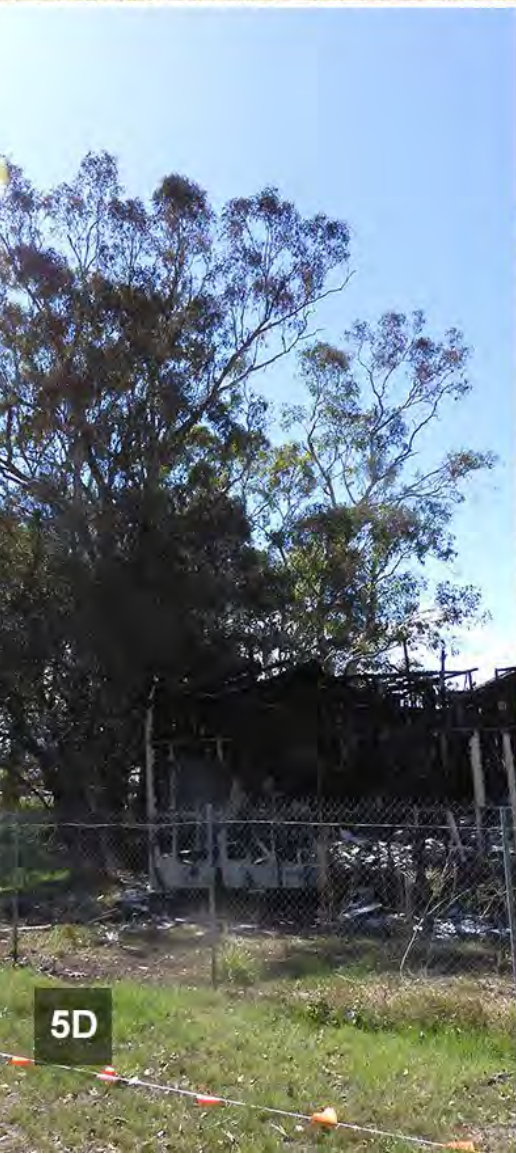
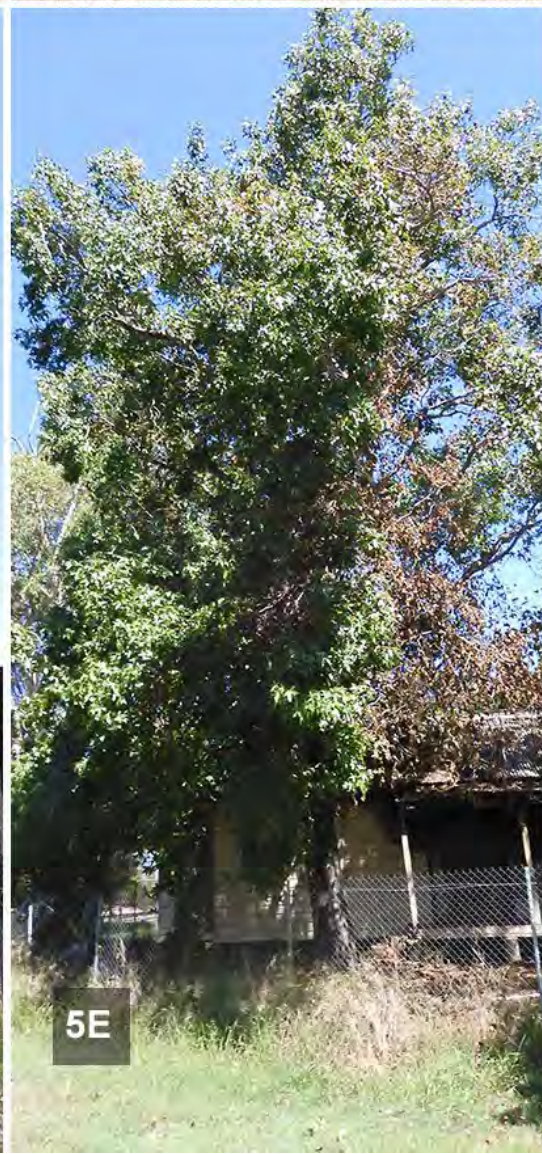
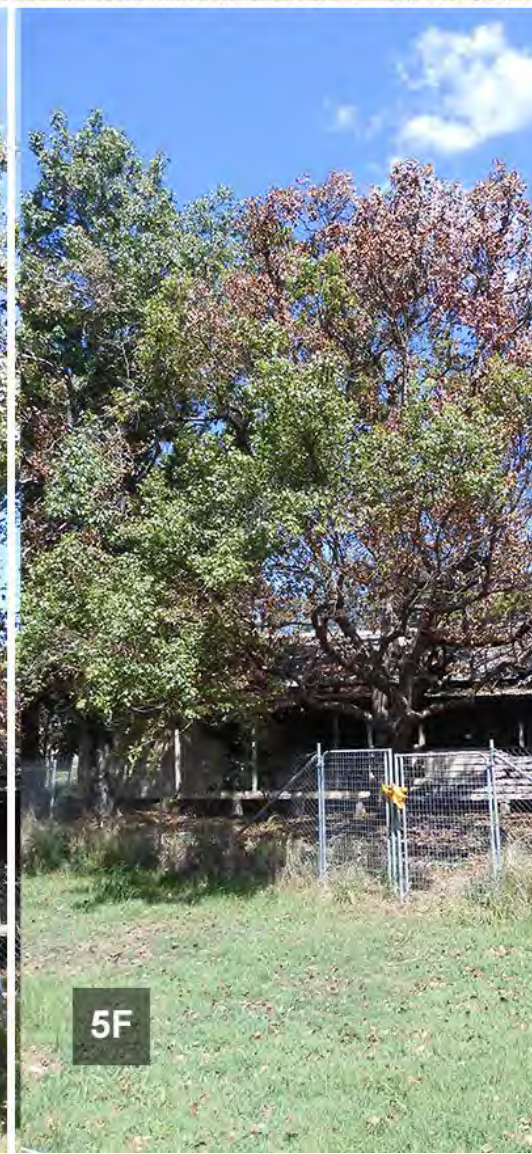
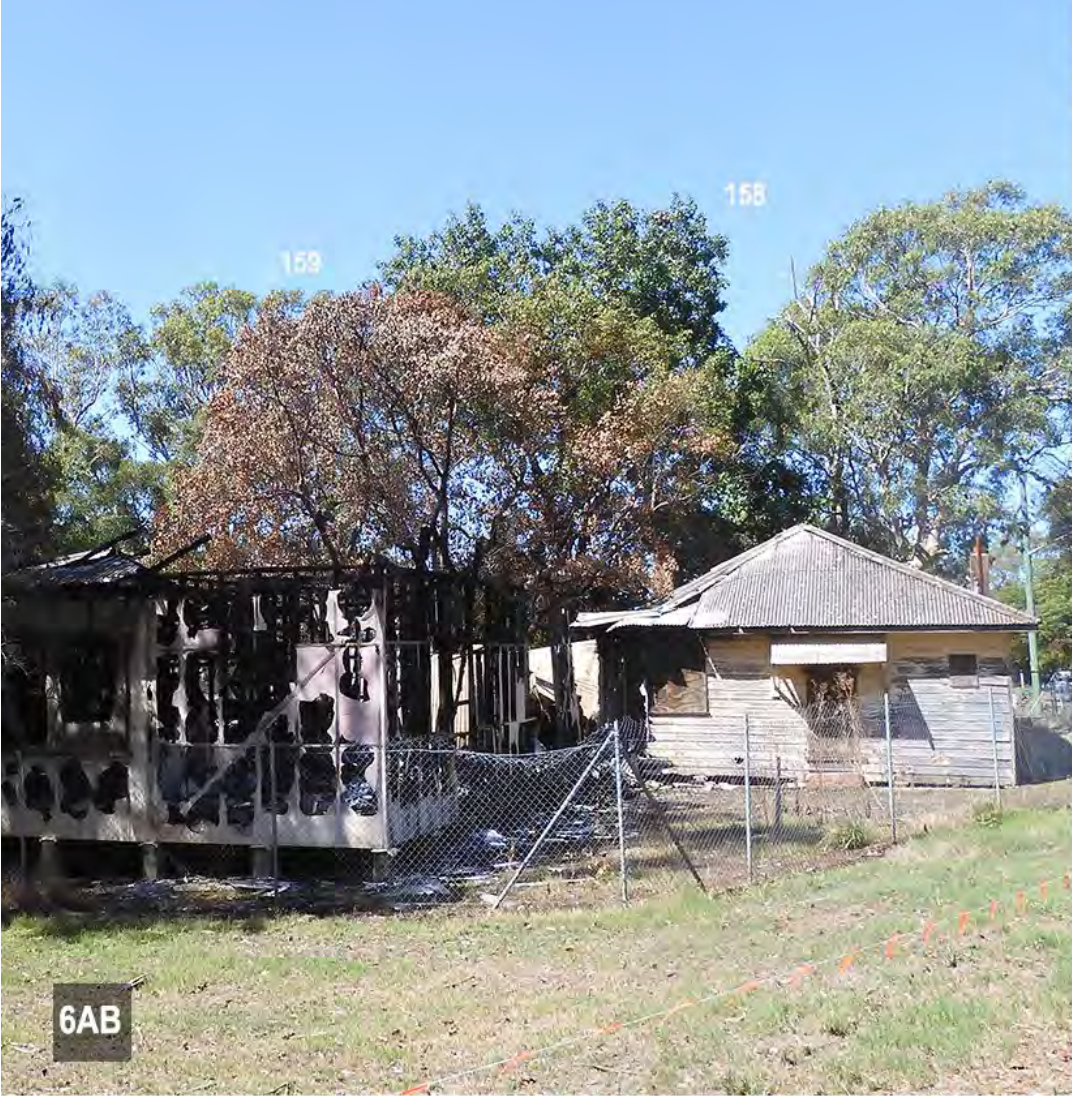
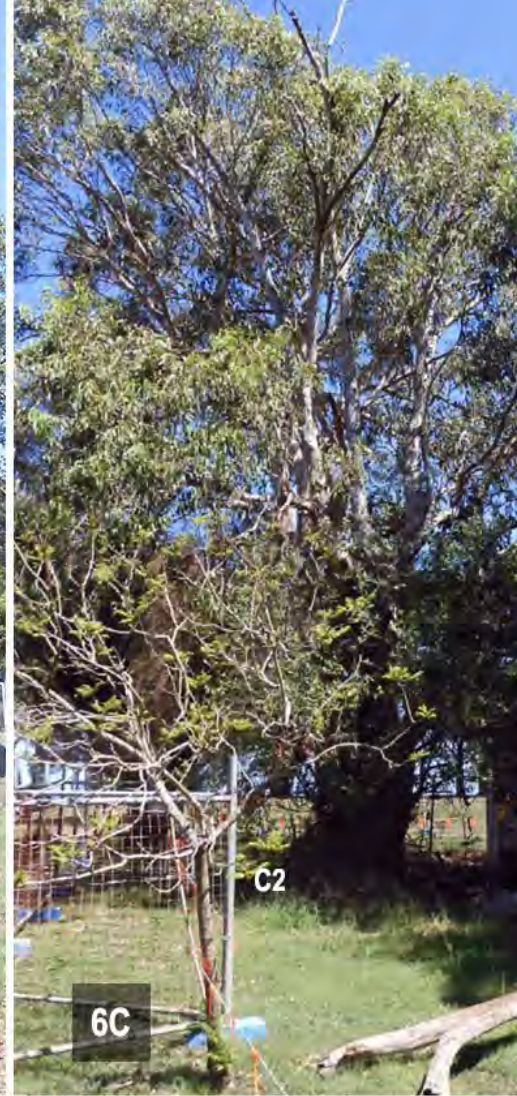
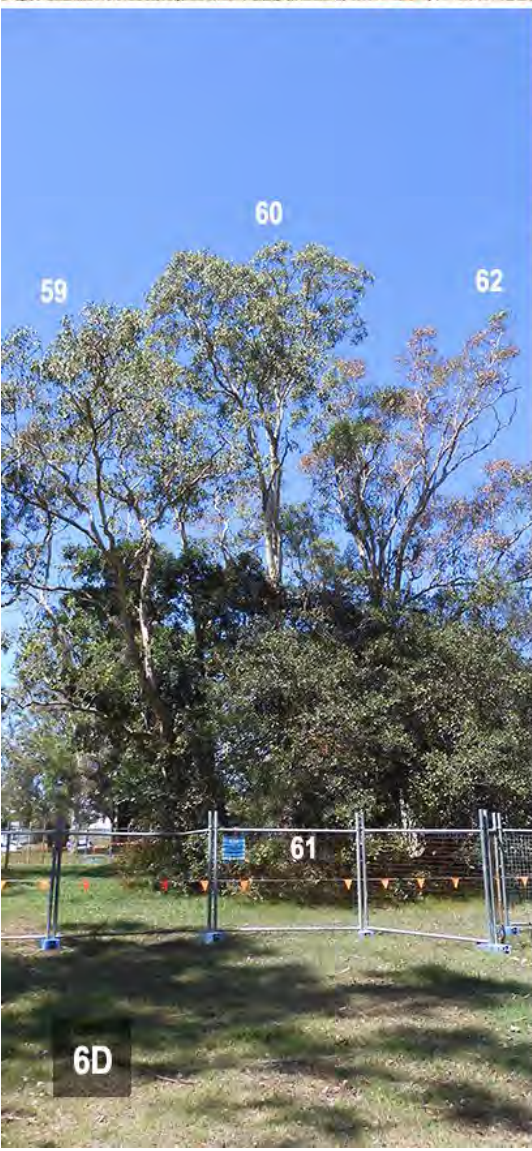
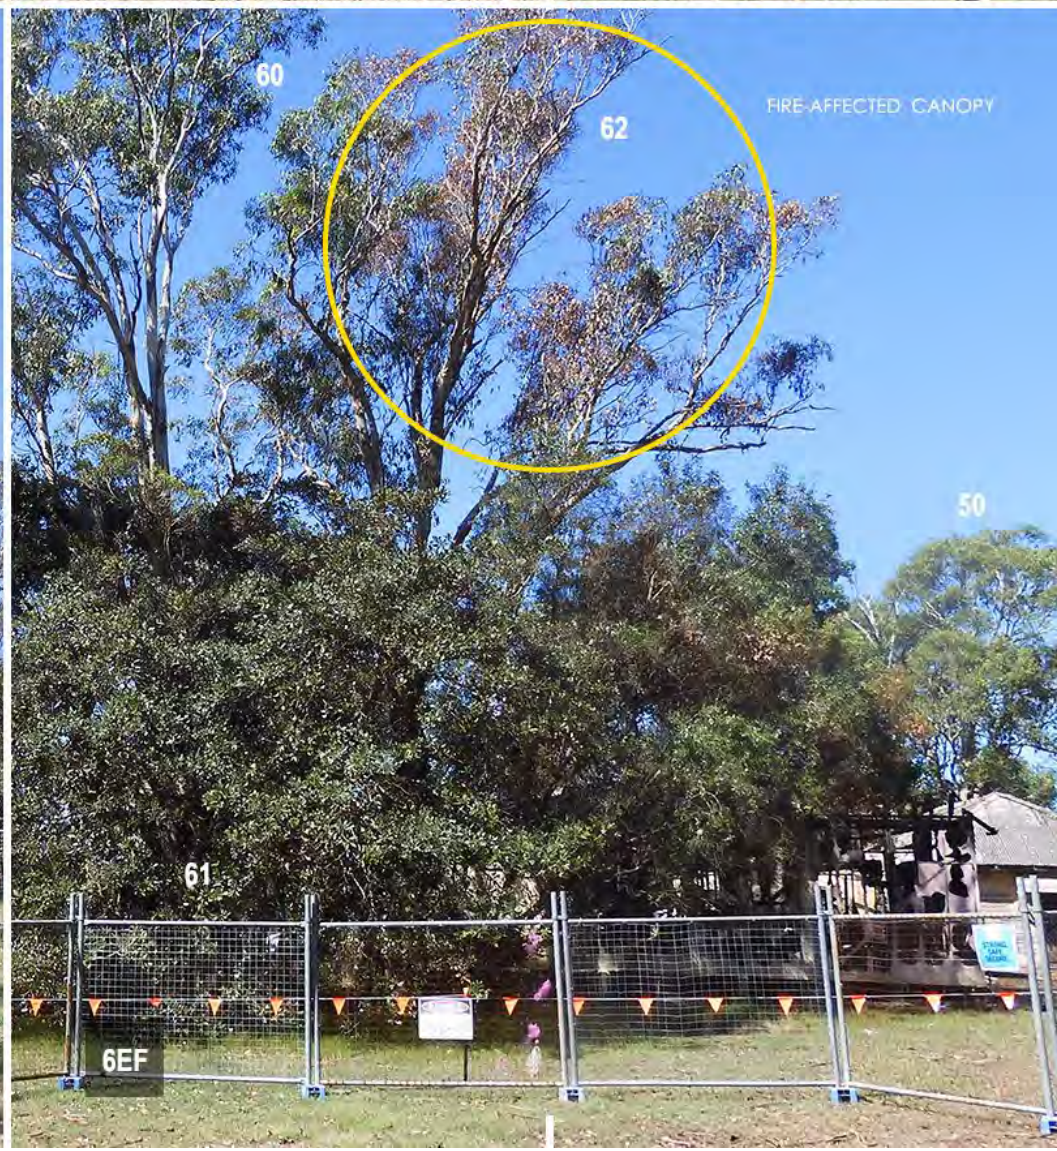
SUMMARY ASSESSMENT			
TREE No.	FIG No.	Bot. NAME	COMMENTS
FIRE AFFECTED TREES			
49	4B	<i>Cupressus leylandii</i>	Dead tree. Suitable for removal.
50	4C	<i>Eucalyptus tereticornis</i>	Tree in decline. Suitable for removal.
57	4D	<i>Eucalyptus tereticornis</i>	Tree in decline. Suitable for removal.
58	4E	<i>Eucalyptus tereticornis</i>	Tree host to strangler fig. Suitable for retention
59	4F	<i>Eucalyptus tereticornis</i>	Tree with poor structure. Suitable for removal.
60	5B	<i>Eucalyptus tereticornis</i>	Tree host to strangler fig. Suitable for retention
61	5A	<i>Ficus rubiginosa</i>	Actively growing strangler fig. Suitable for retention.
62	5D	<i>Eucalyptus tereticornis</i>	Tree significantly affected by fire but should regenerate. Suitable for retention.
158	5E	<i>Liquidambar styraciflua</i>	Tree with partial fire damage to its canopy. Suitable for retention with remedial work.
159	5F	<i>Cinnamomum camphora</i>	Tree significantly affected by fire and will not regenerate adequately. Suitable for removal.

C2	6C	<i>Jacaranda mimosifolia</i>	Struggling tree not affected by fire. Suitable for retention.
OTHER			
48	4A	<i>Cupressus leylandii</i>	Tree in severe decline. Suitable for removal.

FIRE AFFECTED TREES														
Tree ID	Species	Age Class	Height	DBH1	DBH TOTAL	DAB	TPZ	SRZ	Structure	Condition	ULE	Tree AZ	Original Field Comments	Image
49	<i>Cupressus leylandii</i>	M	10	0.78	0.78	1	9.36	3.31	Ex	Ex	1A	A2	Minimal retention requirements	
49	2023 Observations	Tree dead prior to fire. Tree requires removal and replacement.											4B	
50	<i>Eucalyptus tereticornis</i>	OM	17	1.46	1.46	1.35	10.56	3.75	F	F	4D	Z5	Large, co-dominant trunk dead with one dead trunk, borer activity present	
50	2023 Observations	No apparent fire damage/heat impact. Tree in decline with dead co-dominant trunk showing signs of decay and borer activity. Possible habitat tree that would require an ecologist to inspect prior to removal.											4C	
57	<i>Eucalyptus tereticornis</i>	M	14	0.79	0.79	0.85	9.48	3.09	P	F	2C	Z9	Large wound area under plane of lean	
57	2023 Observations	Minor fire damage/heat impact to approximately 10-15% of canopy. Tree already in decline. Hanging branch present shed from Tree 58.											4D

58	<i>Eucalyptus tereticornis</i>	M	16	0.55	0.55	0.62	6.60	2.71	P	P	2C	Z9	Strangler Fig at 4 meters, Minor cambium intact	
58	2023 Observations	No apparent fire damage/heat impact. Strangler fig has grown higher into the canopy since 2018 and almost reached the top of Tree 58's canopy.											4E	
59	<i>Eucalyptus tereticornis</i>	M	13	0.64	0.64	0.65	7.68	2.76	P	P	2C	Z9	Multiple wound areas, hosted by Ficus growing aloft	
59	2023 Observations	No apparent fire damage/heat impact. Tree with strong lean to NNW. ULE Rating now 3C. Unable to observe Ficus within canopy as observed in 2018.											4F	
60	<i>Eucalyptus tereticornis</i>	M	18	0.8	0.80	0.95	9.60	3.24	P	P	2C	Z9	Multiple wound areas, suppressed by Ficus	
60	2023 Observations	No apparent fire damage/heat impact. Supporting Tree 61 which is expected to dominate and take over in time.											5B	
61	<i>Ficus rubiginosa</i>	SM	11	0.4	0.40	0.5	4.80	2.47	Av	Ex	1A	A1	Supressing Tereticornis

61	2023 Observations	No apparent fire damage/heat impact. Currently being supported by Tree 60 which it is expect to dominate over time.											5A	
62	<i>Eucalyptus tereticornis</i>	M	18	0.8	0.80	0.8	9.60	3.01	F	F	2C	Z9	Multiple wound areas	
62	2023 Observations	Significant fire damage/heat impact to the upper canopy although it is expected that the canopy would recover due to epicormic regrowth occurring.											5D	
158	<i>Liquidambar styraciflua</i>	M	14	0.70	0.70	0.78	8.40	2.98	Av	Ex	1B	A2	Included bifurcation@5m, minor overextended branch structure	
158	2023 Observations	Lower portions of the canopy fire damage/heat impact. Approximately 20-30% canopy loss. It is estimated that the tree would survive if left. Pruning of damaged branches would be required.											5E	
159	<i>Cinnamomum camphora</i>	M	12	0.75	0.75	0.75	9.00	2.93	Av	Av	1B	A2	Decline in crown, large DW	
159	2023 Observations	Extensive fire damage/heat impact. This tree appears to have suffered the worst from the fire whilst shielding Tree 158 to some degree.											5F,6AB

C2	<i>Jacaranda mimosifolia</i>	SM	3	N/A	N/A	N/A	N/A	N/A	Av	Av	2B	A2	Small tree struggling under latent ground conditions	
C2	2023 Observations	Minor tree. Not making a strong contribution to Tank Street. Low branching. Sucker growth at base.											6C

OTHER TREES														
Tree ID	Species	Age Class	Height	DBH1	DBH TOTAL	DAB	TPZ	SRZ	Structure	Condition	ULE	Tree AZ	Original Field Comments	Image
48	<i>Cupressus leylandii</i>	M	10	0.68	0.68	0.66	8.16	2.78	Ex	Ex	1A	A2	Minimal retention requirements	
48	2023 Observations	Tree located outside exclusion zone. Tree in severe decline. Passing resident commented that the tree had suddenly started to die over the past four weeks.											4A

Although some of the trees would be suitable for retention following the fire, in order to ensure that the site has been properly decontaminated and the risk of hazard from the presence of asbestos is eliminated, it will be necessary to remove all the trees located within the exclusion area.

Tree 48 should also be removed due its severe state of decline although this tree has not been affected by the fire.

- It is recommended that approval be sought to remove all trees as nominated above.
- As a suggestion, plant **one** standard tree (45 litre) on the site for each tree removed as compensatory planting with suitable trees able to reach a similar size that matches the existing to ensure that the amenity of the site is maintained. It is suggested that the current trees be replaced with *Eucalyptus tereticornis* (Forest Red Gum) due to their suitability to the site conditions, the presence of other Forest Red Gums nearby, and to assist in maintaining and enhancing the rural aspects of the site. (Refer Appendix B)

- It is recommended that an ecologist be engaged to assess Tree 50 due to its potential to provide habitat for local fauna before removal.
- Ensure tree removal work is carried out by or supervised by a qualified tree worker (AQF Level 3 or equivalent) in accordance with the *Guide to Managing Risks of Tree Trimming and Removal Work* (Safe Work Australia, 2016).

- Tree remains to be removed from site to an approved facility that can take asbestos contaminated material.
