Arboricultural Impact Statement Report

**12 Day Street
East Maitland NSW 2323**

Prepared by Mark Bury Consulting

19th June 2023

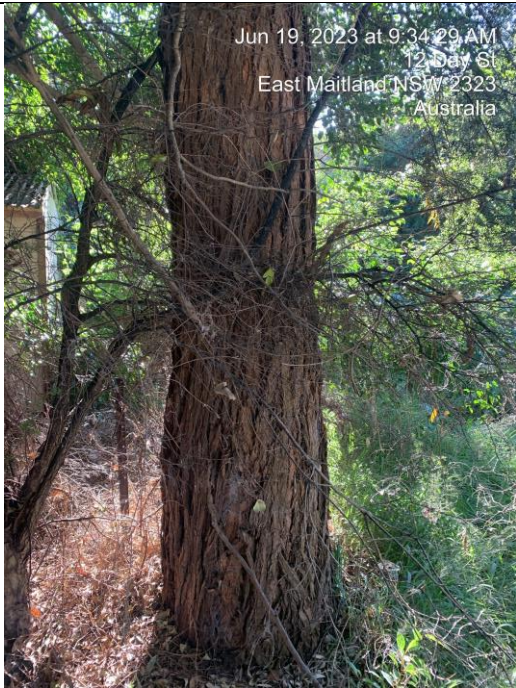
Tree 1
*Eucalyptus
paniculata*
Grey Ironbark

- 5.1 **Tree 1** (*Eucalyptus paniculata* Grey Ironbark) is a tree in fair condition Appendix 1 gives a description of the trees as per AS-4970-2009 Section 2. Appendix 4 gives the location of the tree on the property.
- 5.2 The tree will be affected by the proposed development (See Appendix 6 Construction Impact Statement). The trees soil environment and hydrological environment will be severely affected by the proposed development. Appropriate tree management in this situation would be the removal and replacement of the tree in a more suitable species and location as part of the landscape plan for the site

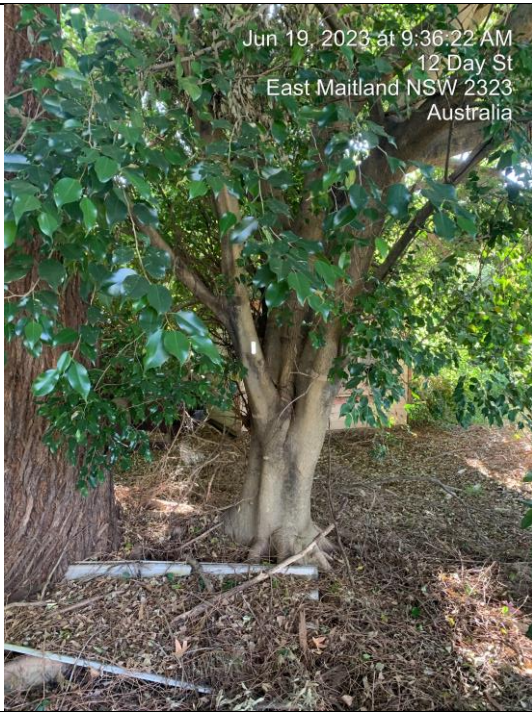
Tree 2
Ficus benjamina
Weeping Fig

- 5.3 **Tree 2** (*Ficus benjamina* Weeping Fig) is a tree in fair condition Appendix 1 gives a description of the trees as per AS-4970-2009 Section 2. Appendix 4 gives the location of the tree on the property.

- 5.4 The tree will be affected by the proposed development (See Appendix 6 Construction Impact Statement). The trees soil environment and hydrological environment will be severely affected by the proposed development. Appropriate tree management in this situation would be the removal and replacement of the tree in a more suitable species and location as part of the landscape plan for the site.

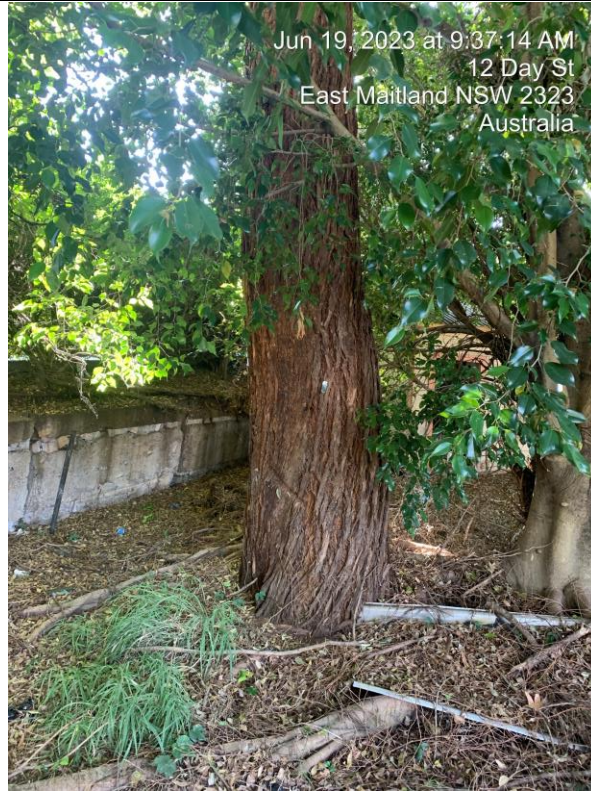
Tree 3
*Eucalyptus
paniculata*
Grey Ironbark

- 5.5 **Tree 3** (*Eucalyptus paniculata* Grey Ironbark) is a tree in fair condition Appendix 1 gives a description of the trees as per AS-4970-2009 Section 2. Appendix 4 gives the location of the tree on the property.

- 5.6 The tree will be affected by the proposed development (See Appendix 6 Construction Impact Statement). The trees soil environment and hydrological environment will be severely affected by the proposed development. Appropriate tree management in this situation would be the removal and replacement of the tree in a more suitable species and location as part of the landscape plan for the site.

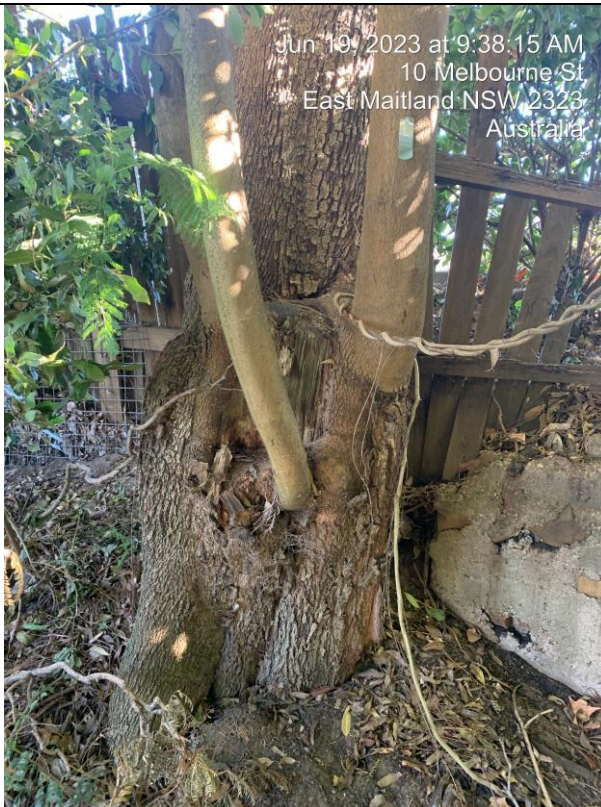
Tree 4
*Jacaranda
mimosifolia*
Jacaranda

- 5.7 **Tree 4** (*Jacaranda mimosifolia* Jacaranda) is a tree in fair condition Appendix 1 gives a description of the trees as per AS-4970-2009 Section 2. Appendix 4 gives the location of the tree on the property.

- 5.8 The tree will be affected by the proposed development (See Appendix 6 Construction Impact Statement). The trees soil environment and hydrological environment will be severely affected by the proposed development. Appropriate tree management in this situation would be the removal and replacement of the tree in a more suitable species and location as part of the landscape plan for the site

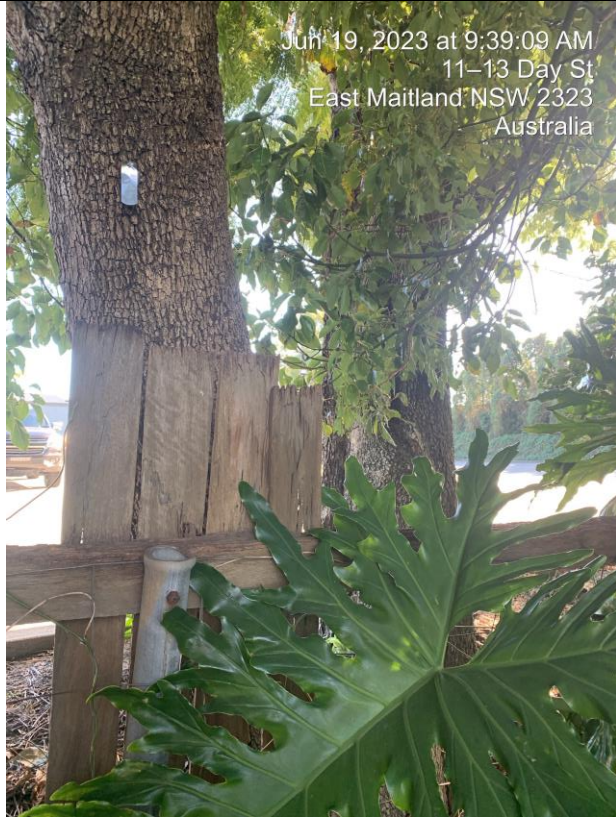
Tree 5
Jacaranda
mimosifolia
Jacaranda

- 5.9 **Tree 5** (*Jacaranda mimosifolia* Jacaranda) is a tree in fair condition Appendix 1 gives a description of the trees as per AS-4970-2009 Section 2. Appendix 4 gives the location of the tree on the property.

- 5.10 The tree will be affected by the proposed development (See Appendix 6 Construction Impact Statement). The trees soil environment and hydrological environment will be severely affected by the proposed development. Appropriate tree management in this situation would be the removal and replacement of the tree in a more suitable species and location as part of the landscape plan for the site.

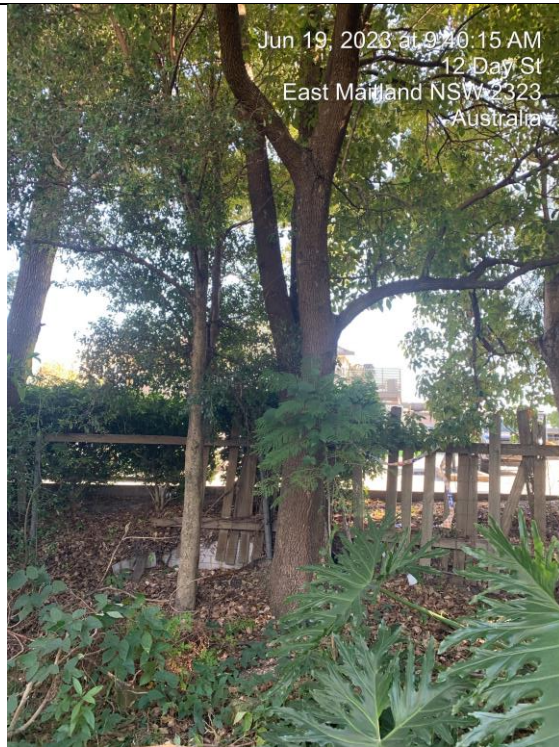
Tree 6
Cinnamomum
camphora
Camphorlaurel

- 5.11 **Tree 6** (*Cinnamomum camphora* Camphor laurel) is a tree in fair condition Appendix 1 gives a description of the trees as per AS-4970-2009 Section 2. Appendix 4 gives the location of the tree on the property.

- 5.12 The tree will be affected by the proposed development (See Appendix 6 Construction Impact Statement). The trees soil environment and hydrological environment will be severely affected by the proposed development. Appropriate tree management in this situation would be the removal and replacement of the tree in a more suitable species and location as part of the

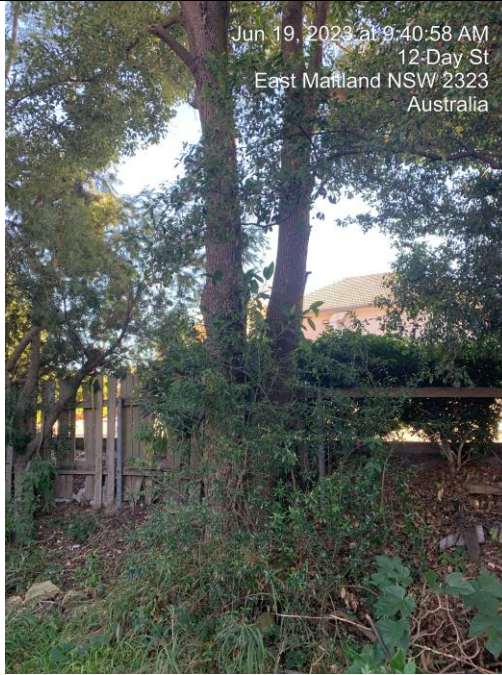
Tree 7
*Cinnamomum
camphora*
Camphorlaurel

- 5.13 **Tree 7** (*Cinnamomum camphora* Camphor laurel) is a tree in fair condition Appendix 1 gives a description of the trees as per AS-4970-2009 Section 2. Appendix 4 gives the location of the tree on the property.

- 5.14 The tree will be affected by the proposed development (See Appendix 6 Construction Impact Statement). The trees soil environment and hydrological environment will be severely affected by the proposed development. Appropriate tree management in this situation would be the removal and replacement of the tree in a more suitable species and location as part of the landscape plan for the site

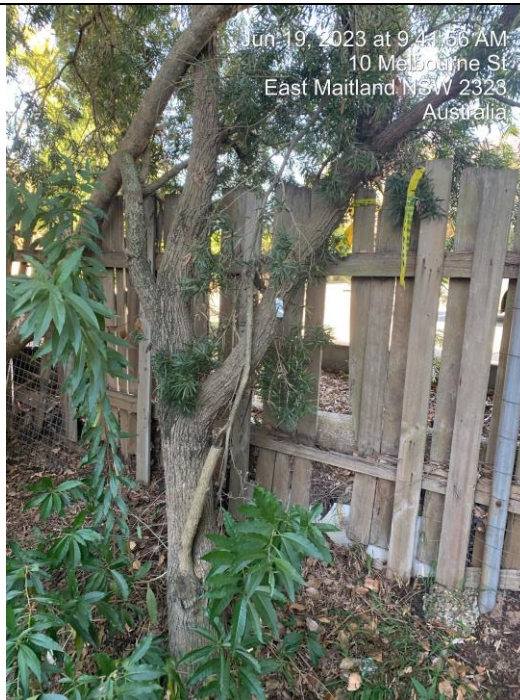
Tree 8
*Callistemon
viminalis*
Weeping
Bottlebrush

- 5.15 **Tree 8** (*Callistemon viminalis* Weeping Bottlebrush) is a tree in fair condition Appendix 1 gives a description of the trees as per AS-4970-2009 Section 2. Appendix 4 gives the location of the tree on the property.

- 5.16 The tree will be affected by the proposed development (See Appendix 6 Construction Impact Statement). The trees soil environment and hydrological environment will be severely affected by the proposed development. Appropriate tree management in this situation would be the removal and replacement of the tree in a more suitable species and location as part of the landscape plan for the site.

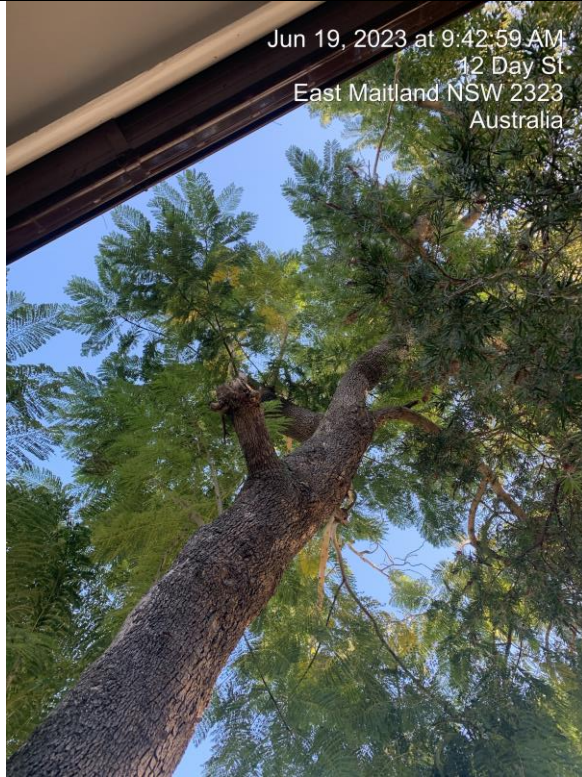
Tree 9
Jacaranda
mimosifolia
Jacaranda

- 5.17 **Tree 9** (*Jacaranda mimosifolia* Jacaranda) is a tree in fair condition Appendix 1 gives a description of the trees as per AS-4970-2009 Section 2. Appendix 4 gives the location of the tree on the property.

- 5.18 The tree will be affected by the proposed development (See Appendix 6 Construction Impact Statement). The trees soil environment and hydrological environment will be severely affected by the proposed development. Appropriate tree management in this situation would be the removal and replacement of the tree in a more suitable species and location as part of the landscape plan for the site.

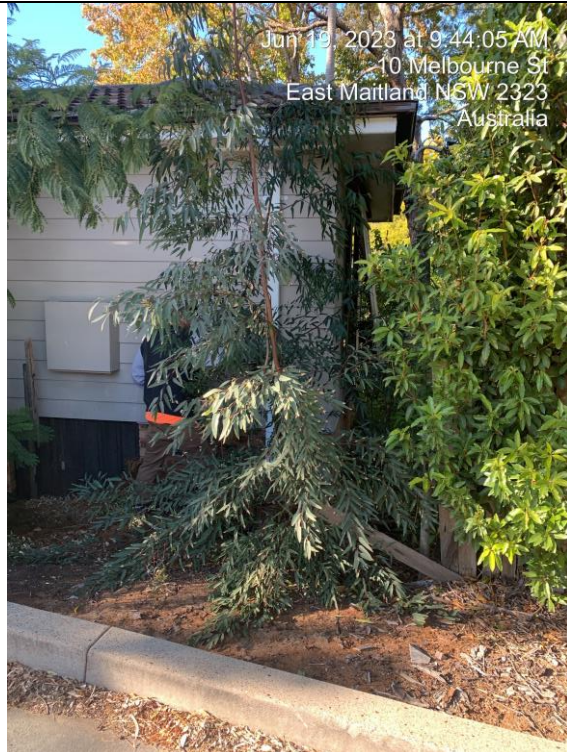
Tree 10
Eucalyptus
paniculata
Grey Ironbark

- 5.19 **Tree 10** (*Eucalyptus paniculata* Grey Gum) is a tree in poor condition Appendix 1 gives a description of the trees as per AS-4970-2009 Section 2. Appendix 4 gives the location of the tree on the property.

- 5.20 The tree will be affected by the proposed development (See Appendix 6 Construction Impact Statement). The trees soil environment and hydrological environment will be severely affected by the proposed development. Appropriate tree management in this situation would be the removal and replacement of the tree in a more suitable species and location as part of the landscape plan for the site

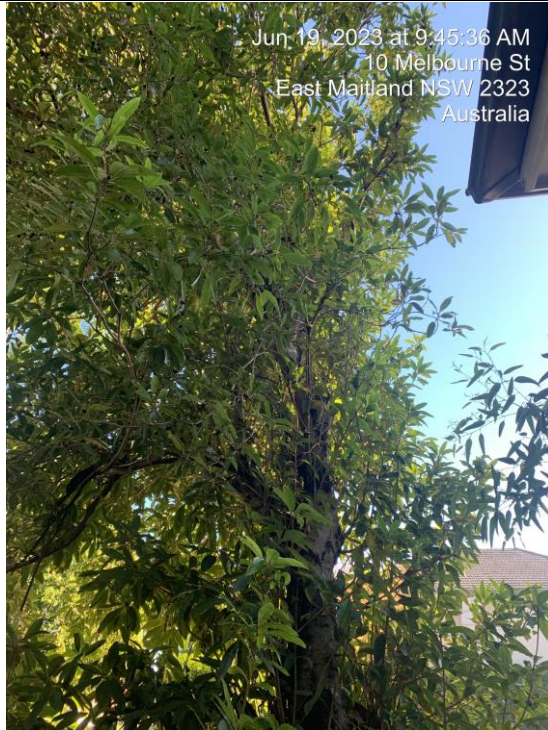
Tree 11
Pittosporum undulatum
Sweet Pittosporum

- 5.21 **Tree 11** (*Pittosporum undulatum* Pittosporum) is a tree in fair condition Appendix 1 gives a description of the trees as per AS-4970-2009 Section 2. Appendix 4 gives the location of the tree on the property.

replacement of the tree in a more suitable species and location as part of the landscape plan for the site

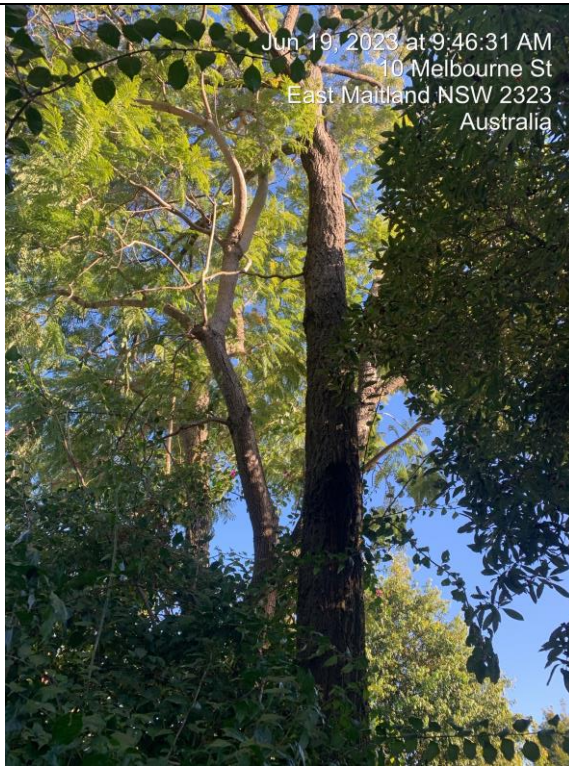
Tree 12
Eucalyptus paniculata
Grey Ironbark

- 5.23 **Tree 12** (*Eucalyptus paniculata* Grey Ironbark) is a tree in fair condition Appendix 1 gives a description of the trees as per AS-4970-2009 Section 2. Appendix 4 gives the location of the tree on the property.

- 5.24 The tree will be affected by the proposed development (See Appendix 6 Construction Impact Statement). The trees soil environment and hydrological environment will be severely affected by the proposed development. Appropriate tree management in this situation would be the removal and replacement of the tree in a more suitable species and location as part of the landscape plan for the site

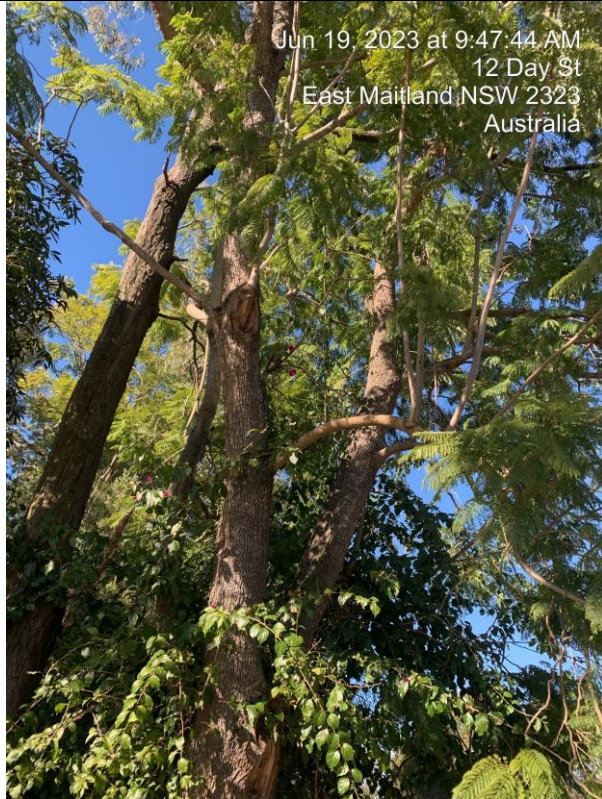
Tree 13
Jacaranda
mimosifolia
Jacaranda

- 5.25 **Tree 13** (*Jacaranda mimosifolia* Jacaranda) is a tree in fair condition Appendix 1 gives a description of the trees as per AS-4970-2009 Section 2. Appendix 4 gives the location of the tree on the property.

- 5.26 The tree will be affected by the proposed development (See Appendix 6 Construction Impact Statement). The trees soil environment and hydrological environment will be severely affected by the proposed development. Appropriate tree management in this situation would be the removal and replacement of the tree in a more suitable species and location as part of the landscape plan for the site

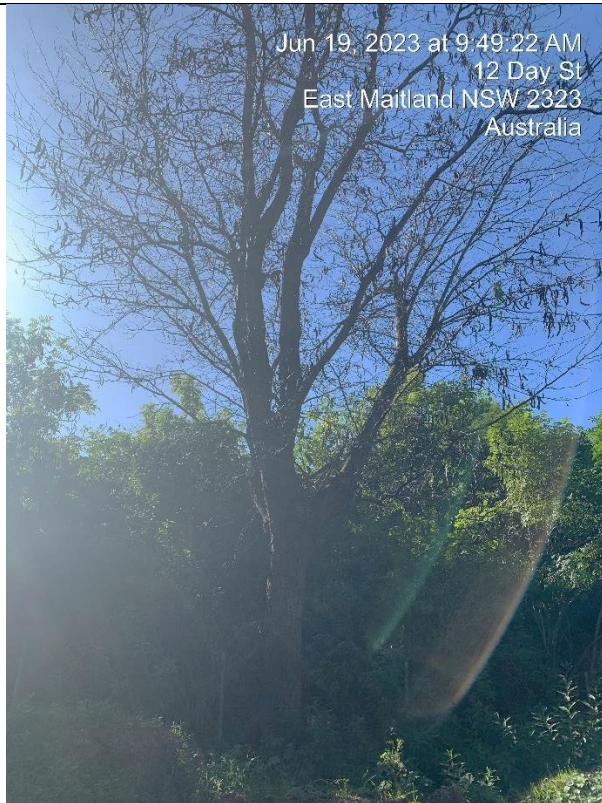
Tree 14
Unknown
Species
Non indigenous

- 5.27 **Tree 14** (*Unknown Species* Non indigenous) is a tree in fair condition Appendix 1 gives a description of the trees as per AS-4970-2009 Section 2. Appendix 4 gives the location of the tree on the property.

- 5.28 The tree will be affected by the proposed development (See Appendix 6 Construction Impact Statement). The trees soil environment and hydrological environment will be severely affected by the proposed development. Appropriate tree management in this situation would be the removal and replacement of the tree in a more suitable species and location as part of the landscape plan for the site

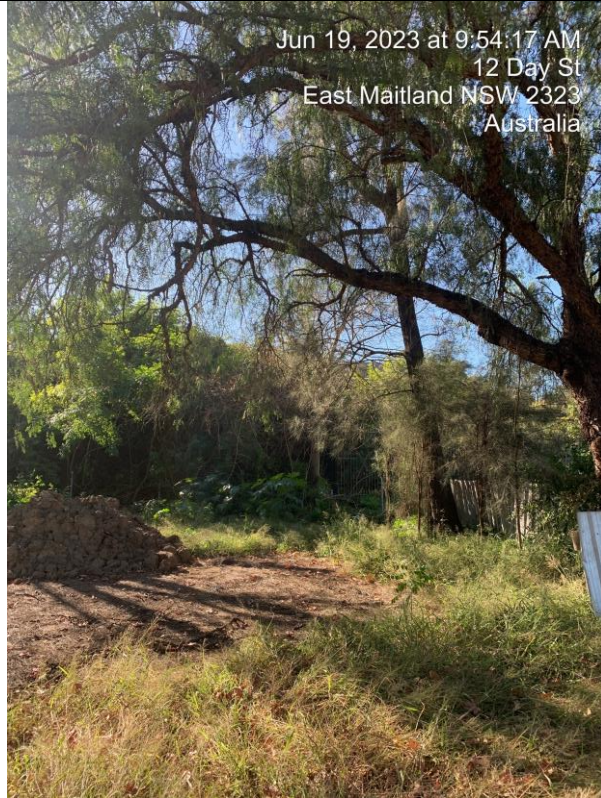
Tree 15
Liquidambar
Styraciflua
Liquidamber

- 5.29 **Tree 15** (*Liquidambar styraciflua* Liquidambar) is a tree in fair condition Appendix 1 gives a description of the trees as per AS-4970-2009 Section 2. Appendix 4 gives the location of the tree on the property.

- 5.30 The tree will be affected by the proposed development (See Appendix 6 Construction Impact Statement). The trees soil environment and hydrological environment will be severely affected by the proposed development. Appropriate tree management in this situation would be the removal and replacement of the tree in a more suitable species and location as part of the landscape plan for the site

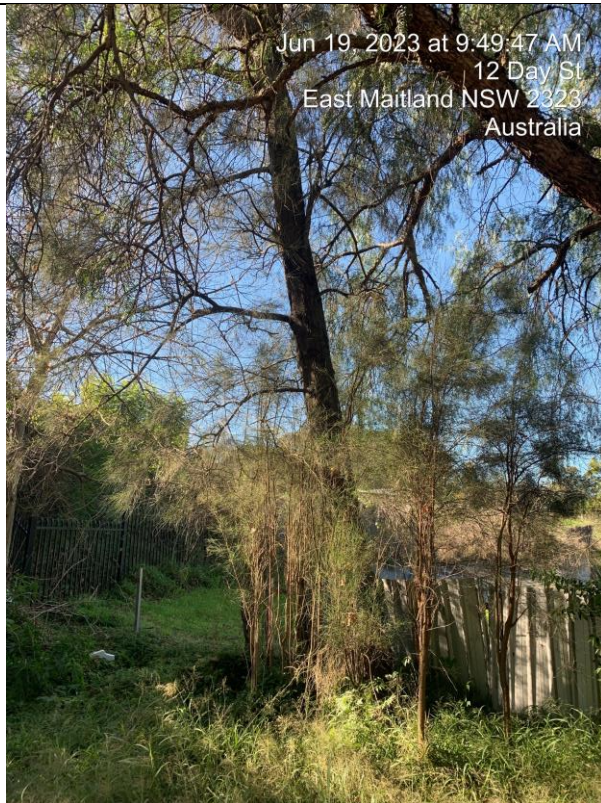
Tree 16
Casuarina
glauca
Swamp Oak

- 5.31 **Tree 16** (*Casuarina glauca* Swamp Oak) is a tree in fair condition Appendix 1 gives a description of the trees as per AS-4970-2009 Section 2. Appendix 4 gives the location of the tree on the property.

Appropriate tree management in this situation would be the removal and replacement of the tree in a more suitable species and location as part of the landscape plan for the site

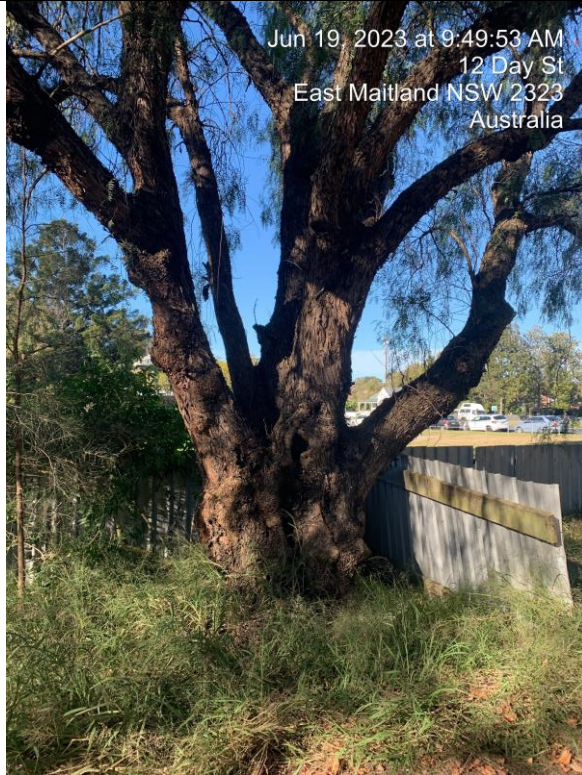
Tree 17
Schinus areira
Peppercorn

- 5.33 **Tree 17** (*Schinus areira* Peppercorn) is a tree in fair condition Appendix 1 gives a description of the trees as per AS-4970-2009 Section 2. Appendix 4 gives the location of the tree on the property.

- 5.34 The tree will be affected by the proposed development (See Appendix 6 Construction Impact Statement). The trees soil environment and hydrological environment will be severely affected by the proposed development. Appropriate tree management in this situation would be the removal and replacement of the tree in a more suitable species and location as part of the landscape plan for the site

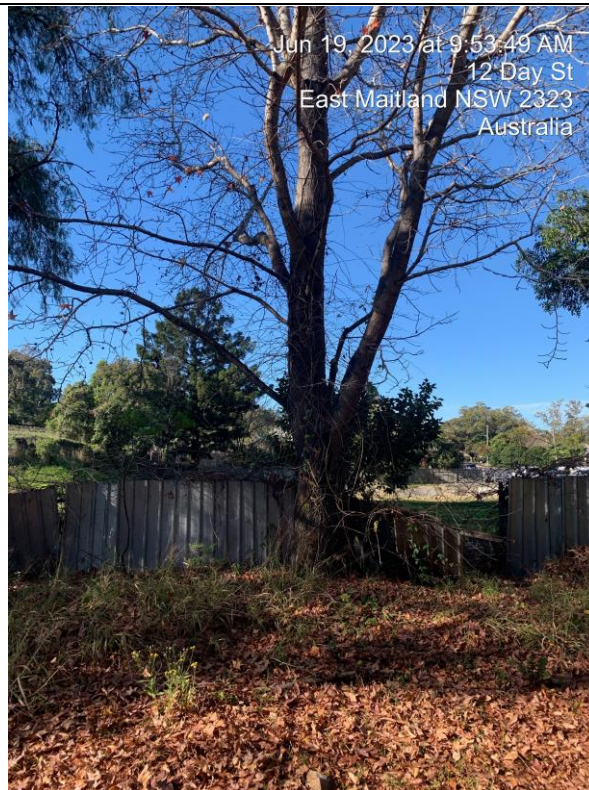
Tree 18
Liquidambar styraciflua
Liquidamber

- 5.35 **Tree 18** (*Liquidambar styraciflua* Liquidambar) is a tree in fair condition Appendix 1 gives a description of the trees as per AS-4970-2009 Section 2. Appendix 4 gives the location of the tree on the property.

- 5.36 The tree will be affected by the proposed development (See Appendix 6 Construction Impact Statement). The trees soil environment and hydrological environment will be severely affected by the proposed development. Appropriate tree management in this situation would be the removal and replacement of the tree in a more suitable species and location as part of the landscape plan for the site

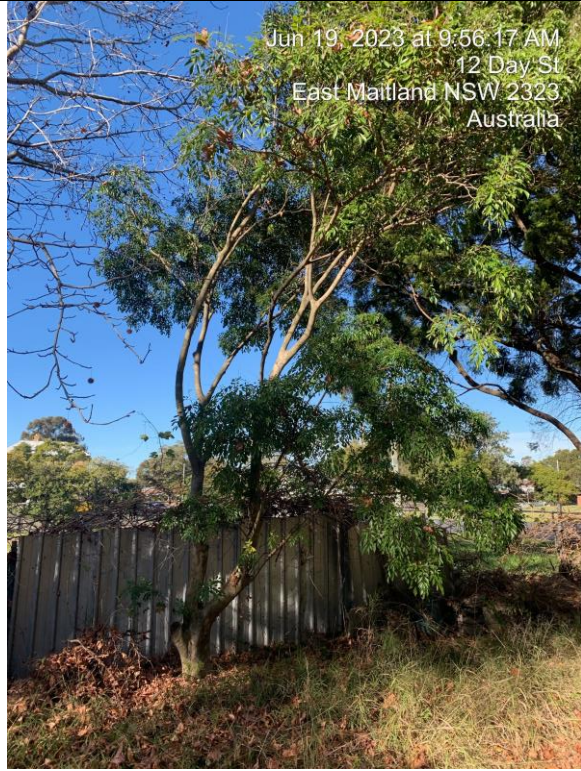
Tree 19
Melia azedarach
White Cedar

- 5.37 **Tree 19** (*Melia azedarach* China Berry) is a tree in fair condition Appendix 1 gives a description of the trees as per AS-4970-2009 Section 2. Appendix 4 gives the location of the tree on the property.

- 5.38 The tree will be affected by the proposed development (See Appendix 6 Construction Impact Statement). The trees soil environment and hydrological environment will be severely affected by the proposed development. Appropriate tree management in this situation would be the removal and replacement of the tree in a more suitable species and location as part of the landscape plan for the site

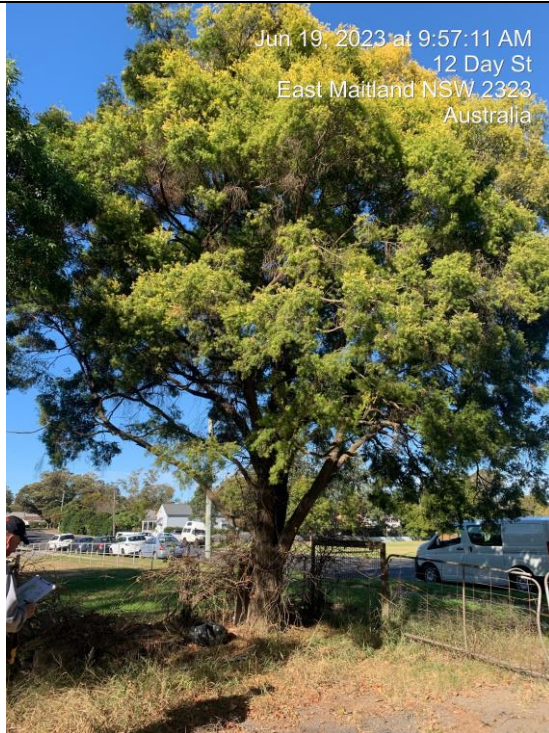
Tree 20
*Melaleuca
bracteata*
Revolution
Green

- 5.39 **Tree 20** (*Melaleuca bracteata* Revolution Green) is a tree in fair condition Appendix 1 gives a description of the trees as per AS-4970-2009 Section 2. Appendix 4 gives the location of the tree on the property.

- 5.40 The tree will be affected by the proposed development (See Appendix 6 Construction Impact Statement). The trees soil environment and hydrological environment will be severely affected by the proposed development. Appropriate tree management in this situation would be the removal and replacement of the tree in a more suitable species and location as part of the landscape plan for the site

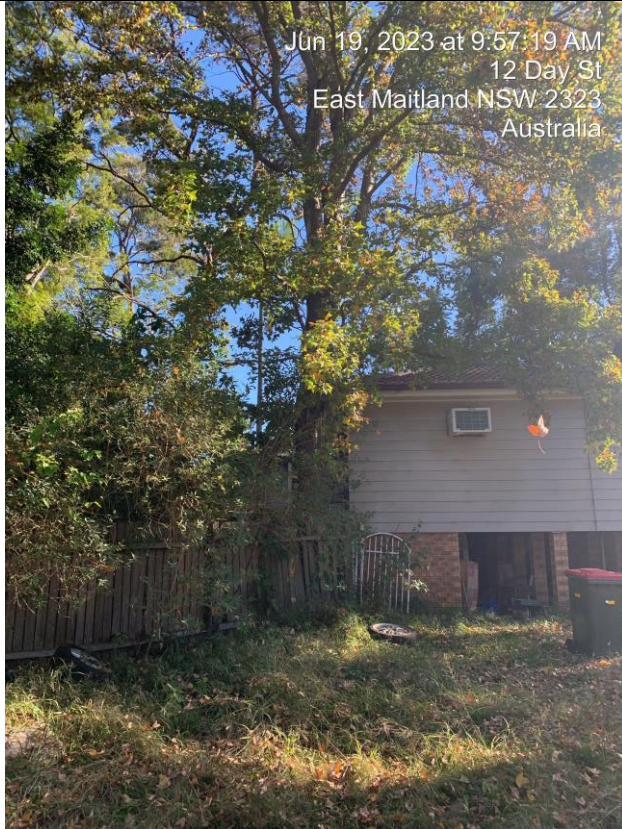
Tree 21
*Liquidambar
styraciflua*
Liquidamber

- 5.41 **Tree 21** (*Liquidambar styraciflua* Liquidambar) is a tree in fair condition Appendix 1 gives a description of the trees as per AS-4970-2009 Section 2. Appendix 4 gives the location of the tree on the property.

environment will be severely affected by the proposed development. Appropriate tree management in this situation would be the removal and replacement of the tree in a more suitable species and location as part of the landscape plan for the site

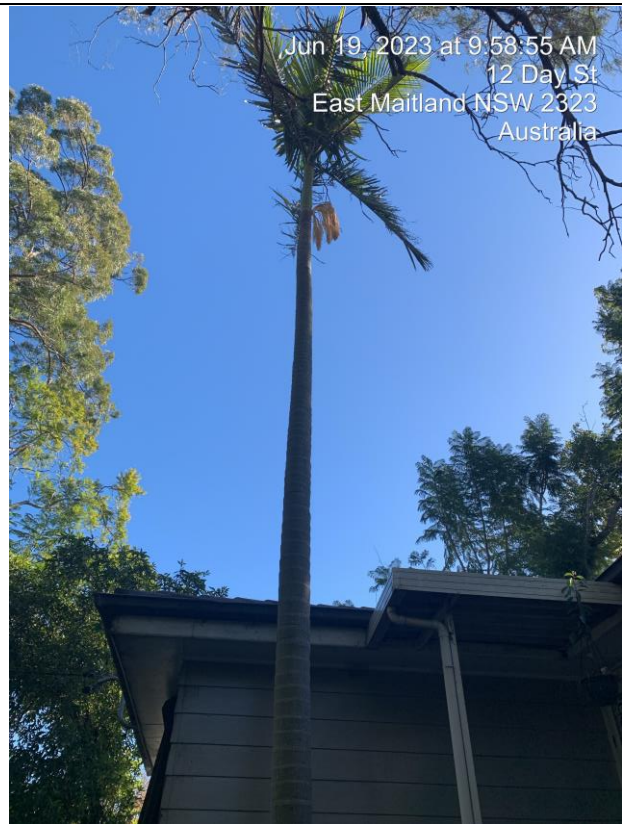
Tree 22
*Archontophoenix
Cunninghamiana*
Bangalow Palm

- 5.43 **Tree 22** (*Archontophoenix cunninghamiana* Bangalow Palm) is a tree in fair condition Appendix 1 gives a description of the trees as per AS-4970-2009 Section 2. Appendix 4 gives the location of the tree on the property.

- 5.44 The tree will be affected by the proposed development (See Appendix 6 Construction Impact Statement). The trees soil environment and hydrological environment will be severely affected by the proposed development. Appropriate tree management in this situation would be the removal and replacement of the tree in a more suitable species and location as part of the landscape plan for the site

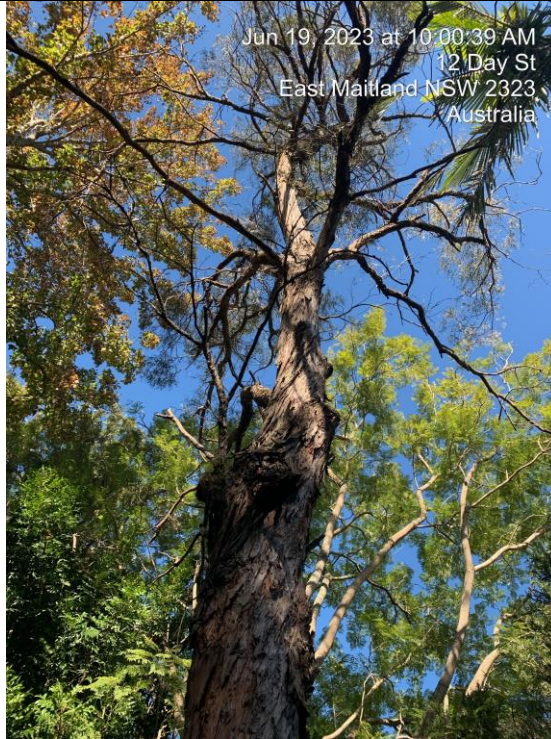
Tree 23
*Eucalyptus
nicholii*
Small Leaved
Peppermint

- 5.45 **Tree 23** (*Eucalyptus nicholii* Small Leaved Peppermint) is a tree in fair condition Appendix 1 gives a description of the trees as per AS-4970-2009 Section 2. Appendix 4 gives the location of the tree on the property.

- 5.46 The tree will be affected by the proposed development (See Appendix 6 Construction Impact Statement). The trees soil environment and hydrological environment will be severely affected by the proposed development. Appropriate tree management in this situation would be the removal and replacement of the tree in a more suitable species and location as part of the landscape plan for the site

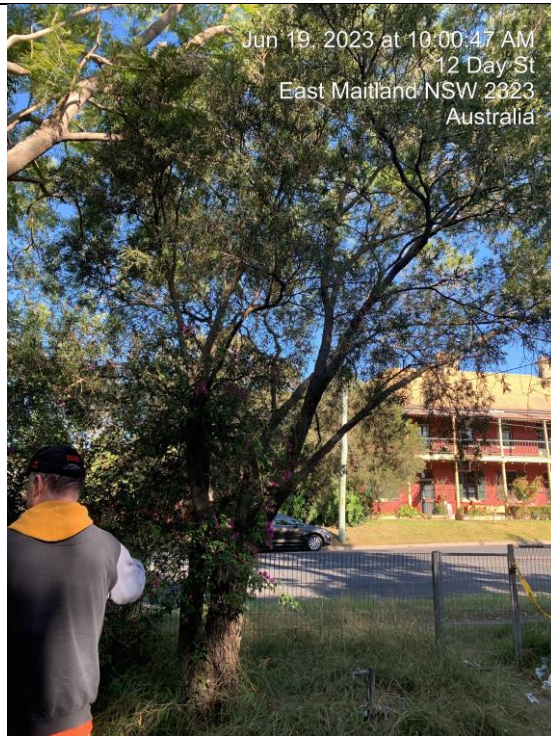
Tree 24
*Callistemon
viminalis*
Weeping
Bottlebrush

- 5.47 **Tree 24** (*Callistemon viminalis* Weeping Bottlebrush) is a tree in fair condition Appendix 1 gives a description of the trees as per AS-4970-2009 Section 2. Appendix 4 gives the location of the tree on the property.

- 5.48 The tree will be affected by the proposed development (See Appendix 6 Construction Impact Statement). The trees soil environment and hydrological environment will be severely affected by the proposed development. Appropriate tree management in this situation would be the removal and replacement of the tree in a more suitable species and location as part of the landscape plan for the site

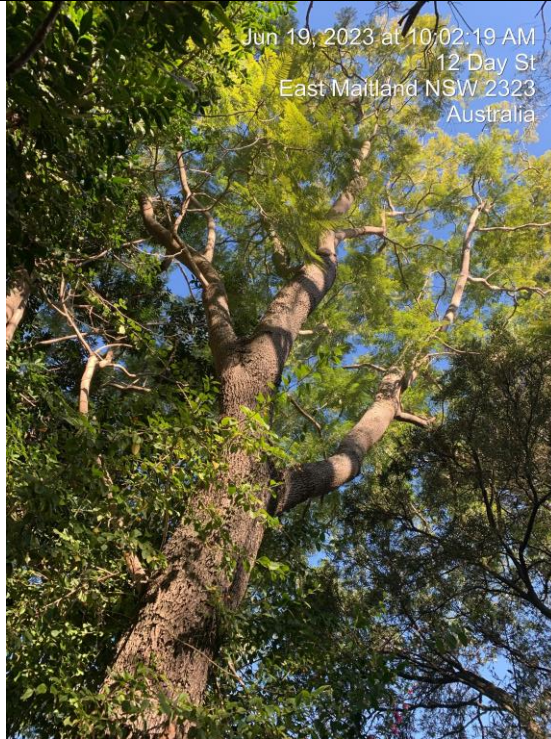
Tree 25
Jacaranda
mimosifolia
Jacaranda

- 5.49 **Tree 25** (*Jacaranda mimosifolia* Jacaranda) is a tree in fair condition Appendix 1 gives a description of the trees as per AS-4970-2009 Section 2. Appendix 4 gives the location of the tree on the property.

- 5.50 The tree will be affected by the proposed development (See Appendix 6 Construction Impact Statement). The trees soil environment and hydrological environment will be severely affected by the proposed development. Appropriate tree management in this situation would be the removal and replacement of the tree in a more suitable species and location as part of the landscape plan for the site

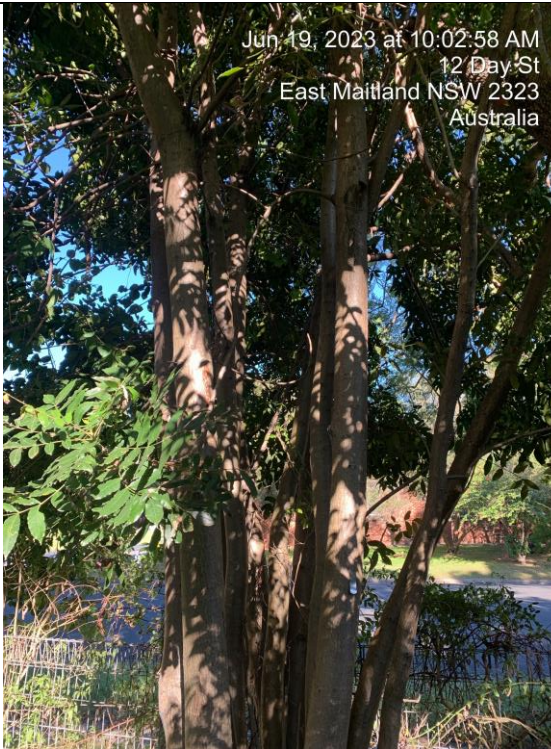
Tree 26
Harpephyllum
Caffrum
Kaffir Plum

- 5.51 **Tree 26** (*Harpephyllum caffrum* Kaffir Plum) is a tree in fair condition Appendix 1 gives a description of the trees as per AS-4970-2009 Section 2. Appendix 4 gives the location of the tree on the property.
