ARBORIST'S REPORT

PROPERTY OF THE PROPOSED DEVELOPMENT:	22 Eurimbla Street, Thornton
TREES TO BE REMOVED:	All Trees
DATE OF REPORT:	19 June 2023
REQUESTED BY:	Advantage Building Design

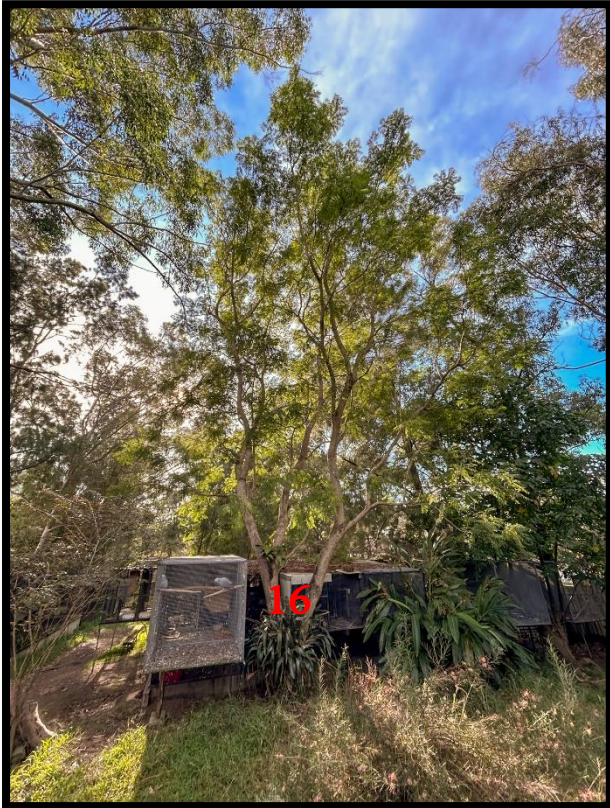
Tree 16.

15	<i>Brachychiton acerifolia</i> (Illawarra Flame Tree)	6	Good	Good	180	2.2	1.7	2B	4 x 4	Good condition.
16	<i>Jacaranda mimosifolia</i> (Jacaranda)	10	Good	Fair (form)	350	4.2	2.2	2B	6 x 5	Generally good condition. Co – dominant stems from 3 metres high (stem union stable).
17	<i>Casuarina cunninghamiana</i> (River Oak)	10	Good	Good	360	4.3	2.2	2B	6 x 6	Good condition.

Based on the observations made during the inspection, information supplied and the considerations in the conclusion, it is recommended that all trees on the site be removed for the development.

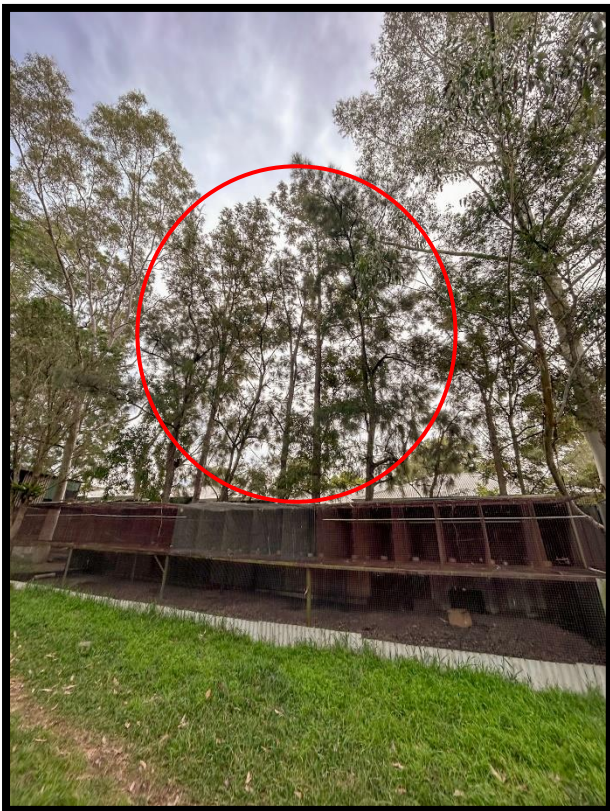
Group 1.

Groups 1 & 2 consist mostly of *Casuarina cunninghamiana* to 8 metres high, lined along the respective boundaries.

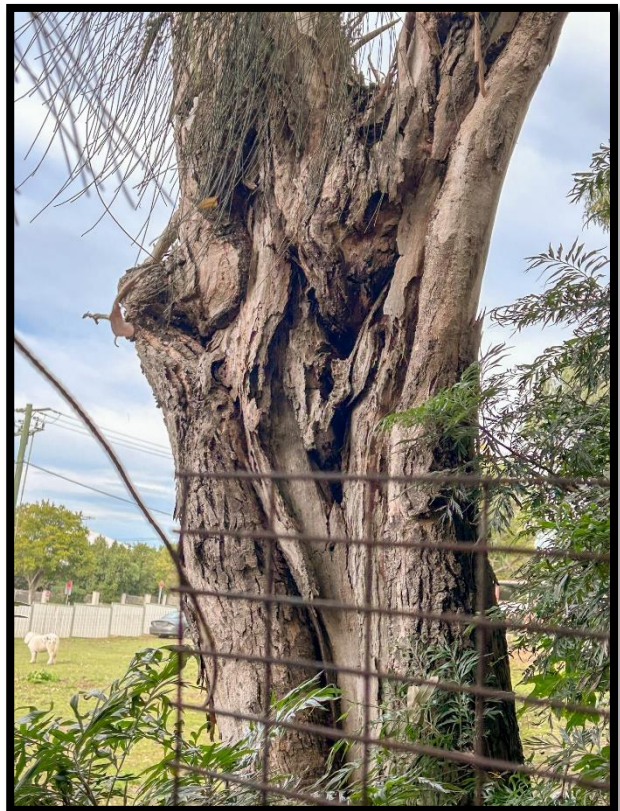
The neighbouring property (24 Eurimbla Street) was not entered, and some trees are adjacent to the fence. Only one of these could be seen from within the subject property (towards the rear), and this is a specimen of *Eucalyptus* sp., approximately 12 metres high.

This tree has severe decay in the trunk, and will require removal for the development. The trees toward the front of the property are smaller, and may be affected by the development. These trees were not able to be approached for identification.

Decay in the trunk of the larger neighbouring tree.

Further recommended is the removal of the Eucalypt toward the rear of 24 Eurimbla Street.
