Report on
Hazardous Building Materials Survey

Block B, Maitland Christian College
75-81 Chelmsford Drive, Metford

Prepared for
Paynter Dixon Constructions Pty Ltd

Project 102070.02
February 2023

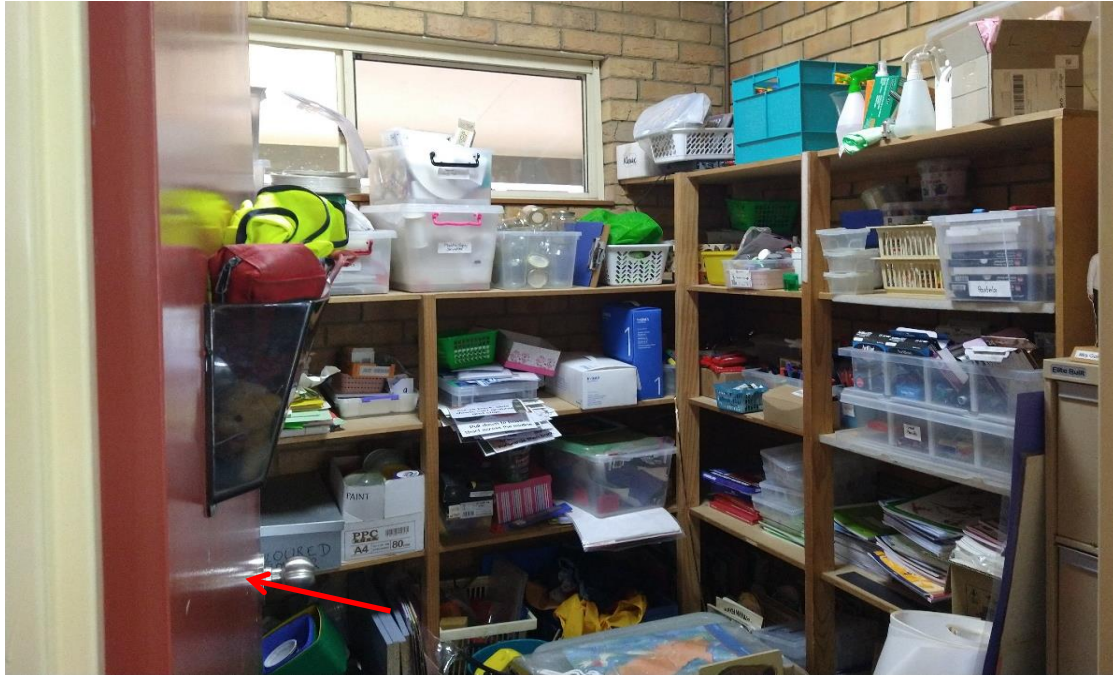
Photograph 1: Block B, B1 - interior, internal door, red, grey, blue layered paint, non-lead paint ($\leq 0.1\%$ lead w/w)

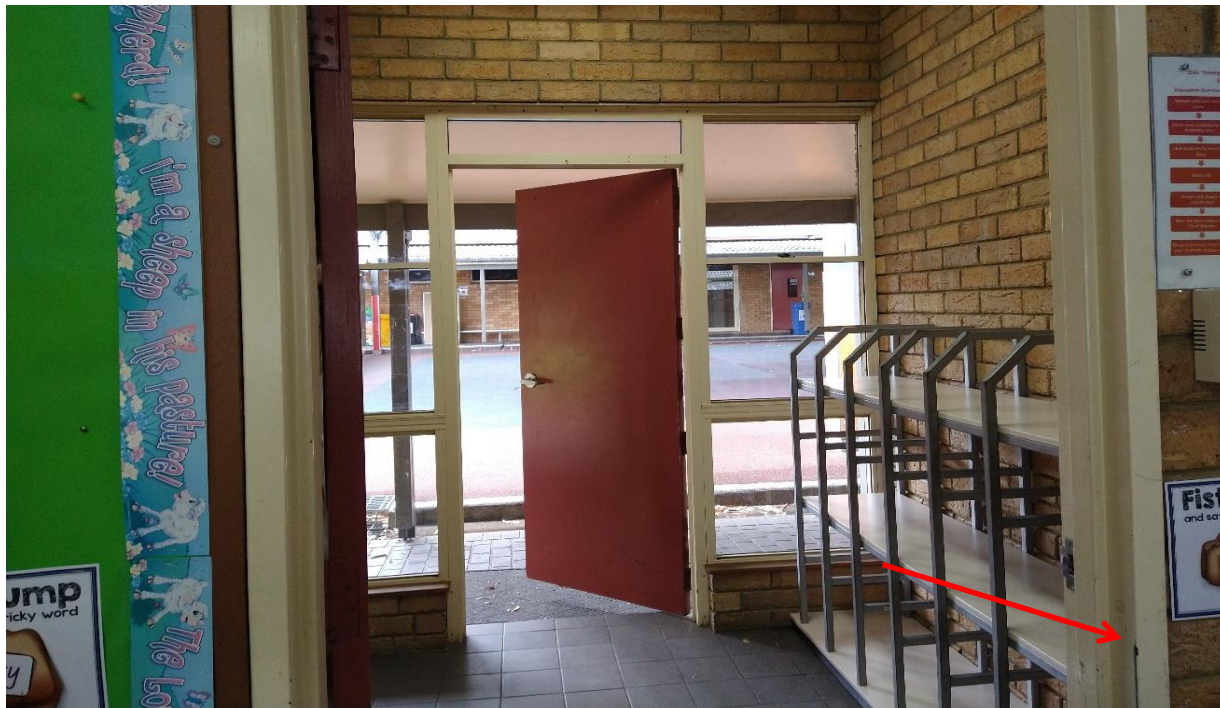
Photograph 2: Block B, B1 - interior, internal door frame, cream paint, non-lead paint ($\leq 0.1\%$ lead w/w)

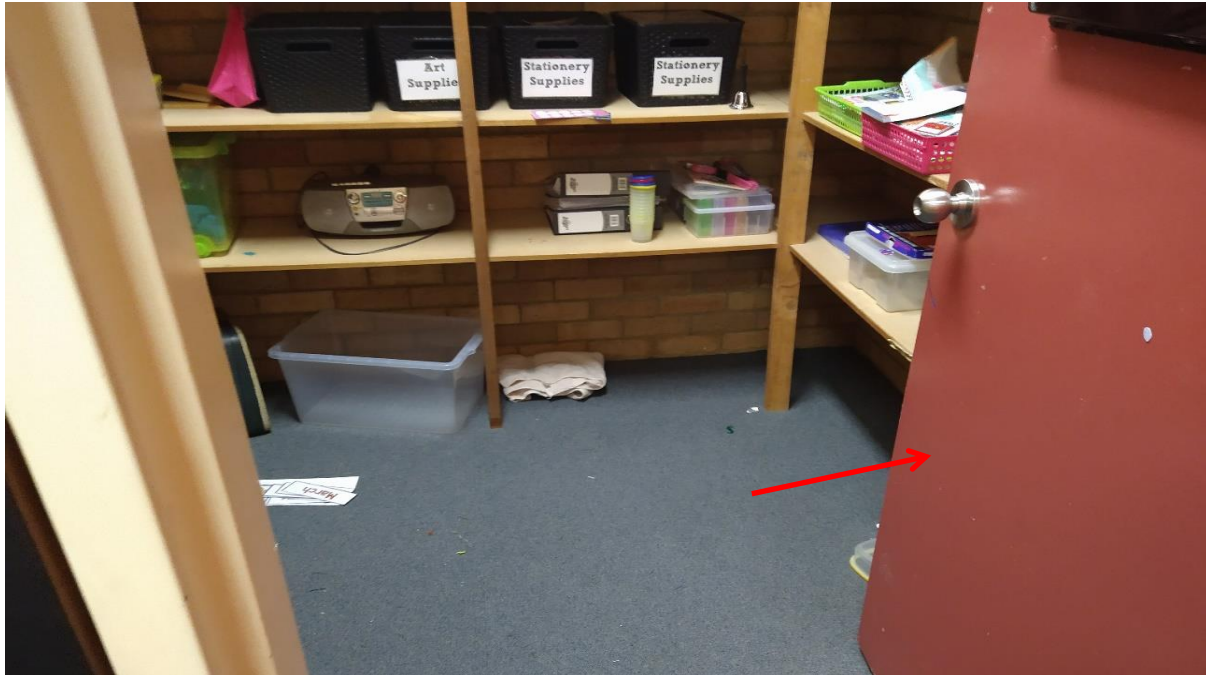
Photograph 3: Block B, B4 - interior, internal door, red, grey, blue layered paint, non-lead paint ($\leq 0.1\%$ lead w/w)

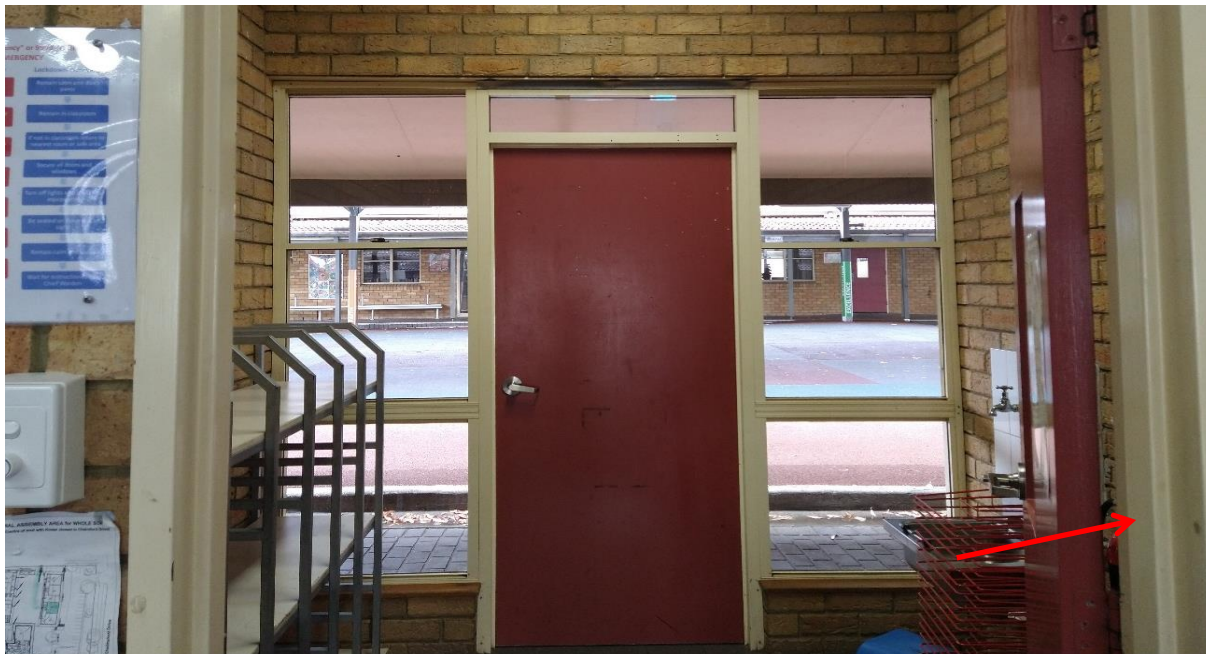
Photograph 4: Block B, B4 - interior, internal door frame, cream paint, non-lead paint ($\leq 0.1\%$ lead w/w)

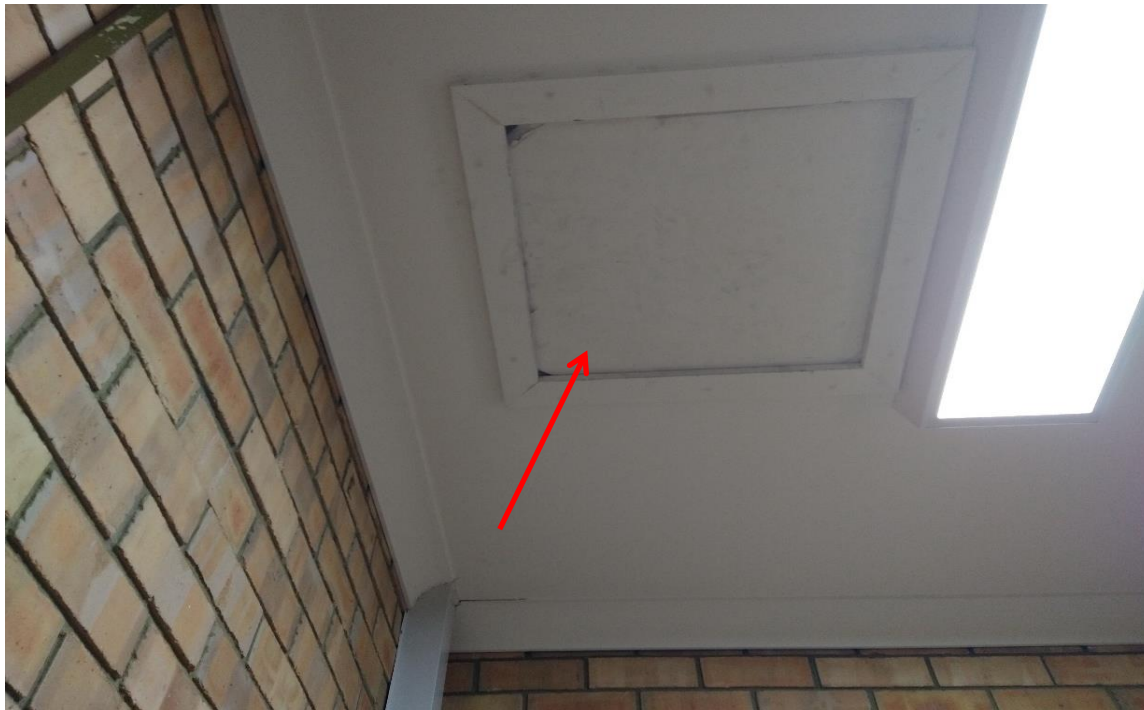
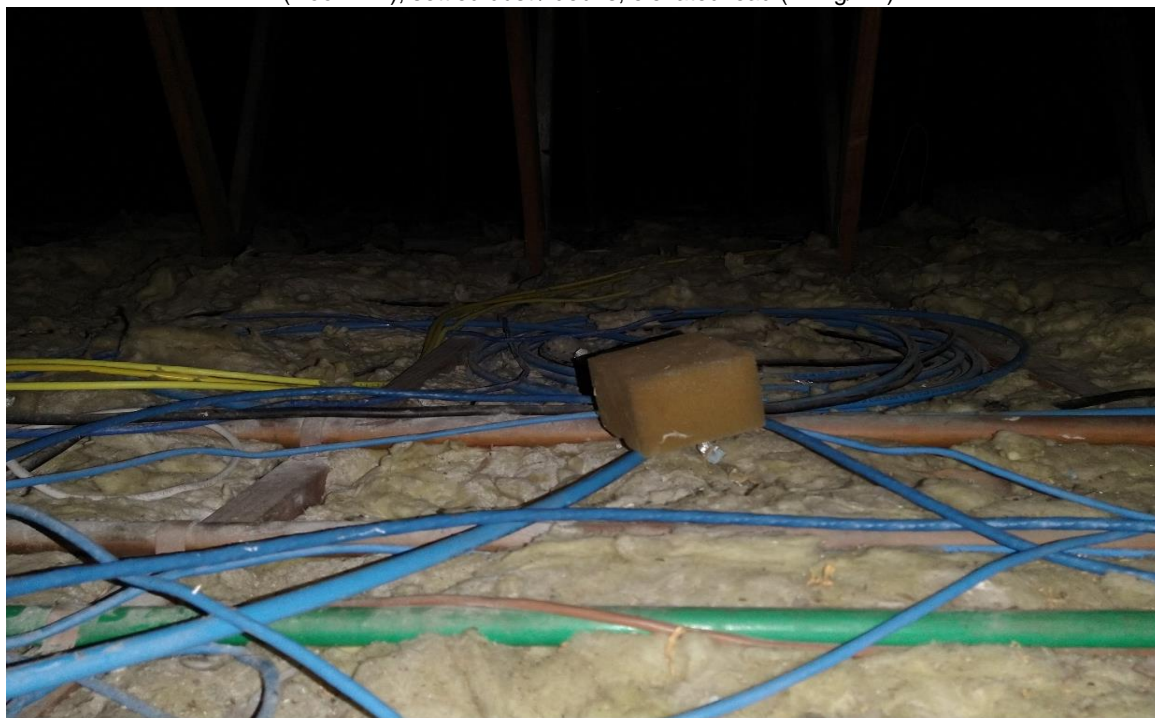
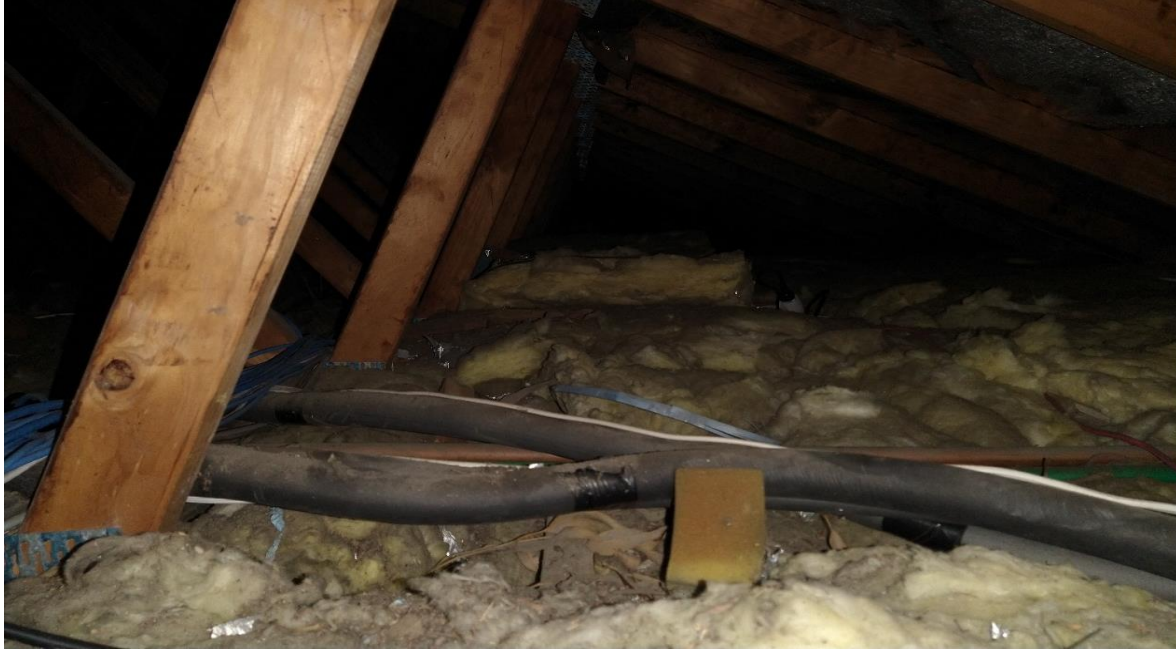
Block B	B2 - interior	ceiling / roof space (Room B2)	settled dust / debris	S5	elevated lead (11mg/m ²)	N/A	N/A	N/A	N/A	N/A	N/A	N/A	N/A	5, 6, 7	<p>Elevated lead concentration detected.</p> <p>Ensure access to building cavity(s) is adequately restricted and entry is only made under controlled conditions.</p> <p>Remove lead contamination if reasonably practicable to do so and prior to any substantive disturbance.</p> <p>Classify material for disposal, if and when required, in accordance with relevant legislative requirements, and NSW EPA Waste Classification Guidelines, and segregate material for disposal if necessary.</p> <p>Implement appropriate controls to prevent exposure and dispersal including during normal occupation and any building work (e.g. maintenance, refurbishment and demolition).</p>									
Block B	exterior	external door and window frames and lintels	cream paint	S6	lead paint (>0.1% lead w/w)	N/A	N/A	N/A	N/A	N/A	N/A	N/A	N/A	8	<p>Lead paint identified. Analysis results are above the threshold concentration criteria for lead paint as outlined in AS4361.2.</p> <p>Any areas of damaged/flaking paint and any associated dust/debris should be removed.</p> <p>Classify material for disposal, if and when required, in accordance with relevant legislation and the NSW EPA Waste Classification Guidelines. Segregate material, if required, for disposal.</p> <p>Minimise disturbance and implement controls to prevent exposure and dispersal during any lead paint abatement activity and any building work (e.g. maintenance, refurbishment and demolition).</p>

Photograph 5: Block B, B2 - interior, ceiling / roof space
(Room B2), settled dust / debris, elevated lead (11mg/m2)

Photograph 6: Block B, B2 - interior, ceiling / roof space
(Room B2), settled dust / debris, elevated lead (11mg/m2)

Photograph 7: Block B, B2 - interior, ceiling / roof space
(Room B2), settled dust / debris, elevated lead (11mg/m2)

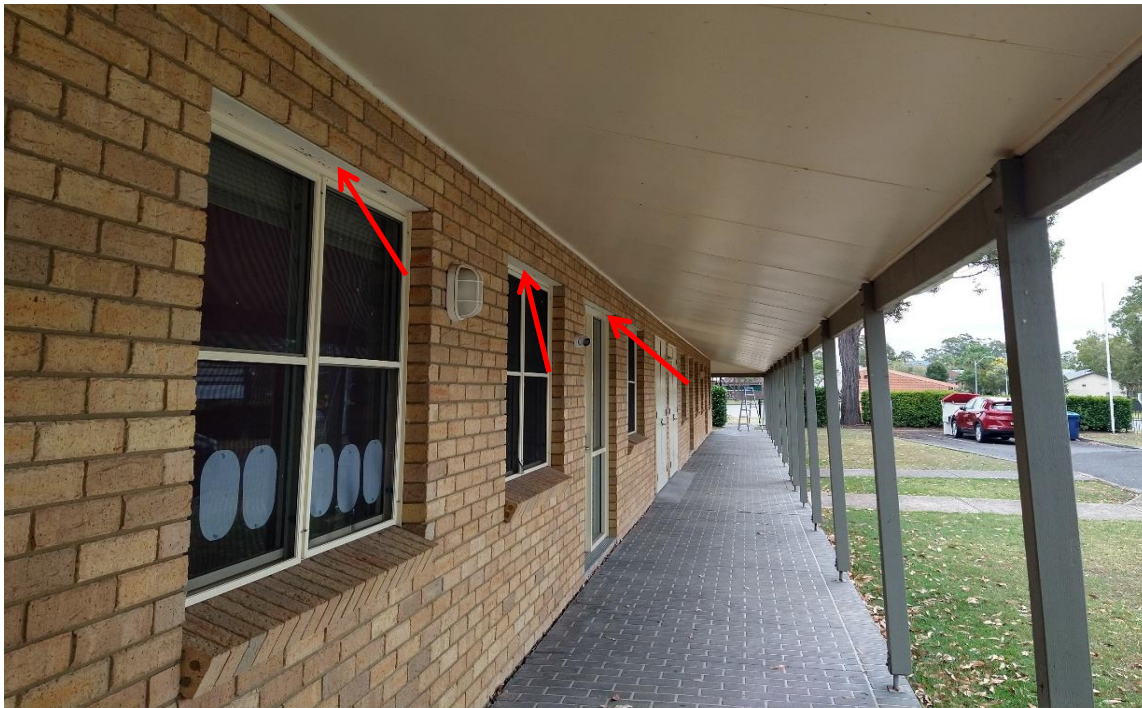
Photograph 8: Block B, exterior, external door and window frames and lintels, cream paint,
lead paint (>0.1% lead w/w)

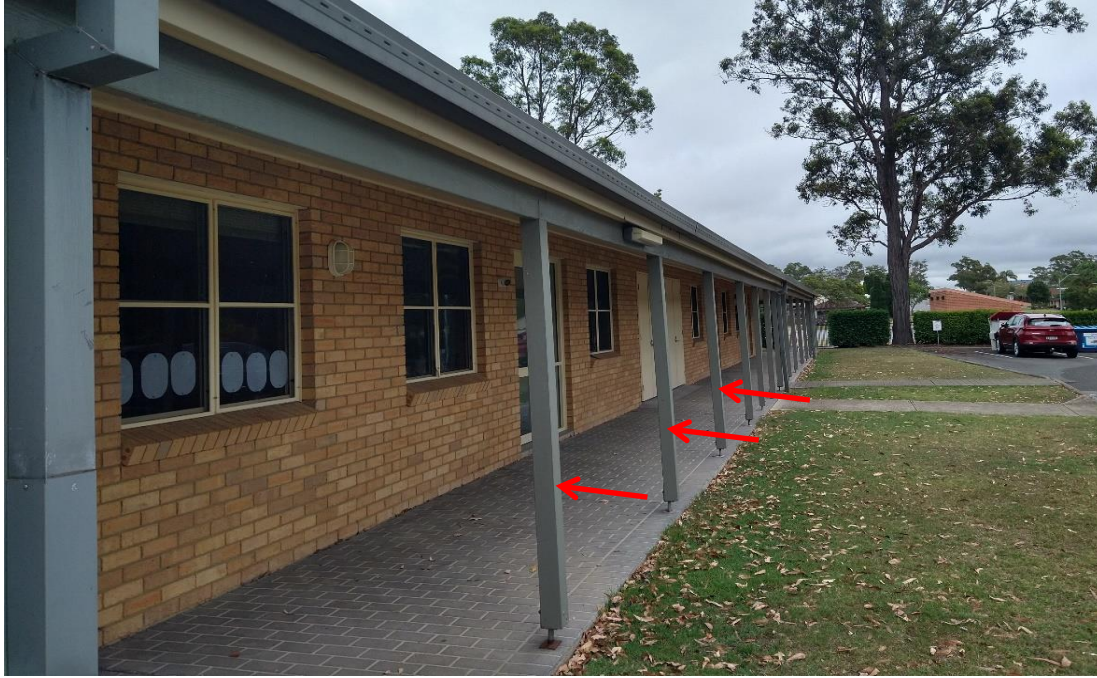
Block B	exterior	awning posts and beams	green paint	S7	non-lead paint (≤0.1% lead w/w)	N/A	N/A	N/A	N/A	N/A	N/A	N/A	N/A	9	No hazardous material identified.									
Block B	throughout	surfaces in general	paint(s)	refer S6	may comprise lead paints	N/A	N/A	N/A	N/A	N/A	N/A	N/A	N/A	refer 6	<p>Lead paint(s) identified in building. Consider further assessment of paints for lead prior to any disturbance. Any areas of damaged / flaking lead paint, and any associated dust / debris, should be removed and consideration given to further control (e.g. stabilisation / sealing) of remaining paint(s).</p> <p>Classify material for disposal, if / when required, in accordance with legislative requirements and the NSW EPA Waste Classification Guidelines. Segregate material for disposal if necessary.</p> <p>Minimise disturbance of lead paint and implement controls to prevent exposure and dispersal during normal site operations and any lead paint abatement activity or building work (e.g. maintenance, refurbishment and demolition).</p>

Photograph 9: Block B, exterior, awning posts and beams, green paint, non-lead paint (≤0.1% lead w/w)

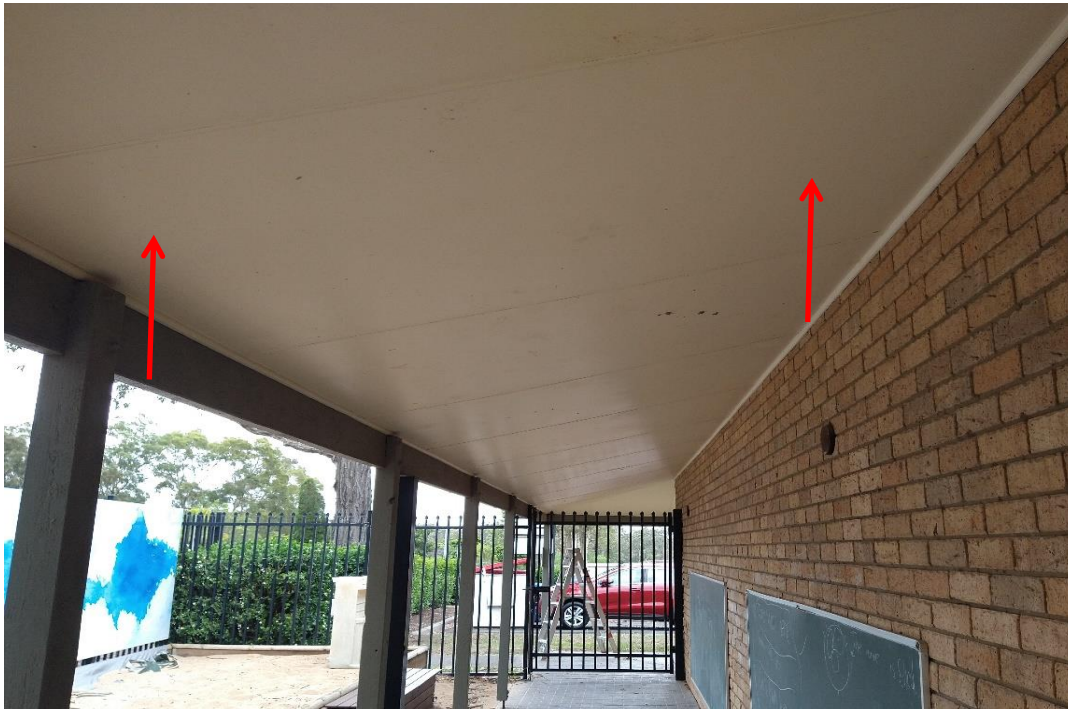
Block B	exterior	awning lining	fibro sheeting	S8	no asbestos detected by analysis	N/A	N/A	N/A	N/A	N/A	N/A	N/A	N/A	10	No hazardous material identified.									
Block B	exterior	eave lining	fibro sheeting	refer S8	suspected non-asbestos	N/A	N/A	N/A	N/A	N/A	N/A	N/A	N/A	11	Suspected non-asbestos. Confirm status of hazardous material(s) when safe access available and prior to any disturbance.									
Block B	interior	ceilings throughout all of Block B	fluorescent light fittings	-	Nil PCB (suspected)	N/A	N/A	N/A	N/A	N/A	N/A	N/A	N/A	N/A	Nil PCB (suspected) - Confirm status of PCB when safe access available and prior to any disturbance.									
Block B	exterior	eaves/ awnings	fluorescent light fittings	-	PCB (suspected)	N/A	N/A	N/A	N/A	N/A	N/A	N/A	N/A	12	PCB (suspected) - Confirm status of PCB when safe access available. Avoid disturbance and reinspect condition on a regular basis. Manage and phase-out PCB-containing components in accordance with the ANZECC PCB Management Plan, April 2003 and NSW EPA PCB Chemical Control Order 1997.

Photograph 10: Block B, exterior, awning lining, fibro sheeting, no asbestos detected by analysis

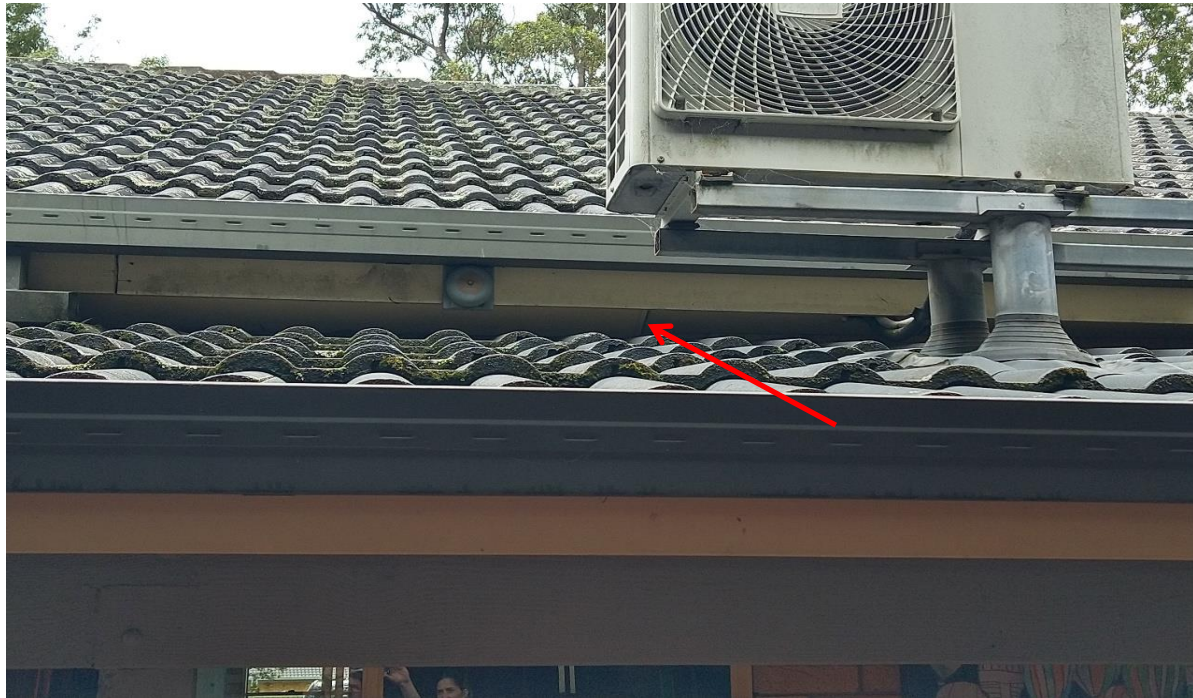
Photograph 11: Block B, exterior, eave lining, fibro sheeting, suspected non-asbestos

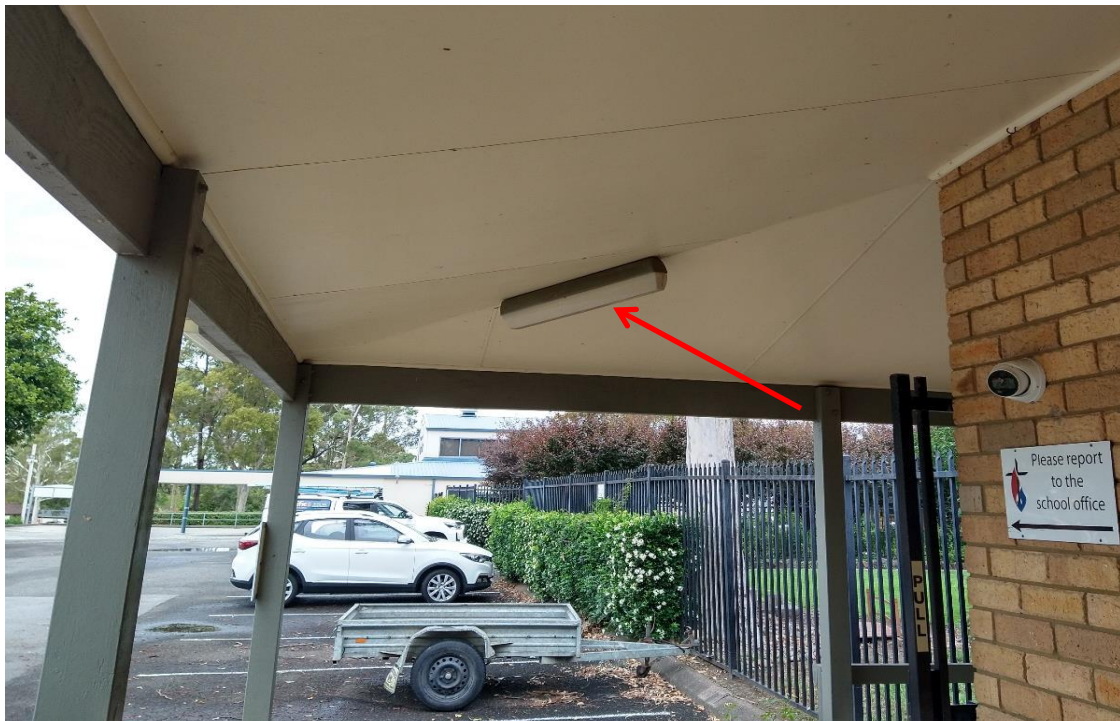
Photograph 12: Block B, exterior, eaves/ awnings, fluorescent light fittings, PCB (suspected)

Any PCB containing capacitors that exhibit leakage should be removed and replaced by a suitably qualified and experienced contractor as soon as possible. Access to areas containing leaking capacitors should be suitably restricted.

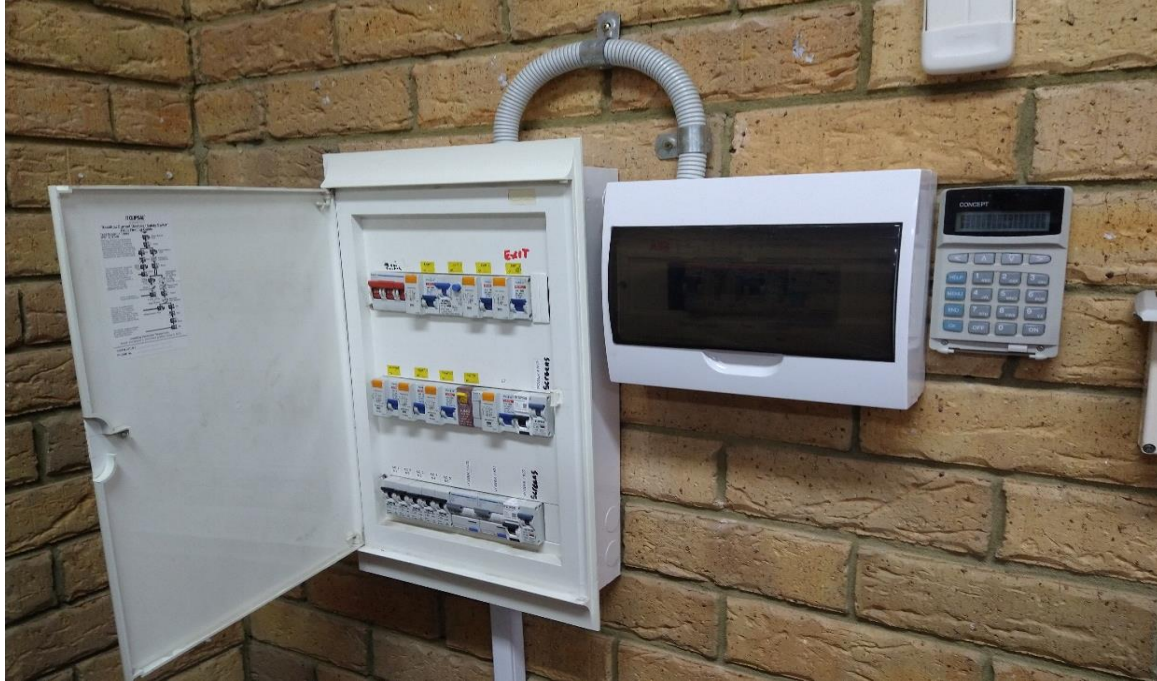
Photograph 13: Block B, B3 - interior, electrical distribution board, plastic backing board, nil asbestos

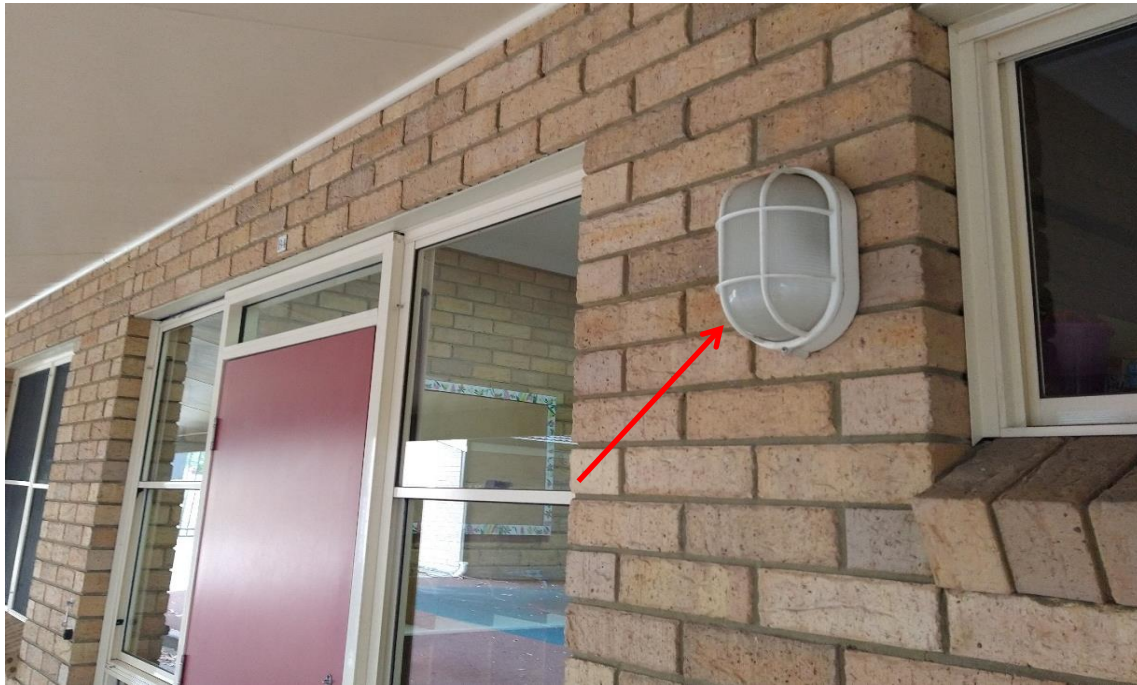
Photograph 14: Block B, exterior, eaves/ awnings, fluorescent light fittings, PCB (suspected)

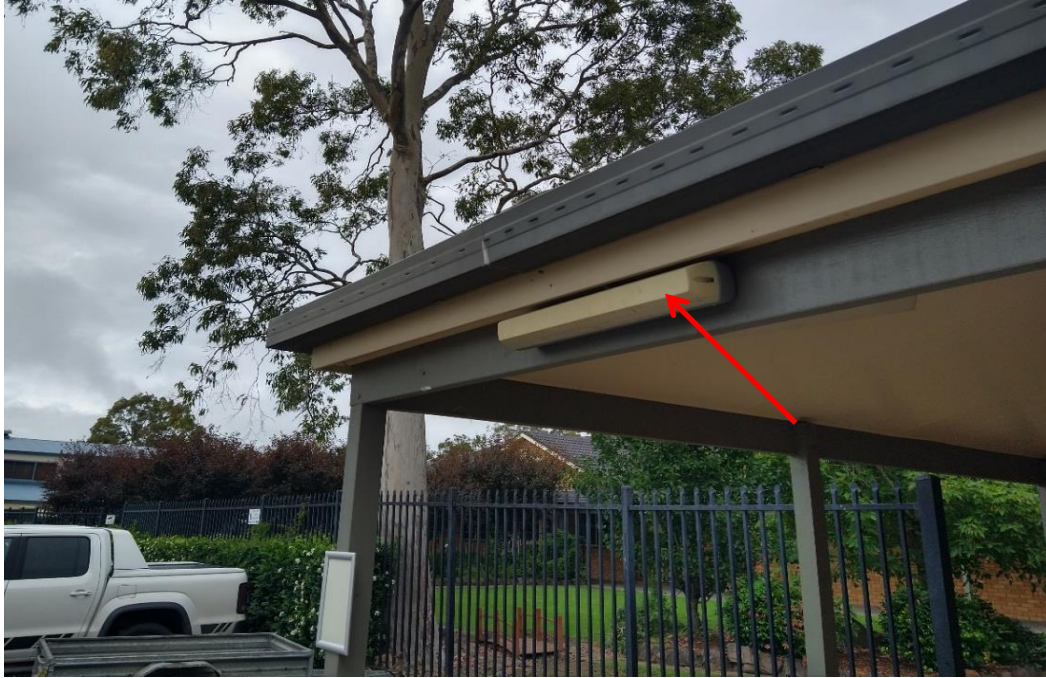
Photograph 15: Block B, exterior, eaves/ awnings, fluorescent light fittings, PCB (suspected)

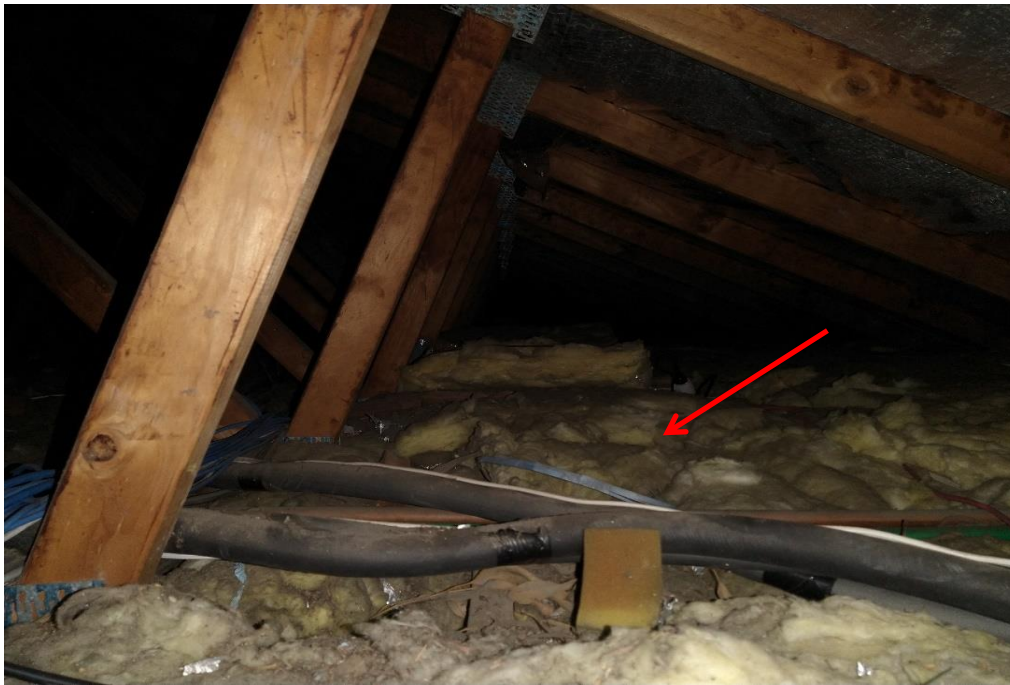
Photograph 16: Block B, interior, ceiling / roof space, insulation, SMF identified visually

SMF materials may generally remain in place providing that they are in good condition and unlikely to be disturbed.

To reduce the potential for disturbance, exposure and environmental contamination SMF materials may be encapsulated or enclosed. Higher risk materials, such as loose fill insulation, may also be removed and replaced.
