RAW EARTH
ENVIRONMENTAL

Preliminary Site Investigation

63 Burg Street,
East Maitland,
NSW, 2323

January 2024

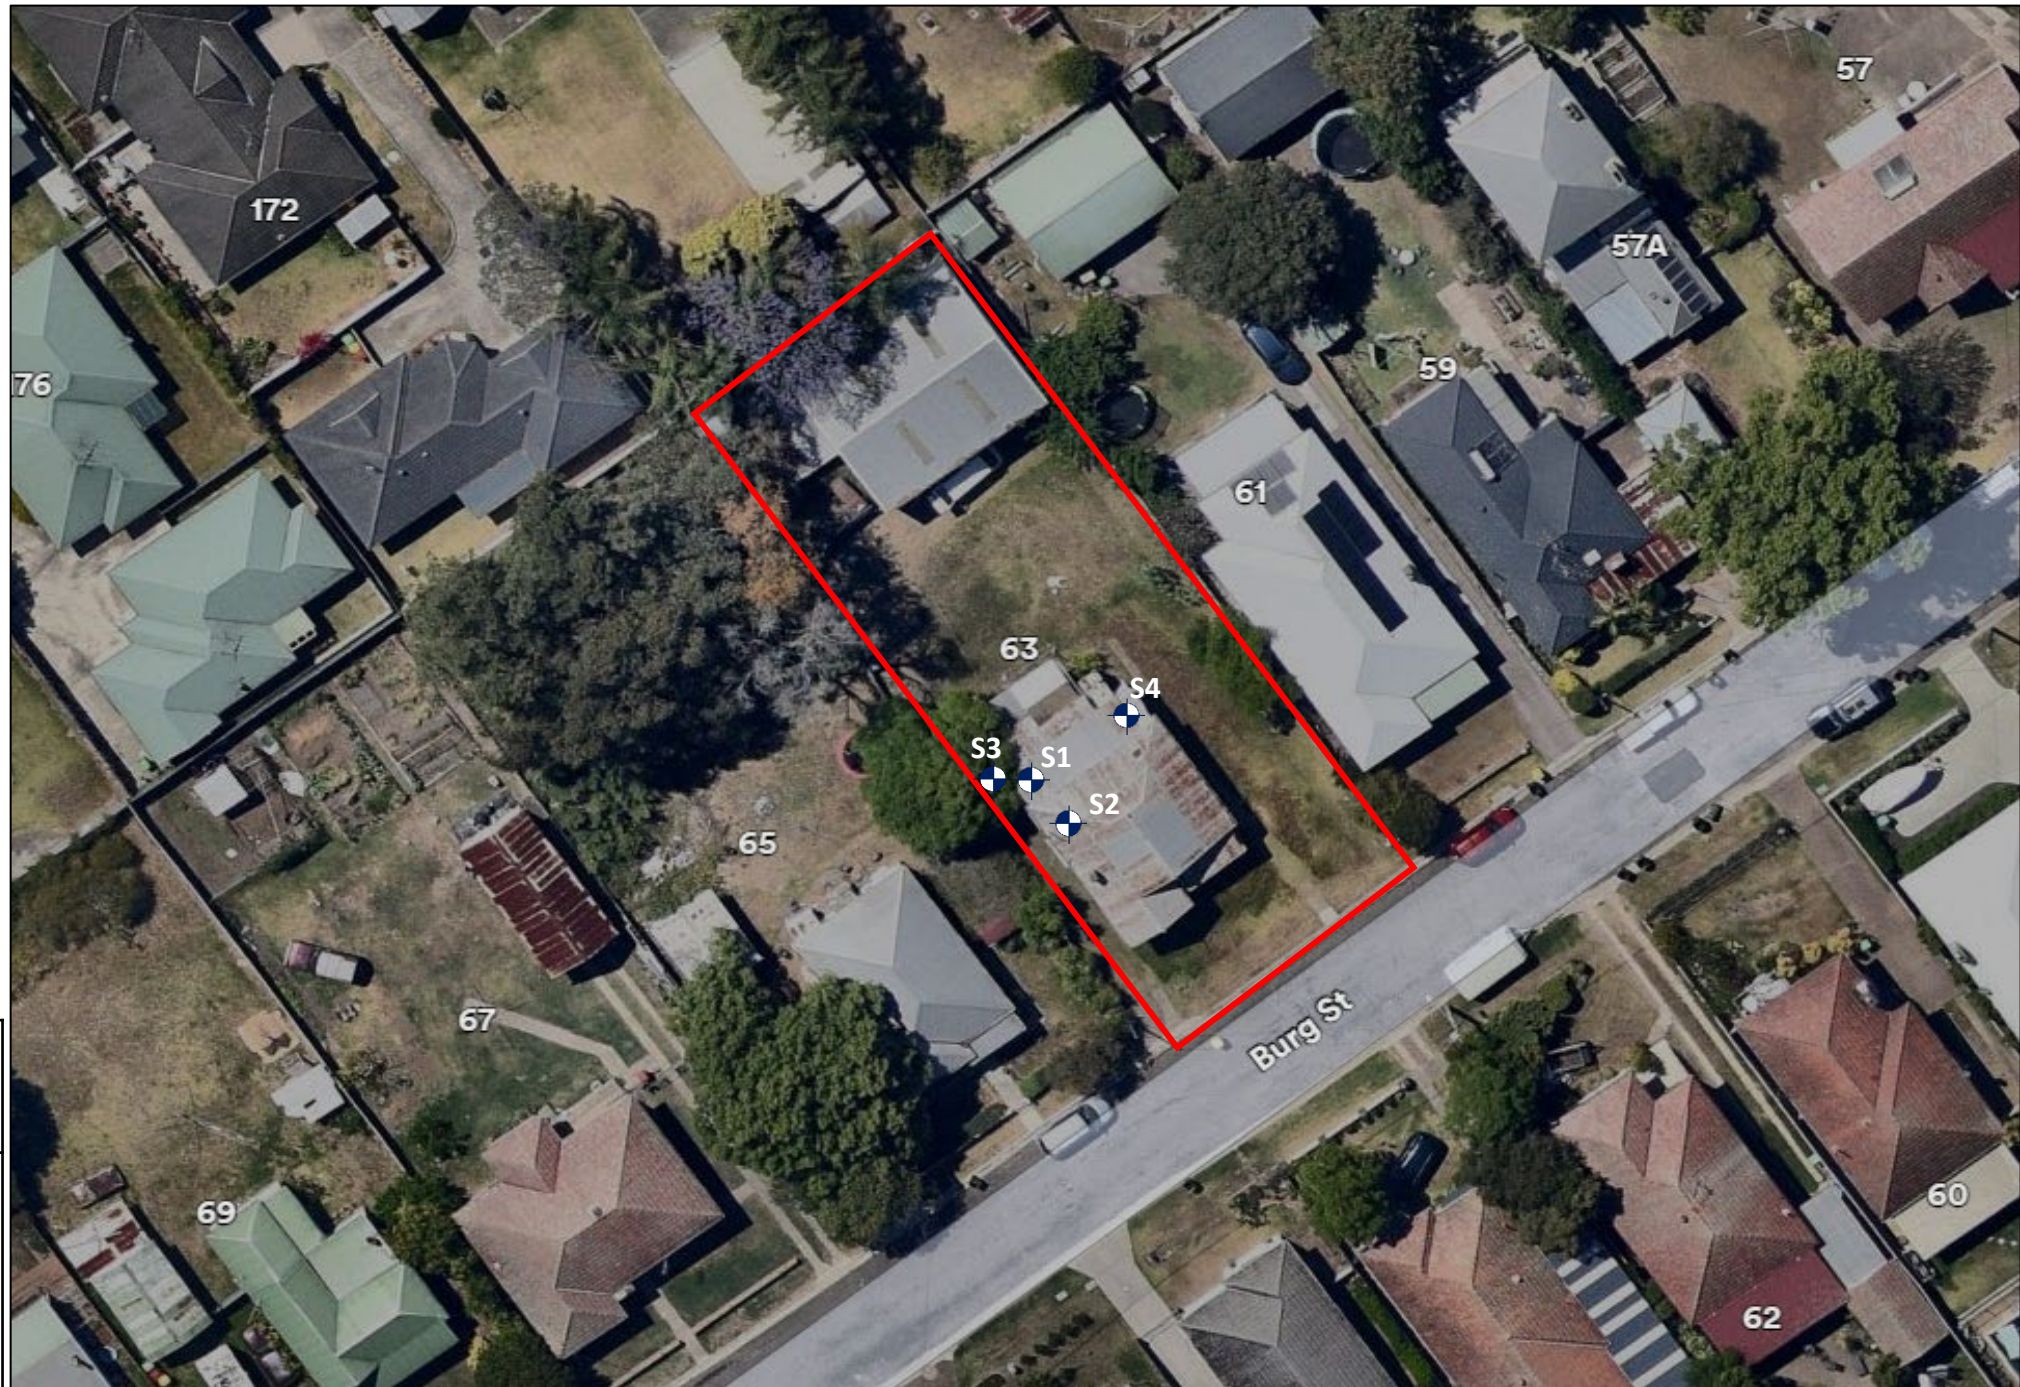
Figure 2b:
Sampling Locations

The samples were taken from various locations from the dwelling's subfloor and adjacent to the driveway. These locations can be seen in further detail in Figure 2b, **Appendix A**. The fragment samples were bonded in nature, ranged in size from 20mm to 200mm and showed low signs of weathering. In accordance with the NEPM (2013) and the *Guidelines for the Assessment, Remediation and Management of Asbestos Contaminated Sites in Western Australia, 2019-2024*, the fragments observed were greater than 7mm x 7mm and were not subject to crumbling by hand. As such, the asbestos has been characterised as bonded ACM, as opposed to Asbestos Fines (AF) or Friable Asbestos (FA).

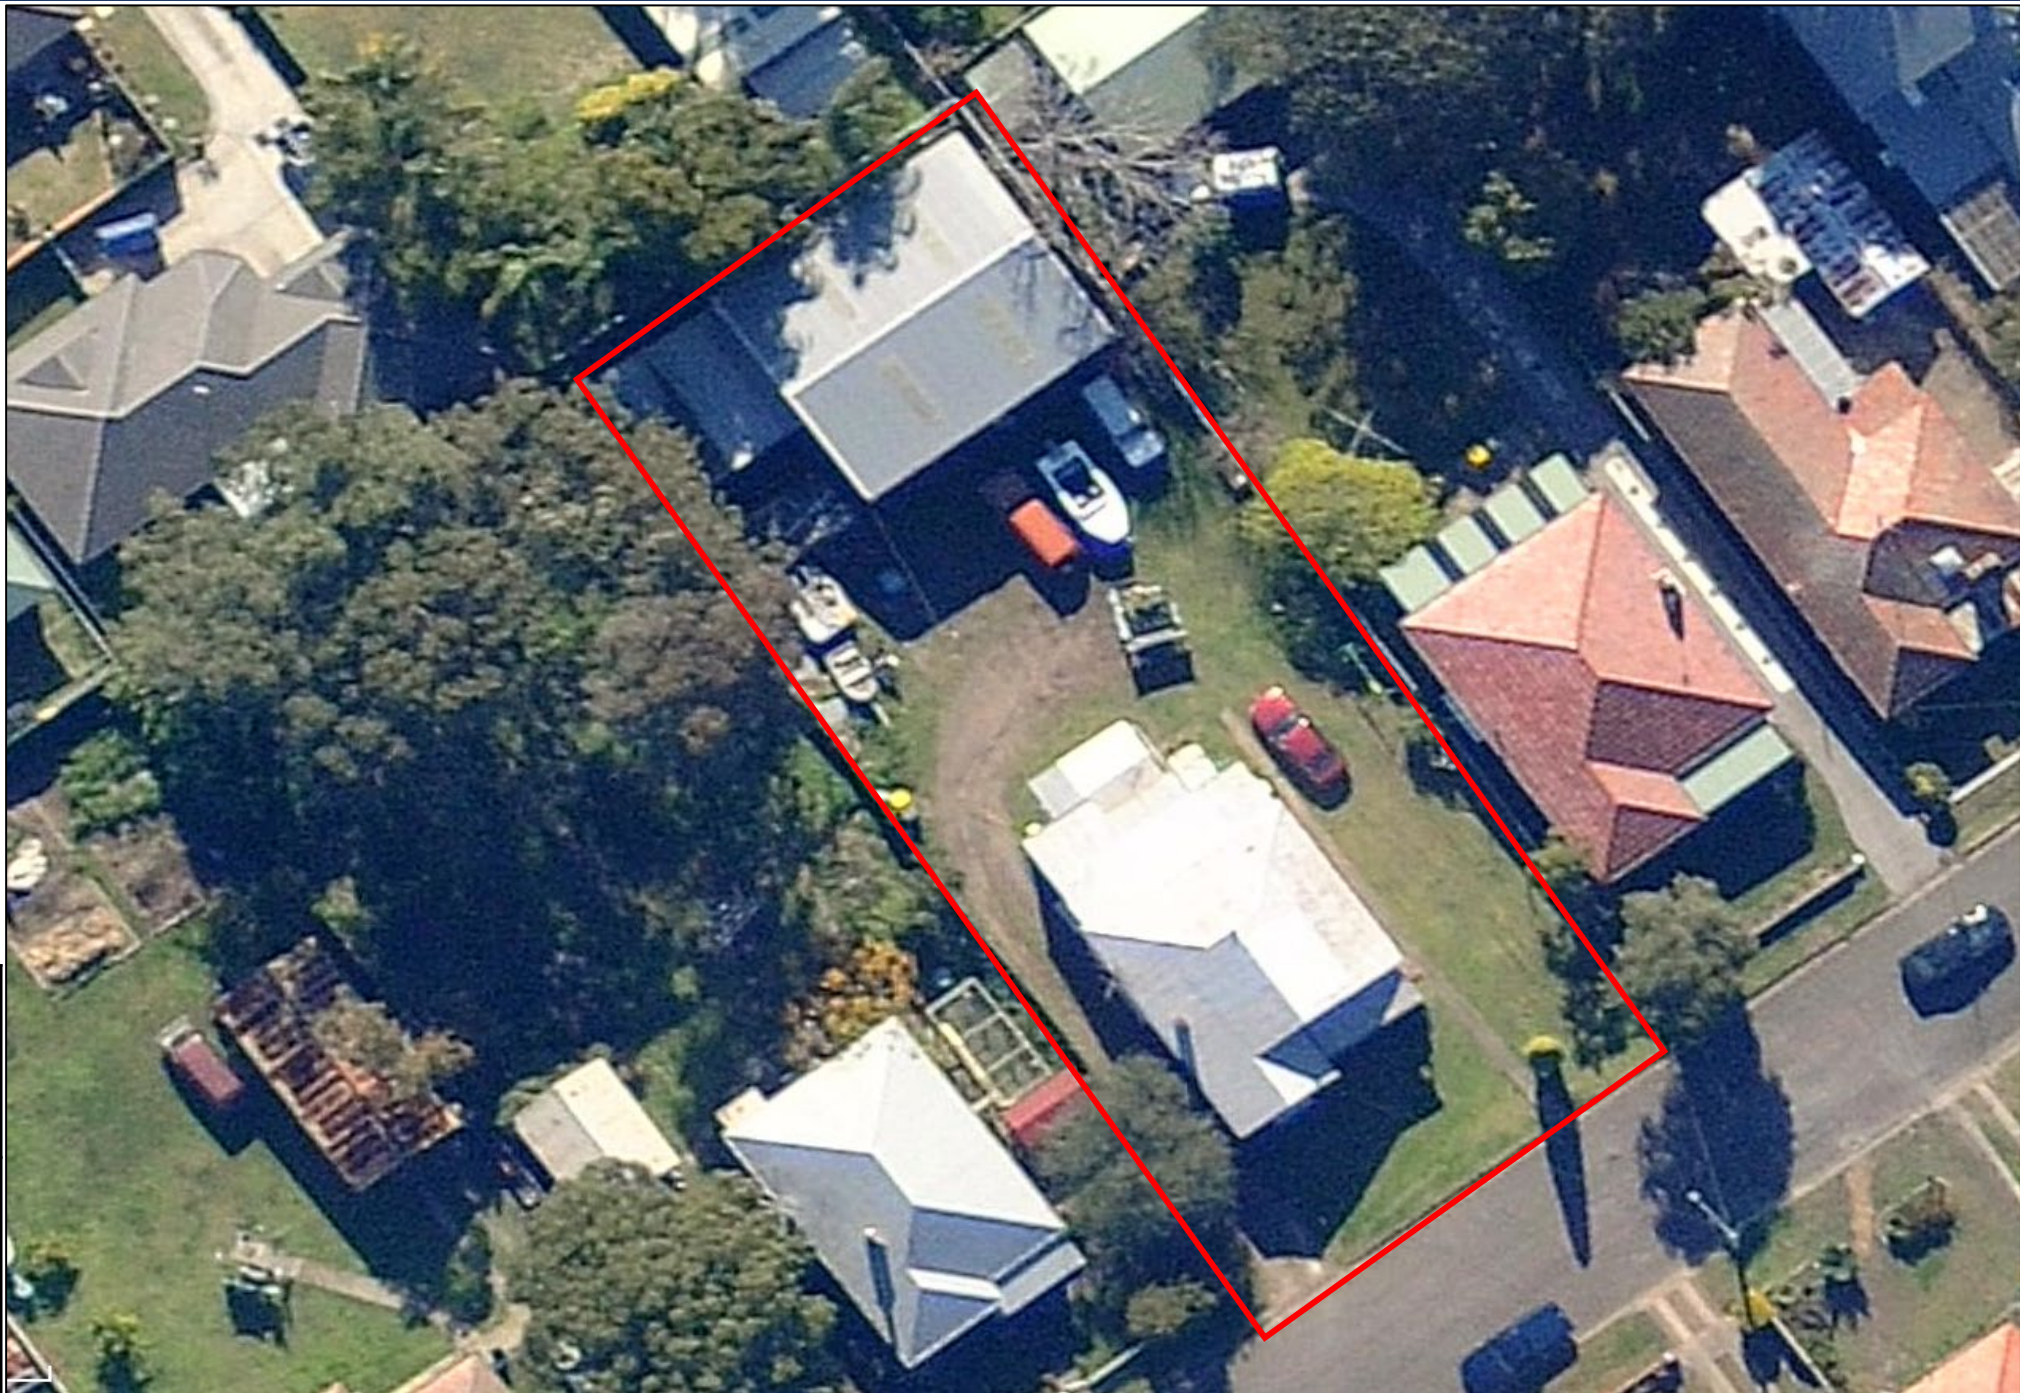
Figure 6a:
Historical Image of Vehicular
Storage Onsite
Jun 2011

Vehicular storage locations are often subject to hydrocarbon contamination due to the nature of having vehicles stored in a location for an extended period of time. During the storage, the components may leak oils and fuels into the surrounding area, which are absorbed by the soil and this leads to hydrocarbon contamination. During the site inspection, no odour or staining was noticed in the vehicular storage shed at the rear of the property or on the ground surface around, which can be seen in the photolog included in **Appendix B**. However, as can be seen in Figures 6a-6c, there is

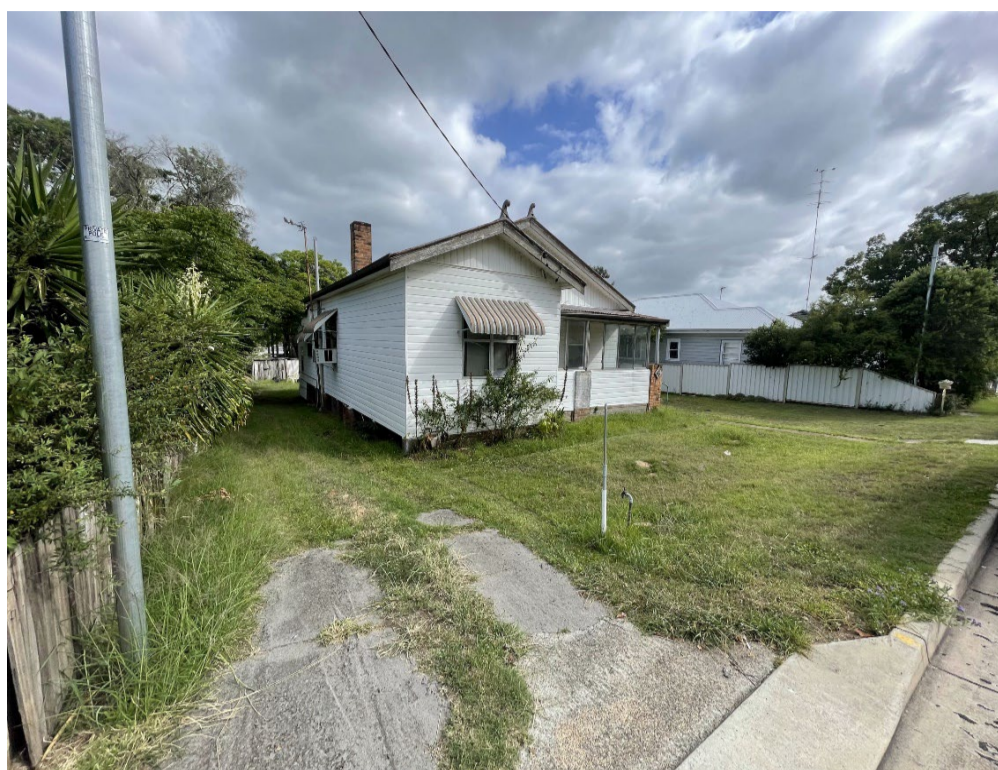
Photo 1: Overview of the property at 63 Burg St, East Maitland, looking north. No visual signs of stress or staining.

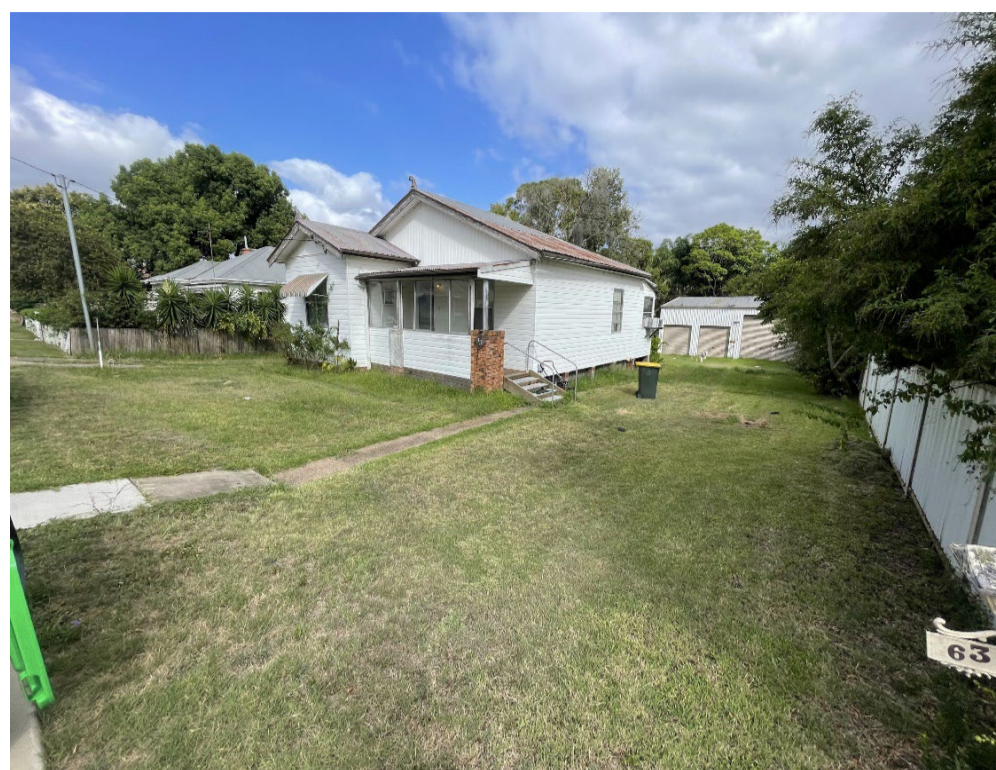
Photo 2: Overview of the front of the property, looking west. No visual signs of stress or staining.

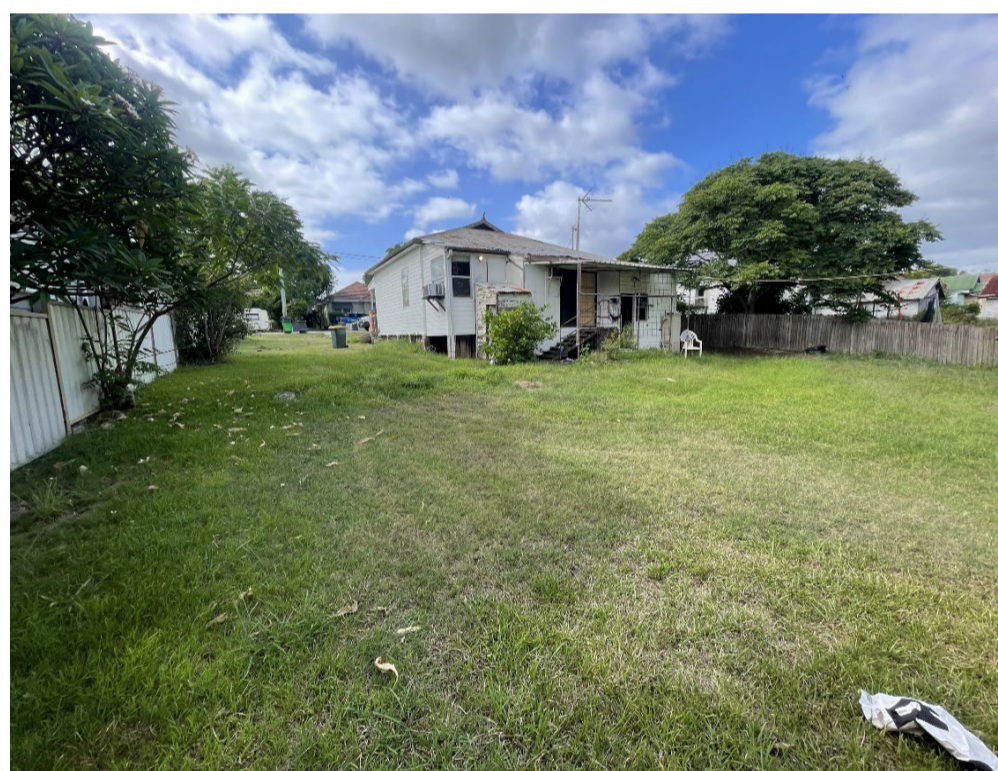
Photo 3: Overview of the backyard space at 63 Burg St, East Maitland, looking south. No visual signs of stress or staining.

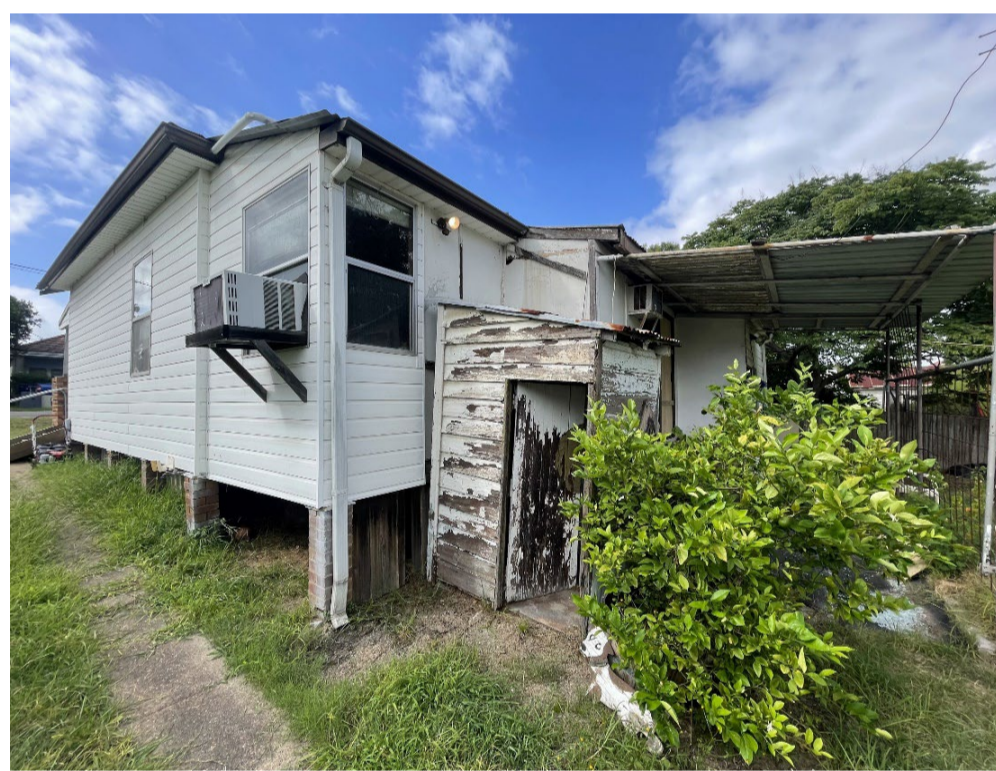
Hazardous building materials such as asbestos and lead-based paint have the potential to be situated within and around the building's footprint. When asbestos-containing material deteriorates or is disturbed, it can release particulates and fibres into the surrounding soil and air. These particles can cause localised contamination which persists for an extended amount of time within the surrounding environment, posing an ongoing risk to individuals and ecosystems, effecting receptors such as ecological flora and fauna, site users and future site workers. Lead dust can be created when lead-based paint is removed by sanding or heat, or when welding or cutting steel coated steel or when dismantling equipment containing lead-based paint. Soil contaminated with lead and asbestos has the capacity to impact human health through incidental ingestion or incidental inhalation.

Photo 4: This image shows a highly weathered outhouse-like structure present in the central portion of the site adjacent to the house. This structure as well as the houses fascia and eaves paint are all very weathered and be a potential source for lead based paint contamination in AEC 3.

- Based on the site inspection and desktop review, a pre-demolition HAZMAT Survey of the existing buildings and structures is recommended due to the age of the building/s and presence of asbestos containing debris underneath and footprint of the Main dwelling.

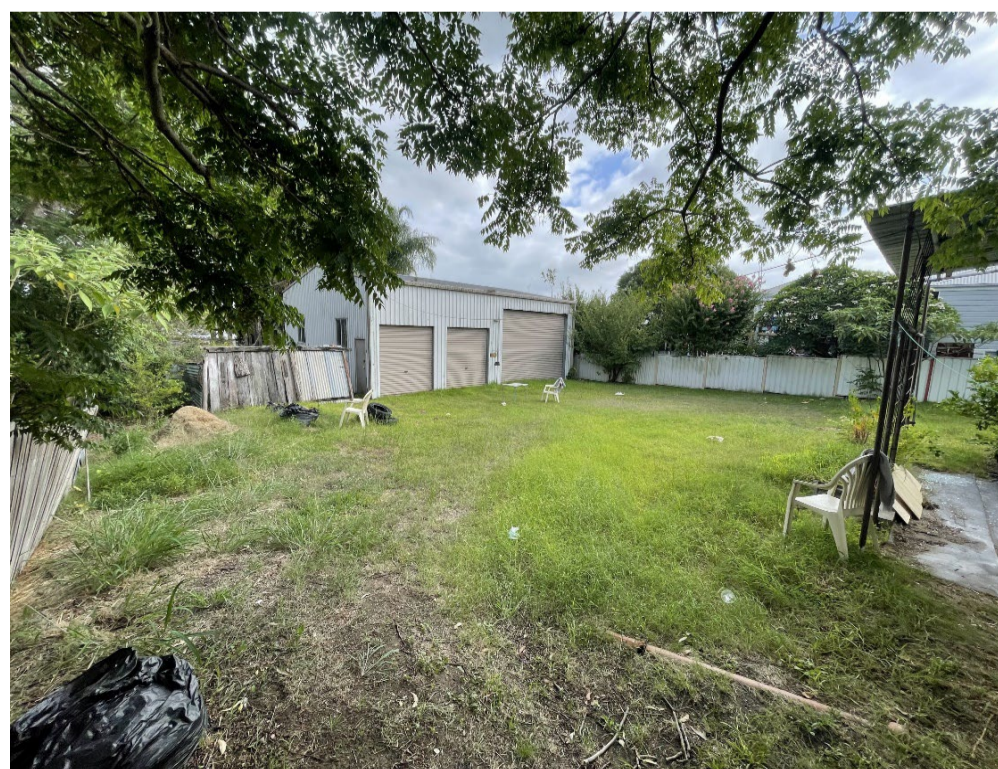
Photo 5: Overview of the backyard space, looking north. No visual signs of stress or staining.

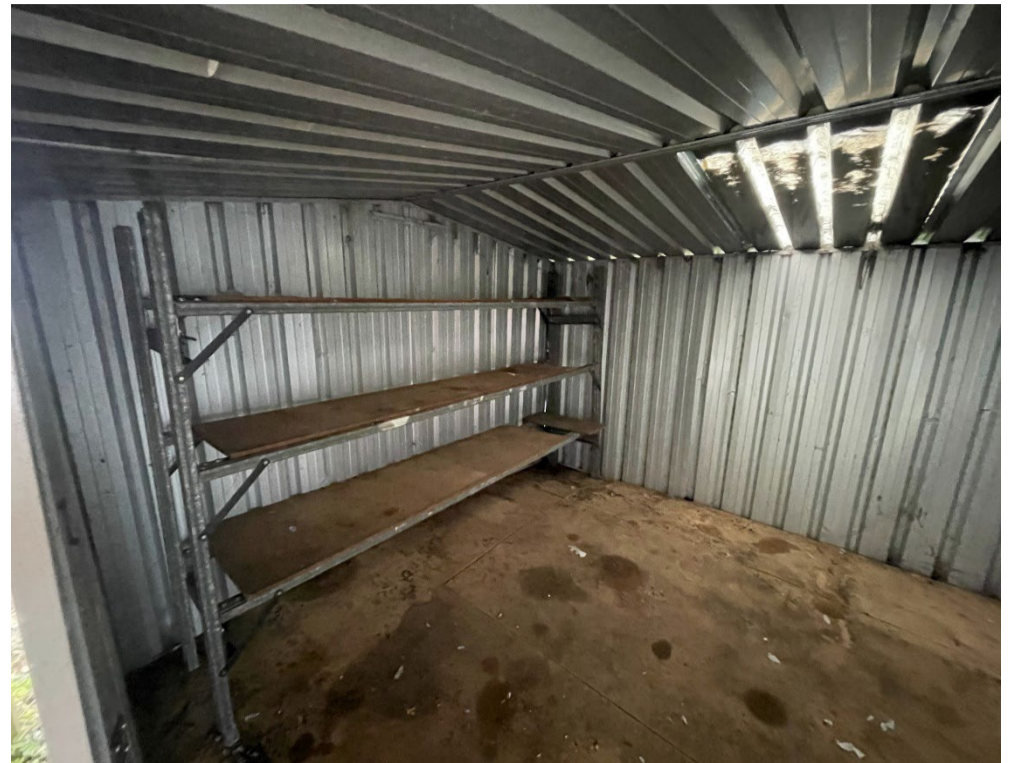
Photo 8: Internal overview of the small sheds adjacent to the large storage shed, both small sheds are empty.

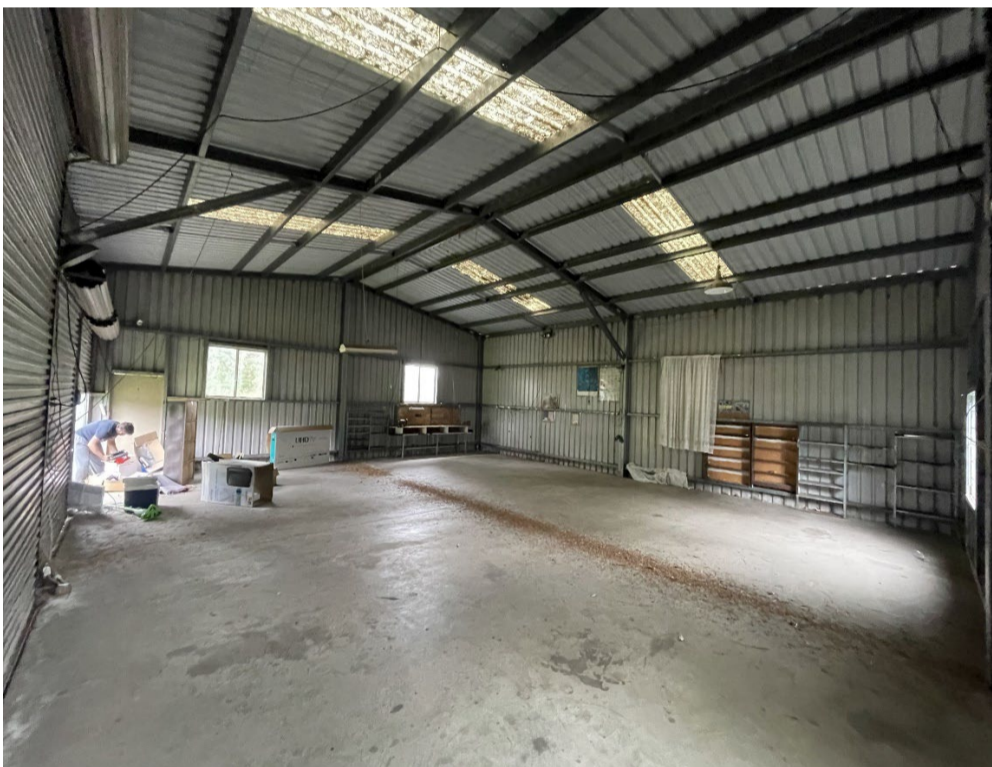
Photo 9: Internal overview of the large storage shed which is almost completely empty.

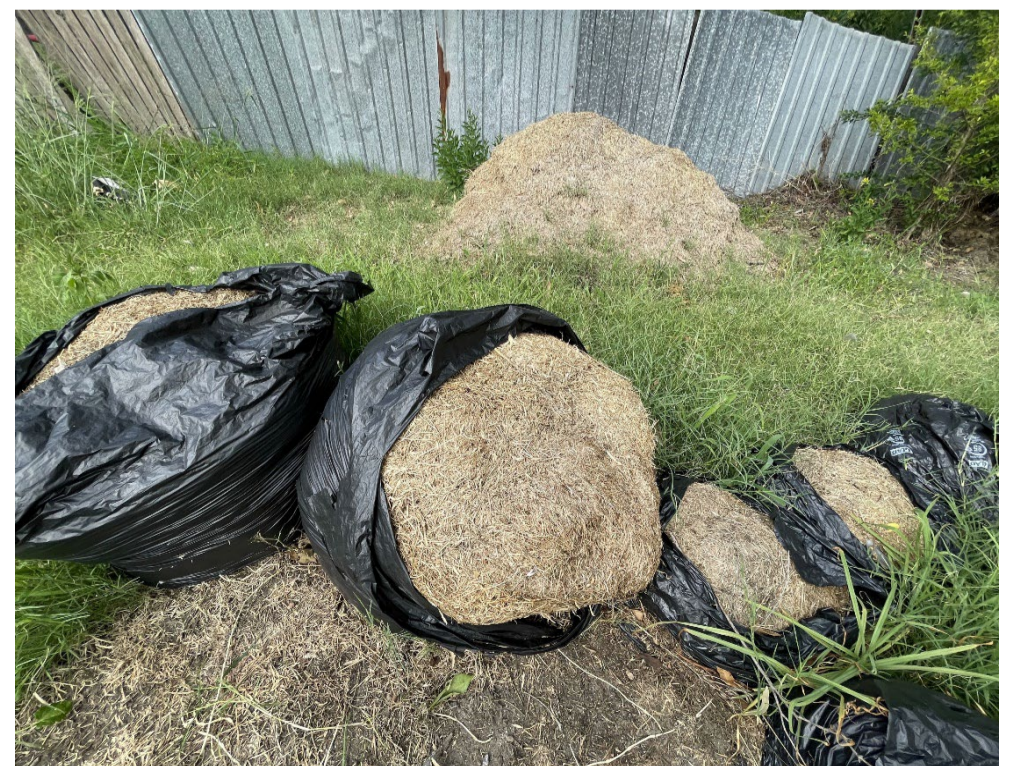
Photo 12: Stockpiled grass clippings/mulch in the northwestern portion of the site. No visual signs of staining.

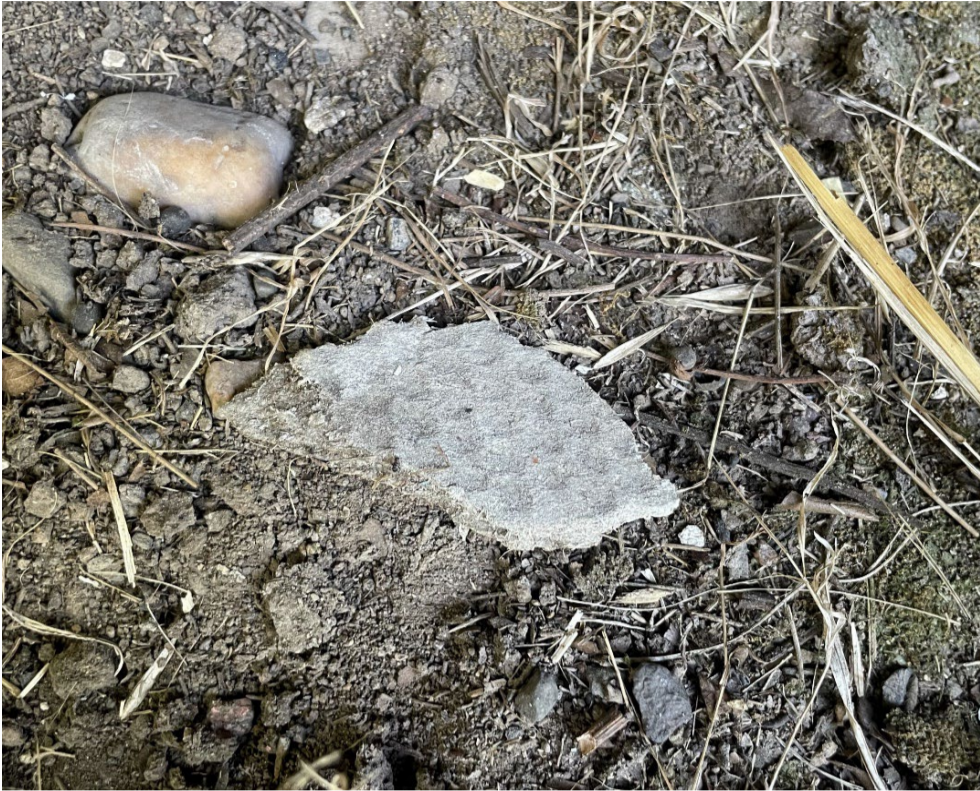
During the site walkover potential asbestos containing materials (PACM) were found to be present within AEC3 underneath the primary dwelling.

In accordance with the NEPM (2013) and the *Guidelines for the Assessment, Remediation and Management of Asbestos Contaminated Sites in Western Australia, 2019-2024*, the fragments observed were greater than 7mm x 7mm and were not subject to crumbling by hand. As such, the asbestos has been characterised as bonded ACM, as opposed to Asbestos Fines (AF) or Friable Asbestos (FA).

Photo 13: Potential Asbestos Containing Material (PACM) sample taken from underneath the dwelling.

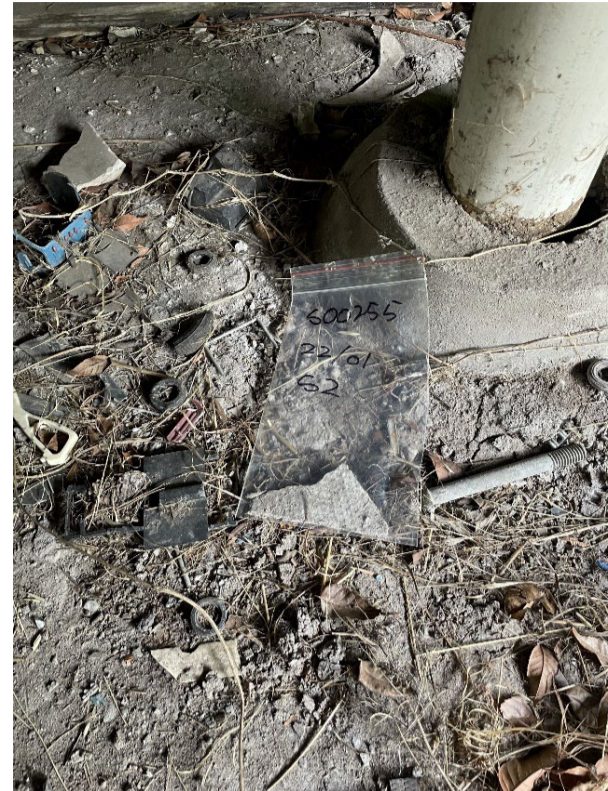
Photo 14: Potential Asbestos Containing Material (PACM) sample taken from underneath the dwelling.

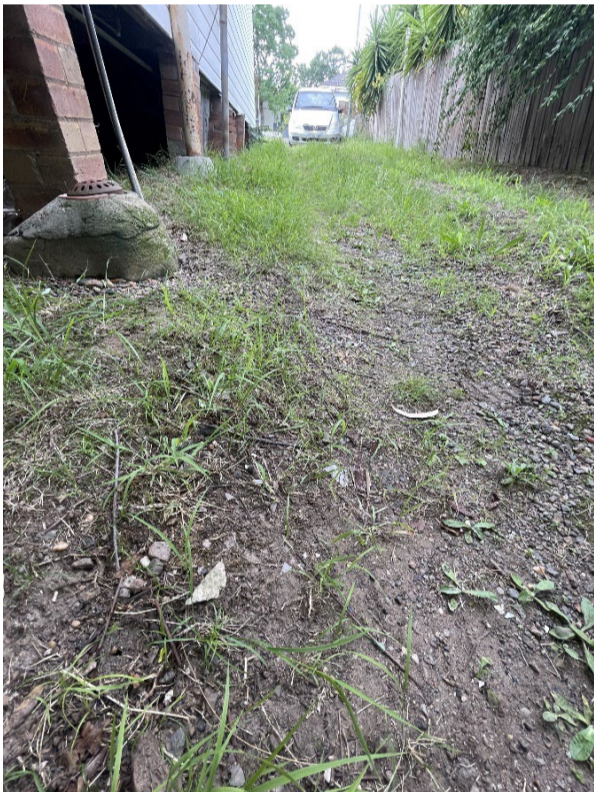
Photo 15: Potential Asbestos Containing Material (PACM) sample found on the driveway adjacent to the dwelling.

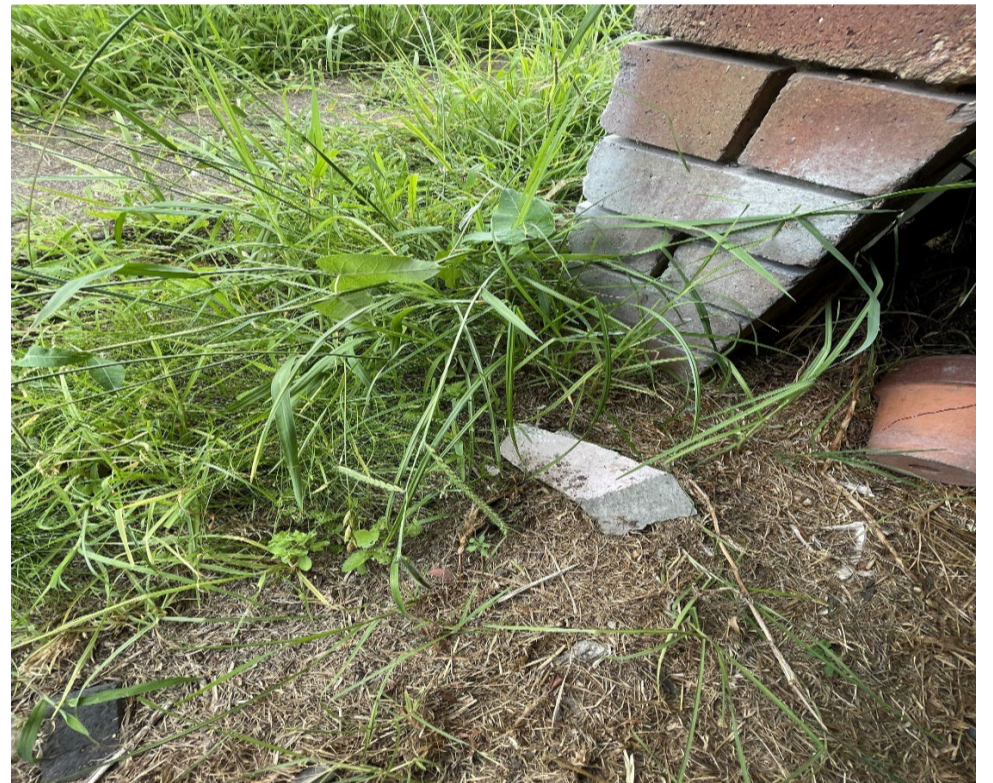
Photo 16: PACM sample S4 taken from the northeastern portion of the dwelling's footprint.

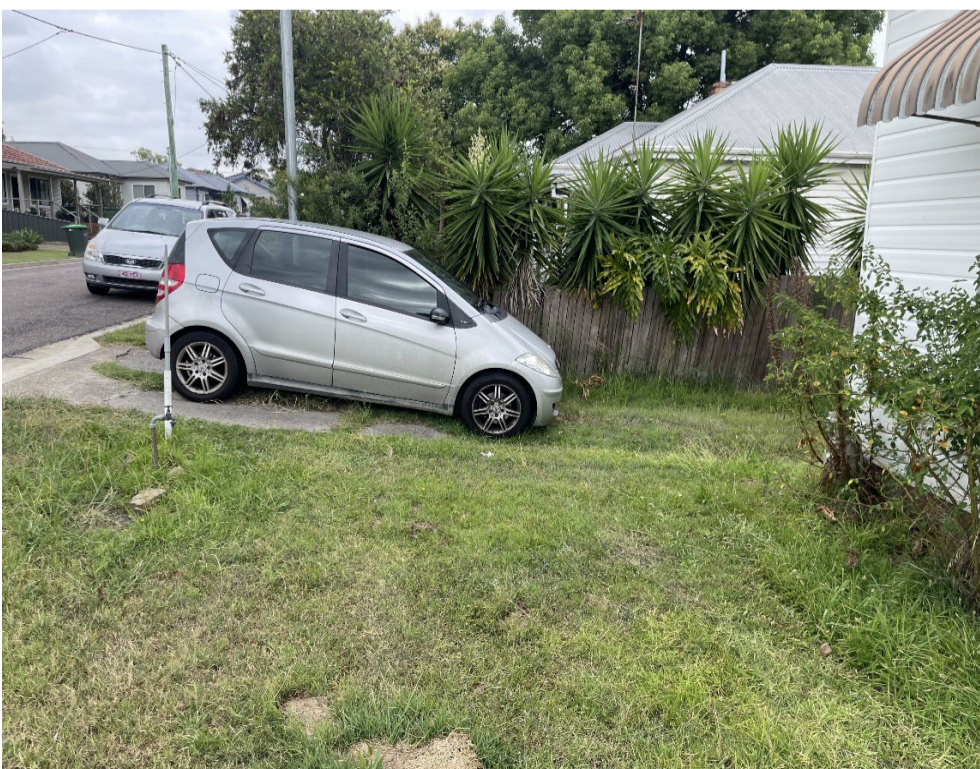
Photo 17: Vehicular storage location on the partially earthen driveway.

- Based on the site inspection, desktop review and the proposed development involving minor excavations for residential development, a DSI with bulk material, soil and groundwater sampling is recommended to assess the contamination status of the soils identified in Area of Environmental Concern AEC1, AEC2 and AEC3. This will confirm the source, pathway, and receptor linkages to the CSM, assessing the risk of exposed soils to future site users and construction workers to ensure suitability for the proposed development. The DSI should be undertaken after site based buildings have been demolished and hardstand infrastructure such as concrete slabs and driveways removed so all soils are accessible, and no data gaps remain.

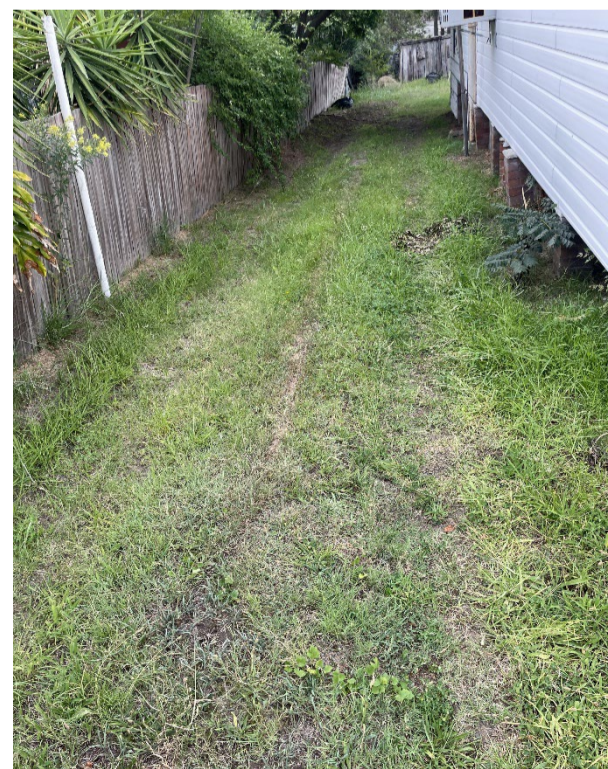
Photo 18: Overview of the earthen driveway showing historical vehicular use.
