# Arboricultural Impact Assessment

Site Address: 19 Bungaree St Maitland

Client: Eagers Automotive Group Pty Ltd

Date: February 2024

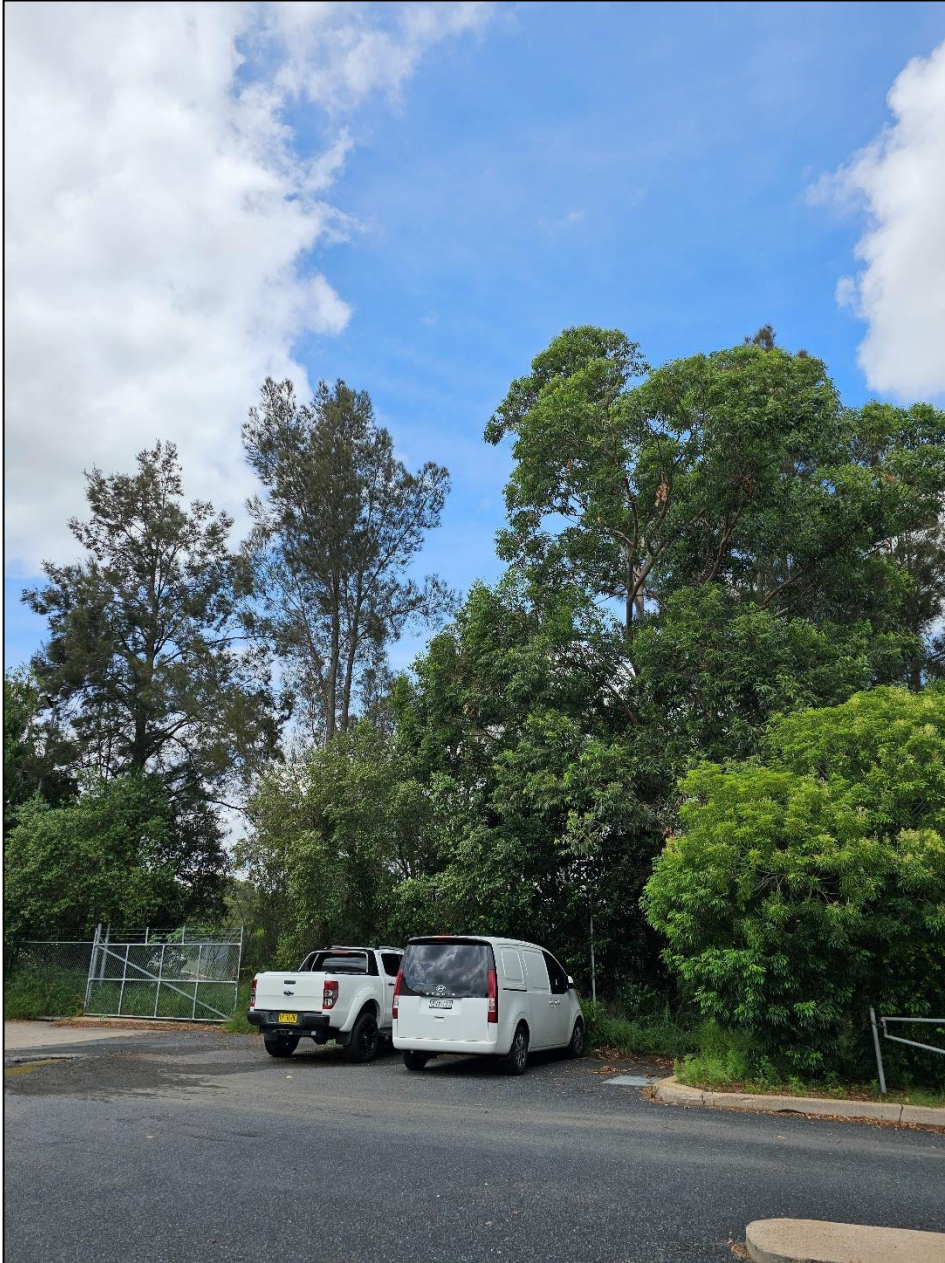
**Figure 1 Trees adjacent to the detention basin.**
