ARBORIST REPORT

ALL SAINTS COLLEGE

***Corner of Hunter Street and Odd Street
Horseshoe Bend***

***PREPARED BY
TATTERSALL LANDER
PTY LTD
DEVELOPMENT CONSULTANTS
February 2022***

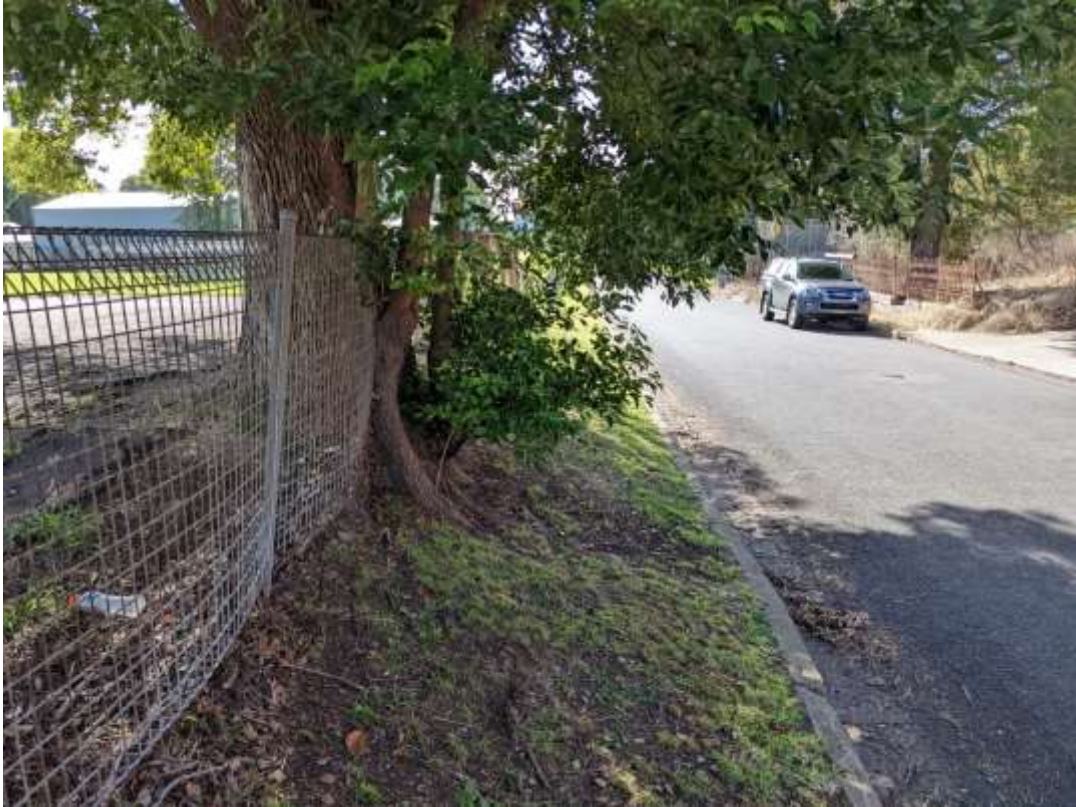
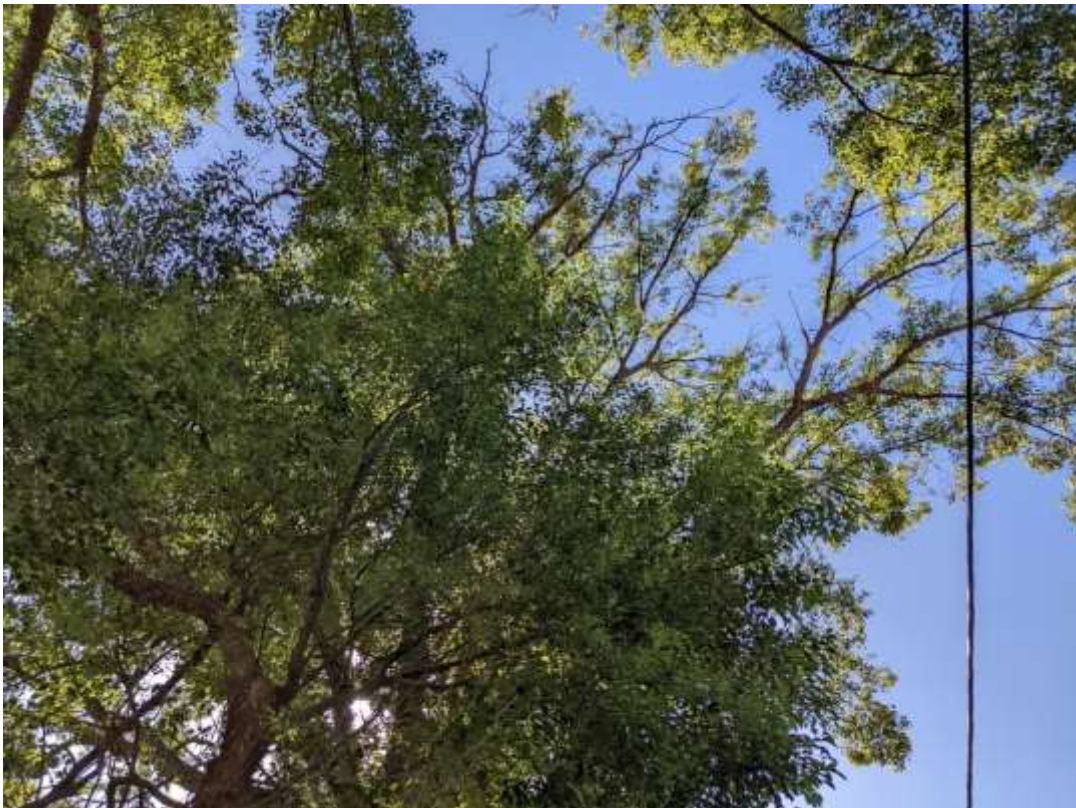
Photograph 1 – Tree 1

Photograph 2 – Trees 1

Tree	Notes
1	Mature. Good vigour. Some small deadwood. Damage to fence and kerb and gutter. Significant damage to asphalt court. This tree is not in the vicinity of the proposed works.
2	Mature. Average vigour. Slightly asymmetrical due to pruning for o/head power lines. Damage to fence. Significant damage to kerb and gutter. Minimal small deadwood. Significant damage to asphalt court. Tree appears to be located in the road reserve. This tree is not in the vicinity of the proposed works.
3	Mature. Excellent vigour. Comms box at base, probable root intrusion. Significant damage to asphalt court. Fence inclusion. Slightly asymmetrical due to pruning for o/head power lines. Given the proximity to the footpath, it is also considered highly likely that this tree will cause lifting of the path in the near future. This tree is not in the vicinity of the proposed works.
4	Very poor vigour. Tree is almost dead. Fence inclusion. Damage to asphalt. Significantly asymmetrical, probably due to proximity to Tree 3. This tree is not in the vicinity of the proposed works.

Tree	Action	Justification
1	Retain	Whilst the tree is a potential weed species, it is not in the vicinity of any works.
2	Retain	Whilst the tree is a potential weed species, it is not in the vicinity of any works.
3	Retain	The tree is native (not indigenous) and is a good specimen and not in the vicinity of any works.
4	Remove	This tree is almost dead.
5	Remove	This tree is in very close proximity to the proposed works such that the SRZ and TPZ will be impacted upon. Whilst the tree is of a significant age, it is also a significant weed species.
6	Remove	This tree is in the location of the proposed works and hence must be removed. It is of no known or suspected heritage value and is not a particularly good specimen.
7	Remove	This tree is in the location of the proposed works and hence must be removed. It is of no known or suspected heritage value and is not a particularly good specimen.
8	Remove	This tree is in the location of the proposed works and hence must be removed. It is of no known or suspected heritage value and is not a particularly good specimen.

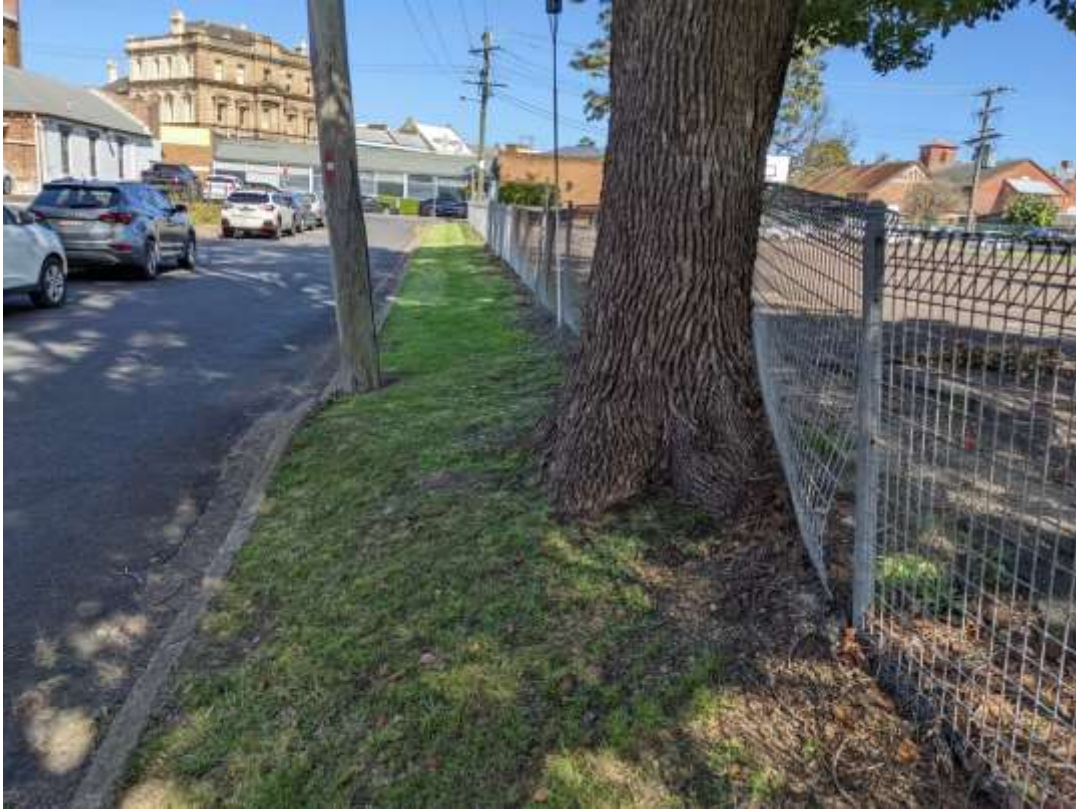
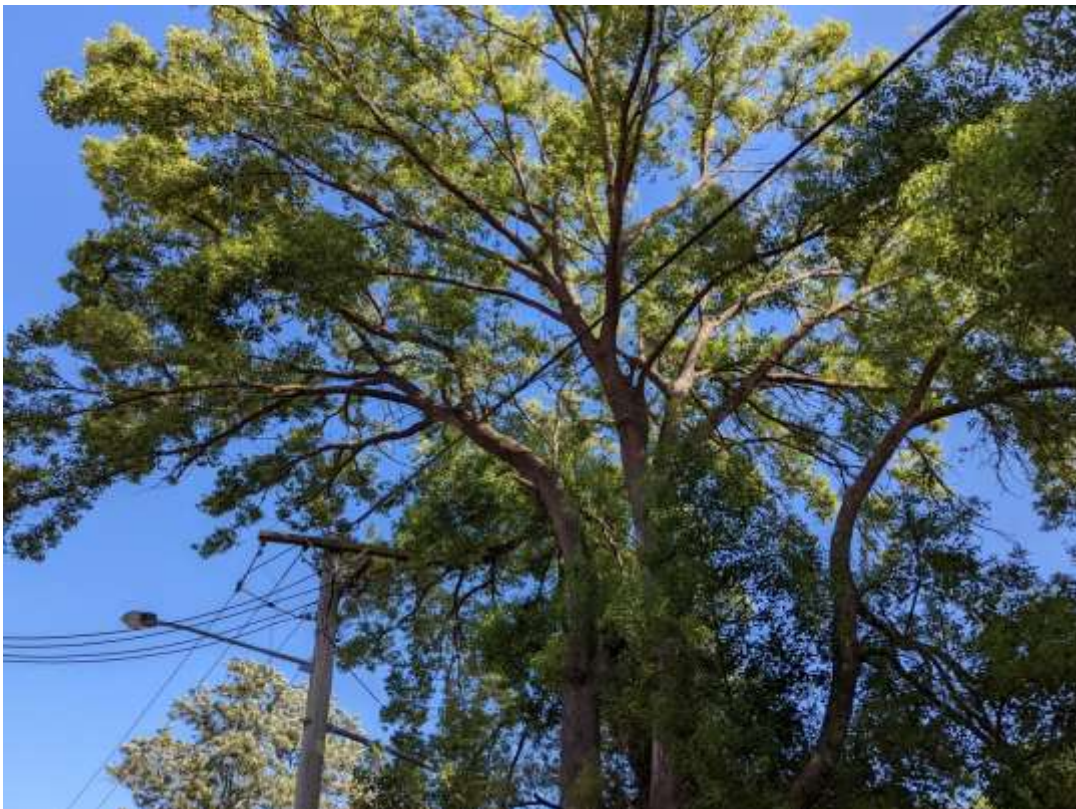
Photograph 3 – Tree 2

Photograph 4 – Tree 2

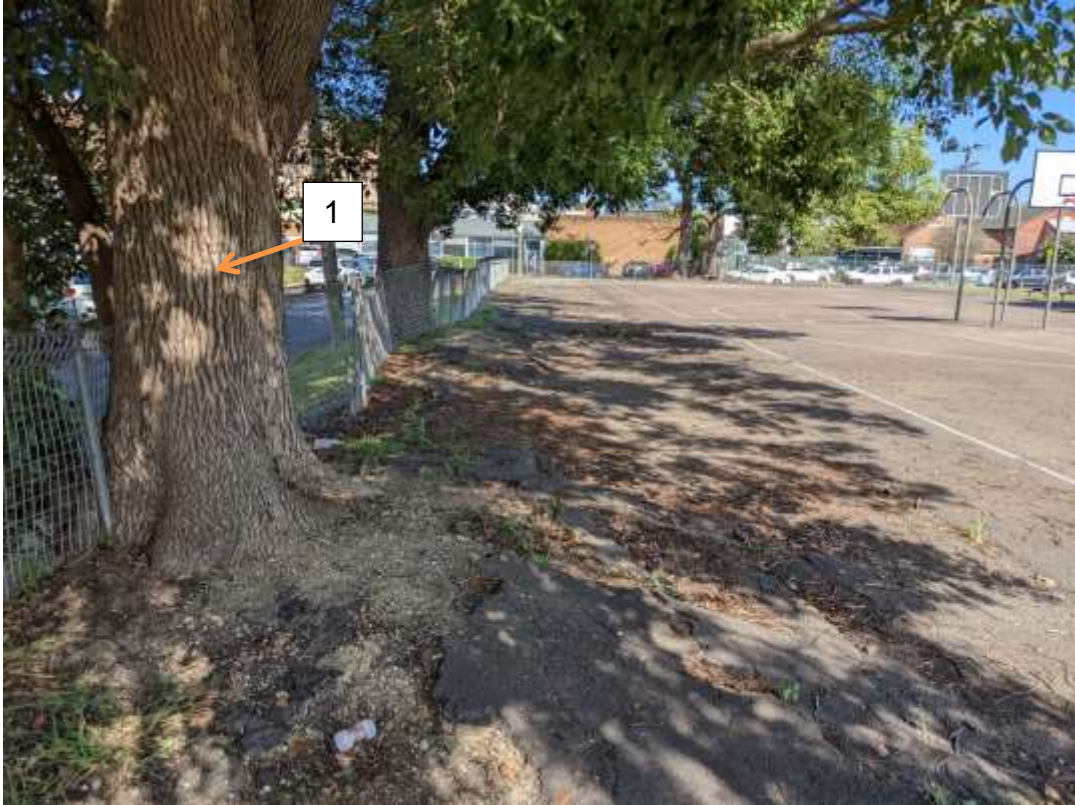
Photograph 5 – Trees 1 and 2 and damage to asphalt

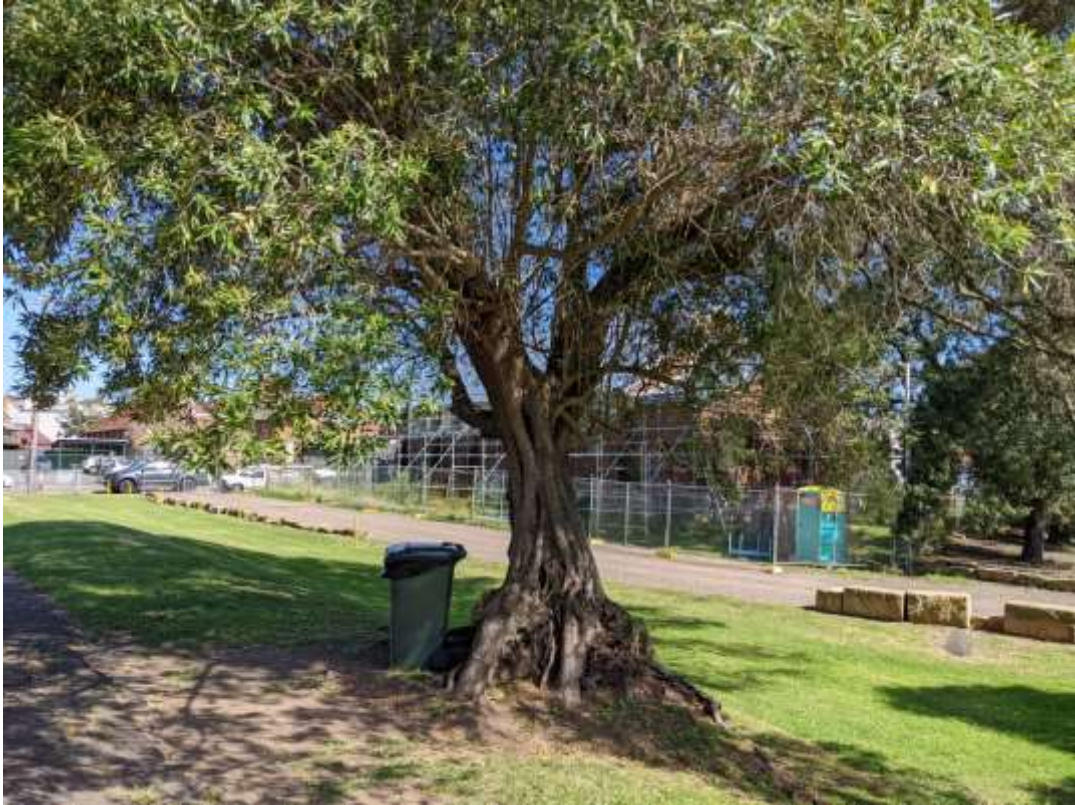
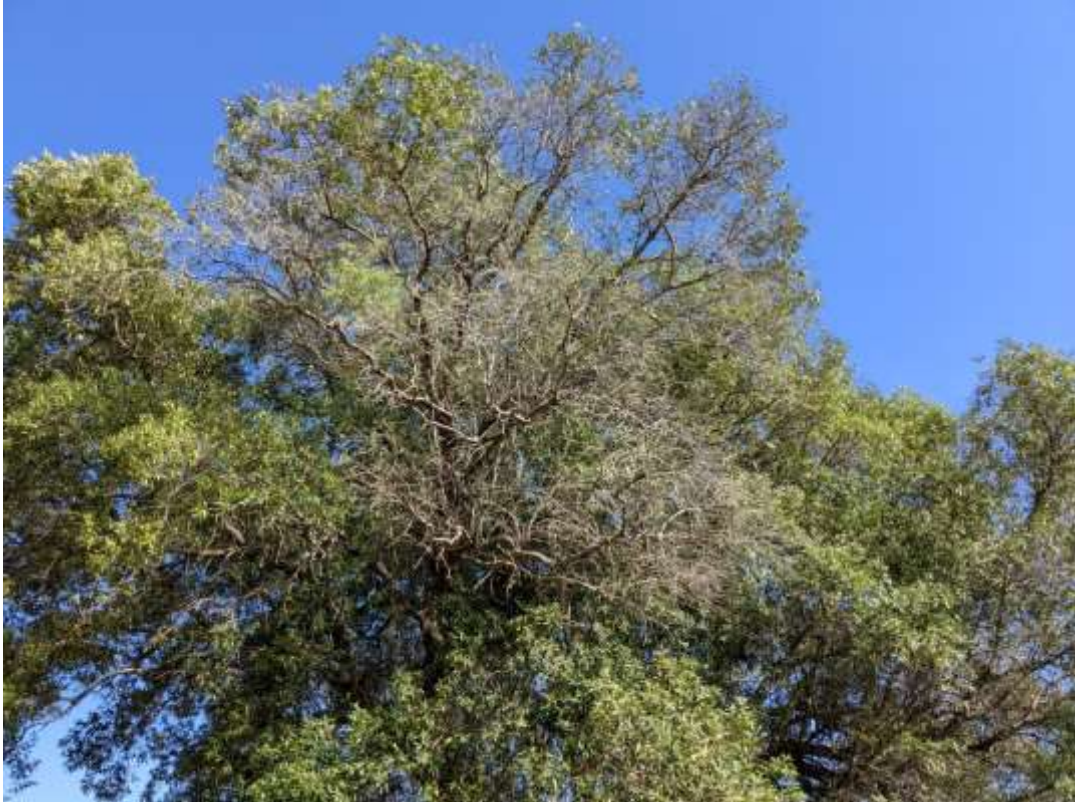
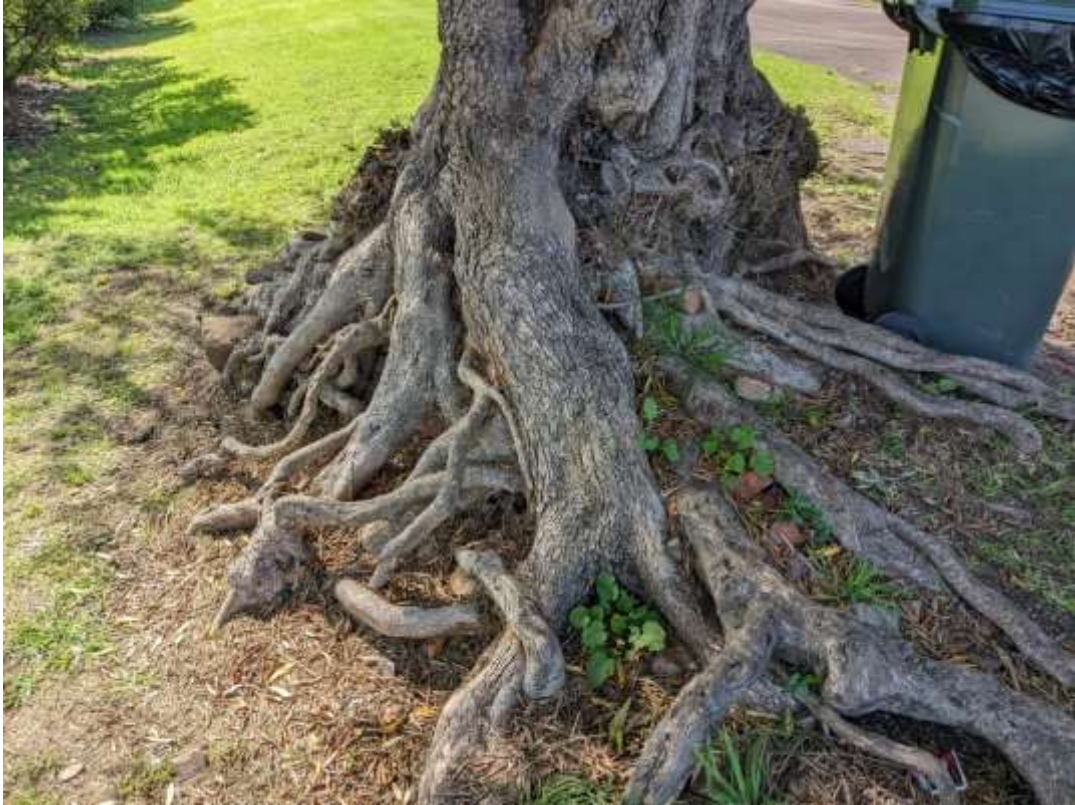
Photograph 11 – Tree 5

Photograph 12 – Tree 5

Photograph 13 – Tree 5

5	Mature – exceptionally old, probably over 100 years. Excellent vigour except for one small dead patch. Roots are exposed and have significant inclusions. It is noted that this tree is not included on the significant tree register and there are no known historical associations relating to this tree. Weed Species.
6	Mature. Good vigour. Small Deadwood. Some/minimal decay in trunk. Asymmetrical. Poor form. Brushes against adjacent building.
7	Mature. Good vigour. Large break approx. half way up trunk. Asymmetrical. Poor form.
8	Mature. Good vigour. Suppressed by Tree 7.
9	Mature. Average vigour. Some small deadwood.
10	Juvenile. Average vigour. Slightly asymmetrical.
11	Mature. Some small deadwood. Very minor dieback.
12	Mature. Excellent vigour. Excellent specimen.
13	Mature. Excellent vigour. Excellent specimen.
14	Mature. Good vigour. Top broken out.
15	Mature. Excellent vigour. Excellent specimen.

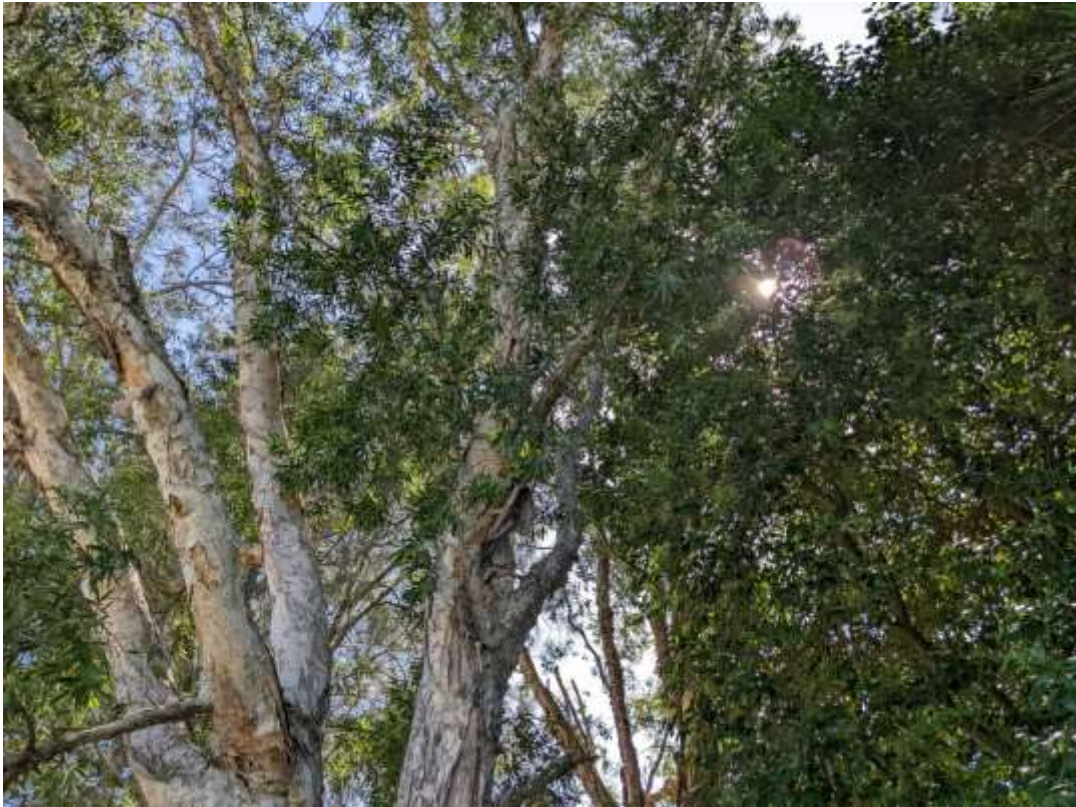
Photograph 31 – Tree 16

16	Mature. Excellent vigour. Excellent specimen BUT significant weed species.
17	Mature. Average vigour. Slightly suppressed by Tree 16. Appears healthy though.
18	Mature. Average vigour. Medium deadwood. Some branch failures. Poor form.
19	Mature. Co-dominant trunks. Excellent vigour.
20	Mature. Average/good vigour
21	Juvenile. Excellent vigour and form.

15	Remove	Whilst this tree is a native and indigenous species, it is in the location of the proposed works and as such, the works are unable to proceed without the removal of this tree.
16	Remove	This tree is in the location of the works and is a significant weed species.
17	Remove	Whilst this tree is a native and indigenous species, it is in the location of the proposed works and as such, the works are unable to proceed without the removal of this tree.
18	Remove	Whilst this tree is a native and indigenous species, it is in the location of the proposed works and as such, the works are unable to proceed without the removal of this tree.
19	Remove	Whilst this tree is a native and indigenous species, it is in the location of the proposed works and as such, the works are unable to proceed without the removal of this tree. It is also noted that the significant failures within this tree combined with the species suggest that there is likely fungal decay within the tree

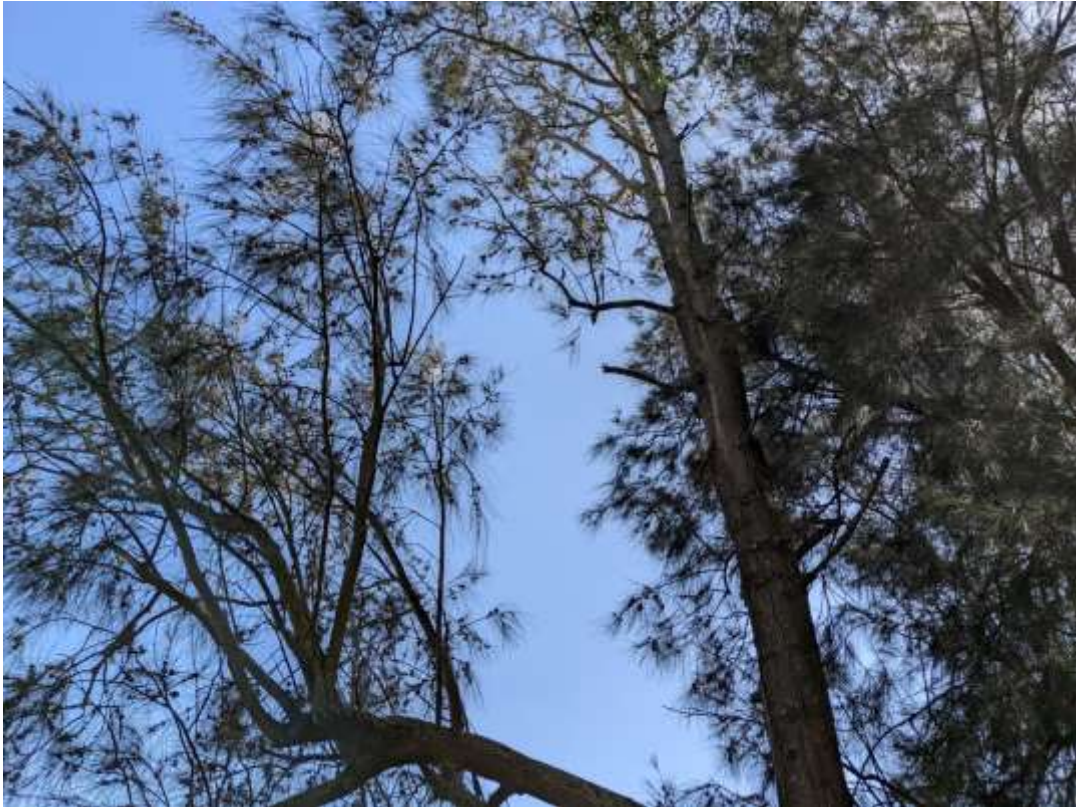
Photograph 33 – Tree 18

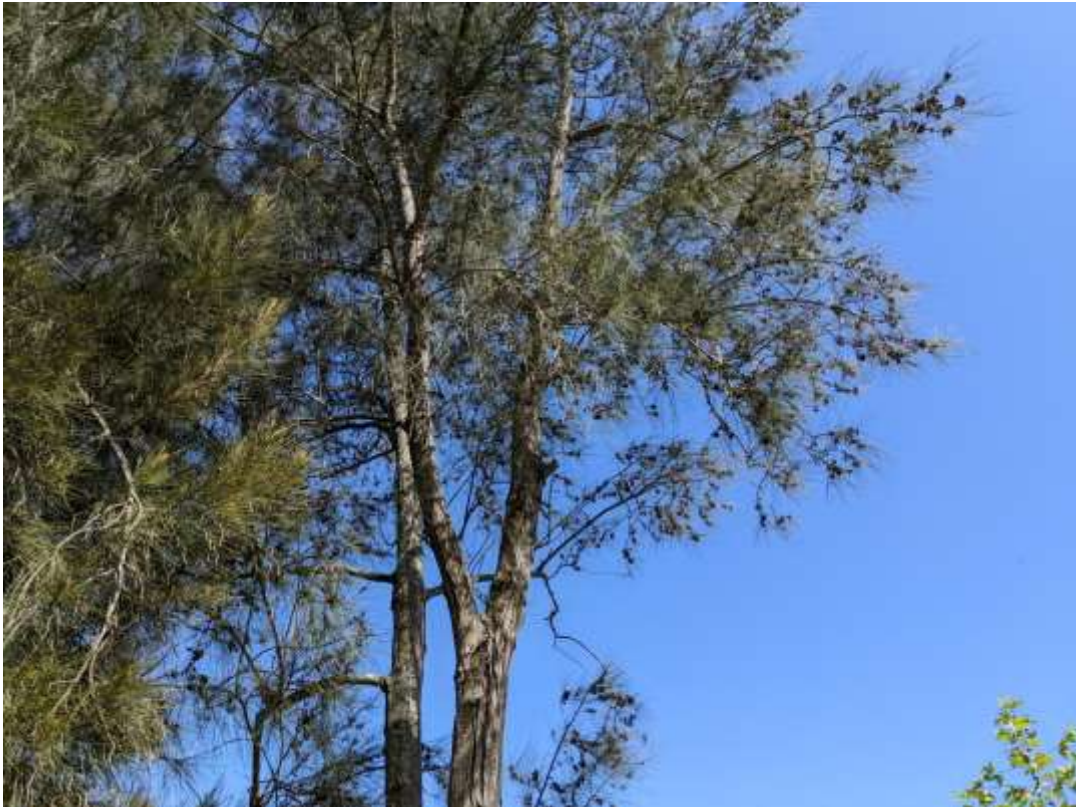
Photograph 36 – Tree 20

20	Remove	Whilst this tree is a native and indigenous species, it is in the location of the proposed works and as such, the works are unable to proceed without the removal of this tree.
21	Retain	This tree is not located such that removal is not required although it will likely need management as it grows so that it does not rub against the building.

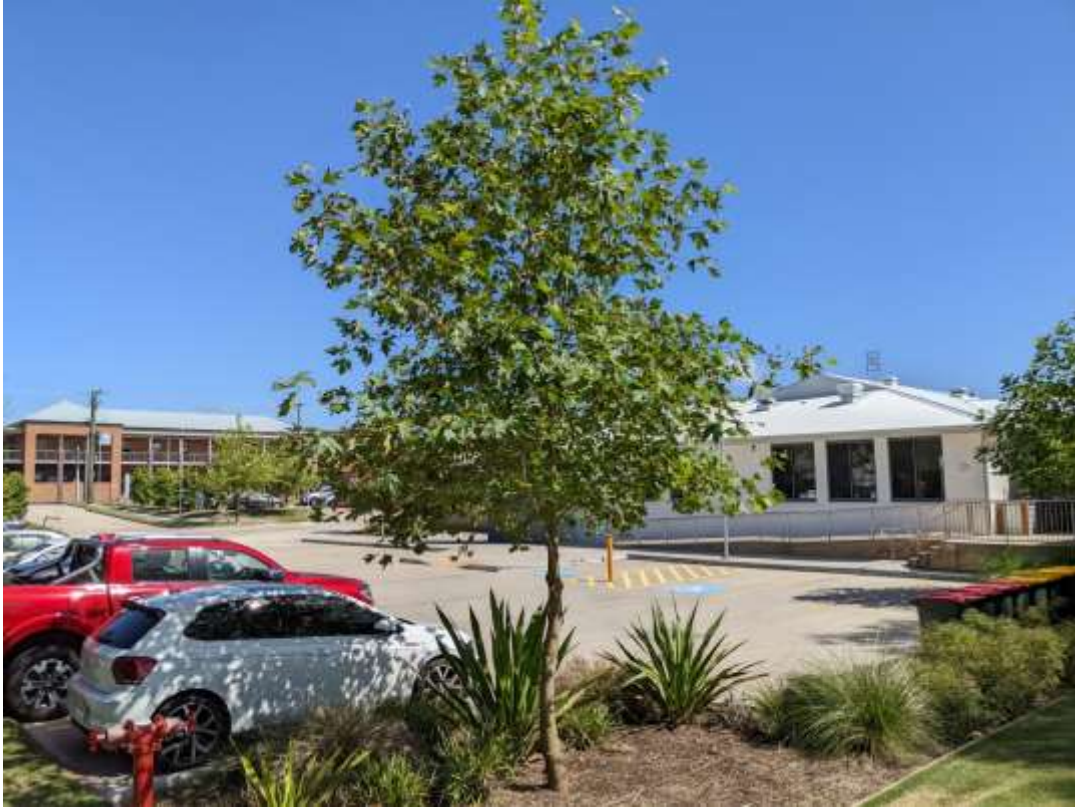
Photograph 37 – Tree 21
