Hazardous Materials Survey

Tenambit Community Hall,
Corner of Tyrell and Kenneth Street,
Tenambit NSW 2323

Report No. A1076_HMS_270723

Date: 4 August 2023

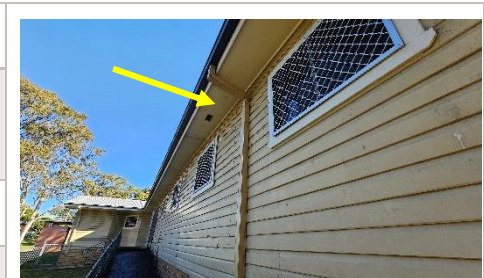
Location - Description	Hazardous Material	Condition	Sample ID	Signage
Exterior – all aspects – eave linings – asbestos cement sheeting	Chrysotile and Amosite asbestos	Good No damage	J10060965/2	No

Minimal Risk R4 - Material is in good condition and sealed. In its current state this material does not pose an immediate health risk to Site users unless disturbed. Remove by a licenced asbestos removalist prior to demolition works commencing.

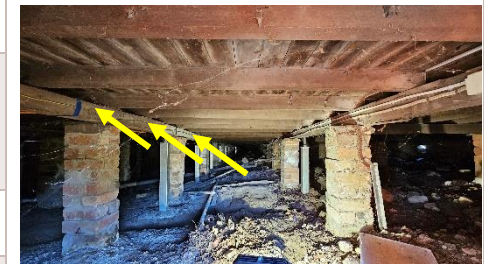
Location - Description	Hazardous Material	Condition	Sample ID	Signage
Subfloor – throughout – packers to piers – assumed asbestos cement sheeting	Assumed asbestos	Poor Unsealed with exposed edges	-	No

Low Risk R3 - Material is in poor condition and unsealed. In its current state this material does not pose an immediate health risk to Site users unless disturbed. Remove by a licenced asbestos removalist during demolition works.

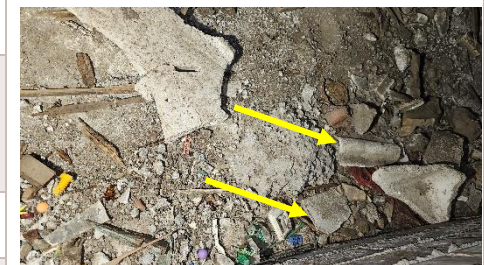
Location - Description	Hazardous Material	Condition	Sample ID	Signage
Subfloor – throughout - ground surface – asbestos cement sheet debris	Chrysotile and Amosite asbestos	Poor Unsealed with exposed edges	J10060964/1	No

Low Risk R3 - Material is in poor condition and unsealed. In its current state this material does not pose an immediate health risk to Site users unless disturbed. Remove by a licenced asbestos removalist during demolition works.

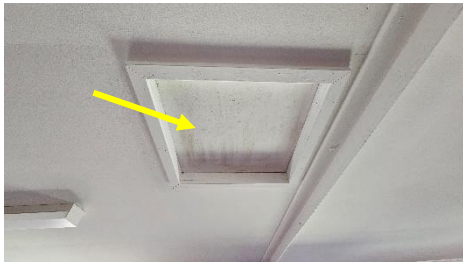
Location - Description	Hazardous Material	Condition	Sample ID	Signage	
Interior – Hall – manhole cover – assumed asbestos cement sheet	Assumed asbestos	Good No damage	-	No

Survey Findings and Hazard Management Recommendations Minimal Risk R4 - Material is in good condition and sealed. In its current state this material does not pose an immediate health risk to Site users unless disturbed. Remove by a licenced asbestos removalist prior to demolition works commencing.					
Interior – Kitchen – manhole cover – assumed asbestos cement sheet	Assumed asbestos	Good No damage	-	No	
Survey Findings and Hazard Management Recommendations Minimal Risk R4 - Material is in good condition and sealed. In its current state this material does not pose an immediate health risk to Site users unless disturbed. Remove by a licenced asbestos removalist prior to demolition works commencing.					 
Interior – ceiling cavity – throughout – plastic wrapped ducting - SMF insulation	Synthetic Mineral Fibre	Good Wrapped in plastic	-	No
