PROPOSED DEVELOPMENT & OLD MINE WORKINGS

PART LOT 141 DP1225076 & LOT 8 DP855275

MOUNT VINCENT ROAD AND WILTON DRIVE

Mine Subsidence and Mining Engineering Pty Ltd
Report prepared by G J COLE-CLARK (B Eng - Syd Uni, MBA Newc)
MIEAust CPEng NER APEC Engineer

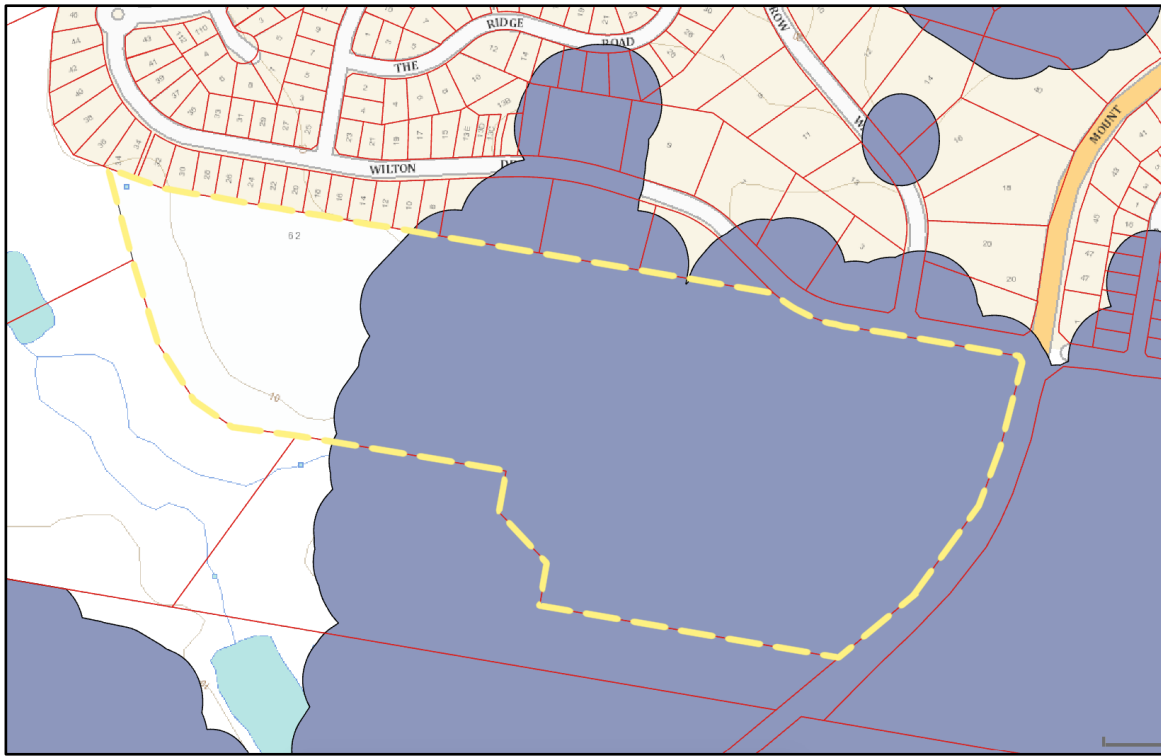
FIG 3: SA NSW mined area blue in with Lot 141 DP1225076 highlighted.

Mining information from the eSpatial NSW website indicates that the area beneath Lot 8 DP855275 and Lot 141 DP1225076 is undermined as shown by the blue shaded area in Figure 3.

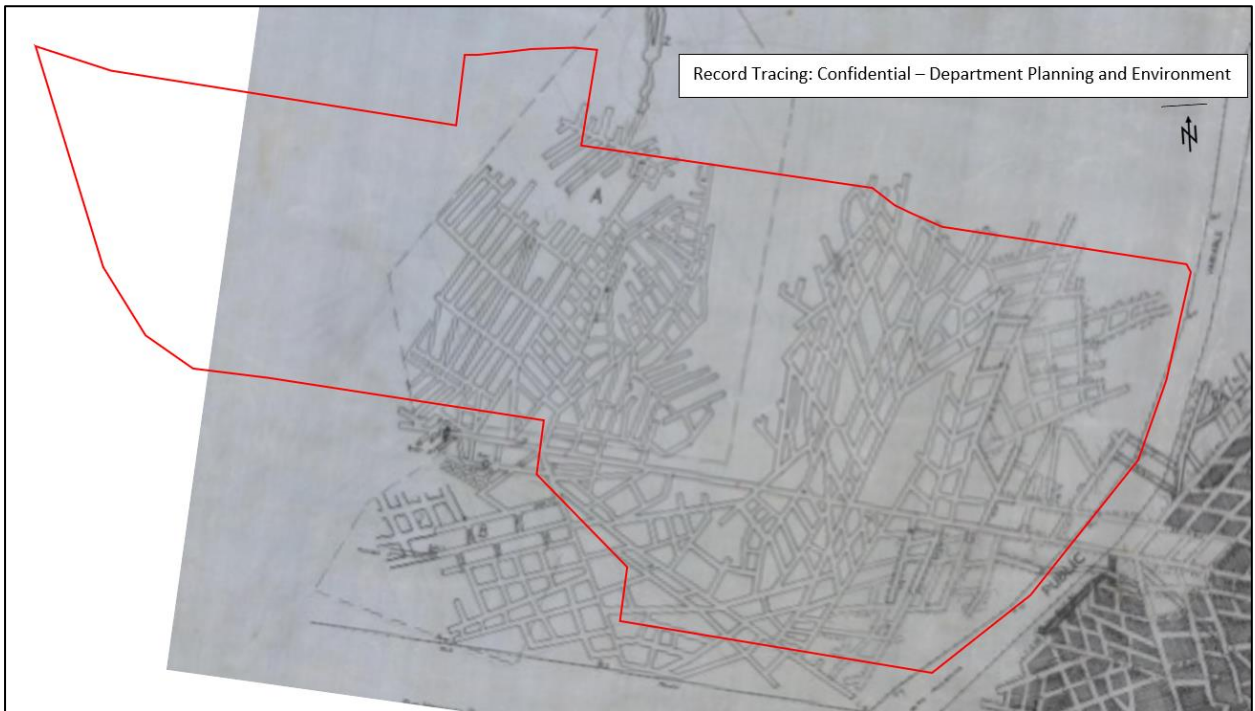
FIG 4: Possible location of Rathluba Seam workings and Lot 8 DP855275 & Lot 141 DP1225076

Record Tracing RT604 indicates Lot 8 DP855275 and Lot 141 DP1225076 are undermined by old and abandoned shallow mine workings in the Rathluba Seam, which is part of the Tomago Coal Measures. In summary:

Figure 4 shows the possible location of recorded old mine workings underlying Lot 8 DP855275 and Lot 141 DP1225076 from Record Tracing RT603. The mine plan indicates that the area was worked by the Bord and Pillar method, which involves the development of a series of headings and cut-throughs that usually leave rectangular shaped pillars of coal to support the mine roof during the development of panels. These pillars can then be extracted, in what is referred to as secondary or pillar extraction, leaving small sections of coal intact to control the collapse of roof material. Although secondary extraction is shown to the east of Mount Vincent Road, it is not shown beneath Lot 8 and Lot 141

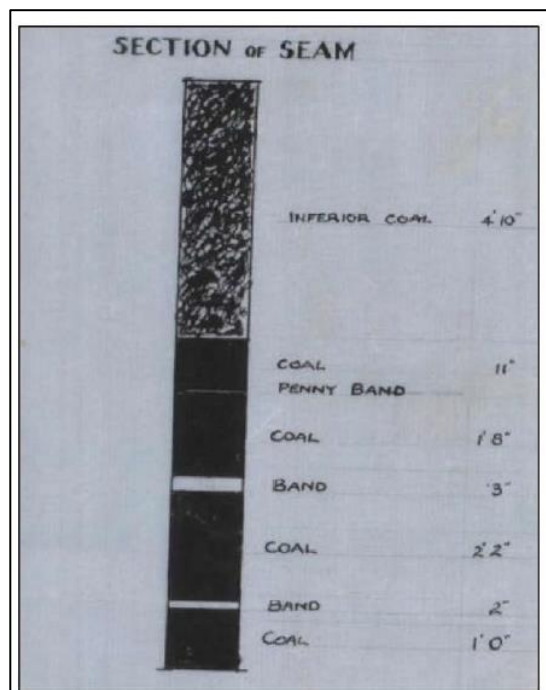
Fig 5: Mine workings and a Rathluba Seam section from Record Tracing

Records indicate the Rathluba Seam had working sections ranging from 5' (1.52m) to around 8' 6" (2.61m) due to varying bands of dirty coal that affected coal quality. Based on references the total seam thickness is around 3.3m.

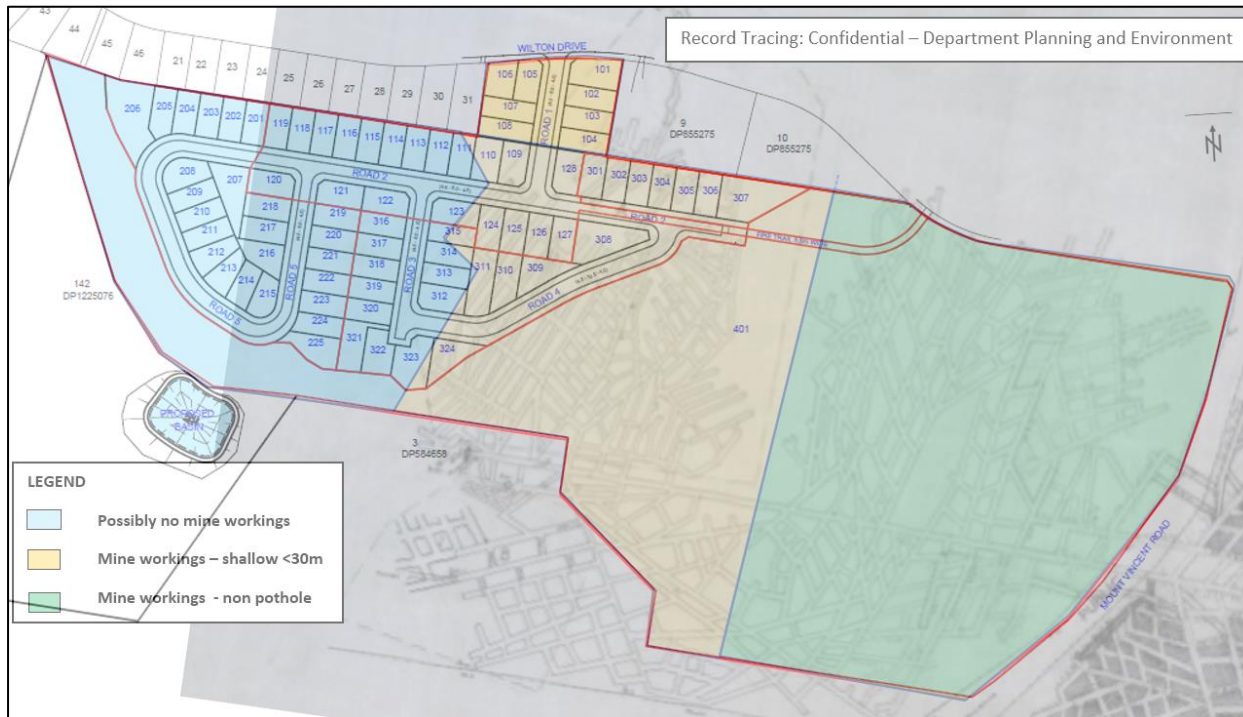
FIG 7: MS&ME plan showing zones based on estimated depth of cover

The depth of cover to the Rathluba Seam increases to the east. The yellow zone in Figure 7 shows the likely area where the depth of cover is <30 metres. There are locations in the eastern portion of this zone where the Record Tracing does not suggest undermining has occurred, or larger mine pillars remain. Further analysis of the mine workings in the eastern area is recommended to achieve a cut-off depth for grouting that is acceptable to SA NSW. SA NSW has designated the whole of Lot 141 DP122507 as Surface Development Guideline 1 – Historical mine workings – risk of pothole subsidence.

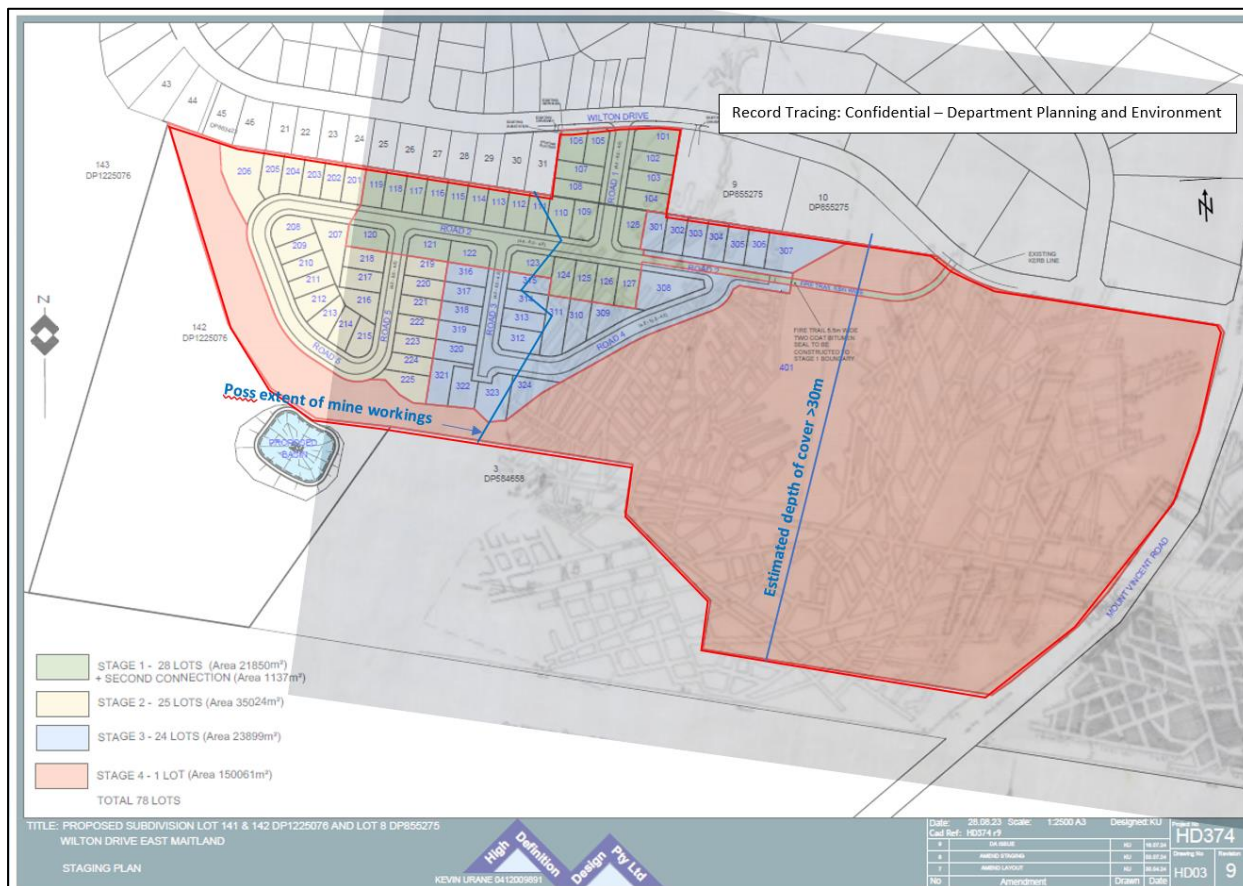
FIG 8: Proposed staged development with mining zones

Based on the information referenced, and the site investigation of lot 141, it is unlikely there are mine workings to the west of the blue line on Figure 8. The line provides a tolerance of around 10m from the predicted mine workings. Drilling appeared to identify the northern extent of the mine workings on lot 141, however, the demarkation became somewhat blurred by the mine workings that were not shown on the record tracing and extend south from Lot 8. Consideration may need to be given to drilling additional north-south boreholes across Lot 141.

Figure 8 shows the proposed staged development and the blue lines for the possible extent of mine workings, and >30m depth of cover line, from Figure 7. Stage 1 of the proposed development includes Lot 8 and an area along the northern boundary of Lot 141. An entry road enters Lot 8 from Wilton Drive and passes through the lot before turning west to link with Stage 2, which will occur on Lot 141. The Stage 1 area includes shallow mine workings that can be remediated by grouting to enable surface development. The grouting of Stage 1 will remediate the access road leading into Stage 2, which the Record Tracing does not show to be undermined. Stage 3 is partially undermined by shallow mined workings that will require grouting prior to surface development of this stage.

Subject to SA NSW’s Notice of Determination, a Grout Plan will be prepared and submitted to SA NSW for their acceptance for development of Stages 1 - 3. Stage 4 will be addressed with SA NSW at a future date.
