# **Hazardous Materials Survey Maitland Gaol Redevelopment 6-18 John Street, East Maitland NSW 2323**

N4952\_HMS\_R0\_161222  
December 2022

Hazmat Services Pty Ltd ("**Hazmat**") was commissioned by Maitland City Council (the "**Client**") to undertake a Hazardous Materials Survey ("**HMS**") of the Maitland Gaol Redevelopment Project buildings (the "**Buildings**") at Maitland Gaol, located at 6-18 John Street, East Maitland NSW (the "**Site**").

This report presents the findings of the HMS undertaken on the 16<sup>th</sup> of December 2022 by Hazmat's Luke Parkins, Senior OHS&E Consultant and Licensed Asbestos Assessor (LAA001373). Photographic records of hazardous materials collected during the survey and a register of hazardous materials and an asbestos risk assessment are contained in **Appendix 2: Hazardous Materials Register**.

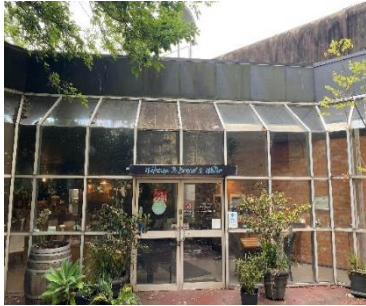
The building exterior is primarily constructed of glass panels, brick, sandstone and fibrous cement panels with aluminium framed windows and a corrugated metal roof. The building interior is primarily constructed of brick, sandstone and concrete wall linings with plasterboard and concrete ceiling linings and ceramic tile, vinyl tile, concrete and vinyl floor sheeting throughout.	✓	✓	x	x
Building 2 – Lieutenant Governor's Residence

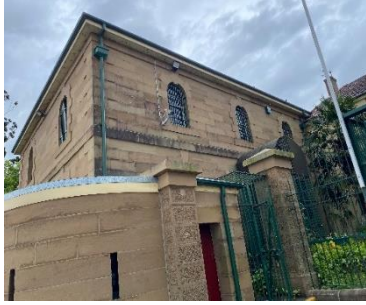
The building exterior is primarily constructed of sandstone and brick with timber framed windows and a tiled roof. The building interior is primarily constructed of sandstone and brick with cement render and fibrous cement and plasterboard wall linings with plasterboard, masonite and cement rendered sandstone and brick ceiling linings and timber floorboard, ceramic tile, vinyl tile and vinyl floor sheeting floor coverings.	✓	✓	✓	x

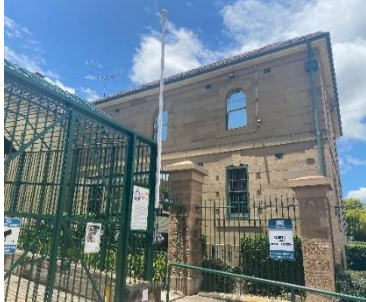
The building exterior is primarily constructed of sandstone and brick with timber framed windows and a tiled roof. The building interior is primarily constructed of sandstone and brick with cement render and fibrous cement and plasterboard wall linings with plasterboard, masonite and cement rendered sandstone and brick ceiling linings and timber floorboard, ceramic tile, vinyl tile and vinyl floor sheeting floor coverings.	✓	✓	✓	x
Building 14 – Stores building

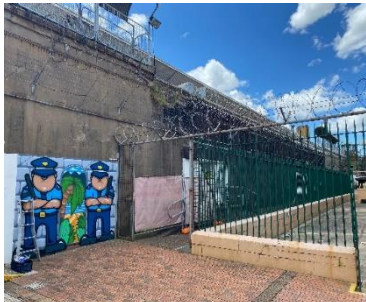
The building exterior is primarily constructed of sandstone and brick with the top of the building acting as a patrolling corridor between guard towers (access to this area was unavailable). The building interior is primarily constructed of sandstone, brick and fibrous cement wall linings with corrugated metal ceiling linings and concrete, carpet and vinyl tile floor coverings throughout.	✓	x	✓	x
