# **Preliminary Site Investigation**

## **Maitland Gaol Redevelopment**

Prepared for Maitland City Council

E221249 RP1

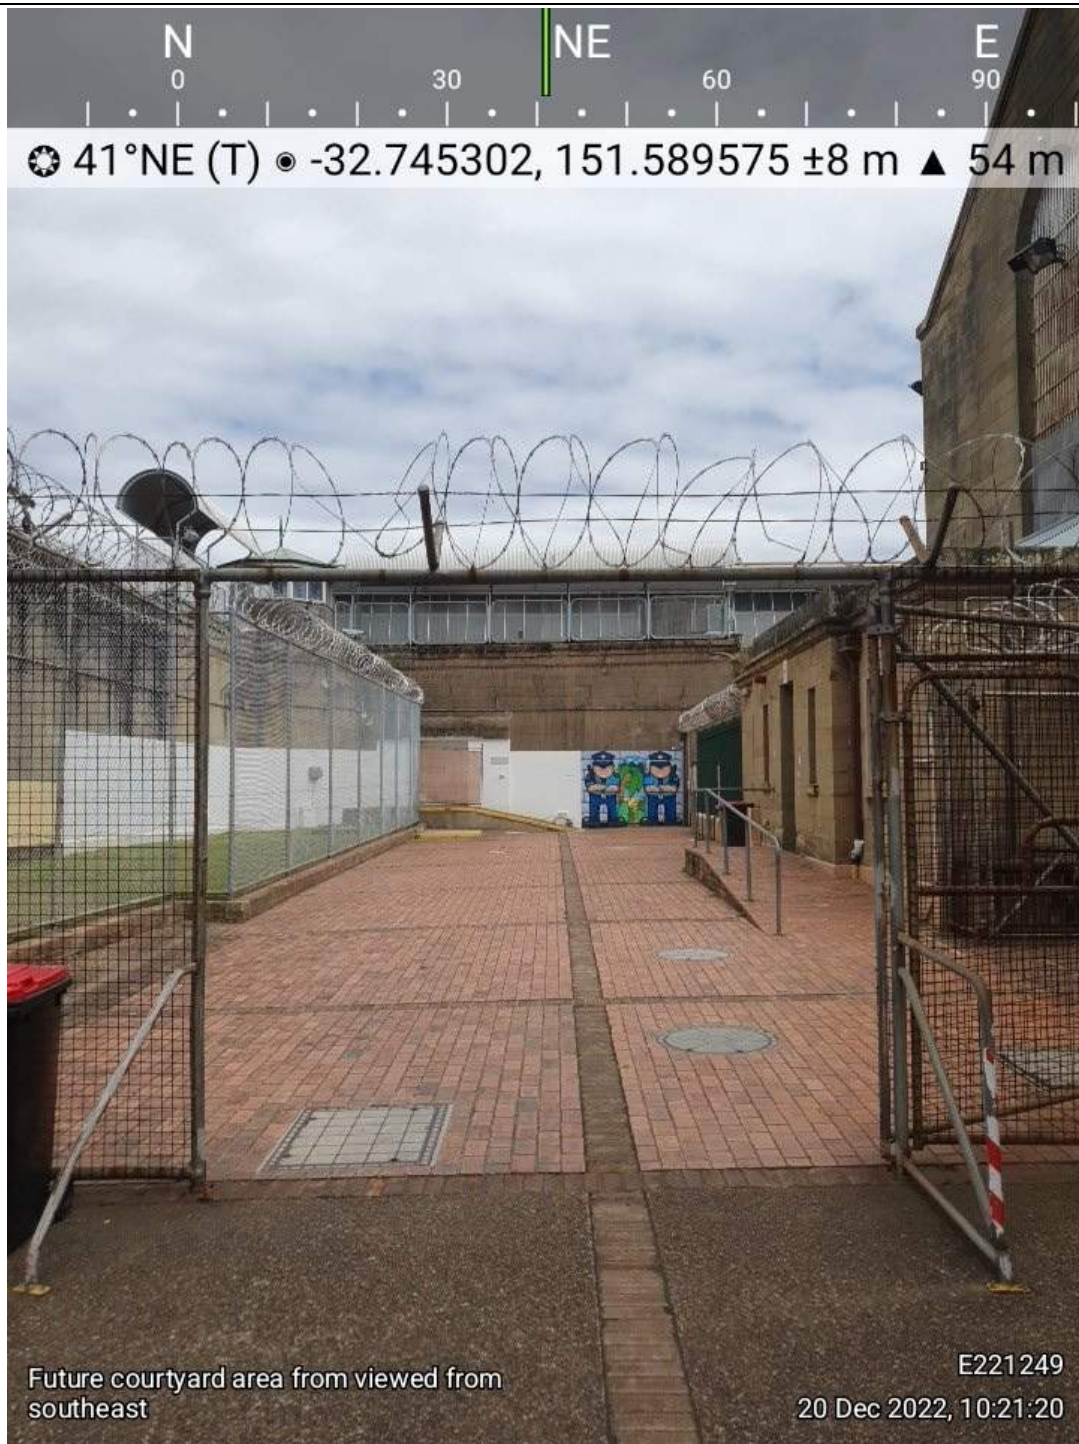
**Photo 7**

Wastewater Cooling Pit	24	A large pit was observed towards the northern area of the Site. It is understood that wastewater from the laundry was held here to cool prior to discharge into the sewer. It was non-operational at the time of inspection.
Courtyard	7	A brick courtyard is present in the central portion of the Site.

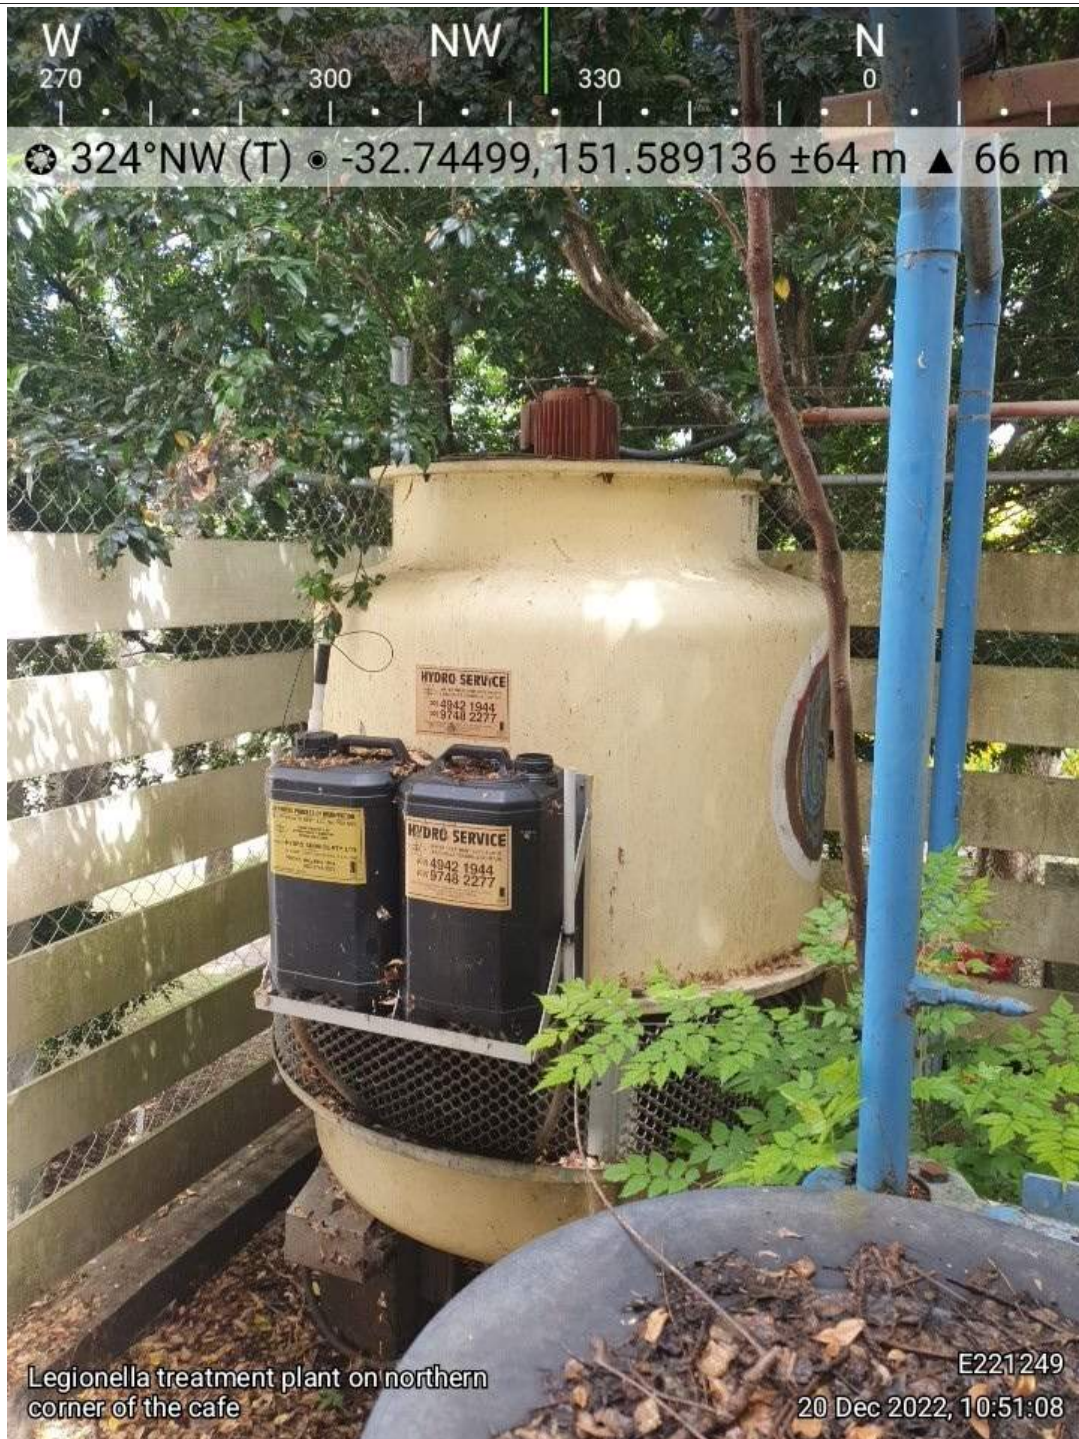
**Photo 16**

Disused legionella treatment plant  
Location: Northern corner of Building 22  
Direction: 324° clockwise from north

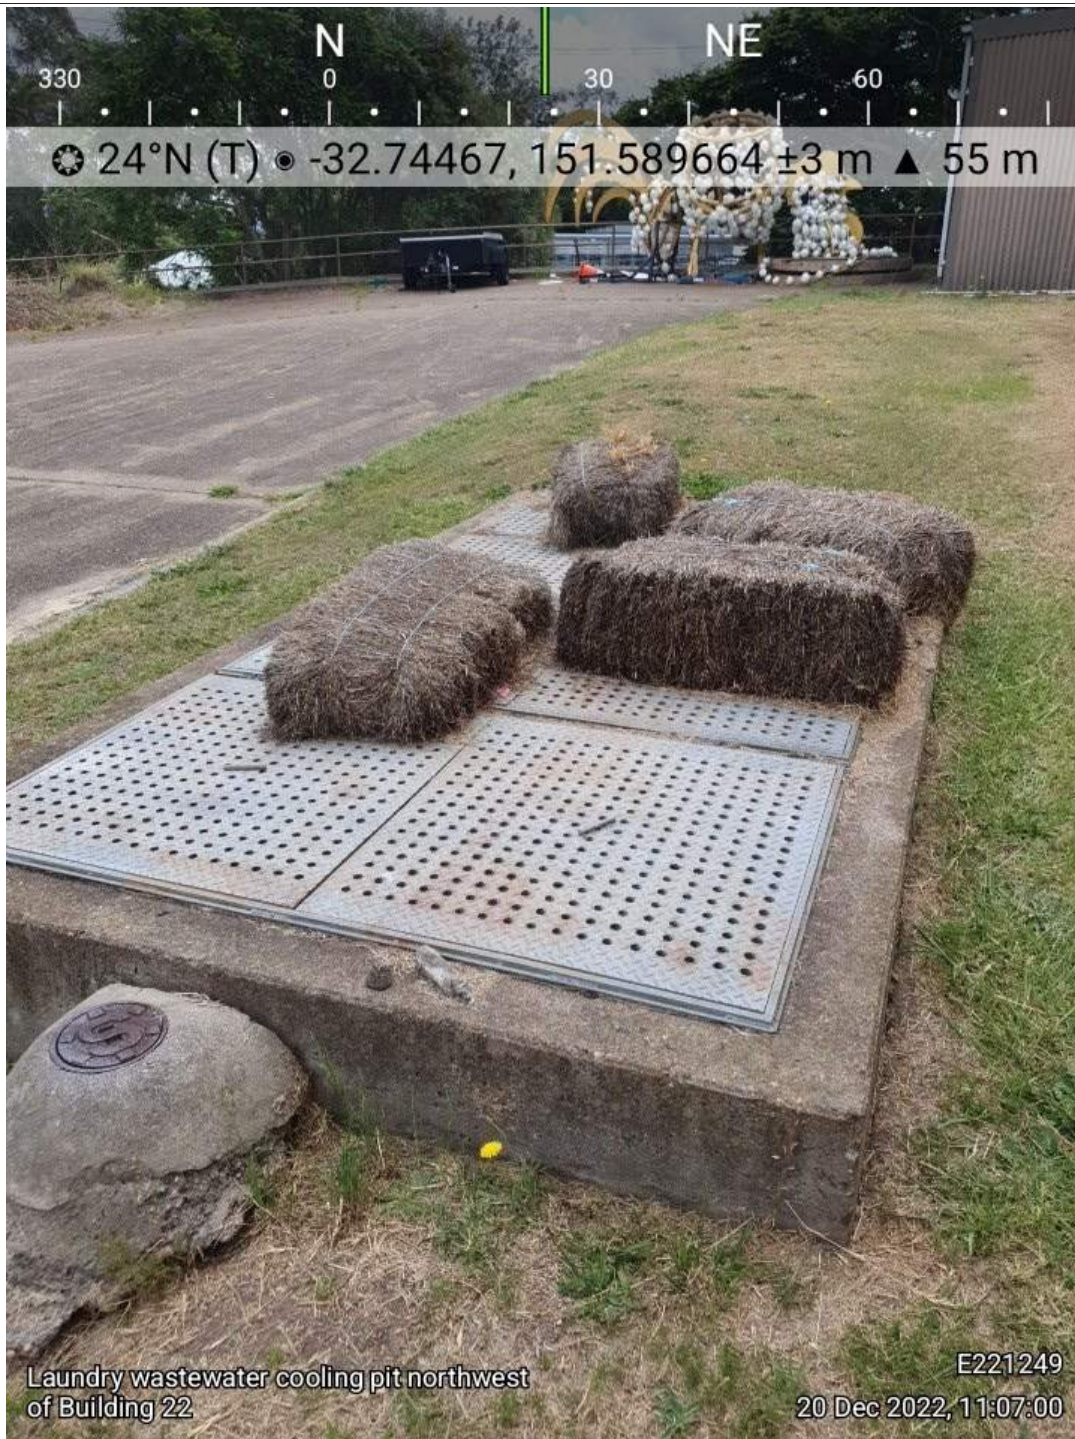
**Photo 24**

Wastewater cooling pit	Oil and grease, surfactants, nutrients, formaldehyde	<p>Unlikely – it is understood that the large pit located north-west of Building 14 was used to cool untreated wastewater from the laundry, prior to discharge into the sewer. Contamination may be present downgradient of the pit resulting from overtopping of the pit although this would be considered unlikely if proper management procedures were observed.</p>
Firefighting training	PFAS <sup>12</sup>	<p>Potential – it is understood that the Gaol relied on the local Fire Brigade. Firefighting training is known to have occurred off-Site at the Gaol however as no formal records exist, firefighting training may have also been undertaken within the Site.</p>
