Preliminary Site Investigation

Maitland Gaol Redevelopment

Prepared for Maitland City Council

E221249 RP1

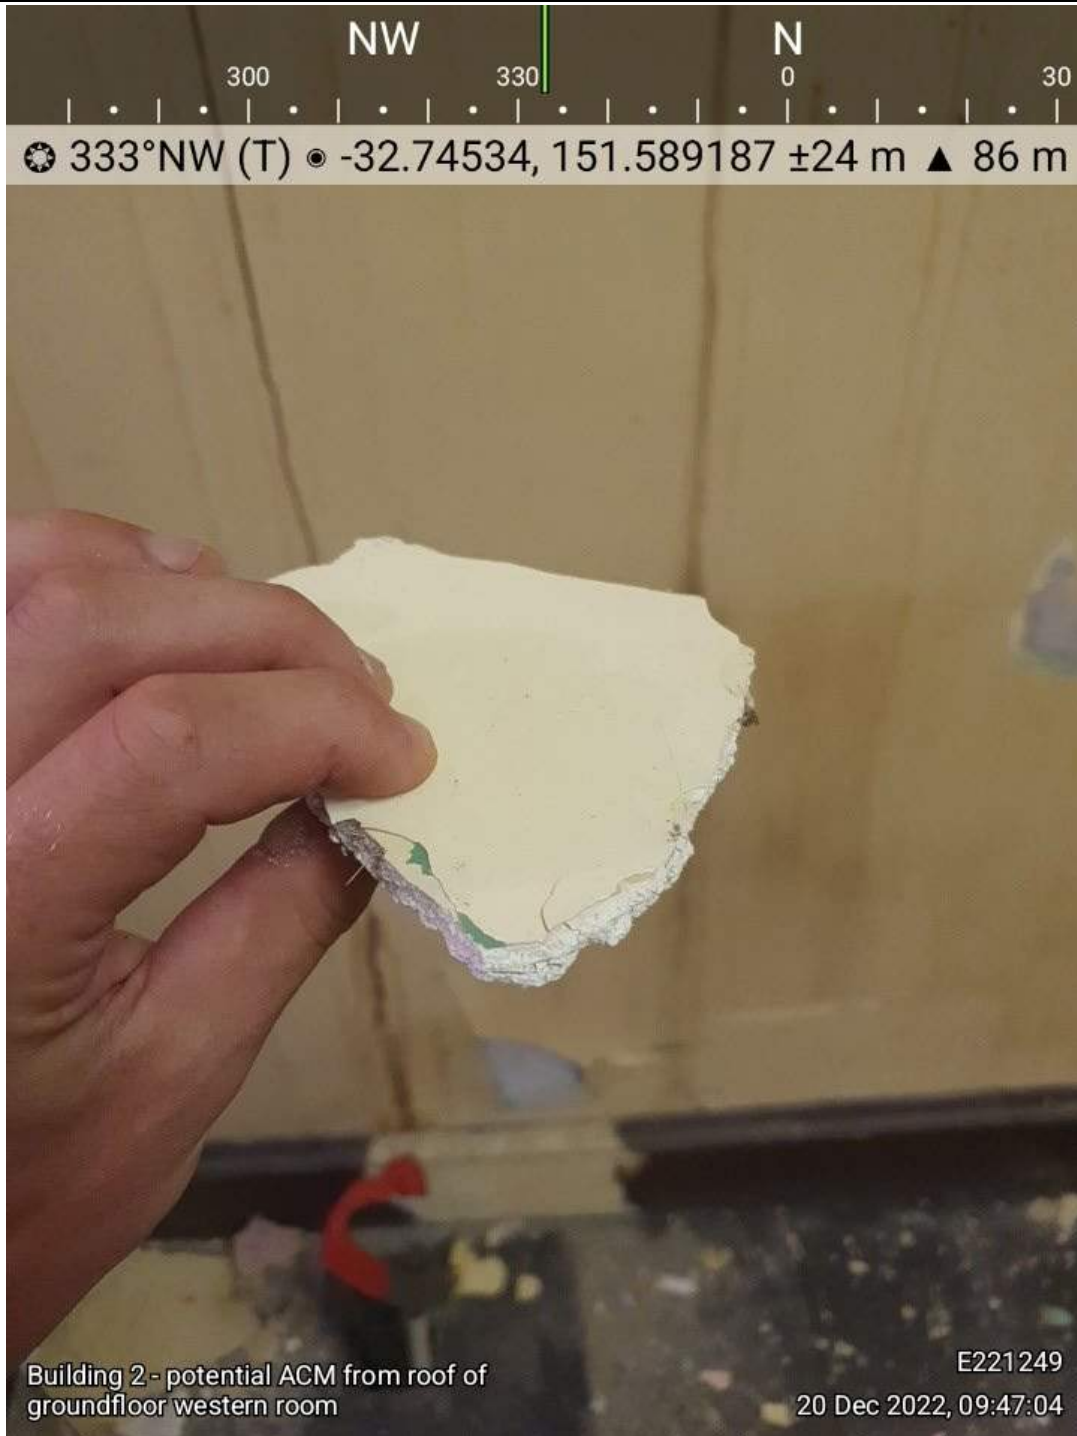
Photo 1

| Feature | Photos (Appendix D) | Comments |
|---|---|--|
| Building 2 – Former Lieutenant Governor’s Residence | 1, 2, 3, 4 and 5 | <p>Building 2 was disused during the time of inspection. A former exercise/gym area was identified in the basement. Other rooms in Building 2 may have been used for office spaces.</p> <p>Potential ACM was observed in the ceiling material of the ground floor and in the wall cladding in the basement. Water damage resulting from ingress of groundwater was observed in the basement. ACM may also be associated with the carpet in the exercise/gym area.</p> |

Potential ACM identified in roof of western room

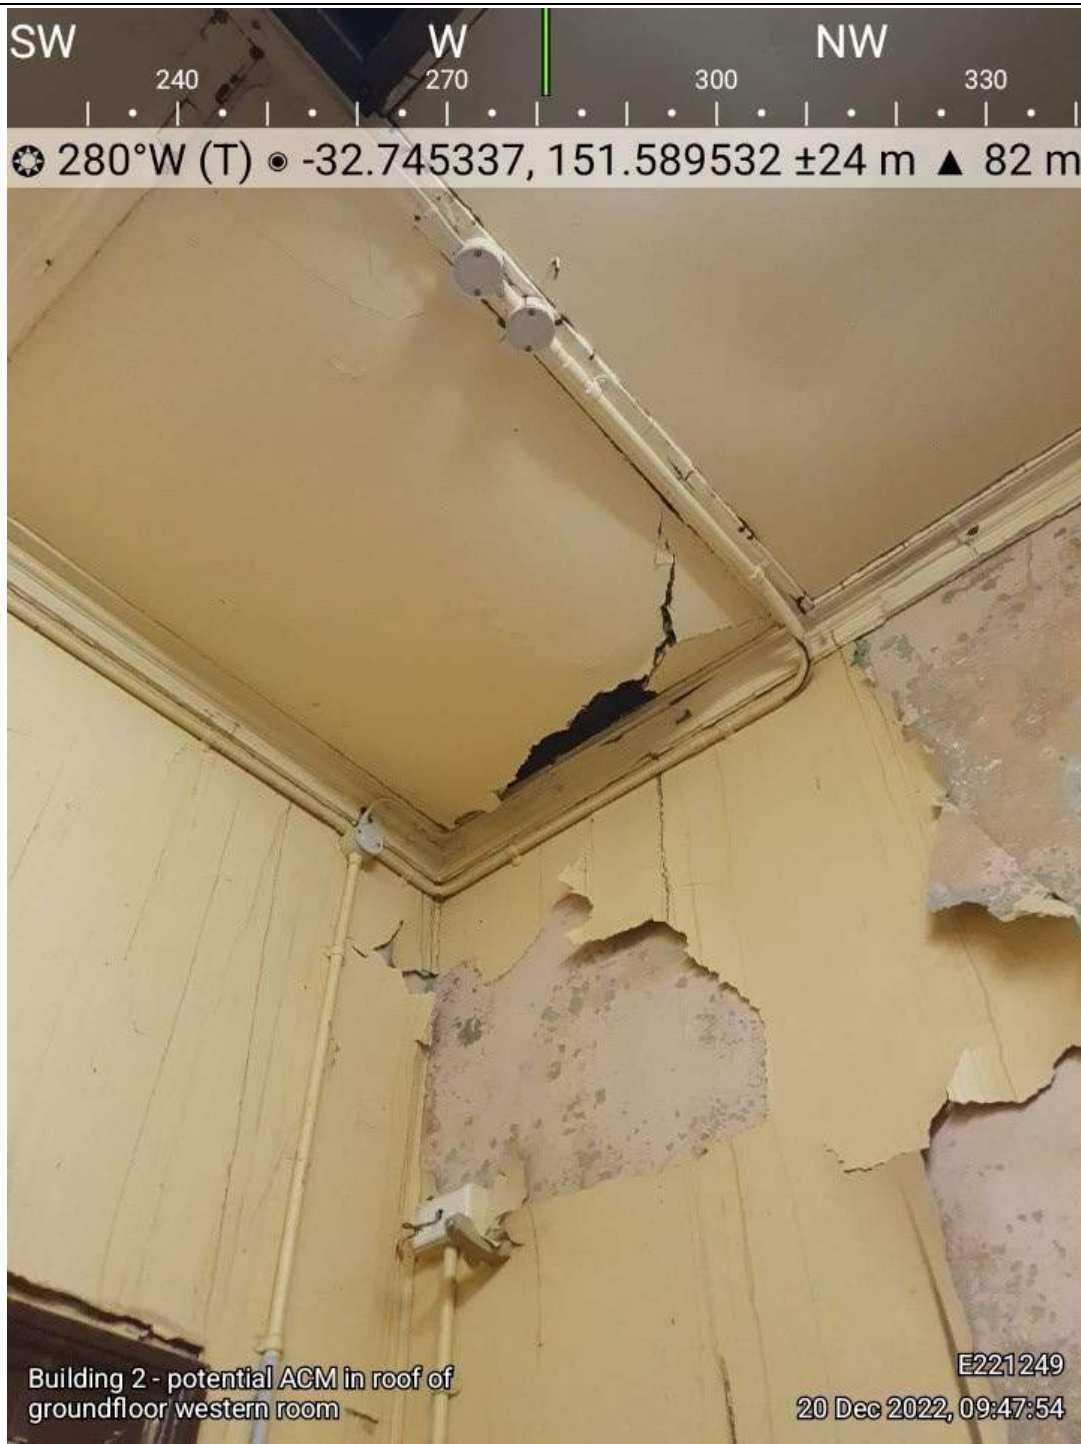
Photo 2

Potential ACM in roof of western room

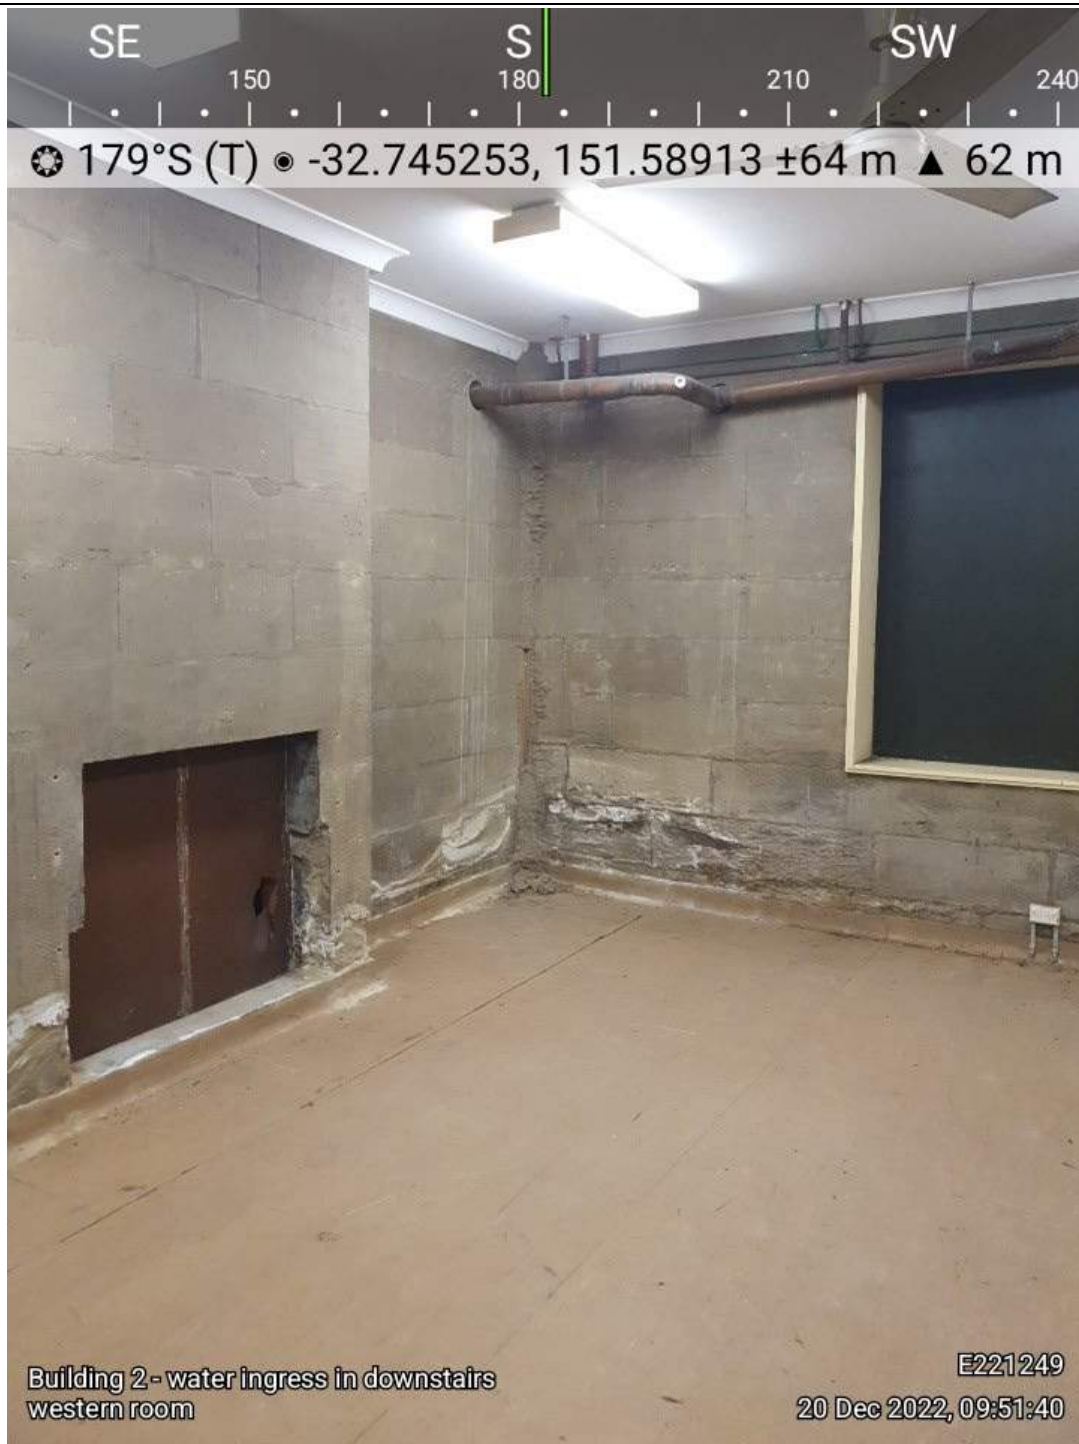
Photo 3

Water ingress in western room

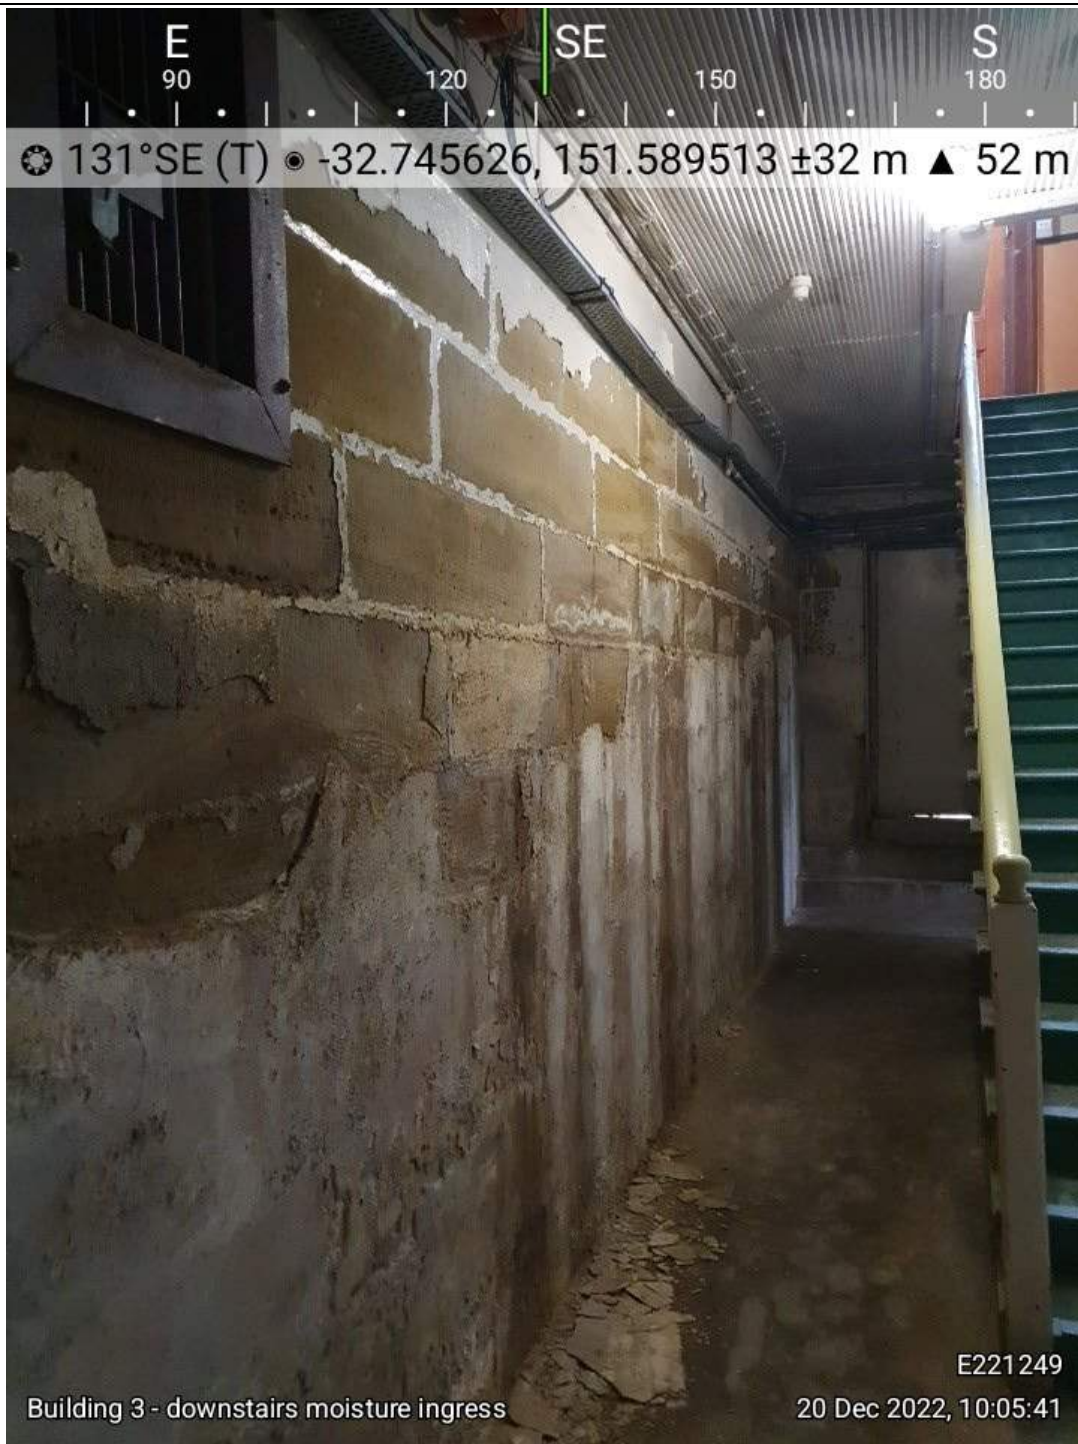
Photo 6

| Feature | Photos (Appendix D) | Comments |
|---|---|--|
| Building 3 – Former Governor’s Residence | 6 | <p>Building 3 was largely used by the Maitland Gaol Visitor Information Centre at the time of inspection. This included a reception area and conference room downstairs and a kitchen area and office space upstairs. Two upstairs rooms were also used as rehearsal spaces for the University of Newcastle’s Conservatorium. The basement is used as document and electronics storage.</p> <p>Potential ACM was observed in the wall cladding in the basement. Water damage resulting from ingress of groundwater was observed in the basement.</p> |

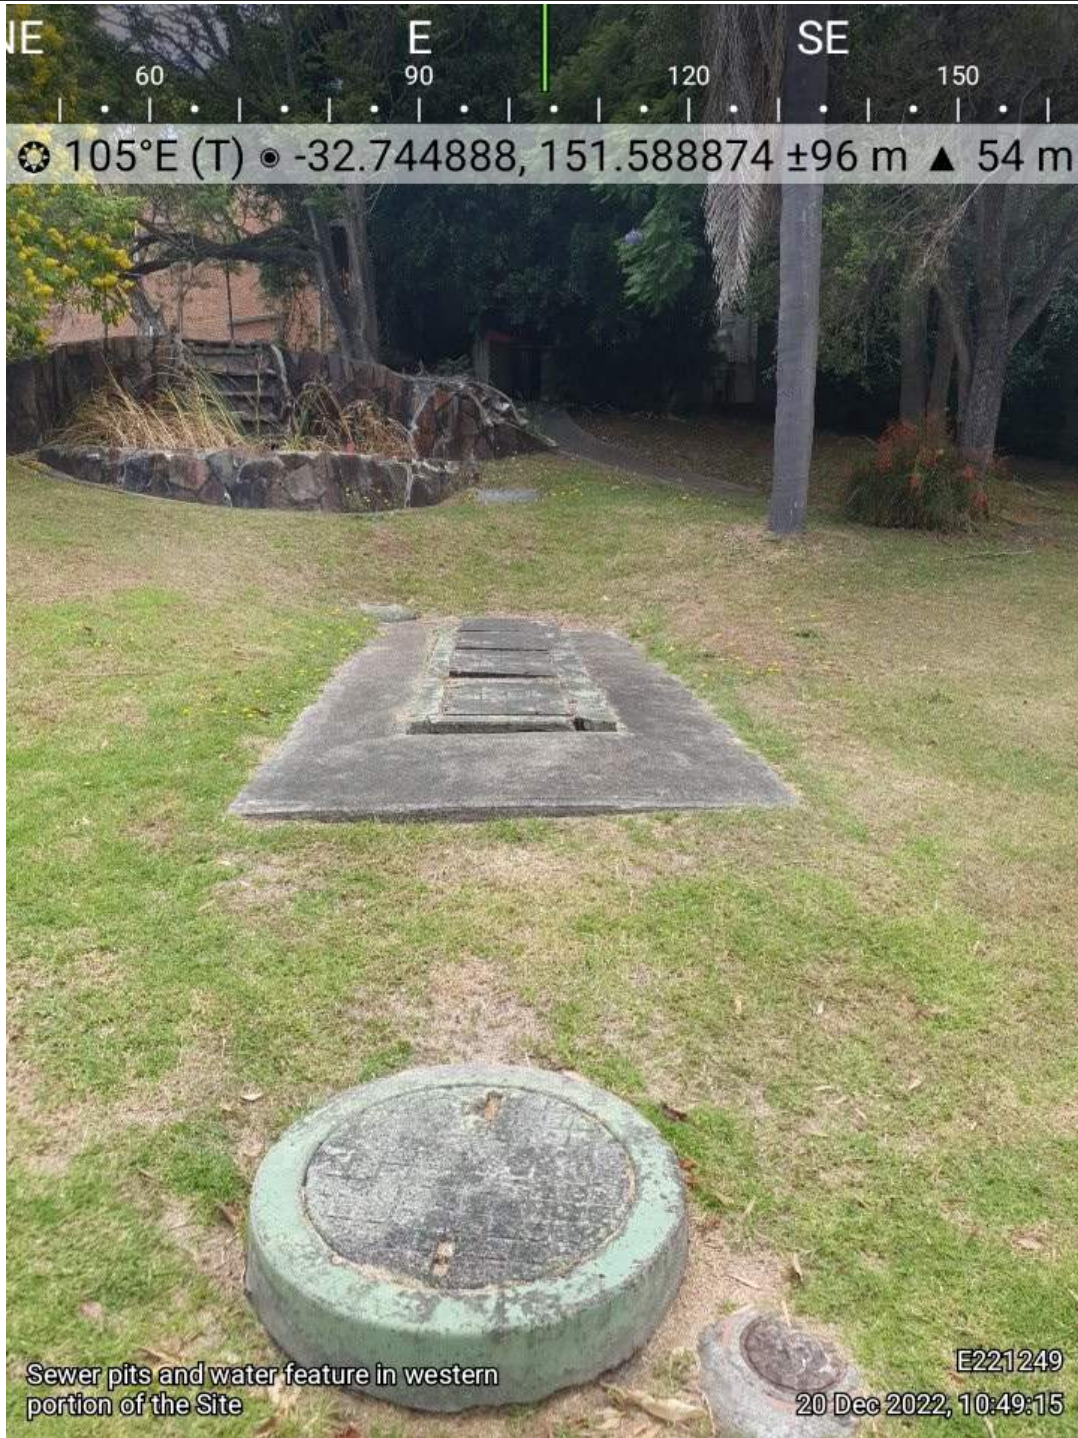
Photo 15

| Feature | Photos (Appendix D) | Comments |
|---|---|---|
| Water Feature | 15 | A disused water feature was observed in the western portion of the Site. |

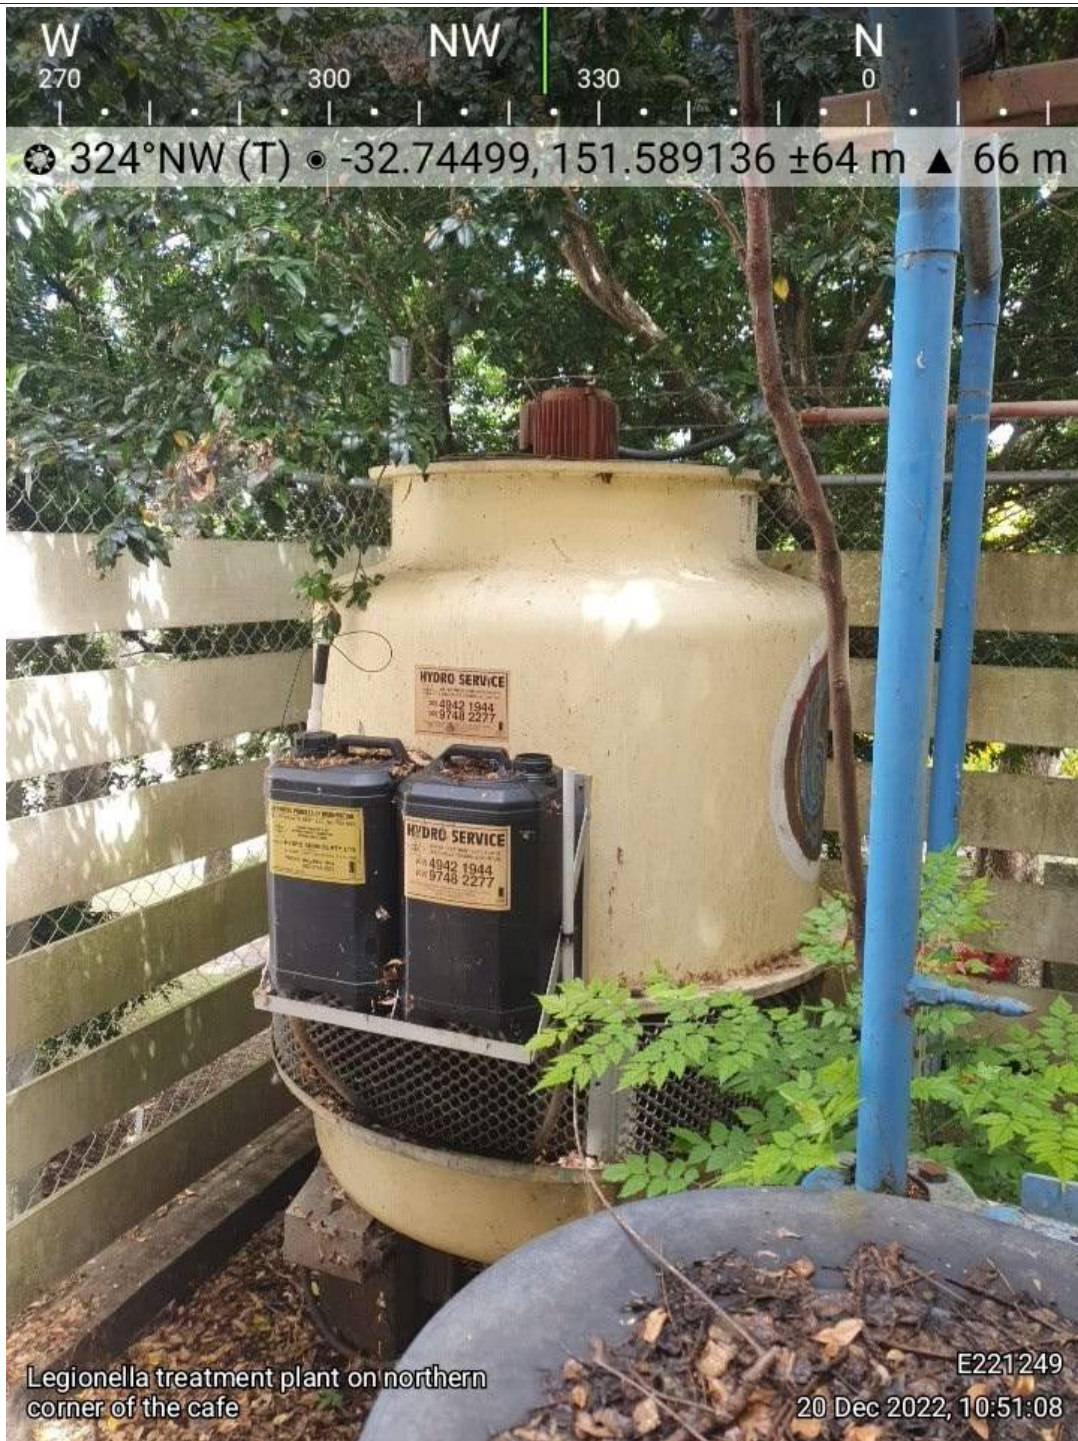
Photo 16

| Feature | Photos (Appendix D) | Comments |
|---|---|---|
| Legionella Treatment Plant | 16 | A disused treatment plant believed to be used for the treatment of legionella in the air conditioning system was observed adjacent to the derelict generator near the Café. Based on observed signage, it is believed that chlorine was used in the treatment process. |

Disused legionella treatment plant
Location: Northern corner of Building 22
Direction: 324° clockwise from north

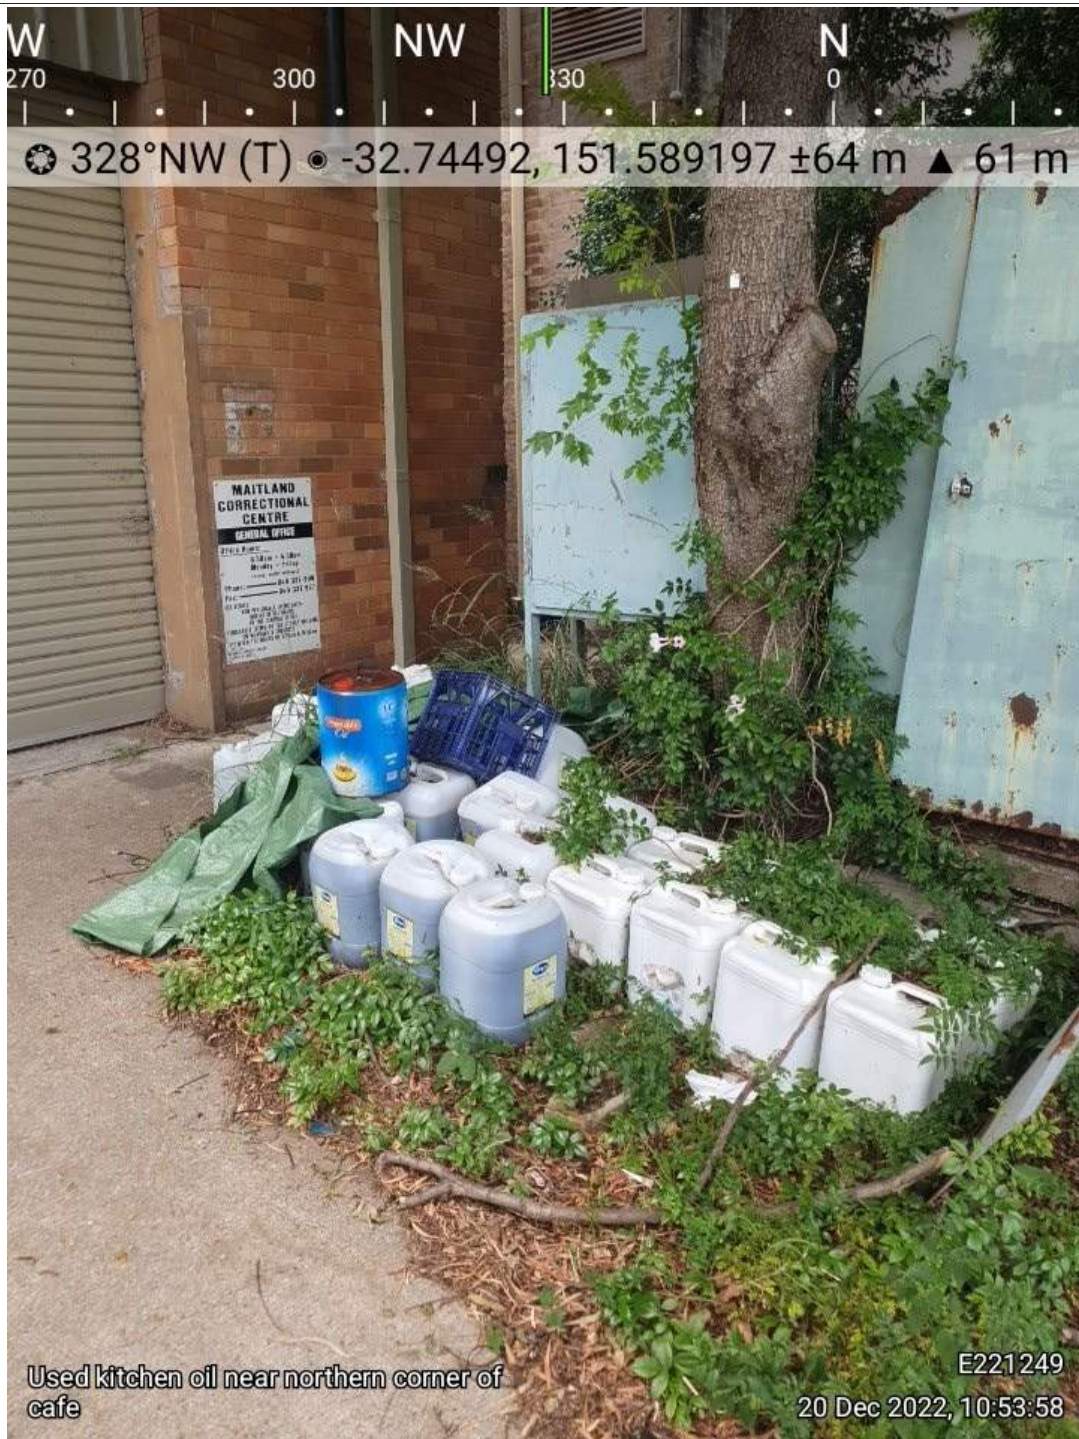
Photo 17

| Feature | Photos (Appendix D) | Comments |
|---|---|---|
| Generator | 17 | A large, derelict generator was observed in the vegetated area near Buildings 14 and 22. Several 20 L plastic and metal cooking oil drums were observed. The drums were filled to varying levels with what appeared to be used cooking oil. The drums appeared to be intact and were in reasonable condition. |

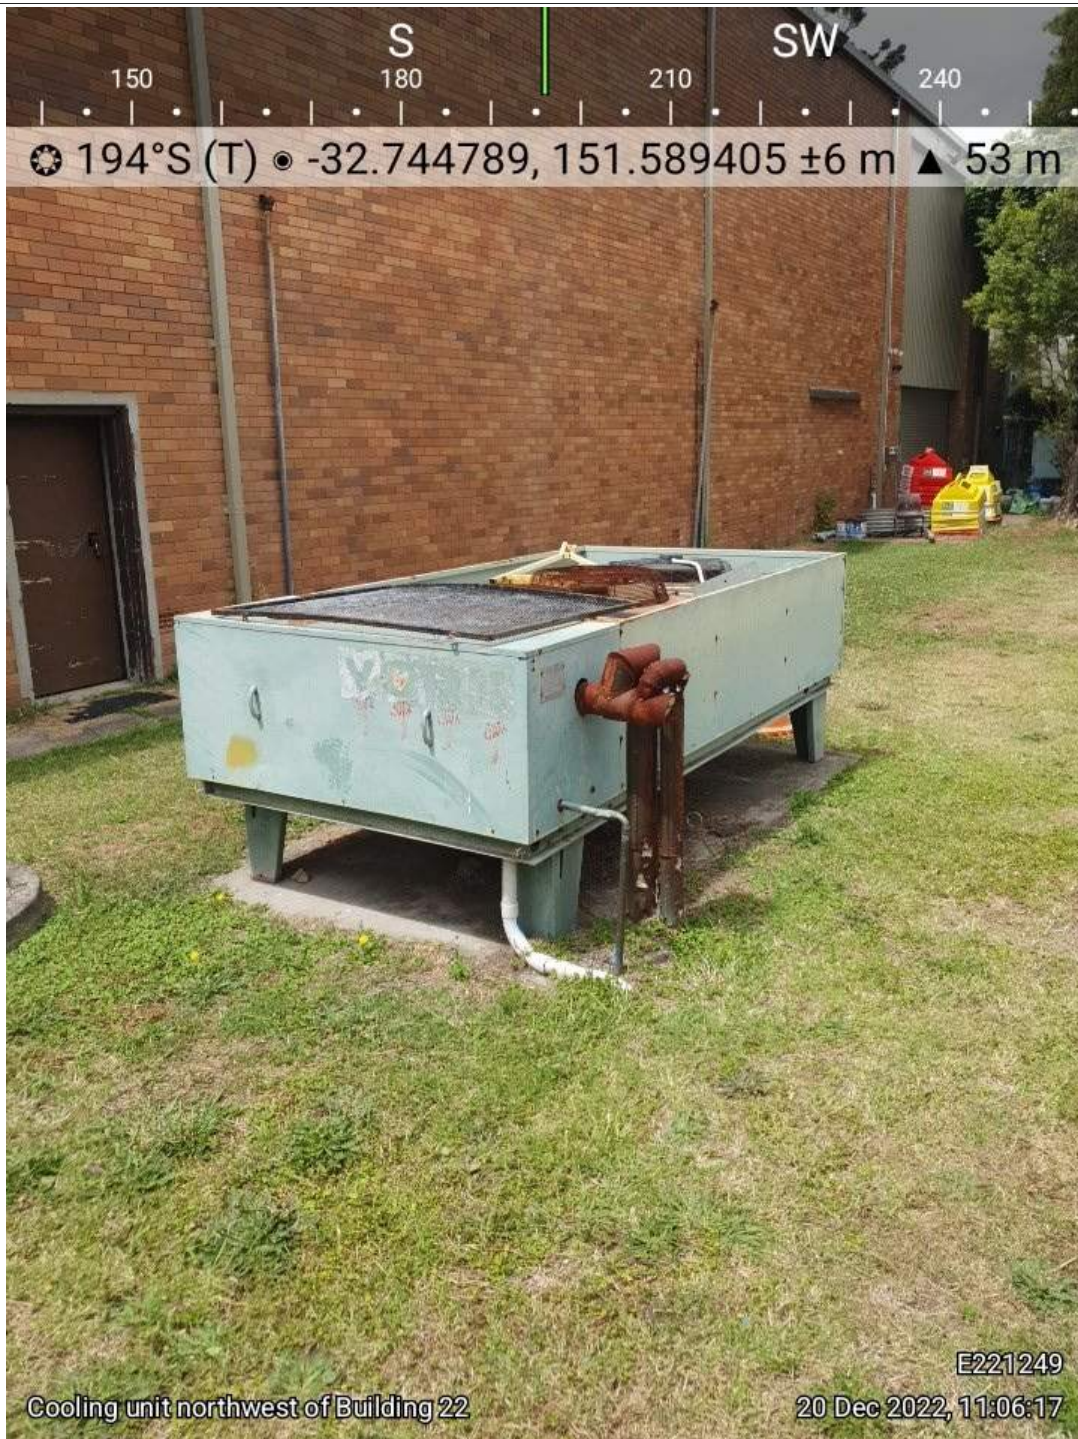
Photo 23

| Feature | Photos (Appendix D) | Comments |
|---|---|--|
| UPSS and Petroleum Bowers | 18, 19, 20 and 23 | <p>Three petroleum bowers (labelled as diesel, super and standard) along with three vents were observed north-west of Building 14. Whilst the exact age of the bowers is unknown, it is estimated that they are over 50 years old. The bowers appeared to be deteriorating with a large amount of surface rust. Fill points and monitoring wells were not observed during the Site inspection.</p> |

| Feature | Photos (Appendix D) | Comments |
|---|---|---|
| Cooling Unit | 23 | A large cooling unit was observed during the Site inspection on the ground to the north-west of Building 14. The unit appears to have been disconnected and was in reasonable condition with some surface rust. |

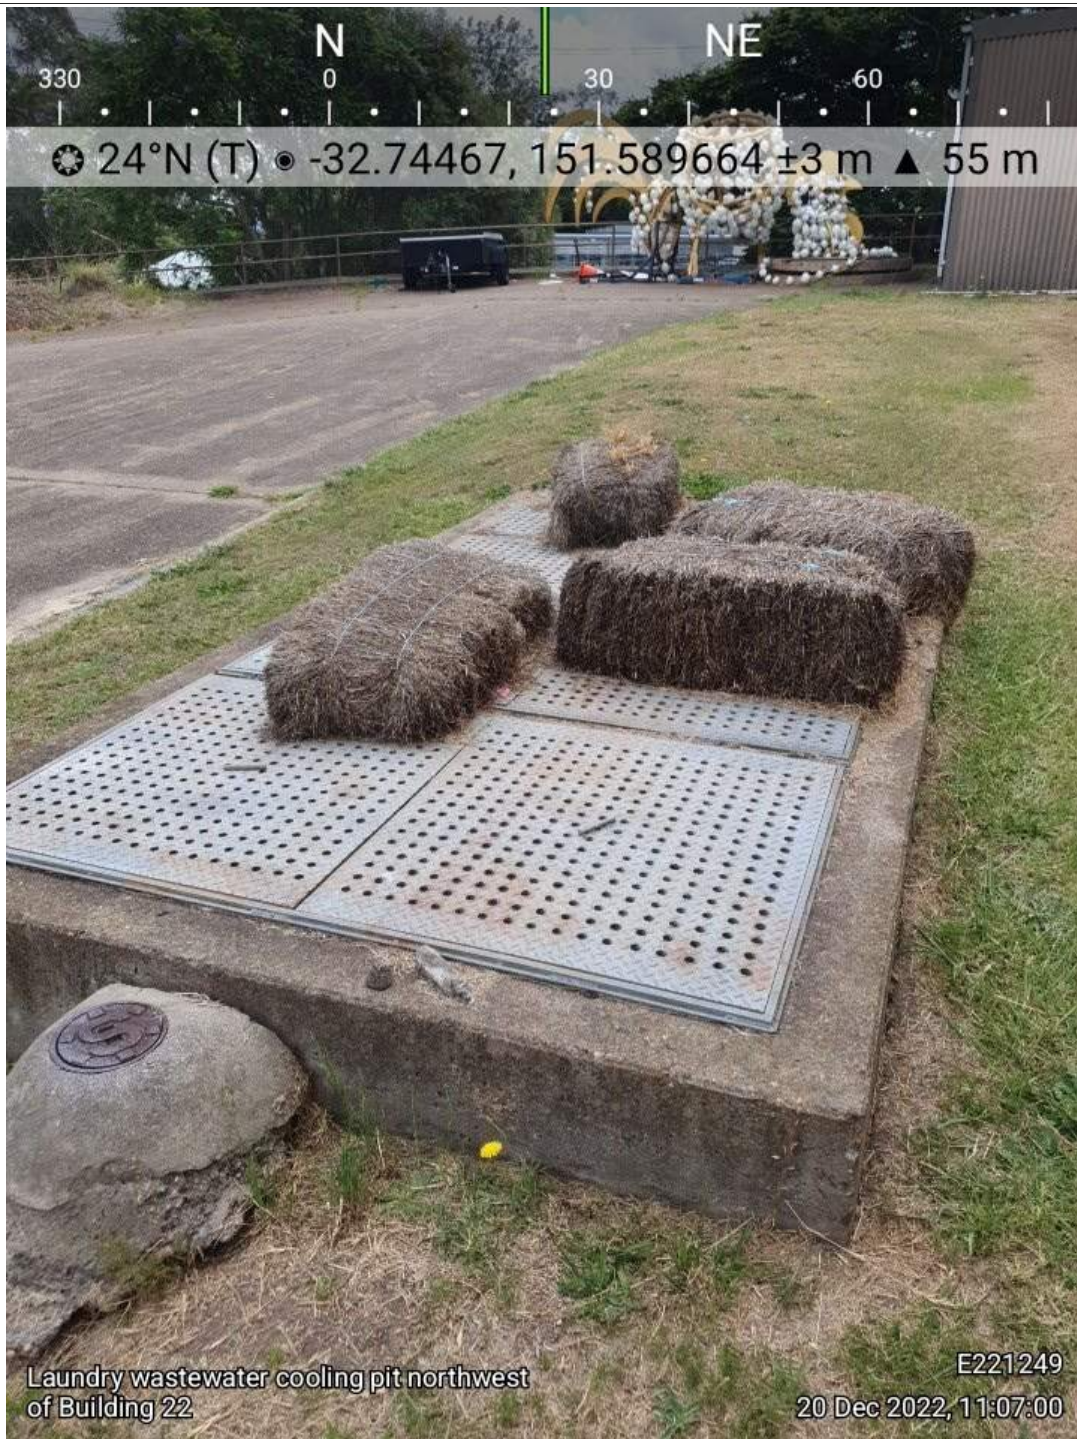
Photo 24

| Feature | Photos (Appendix D) | Comments |
|---|---|---|
| Wastewater Cooling Pit | 24 | A large pit was observed towards the northern area of the Site. It is understood that wastewater from the laundry was held here to cool prior to discharge into the sewer. It was non-operational at the time of inspection. |

Disused legionella treatment plant
Location: Northern corner of Building 14
Direction: 324° clockwise from north
