# ***Arborist Report***

**Client: Largs Property Group**

Address: 2 Dunmore Road,

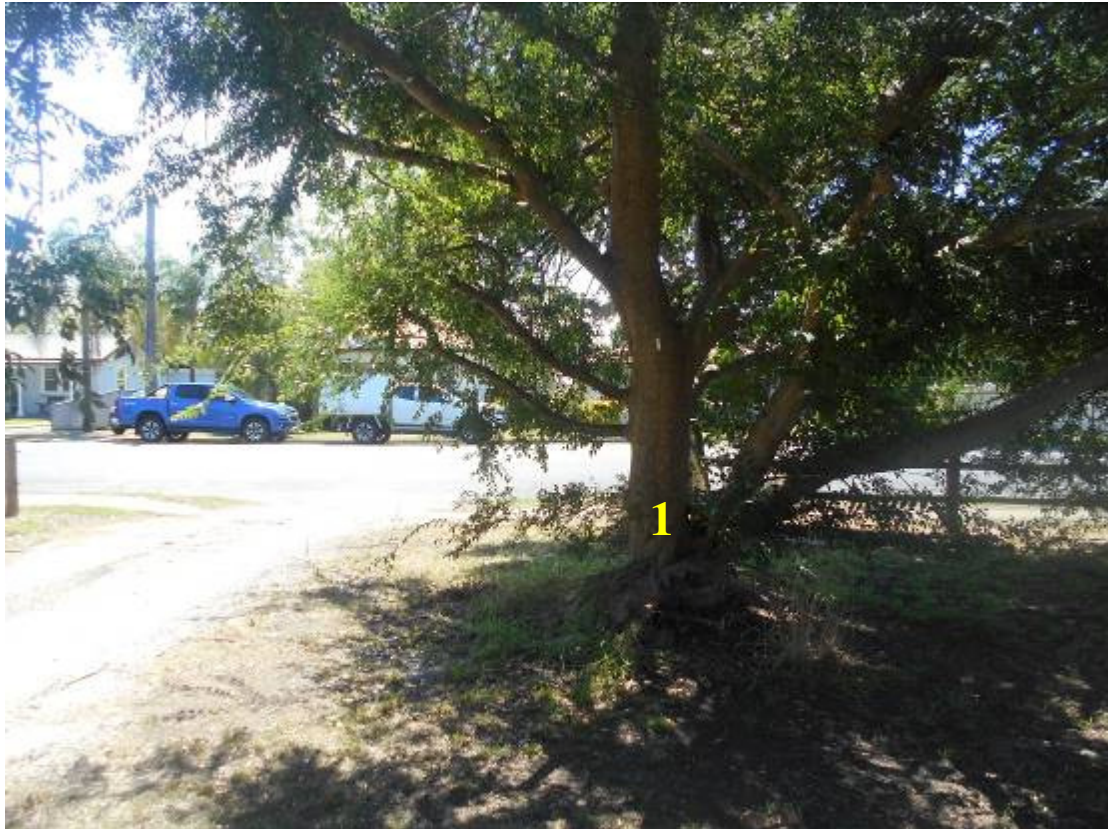
Figure 4 – showing the location of Tree 1.

| Tree No | Scientific Name | Common Name | DBH (MM) | Height (M) | AGE CLASS | Vigour | SPREAD N.E.S.W. | ULE | Comments |
|---|---|---|---|---|---|---|---|---|---|
| 1 | Ulmus parvifolia | Chinese Elm | 420,210,<br>240,220 | 12 | M | G | 7,7,9,7 | 2d | 4 main leaders, Symmetrical, LCR = 90 – 95% |

- It is recommended that Trees 1 - 24 (24 in total) be removed immediately (before commencement of building works) by a qualified arborist (minimum certificate 2 in arboriculture). It is recommended that professional indemnity and public liability insurances be current and sighted before commencement of works begin. The level of cover has to be one in agreement between Largs Property Group and the arborist.

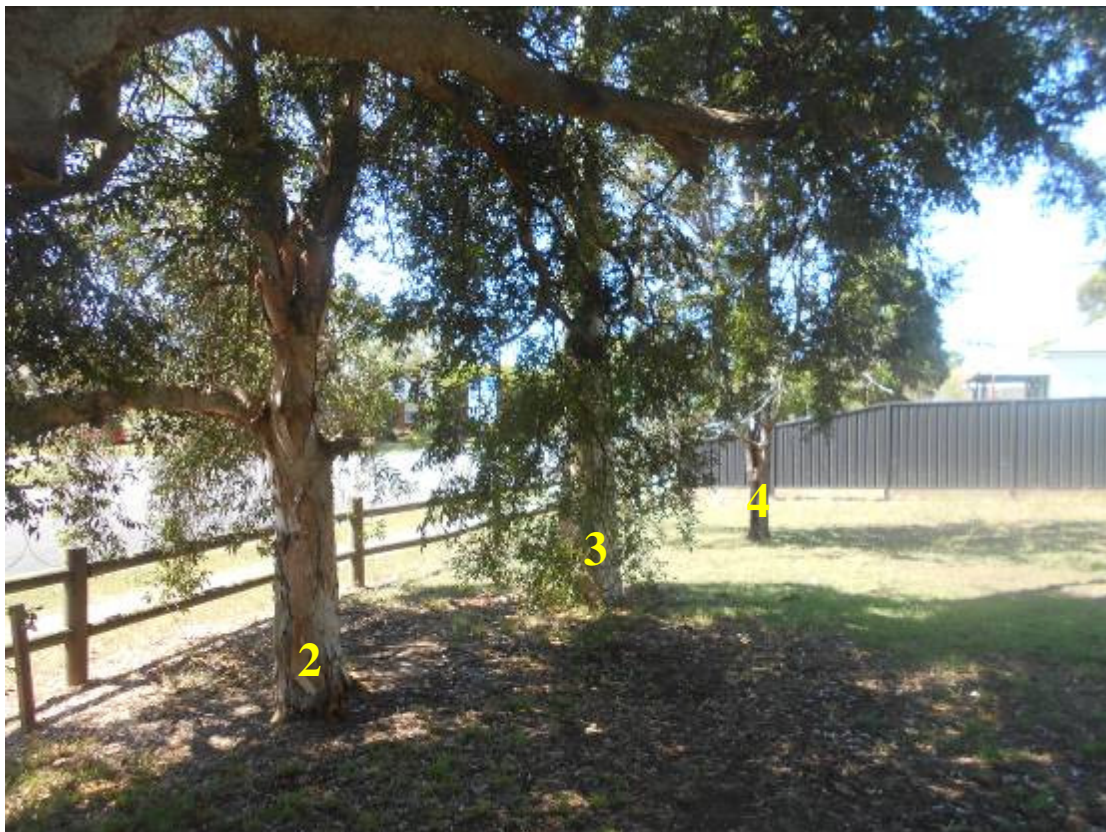
Figure 5 – showing the location of Trees 2 - 4

Tree 2 has been given an SRZ and TPZ of 2.20 & 3.84 metres in accordance with Australian Standards 4970 - 2009. Tree 2 is located 2.6 metres to the proposed development. AS 4970 – 2009 indicates that the TPZ radius is taken from the centre of the trunk. This leaves a spatial separation of 2.79 metres from the centre of the trunk to the proposed development. The overall loss of TPZ has been calculated at 8.56% that complies with AS 4970 – 2009. Tree 2 will be located inside the proposed driveway footprint associated with Units 1 & 2. In order to construct the driveway will require the removal of Tree 2. This species will reach a TPZ of 9 to 10 metres when fully mature. The root plate at this size would encroach into the development. Tree 2 is earmarked for removal before commencement of building works on site.

Tree 3 has been given an SRZ and TPZ of 2.49 & 4.86 metres in accordance with Australian Standards 4970 - 2009. Tree 3 is located in the front yard as shown in Figure 5. Tree 3 is located 2.3 metres to the proposed building footprint (Unit 2). AS 4970 – 2009 indicates that the TPZ radius is taken from the centre of the trunk. This leaves a spatial separation of 2.56 metres from the centre of the trunk to the proposed development and associated earthworks. The overall loss of TPZ has been calculated at 18.09% that doesn't comply with AS 4970 – 2009. Tree 3 is earmarked for removal before commencement of building works on site.

Tree 4 has been given an SRZ and TPZ of 2.00 & 3.12 metres in accordance with Australian Standards 4970 - 2009. Tree 4 is located in the front yard of the subject property. Tree 4 is located 0.6 metres to the proposed internal driveway that will connect to Units 3 – 12. AS 4970 – 2009 indicates that the TPZ radius is taken from the centre of the trunk. This leaves a spatial separation of 0.75 metres from the centre of the trunk to the proposed internal driveway. The overall loss of TPZ has been calculated at 34.85% that doesn't comply with AS 4970 – 2009. The incursion into the SRZ on one side has been calculated at 62.50% that will lead to loss of structural integrity. Tree 4 is earmarked for removal before commencement of building works on site.

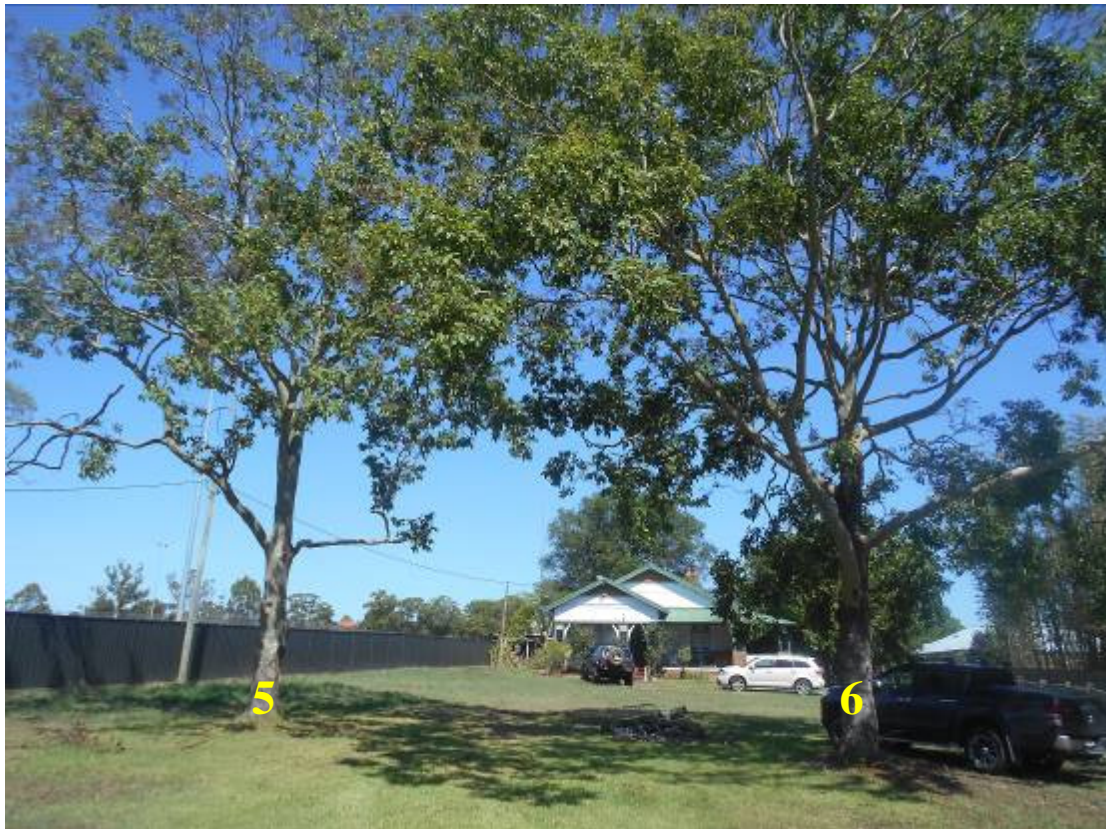
Tree 5 has been given an SRZ and TPZ of 2.65 & 6.36 metres in accordance with Australian Standards 4970 - 2009. Tree 5 is located in the middle of the front yard. Tree 5 is located inside the proposed development (Unit 3). In order to construct the proposed development will require the removal of Tree 5. Tree 5 is earmarked for removal before commencement of building works on site.

Tree 6 has been given an SRZ and TPZ of 2.53 & 5.76 metres in accordance with Australian Standards 4970 - 2009. Tree 6 is located in the middle of the front yard. Tree 6 is located inside the proposed development (Unit 3). In order to construct the proposed development will require the removal of Tree 6. Tree 6 is earmarked for removal before commencement of building works on site.

Figure 6 – showing the location of Trees 5 & 6. Both trees are located inside the proposed building footprint (Unit 3).

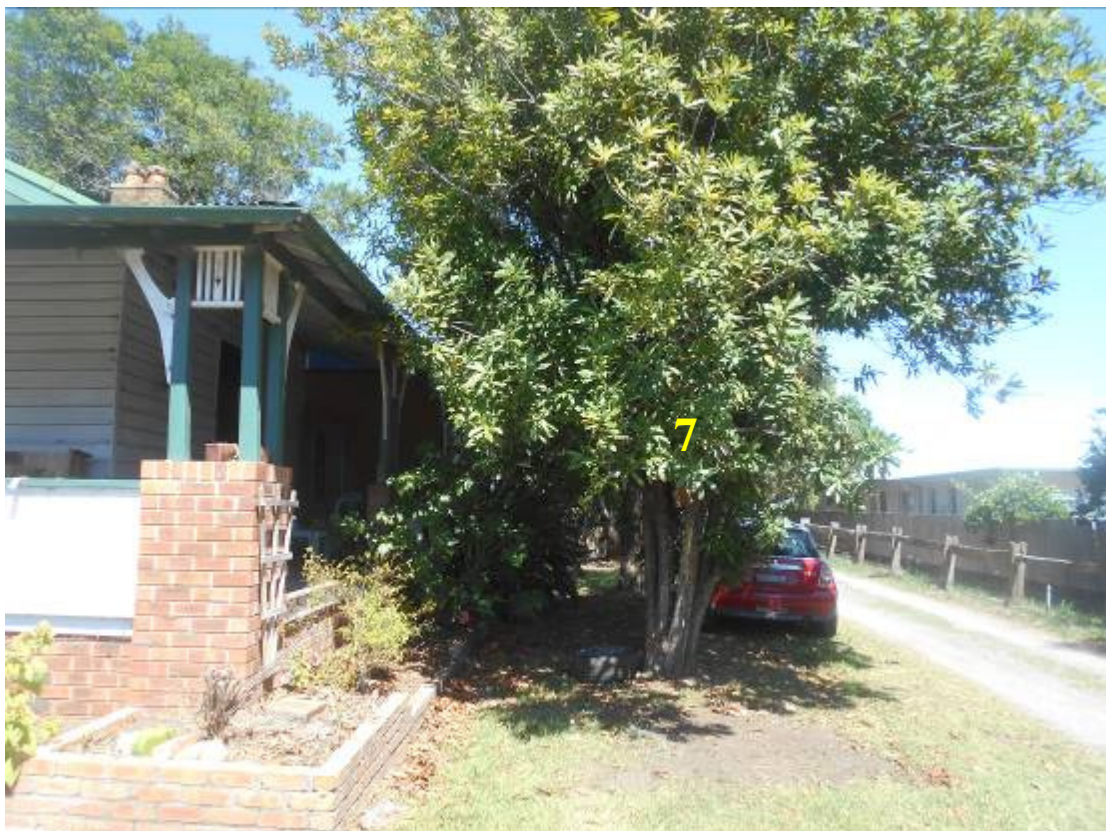
Tree 7 has been given an SRZ and TPZ of 2.61 & 6.12 metres in accordance with Australian Standards 4970 - 2009. Tree 7 is located towards the side of the house as indicated in Figure 7. Tree 7 is located 0.4 metres to the proposed development (Unit 7). AS 4970 – 2009 indicates that the TPZ radius is taken from the centre of the trunk. This leaves a spatial separation of 0.68 metres from the centre of the trunk to the proposed development. The overall loss of TPZ has been calculated at 42.22% that doesn't comply with AS 4970 – 2009. The incursion into the SRZ on one side has been calculated at 62.50% that will lead to loss of structural integrity. Tree 7 is located 2.7 metres to the existing veranda and 4.7 metres to the wall of the building. Tree 7 is considered exempt as it is a nut tree (Maitland DCP – Section 1.1 F). It is also considered exempt as outlined in Maitland DCP – Section 1 – Note 4. Maitland DCP highlights that the 3 metre distance is measured from the closest part of the trunk to the footings of the building. Tree 7 is earmarked for removal before commencement of building works on site.

Figure 7 – showing the location of Tree 7 in the front yard of the subject property.  
Tree 7

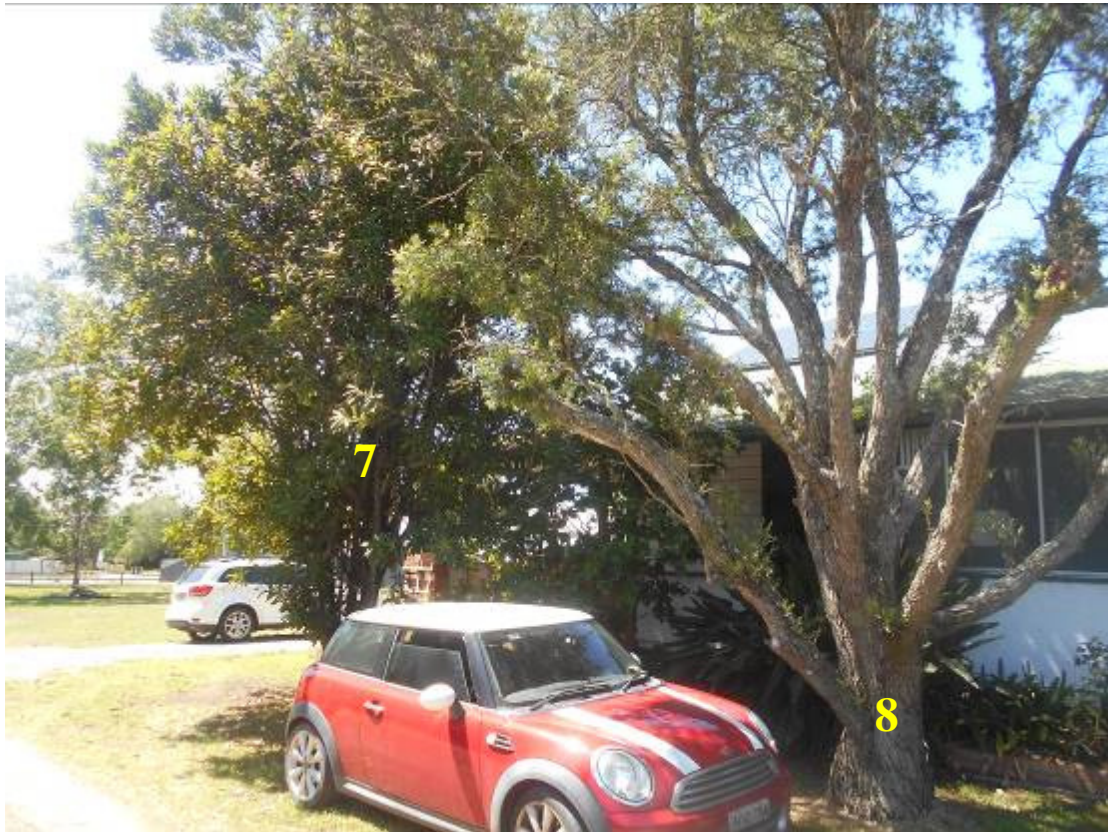
Figure 8 – showing the location of Trees 7 & 8.

Tree 8 has been given an SRZ and TPZ of 2.77 & 8.16 metres in accordance with Australian Standards 4970 - 2009. Tree 8 is located inside the proposed development (Unit 7). In order to construct the proposed development will require the removal of Tree 8. Tree 8 is earmarked for removal before commencement of building works on site.

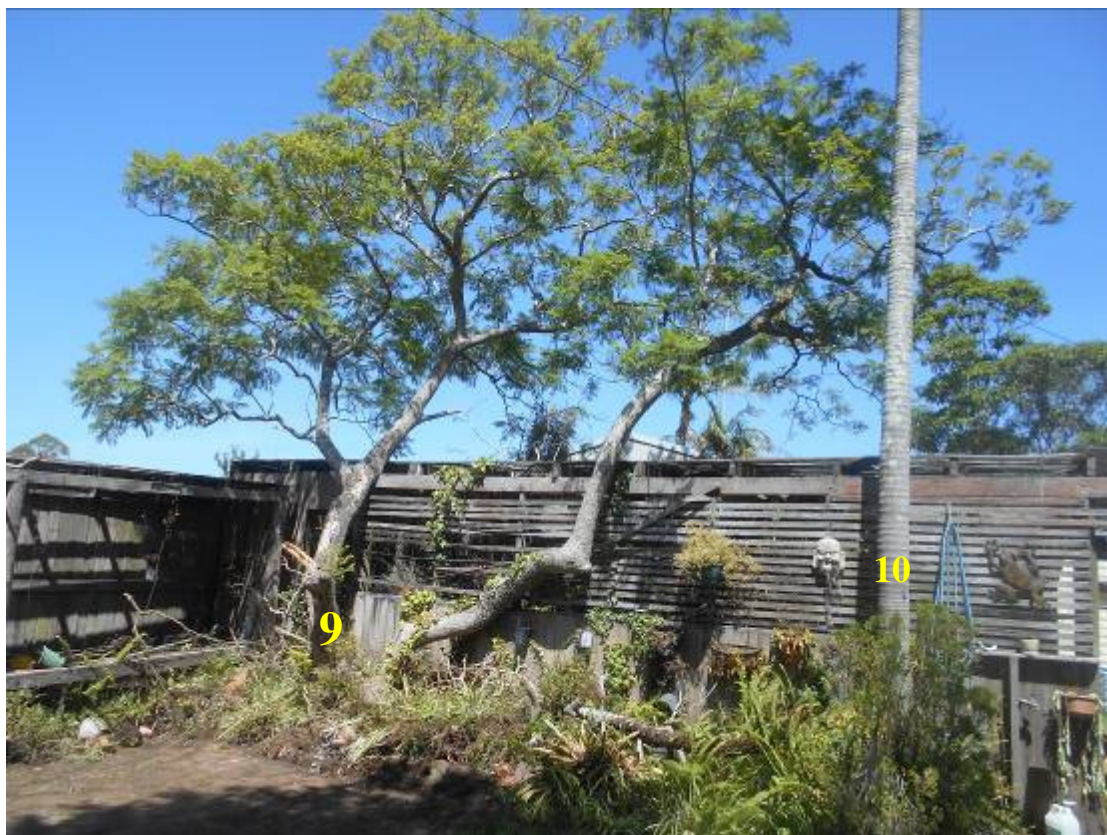
Figure 9 – showing the location of Trees 9 & 10

Tree 9 has been given an SRZ and TPZ of 2.46 & 4.08 metres in accordance with Australian Standards 4970 - 2009. Tree 9 is located in the backyard of the subject property. Tree 9 is located inside the proposed internal driveway. In order to construct the proposed driveway will require the removal of Tree 9. Tree 9 is earmarked for removal before commencement of building works on site.

Tree 10 has been given an SRZ and TPZ of 1.50 & 2.50 metres in accordance with Australian Standards 4970 - 2009. Tree 10 is located inside the proposed development (Unit 9). In order to construct the proposed development will require the removal of Tree 10. Tree 10 is earmarked for removal before commencement of building works on site.

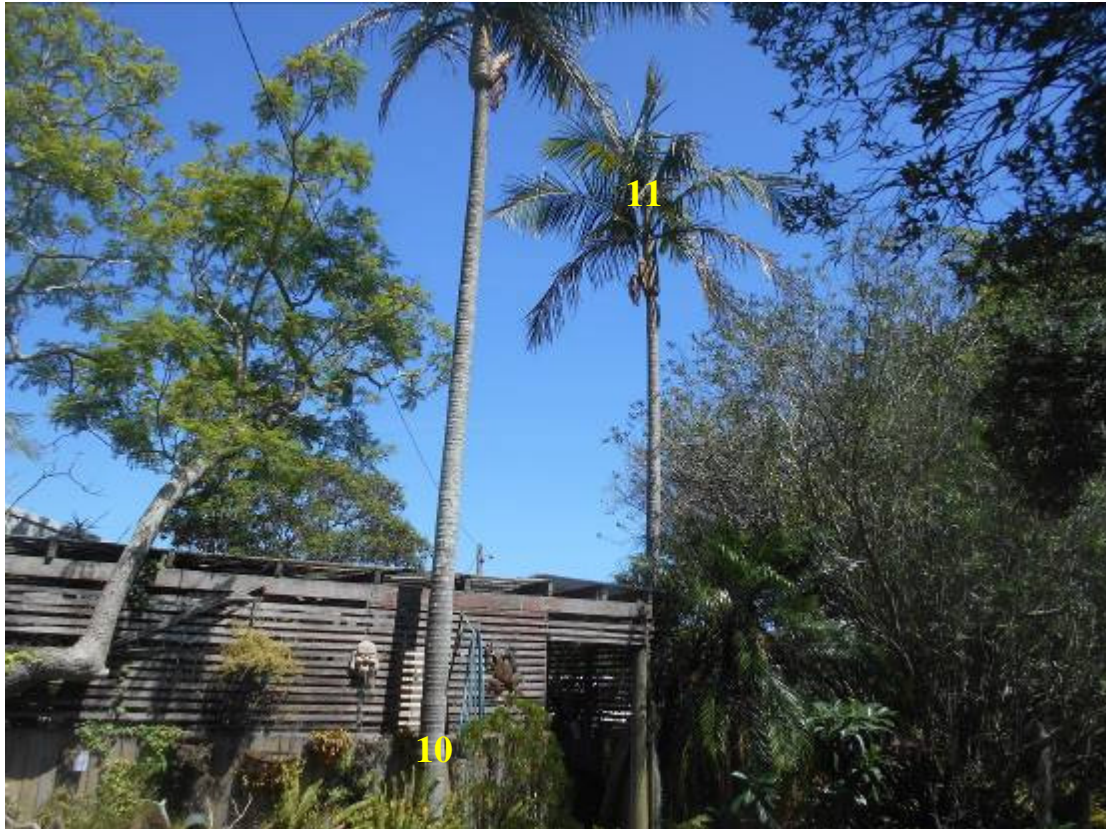
Figure 10 – showing the location of Trees 10 & 11.

Tree 11 has been given an SRZ and TPZ of 1.50 & 2.50 metres in accordance with Australian Standards 4970 - 2009. Tree 11 is located inside the proposed development (Unit 9). In order to construct the proposed development will require the removal of Tree 11. Tree 11 is earmarked for removal before commencement of building works on site.

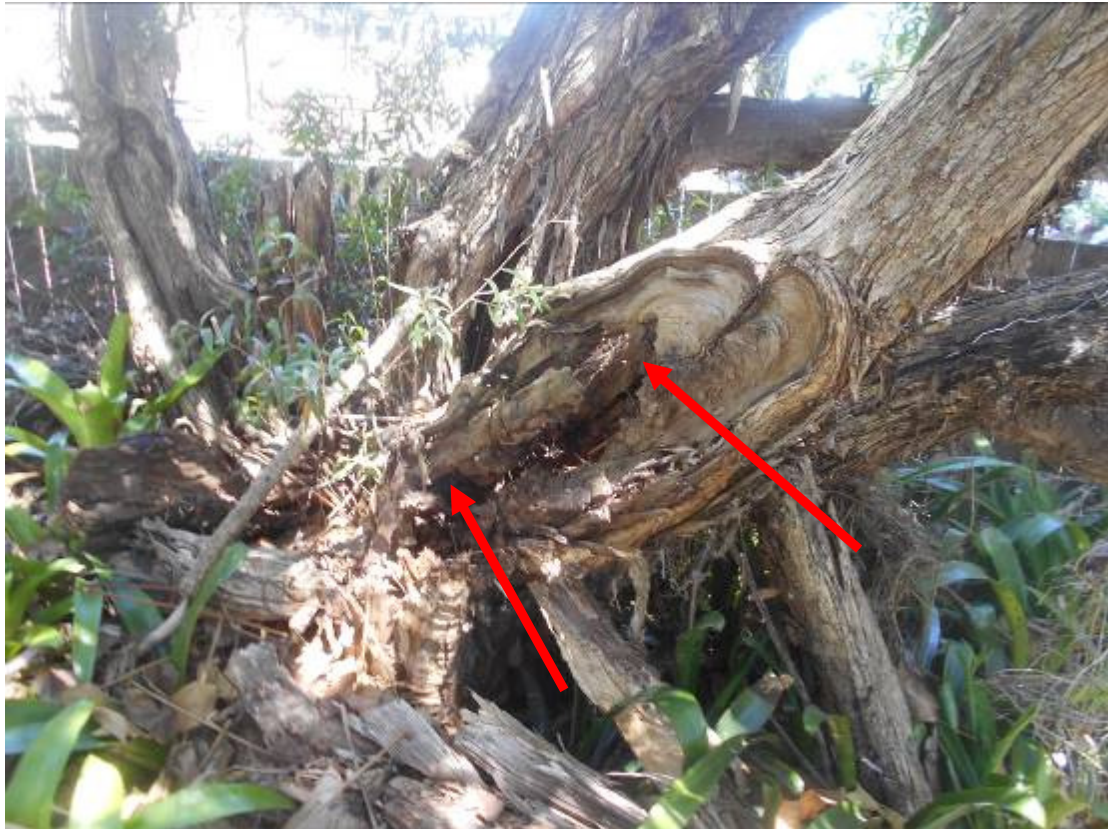
| Tree No | Scientific Name | Common Name | DBH (MM) | Height (M) | AGE CLASS | Vigour | SPREAD N.E.S.W. | ULE | Comments |
|---|---|---|---|---|---|---|---|---|---|
| 12 | Olea europea | Olive | 560 | 6 | OM | F | 7,0,0,1 | 4a | Asymmetrical, major decay in trunk at base, partially failed at ground level (1 <sup>st</sup> order branch). LCR = 65 – 70% |

Tree 12 has been given an SRZ and TPZ of 2.81 & 6.72 metres in accordance with Australian Standards 4970 - 2009. Tree 12 is located inside the proposed development (Unit 10). In order to construct the proposed development will require the removal of Tree 12. Tree 12 is in poor form and condition. Tree 12 has partially failed at ground level and is not growing true to form. Tree 12 is earmarked for removal before commencement of building works on site.

Figure 11 – showing the location of Tree 12. Tree 12 has extensive decay in the trunk at ground level

- There is the potential that Tree 7 is exempt in accordance with Maitland DCP (Part B5). This is due to the distance to the existing dwelling. Tree 7 is also considered exempt due to species type. Trees 12 & 21 have low landscape significance due to species type. Tree 12 is in poor form and condition with extensive decay at the base.

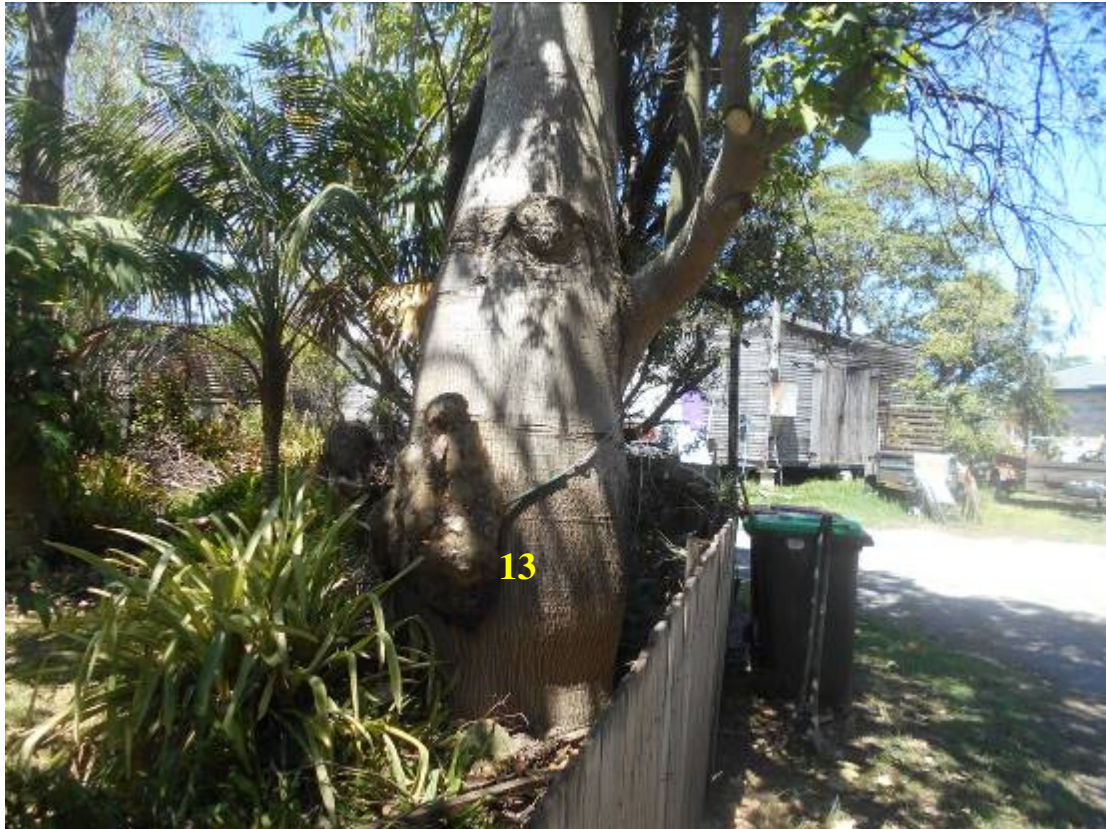
Tree 13 has been given an SRZ and TPZ of 3.42 & 11.64 metres in accordance with Australian Standards 4970 - 2009. Tree 13 is located inside the proposed development (Unit 10). In order to construct the proposed development will require the removal of Tree 13. Tree 13 is earmarked for removal before commencement of building works on site.

Figure 12 – showing the location of Tree 13 in the backyard. Tree 13 will require removal to construct the proposed development.

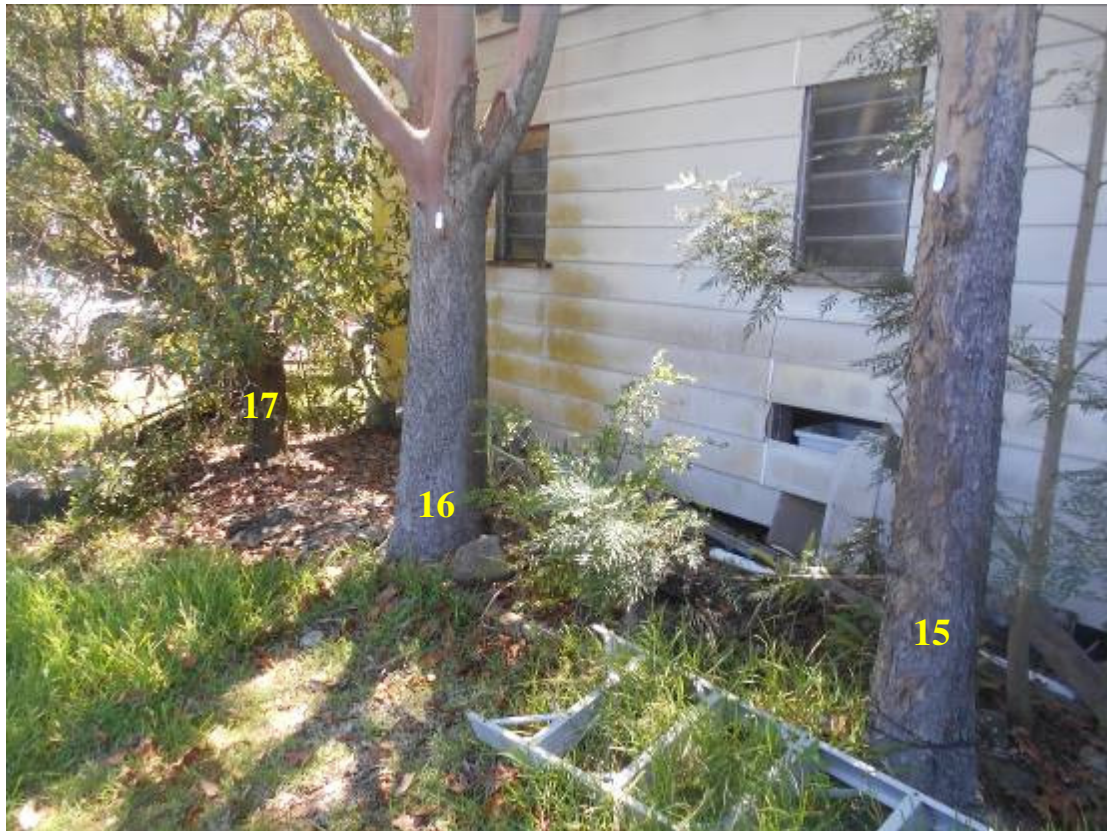
Figure 13 – showing the location of Trees 15 – 17.

Tree 15 has been given an SRZ and TPZ of 1.82 & 2.40 metres in accordance with Australian Standards 4970 - 2009. Tree 14 is located inside the proposed development (Unit 11). In order to construct the proposed development will require the removal of Tree 15. Tree 15 is earmarked for removal before commencement of building works on site.

Tree 16 has been given an SRZ and TPZ of 2.23 & 3.90 metres in accordance with Australian Standards 4970 - 2009. Tree 16 is located inside the proposed development (Unit 11). In order to construct the proposed development will require the removal of Tree 16. Tree 16 is earmarked for removal before commencement of building works on site.

Tree 17 has been given an SRZ and TPZ of 1.83 & 2.76 metres in accordance with Australian Standards 4970 - 2009. Tree 17 is located inside the proposed development (Unit 11). In order to construct the proposed development will require the removal of Tree 17. Tree 17 is earmarked for removal before commencement of building works on site.

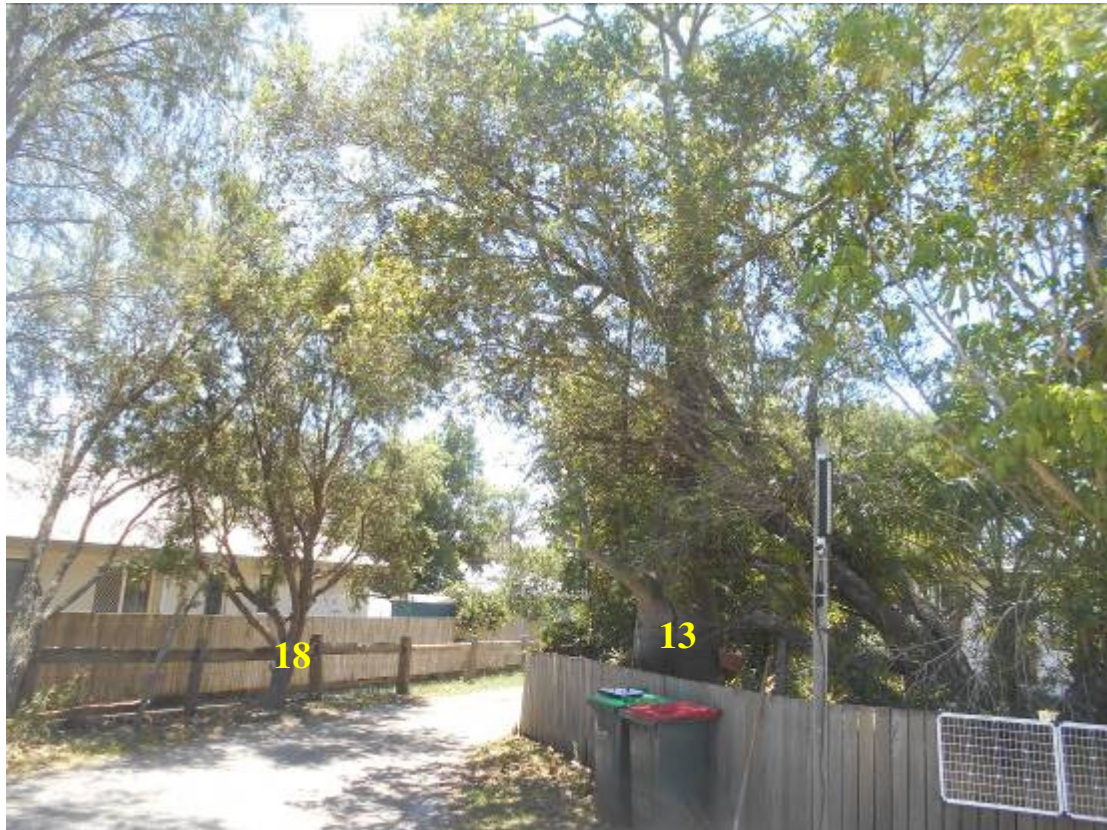
Tree 18 has been given an SRZ and TPZ of 2.00 & 5.04 metres in accordance with Australian Standards 4970 - 2009. Tree 18 is the first of the row of trees along the existing informal driveway. Tree 18 is located inside the proposed development (Unit 9). In order to construct the proposed development will require the removal of Tree 18. Tree 18 is earmarked for removal before commencement of building works on site.

Figure 14 – showing the location of Trees 13 & 18. Tree 18 is the first of a row of trees along the driveway edge that leads to the back of the property.

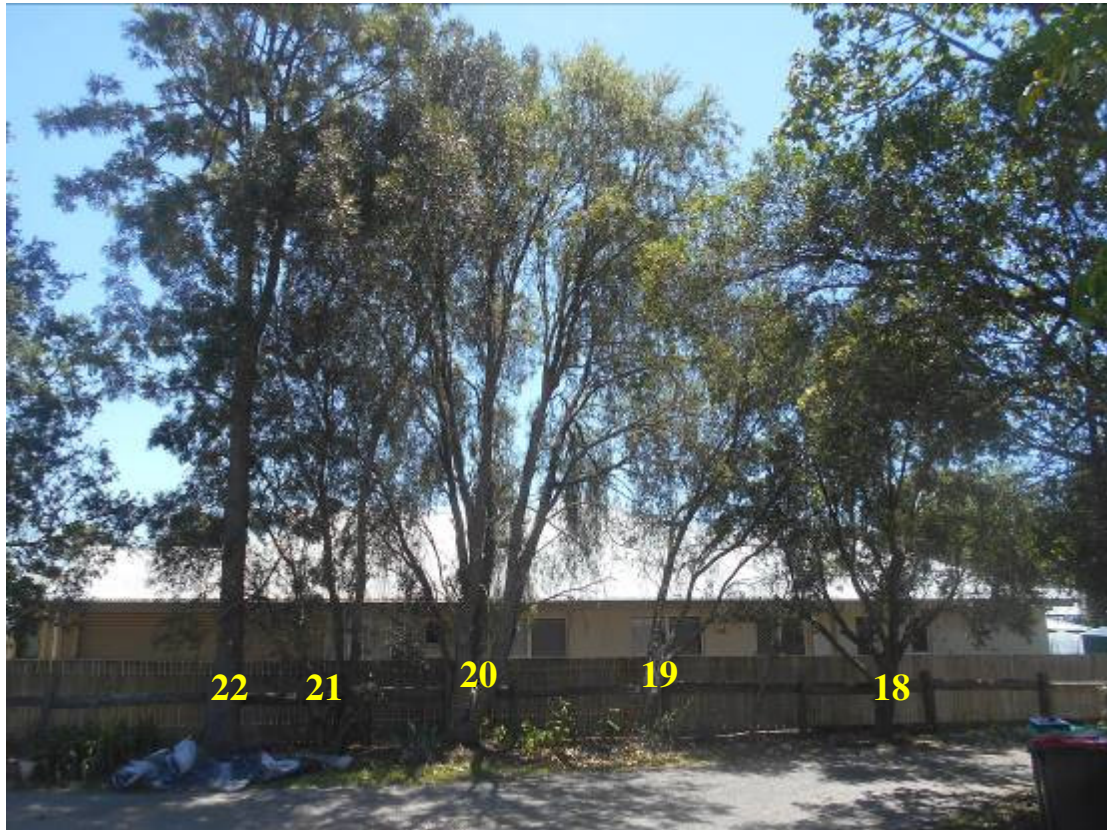
Figure 15 – showing the location of Trees 18 - 22

Tree 19 has been given an SRZ and TPZ of 1.85 & 2.76 metres in accordance with Australian Standards 4970 - 2009. Tree 19 is located inside the proposed development (Unit 10). In order to construct the proposed development will require the removal of Tree 19. Tree 19 is earmarked for removal before commencement of building works on site.

Tree 20 has been given an SRZ and TPZ of 2.49 & 4.56 metres in accordance with Australian Standards 4970 - 2009. Tree 20 is located inside the proposed development (Unit 10). In order to construct the proposed development will require the removal of Tree 20. Tree 20 is earmarked for removal before commencement of building works on site.

Tree 21 has been given an SRZ and TPZ of 2.18 & 3.12 metres in accordance with Australian Standards 4970 - 2009. Tree 21 is located inside the proposed development (Unit 11). In order to construct the proposed development will require the removal of Tree 21. Tree 21 is earmarked for removal before commencement of building works on site.

Tree 22 has been given an SRZ and TPZ of 2.39 & 4.50 metres in accordance with Australian Standards 4970 - 2009. Tree 22 is located inside the proposed development (Unit 11). In order to construct the proposed development will require the removal of Tree 22. Tree 22 is earmarked for removal before commencement of building works on site.

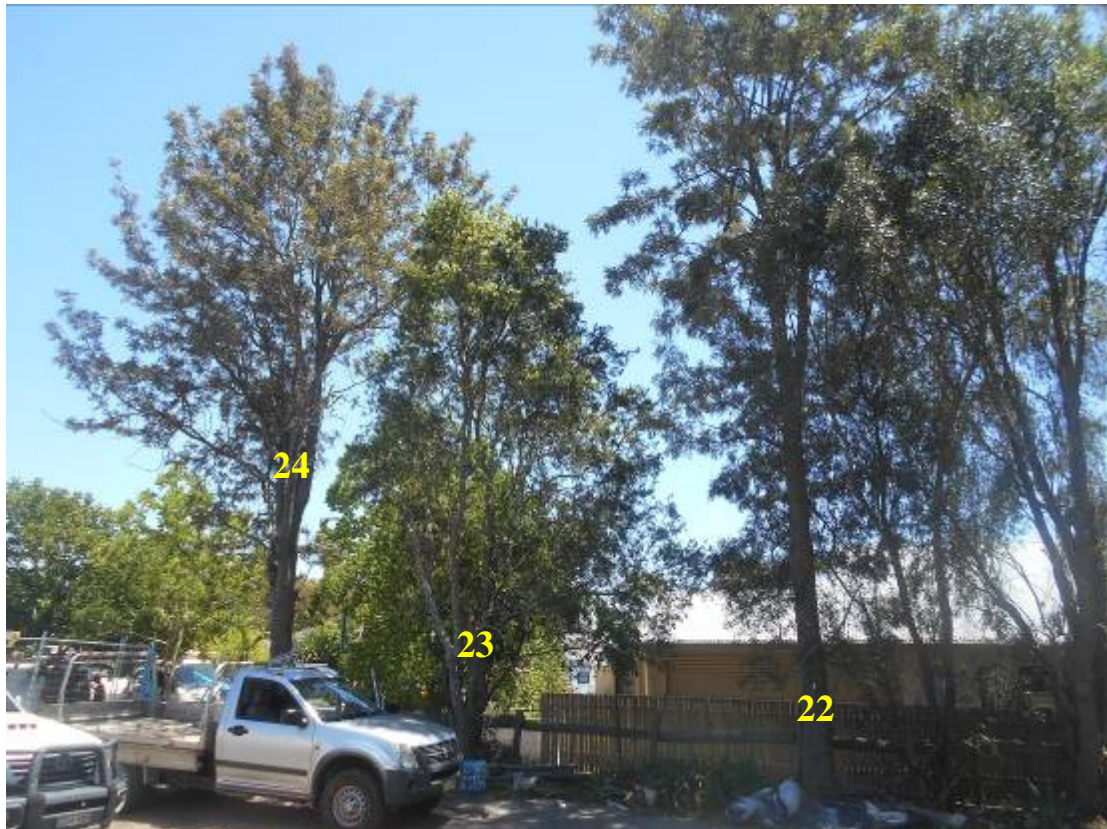
Figure 16 – showing the location of Trees 23 & 24.

Tree 23 has been given an SRZ and TPZ of 2.46 & 5.76 metres in accordance with Australian Standards 4970 - 2009. Tree 23 is located inside the proposed development (Unit 12). In order to construct the proposed development will require the removal of Tree 23. Tree 23 is earmarked for removal before commencement of building works on site.

Tree 24 has been given an SRZ and TPZ of 2.39 & 4.80 metres in accordance with Australian Standards 4970 - 2009. Tree 24 is located inside the proposed development (Unit 12). In order to construct the proposed development will require the removal of Tree 24. Tree 24 is earmarked for removal before commencement of building works on site.
