# Geotechnical Investigation

Anambah Road, Anambah NSW

Prepared for: Thirdi Group c/-Mid North Coast Projects  
EP3867.001 11 December 2024

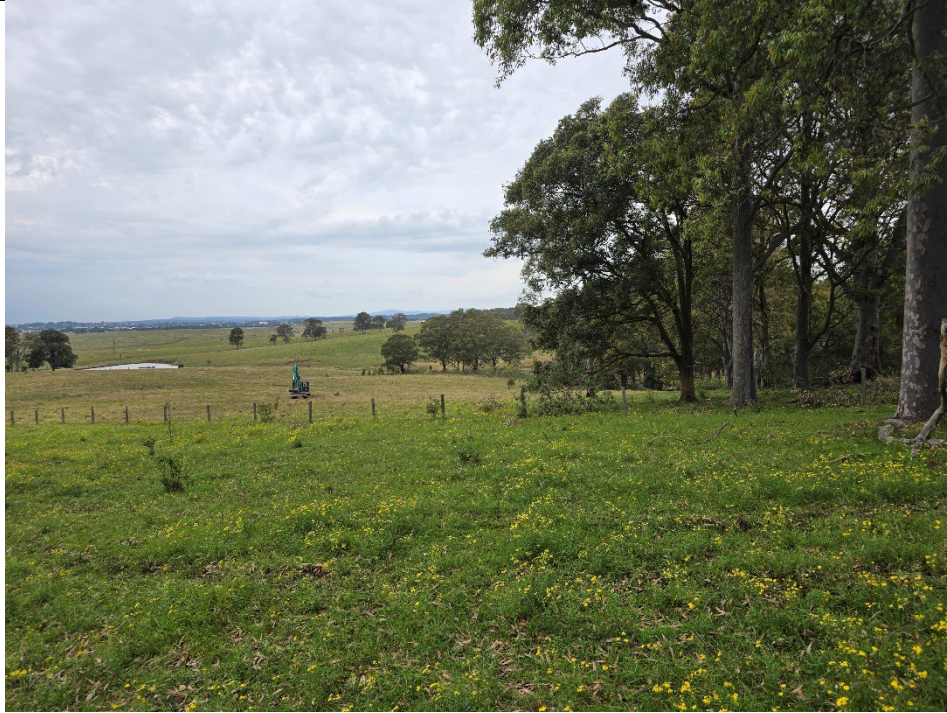
**Plate 3**

**Description:**  
Water dam east  
of site  
boundary

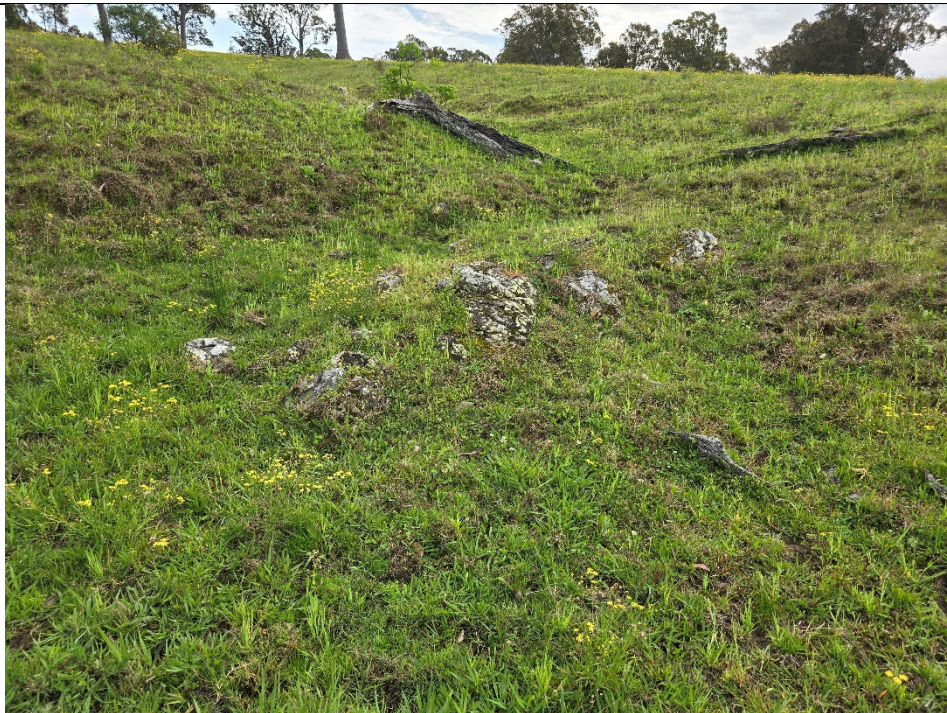
**Plate 4**

**Description:**  
Rock outcrops  
in the elevated  
areas of the  
site

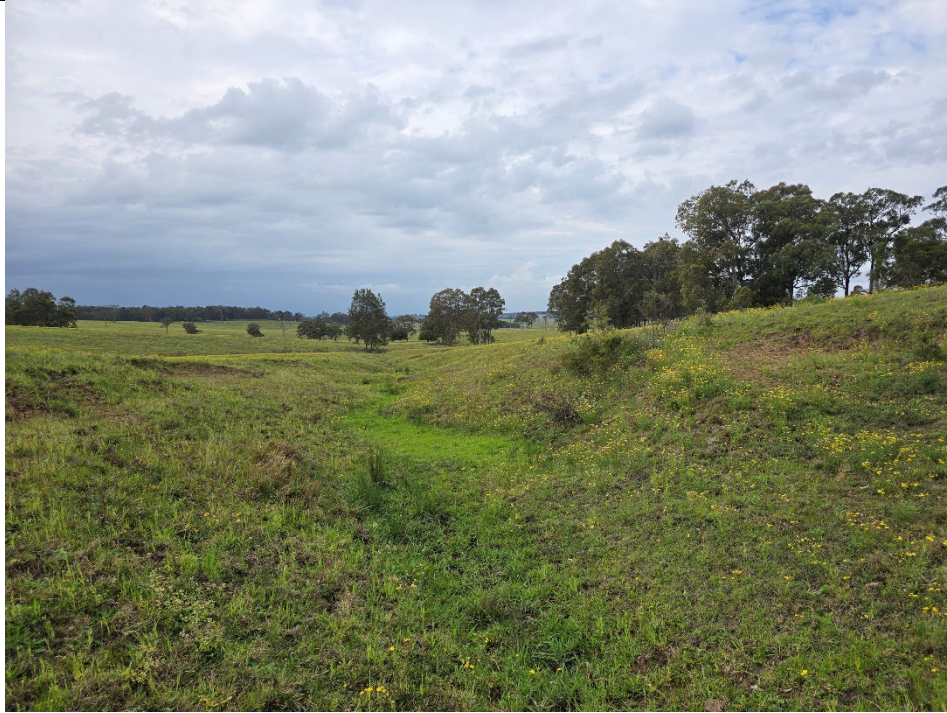
**Plate 5**

**Description:**  
Ephemeral  
creek running  
across the site

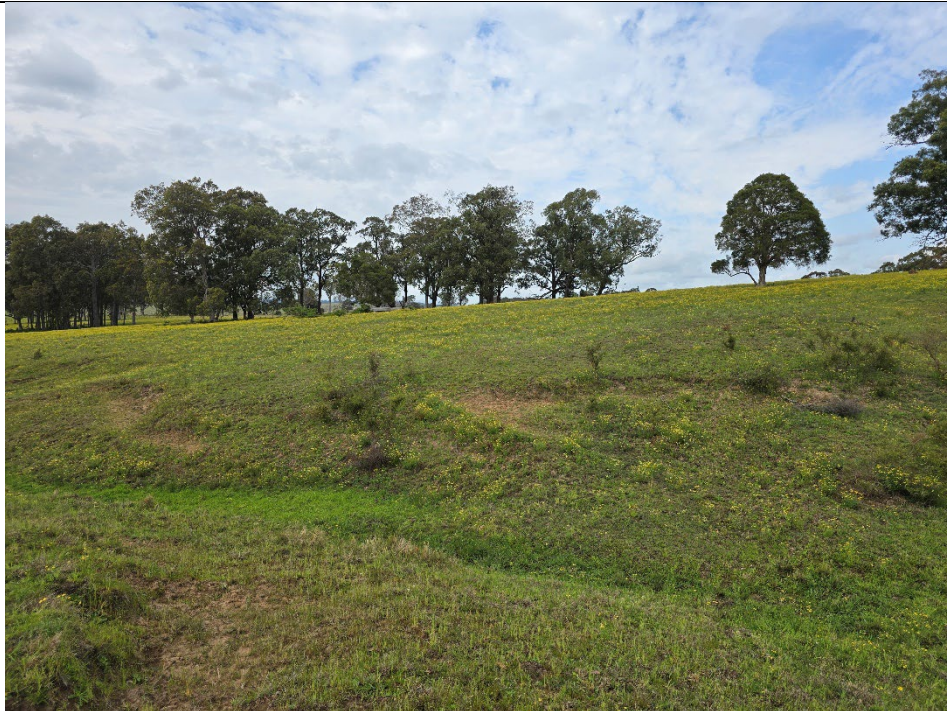
**Plate 6**

**Description:**  
Soil scarps  
along the  
ephemeral  
creek
