Site Inspection Report

From: Stephen Healey Date: 23 December 2021 Pages: 8 Ref.: 10345-001-sir

**Project: Existing Building Review
416 High Street Maitland
Preliminary Site Inspection**

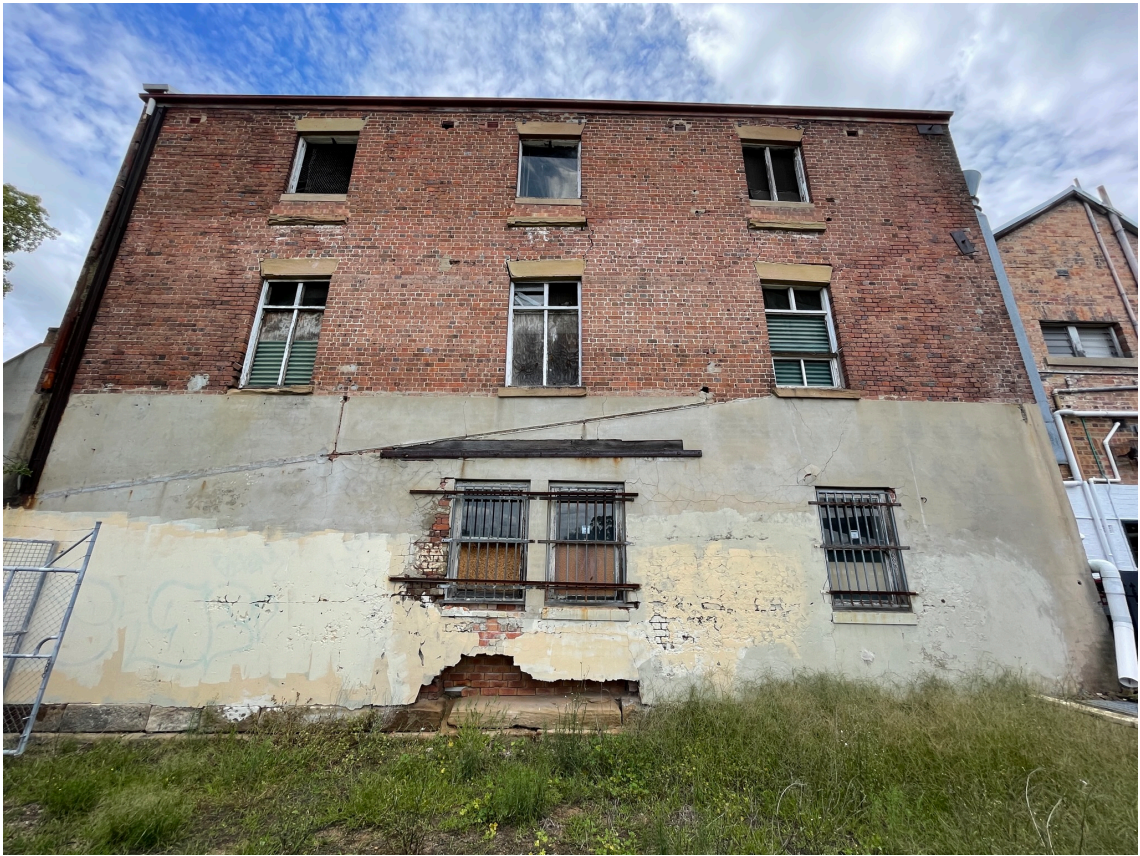
Figure 2 – External View of the Existing Building (Northern Elevation)

As can be from Figure 2 above and Figure 3 below, some external steel framing members & internal tension rods have been installed previously to strengthen or stabilise the building. No further details of these rectification works were available at the time of the inspection.

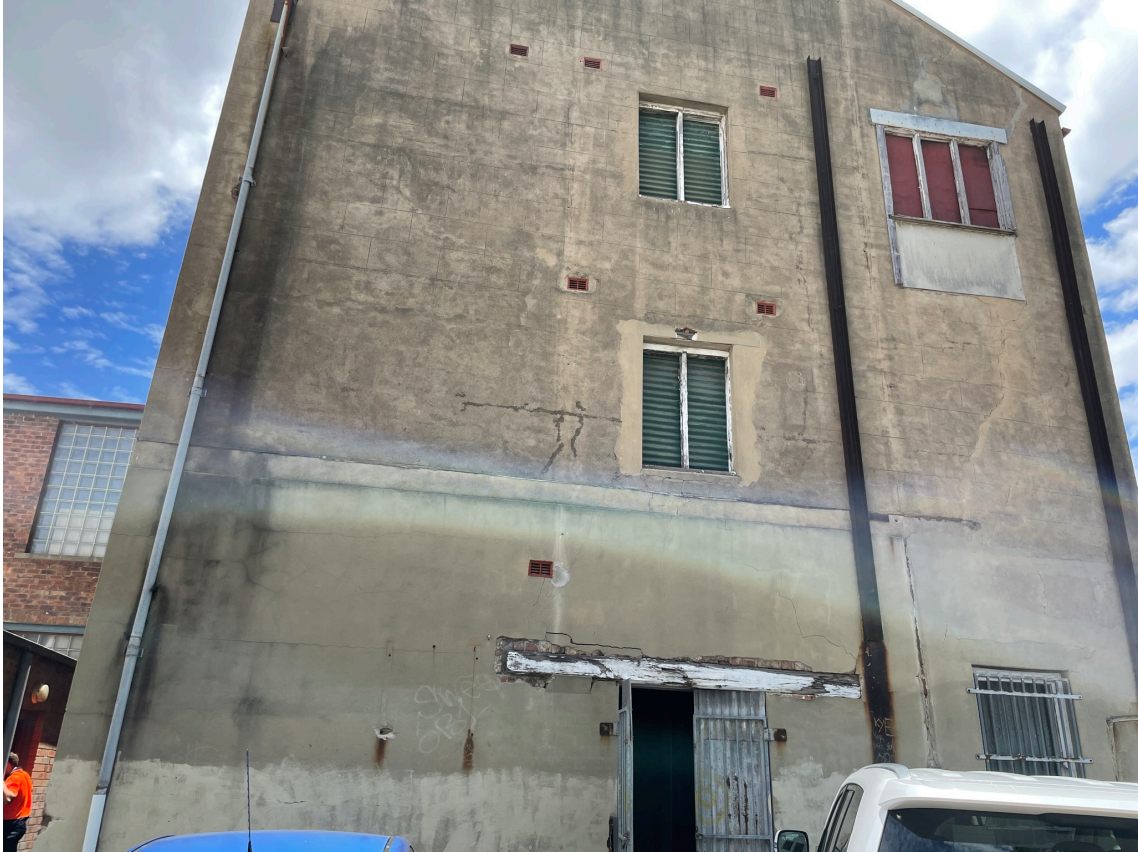
Figure 3 below, shows the external eastern elevation of the building with an external steel bracing member visible on the left hand side of the building (southern side). Figure 4 shows the external southern elevation of the building.

Anchor plates with tension rods are clearly visible just below the roof line. It is not clear if this rectification / strengthening works were carried out at the same time.

Figure 3 – External View of the Existing Building (Eastern Elevation)

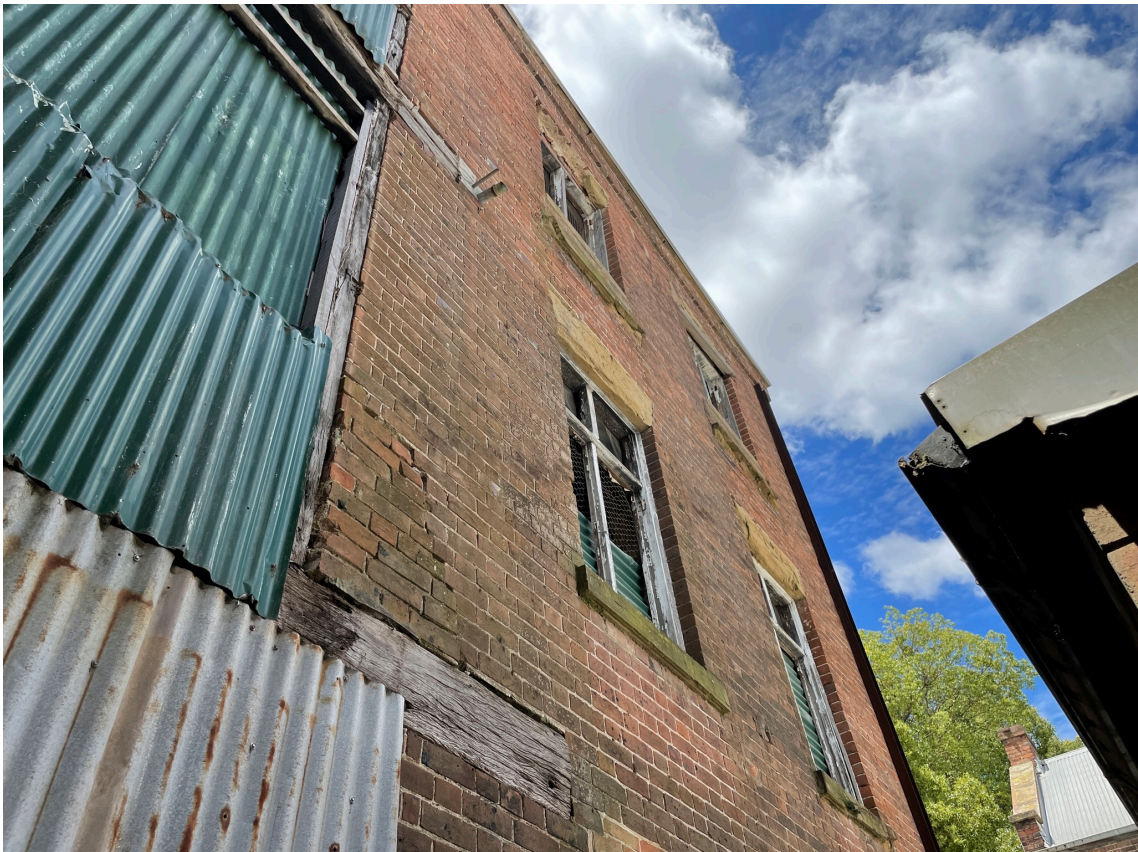
Figure 4 – External View of the Existing Building (Southern Elevation)

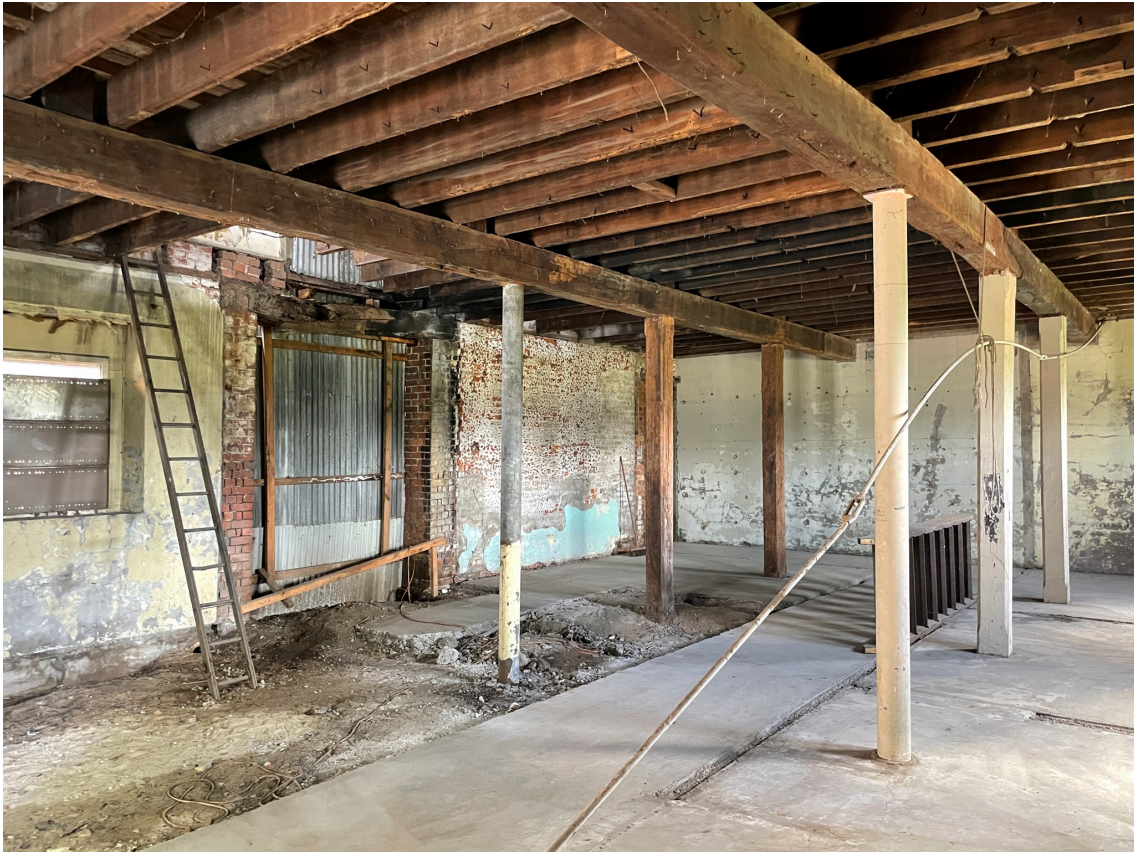
Figure 5 below shows a typical internal view from ground level. Some of the original timber support columns have been removed and some have been replaced by circular steel columns. It is not clear if engineering advice was sought about the column removal but based on the member sizes & spans this would seem unlikely. The column removal may also have occurred because of the fire within the building.

Figure 5 – Internal View of the Existing Building (Looking South West)

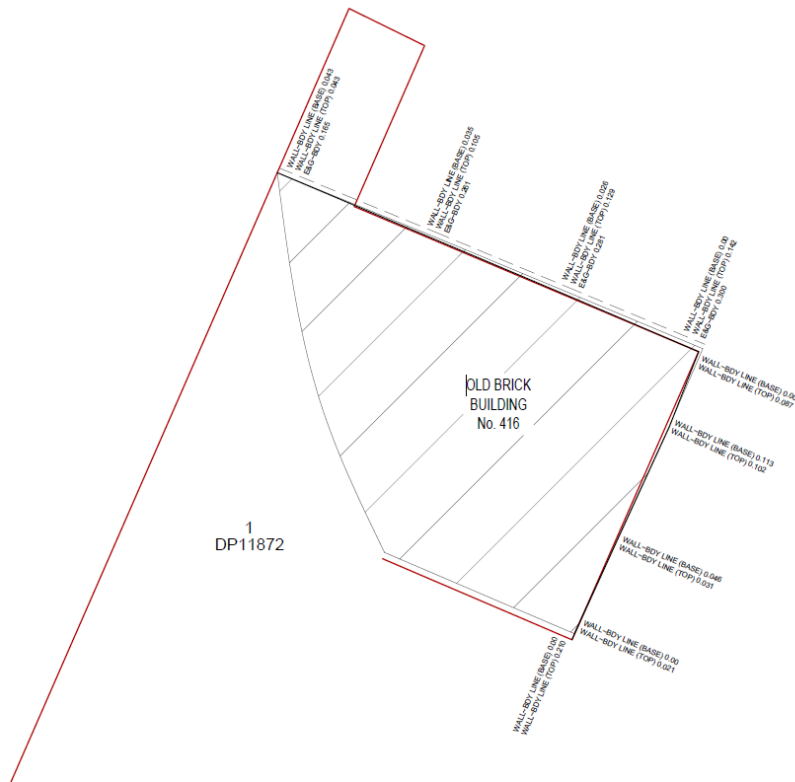
A survey plan of the building was prepared by Earth Surveying which indicates the current position of the building. An extract of this survey is shown in Figure 6 below.

Significant bowing of the walls, out-of-plumb of the walls and out-of-square of the building was identified by the survey. Out of vertical of over 140 mm and out of square of over 130 mm was reported.

Figure 6 – Extract from the Building Position Survey

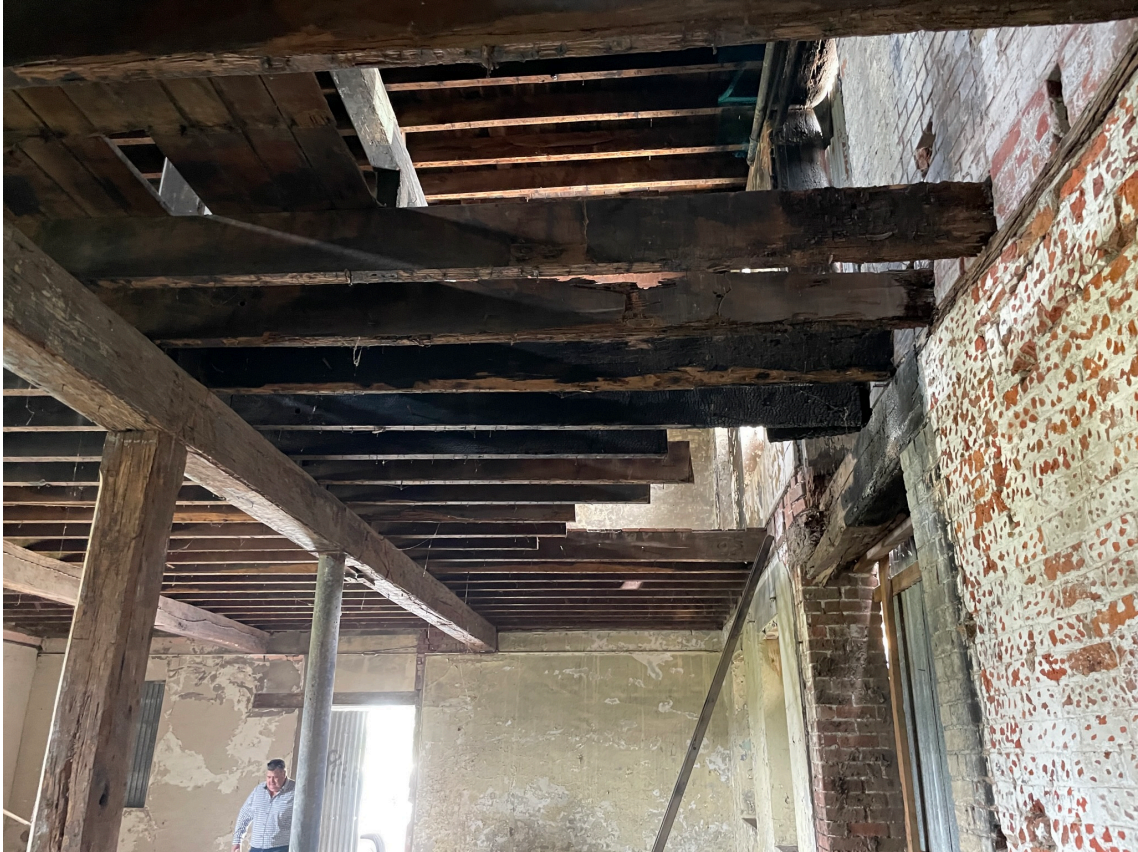
Figure 7 – Internal View of the Fire Damage to the first Floor Timber Framing

Figures 7, 8 & 9 above show the typical fire damage to the internal area of the building. The fire destroyed part of the ground floor level at the existing stair opening, with damage to the second floor level also clearly visible from the ground floor level.

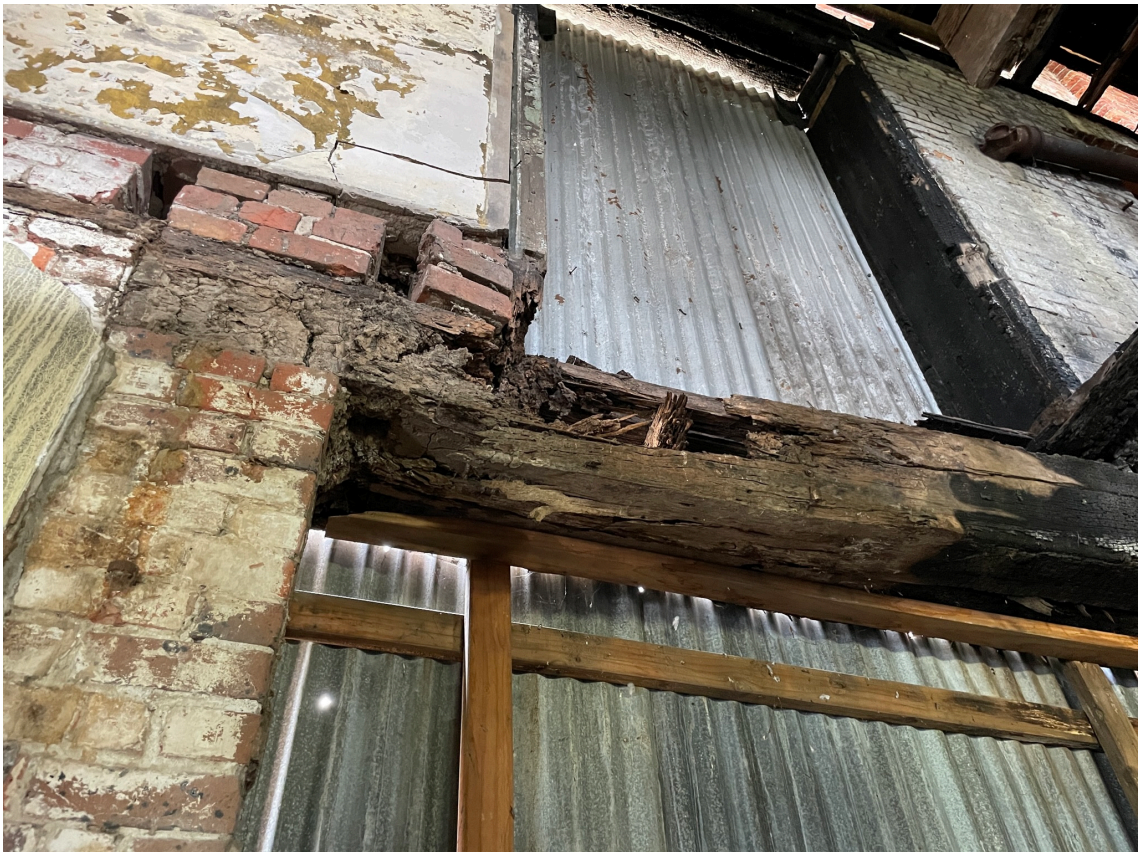
Figure 8 – Internal View of the Fire Damage & Rotted Timber Lintel

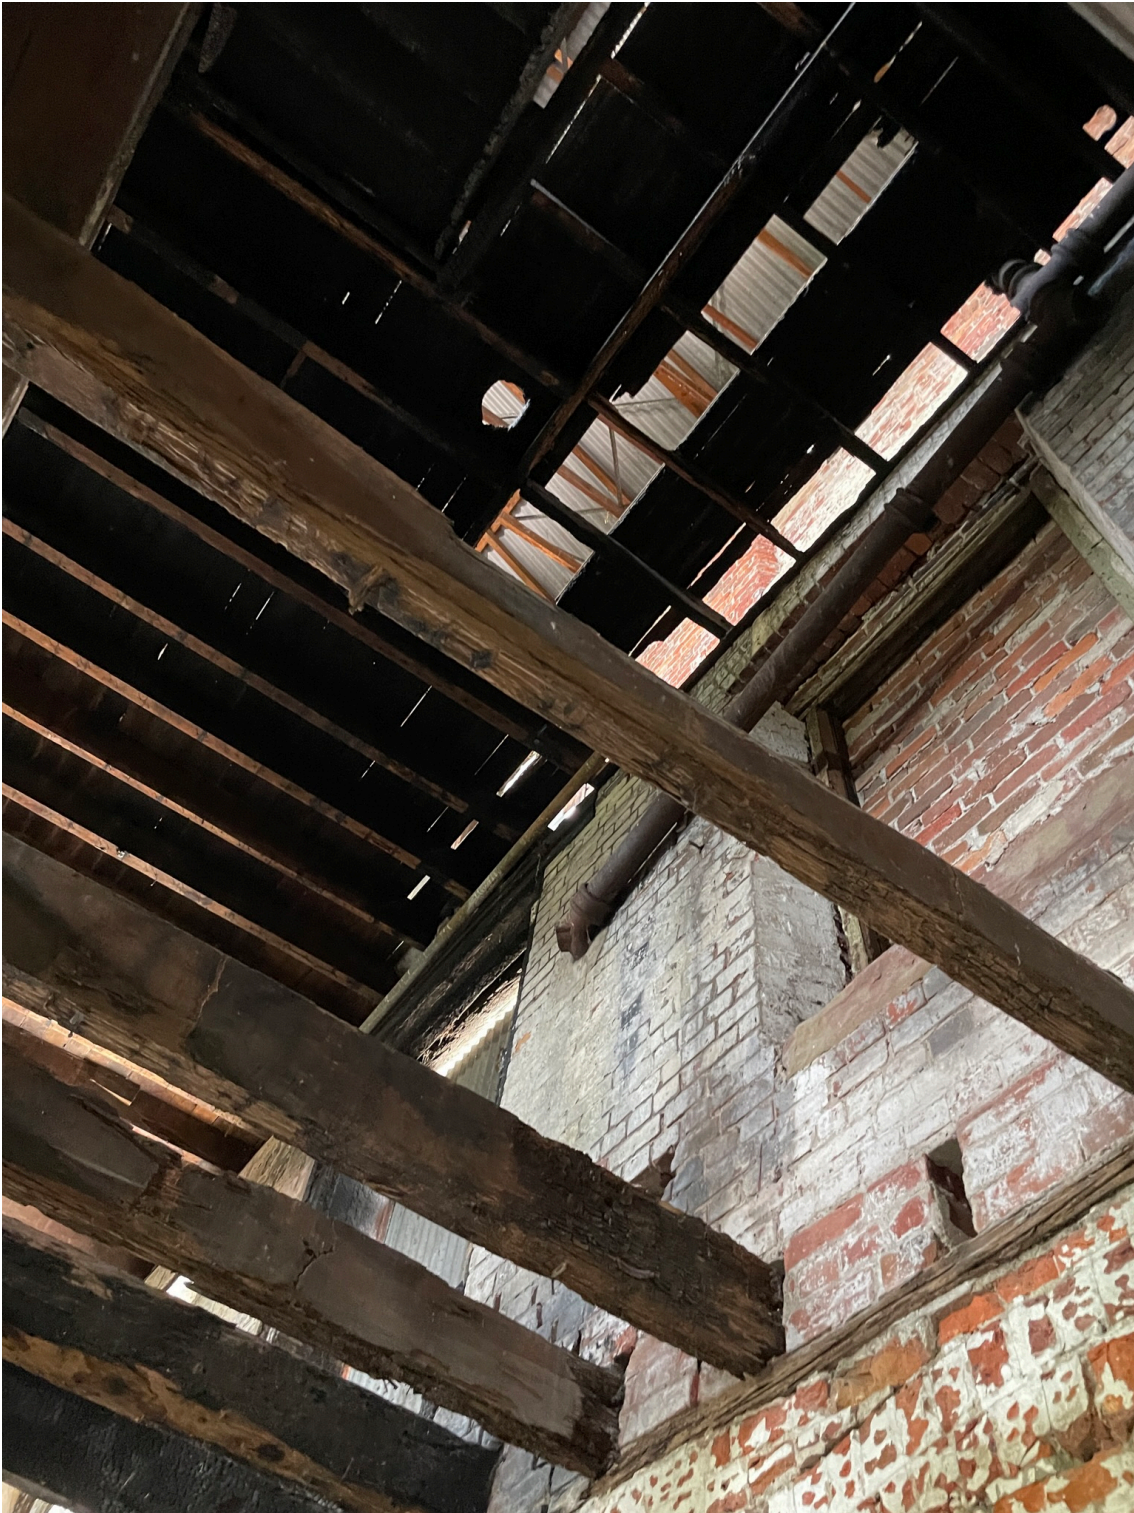
Figure 9 – Internal View of the Fire Damage to the First & Second Floor Timber Framing

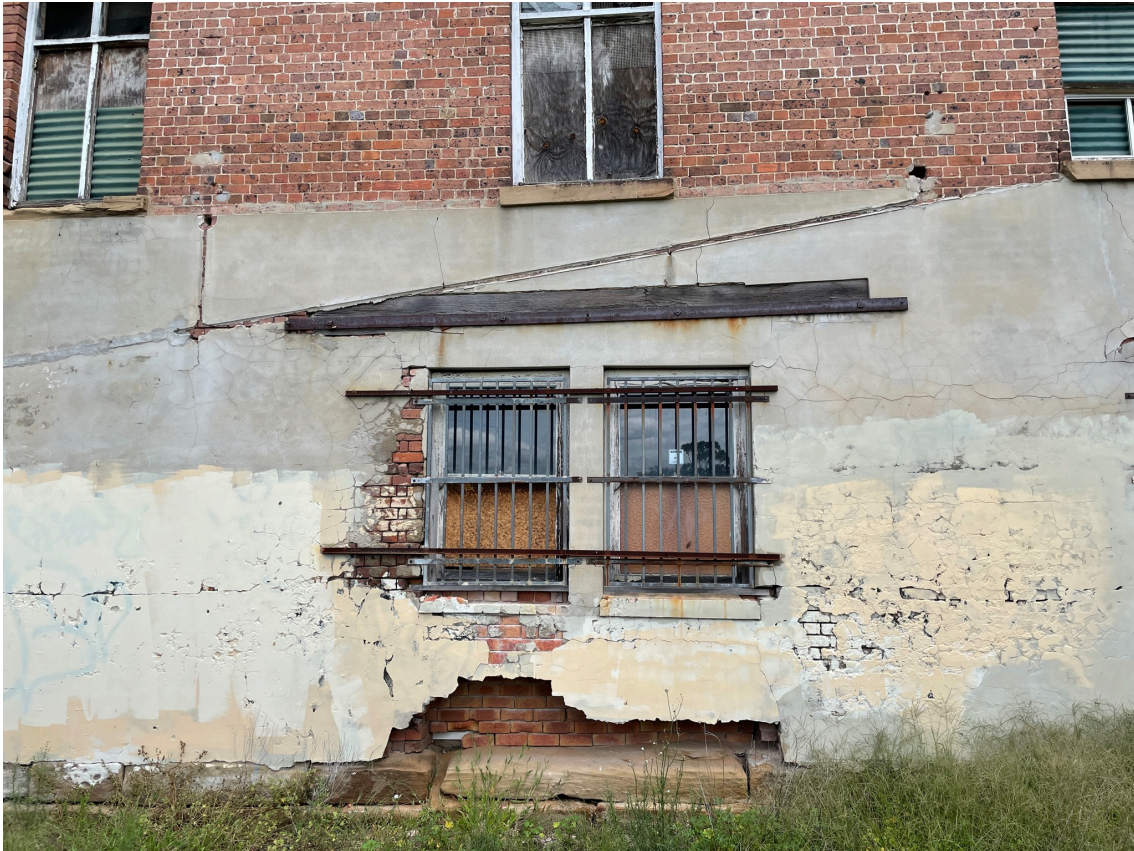
Figures 10 & 11 below show significant defects in the northern masonry wall, including partially collapsed masonry, very significant masonry cracking and rotated & deformed lintels.

Figure 10 – External View of the Partially Collapsed North Wall

Hence, it would be recommended that, due to the very poor condition of this building, demolition & reinstatement using new materials would be the only viable option.

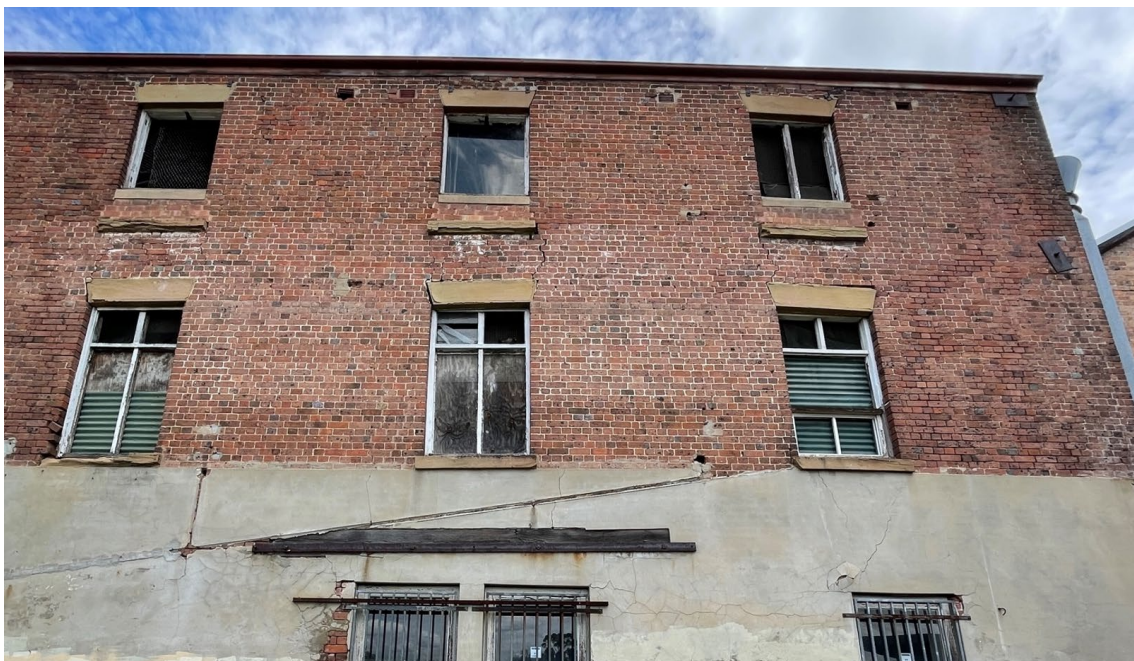
Figure 11 – External View of the Distorted Lintels & Cracked North Wall
