Arboricultural Impact Assessment

Site Address: 62 New England Hwy Maitland

Client: Paul Lemmerman

Date: November 2021

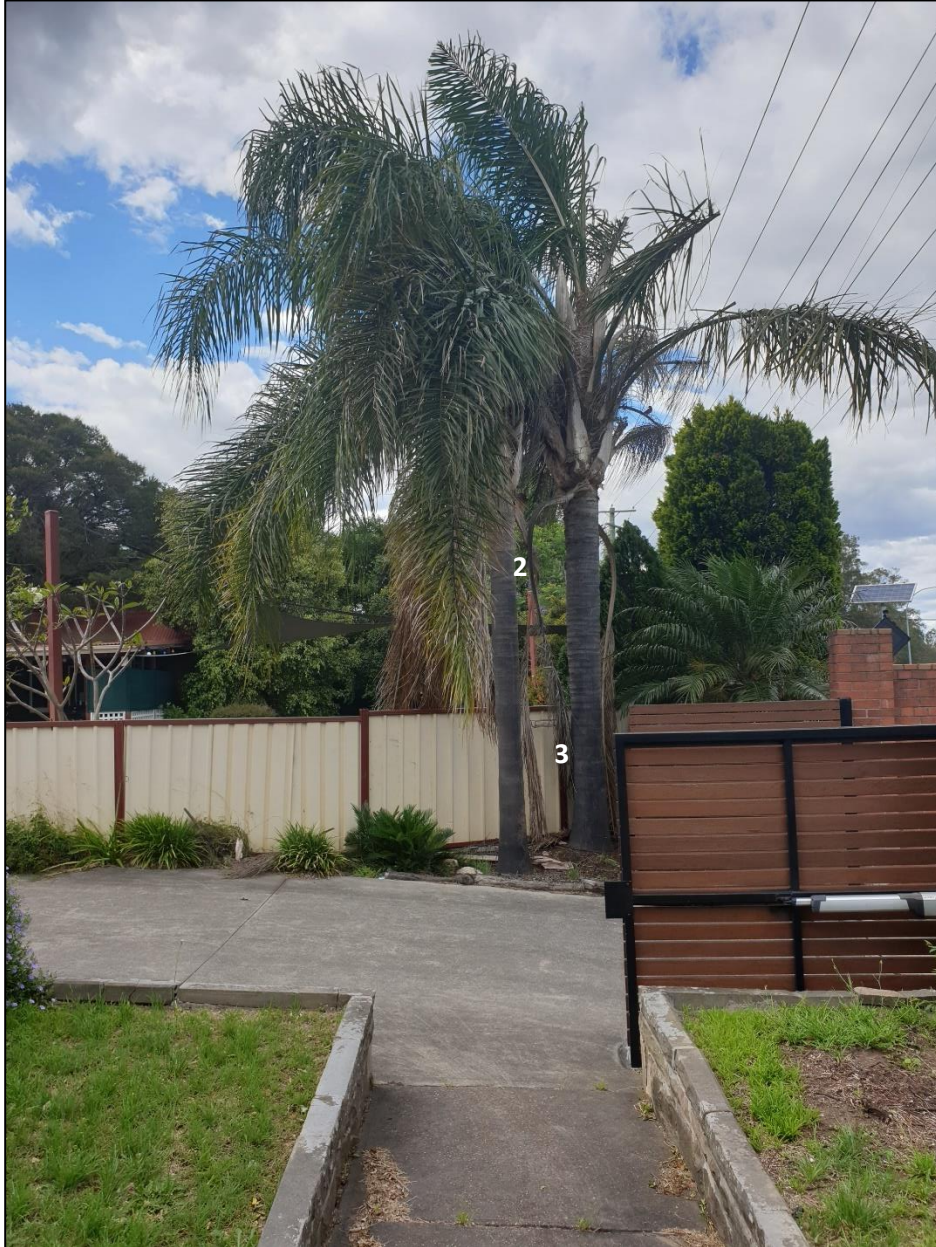
Figure 1 Trees 2 and 3 *Syagrus romanzoffianum*.

Trees 2 and 3 *Syagrus romanzoffianum* are located in the front setback of the proposed Lot 12 within the proposed concrete driveway. This species is generally considered to be undesirable due to its capacity to spread into bushland where it adversely affects biodiversity values. The trees are proposed for removal to facilitate development of the site.

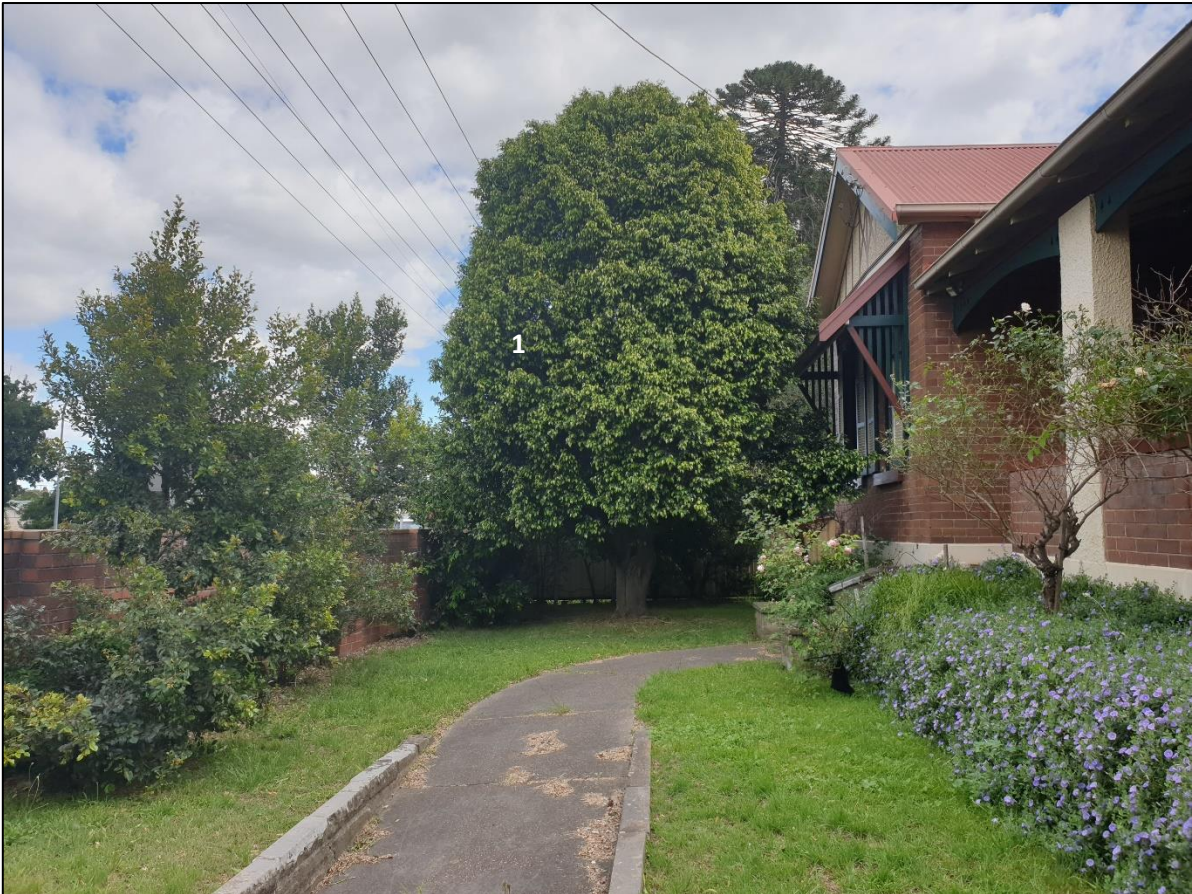
Figure 3 Tree 1 *Ficus benjamina*

Trees 1 *Ficus benjamina* and 4 *Syagrus romanzoffianum* are located on the proposed Lot 13 which houses the existing dwelling which will be retained in its existing form. Accordingly, the trees will not be subject to adverse impacts of development and will be retained. Construction fencing at the boundary of the worksite (lots 11 and 12) will provide adequate protection for the trees during the works.

That Trees 1 *Ficus benjamina* and 4 *Syagrus romanzoffianum* are retained and protected as detailed in section 9.0 of this report and in accordance with the provisions of the Australian Standard AS4970-2009, 'Protection of Trees on Development Sites' (AS4970).

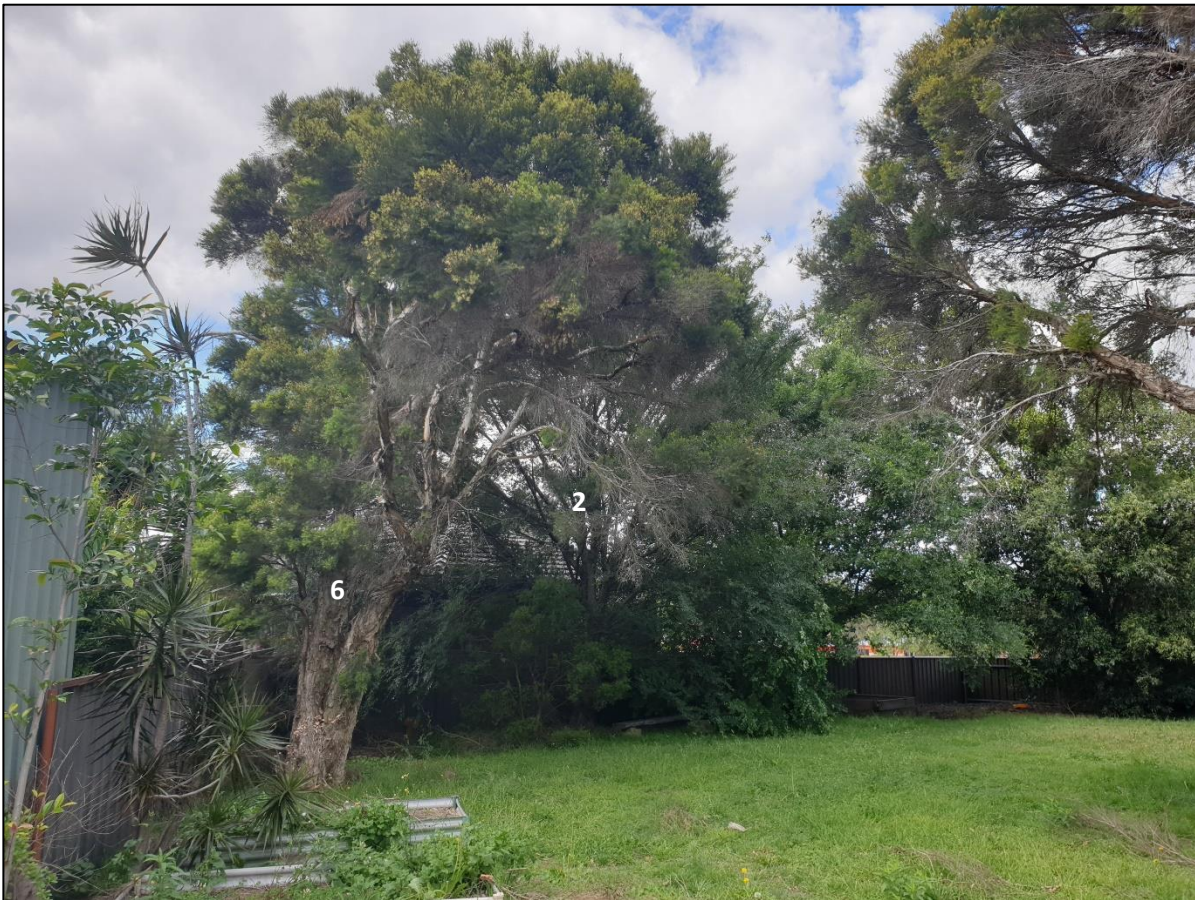
Figure 4 Tree 6 *Melaleuca linarifolia*

Trees 5 and 6 *Melaleuca linarifolia*, 7 and 8 *Ulmus parvifolia* are located on the proposed Lot 11 near the building envelope where they will be subject to major encroachment as detailed at table 7.0; the trees are proposed for removal to facilitate the proposed development.

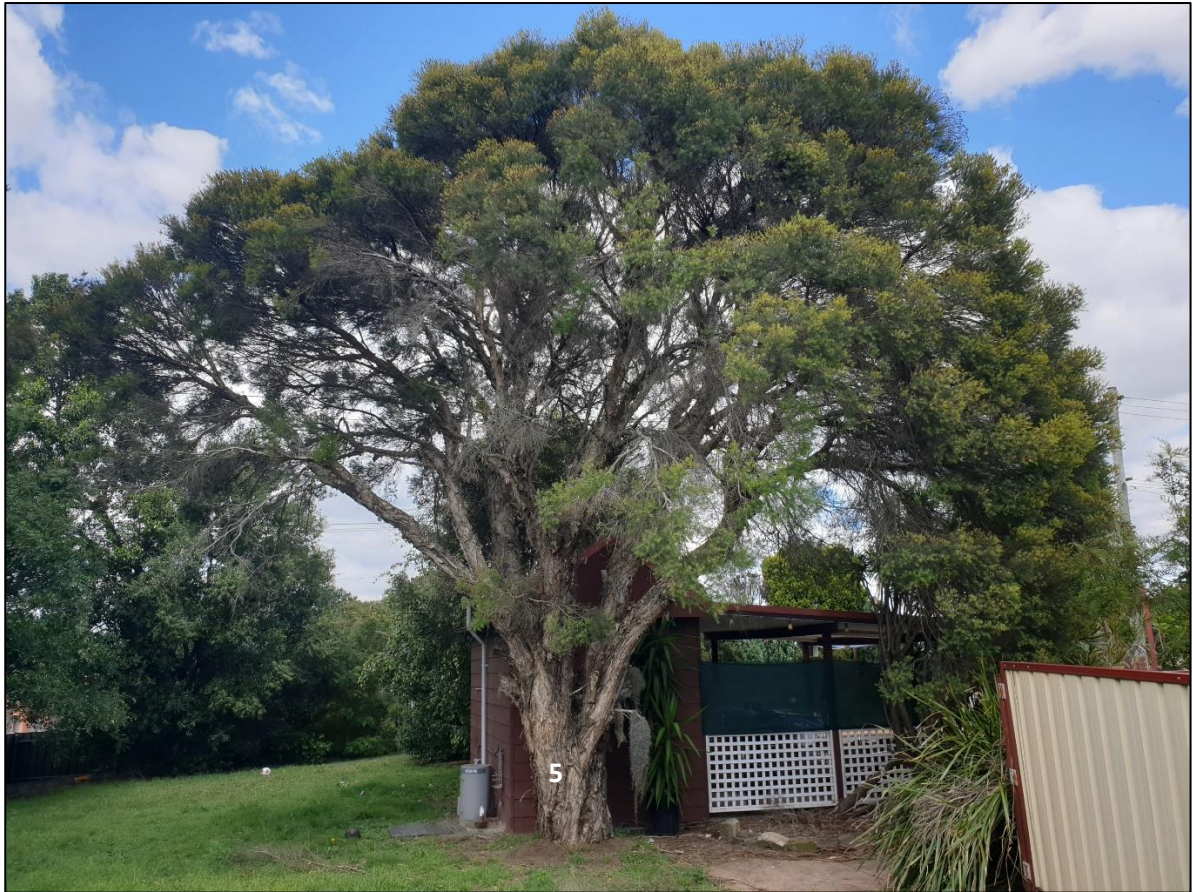
Figure 5 Tree 5 *Melaleuca linarifolia*

Tree 5 which is a large and apparently healthy example of the species is assessed with high retention value and its removal is to be offset by compensatory replacement planting in accordance with Council's requirements. Replacement tree(s) can be accommodated within the front or rear setback of Lots 12 and 13 and the rear setback of Lot 11.

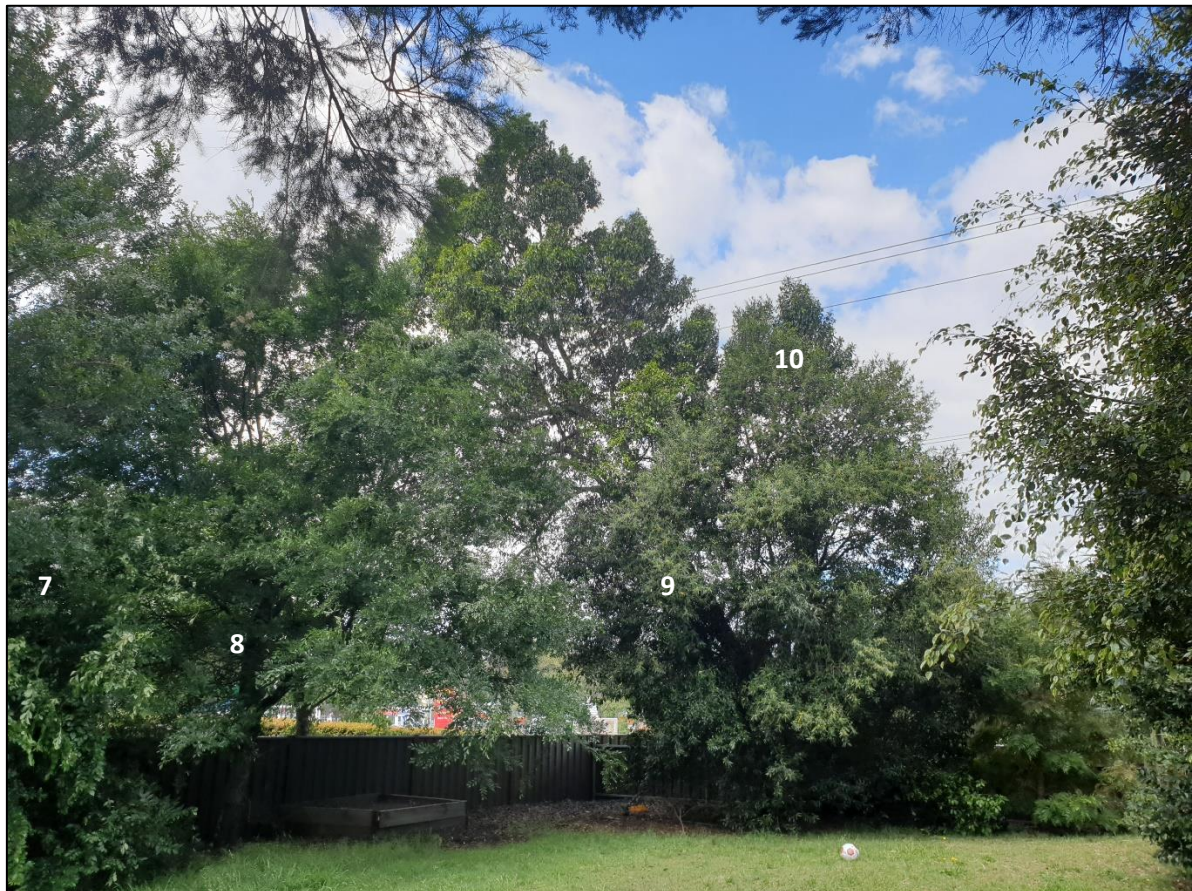
Figure 6 Trees 7 and 8 *Ulmus parvifolia*, 9 *Olea europaea* and 10 *Celtis paniculata*

Trees 9 *Olea europaea*, 10 *Celtis paniculatum*, 12 *Ficus benjamina* and 11 *Cupressus 'Brunniana'* will be subject to major and unsustainable levels of encroachment due to their position within the proposed concrete driveway access. The trees are assessed with low to moderate retention value and are proposed for removal in conjunction with the proposed development.
