**ARBORICULTURAL IMPACT ASSESSMENT REPORT**

**24 KING STREET  
EAST MAITLAND**

**15<sup>th</sup> FEBRUARY 2022**

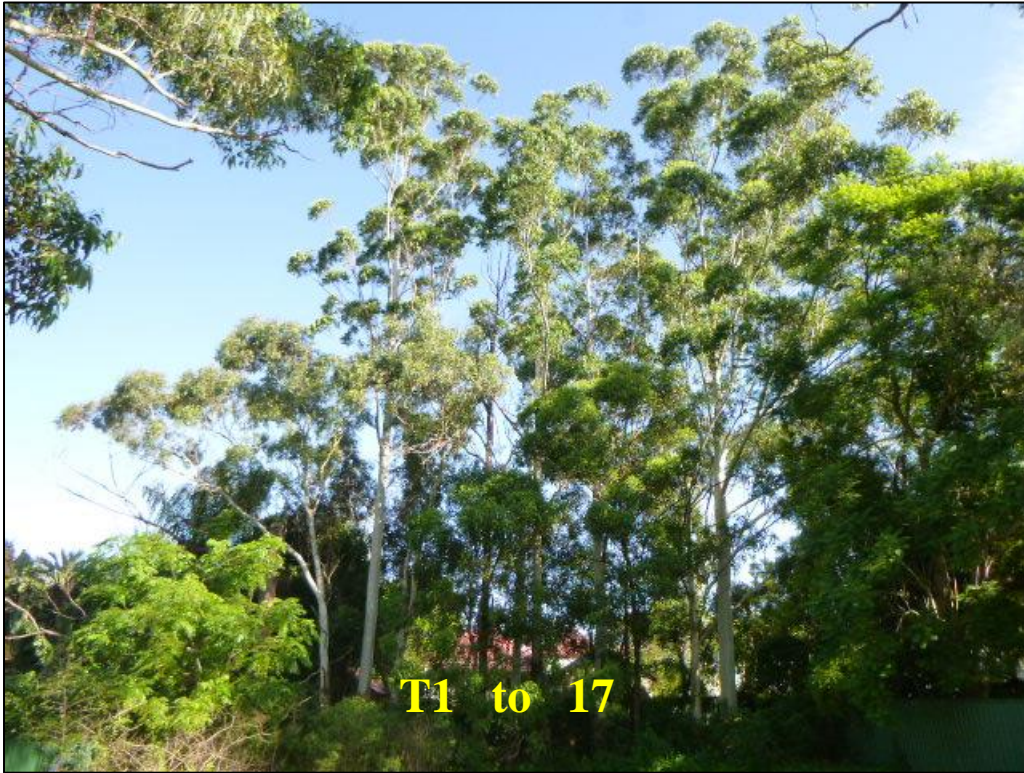
Excavation work will encroach into the calculated TPZ and SRZ's of these trees. The main area of concern is damage that may be caused to roots within the TPZ & SRZ. (Photo's 1, 2, 3 & 4).

Based on the proposed plans excavation work is not expected to encroach within the calculated TPZ's of these trees. Provided no encroachment occurs and ground level within the TPZ's remains unchanged the trees can be retained and are not expected to be impacted upon by the proposed development (Photo's 1, 2 & 3).

As excavation is outside of their SRZ's the main area of concern is damage that may be caused to secondary or minor the roots. Excessive damage to secondary and minor roots may initiate decline in their health and vigour. Removal of smaller absorbing roots can cause immediate water stress. The survival of the tree is linked to its tolerance of water stress and the ability of the tree to form new root rapidly (Photo's 1, 2 & 3).

**Photo 1 – Tree Nos. 1 to 17 within close proximity to proposed stormwater easement**

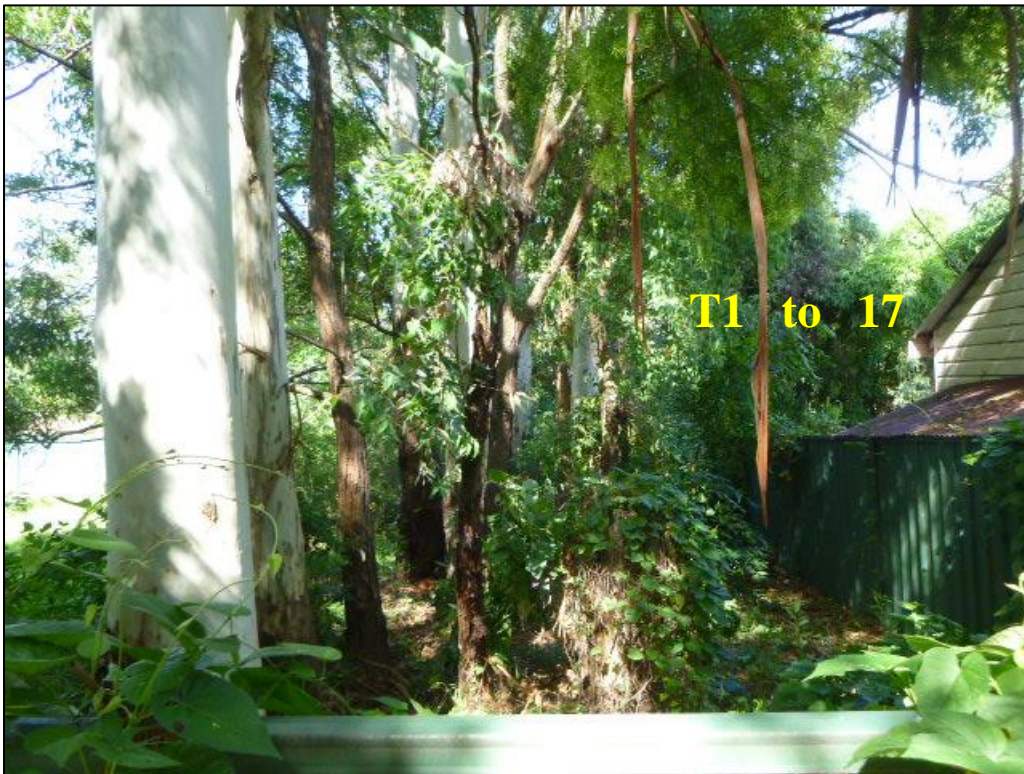
**Photo 2 – Tree Nos. 1 to 17 within close proximity to proposed stormwater easement**

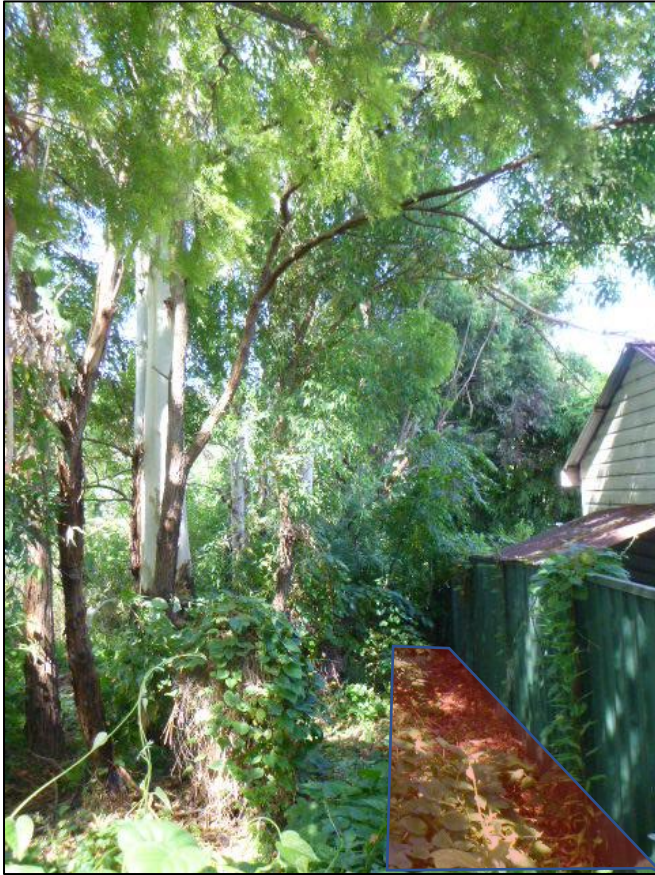
**Photo 3 – Proposed line of stormwater easement**

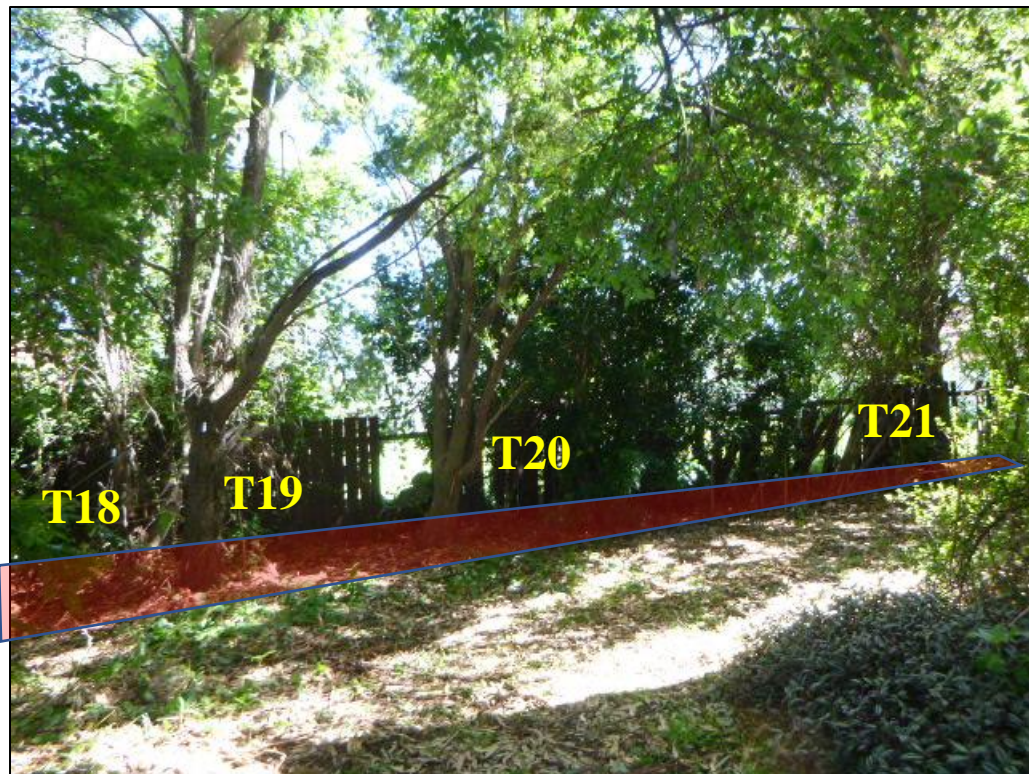
Tree Nos. 18, 20 & 21 are in direct line of the proposed easement and as such their removal would be necessary to facilitate the works as proposed (Photo 4).

The retention of any of these trees would require alternative non- destructive excavation methods (as opposed to open trench method) to be undertaken.

**Photo 4 – Tree Nos. 18, 20 & 21 in direct line of proposed stormwater easement.  
Trenching also within SRZ of Tree No. 19**

### 1. Removal of Tree Nos. 19, 20 & 21

Trees are in direct line of the trench and as such their removal would be necessary to facilitate the development as proposed

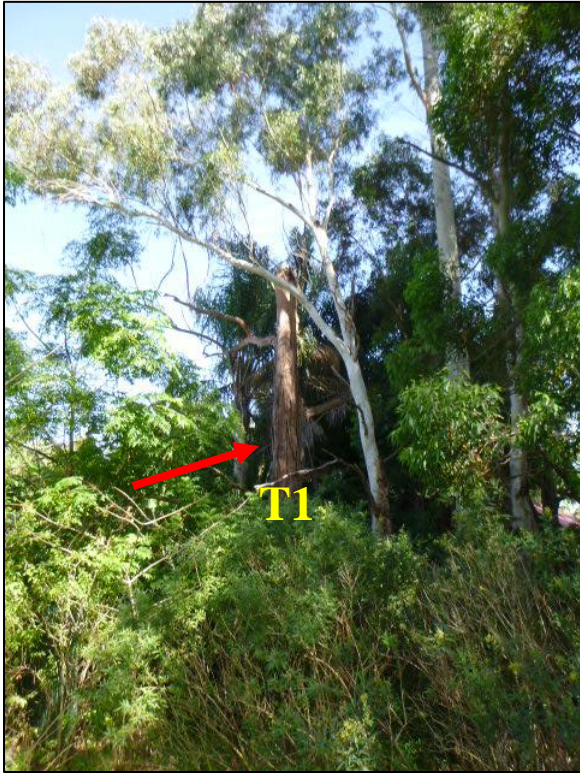
**Photo 5 – Dead Tree**

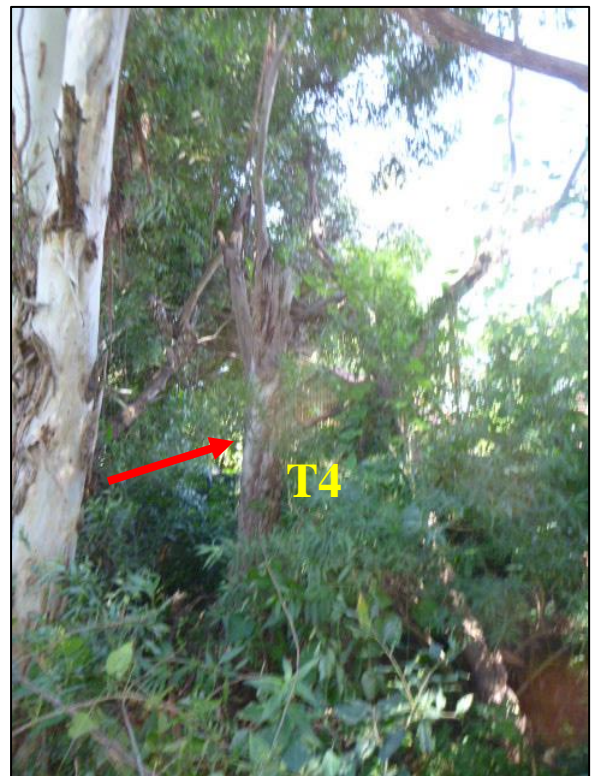
**Photo 6 – Dead Tree**

4	Dead tree	M	5>10	3112	310	470	3.7	2.41	Poor	Poor	1	4a	Dead Tree (Photo 6)	Potential damage to roots within the TPZ / SRZ
5	<i>Eucalyptus saligna</i> Sydney Blue Gum	M	25>30	3334	540	690	6.5	2.83	Good	Good	5	1b	No significant signs of dieback or decline No significant structural defects	Potential damage to minor or secondary roots within the TPZ
6	<i>Eucalyptus camaldulensis</i> River Red Gum	M	15>20	1271	310	380	3.7	2.20	Good/ Fair	Fair	4	3d	Initial to moderate stage of decline state of decline. Dead small & medium size branches & dieback of other branches Fair habit & form Suppressed canopy orientated to the east	Potential damage to minor roots within the TPZ
7	<i>Eucalyptus microcorys</i> Tallowwood	S/M	10	1263	220	240	2.6	1.82	Good/ Fair	Good	5	1b	No significant signs of dieback or decline No significant structural defects Fair habit & form Suppressed canopy orientated to the west	Excavation works outside if TPZ No direct impacts expected

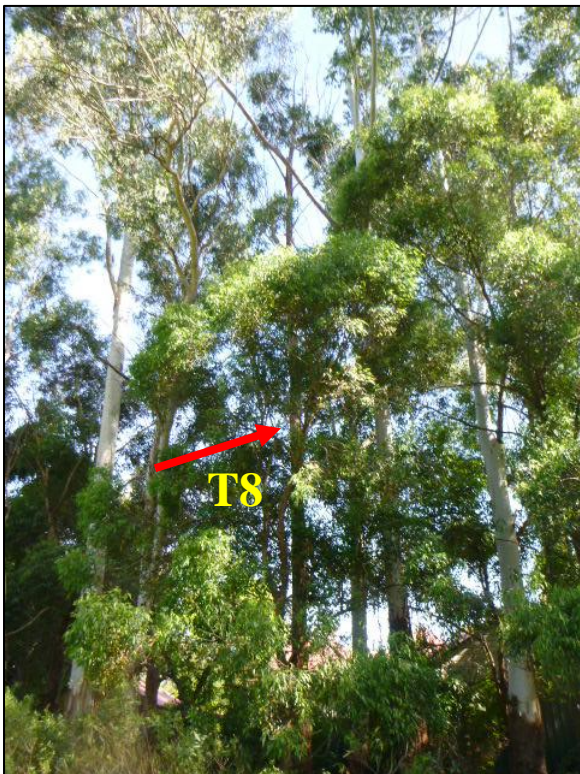
**Photo 7 – Dead Tree**

8	Dead tree	M	20>25	2222	460	520	5.5	2.51	Poor	Poor	1	4a	Dead Tree (Photo 7)	Potential damage to roots within the TPZ / SRZ
9	<i>Eucalyptus saligna</i> Sydney Blue Gum	M	25>30	9524	380	550	4.6	2.57	Good	Good	5	1b	No significant signs of dieback or decline No significant structural defects	Potential damage to roots within the TPZ / SRZ
10	<i>Eucalyptus saligna</i> Sydney Blue Gum	M	20>25	2425	550	630	6.6	2.73	Fair	Good/ Fair	4	2d	Some dead small & medium size branches No significant signs of dieback or decline Substantial borer damage to lower trunk resulting in exposed dead and decaying wood, cracking and loose bark affecting up to 60% stem circumference Fair response growth (Photo 8)	Potential damage to minor or secondary roots within the TPZ
11	<i>Eucalyptus saligna</i> Sydney Blue Gum	M	20>25	9353	620	720	7.4	2.88	Good	Good	5	1b	Dead large branch to east otherwise no significant signs of dieback or decline No significant structural defects	Potential damage to roots within the TPZ / SRZ

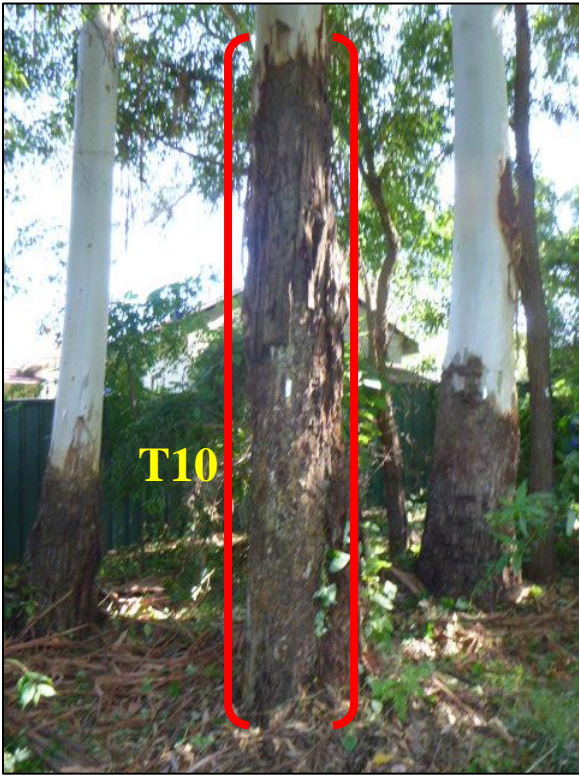
**Photo 8 – Borer damage to trunk**

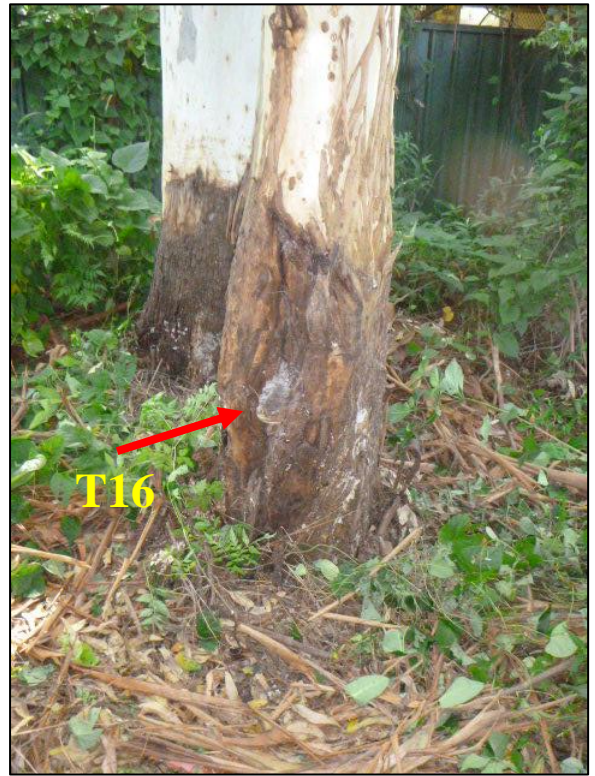
**Photo 9 – Diseased Tree**
