**ARBORICULTURAL IMPACT ASSESSMENT
CARPARK UPGRADE**

WOODBERRY LEARNING CENTER

**WOODBERRY ROAD
WOODBERRY**

28th JUNE 2022

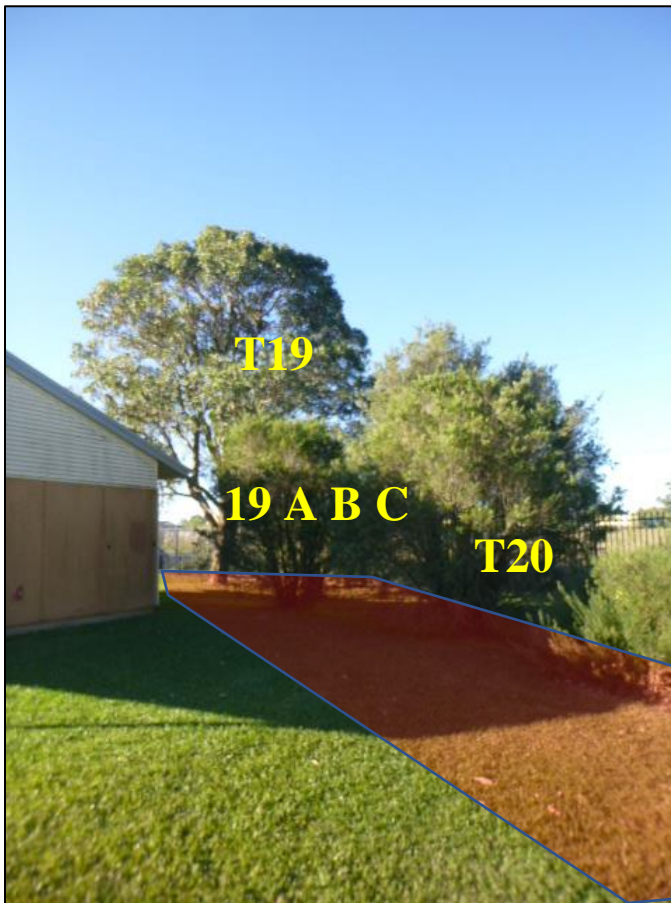
Tree No	Botanical Name Common Name	Age	HGT (m)	Canopy Spread(m) N S E W	DBH (mm)	Structure	Health	Condition	SULE	Comments
19	<i>Corymbia eximia</i> Yellow Bloodwood	M	10>15	6556	450 400	Good	Good	5	1b	No significant signs of dieback or decline No significant structural defects (Photo 1)
19A	<i>Agonis flexuosa</i> Willow Peppermint	M	<5	2211	Multi Avg. <100	Poor	Good	3	3b	Previously cut to short stump Poor branch structure - Multi stemmed epicormic shoots re-sprouting from stump (Photo 1)
19B	<i>Callistemon viminalis</i> Weeping Bottlebrush	S/M	<5	1122	Multi Avg. <100	Poor	Good	3	3b	Previously cut to short stump Poor branch structure - Multi stemmed epicormic shoots re-sprouting from stump (Photo 1)
19C	<i>Callistemon viminalis</i> Weeping Bottlebrush	S/M	<5	1111	Multi Avg. <100	Poor	Good	3	3b	Previously cut to short stump Poor branch structure - Multi stemmed epicormic shoots re-sprouting from stump (Photo 1)

20	<i>Callistemon viminalis</i> Weeping Bottlebrush	S/M	5	2332	140 140 120 110	Good	Good	5	2d	No significant signs of dieback or decline No significant structural defects (Photo 1)
21	<i>Eucalyptus sideroxylon</i> Red Iron Bark	M	15	7151	350	Good/ Fair	Good	5	2d	Dieback of some small branches but no significant signs of decline Fair habit & form Suppressed canopy orientated to the northeast Not likely to develop into a good representative of the species No significant structural defects (Photo 2 & 3)

Based on the Site Plan Tree Nos. 19, 19A, 19B, 19C, 20, 21, 22, 23, 24, 24A, 25, 26 & 27 are within the footprint of the driveway / carparking area and as such their removal will be necessary to facilitate the development as proposed (Photo 1, 2 & 3).

Photo 1 -Trees within footprint of the proposed driveway / carpark

1. Removal of Tree Nos. 19, 19A, 19B, 19C, 20, 21, 22, 23, 24, 24A, 25, 26 & 27

The trees are within the footprint of the driveway /carparking area and such their removal would be necessary to facilitate the development as proposed

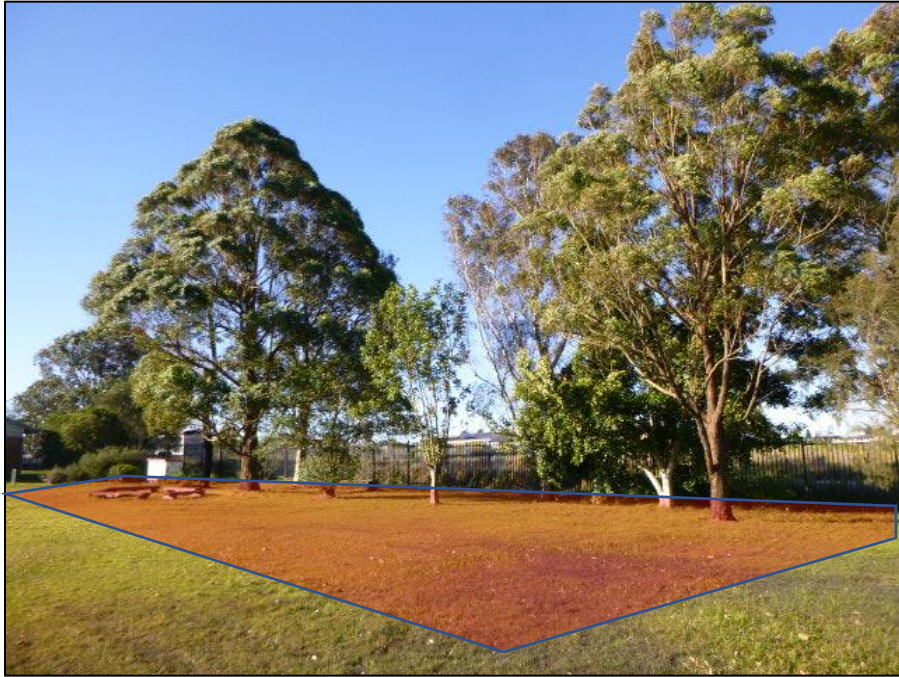
Tree No	Botanical Name Common Name	Age	HGT (m)	Canopy Spread(m) N S E W	DBH (mm)	Structure	Health	Condition	SULE	Comments
22	<i>Corymbia maculata</i> Spotted Gum	M	15	3631	480	Good	Good	5	1b	No significant signs of dieback or decline No significant structural defects Poor Architecture = Fair habit & form Canopy spread partially restricted by larger adjacent tree - Orientated to the east (Photo 2 & 3)
23	<i>Eucalyptus microcorys</i> Tallowwood	M	20	5757	610	Good	Good	5	1b	No significant signs of dieback or decline No significant structural defects (Photo 2 & 3)
24	<i>Tristaniopsis laurina</i> Water Gum	M	5	2222	Multi Avg. 4x100	Good	Good	5	2d	No significant signs of dieback or decline No significant structural defects (Photo 2 & 3)
24A	<i>Cupaniopsis anacardioides</i> Tuckeroo	S/M	5>10	2121	Multi Avg <100	Fair	Good	4	2d	No significant signs of dieback or decline Poor branch structure - Damaged trunk resulting in epicormic regrowth indicated by crooked ends and vertical growth. Buttress wood indicated a more stable attachment (Photo 2 & 3)

25	<i>Eucalyptus spp.</i> Eucalyptus Tree	M	15>20	3735	350	Good	Good/ Fair	5	3a	Initial state of decline. Dieback of small branches, twigs & thinning of crown foliage Whilst no significant signs of decline were evident health & vigour appears to be slightly diminished Crown density approx. 70% No significant structural defects (Photo 2 & 3)
26	<i>Ficus benjamina</i> Weeping Fig	M	10>15	5363	270 220 190	Good	Good	5	1b	No significant signs of dieback or decline No significant structural defects Fair habit & form Canopy spread partially restricted by larger adjacent tree - Orientated to the east (Photo 2 & 3)

**Photo 2 -Trees within footprint of the proposed driveway/carpark
View looking to the northeast**

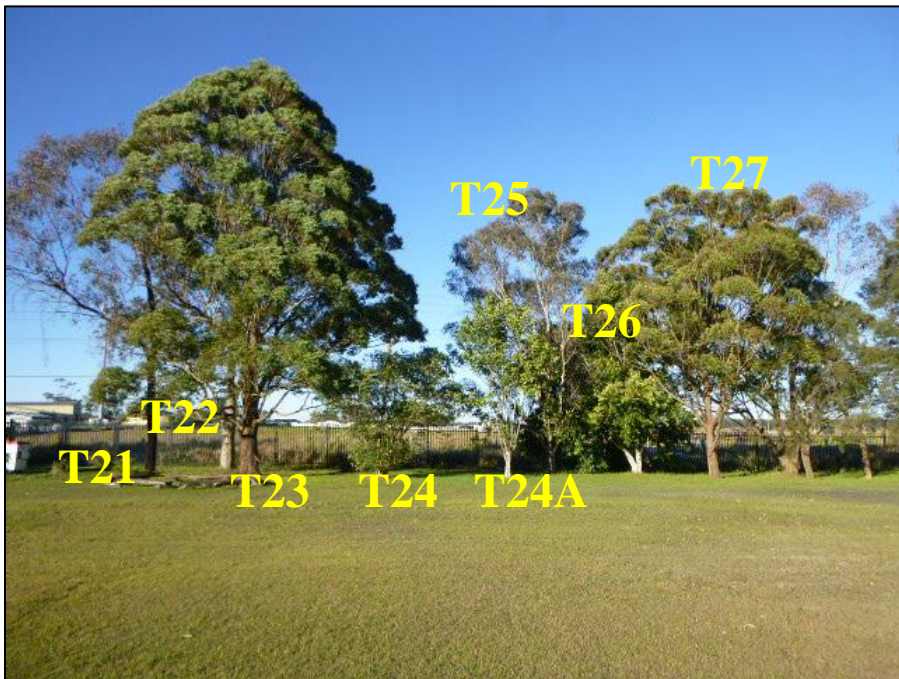
**Photo 3 -Trees within footprint of the proposed driveway/carpark
View looking to the east**

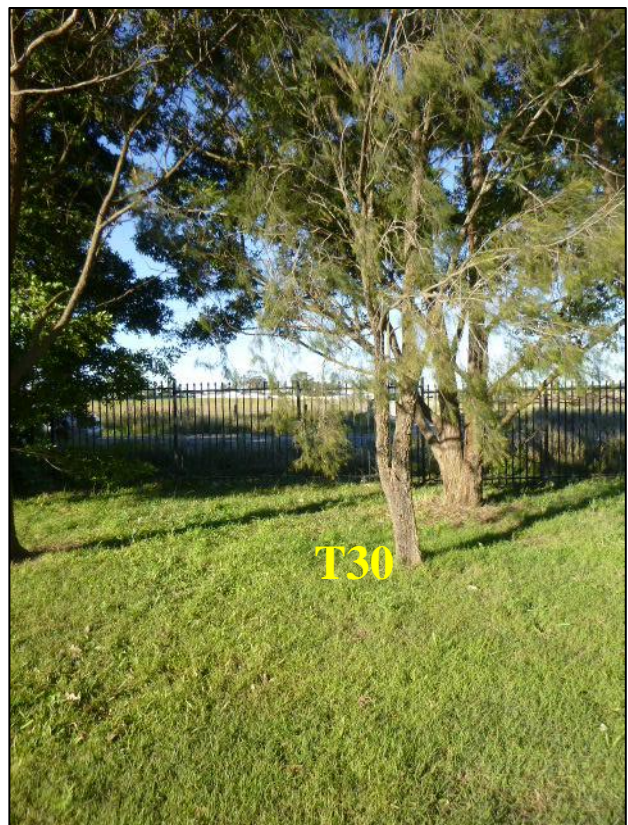
30	<i>Casuarina glauca</i> Swamp Oak	S/M	10	2133	180 130	Good	Good	5	2d	No significant signs of dieback or decline No significant structural defects (Photo 4)

Due to the close proximity of construction and extent of encroachment into its TPS & SRZ it is likely that the trees will be adversely impacted upon by the development that may be detrimental to both stability and / or health & vigour (Photo 4).

Photo 4 - Construction of within TPZ & SRZ

2. Removal of Tree No. 30

Due to the close proximity of construction and extent of encroachment into its TPZ and or SRZ its removal would be necessary as it will be adversely impacted upon in a manner that will be detrimental stability and/ or their overall condition

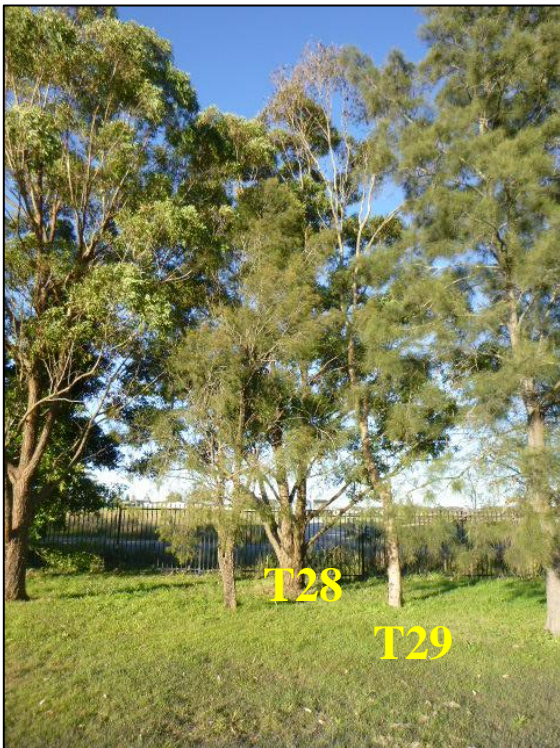
Tree No	Botanical Name Common Name	Age	HGT (m)	Canopy Spread(m) N S E W	DBH (mm)	Structure	Health	Condition	SULE	Comments
27	<i>Eucalyptus microcorys</i> Tallowwood	M	15>20	5566	400	Good	Good	5	1b	No significant signs of dieback or decline No significant structural defects (Photo 2 & 3)
28	<i>Eucalyptus microcorys</i> Tallowwood	M	15>20	3744	320 340 120 120	Good/ Fair	Good/ Fair	5	2d	Some dead small & medium size branches but no significant signs of decline Co-dominant trunks minor bark inclusion No cracking or splitting could be seen at the co-dominant union that would indicate failure was imminent or probable Remove DW 30mm or over in diameter Remove or prune branches that are in decline (Photo 5)
29	<i>Eucalyptus spp.</i> Eucalyptus Tree	S/M	10>15	2221	250	Fair	Good/ Fair	4	2c	No significant signs of dieback or decline Whilst no significant signs of decline were evident health & vigour appears to be slightly diminished and crown density appears to be thinning Fair habit & form- Bent/bowed trunk Not likely to develop into a good representative of the species (Photo 5)

Based on the proposed plan the construction of the carpark will slightly encroach into TPZ of the tree but will remain outside of its SRZ (Photo 5).

Photo 5
Encroachment less than 10% of TPZ of T28
Encroachment not within SRZ of T29

- Any excavation within the root zone must be carried out carefully to avoid excessive damage to roots.
- No roots shall be cut within the calculated SRZ of a tree.

3. Retention of Tree No. 28

Although construction may occur within the TPZ it is expected that encroachment will be less than 10% and that as the area lost to encroachment is outside the SRZ and can be compensated for elsewhere and contiguous with the TPZ the tree should not be significantly impacted upon by the proposed development

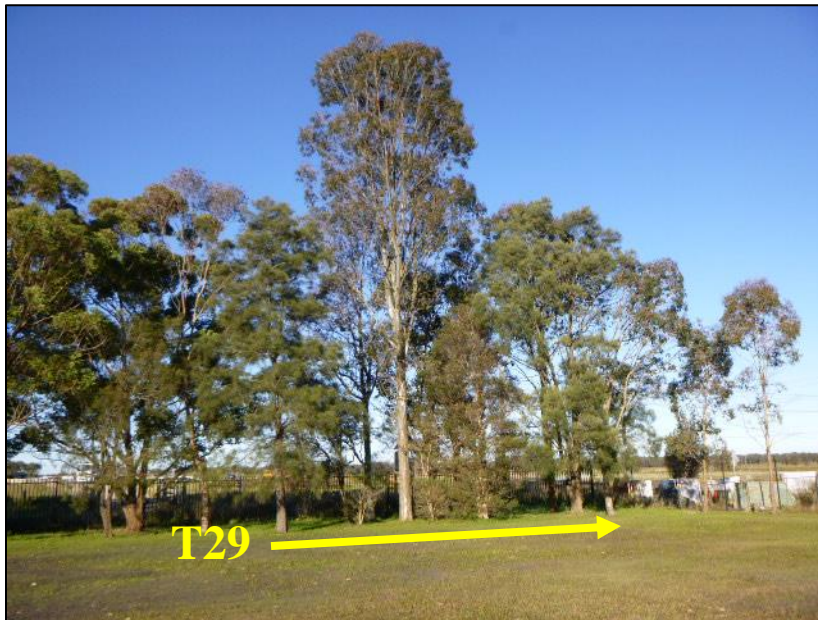
Based on the proposed plans construction is not expected to encroach within the calculated TPZ's of Tree No. 29 or any other trees further south of Tree No. 29. It is considered that provided encroachment does not exceed more than 10% of their TPZ's and ground levels within the TPZ's remain unchanged they can be retained should not be impacted upon by the development (Photo's 5, 6 & 7).

Photo 6 - Construction not within TPZ of trees

4. Retain Tree No. 29 and all other remaining trees

Construction is not expected to encroach within the calculated TPZ's of these trees and as such they are not expected to be impacted upon by construction.

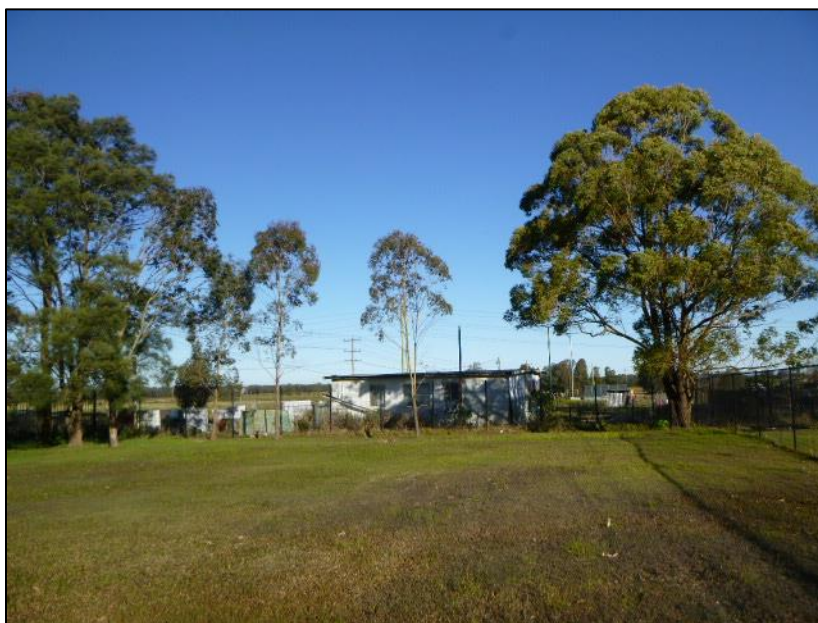
Photo 7 - Construction not within TPZ of trees
