Arborist Impact Assessment

Proposed Residential Subdivision 69 Kensington Rd, Bolwarra NSW

20 December 2022 AEP Ref: 2526 Revision: 01

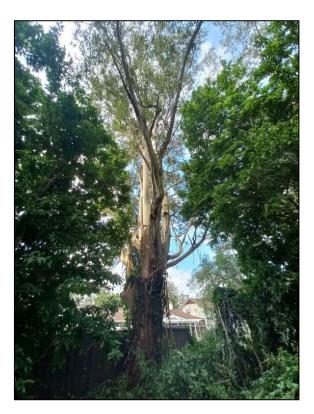
- Tree 57, a mature *Eucalyptus pilularis* (Blackbutt). This tree is of a very large size, and is significant within the landscape. Furthermore, there is at least one hollow present within the higher canopy, which could provide habitat value for native fauna species.

Plate 1: Tree 57, a significant tree that should be retained.

- Tree 57 (Eucalyptus pilularis). This tree has a 5.4 % encroachment into the TPZ a building
 footprint. To retain this tree, TPZ Fencing will be required to be established at the boundary of
 the building footprint closest to this tree. The TPZ of this tree can feasibly offset into
 unimpacted areas.

- Tree 55, 56, 58 & 59 will require a continuous TPZ fence in conjunction with Tree 57 as displayed in **Figure 4**.
- Tree 62, 66 will require a continuous TPZ fence in conjunction with Tree 74 as displayed in Figure 4.

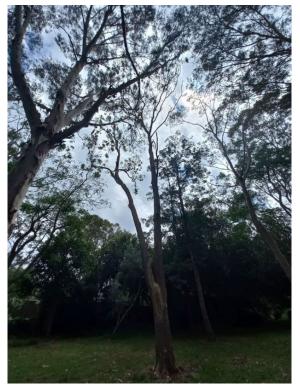
- Tree 64, a mature Eucalyptus robusta (Swamp Mahogany). This tree is in significant decline, with low vigour, defoliation and a small photosynthetic area. Additionally, this tree has several large dead branches and co-dominant leaders with a poor branch connection. This tree is in poor health condition.

Plate 2: Tree 64, a hazardous tree that should be removed.

- Tree 64 (Eucalyptus robusta). This tree is in significant decline, with low vigour, defoliation
 and small photosynthetic area. Additionally, this tree has several large dead branches and codominant leaders with a poor branch connection. Given the height and size of the tree, this
 decline and defect could represent a significant hazard to future development or site usage
 and the tree should be removed.

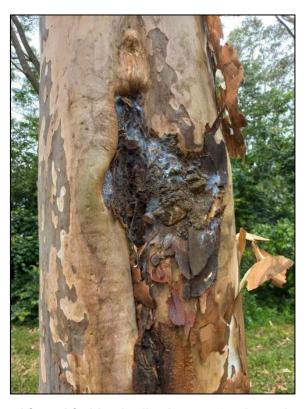
- Tree 70, a mature Corymbia maculata (Spotted Gum), whilst presenting a healthy crown, displays signs of advanced and significant decay within the stem, confirmed by wood resonance testing. This is associated with an old pruning wound that has incursion from fungal fruiting bodies, and is located at 1-2m above ground level and is consistent throughout the stem at this height. This tree is in Poor Structural Condition.

Plate 3: Stem decay and fungal fruiting bodies in tree 70, a hazardous tree that should be removed.

- Tree 70 (Corymbia maculata). This tree appears to be healthy in the crown, but as previously discussed in Section 4.0, there is a large section of advanced decay within the stem centred around an old pruning wound on the western side of the tree as confirmed by wood resonance testing. Given the height of the tree, and the likely direction of failure (to the west), this defect represents a significant hazard to future development or site usage and the tree should be removed.

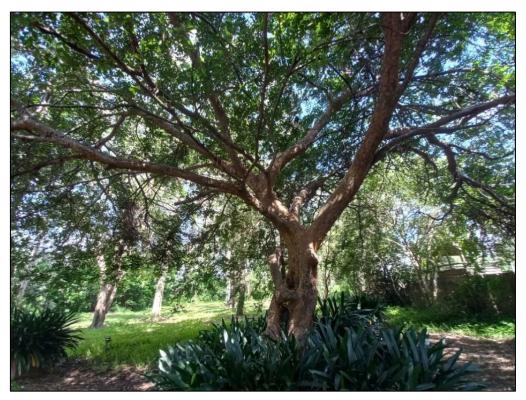
Plate 4:Tree 74, a Tree that should be retained. Note the low canopy.

- Tree 74 (*Ulmus parviflora*). This tree has a large, low canopy which will be encroached in the west by a building footprint. Canopy branches within the footprint should be pruned.

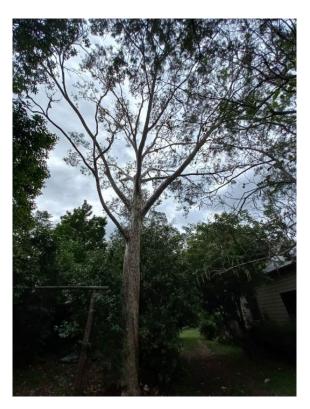
- Tree 19, a mature *Corymbia maculata* (Spotted Gum). This tree is of a very large size, and is significant within the landscape. Furthermore, this tree is highly visible from the street and surrounding properties.

Plate 5: Tree 19, a significant tree that should be retained.

- Tree 19 (Corymbia maculata). This tree has SRZ encroachment from a proposed driveway.
 This final design must be a permeable, non-compacted surface (gravel) driveway to retain this
 tree. Further ground protection measures will be required for movement of heavy equipment
 through the TPZ of this tree. If these measures are not taken then removal will have to be
 considered.
 - A further 10 trees can be retained dependent on the final design of the driveway. This
 final design must be a permeable, non-compacted surface (gravel) driveway to retain

these trees (as noted above), as encroachment by the driveway occurs within the TPZ or SRZ of these trees. Further ground protection measures will be required for movement of heavy equipment through the TPZ of this tree. If these measures are not taken then removal will have to be considered.

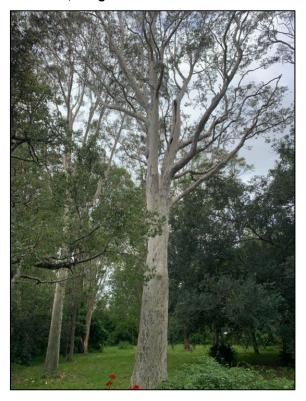
- Tree 44, a mature Corymbia maculata (Spotted Gum). This tree is of very large size, and is significant within the landscape. Furthermore, there is at least one hollow present within the higher canopy, which may provide habitat value for native fauna species.

Plate 6: Tree 44, a significant tree that should be retained.

- Tree 44 (Corymbia maculata). This tree has a 13.5 % encroachment into the TPZ by a building footprint. To retain this tree, either TPZ Fencing as displayed in Figure 4. will be required to be established at the boundary of the building footprint closest to this tree, or ground protection measures placed within unimpacted areas of the TPZ (Appendix D). The TPZ of this tree can feasibly offset into unimpacted areas. Tree-sensitive construction techniques should be considered for the building footprint within the TPZ of this tree.

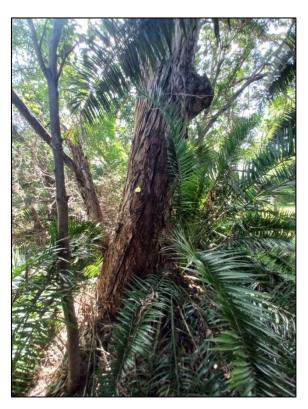
- Tree 39, a mature Eucalyptus pilularis (Blackbutt). This tree is exhibiting early subsidence of
 the root-ball, with a lean to the north and soil upheaval on the southern side of the tree.
 Additionally, there is cracking in the stem, decay with fungal fruiting bodies and cracking in
 large canopy branches. Further dieback was noted throughout the higher crown. This tree has
 a poor structural condition.

Plate 7: Tree 39, a hazardous tree that should be removed. Note the subsiding lean, which is to the North.

- Tree 39 (Eucalyptus pilularis). This tree is exhibiting early subsidence of the root-ball, with a lean to the north and soil upheaval on the southern side of the tree. Additionally, there is cracking in the stem, decay with fungal fruiting bodies and cracking in large canopy branches. Given the large size of the canopy, height of the tree and direction of the lean mean that these defects represent a significant hazard to future development or site usage and the tree should be removed.

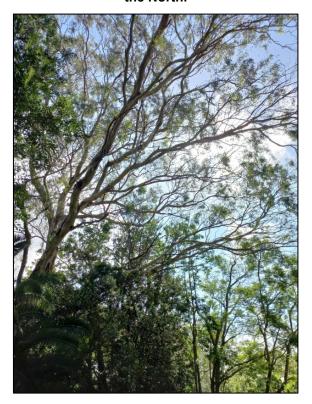
Plate 8: The higher canopy of Tree 39.
