CONSERVATION MANAGEMENT PLAN

MAITLAND MERCURY

2 Hunter Street and 258 High Street, Maitland

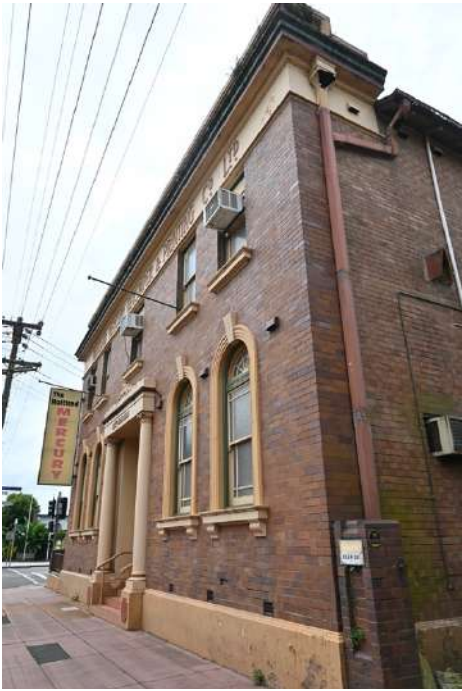
<p>Front façade of Building 01 which is in good condition.</p>	<p>The exterior of this building demonstrates a high level of integrity and intactness.</p>

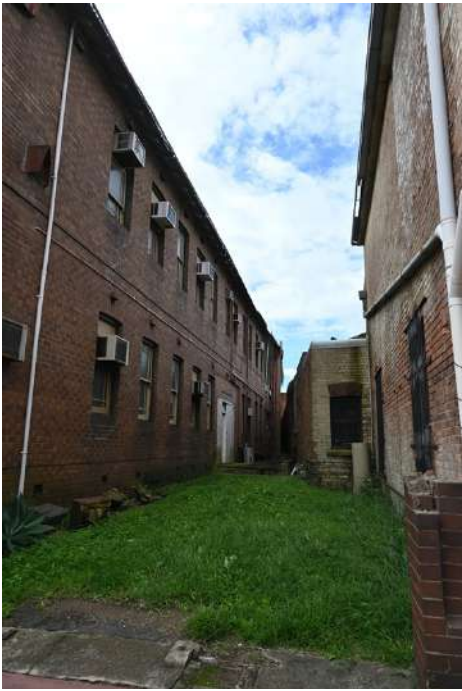
<p>The south-eastern elevation of Building 1 is in good condition overall.</p>	<p>A number of air conditioning units have been installed and the upper portion of windows removed. These windows should be replaced to match existing in all aspects.</p>

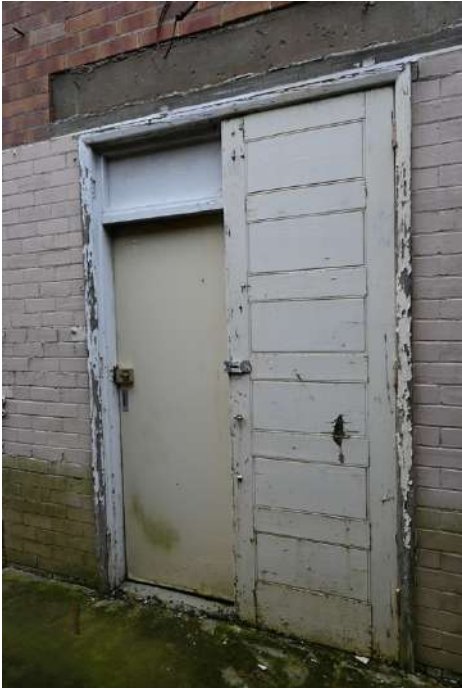
<p>Side access door within south-eastern elevation in poor condition.</p>	<p>This minor element within the whole façade has lost integrity and intactness through changes made over time. Any future work undertaken on the property should rectify this element and return it to its former state. Peel Away or similar product should be used to carefully remove paint from brickwork.</p>

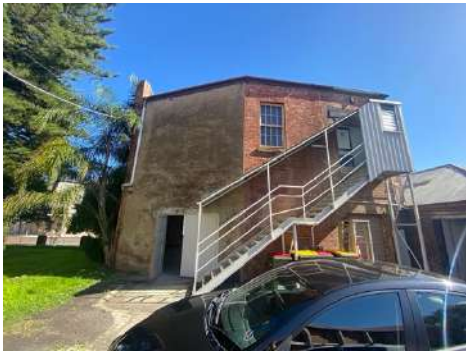
<p>View to rear elevation, looking from left to right, the rendered section is at an angle and is original, the brickwork with window is part of the original 1882 building and the brickwork abutting the top of the stairs is the later 1970's addition. Reasonable condition.</p>	<p>Intactness is low and all elements have lost integrity as a result of modifications and lack of repair over time.</p>
 	<p>Southern wall of Building 02 which was constructed following the demolition of the remainder of the original building. All in good condition.</p>	<p>Wall is well intact but is a later element to the original building.</p>

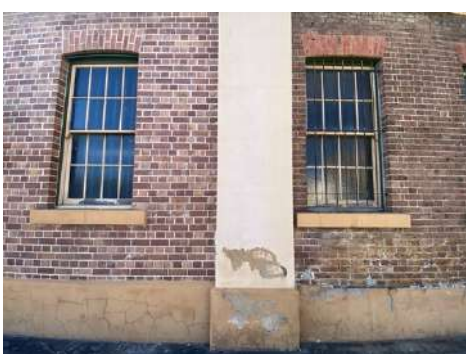
<p>Junction between the 1882 façade (image right) and 1970's two storey addition (image left). Windows appear to be relocated from original parts of the building. All in good condition.</p>	<p>Well intact and with relatively high levels of integrity.</p>

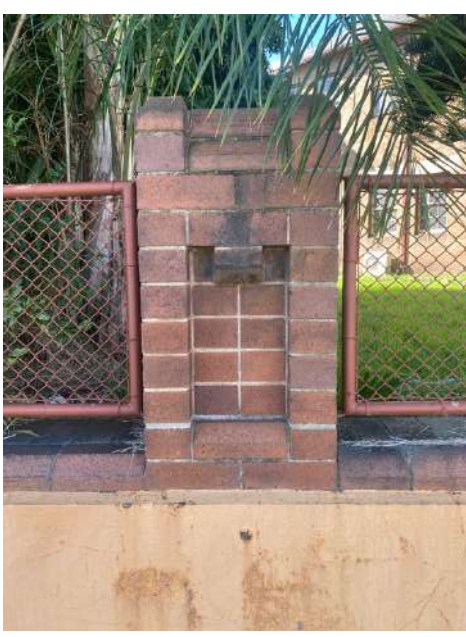
<p>Boundary fence and plinth which continues the original structure and connects to Building 01 as it wraps around the corner from Hunter Street to High Street. Generally in good condition.</p>	<p>Well intact and with good levels of integrity.</p>

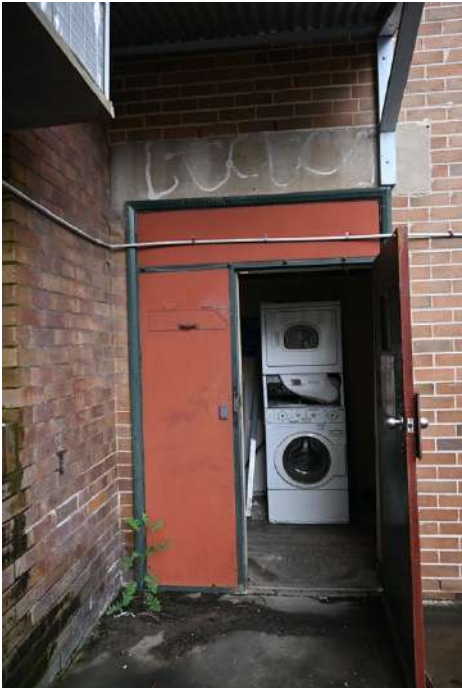
<p>Rear entrance into the original portion of the building. This element is in reasonable condition, having undergone some modification and in need of some repair.</p>	<p>This element is reasonably well intact, the awning over should be removed, graffiti removed and doors replaced as part of any future conservation works.</p>

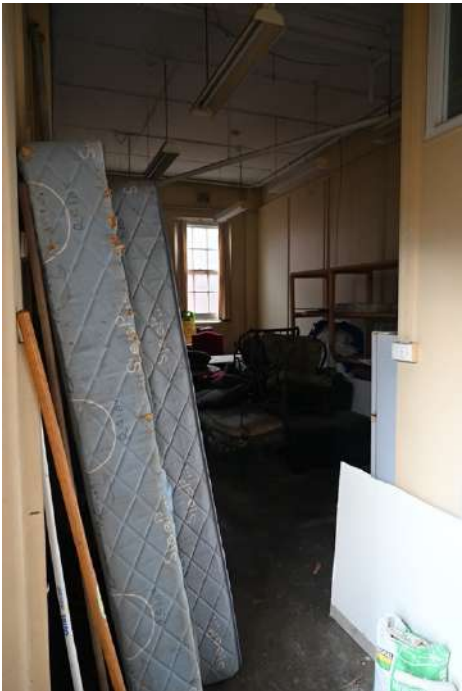
<p>Looking from the rear entrance and into the Lunch Room.</p>	<p>Original ceilings and windows remain relatively well intact with later partition walls obscuring the space currently but able to be removed and the affected elements made good.</p>

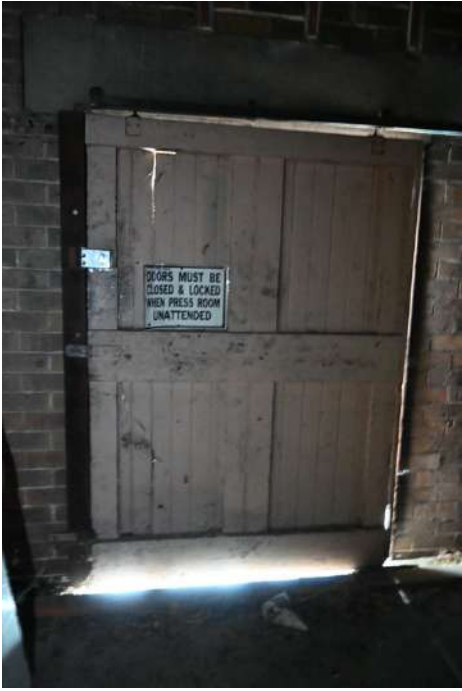
<p>Timber doors within the western elevation of the 1970s addition to Building 01.</p>	<p>Doors are intact and appear to remain operable though significance is not particularly high.</p>

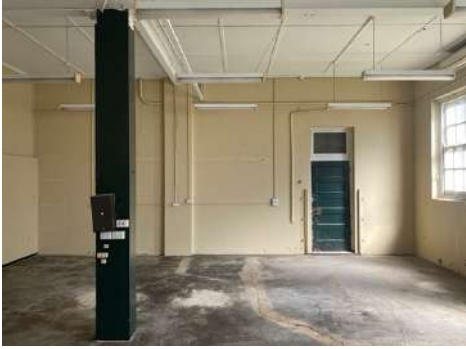
<p>Administration Room looking south. Door is an earlier external door into the space between the front and rear portions of Building 01 but now accesses the female toilets.</p>	<p>Good degree of intactness and integrity.</p>

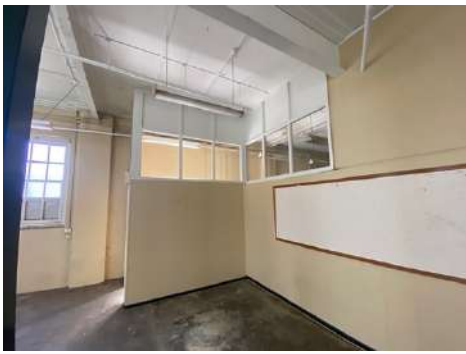
<p>Looking north-east towards a later partition wall within the space that could be removed.</p>	<p>The space is relatively well intact with little loss of integrity. Later partition walls are intrusive and could be removed and original features made good.</p>
<p>General Office</p>		
 	<p>Office within the 1960's rear addition and accessing the 1970's addition. Ceilings are part of the 1970's additions. Fair condition.</p>	<p>Fair degree of intactness and integrity.</p>
<p>Administration Office</p>

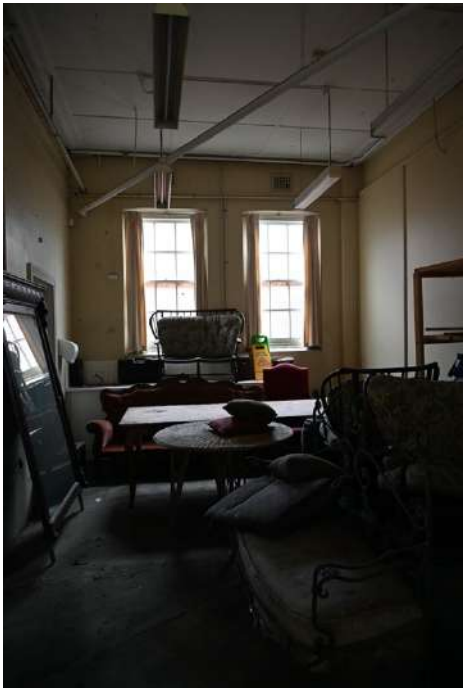
<p>Lunch Room looking south-east. Overall good condition. Wall to image right is a later partition and could be removed.</p>	<p>The space is relatively well intact with little loss of integrity. Later partition walls are intrusive and could be removed and original features made good.</p>

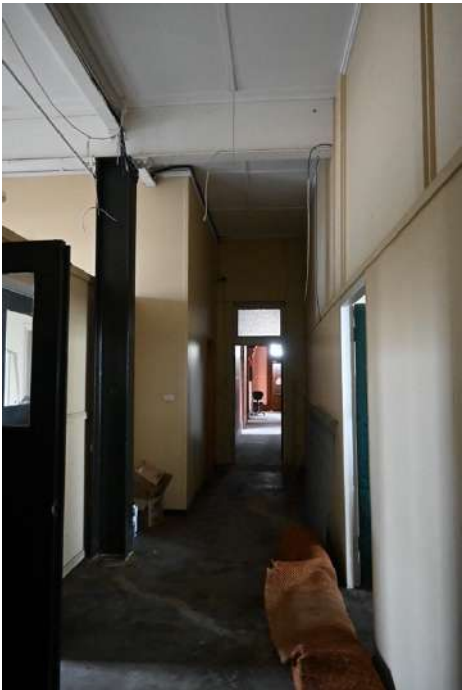
<p>Overall fair condition. Both left and right walls within this image are later partitions and could be removed. The Administration Room is to the right of the image.</p>	<p>The space is relatively well intact with some loss of integrity. Later partition walls are intrusive and could be removed and original features made good.</p>

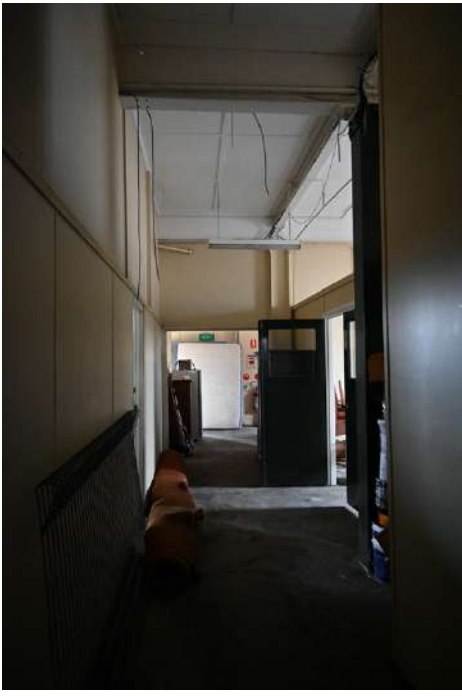
<p>Overall fair condition. Both left and right walls within this image are later partitions and could be removed. The Administration Room is to the left of the image.</p>	<p>The space is relatively well intact with some loss of integrity. Later partition walls are intrusive and could be removed and original features made good.</p>

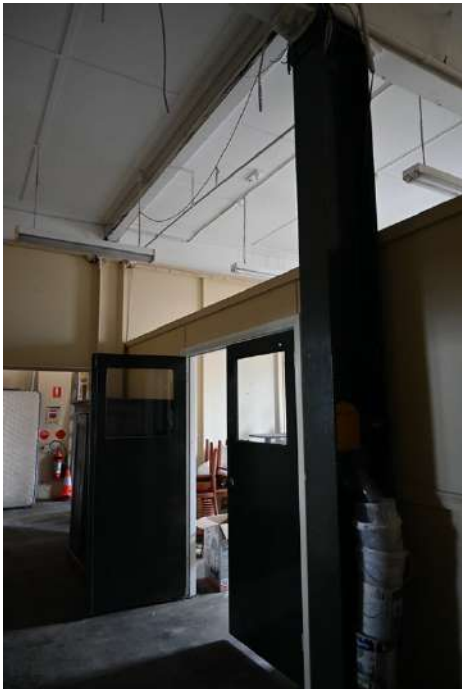
<p>Overall fair condition. Looking north with the Administration Room to the left of the image.</p>	<p>The space is relatively well intact with some loss of integrity. Later partition walls are intrusive and could be removed and original features made good.</p>

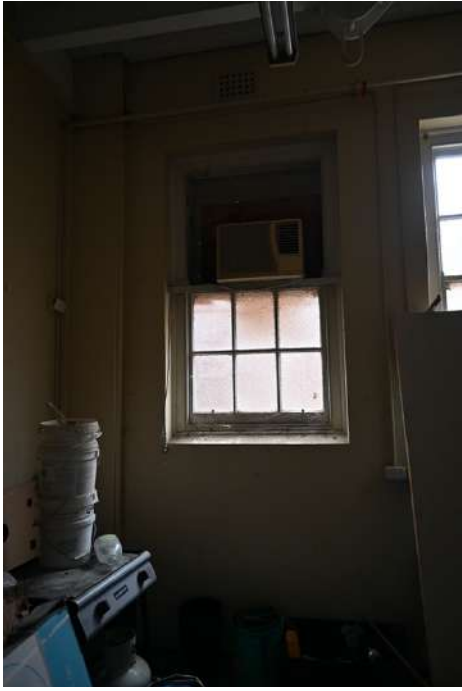
<p>Windows within south-eastern wall are generally well intact however later air conditioning installation has removed the upper portion of one window.</p>	<p>Generally intact with some loss of integrity due to the installation of later partition walls and window alterations which could be made good.</p>

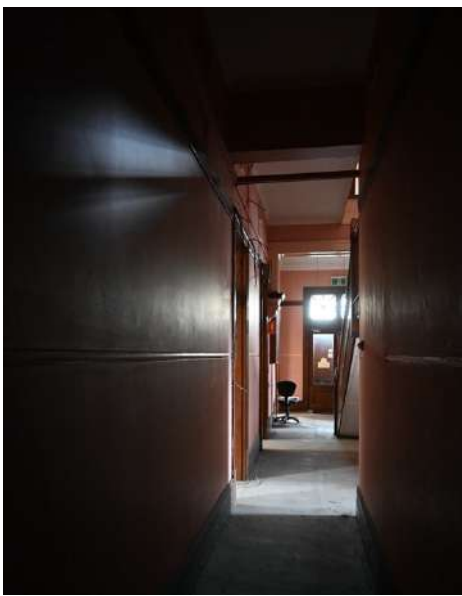
<p>View looking towards the front doors of the building onto High Street. Overall good condition.</p>	<p>Good level of intactness and integrity.</p>

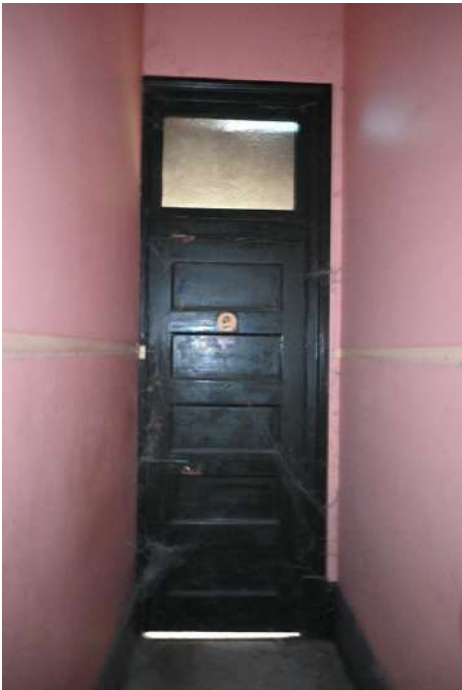
<p>Women's toilet within detached structure between front and rear portions of the original building not accessible. Door shown would originally have been an external door into this courtyard space. Good condition.</p>	<p>Good level of intactness and integrity.</p>

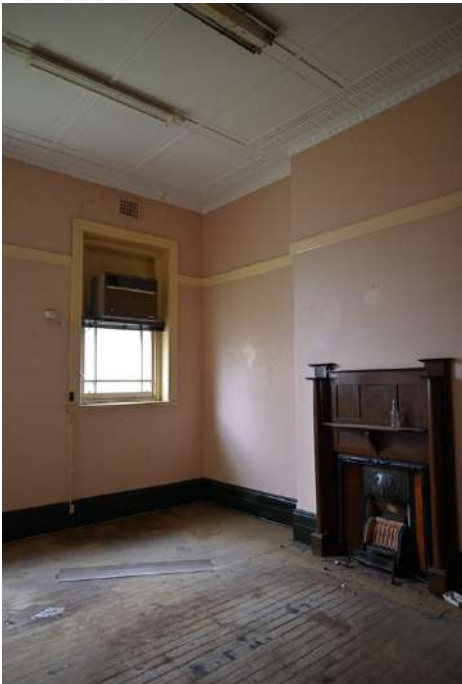
<p>View within Secretary's Office looking southerly and showing an original fireplace, window in south-eastern wall, original floorboards and ceilings. Generally in good condition.</p>	<p>Good level of intactness and integrity.</p>

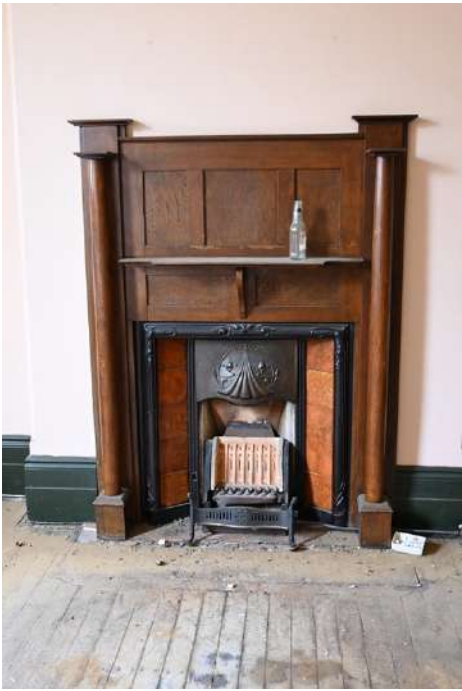
<p>Fireplace within Secretary's Office in good condition.</p>	<p>Good level of intactness and integrity.</p>

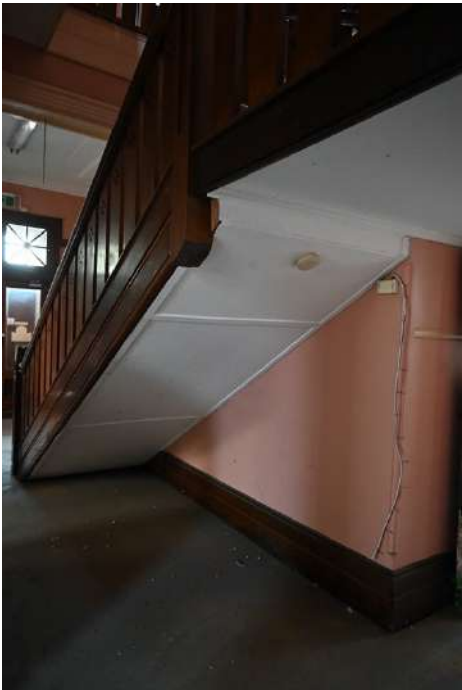
Entry stairwell in very good condition overall.	Good level of intactness and integrity.

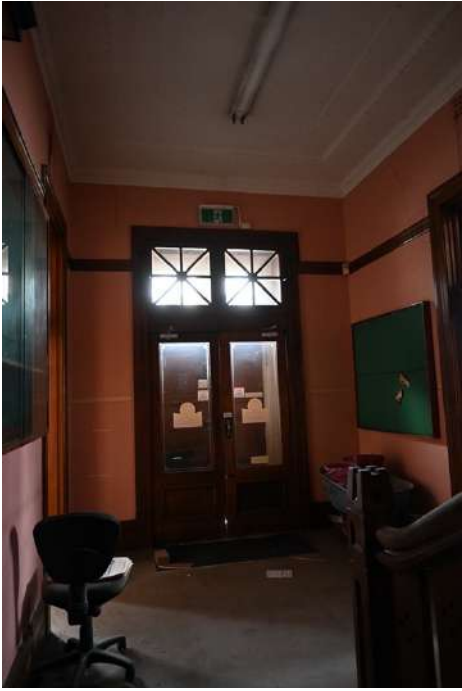
<p>Front entrance doors and showing ceiling and flooring all in good condition.</p>	<p>Good level of intactness and integrity.</p>

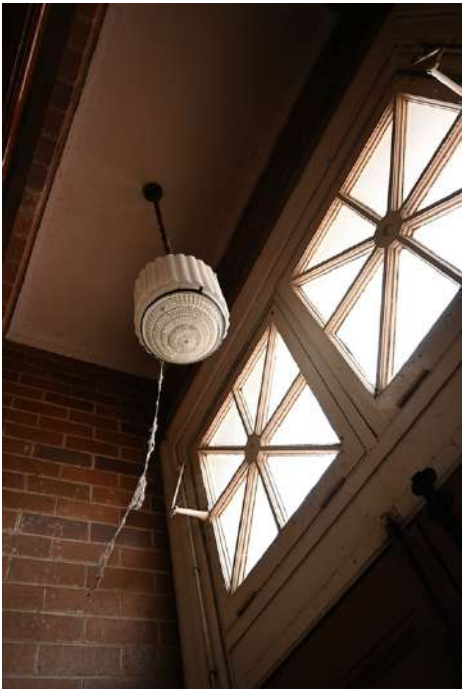
<p>Detail view to fanlight over front doors and showing pendant light above all in excellent condition.</p>	<p>Good level of intactness and integrity.</p>

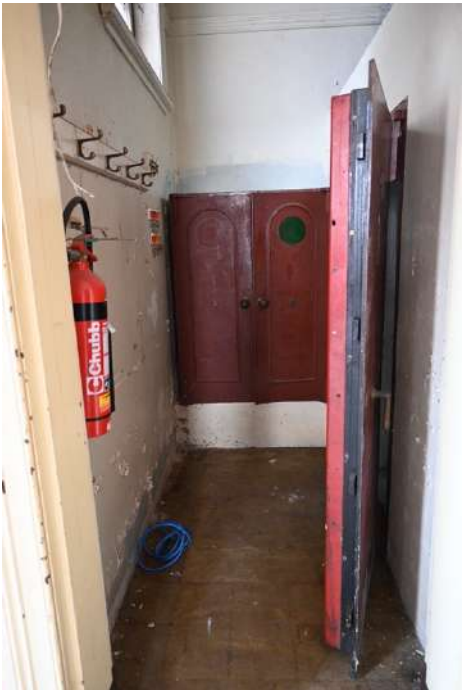
<p>View looking from within the Front Office and into the Safe Room. Existing lockbox and safe door are in good condition.</p>	<p>Good level of intactness and integrity.</p>

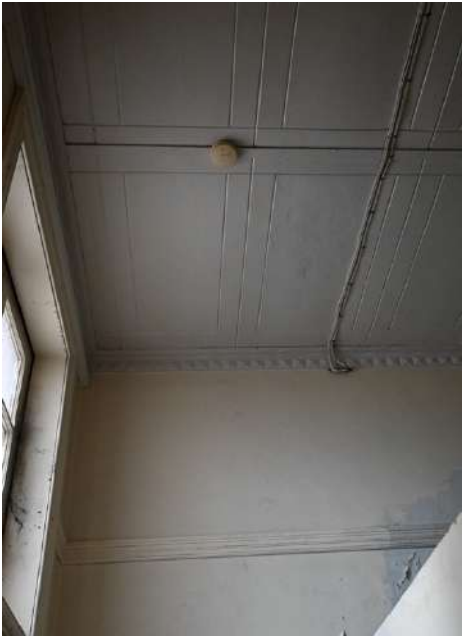
<p>Ceiling within safe room space is in good condition.</p>	<p>Good level of intactness and integrity.</p>

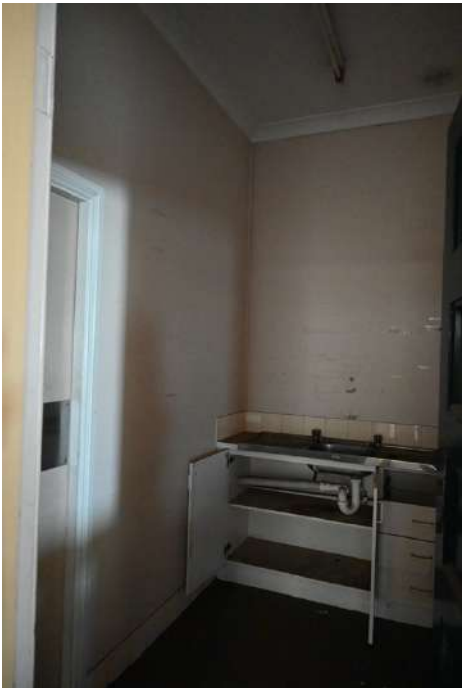
<p>Poor overall condition.</p>	<p>Original ceilings have been replaced and the internal fitout is not original. As a result, intactness and integrity are both low.</p>

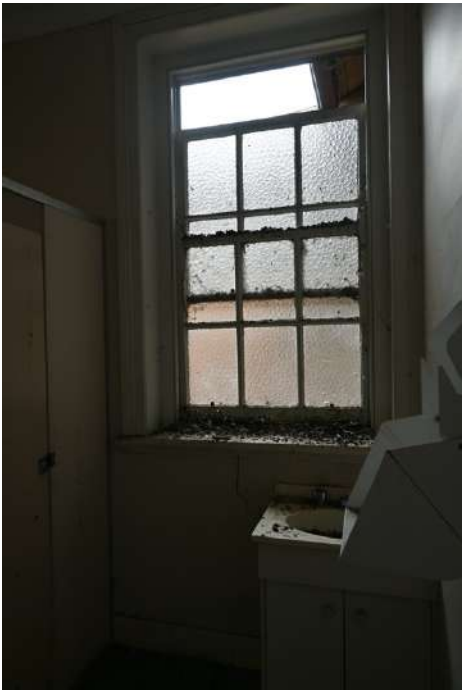
<p>Window within female toilets in moderate but recoverable condition. Bird nesting has caused ongoing damage and should be rectified.</p>	<p>Intactness and integrity are both moderate but recoverable.</p>

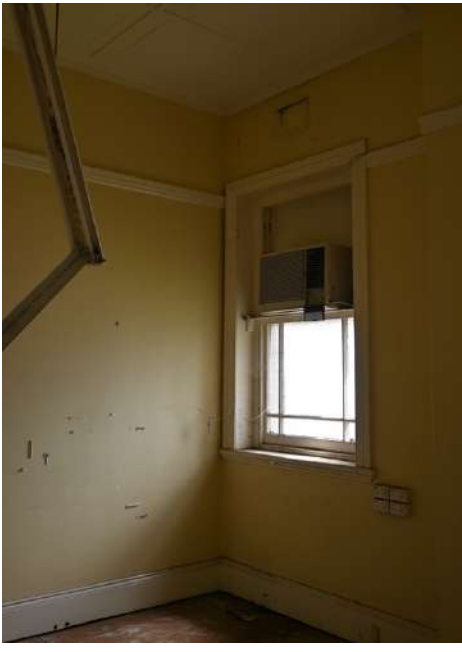
<p>Both external windows have been altered to allow air conditioning units to be installed. Original ceilings, floors and architraves remain. All is generally in good condition.</p>	<p>Reasonable level of intactness and integrity.</p>

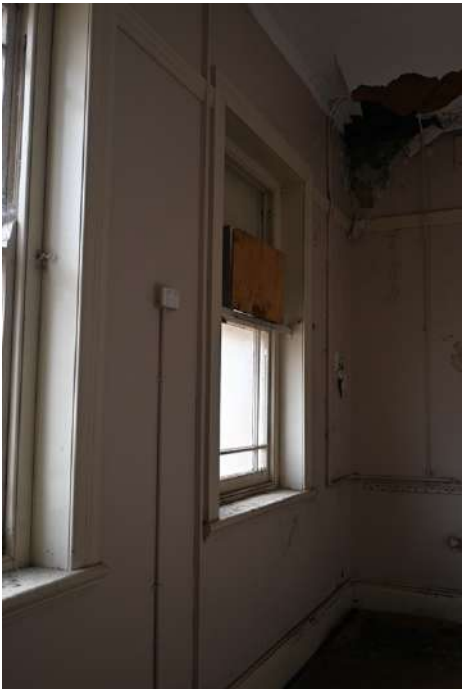
<p>View to north-western wall and showing substantial damage to western corner. Window has been altered to allow installation of air conditioning.</p>	<p>Damage is local to western corner and original ceilings are otherwise intact and in reasonable condition.</p>

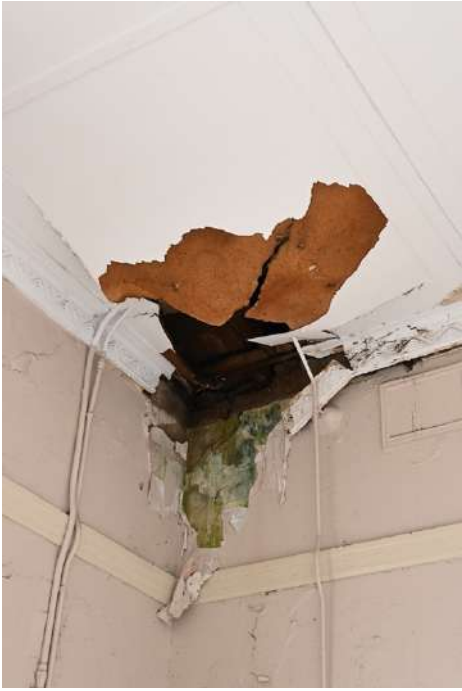
<p>Substantial damage to western corner likely from a failed box gutter behind the parapet wall of the front elevation.</p>	<p>Damage is local to western corner and original ceilings are otherwise intact and in reasonable condition.</p>

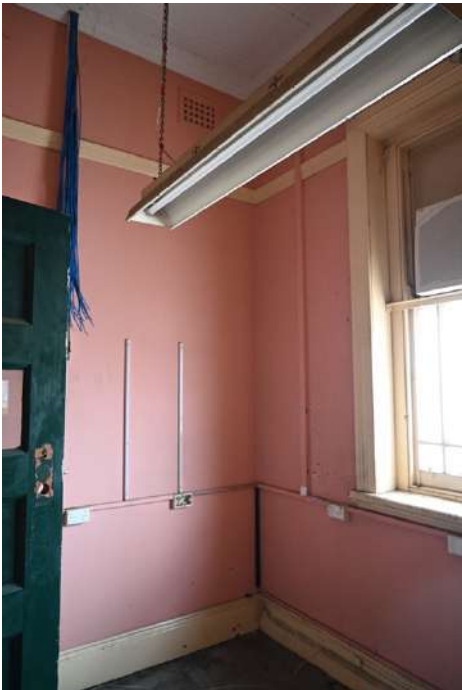
<p>View showing window within front elevation which has been altered to accommodate air conditioning. Remainder of the room and features are in good condition.</p>	<p>Reasonable level of intactness and integrity, later installations appear readily removable in order to improve the condition of this room.</p>

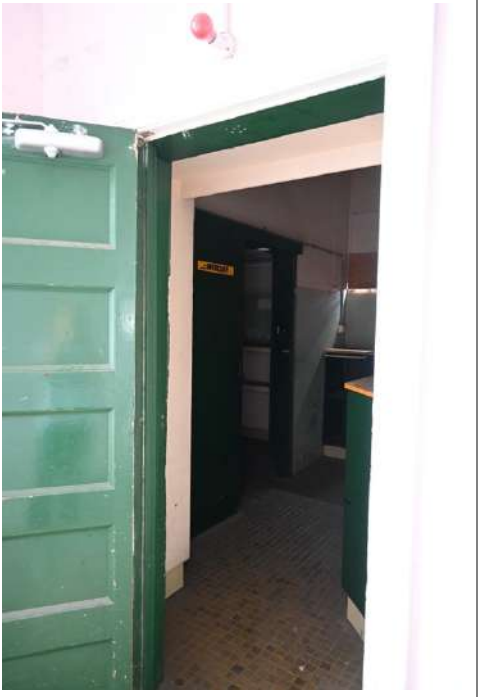
<p>Looking from Office 4 and into the Dark Room. Doors are original and in good condition. Ceilings, wall coverings and fitout are of lower significance. Generally in reasonable condition.</p>	<p>Floor coverings are not original. Low levels of intactness and integrity overall.</p>

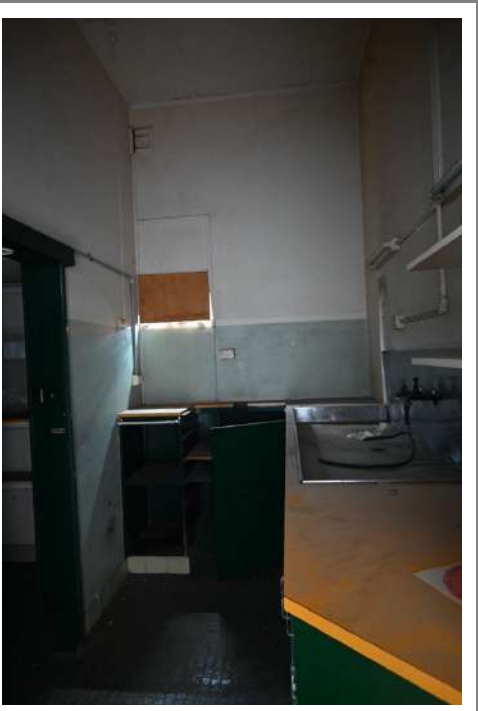
<p>Front half of the Dark Room showing fitout, replacement ceilings and non-original floor coverings.</p>	<p>Floor coverings are not original. Low levels of intactness and integrity overall.</p>

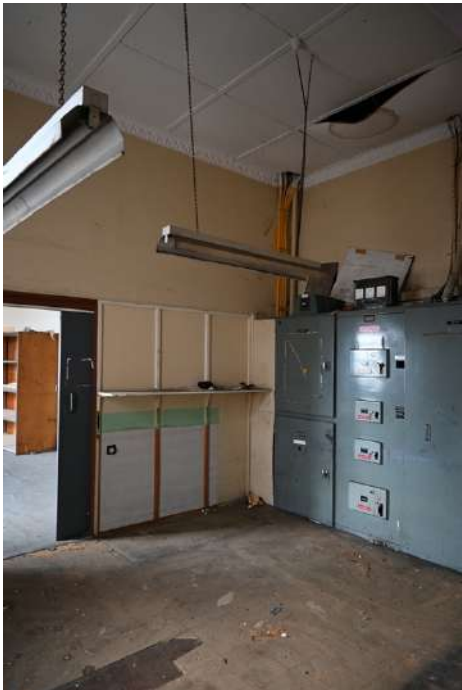
<p>Former powder room used as storage and control room space. Some damage consistent with the age of the building but generally in good condition.</p>	<p>Reasonable level of intactness and integrity.</p>

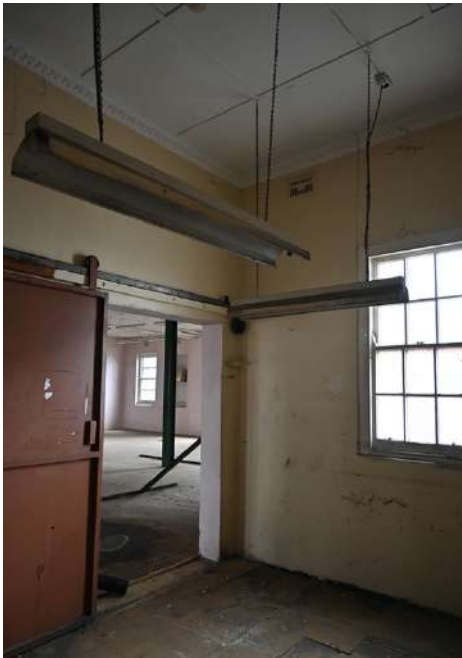
<p>Former powder room used as storage and control room space. Some damage consistent with the age of the building but generally in good condition.</p>	<p>Reasonable level of intactness and integrity.</p>

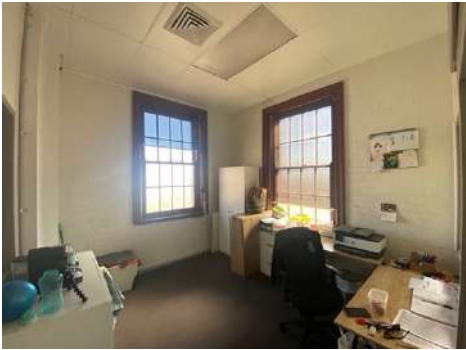
<p>Office within later two storey addition to the 1882 building. Good condition overall.</p>	<p>Good levels of intactness and integrity though suspended ceilings and floor coverings diminish this to some extent. This is a later portion of the building of much lower significance.</p>

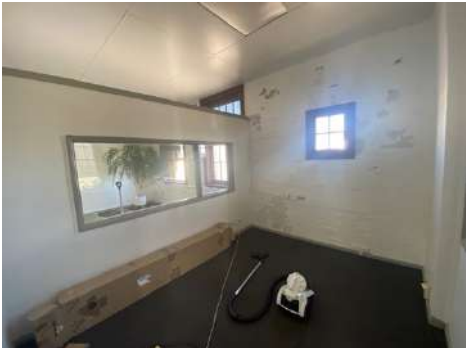
<p>Yoga space showing smaller square window within infilled original window space.</p>	<p>Good levels of intactness and integrity though suspended ceilings and floor coverings diminish this to some extent.</p>

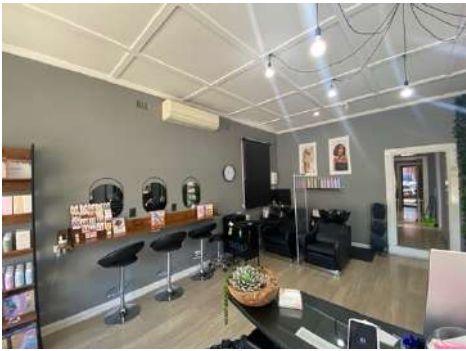
<p>Hairdressers fitout in use within the 1970's single storey adjoining element. Very good condition.</p>	<p>Well intact but of little significance.</p>

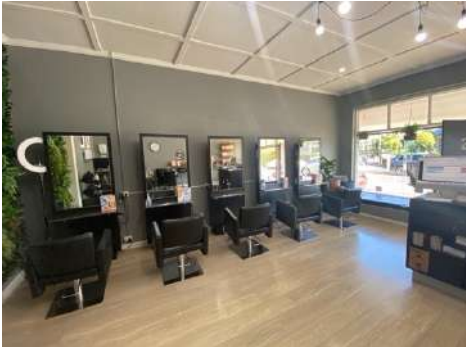
<p>Hairdressers fitout in use within the 1970's single storey adjoining element. Very good condition.</p>	<p>Well intact but of little significance.</p>
