FIRE SAFETY ASSESSMENT

Maitland Regional Art Gallery

Date: 23rd February 2022

Report Number: 210705-11

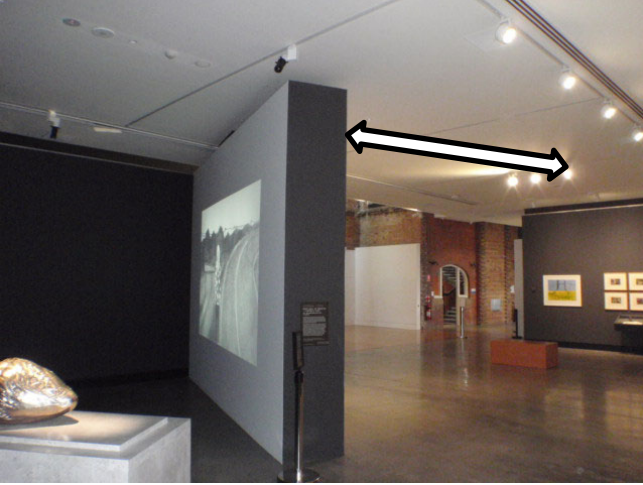
Measure	Ref	Issues / Information	Recommendations	Key	\$ Estimate
Automatic smoke detection and alarm system (cont'd)	1.3	<p>Ground floor main gallery space –At the time of assessment a free standing partition wall had been constructed to subdivide the room such that the smoke detector locations did not comply exceeding 5m (8m) from the partition on the other side. The partition wall extends within 300mm from the ceiling. The standard requires such elements to be considered as a wall and the detectors spaced accordingly.</p>

<p>Modify the display partition such that the gap between the top and the underside of the ceiling is more than 300mm. This will provide the greatest degree of flexibility for the display space with no limitations on the positioning.</p> <p>OR</p> <p>Install additional smoke detectors to enable flexibility to subdivide the gallery area and maintain detector spacing as nominated in AS1670.1.</p> <p>This would likely require approximately 2 additional smoke detectors as a minimum combined with some guidelines and limitations on the placement of the partitions and panels.</p> <p>OR</p> <p>Remove the partition or relocate it such that the smoke detector spacing is not compromised. This would severely limit flexibility for the space and require strict procedures for ongoing positioning of the partitions and use of the area.</p>	Performance	<p>1K</p> <p>2K</p> <p>0.1K</p>

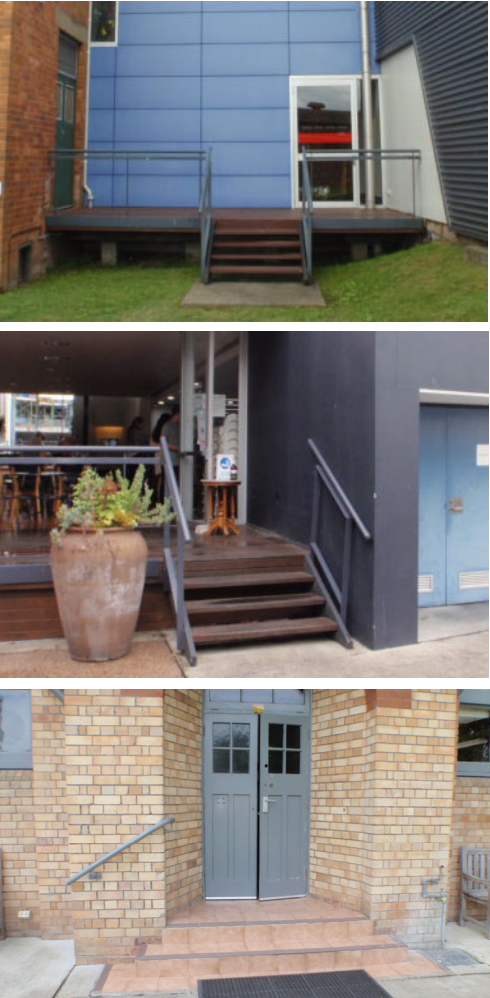
Measure	Ref	Issues / Information	Recommendations	Key	\$ Estimate
Emergency lights (cont'd)	2.6	<p>External stairs connecting the ground floor exit doors to ground level have no emergency lighting. The stairs are considered as required stairs and must be provided direct illumination from an emergency light.</p>

<p>Install a weatherproof emergency light to provide direct illumination of not less than 1 lux to the external stairs in accordance with AS2293.1.</p> <p>The emergency light is to be supplied from the DB controlling the normal lighting in the area and interfaced to both the normal lighting serving the area and the test timer unit.</p>	Performance	2.5K

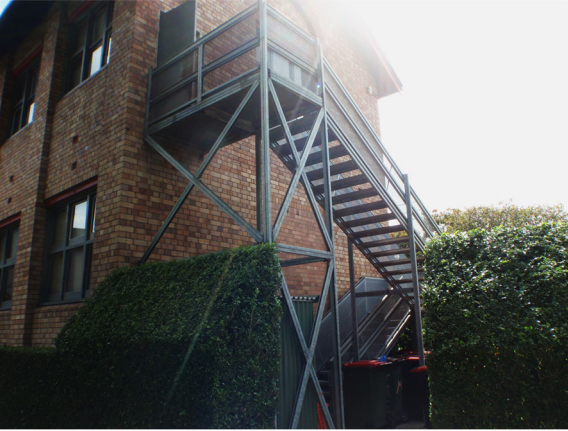
Measure	Ref	Issues / Information	Recommendations	Key	\$ Estimate
Emergency lights (cont'd)	2.7	<p>External stairs connecting the 1st floor exit door to ground level has no emergency lighting. The stairs are considered as required stairs and must be provided direct illumination throughout from emergency lights.</p>

<p>Install weatherproof emergency lights to provide direct illumination of not less than 1 lux throughout the external stairs in accordance with AS2293.1.</p> <p>The emergency light is to be supplied from the DB controlling the normal lighting in the area and interfaced to both the normal lighting serving the area and the test timer unit.</p>	Performance	1.5K
Exit signs (illuminated)	3.1	<p>Self-contained exit signs are installed above required exit doors with directional exit signs installed over corridors and door in the path of travel to exits.</p> <p>The control arrangement includes test timer units for manual testing in the distribution boards accessible during assessment</p> <p>The exit signs are supplied from multiple distribution boards located throughout the ground and 1st floor.</p> <p>The installation generally aligns with requirements of BCA2008 and AS2293.1-2005, corresponding to the date of the construction certificate for the 2009 extensions and modifications.</p>	Na	Information	-

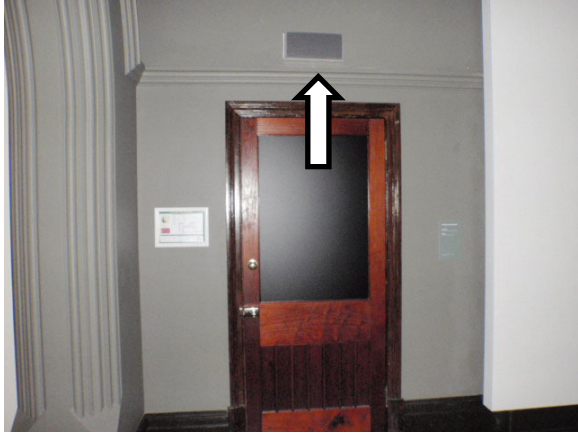
3.6	Ground floor gallery High Street side - The door in the path of travel near the old stair has an illuminated exit sign which has been taped over. The corridor behind has been modified and closed off with a partition wall such that there is no path of travel to an exit. It is likely the tape will be removed by a well meaning service contractor creating egress issues. Exit signs must not be taped over or modified. Replacing the diffuser with one including a running man and arrow left would resolve the issue as the path of travel would comply without this door which has two latch operating devices.

Replacing the diffuser with one including a running man and arrow left in accordance with AS2293.1.	Non-conformance	0.2K

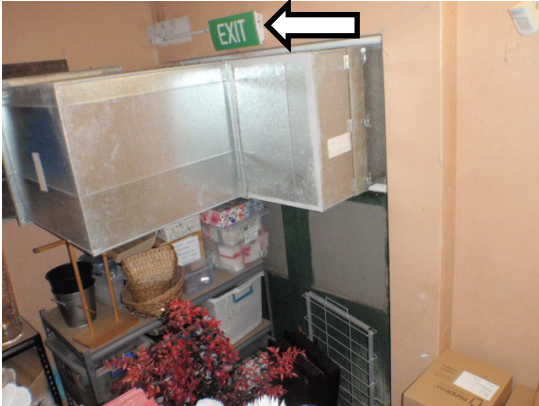
Measure	Ref	Issues / Information	Recommendations	Key	\$ Estimate
Exit signs (illuminated) (cont'd)	3.7	<p>Ground floor stair east end – The discharge door at the base of the original stair which is no longer a required stair for egress has an old style exit sign installed above a duct. The sign does not appear to have mains power and was not illuminated. The door was obstructed by stored items.</p>

Disconnect and remove the illuminated exit sign.	Non-conformance	0.4K
	3.8	<p>Ground floor rear exit – The exit sign is installed too high above the plane of view at 3.8m above floor level. The sign should be installed immediately above the door or at a height of not more than 2.7m.</p>

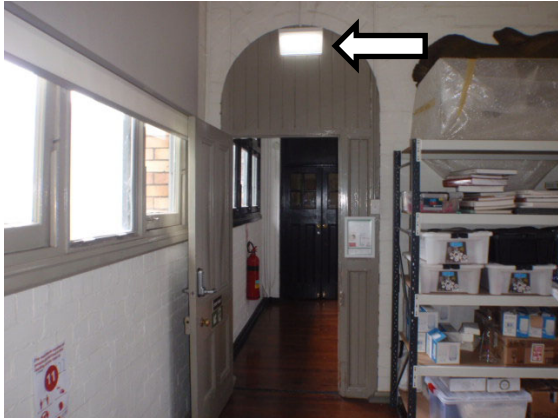
Measure	Ref	Issues / Information	Recommendations	Key	\$ Estimate
Exit signs (illuminated) (cont'd)	3.11	<p>1st floor staff only room adjacent to the staff kitchenett – The running man exit decal is missing from the exit sign.</p>

Replace the missing running man exit decal	Performance	0.2K
Fire Blankets	4.1	<p>Fire blankets are installed in the Cafe kitchen, the 1st floor staff kitchenette and the ground floor work room. Fire blankets are not a statutory fire safety measure and thereby are not normally included on the fire safety schedule. They are sometimes nominated as a condition for the fitout of commercial kitchens as appears to be the case in this instance where they were included on the fire safety schedule. This measure has been retained on our schedule as it was specifically identified on the relevant schedule attached to the construction certificate and the fire safety certificate.</p>	Na	Information	-

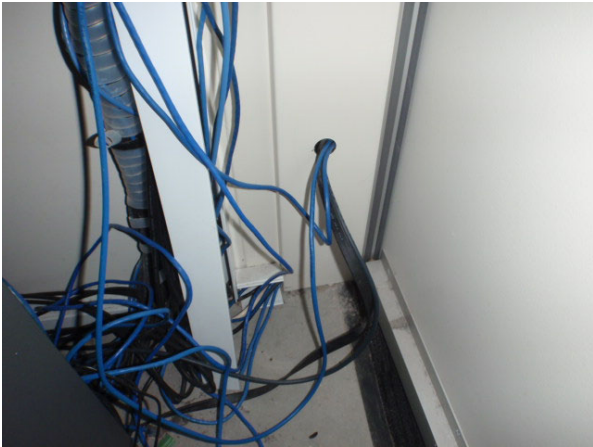
Measure	Ref	Issues / Information	Recommendations	Key	\$ Estimate
Fire doors (cont'd)	5.7	<p>Ground floor distribution board enclosure behind reception – The fire rated assembly has multiple issues including a hole in the frame approximately 20mm diameter with data cables run into the cavity. There appears to be no backfilling in the frame. The pair of fire doors do not have the required self-closers.</p> <p>The assembly in its current condition can not meet the relevant performance requirements of the fire door standard. There are no provisions in BCA requiring such an enclosure to be fire rated and include fire rated doors. We suspect they have been installed mistakenly by the builder to meet the requirement for a non-combustible enclosure for the switch board as per BCA part D2.7. We have omitted this set of doors from the proposed schedule</p>

<p>To prevent future confusion during assessments, place a sign / label on the fire door set advising the assembly is not required to comply as a fire rated assembly. The signs should be placed on the frame inside the enclosure close to the compliance tags.</p>	Non-conformance	0.2K

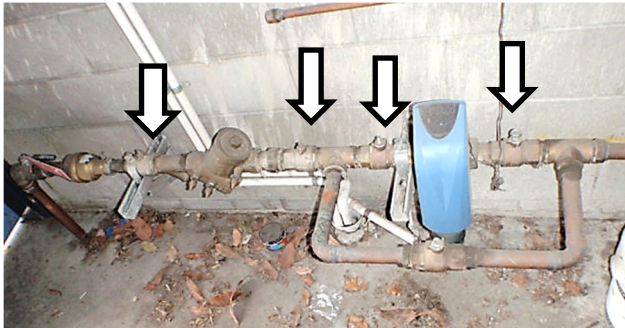
6.3	<p>The valves capable of isolating water supply to fire hose reels at the meter assembly and subsequent back flow devices are not locked open with the required warning signs. The main valve has been locked and labelled. The remaining valves have the handles removed, however they can be simply closed with a spanner.</p>

<p>Lock open the subsidiary isolating valves at the backflow unit that are capable of isolating supply to the fire hose reels (4 in total).</p> <p>Install the required warning signs to comply with BCA part E1.4 and AS2441 on each of the 4 locked subsidiary valves The warning signs must be weather resistant with 8mm high upper case lettering,</p> <p>FIRE SERVICE VALVE - CLOSE ONLY TO SERVICE FIRE HOSE REELS.</p>	Non conformance	0.6K

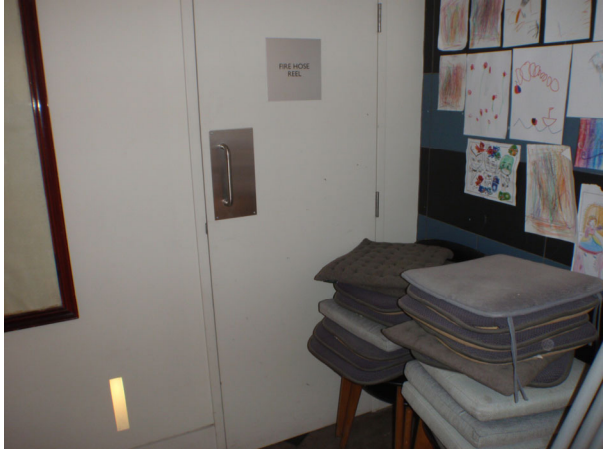
Measure	Ref	Issues / Information	Recommendations	Key	\$ Estimate
Fire hose reels (cont'd)	6.4	<p>Café fire hose reel – At the time of inspection the enclosure was blocked by stored chairs and items, that had to be removed to open the enclosure door. The sign on the enclosure door is also undersized well below the minimum 50mm high lettering size required under the standard.</p>

<p>Relocate all stored items and implement procedures to ensure Café staff do not store items that obstruct either the view of or access to the fire hose reel.</p> <p>Replace the undersized signs with one that has minimum 50mm high letters to read FIRE HOSE REEL</p>	Performance	0.2K

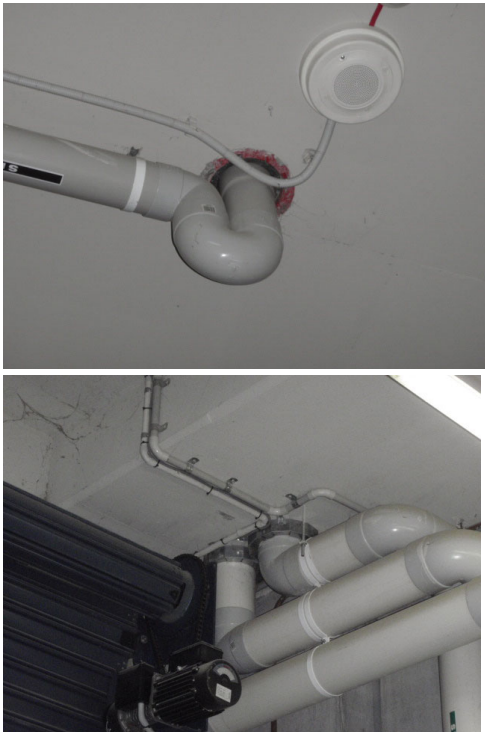
Measure	Ref	Issues / Information	Recommendations	Key	\$ Estimate
Fire seals (cont'd)	8.6	<p>1st floor of the 2009 extension – The intermediate floor between ground level and the 1st floor is constructed of concrete with multiple PVC storm water and floor waste service penetrations below the pump room and switch room that are fitted with either cast in fire collars or retrofitted fire collars.</p> <p>BCA specification C1.1 clause 4.1(i) nominates a floor separating storeys for a class 9b building of type B construction should achieve a 30/30/30 fire rating</p> <p>The fire sealing of the penetrations is consistent with this provision. Access is limited for some of the collars fitted close to the external walls visible from below in the loading dock area.</p>

<p>Investigate the approval files and design documentation to verify the floor is required to be fire rated with fire seals fitted.</p> <p>Obtain an opinion from an accredited principle certifying authority.</p> <p>Using access equipment to reach the penetrations carry out a close inspection to verify the retrofitted collars are complete around the circumference of each pipe and have not been cut down or modified to fit outside of the manufacturers tested system. Verify the fixings are correctly installed in line with the manufacturers tested system.</p>	Performance	1-5K

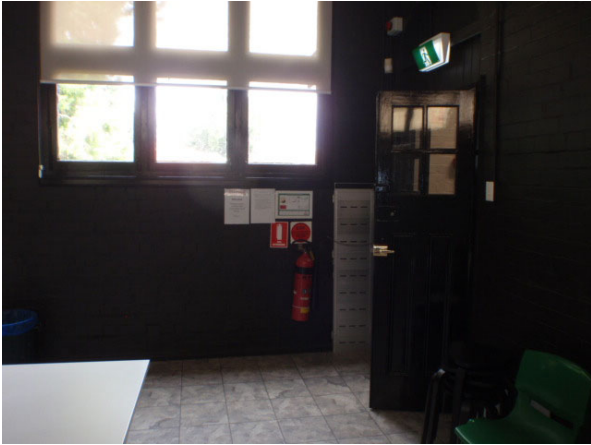
Measure	Ref	Issues / Information	Recommendations	Key	\$ Estimate
Portable fire extinguishers (cont'd)	11.3	<p>Building B – A number of extinguishers have location pictograms well below the minimum 2m height nominated in the extinguisher standard. They are mostly installed in unsuitable locations below windows. The extinguishers in these instances are considered supplementary however where installed they should be located such that the signs can meet the requirements nominated under AS2444.</p>

Review and relocate extinguishers and associated signs such that the locations signs can be installed at the required 2m height above floor level.	Non conformance	1K
Warning & operation signs	12.1	<p>The building is fitted with a lift for disabled access to the 1st floor. The building code part E3.3 requires warning signs regarding the use of lifts in fire be installed at each lift control panel/lift call point.</p> <p>The required signs were in place at each call point at the time of our assessment.</p> <p>We have assessed the warning and operation signs against BCA2008 part E3.3 corresponding to the date of the construction certificate for the 2009 extensions and modifications.</p>	Na	Information	-

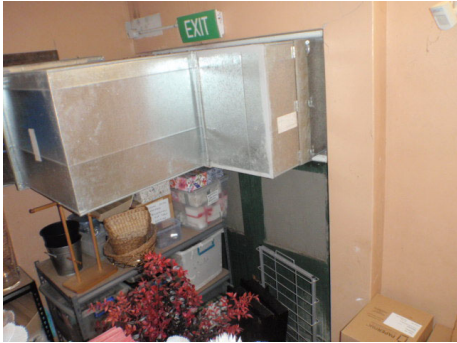
13.2	<p>Building A east stair - The internal stair and discharge door at the have not been considered as exits. The entry door on each level is locked and the stair is used as a storeroom. The former discharge door at the ground level was obstructed at the time of assessment, the door latch has not been upgraded and the old exit sign has been disconnected. The stair and discharge were no longer required as exits when the 2009 extensions created additional exits and paths of travel.</p>

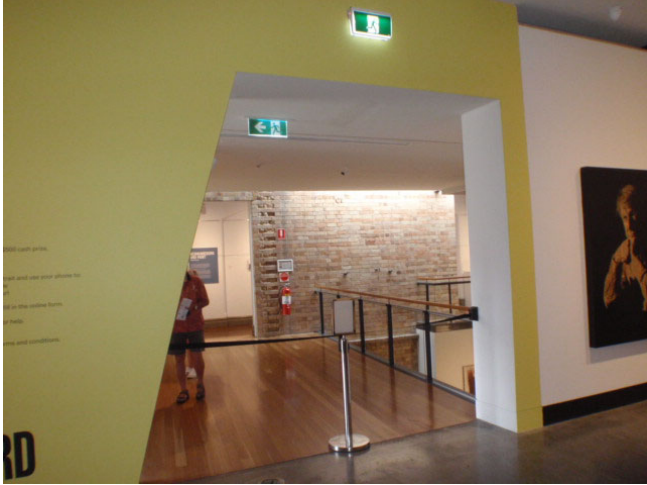
Measure	Ref	Issues / Information	Recommendations	Key	\$ Estimate
Paths of travel (cont'd)	13.3	<p>1st floor Gallery exit path – At the time of assessment the path of travel to the marked exit was obstructed by a bollard and tape barrier spanning the entire opening. The gallery was full of people with a major exhibition underway. It is an offence to obstruct an exit or path of travel to an exit, even a simple tape barrier may prevent people using the exit or create confusion and affect an evacuation.</p> <p>The manager was advised of the issue at the time and removed the tape to provide a clear path of travel.</p>

Tape barriers or any form of barrier must not be used to obstruct paths of travel or access to exits except when works are being conducted and the areas are closed to occupants. At such times consideration of adequate egress must be made for those working in the area.	Information	-

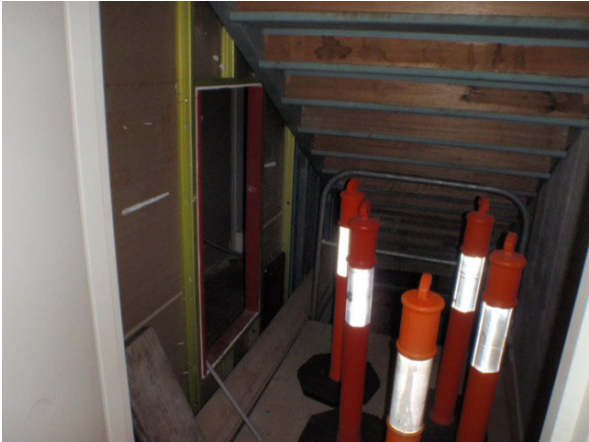
13.7	<p>Ground floor under stair enclosure – The storeroom adjacent to the lift extends under the required exit stair but includes only partial enclosure by fire rated construction. The second fire rated door at the back of the storeroom opens to an area below the stairs that is enclosed but does not include fire rated construction. It was used for storage at the time of our assessment.</p> <p>The enclosure of this space without fire rated construction does not comply with BCA part D2.8(b).</p>

<p>Investigate the approval files and design documentation to verify whether some form of concession was applied. Obtain an opinion from an accredited principle certifying authority whether the fire rated linings and construction must extend through this area.</p> <p>Upgrade the construction fire rated linings and construction to comply with BCA part D2.8(b) as per the principle certifying authority advice.</p>	Non-conformance	10K
