Proposed Subdivision -
Preliminary Geotechnical
Assessment

Lochinvar Ridge, Stages 8 to 14
Lots 2 & 3 DP1256730,
70 Christopher Road, Lochinvar

NEW17P-0034A-AF.Rev2
21 October 2021

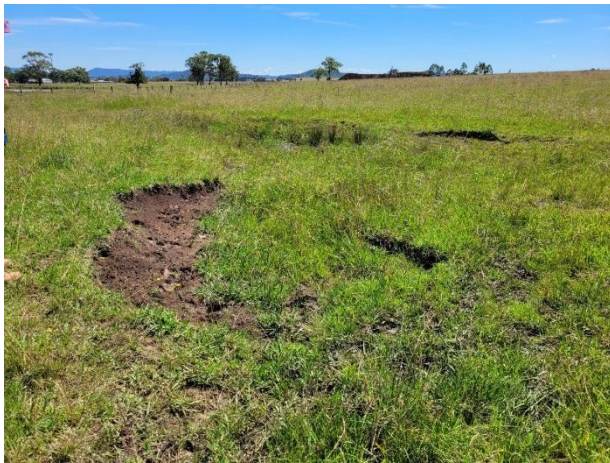
Photograph 13: From northwest of Pond 1 facing northwest. Visible gully erosion and areas of ponded water in drainage depression.

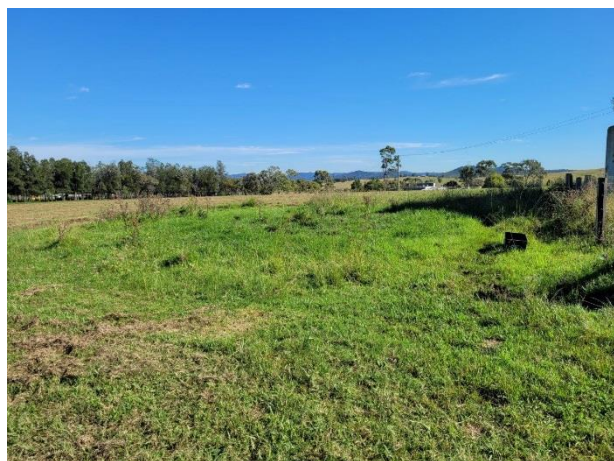
Photograph 18: From northern portion of site (proposed Stage 8) facing north towards area of wet/boggy ground.

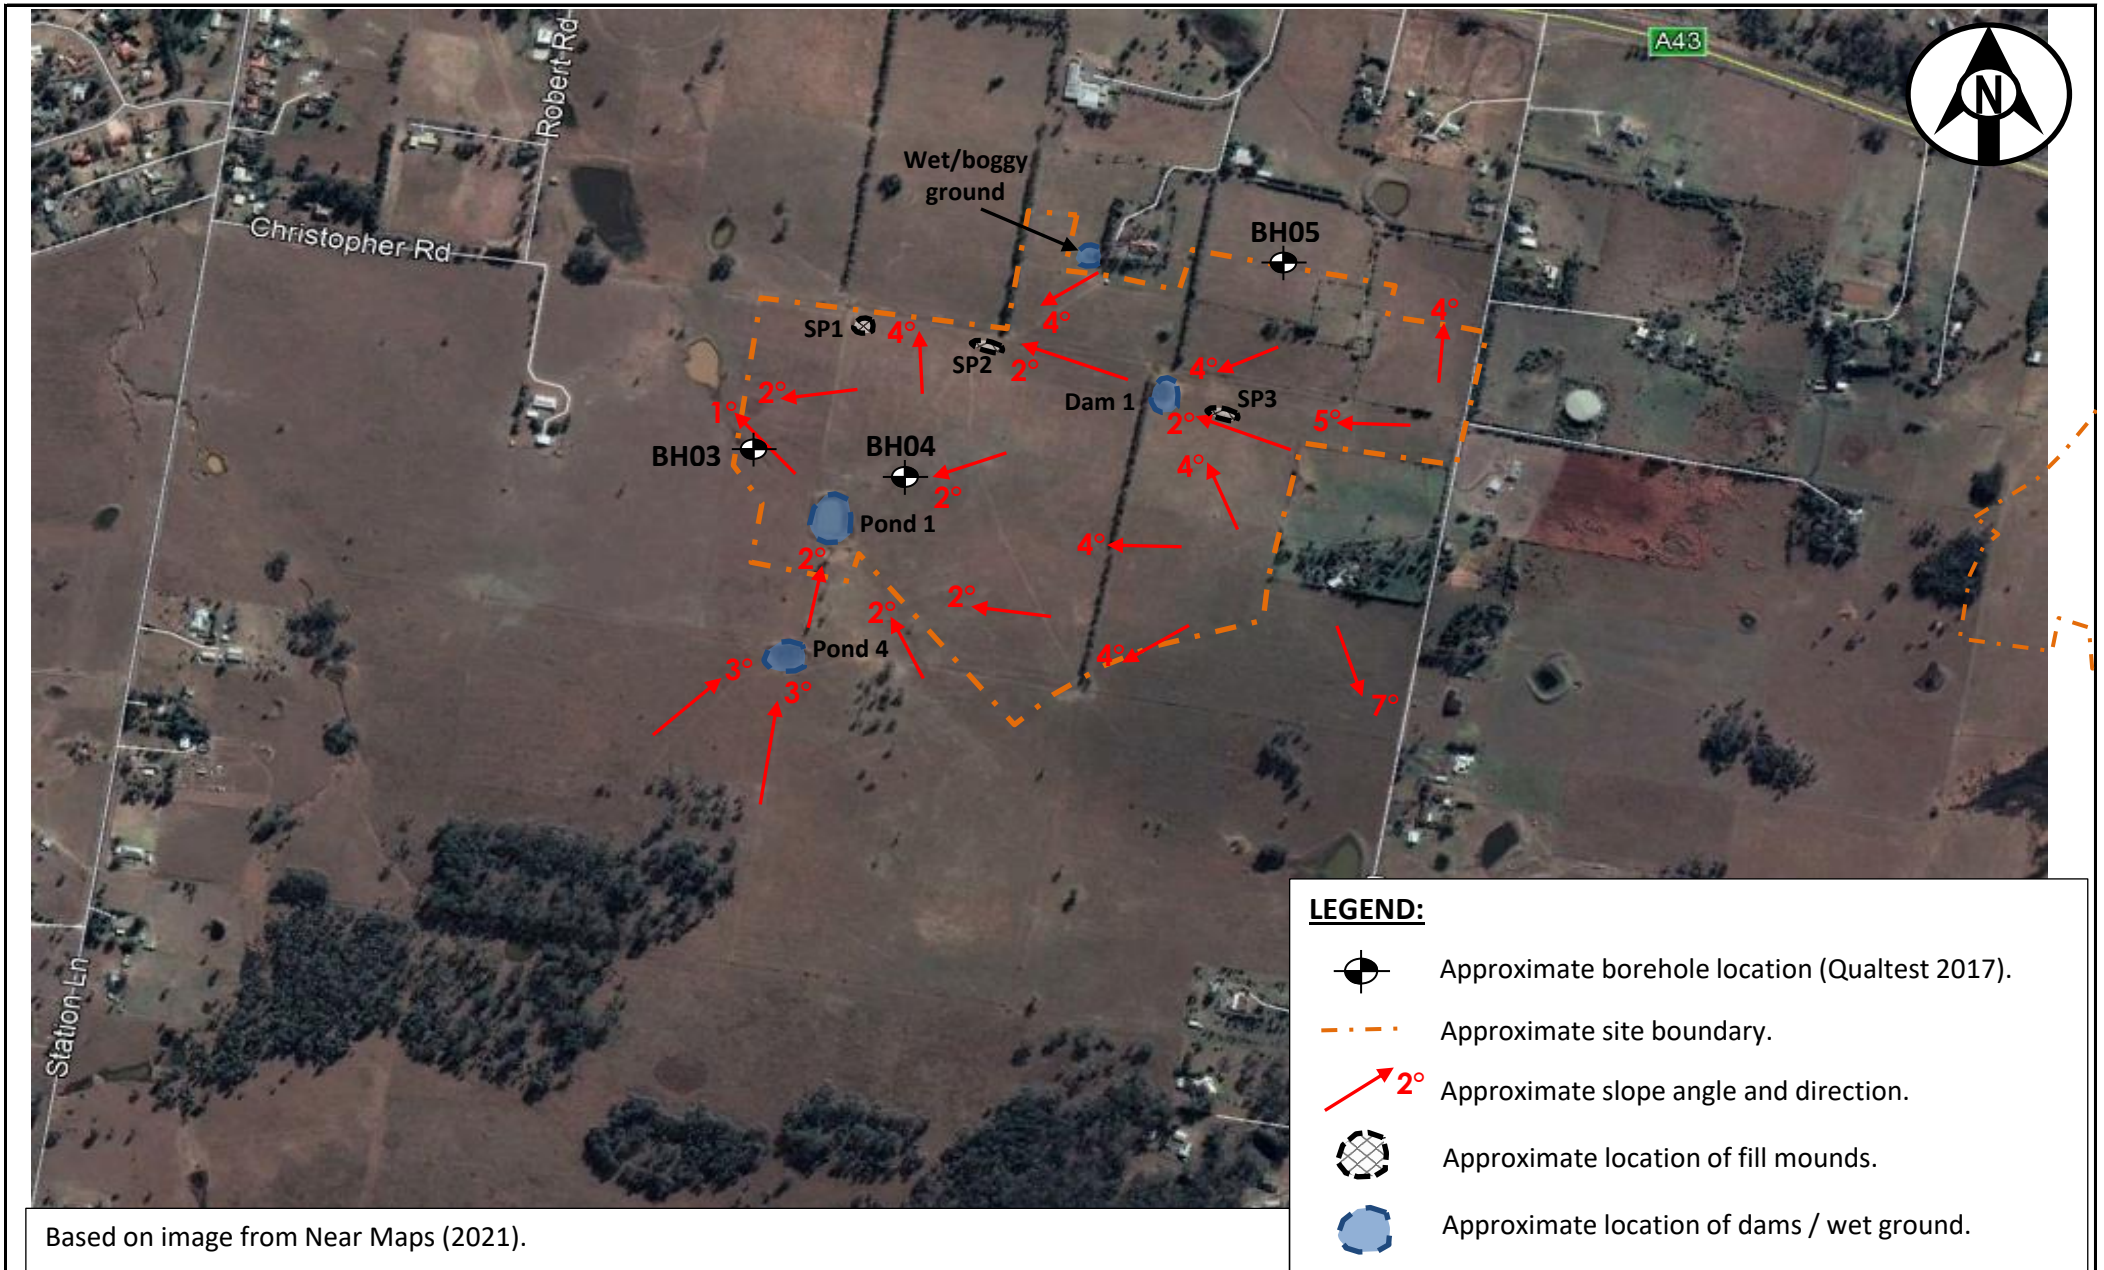
FIGURE AF1.Rev2: Site Location & Approximate Test Locations

Vegetation generally comprises of moderate grass cover and some scattered trees, as shown on Figure AF1.Rev2. An area of lighter coloured and longer grass was observed in the central part of the site, near the dams.
