# Site Classification Investigation

**Client:** TJ & AJ Pty Ltd **Agility Job No:** 2022472  
**Builder:** Alva Property Group **Builder Job No:** -  
**Site Address:** 35 Raymond Terrace Road, East Maitland  
**Fieldwork Date:** 22.08.22 **Fieldwork By:** JH  
**Reported By:** JH **Reviewed By:** MS

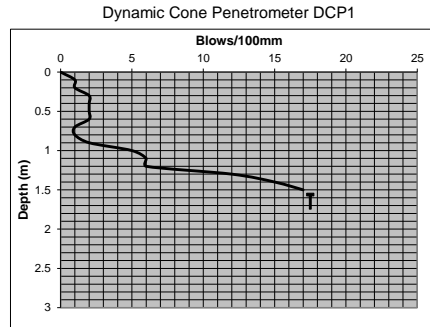
Location: BH1

Depth	Material	Density	Moisture
0.0 - 0.3	FILL/TOPSOIL: Sandy CLAY, f-m sand	-	M
0.3 - 0.5	SLOPEWASH: Silty CLAY, lp, grey with f-m sand, trace f-m subrounded gravel	-	M
0.5 - 0.9	CLAY, hp, grey, trace f subrounded gravel (residual soil)	F-St	M
0.9	Hand auger borehole terminated (limit of investigation)

XW Rock Depth: NE Sample Recovered 0.6 - 0.9  
 Equipment: Trailer mounted drill-rig with 115mm ø solid flight auger

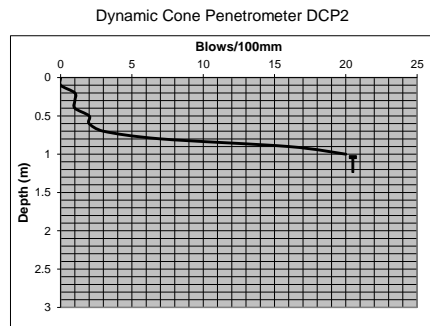
Location: BH2

Depth	Material	Density	Moisture
0.0 - 0.2	FILL/TOPSOIL: Sandy CLAY, f-m sand	-	M
0.2 - 0.4	SLOPEWASH: Silty CLAY, lp, grey with f-m sand, trace f-m subrounded gravel	-	M
0.4 - 0.7	CLAY, hp, grey, trace f subrounded gravel (residual soil)	F-St	M
0.7	Hand auger borehole terminated (limit of investigation)

XW Rock Depth: NE  
 Equipment: Trailer mounted drill-rig with 115mm ø solid flight auger

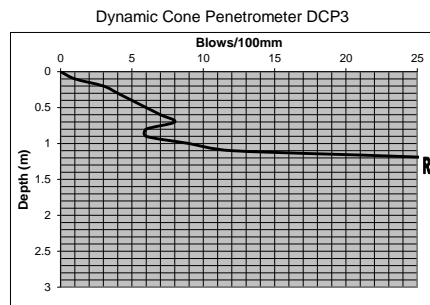
Location: BH3

Depth	Material	Density	Moisture
0.00 - 0.20	FILL/TOPSOIL: Sandy CLAY, f-m sand	-	M
0.20 - 0.40	SLOPEWASH: Silty CLAY, lp, grey with f-m sand, trace f-m subrounded gravel	-	M
0.40 - 0.70	CLAY, hp, grey, with f-m subrounded gravel (residual soil)	St	M
0.70 -	Hand auger borehole terminated (limit of investigation)

XW Rock Depth: NE  
 Equipment: Trailer mounted drill-rig with 115mm ø solid flight auger
