Report on  
Hazardous Material Survey - Buildings 10, 11, 12, 13  
and 14

Existing Buildings, Closebourne Retirement Living  
Morpeth Road, Morpeth

Prepared for  
Lend Lease (Retirement Living)

Project 81251.13  
September 2016

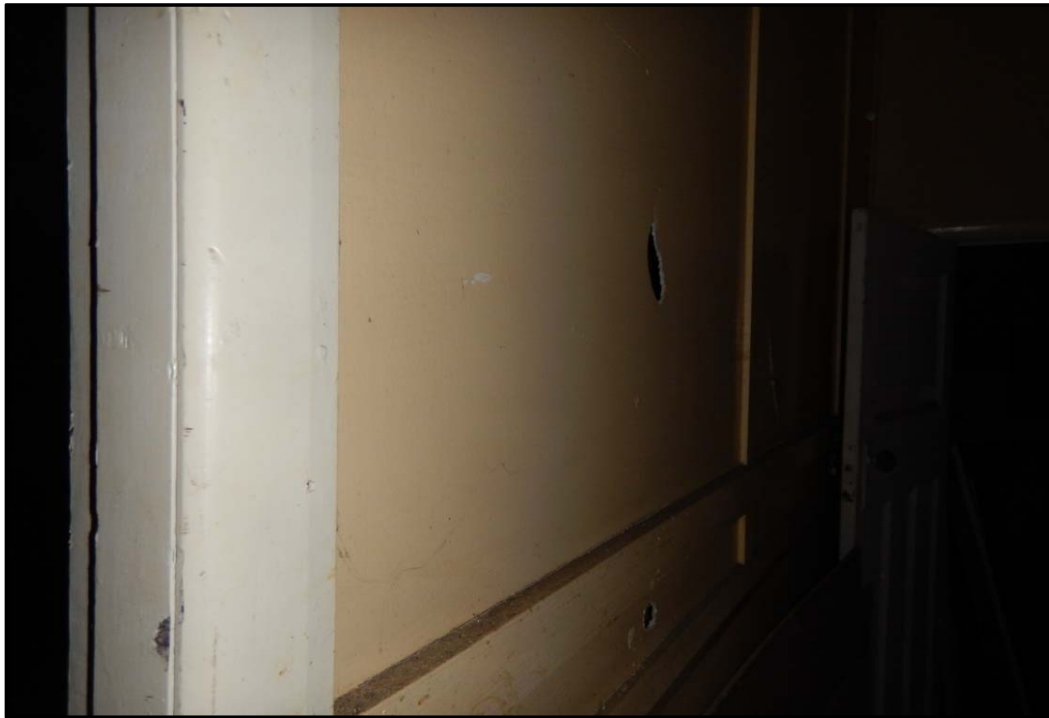
Location Description	Sample No	Photo No	Asbestos Type	Friability Status	Product Type	Extent	Recommendation (A1 - A4)*	Comments / Action
<b>Building 10</b>								
Wall sheeting above picture rail in hall (similar in all rooms)	B10A1	1	<b>Chrysotile</b>	Bonded	Cement Sheeting	~250m <sup>2</sup>	A1	Remove prior to any demolition or refurbishment works that may disturb the installation. Should the material not be affected by the works, leave in-situ, affix asbestos warning labels, manage and re-inspect.
Classroom wall sheeting above picture rail	B10A2	2	<b>Chrysotile</b>	Bonded	Cement Sheet	~70m <sup>2</sup>	A1	Remove prior to any demolition or refurbishment works that may disturb the installation. Should the material not be affected by the works, leave in-situ, affix asbestos warning labels, manage and re-inspect.
Corrugated asbestos sheeting on roof	B10A3	3	<b>Chrysotile</b>	Bonded	Corrugated Cement Sheeting	~200m <sup>2</sup>	A1	Remove prior to any demolition or refurbishment works that may disturb the installation. Should the material not be affected by the works, leave in-situ, affix asbestos warning labels, manage and re-inspect.

Photo 1: Building 10 - Wall sheeting above picture rail in hall (all rooms)

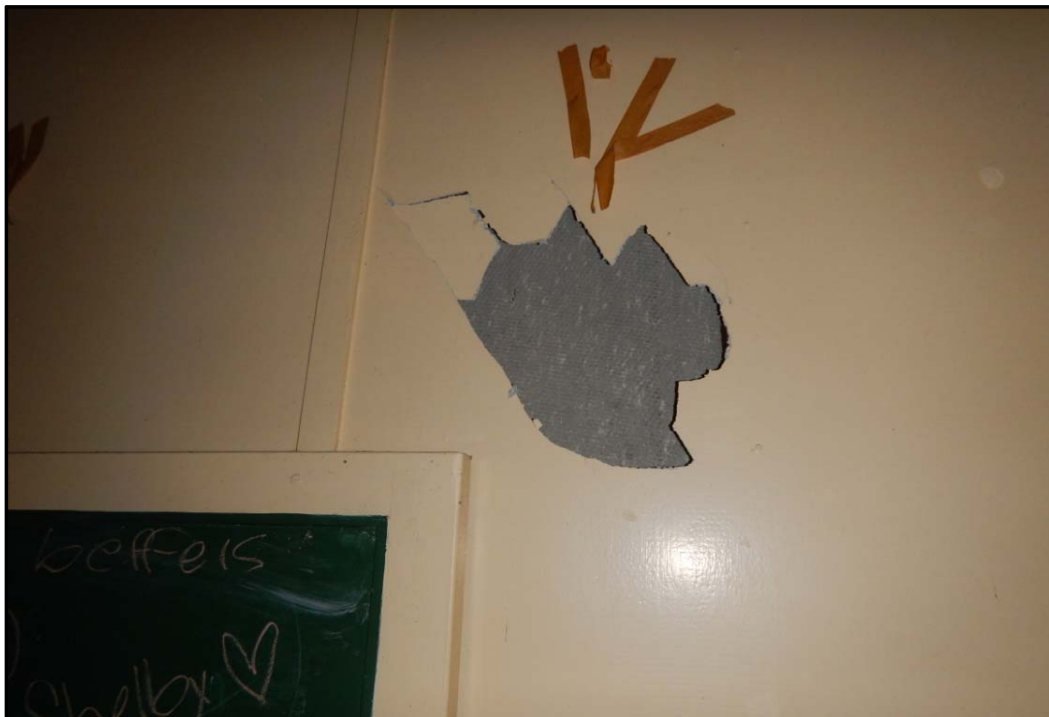
Photo 2: Building 10 - wall sheeting in classroom above picture rail

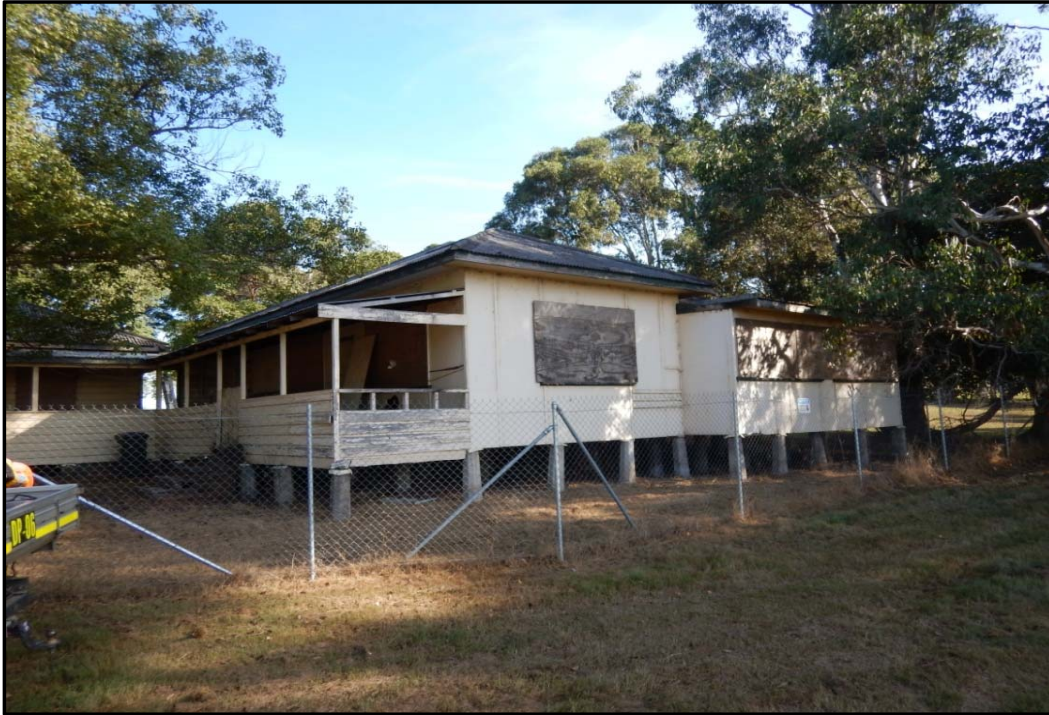
Photo 3: Buildings 10 and 11 - Asbestos corrugated roofing

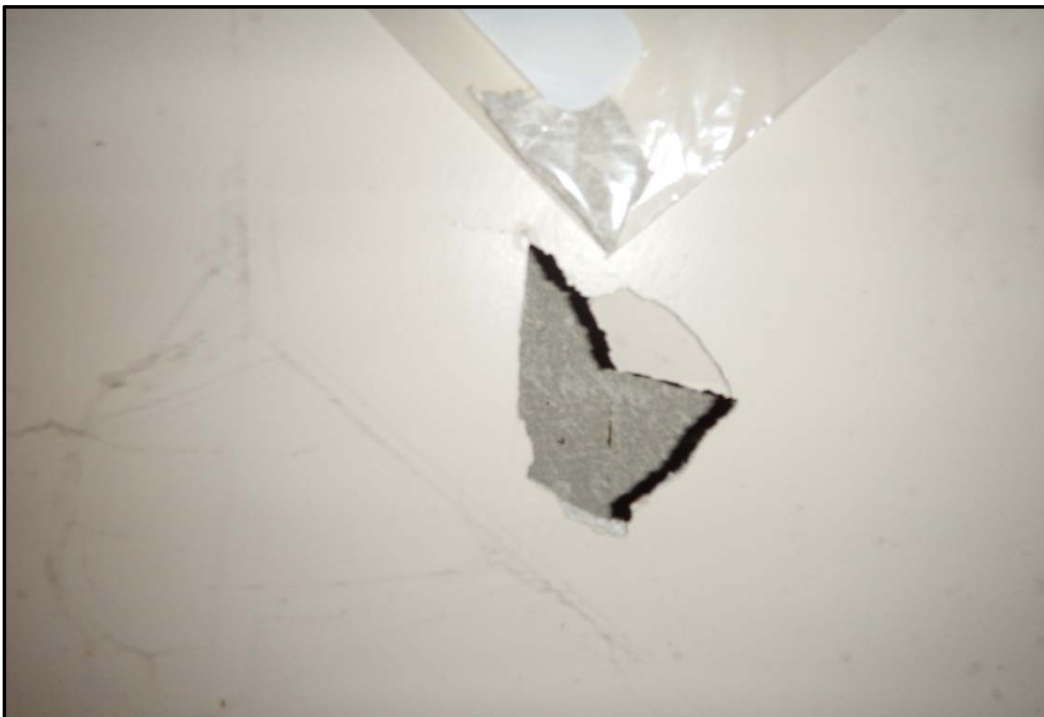
Location Description	Sample No	Photo No	Asbestos Type	Friability Status	Product Type	Extent	Recommendation (A1 - A4)*	Comments / Action
<b>Building 11</b>								
Sunroom wall sheets	B11A1	4	<b>Chrysotile</b>	Bonded	Cement Sheeting	~36m <sup>2</sup>	A1	Remove prior to any demolition or refurbishment works that may disturb the installation. Should the material not be affected by the works, leave in-situ, affix asbestos warning labels, manage and re-inspect.
Bedroom 1 all walls above picture rail (similar in Bed 4, hall, Bed 2, kitchen)	B11A2		<b>Chrysotile</b>	Bonded	Cement Sheet	~230m <sup>2</sup>	A1	Remove prior to any demolition or refurbishment works that may disturb the installation. Should the material not be affected by the works, leave in-situ, affix asbestos warning labels, manage and re-inspect.
Kitchen vinyl flooring sheets	B11A3	6	<b>Chrysotile</b>		Vinyl Flooring	~16m <sup>2</sup>	A1	Remove prior to any demolition or refurbishment works that may disturb the installation. Should the material not be affected by the works, leave in-situ, affix asbestos warning labels, manage and re-inspect.

Photo 4: Building 11 - Wall sheathing in sunroom

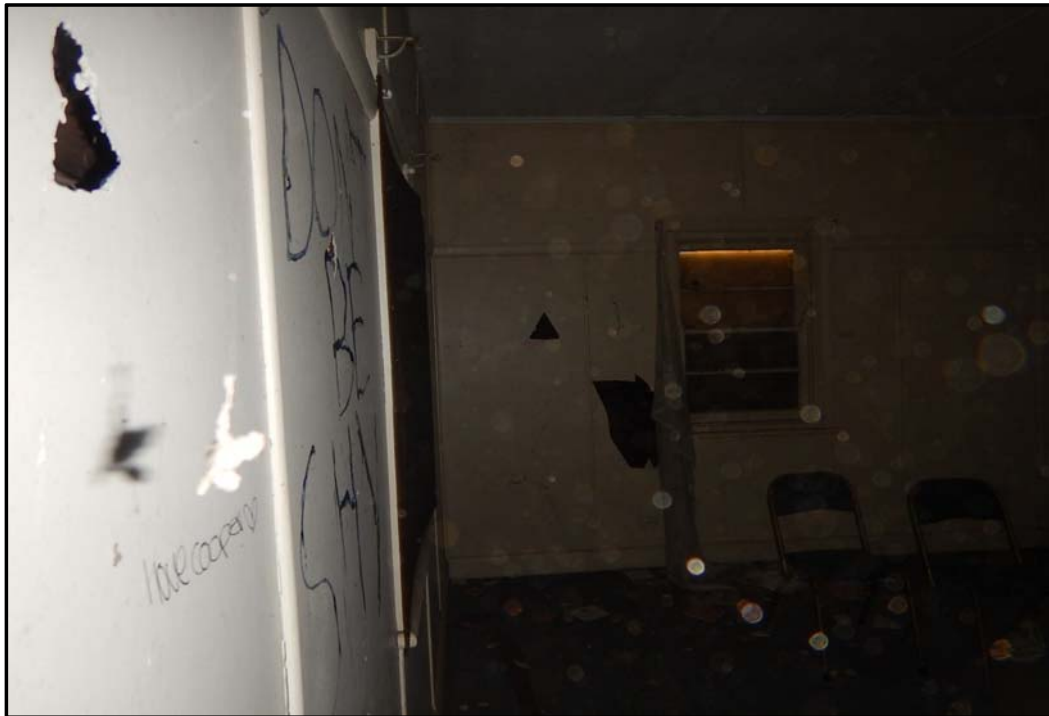
Photo 5: Building 11 - Wall sheeting in Bed 1

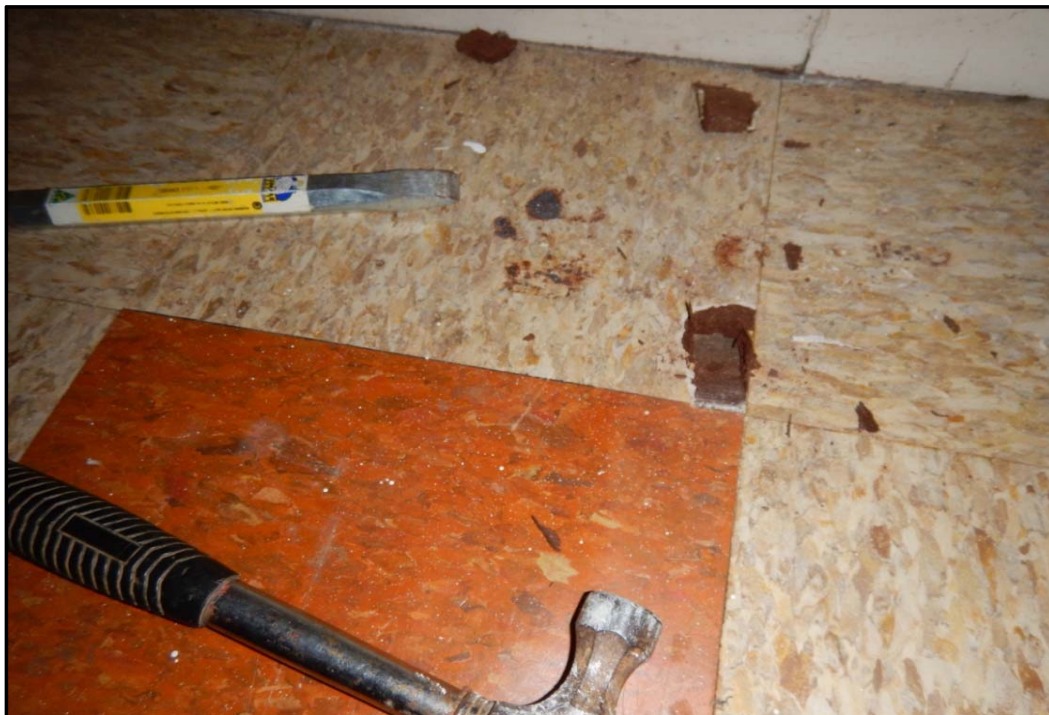
Photo 6: Building 11 - Vinyl flooring sheets in kitchen

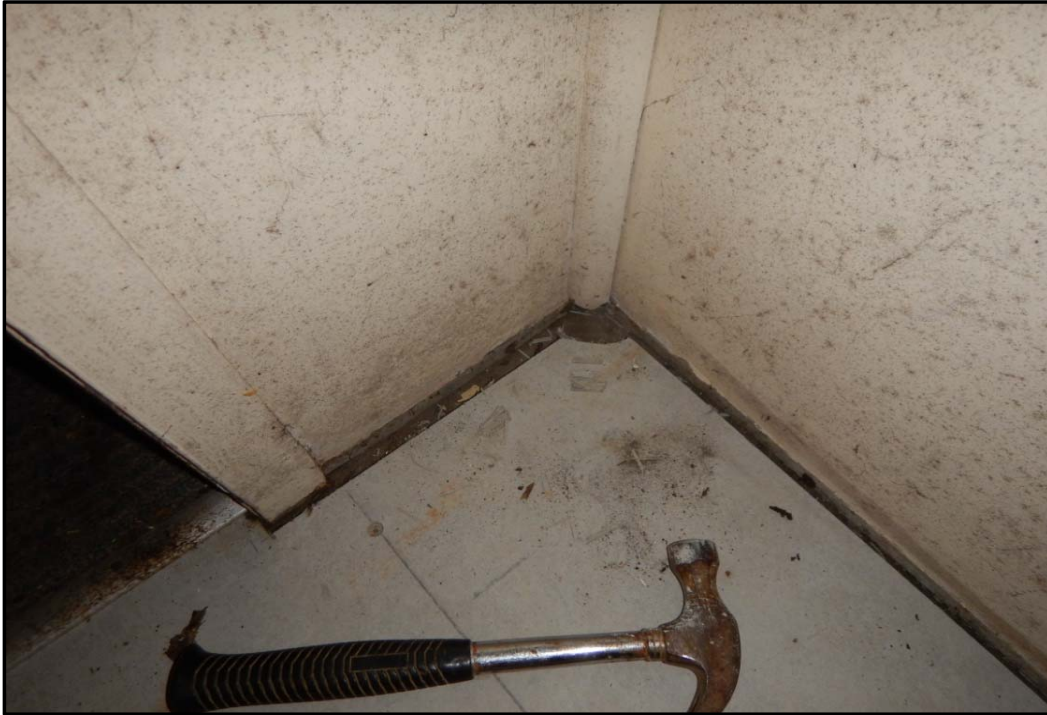
Photo 7: Building 11 - Toilet wall sheets

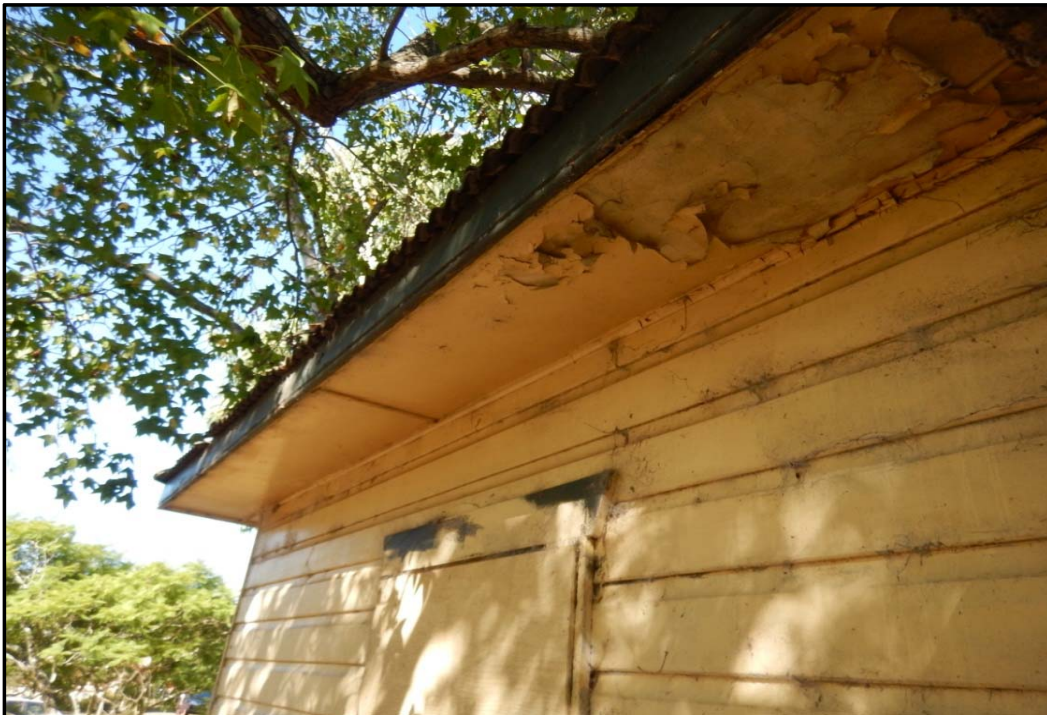
Photo 8: Building 11 - External Eaves

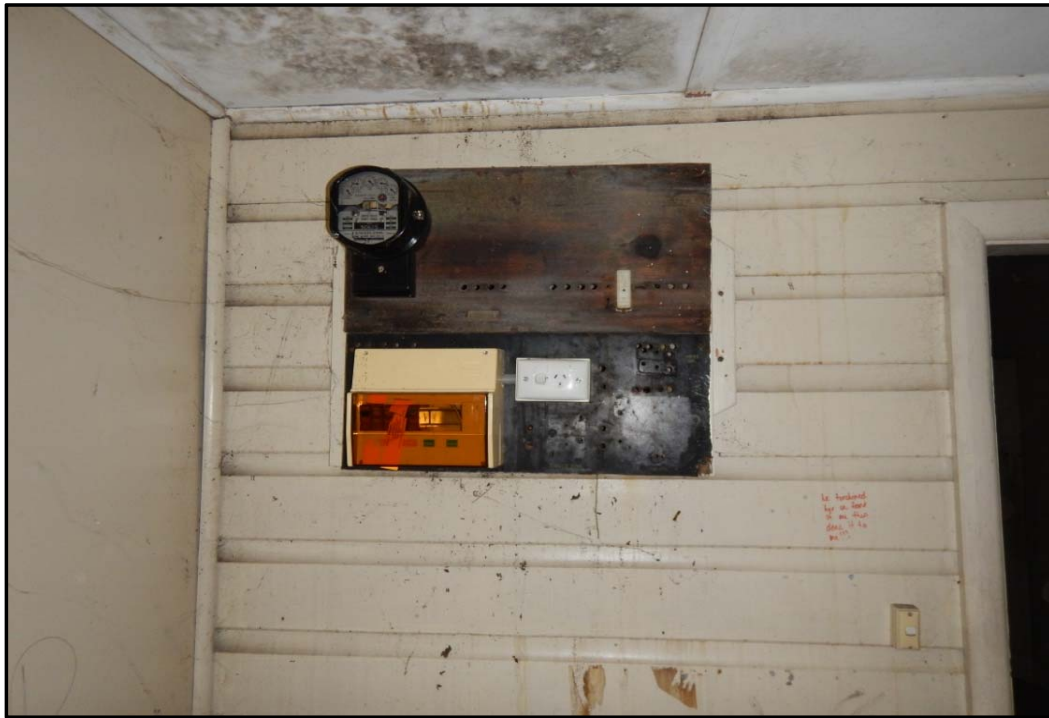
Location Description	Sample No	Photo No	Asbestos Type	Friability Status	Product Type	Extent	Recommendation (A1 - A4)*	Comments / Action
<b>Building 11</b>								
Electrical Board	B11A5	9	<b>Assumed Zelemite</b>	Bonded	Cement Sheet	<1m <sup>2</sup>	A1	Remove prior to any demolition or refurbishment works that may disturb the installation. Should the material not be affected by the works, leave in-situ, affix asbestos warning labels, manage and re-inspect.
Corrugated asbestos sheeting on roof	Assumed	3	<b>Assumed Chrysotile (as B10A3)</b>	Bonded	Corrugated Cement Sheeting	~200m <sup>2</sup>	A1	Remove prior to any demolition or refurbishment works that may disturb the installation. Should the material not be affected by the works, leave in-situ, affix asbestos warning labels, manage and re-inspect.
Fibrous material in roof space	B11SMF1	10	<b>Chrysotile</b>	Fibrous	Insulation	~4m <sup>2</sup>	A1	Remove prior to any demolition or refurbishment works that may disturb the installation. Should the material not be affected by the works, leave in-situ, affix asbestos warning labels, manage and re-inspect.

Photo 9: Building 11 - Electrical Board

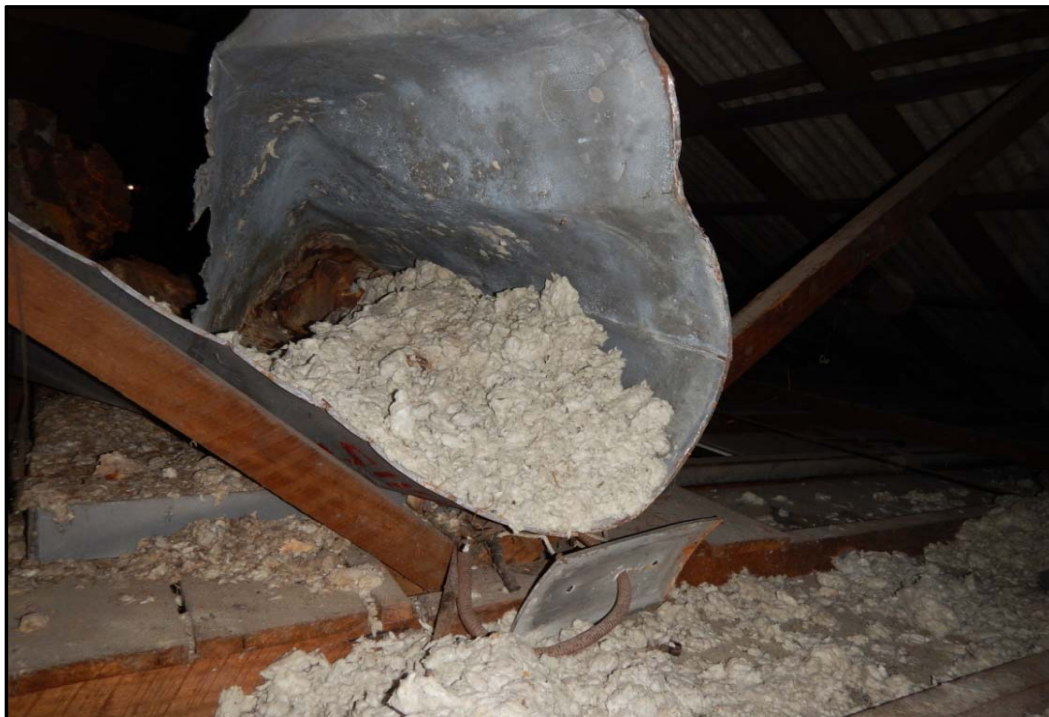
Photo 10: Building 11 - Fibrous material in roof space

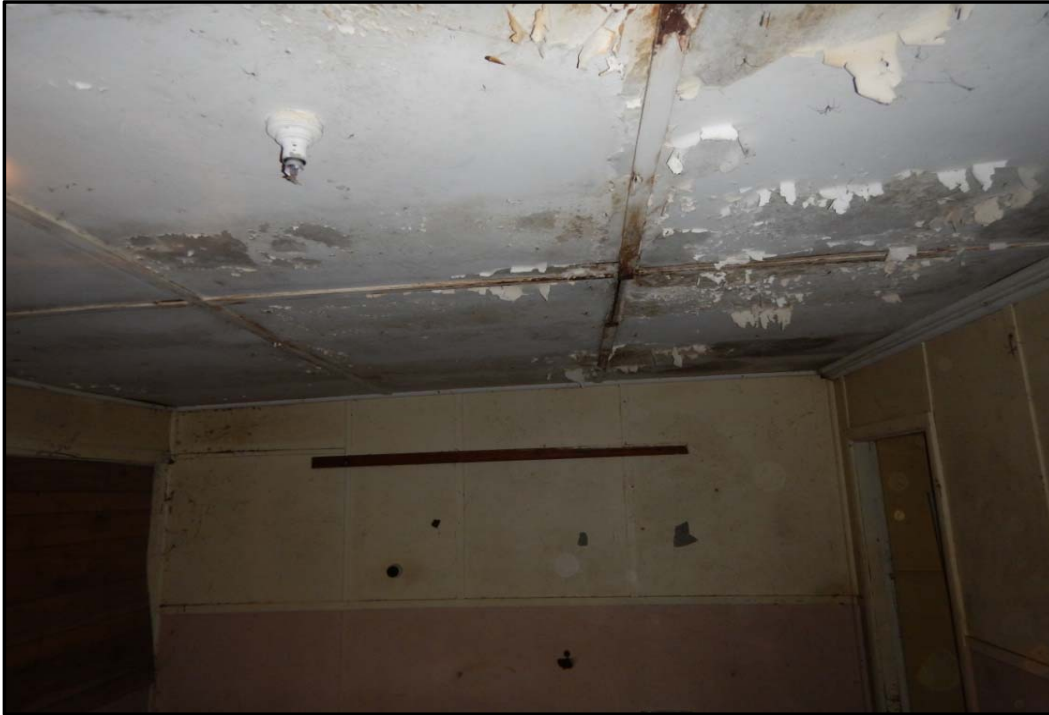
Location and description	Sample ID	% Lead	Photo No.	Recommendation
<b>Building 10</b>				
White ceiling paint in room 2	B10P1	<0.05	11	<1.0% Not classified as lead based paint.
<b>Building 11</b>				
Beige exterior walls and posts	B11P1	2.4	12	Lead based paint

Photo 11: Building 10 - White paint in Room 2

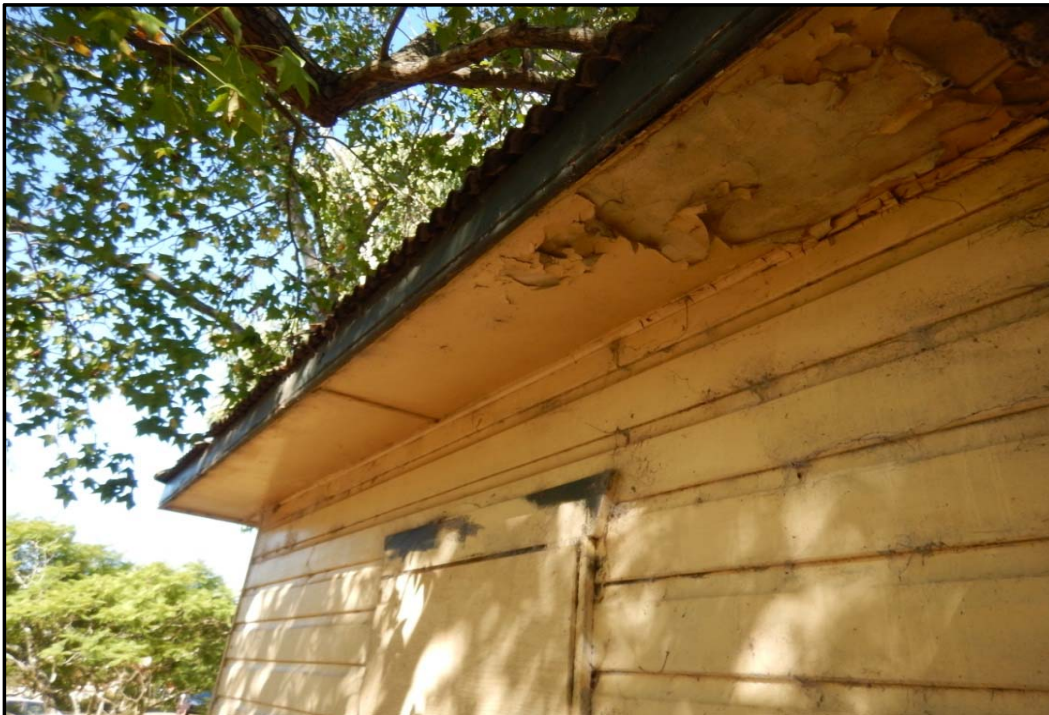
Photo 12: Building 11 - Beige exterior walls and posts

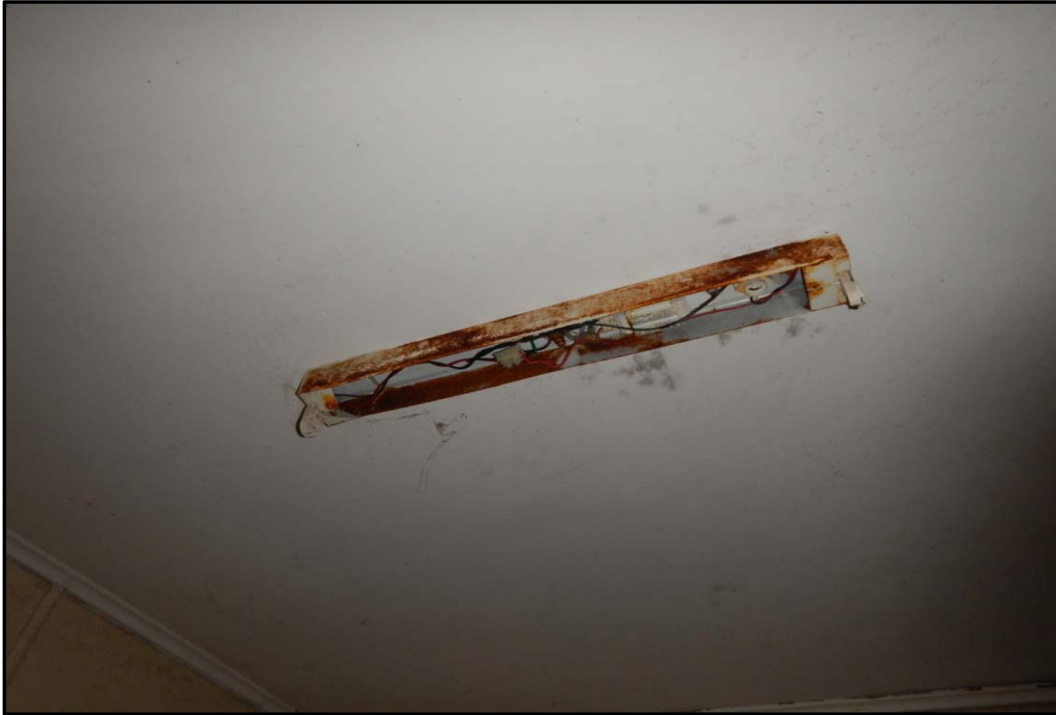
Location and description	Sample ID	Photo No	Recommendation
Fluorescent light fittings (both buildings)	Visual observation	13	-

**Photo 13: Buildings 10 and 11 - Fluorescent lighting**

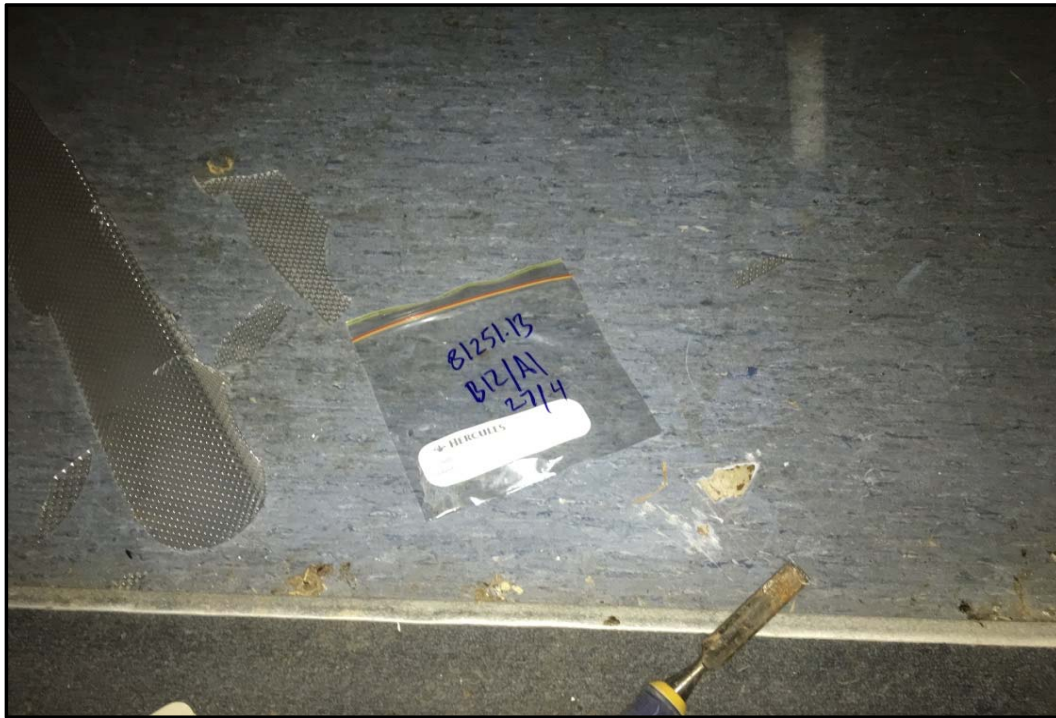
Location Description	Sample No	Photo No	Asbestos Type	Friability Status	Product Type	Extent	Recommendation (A1 - A4)*	Comments / Action
<b>Building 12 – Dorms</b>								
Laundry, Kitchen, Bathroom foyer (first and second floors) Light Blue Vinyl Sheeting	B12/A1	14	<b>NAD</b>	Bonded	Vinyl Sheeting	~50 m <sup>2</sup>	-	-
Bathroom and shower partitions (first and second floors) Compressed Fibrous Cement	B12/A2	15	<b>NAD</b>	Bonded	Fibrous Cement	~30 m <sup>2</sup>	-	-
Electrical distribution board – First Floor of building	Visual Assumed	18	<b>Not Known</b>	Bonded	Zelemite	~1m <sup>2</sup>	A1	Remove prior to any demolition or refurbishment works that may disturb the material. Should the material not be affected by the works, leave in-situ, affix asbestos warning labels, manage and re-inspect.

Photo 14: Light Blue Vinyl Laminte Sheeting in Bathroom, Kitchen and Laundry

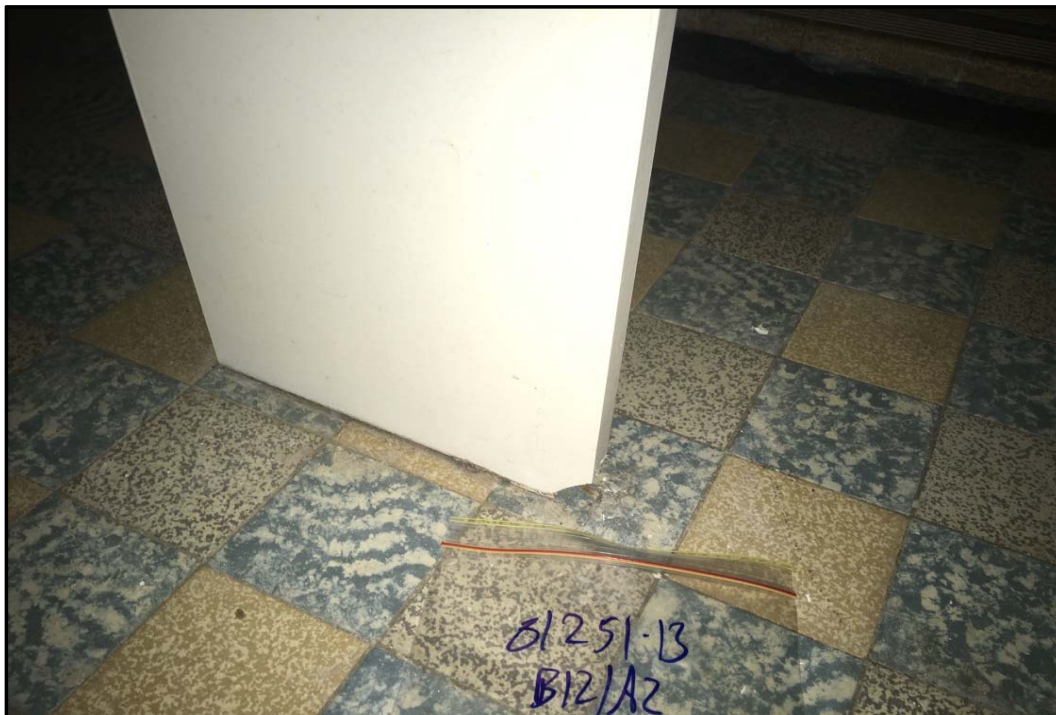
Photo 15: Compressed Fibrous Cement within Bathroom Partions

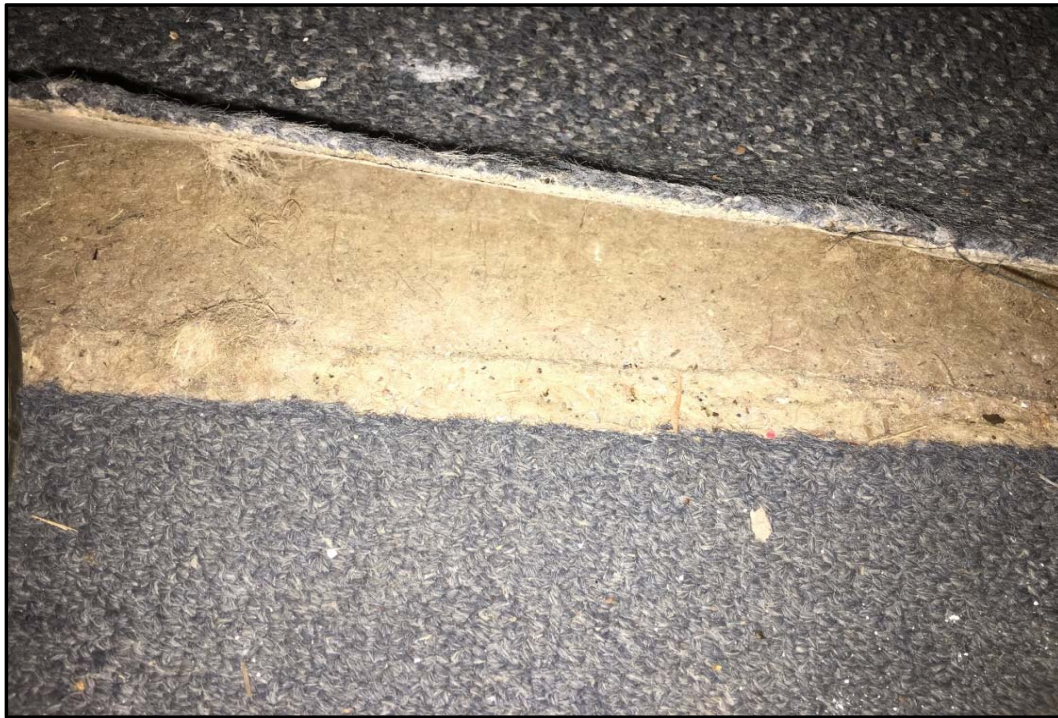
Location and description	Sample ID	Photo No.	Friability	Recommendation
Carpet Underlay under (entire floor area ~900m <sup>2</sup> ).	Visual observation	16	Friable	Remove prior to major demolition/refurbishment works. Should the material not be affected by the proposed works, leave and maintain in good condition.
Insulation within internal wall voids (assuming all internal wall cavities ~1000m <sup>2</sup> ).	Visual observation	17	Friable	Remove prior to major demolition/refurbishment works. Should the material not be affected by the proposed works, leave and maintain in good condition.

Photo 16: Brown SMF underlay under carpeted areas

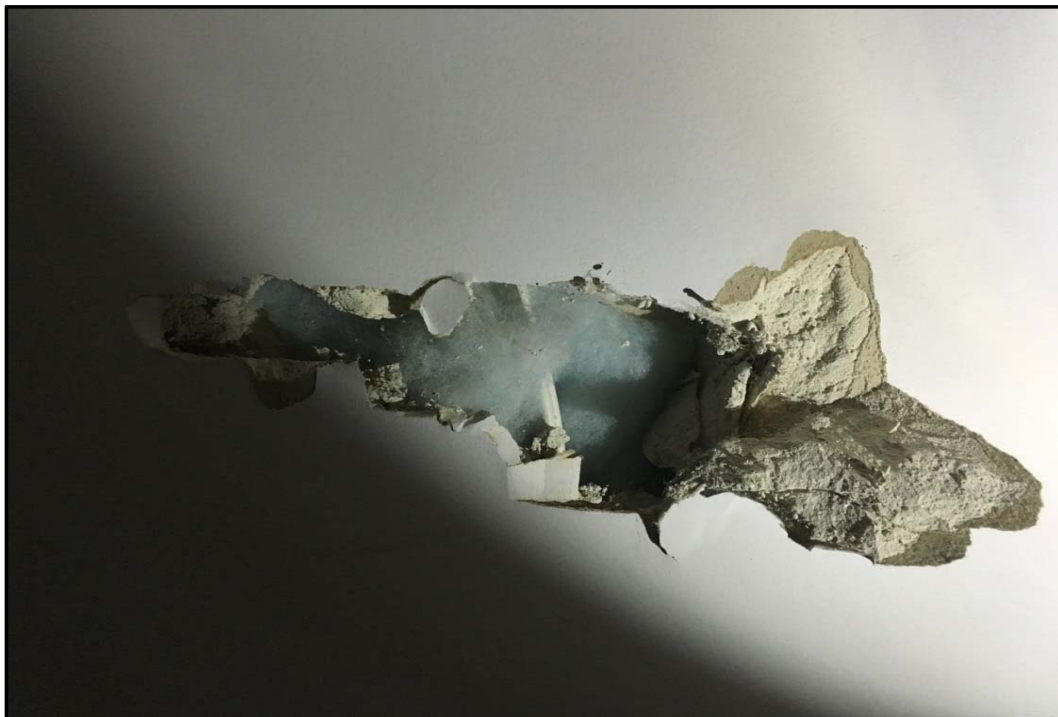
Photo 17: Insulation filling between internal wall cavities

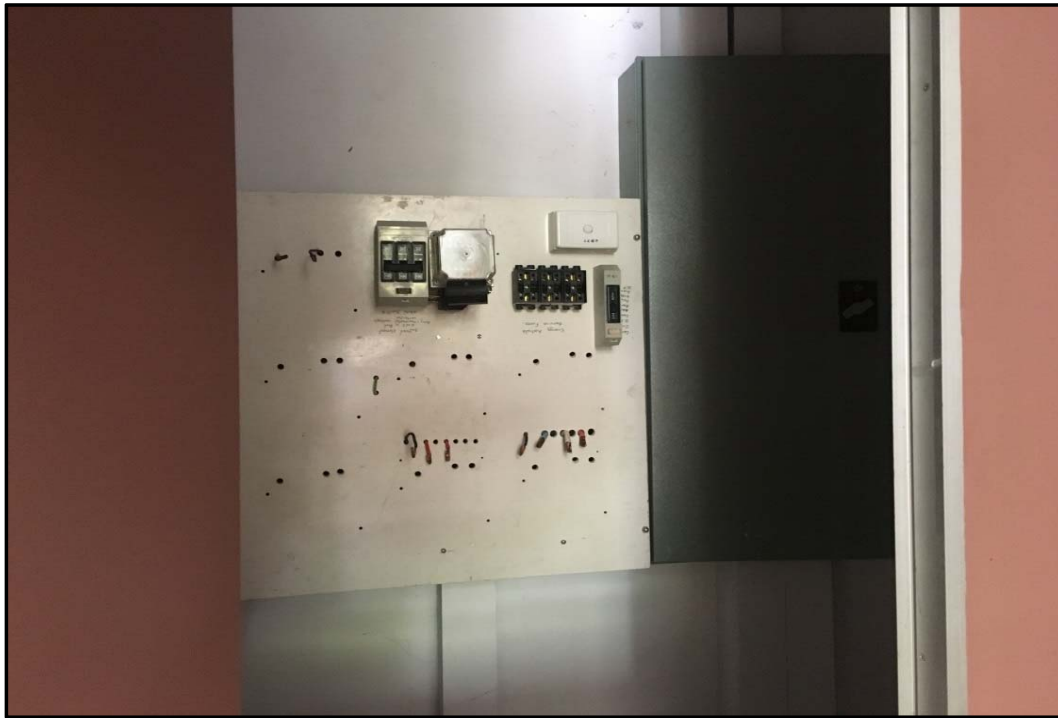
**Photo 18: Electrical Distribution Board, First Floor**

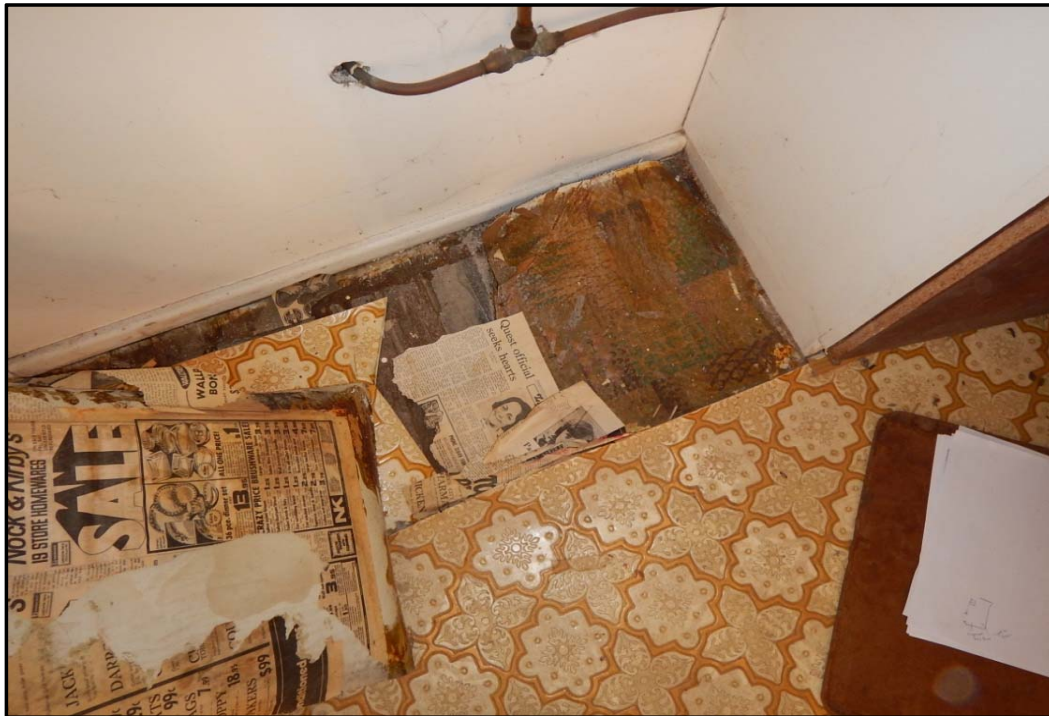
Photo 19: Building 13 - Vinyl flooring in lower Room 1

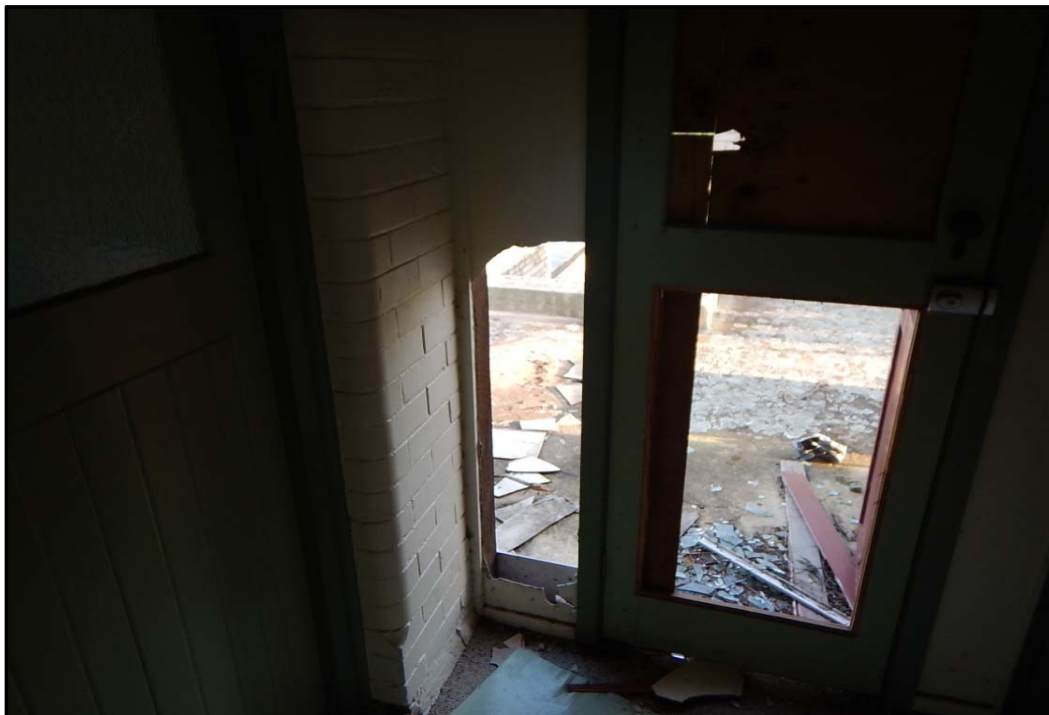
Photo 20: Building 13 - Exterior wall in access to livable roof space

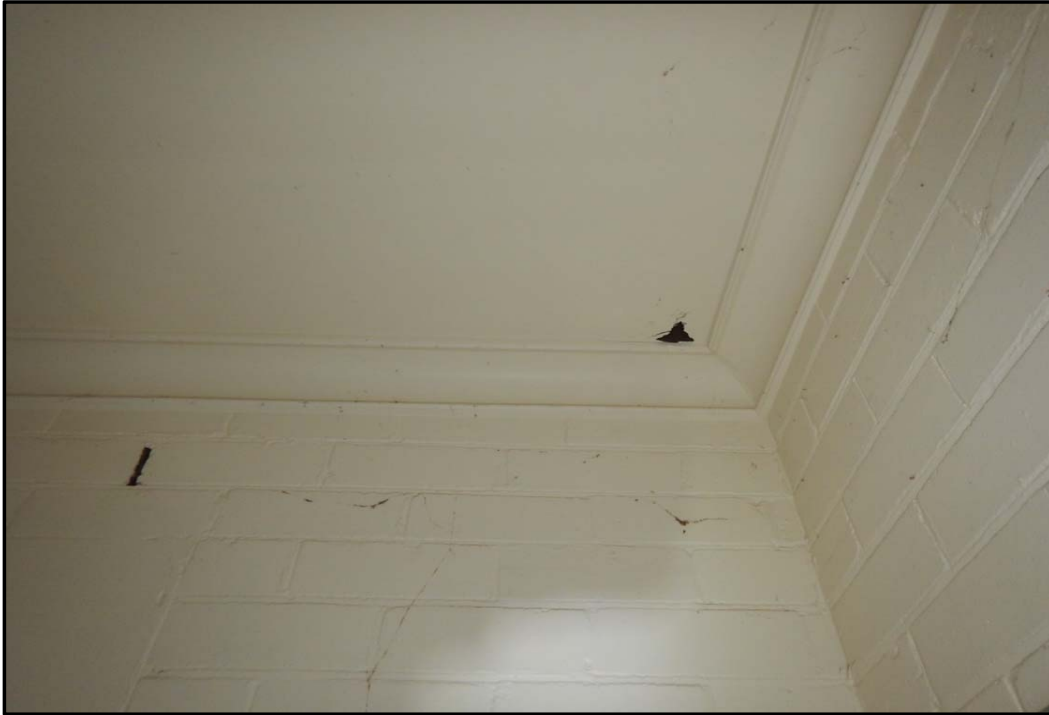
Photo 21: Building 13 - Ceiling sheet outside upper floor bathroom

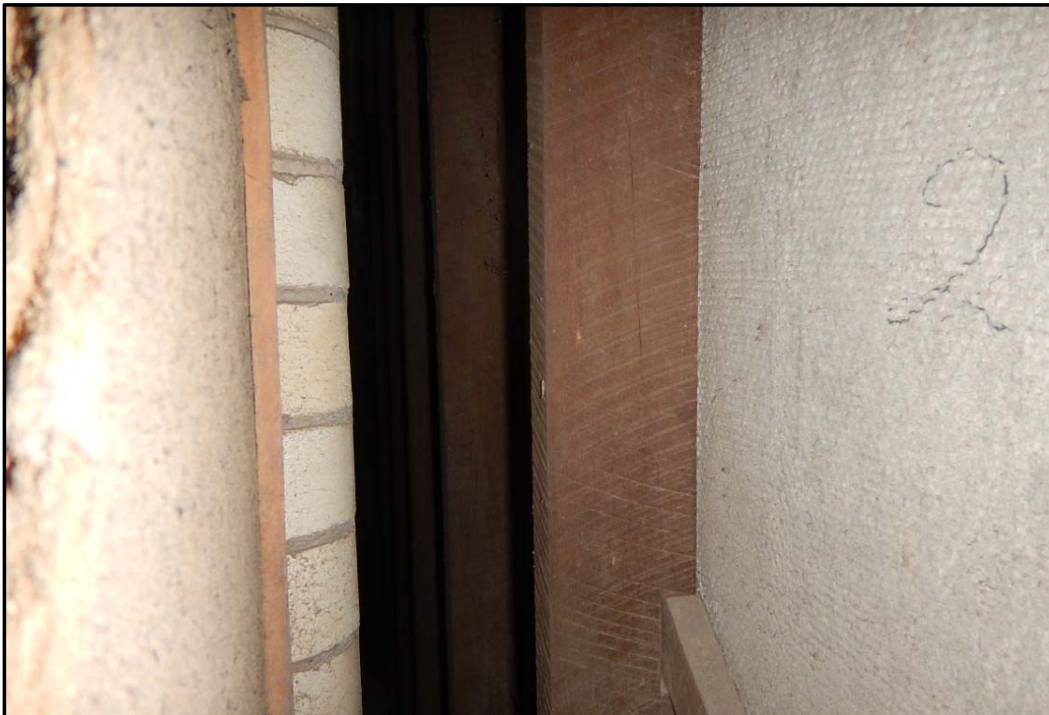
Photo 22: Building 13 - Asbestos common wall between Buildings 13 and 14

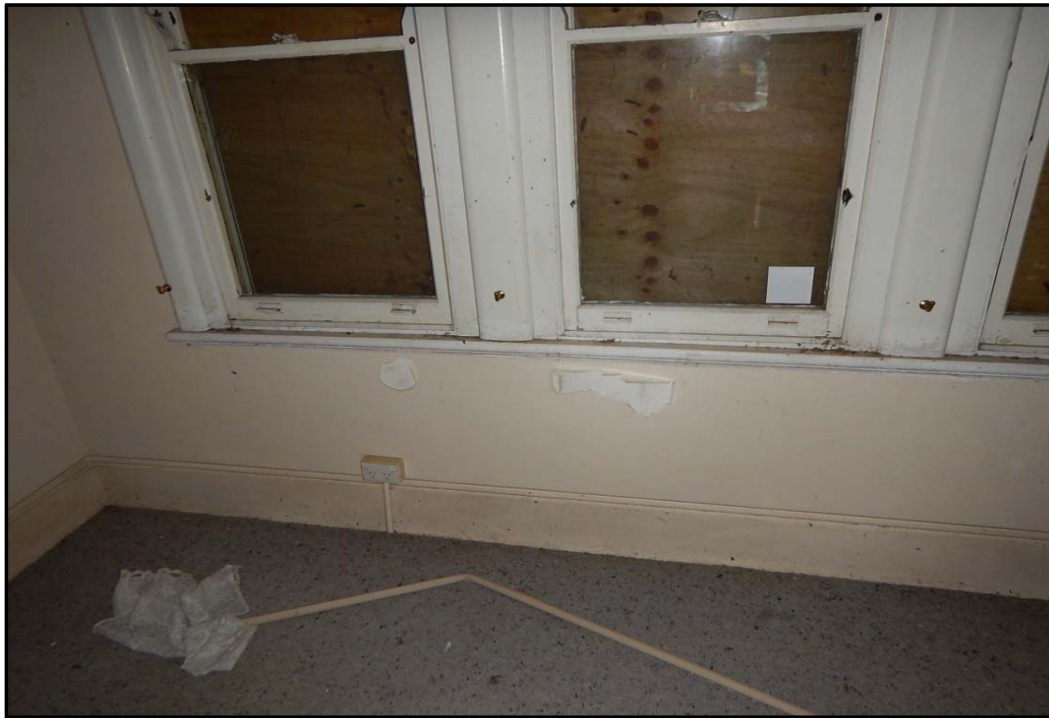
Photo 23: Building 13 - Interior beige paint

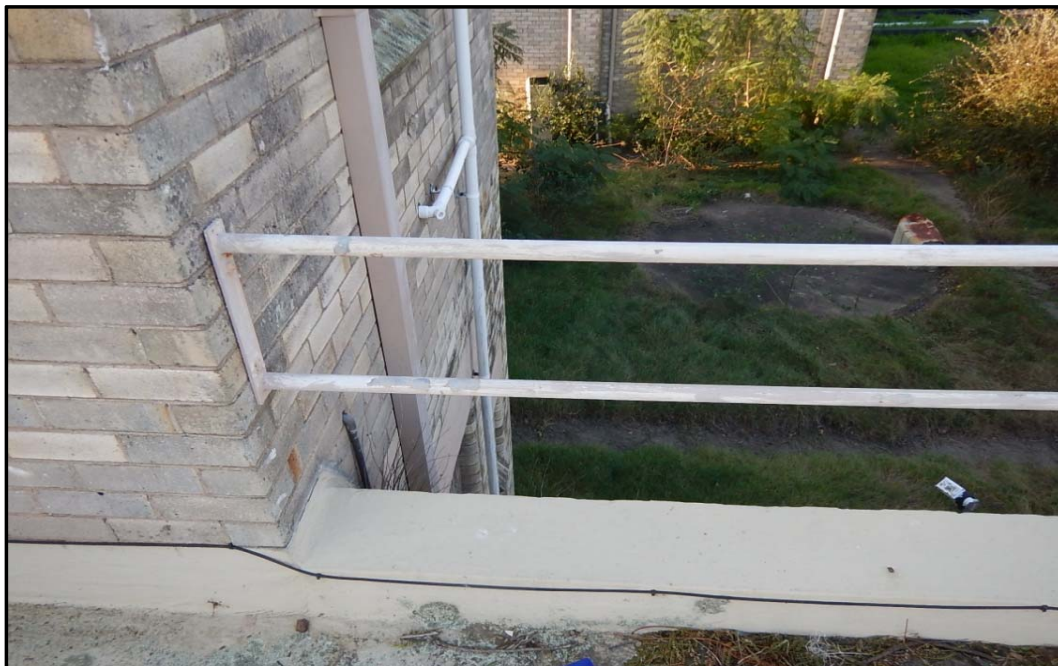
Photo 24: Building 13 - Light pink / cream paint, exterior rails, livable roof area

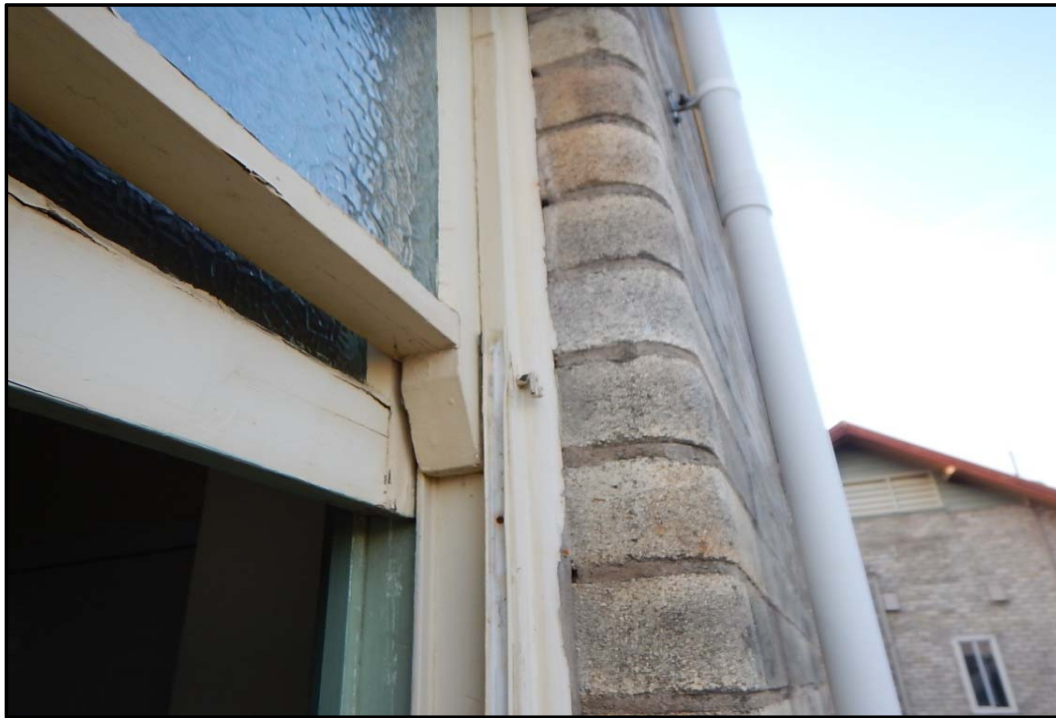
Photo 25: Building 13 - Lt yellow/cream exterior paint upper storey bathroom

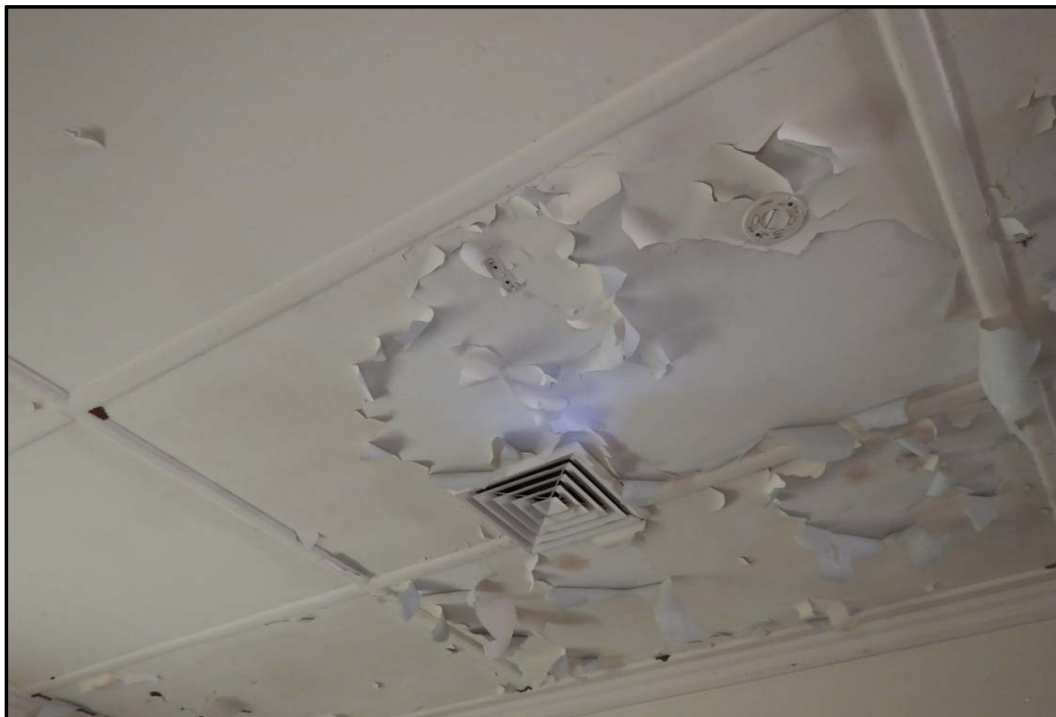
Photo 26: Building 13 - Beige paint on ceiling in upper floor landing

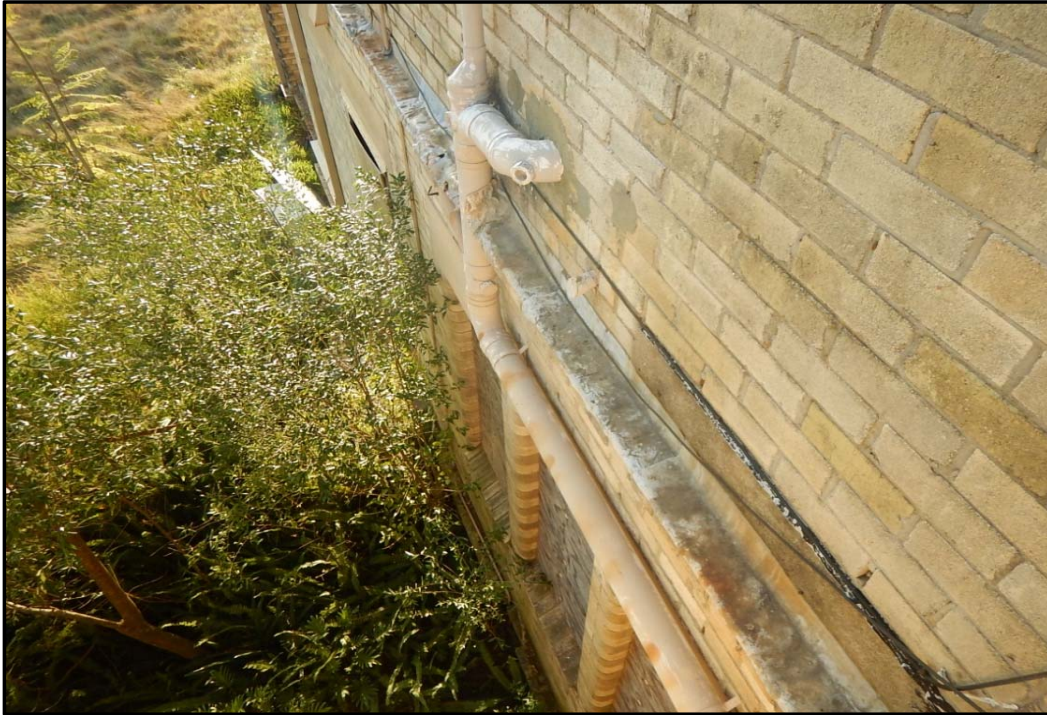
**Photo 27: Building 13 - Lead flashing and damp course**

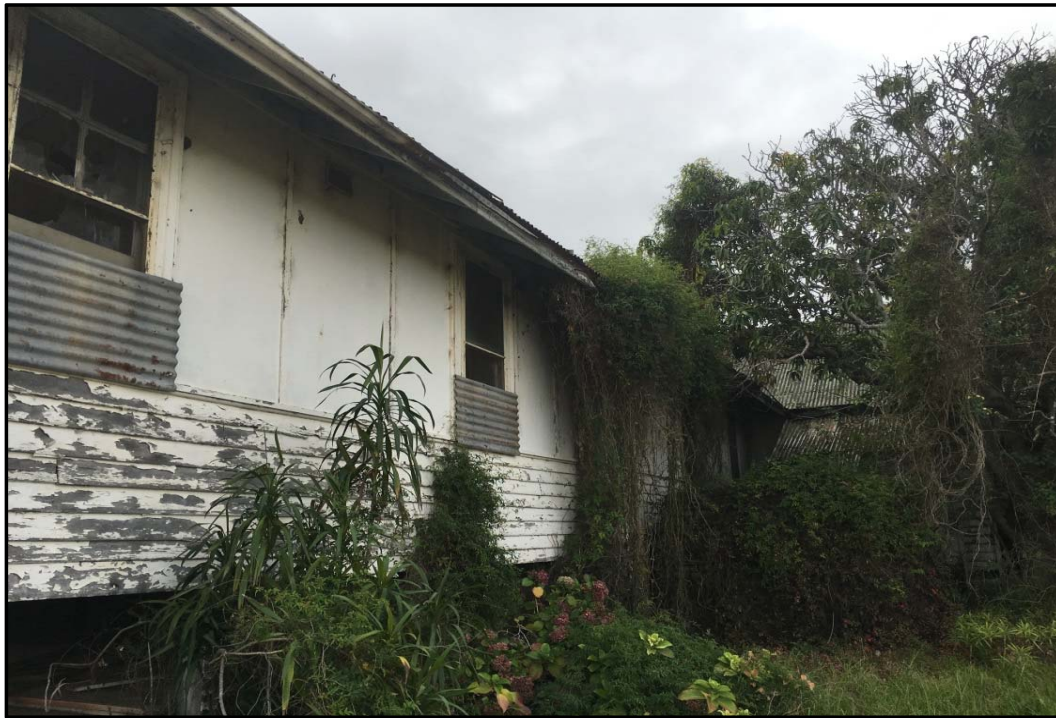
Photo 28: Building 14 - External building cladding comprising ACM, looking north east
