Report on  
Hazardous Material Survey - Buildings 10, 11, 12, 13  
and 14

Existing Buildings, Closebourne Retirement Living  
Morpeth Road, Morpeth

Prepared for  
Lend Lease (Retirement Living)

Project 81251.13  
September 2016

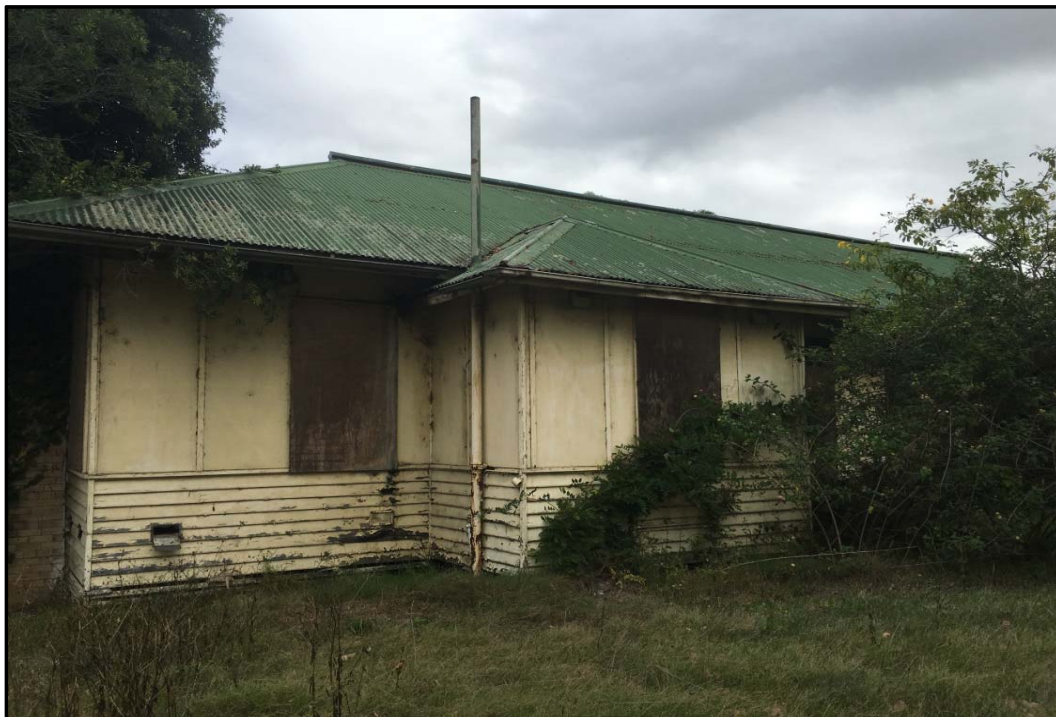
Photo 29: Building 14 - External building cladding comprising ACM, looking south

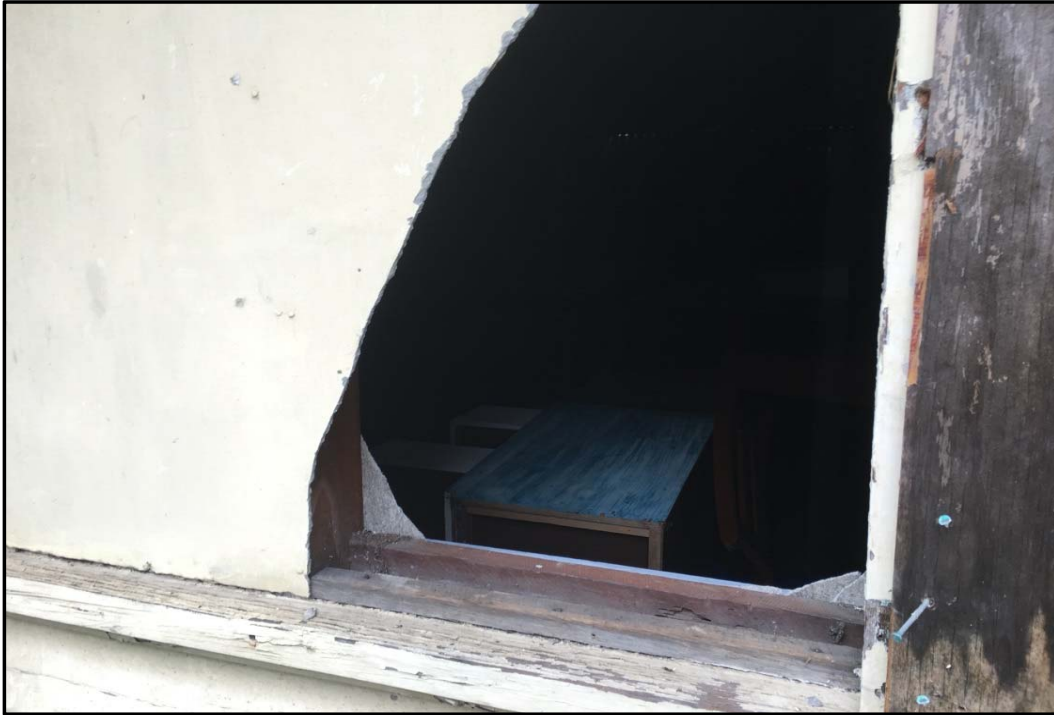
Photo 30: Building 14 - Damaged external and internal wall linings

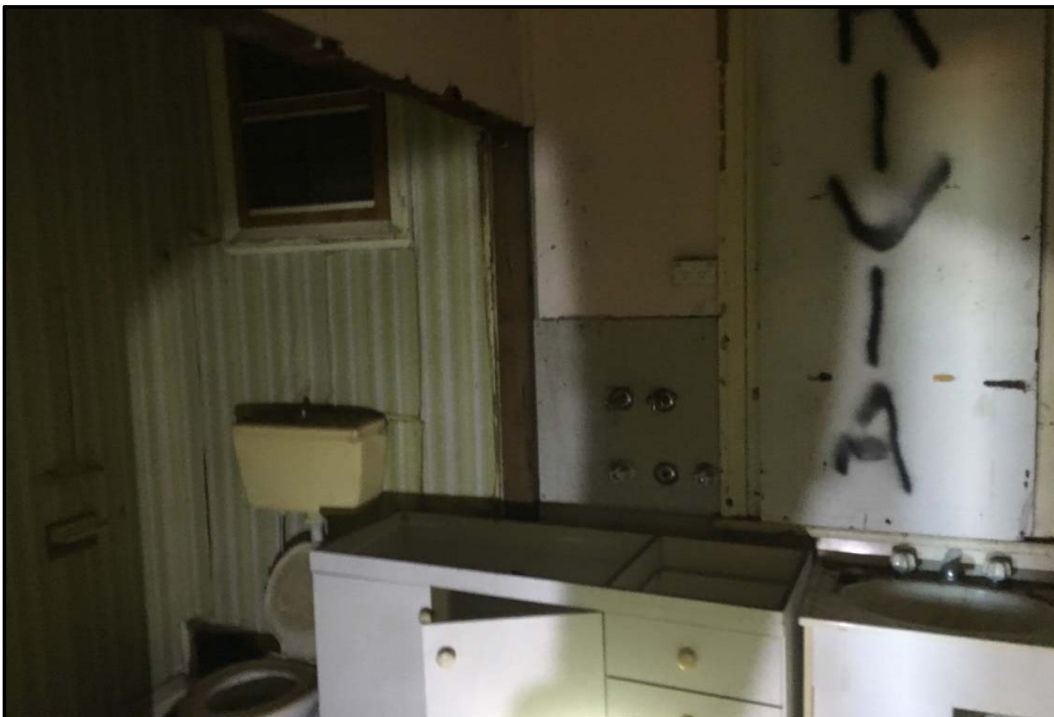
Photo 31: Building 14 - Internal wall linings, comprising ACM in bathroom area

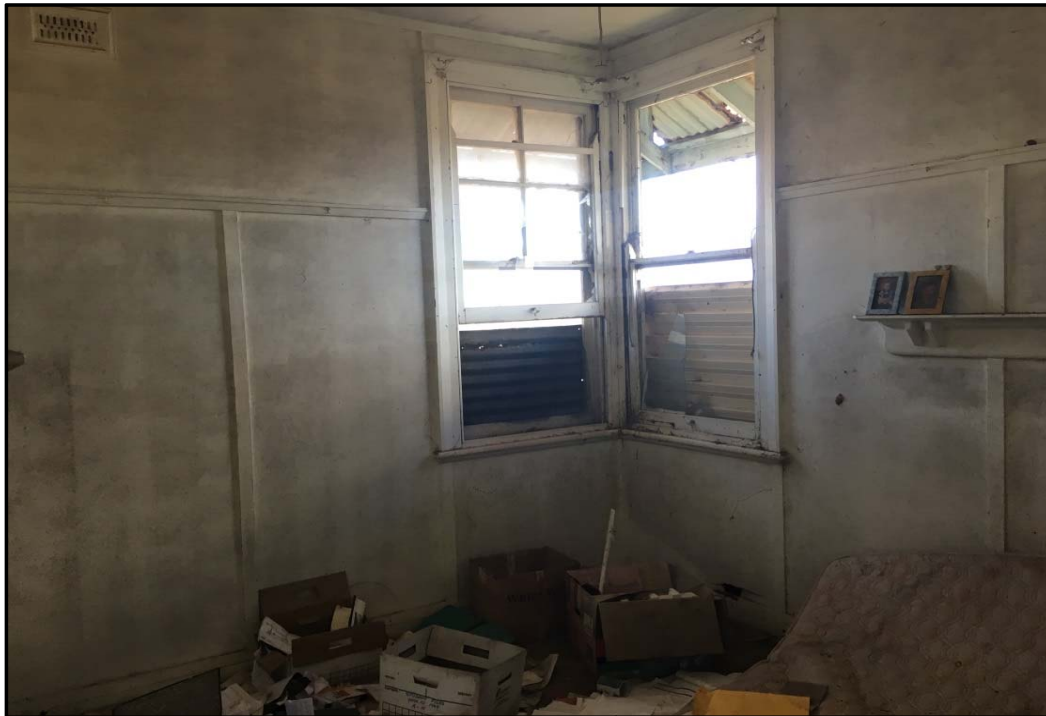
Photo 32: Building 14 - Internal wall lining, comprising ACM in rooms

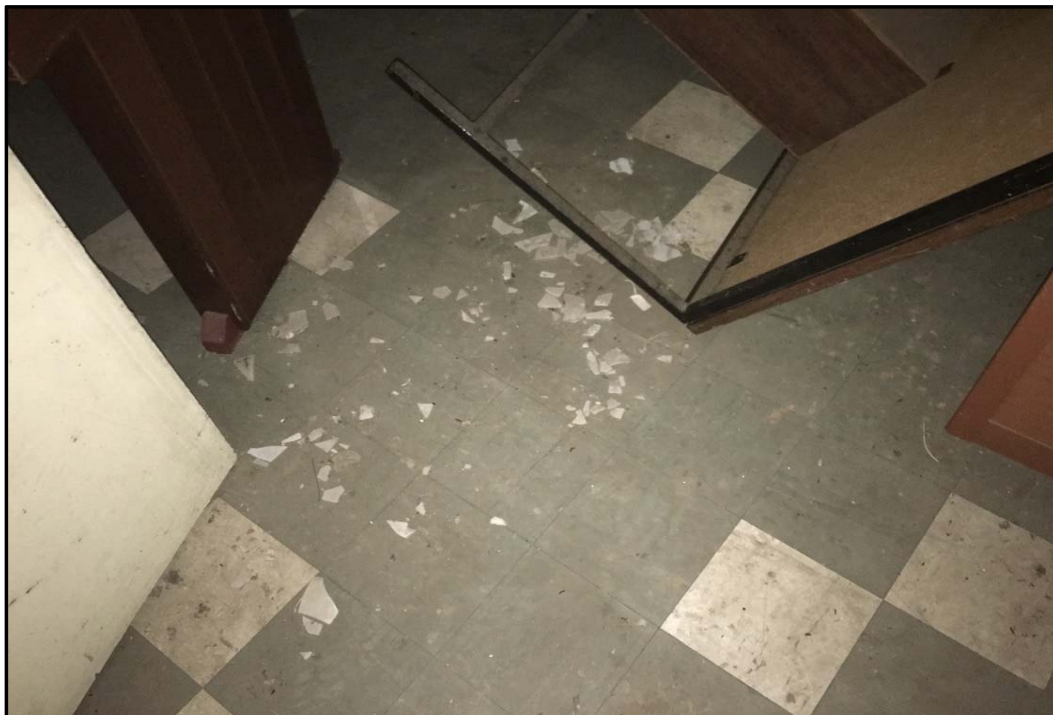
Photo 33: Building 14 - Light green vinyl tile

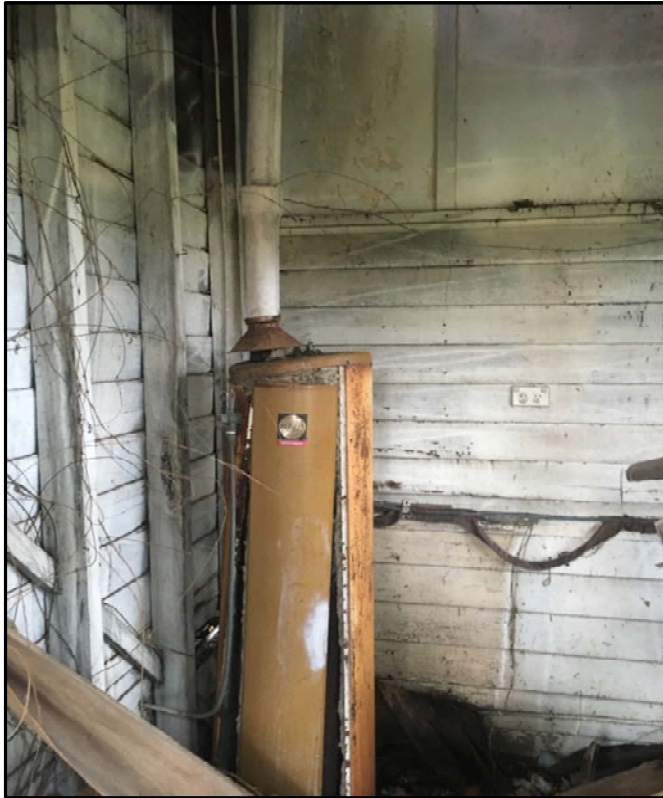
**Photo 34: Building 14 - Hot water system with cement flue assumed to comprise ACM**

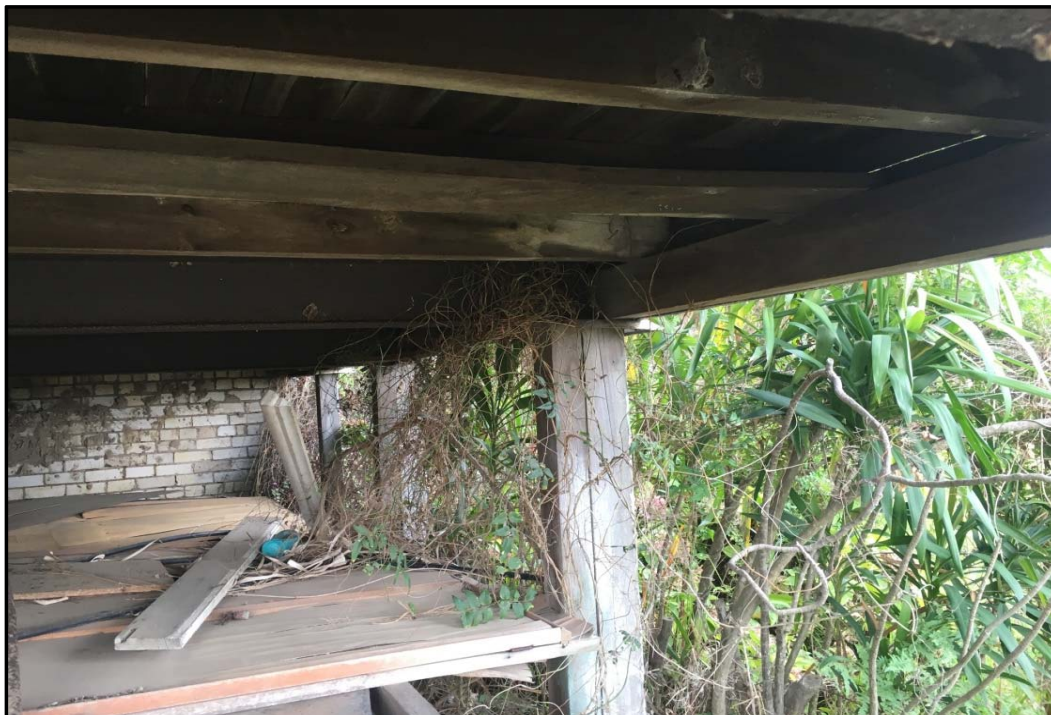
**Photo 35: Building 14 - Subfloor zone with assumed lead damp proof course over brick footings**

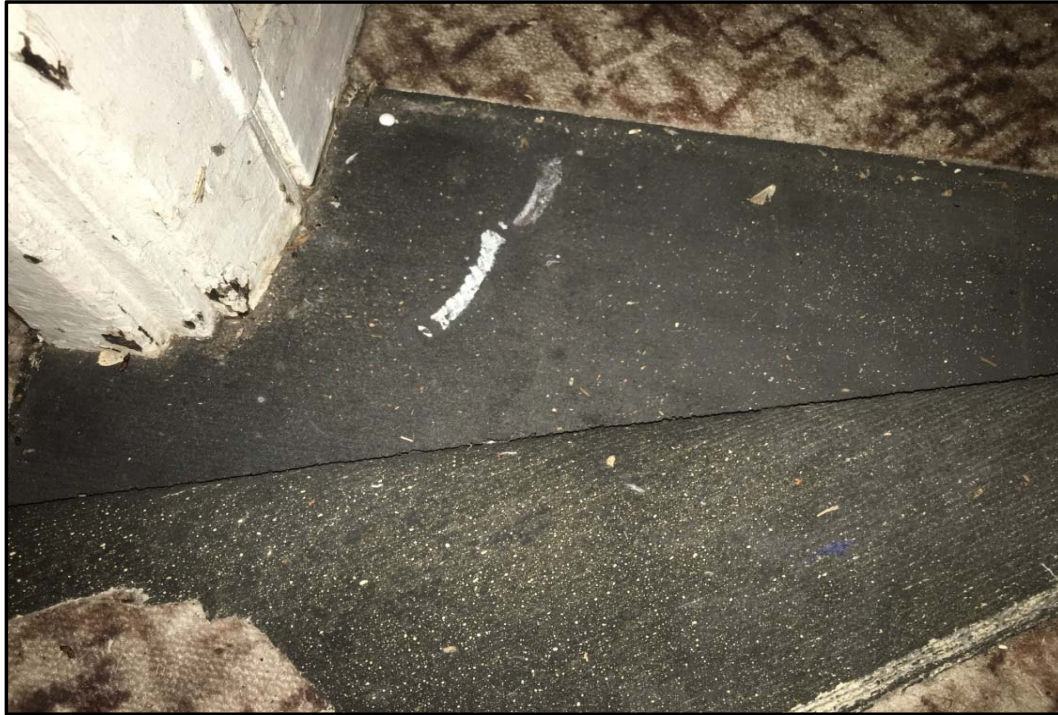
Photo 36: Building 14 - Carpet underlay assumed to comprise SMF
