DETAILED MINE SUBSIDENCE ASSESSMENT

Regrowth Kurri Kurri, Precinct 1

Prepared for Loxford Project Management Pty Ltd

RCA ref 15924-203/1

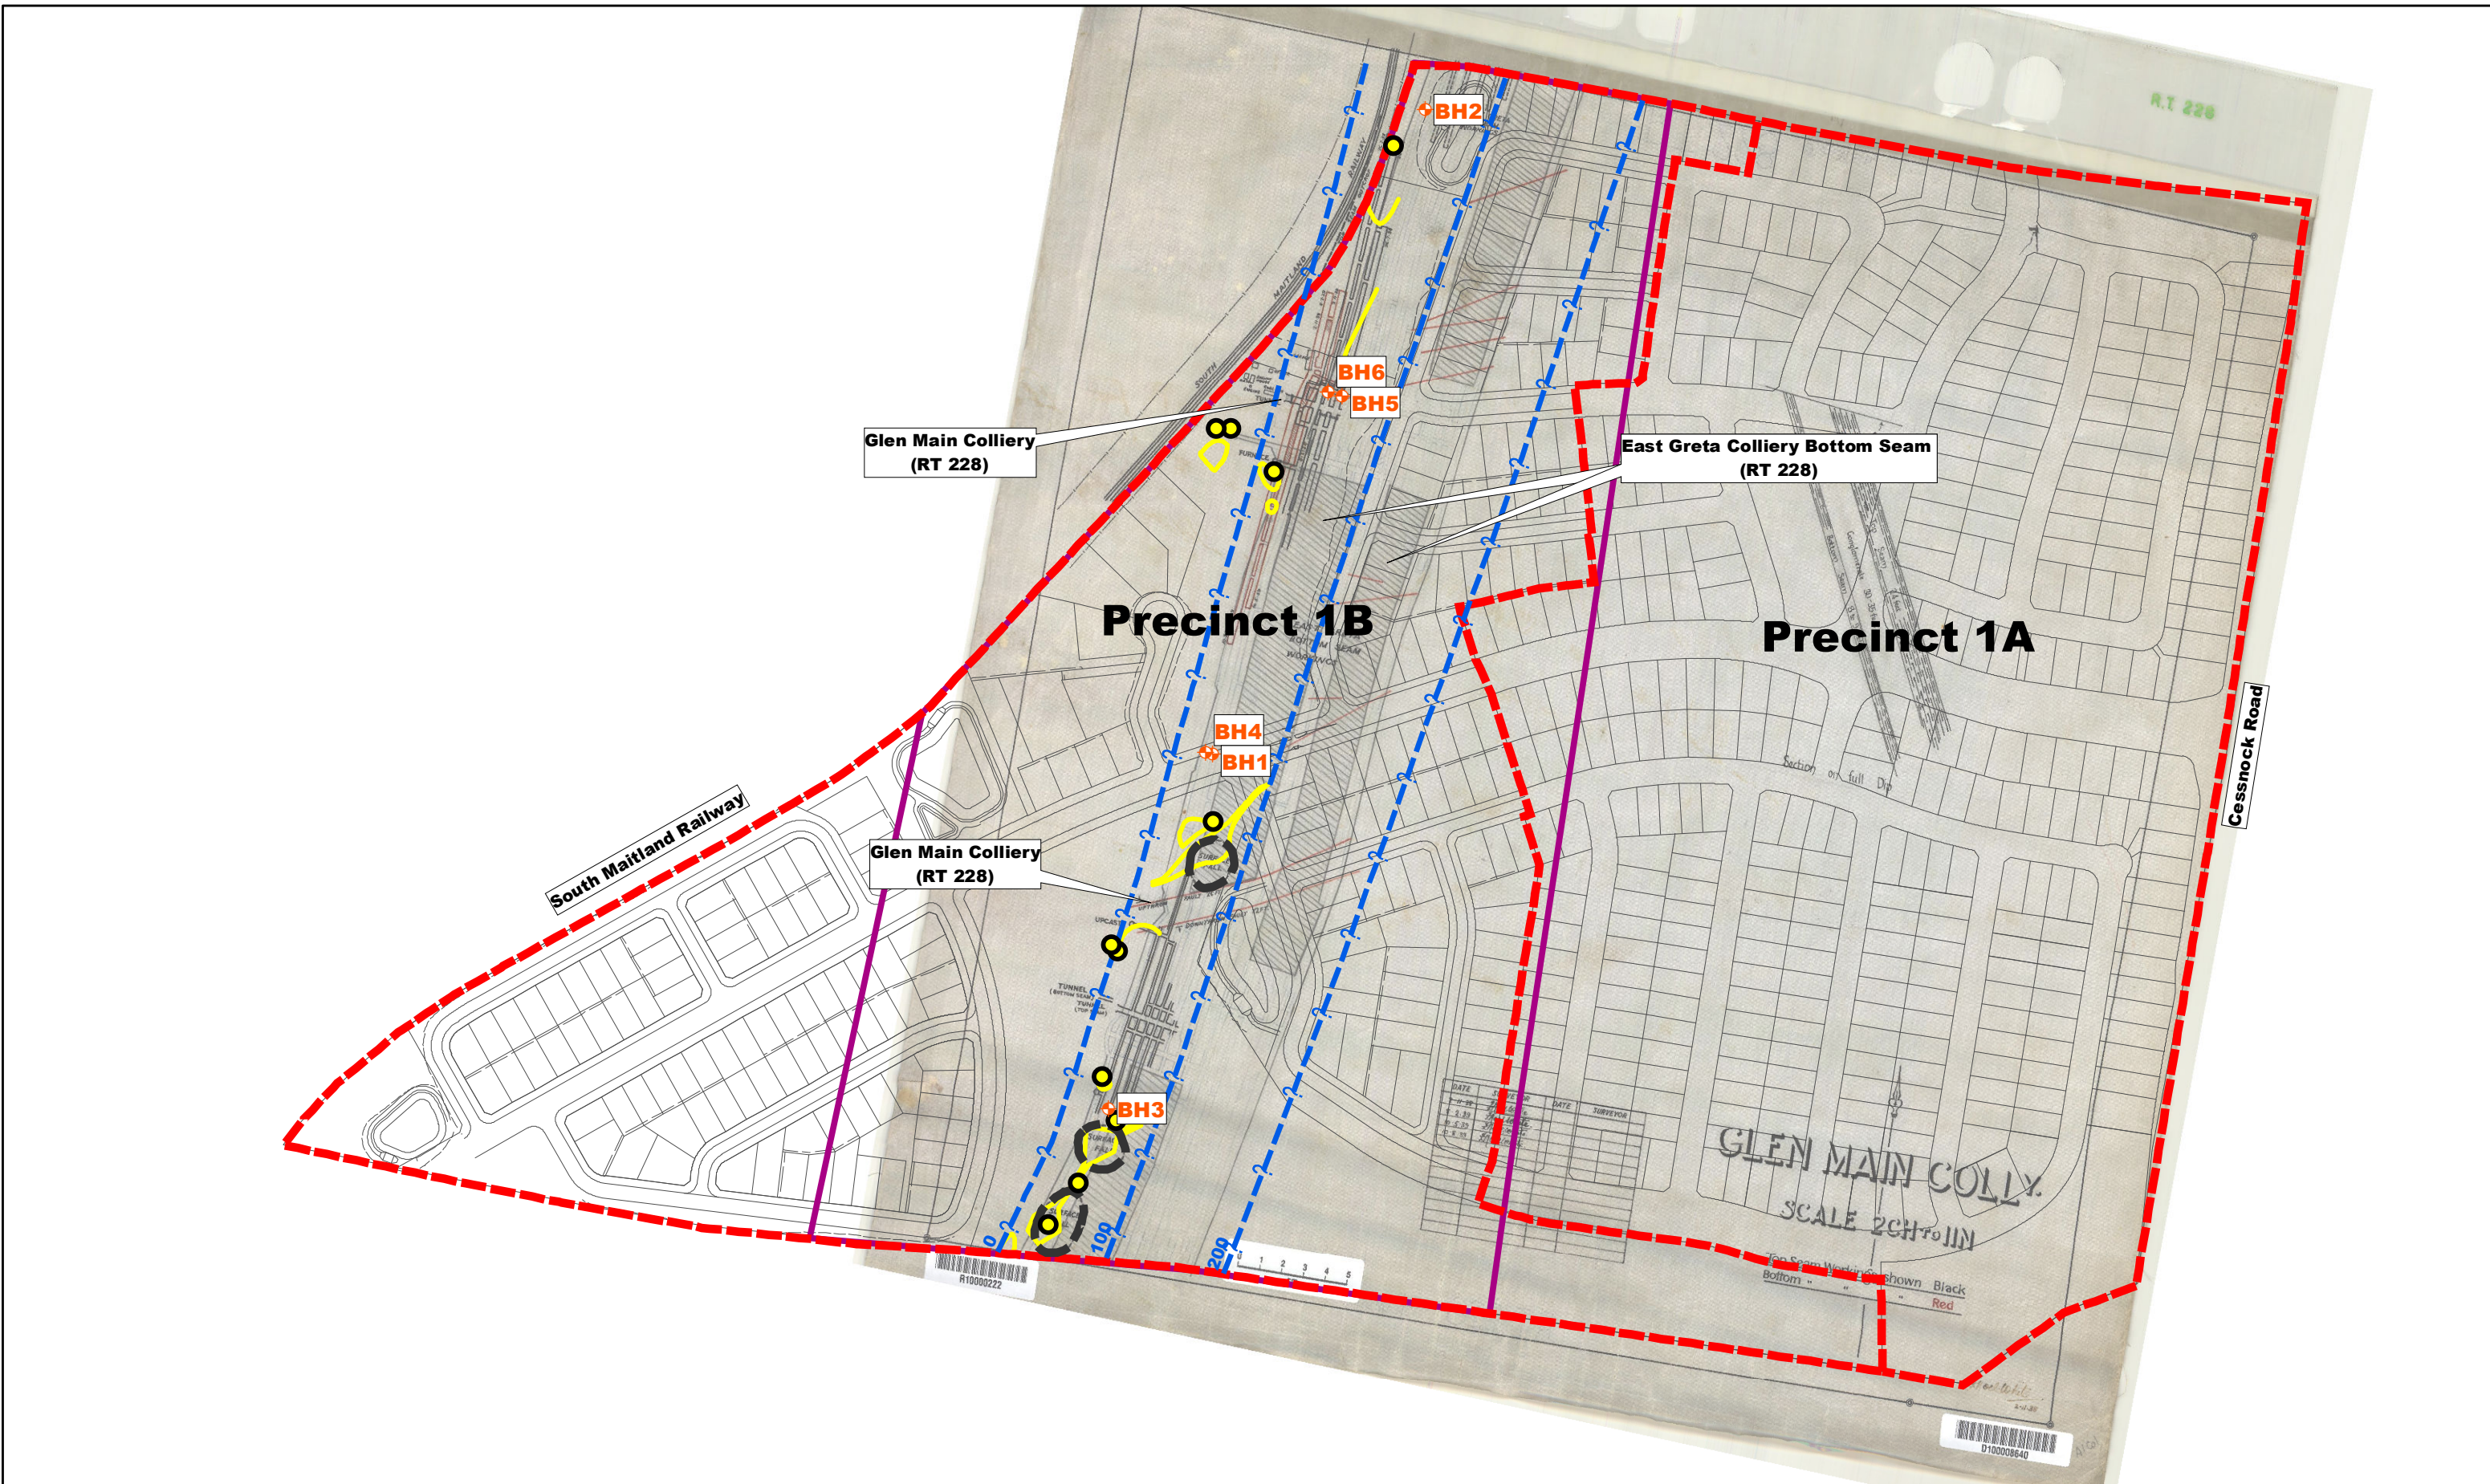
CLIENT Loxford Project Management Pty Ltd		RCA Ref 15924-203/1	
DRAWN BY MA	SCALE 1:4,000 (A3)	DRAWING No 4	REV 1
APPROVED BY MA	DATE 2/08/2022	OFFICE NEWCASTLE

- Identification on RT's. RT 288 shows three areas of surface falls each of which lie over workings of the East Greta Colliery. Reference to **Drawing 4** indicates that the surface falls align with surveyed surface subsidence features at the site. These features are assumed to be caused by pillar collapse and/or pillar removal and suggest trough and/or pothole subsidence of up to about 2m may have occurred. The depth of cover to the seams in the areas of these falls is assessed to be in a range up to about 60m.
- Subsidence features logged at the surface as identified in Ref [1] and positioned on **Drawings 2, 3 & 4**. The features are primarily in the shallow (less than about 50m cover zone).
- Well documented history at this site and in the broader Greta Coal Seam workings of pothole and trough subsidence.

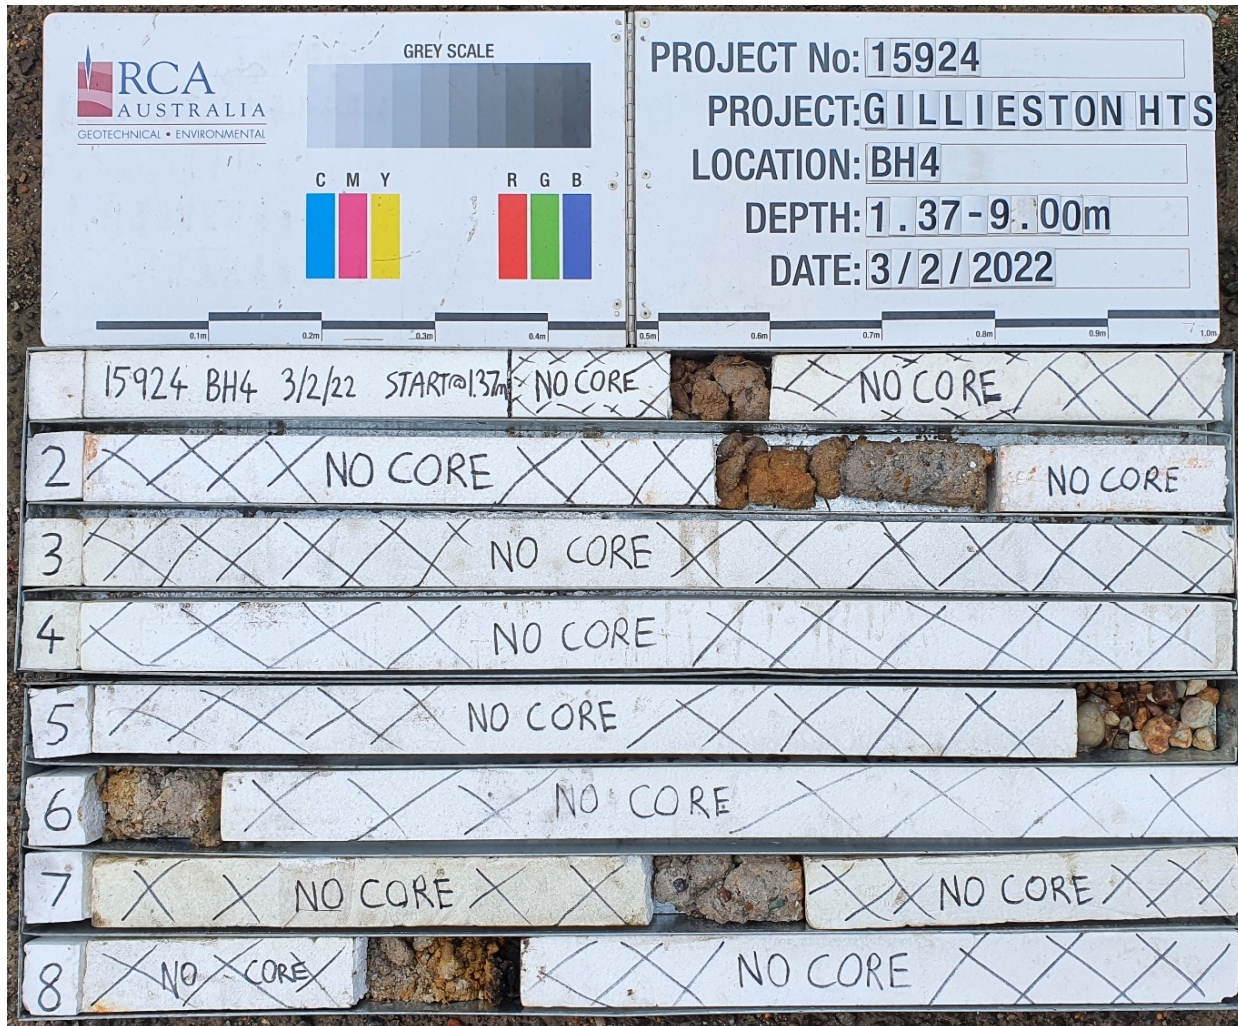
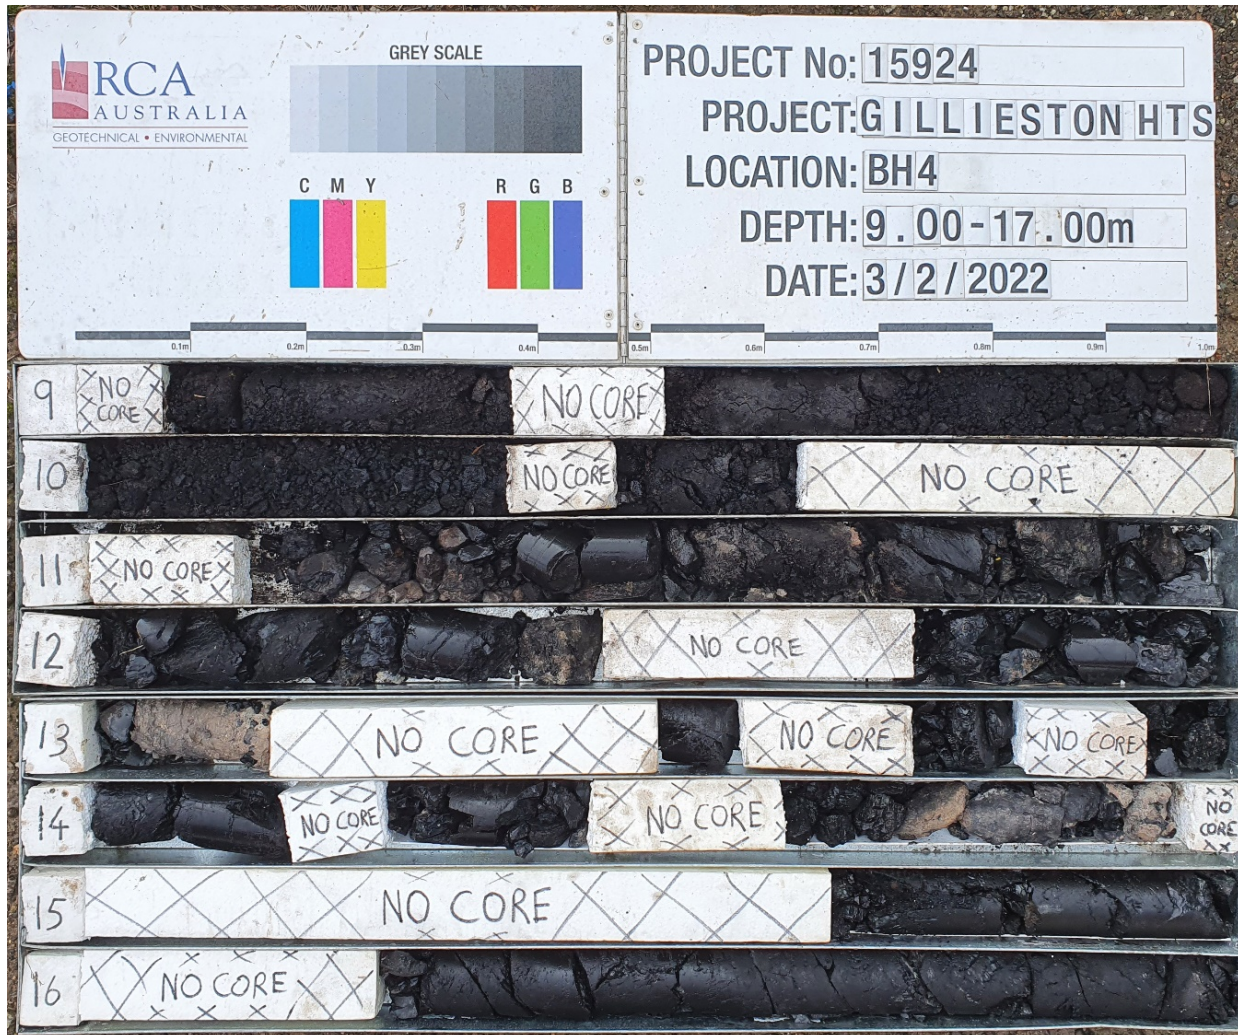
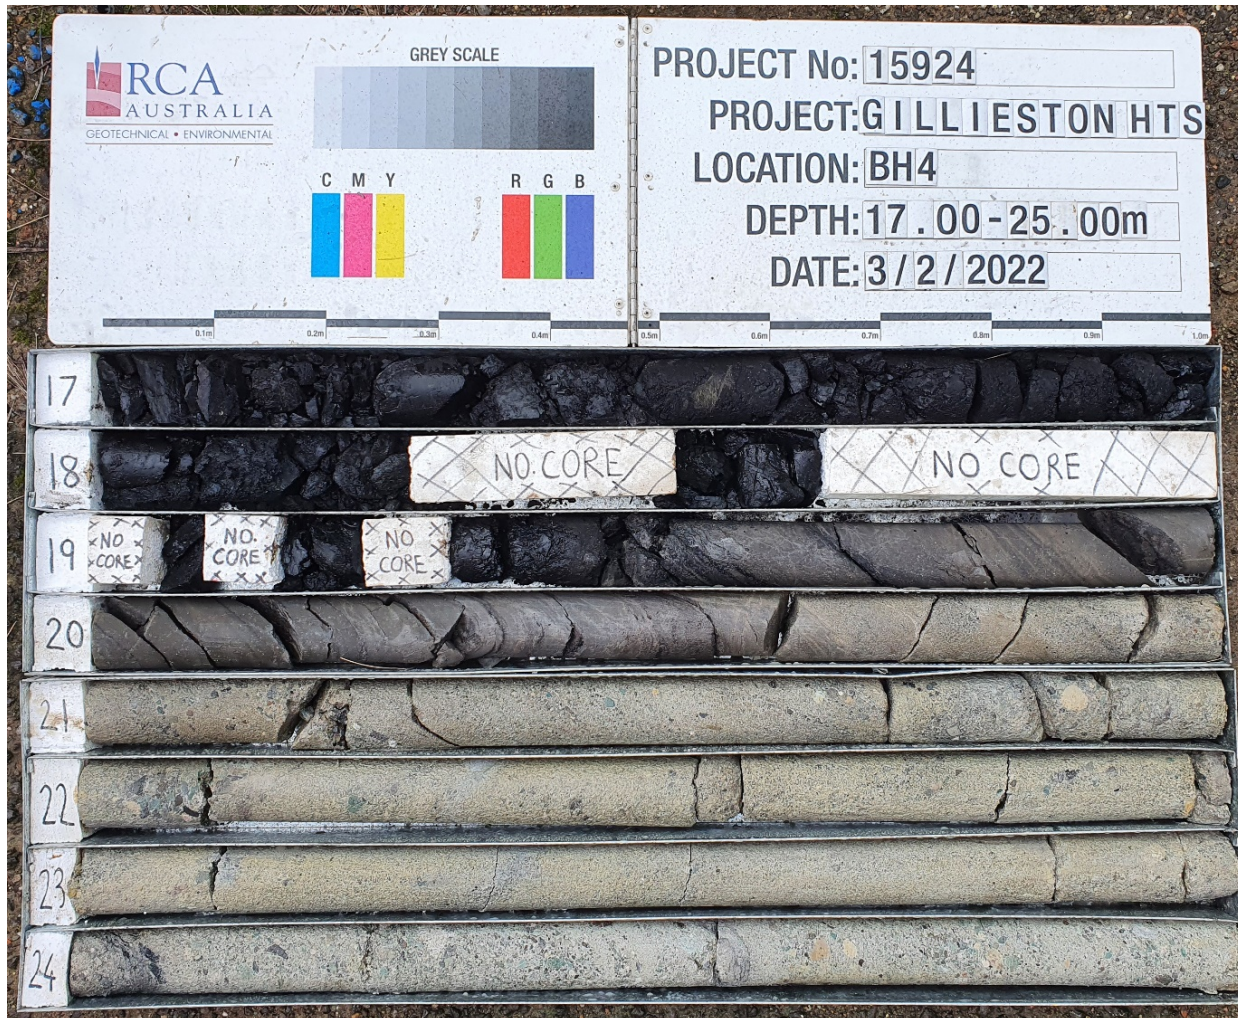
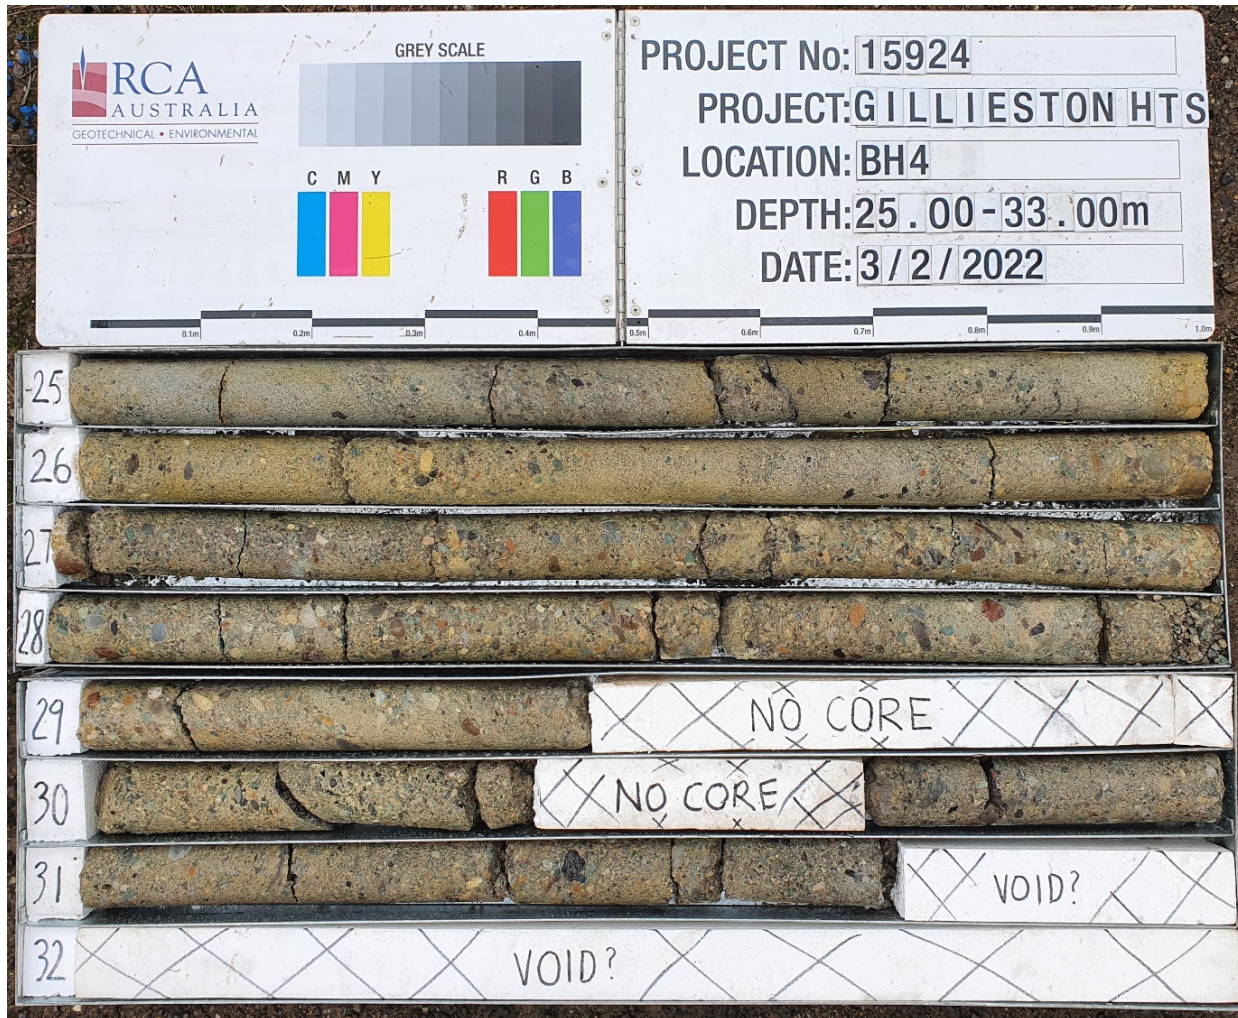
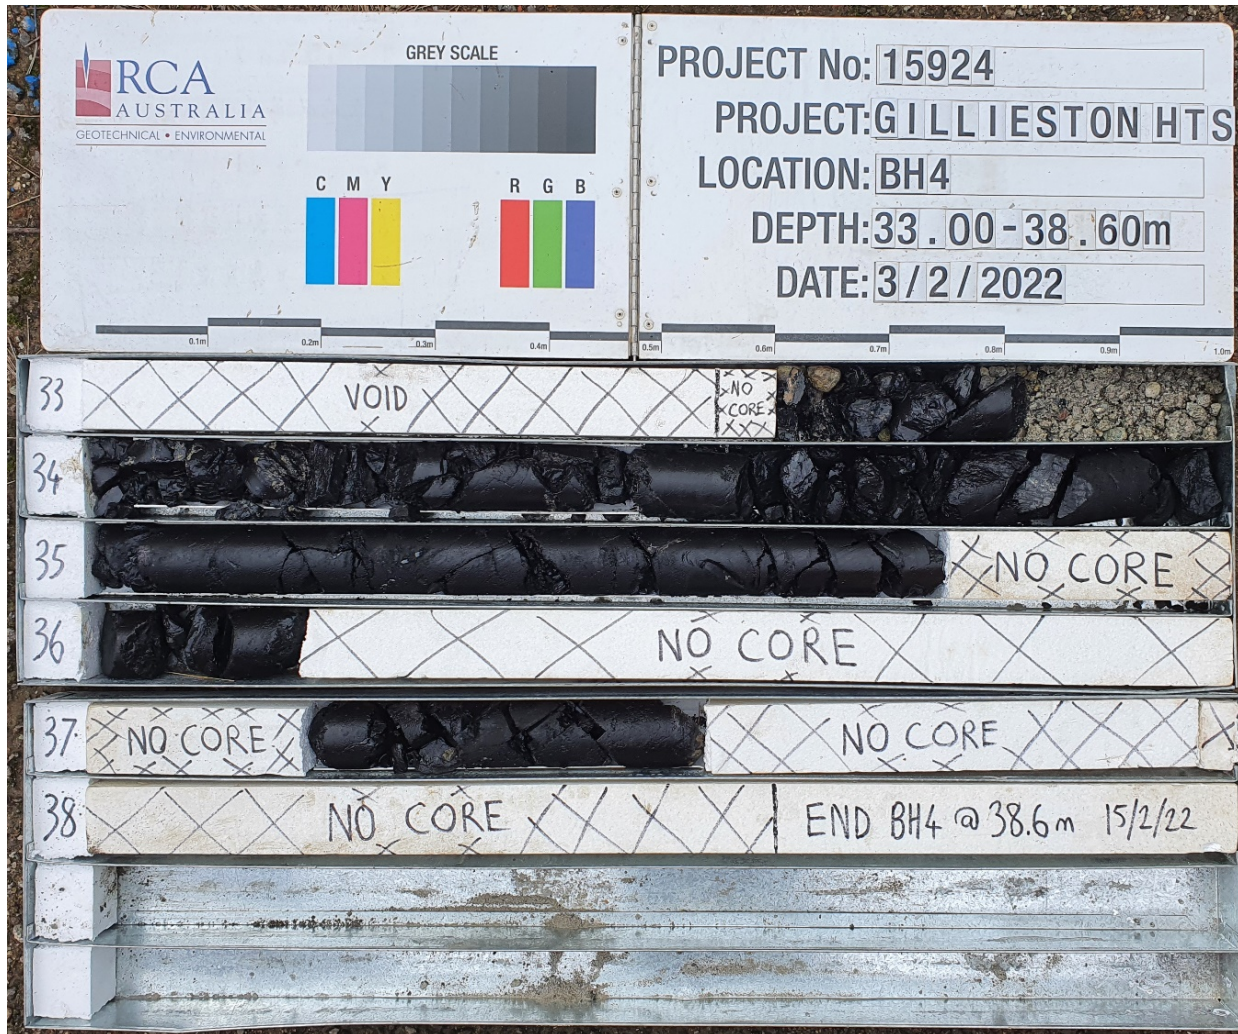
BH4 was cored with substantial loss of core considered to be reflective of subsidence and strata fracturing. BH4 encountered the top seam at a depth of 8.35m to 19.62m with no loss of drilling resistance to suggest voids or disturbance. It is assumed that BH4 penetrated a pillar. At the bottom seam level a void was encountered at 31.72m with intermittent rubble, core loss and voids encountered to a depth of 38.6m where drilling was unable to be continued. The presence of a void strongly suggests the presence of a bord at the bottom seam level and possibly some seam closure and subsidence.
