**PRELIMINARY
TREE ASSESSMENT**

For:
Bathla

Site Address:
176 Wollombi Rd,
Farley

Job No.
6274

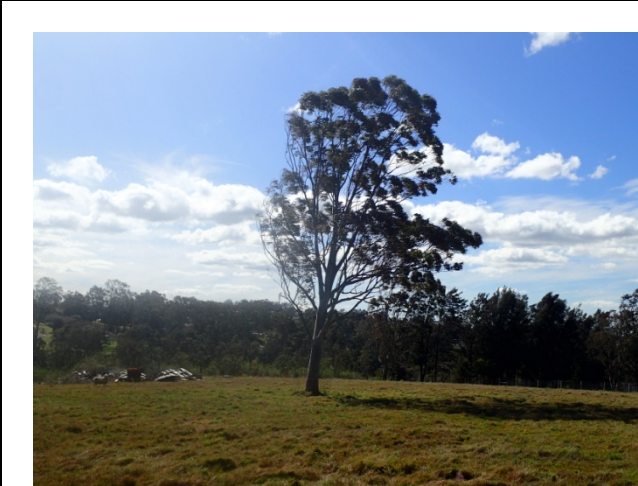
Plate 1 – T1

No.	Scientific Name	Age Class	Health	Condition	Height (m)	Spread (m)	D BH (mm)	On / Off Site	Disease	Retention Value	TPZ / SRZ (m) [Based on AS4970- Can be varied subject to detailed inspection]
1	<i>Corymbia maculata</i>	M	G	G	16	10	522	On	-	Very High	6.26 / 2.519 Animal trunk scuffs. Cavity and wound in co-dominant junction
2	<i>Cinnamomum camphora</i>	M	G	G	8	16	Multi	On	-	Low	-
3	<i>Eucalyptus pilularis</i> (as)	M	G	G	> 20	> 20	713	On	-	Very High	8.56 / 2.87
4	<i>Jacaranda mimosifolia</i>	M	G	G	8	10	500 Bse	On	-	Mod	6 / 2.47 Multi trunk
5	<i>Melaleuca armillaris</i>	O	A	A	7	10	Multi	On	Y	Low	-
6	<i>Eucalyptus punctata</i> (as)	M	A	P	12	15	600 Bse	On	Y	Low	- Significant fungal attack
7	<i>Melaleuca armillaris</i>	M	G	G	8	10	500 Bse	On	-	Mod/ Low	-
8	<i>Eucalyptus robusta</i>	M	G	G	16	12	900 Bse	On	-	High	10.8 / 3.16 Dual Trunk
9	<i>Eucalyptus punctata</i> (as)	M	A	P	16	12	525	On	Y	Low	- Significant fungal attack, thinning crown and trunk wound

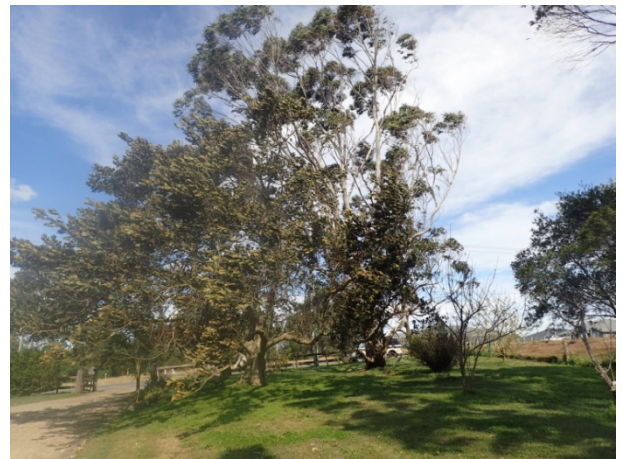
Plate 4 – T13-T14

10	<i>Leptospermum petersonii</i>	M	G	g/a	4	5	350 Bse	On	Y	Low	-
11	<i>Callistemon viminalis</i>	M	G	G	4	5	250	On	-	Low	-
12	<i>Morus nigra</i>	Exempt specimen									
13	<i>Eucalyptus species</i>	M	G	G	18	> 20	>1k	On	-	Very High	12 / 3.31
14	<i>Ficus macrophylla</i>	M	G	G	12	> 20	748	On	-	Mod/ High	8.98 / 2.93
15	<i>Eucalyptus species</i>	Dead									
16	<i>Callistemon viminalis</i>	O	A	A	6	6	500 Bse	On	Y	Low	- Deadwood, thinning crown and coppiced
17	<i>Callistemon viminalis</i>	O	A	P	5	10	600 Bse	On	Y	Low	- Dead codominant leaders
18	<i>Melaleuca 'CV'</i>	M	G	G	4	6	350 Bse	On	-	Low	-
19	<i>Eucalyptus crebra</i> (as)	M	G	G	16	> 20	487	On	-	Very High	5.847 – 2.45
20	<i>Unidentified deciduous shrub</i>	M	?	P	< 3	5	150 Bse	On	Y	Low	Trunk wound and borers
