CLOSEBOURNE GARDEN PAVILION

TREE ASSESSMENT REPORT

DECEMBER 2022

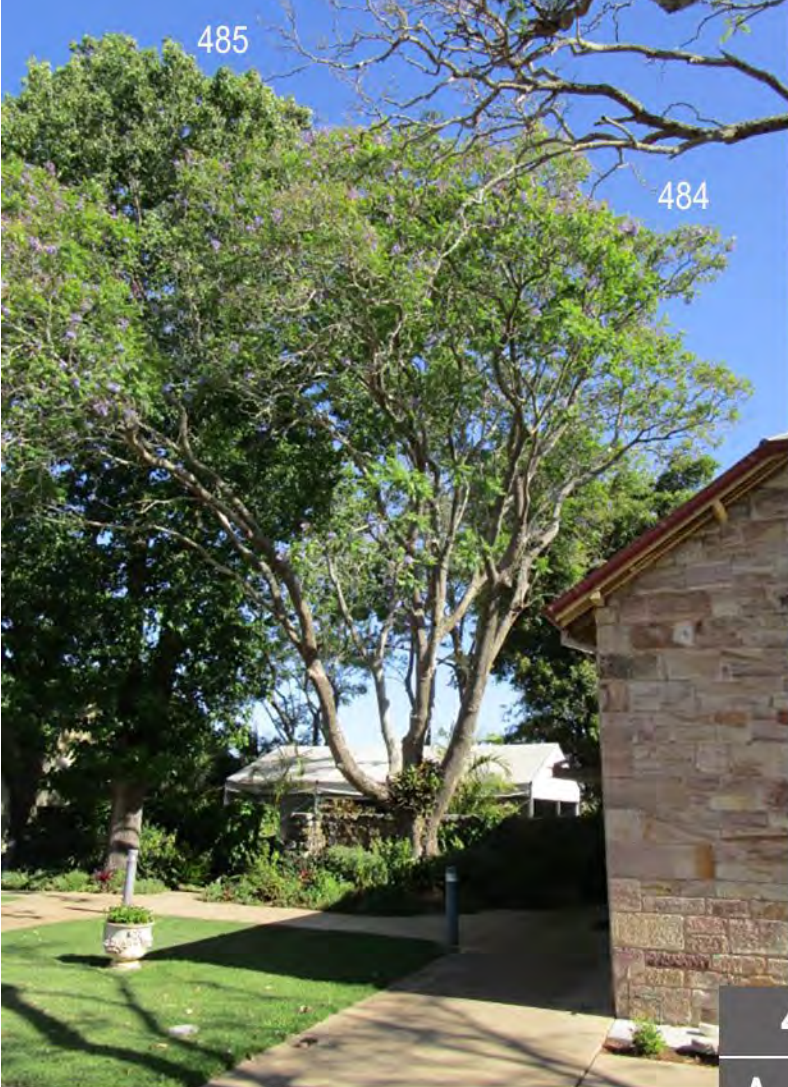
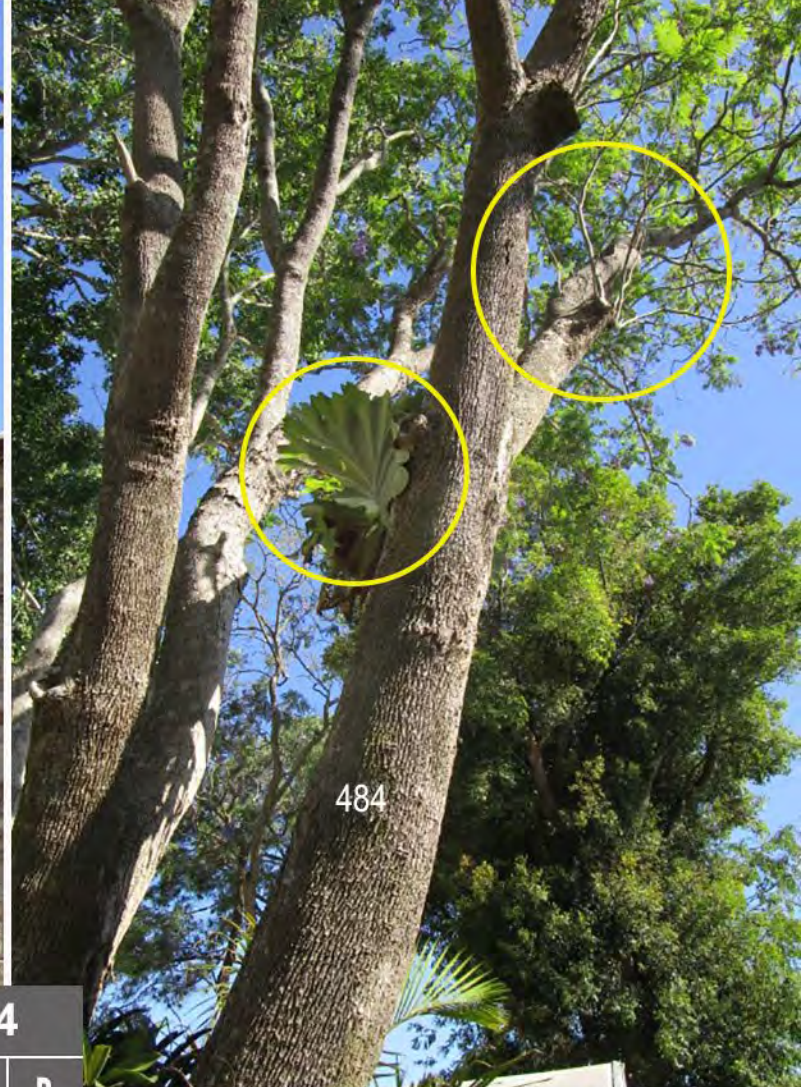
4	
A	B
C	D

SUMMARY ASSESSMENT			
TREE No.	FIG No.	Bot. NAME	COMMENTS
484	4A/B	<i>Jacaranda mimosifolia</i>	Tree located in well-tended garden. Occurring close to sandstone block wall with no apparent structural damage to wall. Evidence of prior pruning of branches that once overhanging the chapel building. Now with good callus. Water shoots present associated with pruning sites. Tree contains <i>Dendrobium</i> sp. (Tree Orchid) and <i>Platyserium</i> sp. (Staghorn) within canopy. (Refer Fig No. 4B.)
485	4A/C/D	<i>Liquidambar styraciflua</i>	Tree located in well-tended garden. Located close to sandstone block wall with no apparent structural damage. Some trunk damage in upper canopy. Some prior removal of lower branches now well callused. Co-dominant trunk @ 3m AGL with good branch architecture.
486	4C/D	<i>Jacaranda mimosifolia</i>	Tree located in well-tended garden. Located close to sandstone block wall with no apparent structural damage. Asymmetric canopy favouring the east due to dominance of Tree 485. Tree contains <i>Dendrobium</i> sp. (Tree Orchid) and <i>Platyserium</i> sp. (Staghorn) within canopy.

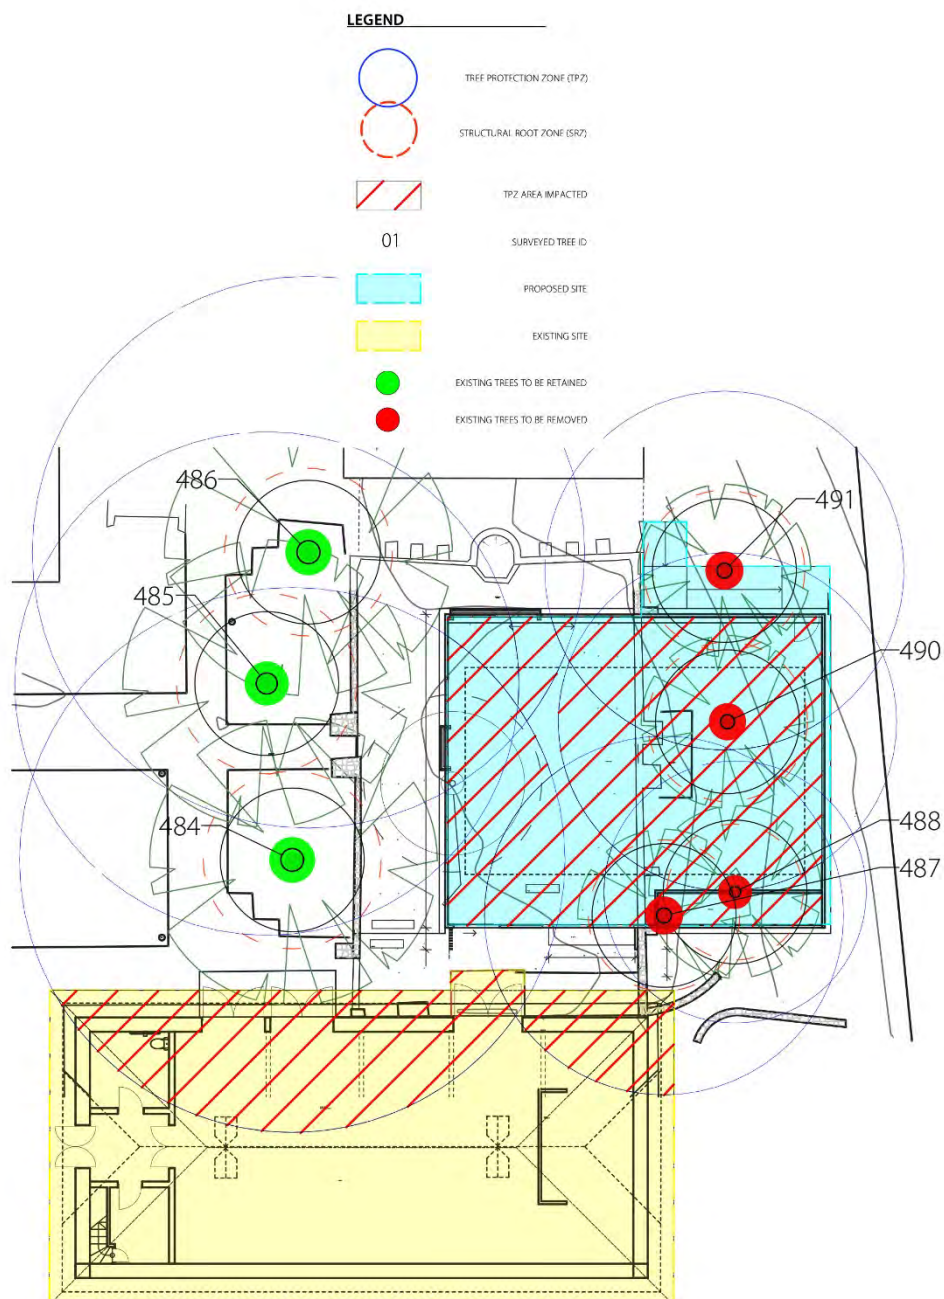
FIGURE 6: TPZ/SRZ/TREE REMOVAL DIAGRAM [BASE SOURCE: CNA DESIGN STUDIO]

Based on the current design, it will not be possible to retain any of the existing trees south of the Calvary Garden wall (i.e. Trees 487, 488, 490 and 491).

The trees growing to the north of the wall may experience some reduction to their root plates as development occurs with the calculated TPZs (Tree Protection Zone). Encroachment on Trees 484, 485 and 486 are approximately 11%, 6.6% and 6% respectively. Based on the requirements of AS 4970 – *Protection of trees on development sites*, this is not considered to be significant. Other mitigating factors include: the vigour of the trees; and, the presence of the wall and marquee would limit root growth into the Calvary Garden.

- It is recommended that approval be sought to remove Trees 487, 489, 490 and 491. This can be undertaken as part of the DA process.
- As a suggestion, plant **one** standard tree (45 litre) on the site for each tree removed as compensatory planting with suitable trees able to reach a similar size that matches the existing to ensure that the amenity of the site is maintained.
- Ensure tree removal work is carried out by or supervised by a qualified tree worker (AQF Level 3 or equivalent) in accordance with the *Guide to Managing Risks of Tree Trimming and Removal Work* (Safe Work Australia, 2016).
- Tree remains to be mulched. Mulch can be used around remaining trees and within planter beds located elsewhere on site. If not practical to mulch fallen trees on site, the material can be disposed of in a legal manner off site and imported mulch used.
