Preliminary Geotechnical Assessment

507 Raymond Terrace Road, Chisholm, NSW

Prepared for: Allam Property Group
EP1977.002 7 April 2021

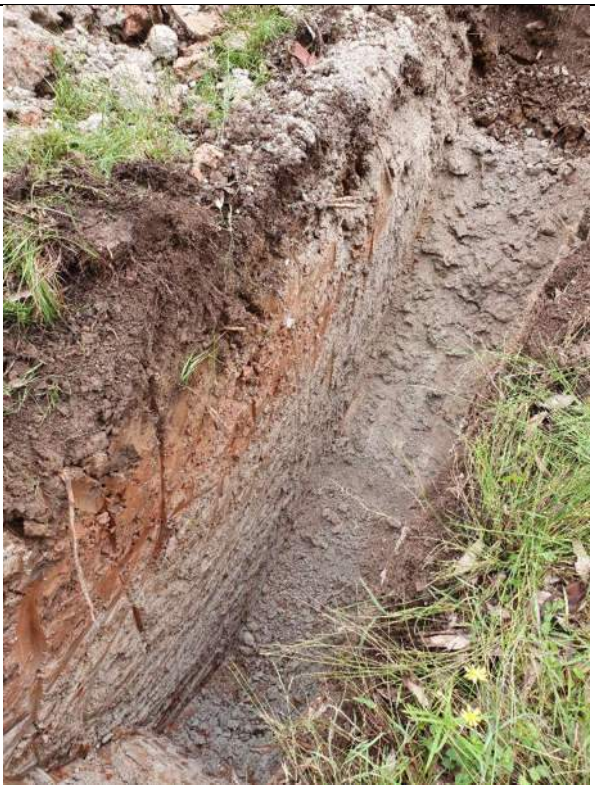
<p>Plate 3</p> <p>Description:</p> <p>Residual Sandy CLAY colour change from mottled orange and red to mottled grey and orange.</p> <p>Date: 25/02/2021</p>

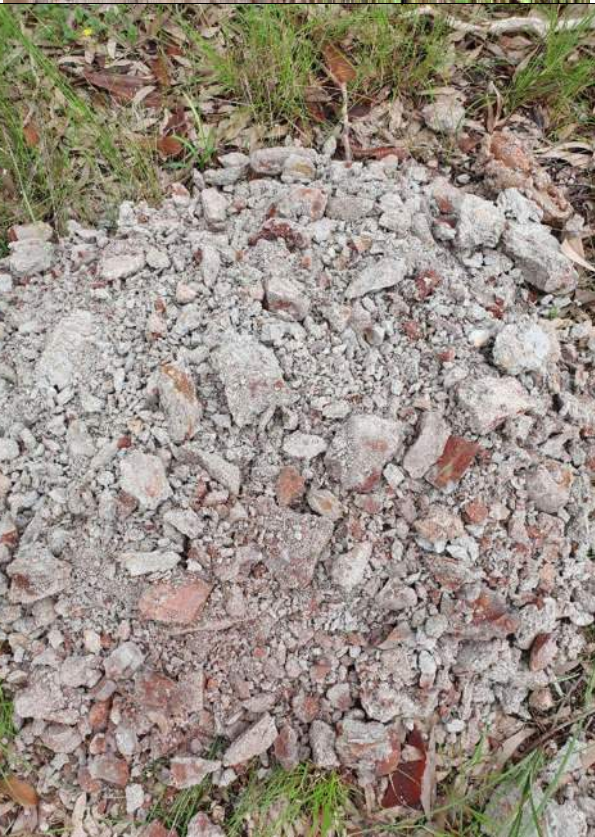
<p>Plate 4</p> <p>Description:</p> <p>Extremely weathered sandstone encountered in all the test pits across the Site.</p> <p>Date: 25/02/2021</p>
