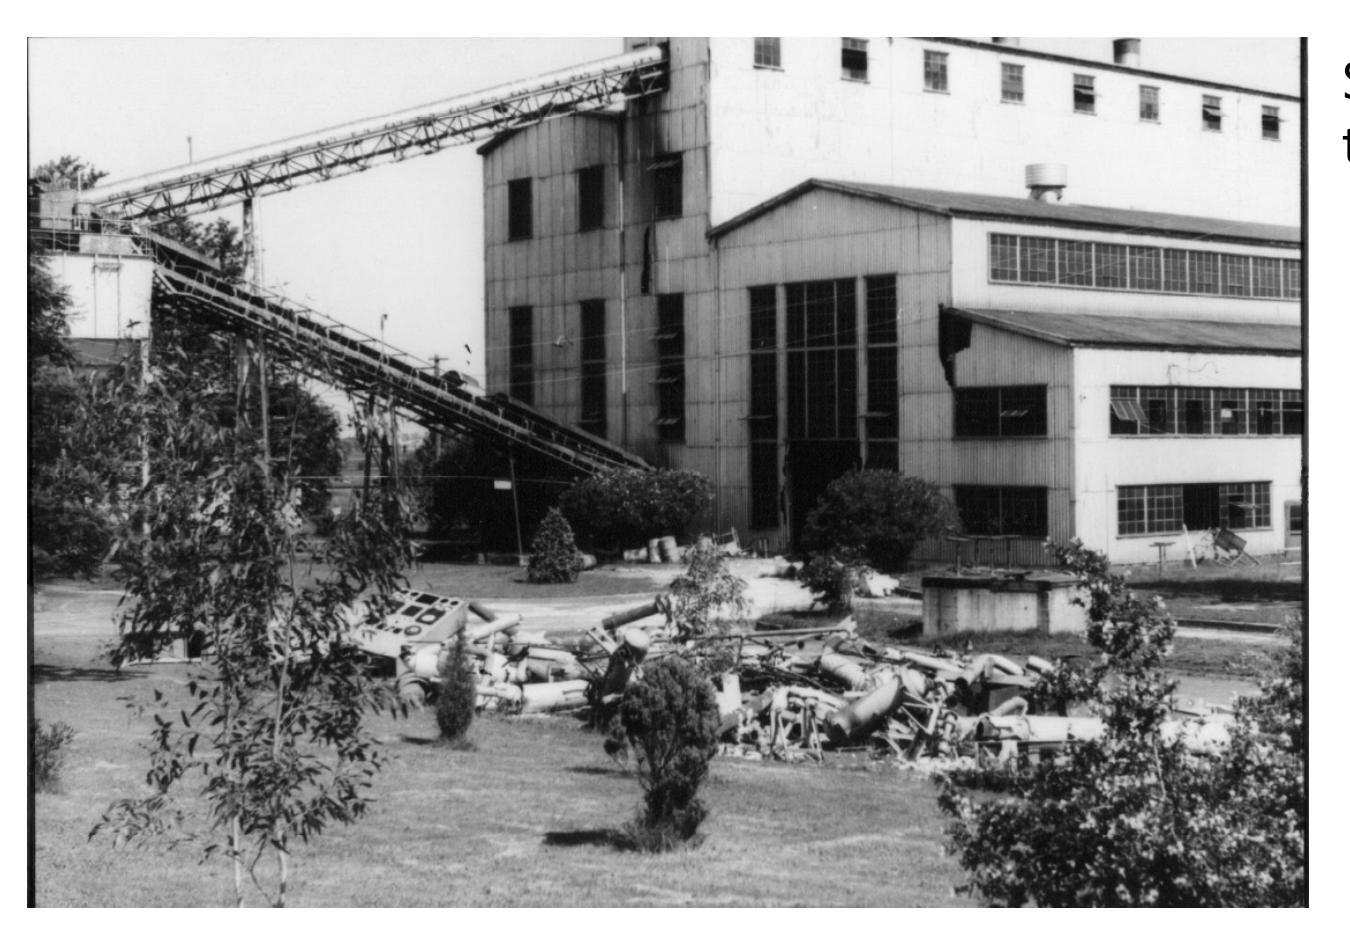
- Based on historical photos, the power station included multiple components that likely included both bonded and friable asbestos materials.
- Demolished materials were stockpiled throughout the working power station site.
- At this point in time, asbestos was not considered a hazardous substance and demolition and removal would not have been controlled to the standards of today.

Stockpiled material during demolition of the facility.

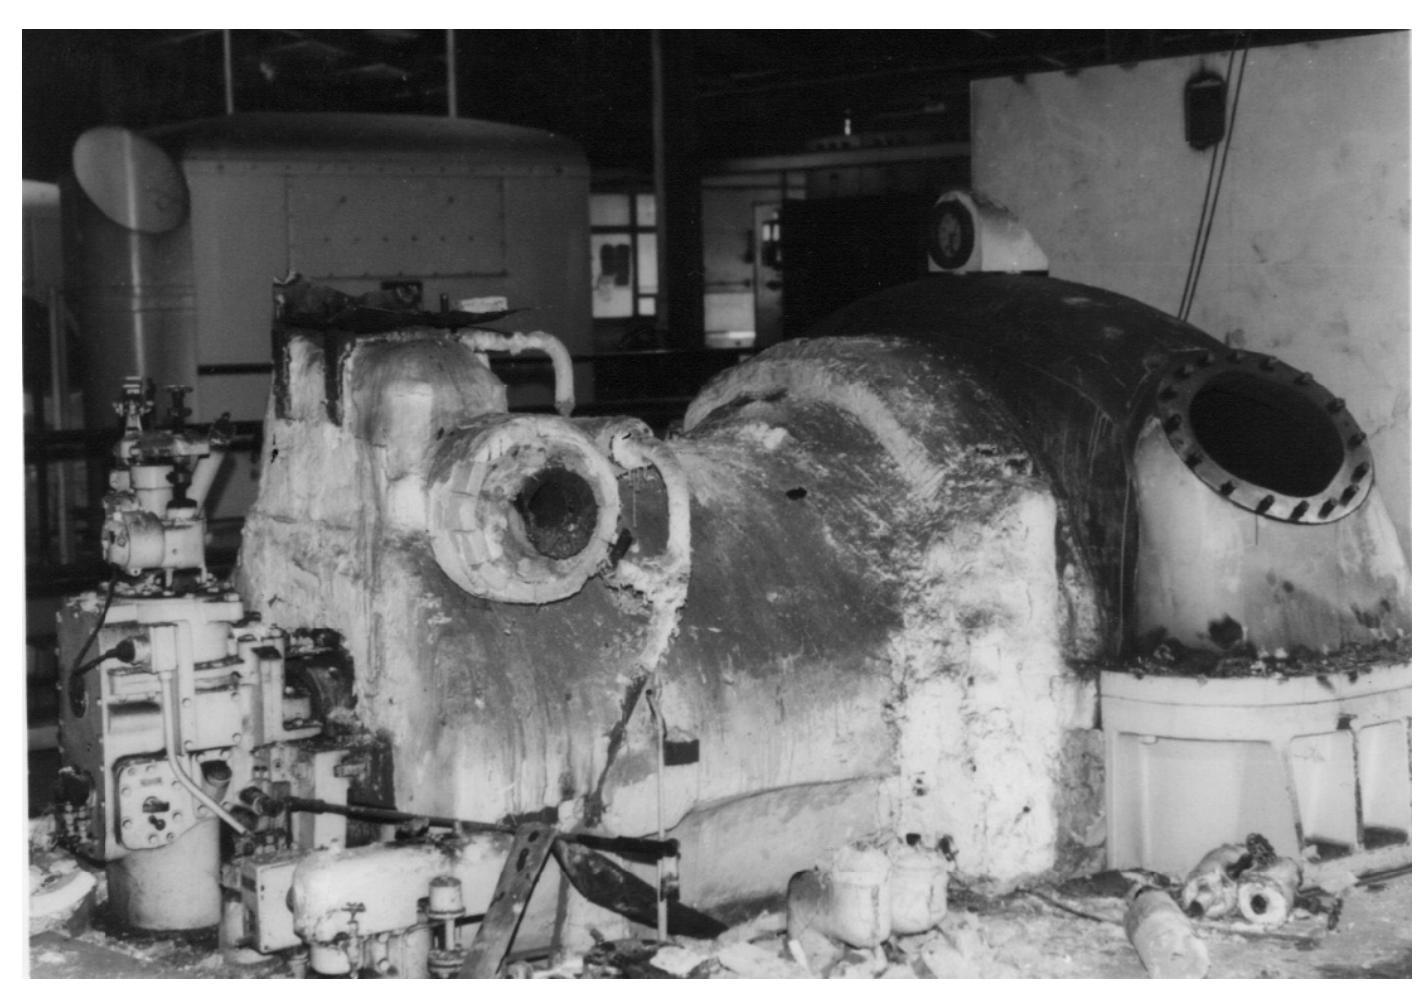
An example of a boiler/furnace that was likely insulated with asbestos material.

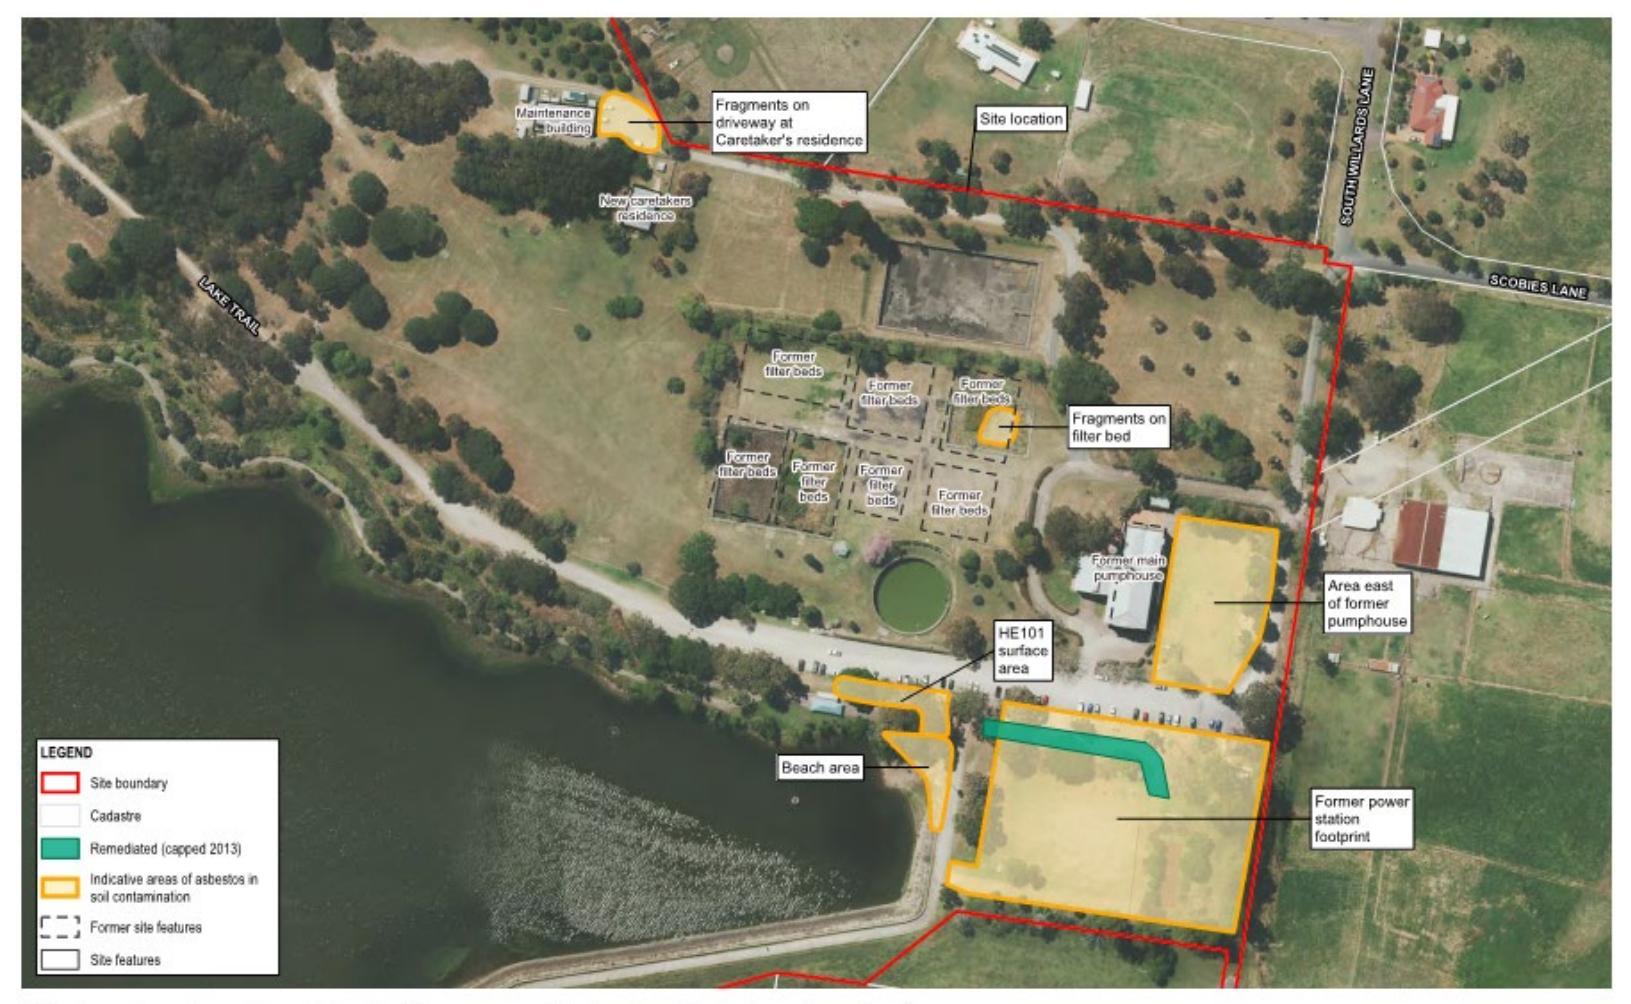
- Chemical contamination in soils, sediments and water was present, but is generally below human health levels and will not affect the suitability of the site for its current use as a recreational facility.
- Asbestos containing material (ACM) present in construction materials within the Pumphouse building.
- Asbestos contamination (ACM fragments) was present on the floor of Sand Filter Bed 2, on the driveway surface near the Caretaker's Residence, on the ground surface near the miniature railway station and on the ground surface near the old workers cottages site.
- Significant asbestos contamination (ACM Fragments, Friable Asbestos) in soil is
 present throughout the pumphouse lawn, the power station lawn, the embankment
 to the reservoir beach and to the Northeast of the amenities building.

Site location layout and indicative areas of asbestos in soil contamination

Remediation by Consolidation and Containment (subject to approvals and funding) is proposed including a mix of capping in-situ and site containment within the existing water filtration structures to facilitate future use requirements and site constraints.

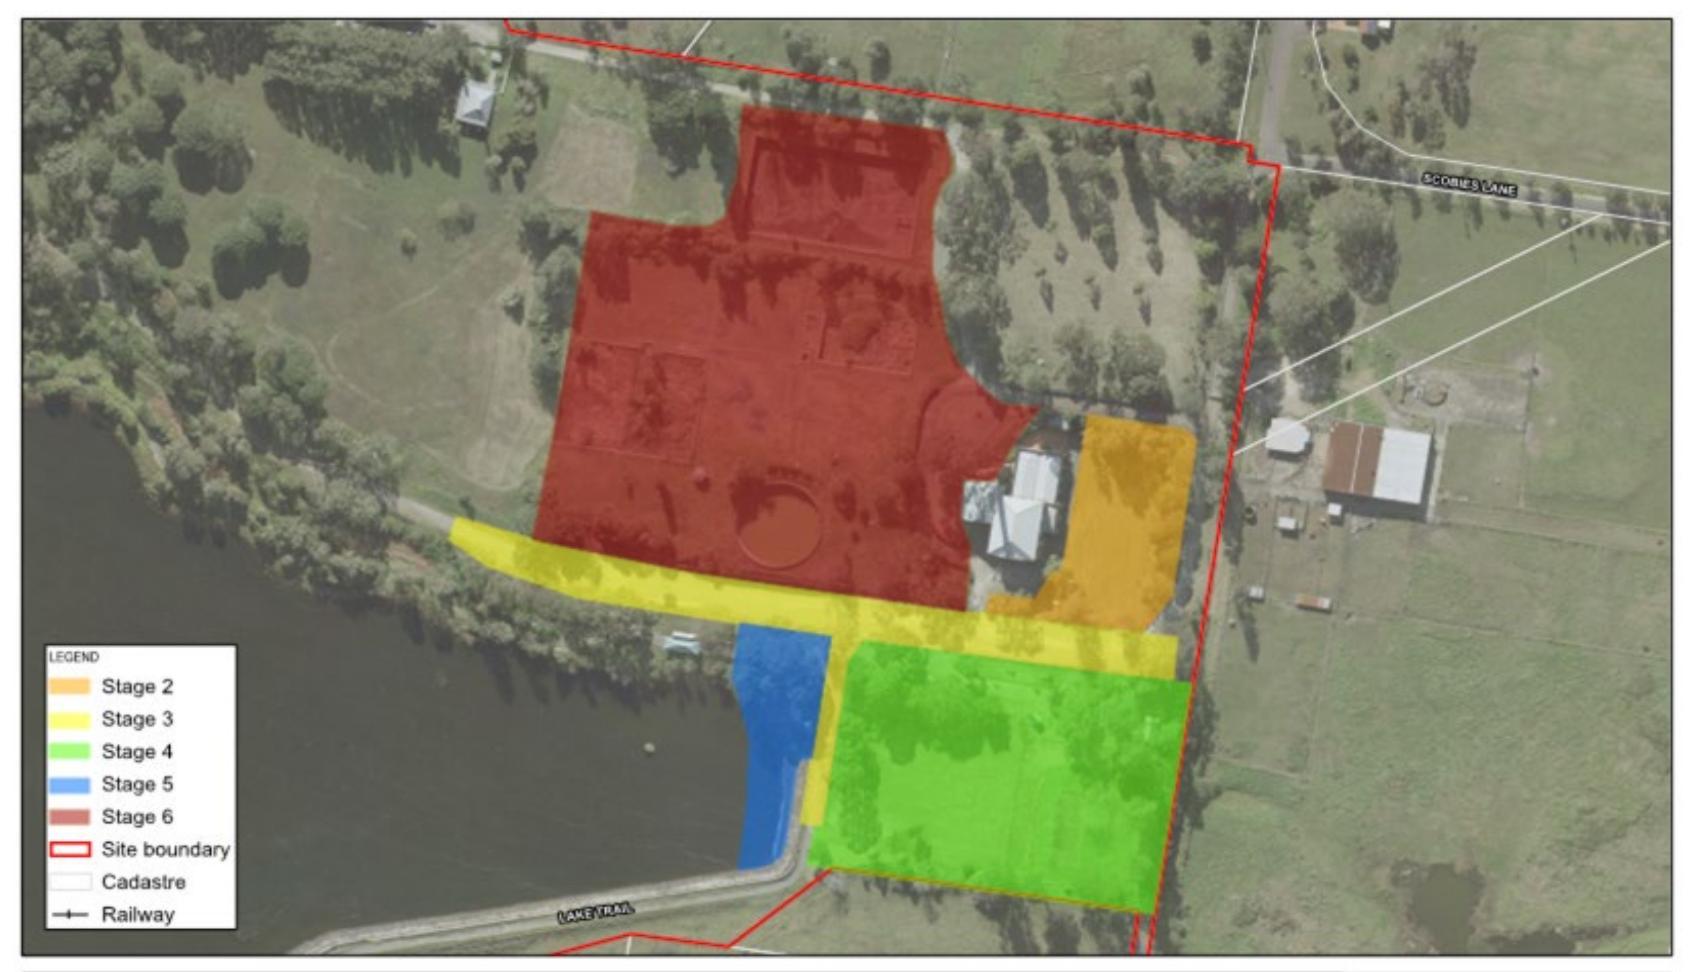
Proposed remediation stages 2 – 6

- Re-opening the site under controls (Stage 1 completed)
- Eastern Lawn adjacent the pump house (Stage 2)
- Carpark and roadway (Stage 3)
- Power Station Lawn, south of Carpark (Stage 4)
- Reservoir Beach and area east of Miniature Rail Station (Stage 5)
- Former water treatment system and filter beds (Stage 6, but included in stages 2 5)
