## 8 Grant Street, Maitland, NSW, 2320

# Arboricultural Impact Assessment For proposed development.

Performed February 29, 2024

REPORT REF JN19420 VERSION 1

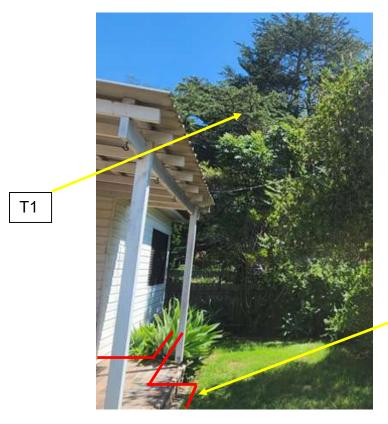
FIGURE 6 - T1 AND APPROXIMATE LOCATION OF PROPOSED DWELLING

Excavations for footings and plumbing within the TPZ of T1, T4 and T5 are to be hand dug prior to machinery being used. Roots should be exposed to the edge of the required area and any encountered greater than 10mm should be cut neatly with pruning saw or secateurs. Hessian is to be laid over the exposed roots and soil profile and kept moist until such time as they are backfilled.

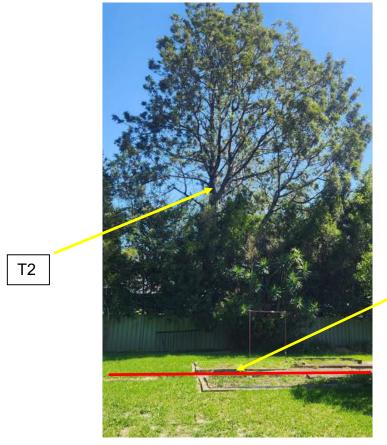
The footprint of the Multi Storey Residential (15 x Unit) Development is also located within the TPZ of trees T1 (Himalayan Cedar),T2 (Silky Oak),T4 (English Oak),T5 (Norfolk Island Pine) as shown in Figure 6,Figure 7 and Figure 8 below. It represents a minor encroachment of 2.46% in the TPZ of T1 and 2.42% in the TPZ of T4 and an acceptable encroachment of 9.05% into the TPZ of T2 and 10.49% into the TPZ of T5.

FIGURE 7 – T2 AND APPROXIMATE LOCATION OF PROPOSED DWELLING

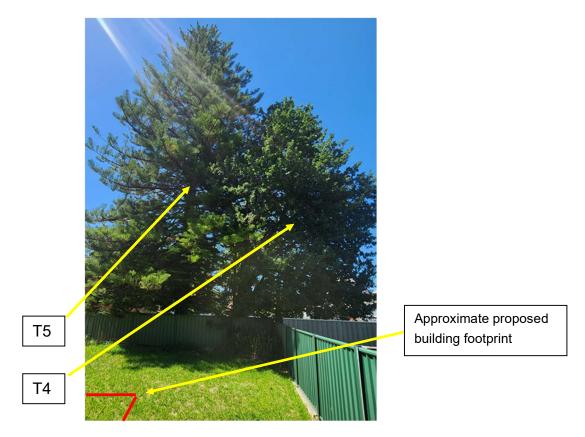
FIGURE 8 - T4 AND T5 APPROXIMATE LOCATION OF PROPOSED DWELLING

T4	Quercus Robur (English Oak)	13.5	4N 4E 7S 5W	0.57	0.71	Mature	Good	<5%	Good	Medium	Good overall condition given species type and climate, asymmetry and suppressed crown to the South due to adjacent tree.	5	MODERATE
Т5	Araucaria heterophylla (Norfolk Island Pine)	23	4N 4E 3S 5W	0.79	0.95	Mature	Good	<5%	Good	Medium	Minor deadwood in crown reduced crown size to the south due to adjacent tree. Good vitality	5	MODERATE
Т6	Murraya paniculata (Orange Jasmine)	5	2N 2E 2S 2W	0.26 Multi Stem	0.42	Mature	Good	<5%	Good	Medium	Multi stem tree, large flush cut wounds from poor pruning and previously topped to reduce height.	4	LOW
Т7	<i>Murraya paniculata</i> (Orange Jasmine)	5	2N 2E 2S 2W	0.29 Multi Stem	0.52	Mature	Good	<5%	Good	Medium	Multi stem tree, large flush cut wounds from poor pruning and previously topped to reduce height.	4	LOW
Т8	Callistemon citrinus (Crimson Bottlebrush)	5	2N 2E 2S 2W	0.34 Multi Stem	0.54	Mature	Good	<5%	Good	Medium	Multi stem tree previously topped at 2m to reduce height secondary regrowth forming crown.	4	LOW
