Geotechnical Investigation

Proposed Commercial Development Cnr Tyrell Street & Kenneth Street, Tenambit

Report Ref: G0237-GI-001-Rev0

10 August 2023

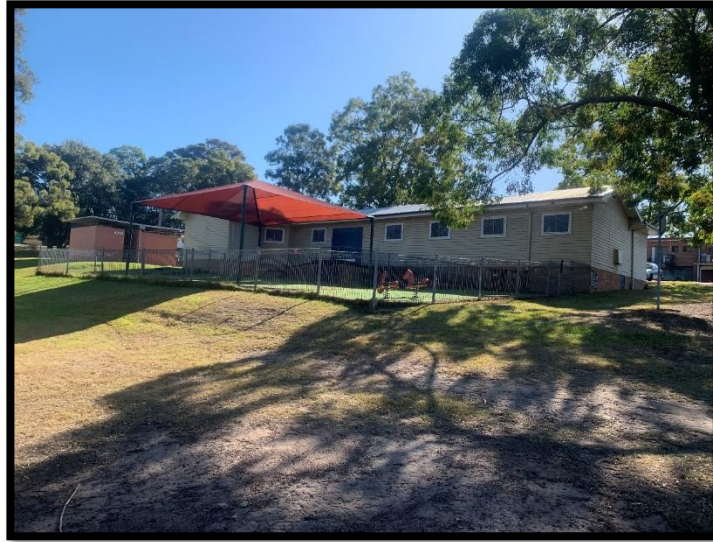
Figure 1 - Photograph of site

Topographically the site slopes towards the south boundary.
