TREE ASSESSMENT

TEMANBIT COMMUNITY CENTRE

**SINCLAIRE and TYRELL STREETDS
TENAMBIT**

23rd OCTOBER 2023

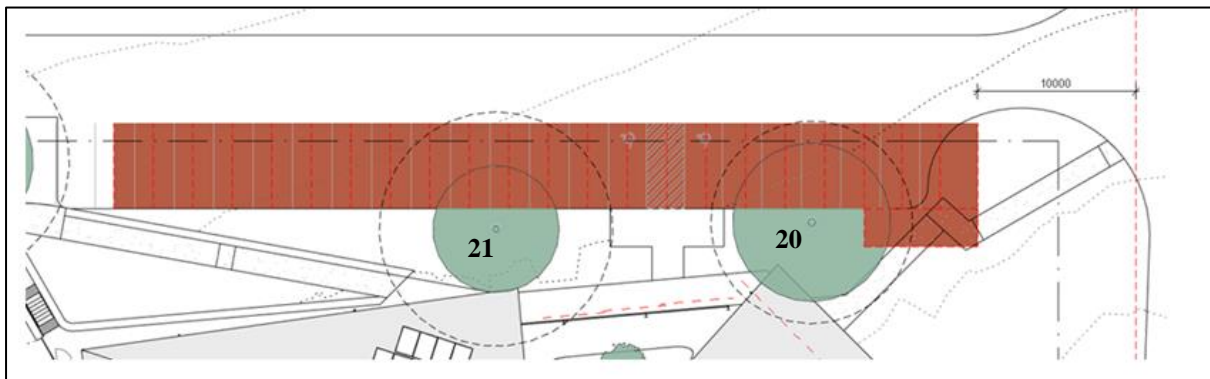
The assessment is based on the excerpt of the plans provided by Alison Cronin | Senior Project Architect | Maitland City Council below.

Based on the information provided changes to the carpark are required to elevate the southern alignment in the order of 200-250mm to achieve flatter grades over the carparking area that will result in changed levels at the base of the trees and construction within the TPZ & SRZ.

Due to their close proximity to the existing bitumen construction will encroach well into the TPZ & SRZ off the trees. According to Australian Standards – AS 4970 – 2009, Protection of Tree on Development Sites encroachment is considered to be major where construction will encroach into the SRZ or encroach more than 10% into the calculated TPZ of a tree.

Ideally, if possible, the existing bitumen should be retained and new sub-base and bitumen laid directly on top. This will eliminate the need for any excavation works and potential for damage to roots and impacts associated with compaction, oxygen supply and associated beneficial fungi and micro-organisms is not likely to be significantly altered.

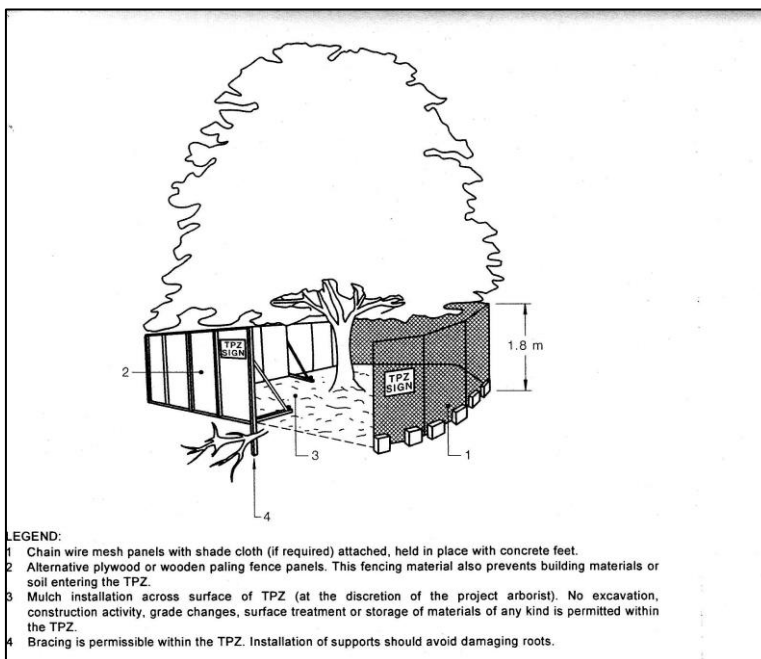
Figure 1 - Example of TPZ fencing

Due to the close proximity of the works to the trees Tree Protection Measures should be put in place to prevent potential damage to trunks & branches.

- As optimal Tree Protection Zones cannot be achieved due to construction constraints 1800mm high chain link temporary fencing installed as close as possible to the edge of construction then incorporate remaining TPZ radius where possible (Figure 1)
- Where fencing may not be appropriate or practical boards and padding should be used for trunk and branch protection that will help to prevent damage to bark when maneuvering and operating machinery near surrounding trees. Boards must be strapped to trees not nailed (Figure 2).
