ARBORICULTURAL IMPACT ASSESSMENT REPORT

**MAITLAND GAOL
6-18 JOHN STREET
EAST MAITLAND**

MAITLAND CITY COUNCIL

13th JANUARY 2023

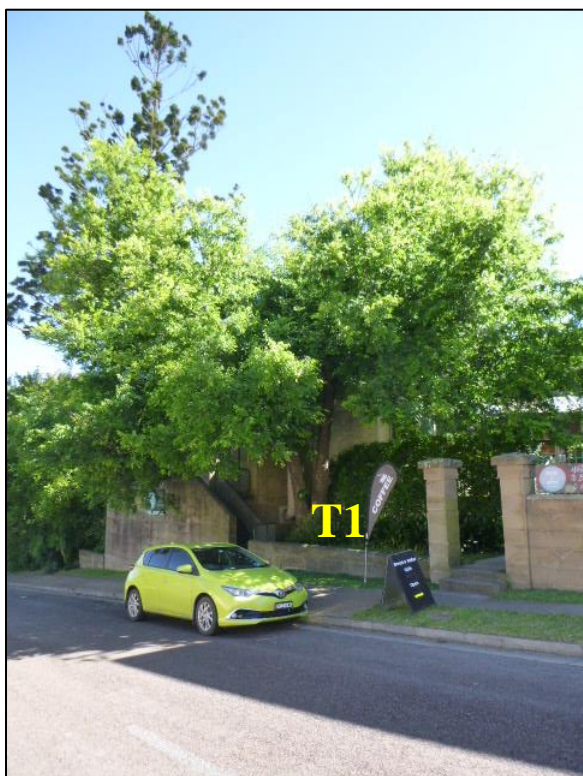
The retention of the tree would require significant changes to the design / development footprint and alternative construction methods to be utilized that would enable it to be retained and survive the impacts of construction.

However, it is considered that protection zones required to retain the tree in good, safe condition that re-design options will be difficult to achieve and always likely to result in conflict between tree roots and construction that will have a detrimental impact on the tree reducing its retention value

Photo 1 – Tree proposed to be removed

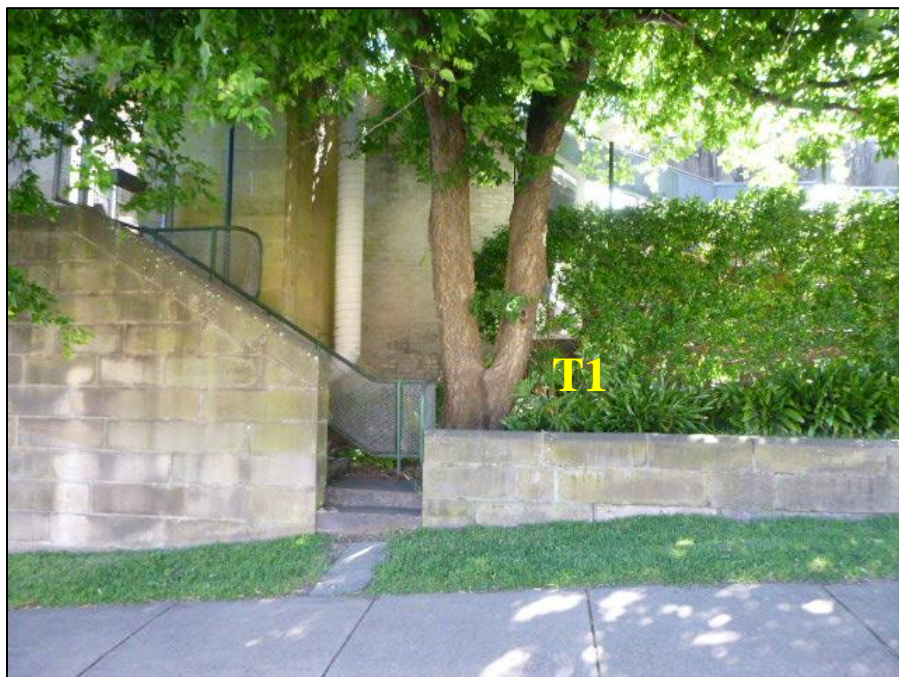
Photo 2 – Tree impacted upon by demolition of existing structures and construction associated with the new development

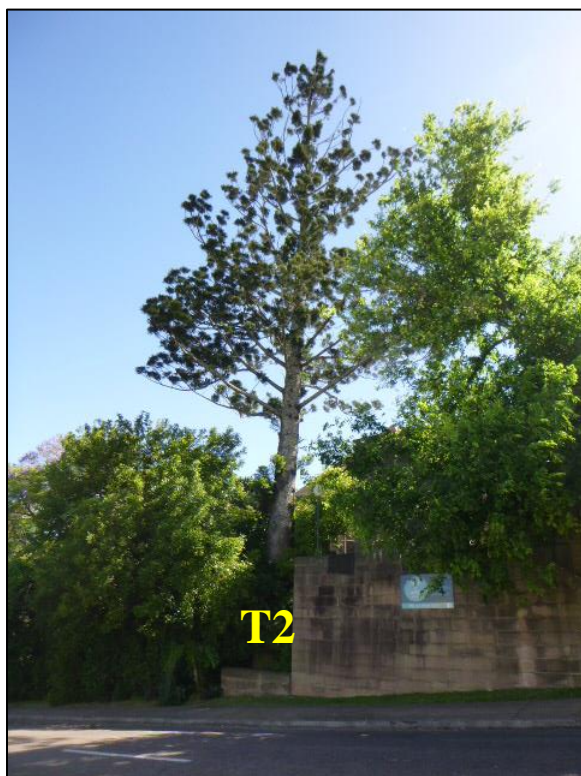
Photo 3 – Tree has an historical association with the building

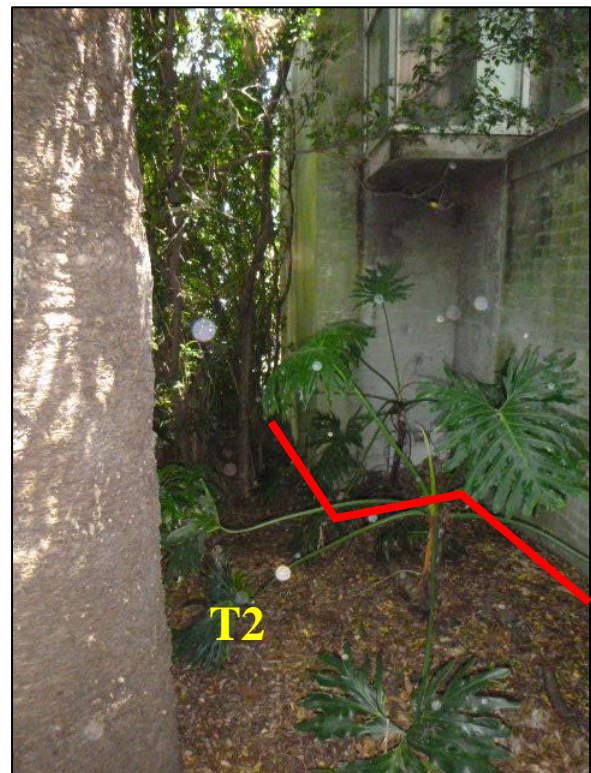
At this stage it is envisaged foundation footings are likely to have acted as a form of root barrier preventing radial spread of roots. Roots are forced to grow down and/ or linearly along the wall (Photo 4).

Photo 4 - Existing footings of adjacent wall to be retained to minimize impacts to roots

To minimize the impacts to roots it is proposed to demolish the existing wall to ground level. This will enable the foundation footings to be retained and minimize the impacts to roots.

It is recommended that a suitably qualified arborist (AQF level 5 or equivalent) is on site to supervise excavation works within the TPZ of these trees to assess impacts in relation to retention / removal during excavation works.

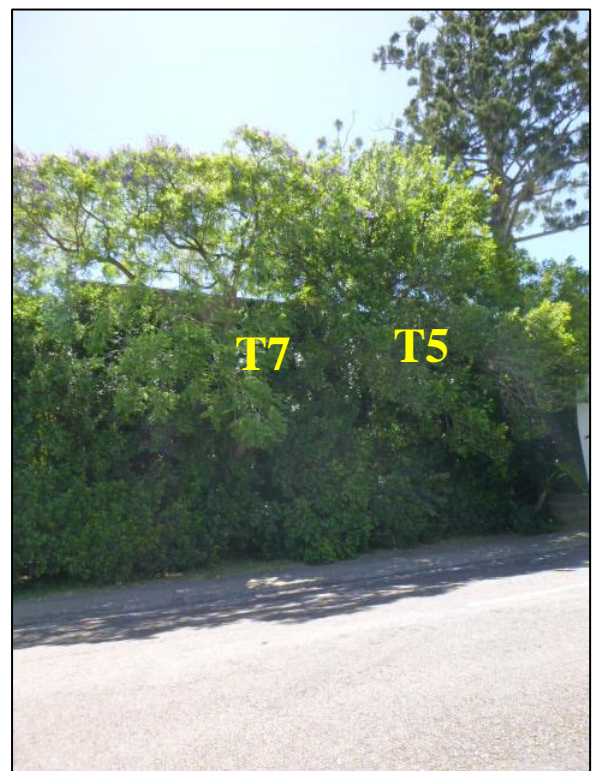
At this stage it is envisaged foundation footings are likely to have acted as a form of root barrier preventing radial spread of roots. Roots are forced to grow down and/ or linearly along the wall (Photo 5).

Photo 5
Trees to be retained
Existing footings of adjacent wall to be retained to minimize impacts to roots

To minimize the impacts to roots it is proposed to demolish the existing wall to ground level. This will enable the foundation footings to be retained and minimize the impacts to roots.

It is recommended that a suitably qualified arborist (AQF level 5 or equivalent) is on site to supervise excavation works within the TPZ of these trees to assess impacts in relation to retention / removal during excavation works.

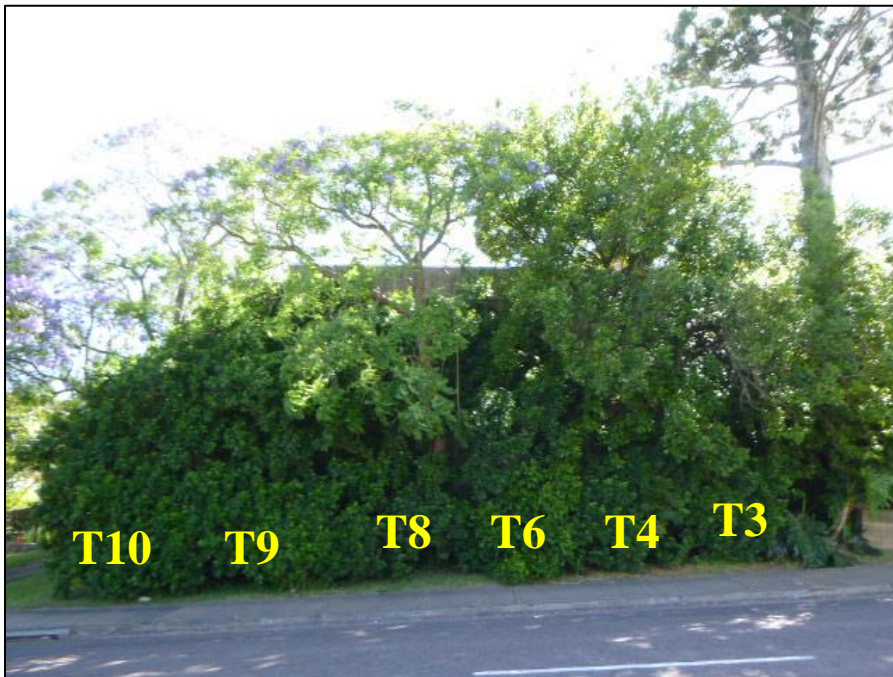
Whilst it is proposed to demolish the existing wall to ground level and the impacts to roots may be minimal enabling the tree to be retained due to their close proximity to each other branch and foliage orientation of individual trees form asymmetrical crowns resulting in their relatively poor overall habit & form.

Photo 6 – Removal of small trees (shrubs) will provide space for new plantings

Whilst it is possible that they could be retained their removal is preferred and will provide space for replacement planting to be undertaken as required in accordance with the landscape design (Photo 6).

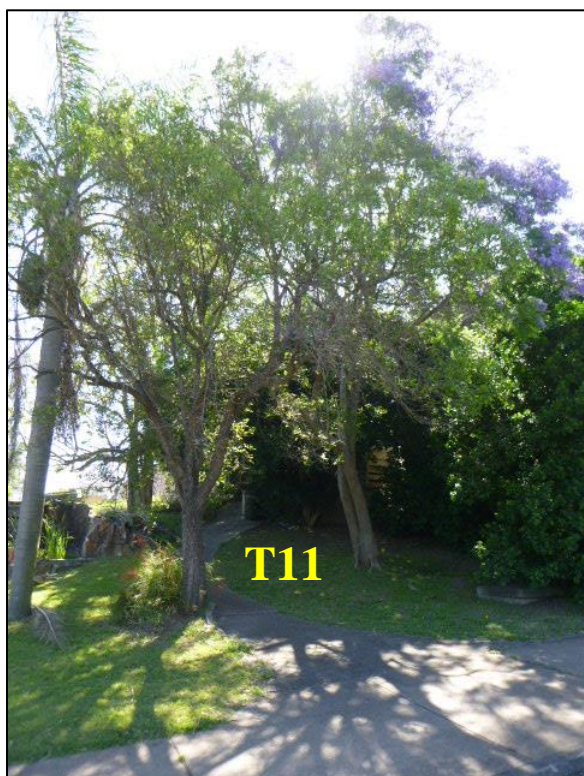
Based on the Basement Plan construction of the new path will encroach well into the TPZ and SRZ of the tree. The main area of concern is severance / damage to roots within the SRZ and excessive damage to roots within the TPZ.

Photo 7- New Path within TPZ / SRZ

The retention of the tree would require significant changes to the design / development footprint and / or alternative construction methods to be utilized that would enable it to be retained and survive the impacts of construction.

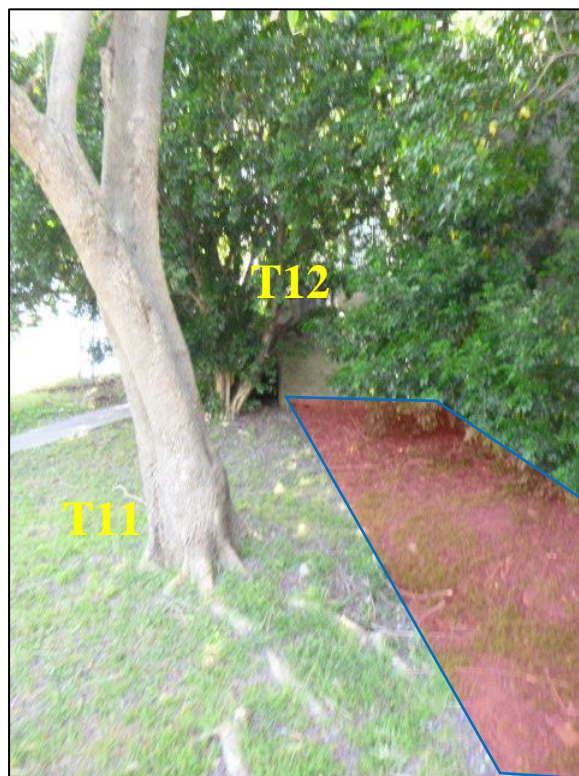
Photo 8 - Construction of new path with TPZ & SRZ of T11 & 12

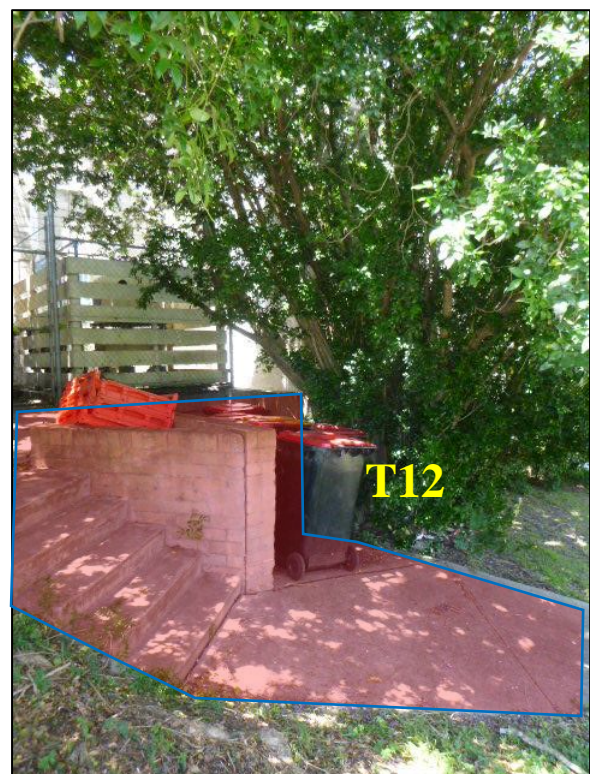
Due to the close proximity of demolition and extent of encroachment into its TPZ and SRZ it is considered that the tree is likely to be adversely impacted upon and as such would be removed to facilitate the development as proposed (Photo 8 & 9).

Photo 9 - Demolition of existing structures within TPZ / SRZ

Its removal would not significantly diminish the visual character and amenity of the area and will provide space for replacement planting to be undertaken as required in accordance with the landscape design.

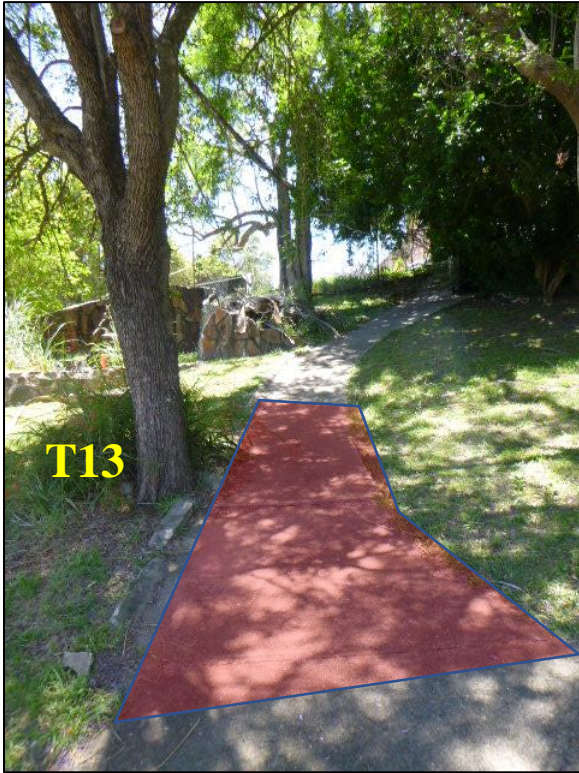
Pavement can be removed without significantly impacting on the trees however must be removed in a manner that will not cause damage to roots (Photo 10).

Photo 10 – Path close to tree

Removal of the concrete or bitumen should not be undertaken by means of crushing or shattering or by other means that involve pounding as the force of pounding impacts could result in damage to roots that may be close to the surface or compaction of soil.

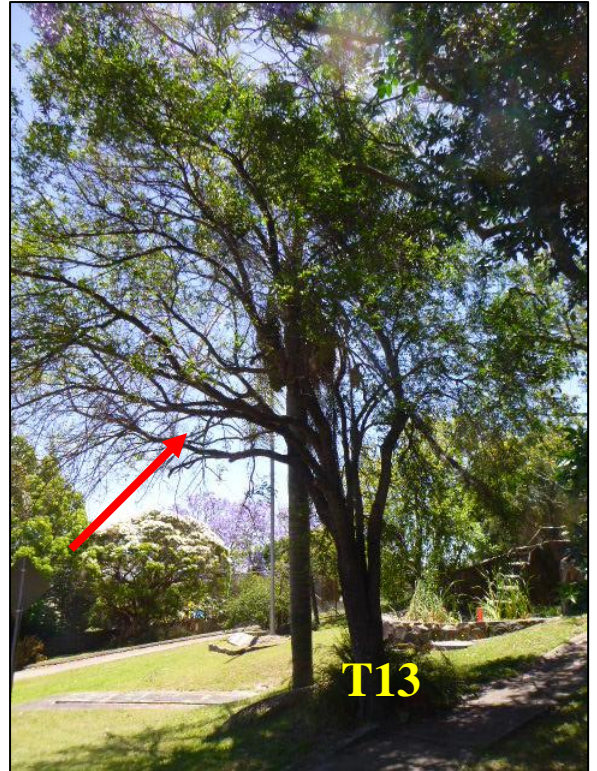
Photo 11 – Dead branches particularly on western side

With some remedial action to improve health & vigour and some pruning to remove dead branches it is possible the tree may eventually recover.

Alternatively if its removal is preferred it could be replaced with a better quality tree that will be more sustainable for long term retention and will provide space for replacement planting to be undertaken as required in accordance with the landscape design.

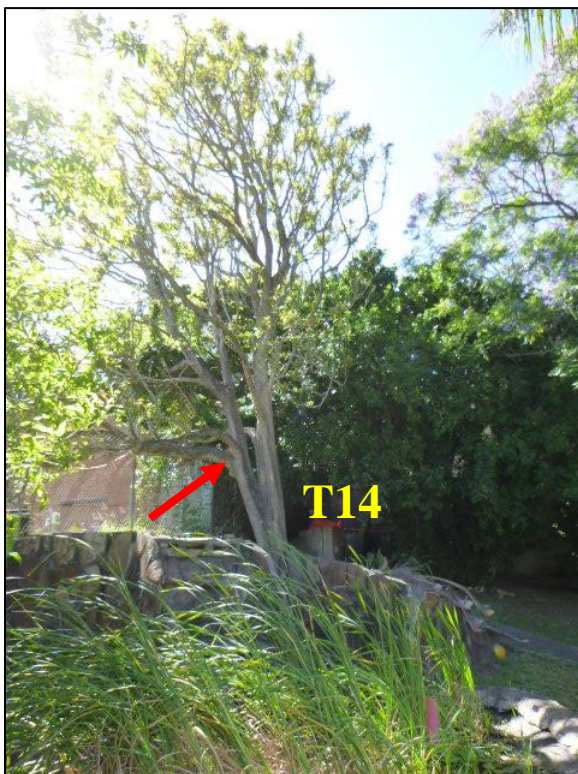
It is considered that due to its state of decline and other structural defects that over the short term (less than 5-15 years) the tree would eventually be removed regardless of the impacts of the development

Whilst its removal would be noticeable from the street due to its state of decline its retention value is considered to be low. As such its removal would not significantly diminish the visual character and amenity of the area and will provide space for replacement planting in accordance with the landscape design with a better quality tree that will be more suitable and sustainable for long term retention (Photo 12).

Photo 12 – Tree in decline & split at branch union

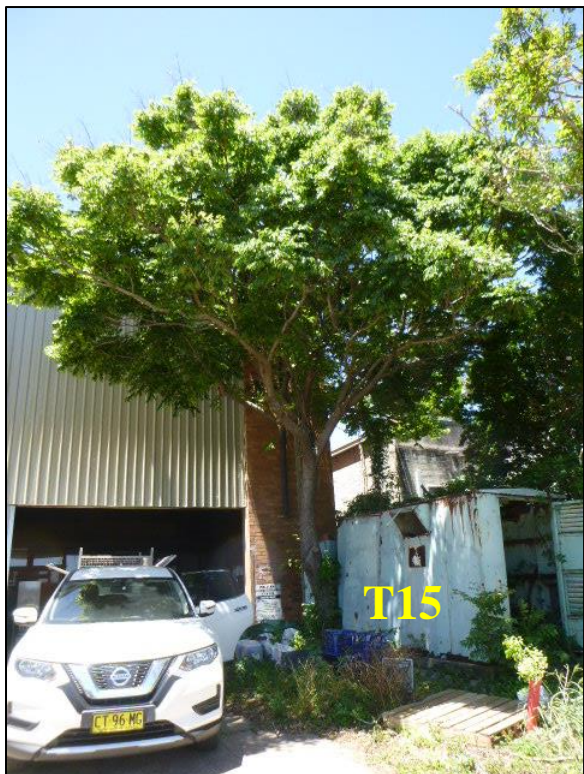
Due to the close proximity of demolition and extent of encroachment into its TPZ and SRZ it is considered that the tree is likely to be adversely impacted upon and as such would be removed to facilitate the development as proposed (Photo's 13 & 14).

Photo 13 – Tree proposed to be removed

Its removal would not significantly diminish the visual character and amenity of the area and will provide space for replacement planting to be undertaken as required in accordance with the landscape design.

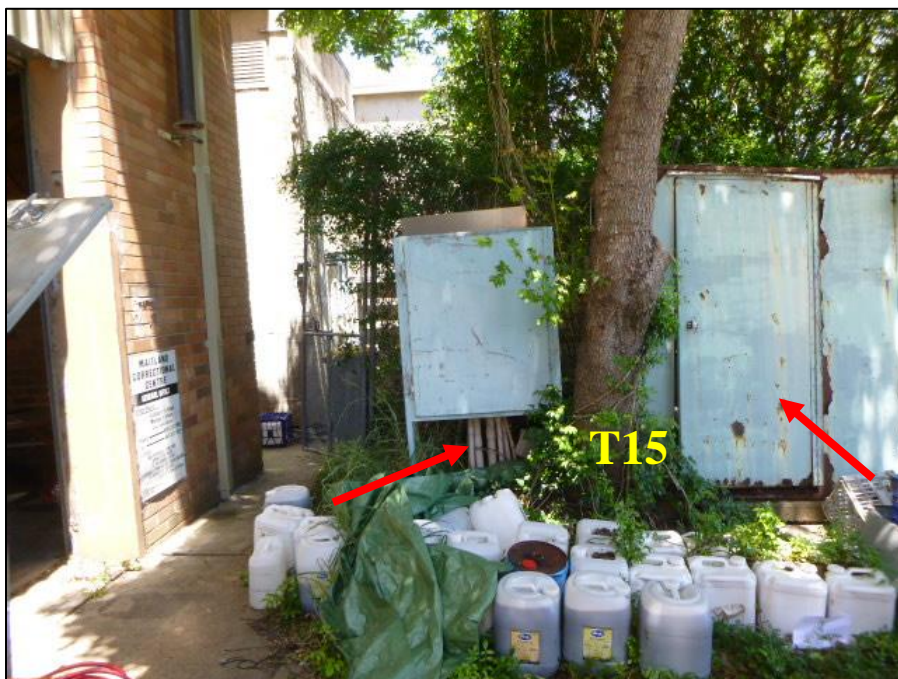
Photo 14 - Removal of generator and associated cables within SRZ

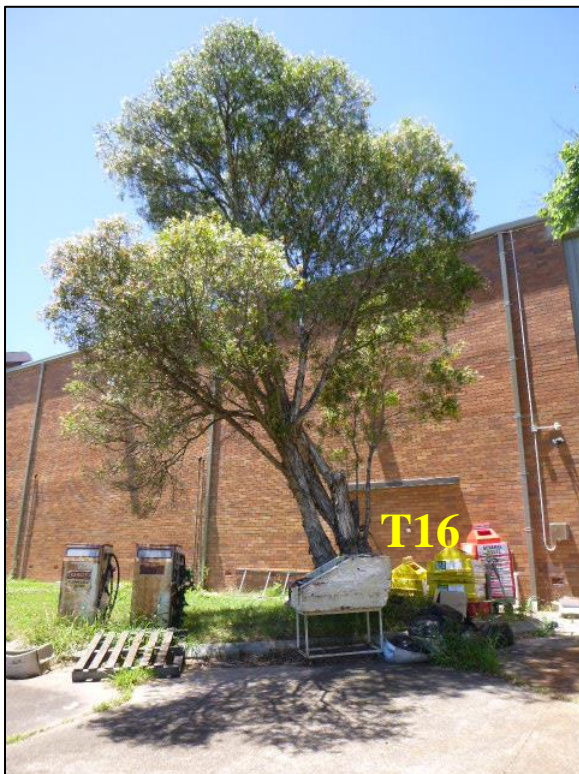
Photo 15 – Tree proposed to be removed & replaced

Whilst it is possible that they could be retained their removal is preferred and will provide space for replacement planting to be undertaken as required in accordance with the landscape design (Photo 15 & 16).

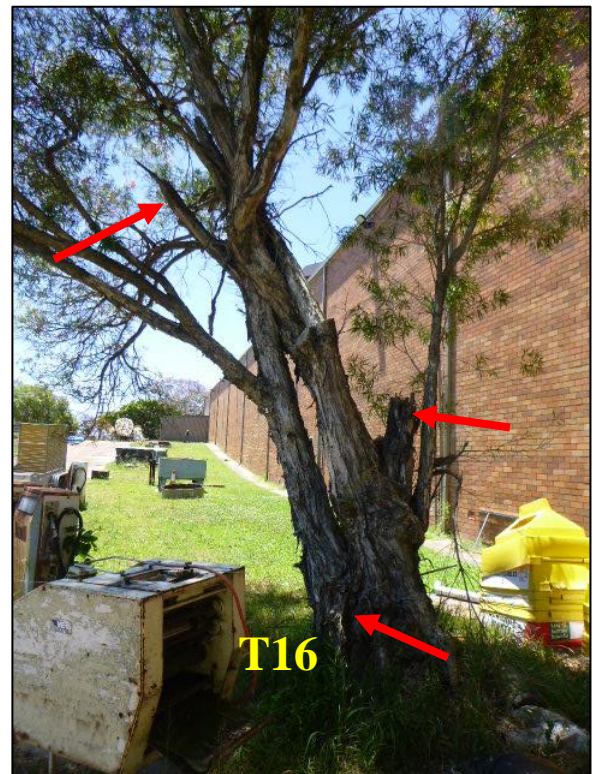
However, the tree has had numerous pruning events to remove branches that were overhanging the driveway and previous failure of large branches to north and the previous failure of the co-dominant trunk to northwest indicate that over time, the tree has developed a history of branch failures over time.

Photo 16 – Previous failures
