Site Classification with Foundation Parameters

Proposed Commercial Development Maitland Gaol, 6/18 John St, East Maitland

Report Ref: G0197-SCFP-001-Rev0

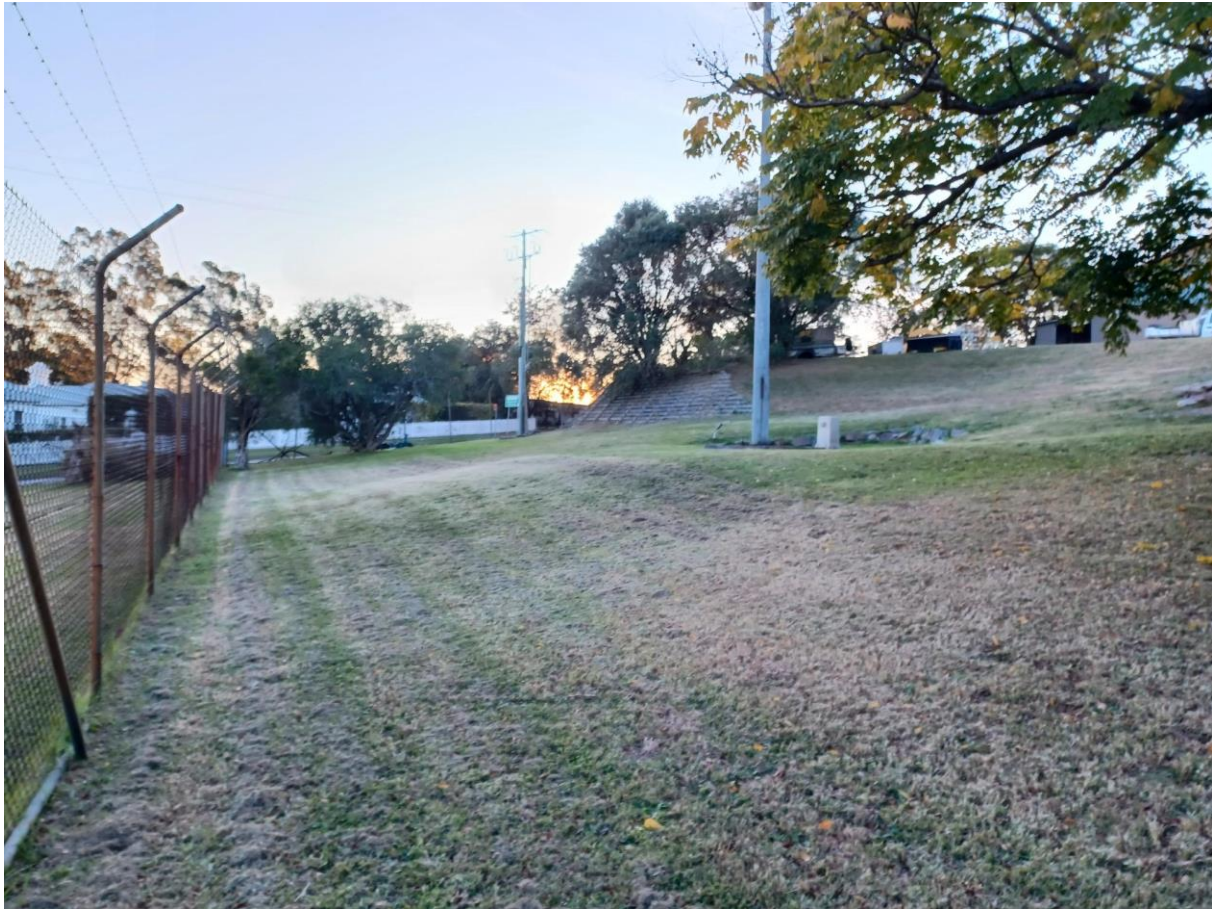
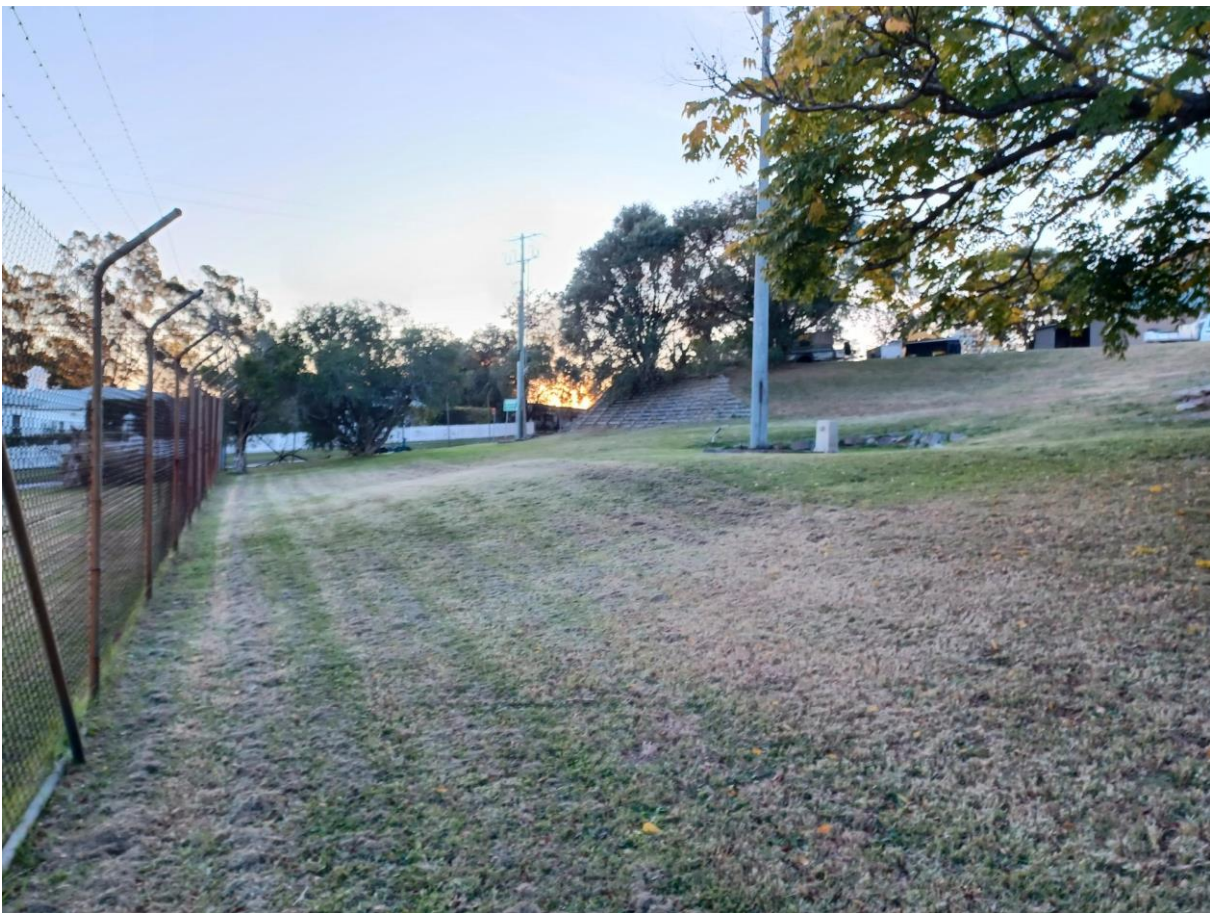
Figure 1 – Photograph of site

The site was consisting of an existing concrete driveway, garden with short grass and multiple growing to mature trees and fence in the middle of the lot.

The site surface levels appeared to be previously modified by earthworks activities with filling evident across the site.

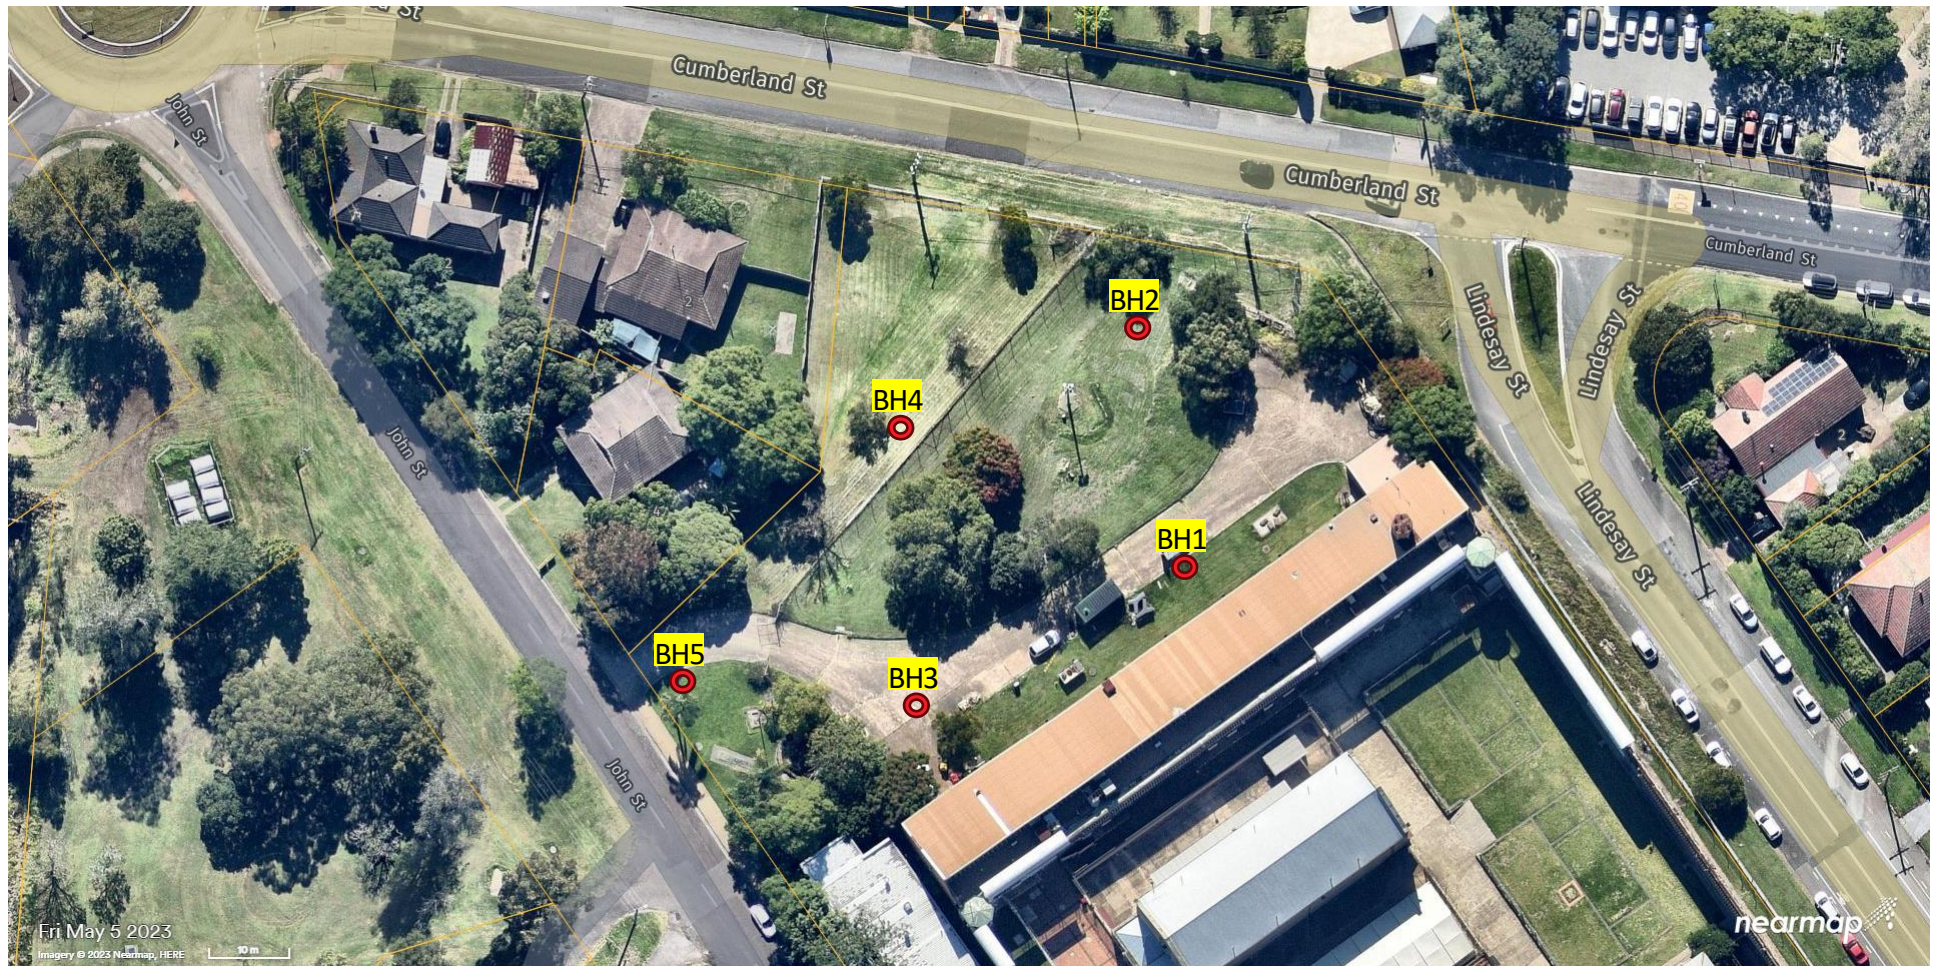
Borehole Location Plan

*taken from nearmaps showing the approximate locations of Geotechnical Boreholes at 6/18 John St, East Maitland NSW 2323
