arboricultural impact assessment report

AIA-01

Revision A, Issued for Development Application 11 June, 2020

PROJECT Residential Aged Care Facility at 7 Martin Close and 42 Stronach Ave

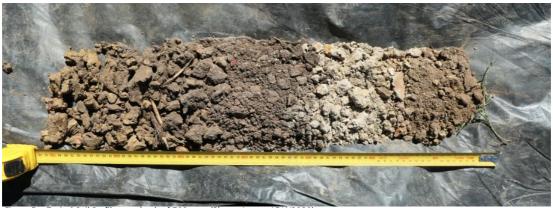
The clay filling material and the lower subsoils, however are very heavy clays and will potentially pose greater issues for waterlogging and potential soil compaction, if trafficked when moist or by heavy equipment. It will therefore be <u>very important</u> to ensure, during construction, that the tree protection areas are well protected and trafficking of the areas with any machinery is prohibited, particularly when the ground is wet or through the cooler months. The very heavy nature of the soils may also lead to waterlogging during particularly wet periods or if too

much irrigation is applied. Care will need to be exercised in the landscape design and implementation to ensure that excess water does not accumulate in any unnatural or localised low points which may lead to potential waterlogging and health issues for the existing trees and future landscaping.

Figure 5 – Typical Soil Profile to a depth of 700mm. (Photo: Arterra 15/4/2020)

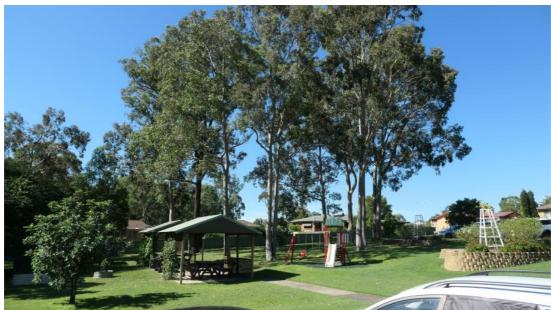
Figure 6 – Group 1 is a significant stand of endemic trees and these have been a focus of tree retention on the project. (Photo: Arterra 15/4/2020)

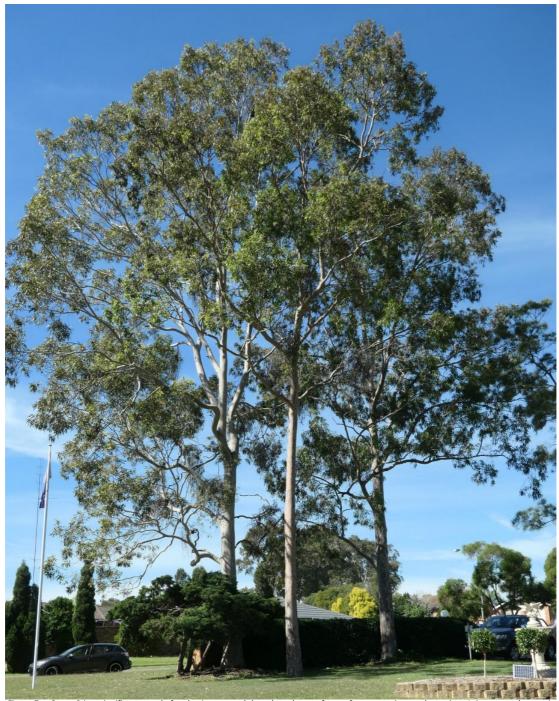
Figure 7 – Group 2 is a significant stand of endemic trees and these have been a focus of tree retention on the project. It is proposed to retain existing ground levels around these trees. (Photo: Arterra 15/4/2020)

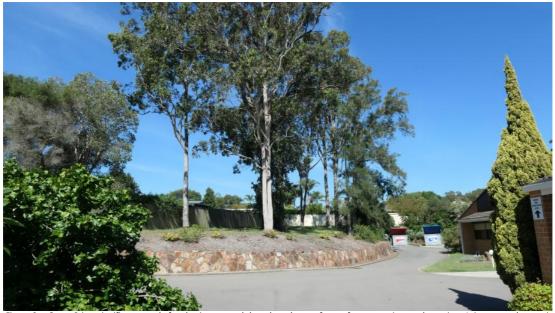
Figure 8 – Group 3 is a significant stand of endemic trees and these have been a focus of tree retention on the project. It is proposed to retain existing ground levels around the trees and a new retaining wall will be built in front of the existing level change in order to protect and retain the trees (Photo: Arterra 15/4/2020)

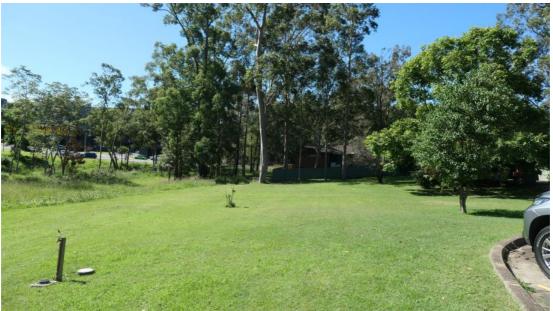
Figure 9 — Numerous existing endemic trees occur along the adjoining riparian corridor of Two Mile Creek. It is proposed to retain existing ground levels and avoid disturbance around these trees that are mostly outside the site's boundaries. (Photo: Arterra 15/4/2020)

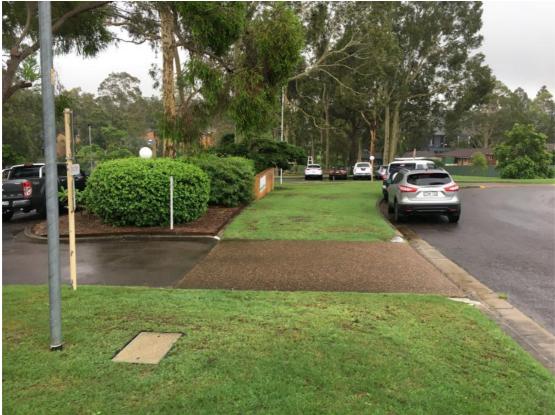
This tree has a nominal TPZ radius of 6.96m and is located between the two site driveways off Martin Close. It is mature and in good condition.

The cause of the likely incursion from the proposed development will be from the relatively minor excavation for an adjoining pedestrian pathway and the proposed new electrical kiosk which needs to located adjoining the road reserve. The incursion is approximately 15% of the nominal TPZ. Although technically considered a major incursion, it is the author's opinion that this level of disturbance is acceptable due to the following reasons.

- The tree shares a generous Tree Protection Area with adjoining similar species
- The tree is currently healthy and vigorous and should withstand the nominal 15% incursion.

Figure 10 – Area adjacent to T208 illustrating the existing impacts of walling and carpark in the vicinity of the tree. (Photo: Arterra 17/2/2020)

- Work will be done to improve the growing conditions surrounding the tree the removal of grasses and mulching of the tree surrounds and supplementary irrigation during construction.

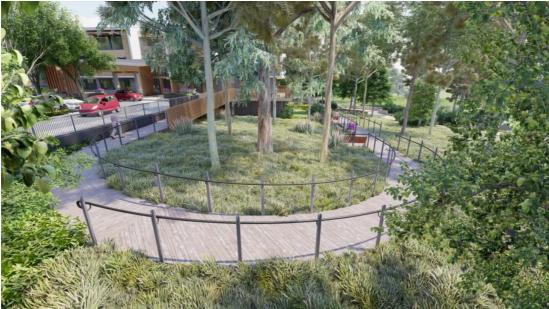
For example, the proposed accessible boardwalk in the northern portion of the site is designed to be a slightly elevated walkway and has been located outside the trees' SRZ's. Supports for the walkway shall be via low impact screw piling. Temporary mulching of the ground surface will help limit the soil compaction and other disturbances during construction.

Figure 11 – Area adjacent to important trees T222-229 illustrating the low impact construction of a pedestrian boardwalk that will float just above the existing ground levels and be supported by screw piles. No grading or services are proposed in the TPA. All boardwalk work is contained outside of the SRZ of the trees. (Image Source: Arterra accurate site model render)
