Arborist Report

Client: Quicksilver Developments

Address: 258 High Street, MAITLAND N.S.W 2320

Project: 258 High Street, Maitland Client: Quicksilver Developments

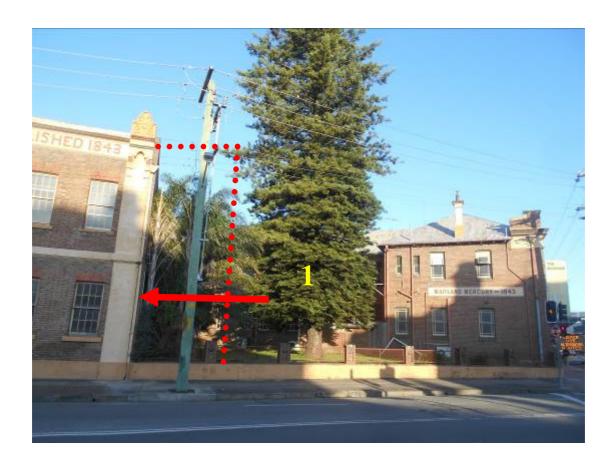
Figure 3 – showing the location of Tree 3 that is situated in the front setback next to High Street. This species is located 9.4 metres to the existing building as highlighted in red. This distance is measured from the trunk at 1.4 metres above ground level to the brick wall. The proposed development will be located closer to Tree 1 as outlined in red.

There is the existing footpath and road to one side. This species is located within 3 metres to the footpath and 7 metres to the road. Tree 1 is located 9.4 metres to the existing building on one side and 5.4 metres to the building to the rear. The overall area of TPZ has been calculated at 334.59m2 in accordance with AS 4970 - 2009. The proposed development will extend closer to the trunk. The development will be within 5.8 metres to the trunk. AS 4970 - 2009 indicates that the TPZ radius is taken from the centre of the trunk. This leaves a spatial separation of 6.28 metres from the centre of the trunk to the proposed development. The existing buildings to the western side will remain with no proposed building works. The total floor area to be constructed inside the TPZ has been calculated at 58.54m2. The overall loss of TPZ has been calculated at 17.49% that doesn't comply with AS 4970 - 2009. All building works will be located outside of the SRZ. In order to reduce the loss down to 10% to comply with AS 4970 - 2009 will be to construct the proposed development on screw pile piers or similar method of construction inside the TPZ. If this can be achieved will allow the retention of Tree 1.

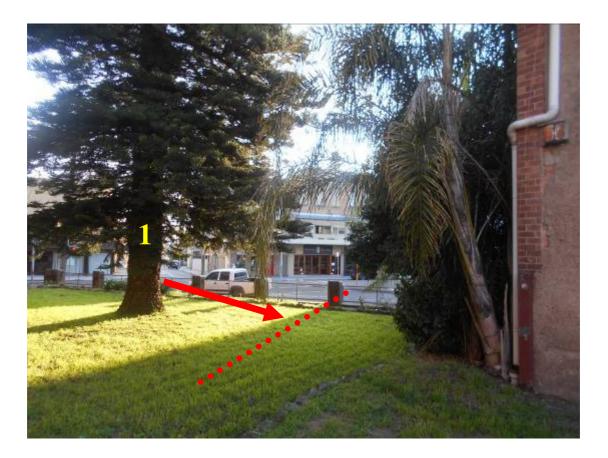
Figure 4 – the building line will encroach into the TPZ as noted in red. The area lost has been calculated at 58.54m2. The loss of TPZ can be reduced when constructing the development on bearers and joists.

Allowing for sixteen footings within the TPZ to be no greater than 350mm in diameter. This will be a net loss within the TPZ of 5.6m2. This would reduce the loss of TPZ down to 1.67%. Taking into consideration that the remainder of the TPZ remains intact including the soil profile and the organic layer associated with the TPZ. This would require all works inside the remaining section of grassed area within the TPZ to be constructed using non mechanised methods. This includes all grassed areas outside of the proposed development. This will require minimal disruption to the root plate including no other hardstand areas or excavation works inside the TPZ. If this can be achieved will allow the retention of Tree 1. Tree 1 is earmarked for retention and incorporation into the development.

- ➤ It is recommended that Tree 1 (1 in total) be retained and incorporated into the development. It is recommended that bearers and joists, screw pile piers or similar method of construction be used within the TPZ (10.32 metres). It is recommended that all footings associated with the development inside the TPZ be undertaken before commencement of building works to determine the locations. It is recommended that no structural roots greater than 60 70mm in diameter be pruned. Upon finding roots greater than 60 70mm will require the footing to be dug to an alternative location. All footings are to be dug by hand (shovel) to the required depth within the TPZ. It is recommended that final footing placement be a minimum of 100mm to all structural roots to allow for spatial separation and expansion of the root plate.

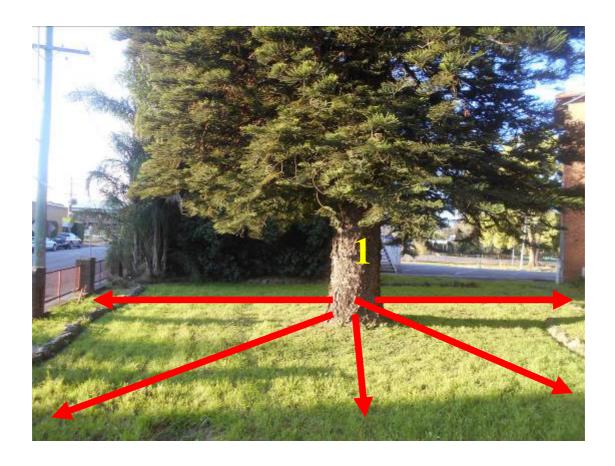
Figure 5 – showing the remainder of the TPZ that is to remain intact. This includes removal of the existing grass if required to be undertaken by non-mechanised methods. This also includes the section of TPZ that is to remain between the trunk and the proposed development.

- ➤ It is recommended that all other areas of the TPZ being the grass area be retained at existing soil levels. It is recommended that the existing grass be retained inside the section of TPZ not subject to development. This includes retaining the grass in all four quadrants during construction works up to the proposed development to protect the root plate. The section of grass that is to retained during construction works is to remain intact until the landscaping phase. This will protect the tree during construction works and avoid the soil from drying out during this phase. The grass can be removed after completion of all building works associated with the development. Removal of the grass if required to be removed before this stage is to be undertaken by non-mechanised methods and the entire section of TPZ (grass) to be replaced with mulch a minimum of 100mm thick. The existing garden beds and concrete edges are to be removed by non-mechanised methods inside the TPZ.

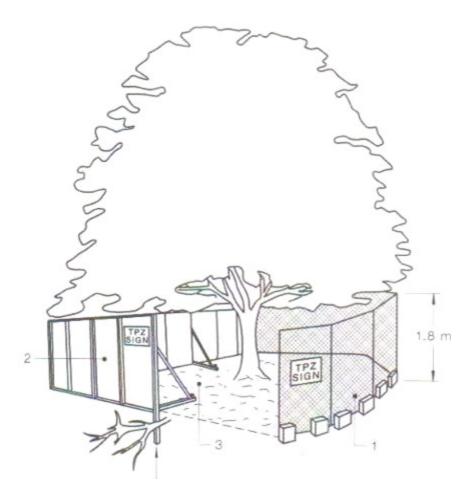
➤ Figure 6 – showing the proposed fencing that is to be put in place before the commencement of building works on site (Tree 1 only). Source: Australian Standards 4970 - 2009

- ➤ It is recommended that protection measures be put in place that aid in the preservation of Tree 1 (1 in total). It is recommended that 1.8 metre inter locking chain wire fencing be installed before commencement of all civil and building works on site as indicated in Figure 6. Protection fencing is to be installed to the outer edge of the boundary as indicated in Figure 6. The development side is to have the fencing erected a minimum of 4.6 metres from the trunk. This will allow scaffolding to be erected and placed inside the TPZ. The scaffolding is to be erected at existing soil levels or rumble boards to protect this section of TPZ that is outside of the fenced zone. Protection fencing is to be installed before commencement of all civil & building works and remain in place until the release of the occupation certificate.

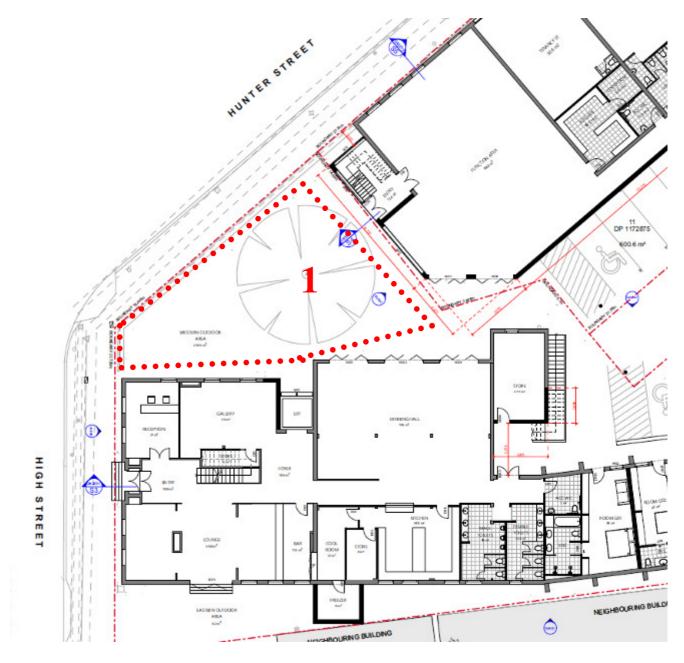
Figure 7 - Close up of the subject property and canopy area of Tree 1. The red dashed area represents the fenced area that is to be cordoned off before all civil and building works on site. Not to scale

- The remainder of the grass area that is not being used for development is to remain at existing soil levels. The SRZ (3.25 metres) from the centre of the trunk or 2.77 metres from the trunk is to be set aside as a mulched garden bed devoid of hardstand areas. The remaining sections of TPZ can be utilised as permeable paving or similar method of construction that doesn't require concrete or excavation works. No formwork or excavation works are allowed in this zone outlined as the grass area within the TPZ (Figure 7).

- ➤ It is recommended that all parking of vehicles and use of machinery be kept outside of the designated fenced area at all times. No placement or use of machinery is allowed within the designated TPZ fenced area (Figure 7).
