# Report on Geotechnical Investigation

442 Louth Park Road Residential Subdivision

81022027-002.1

Prepared for  
NewPro25 Pty Ltd

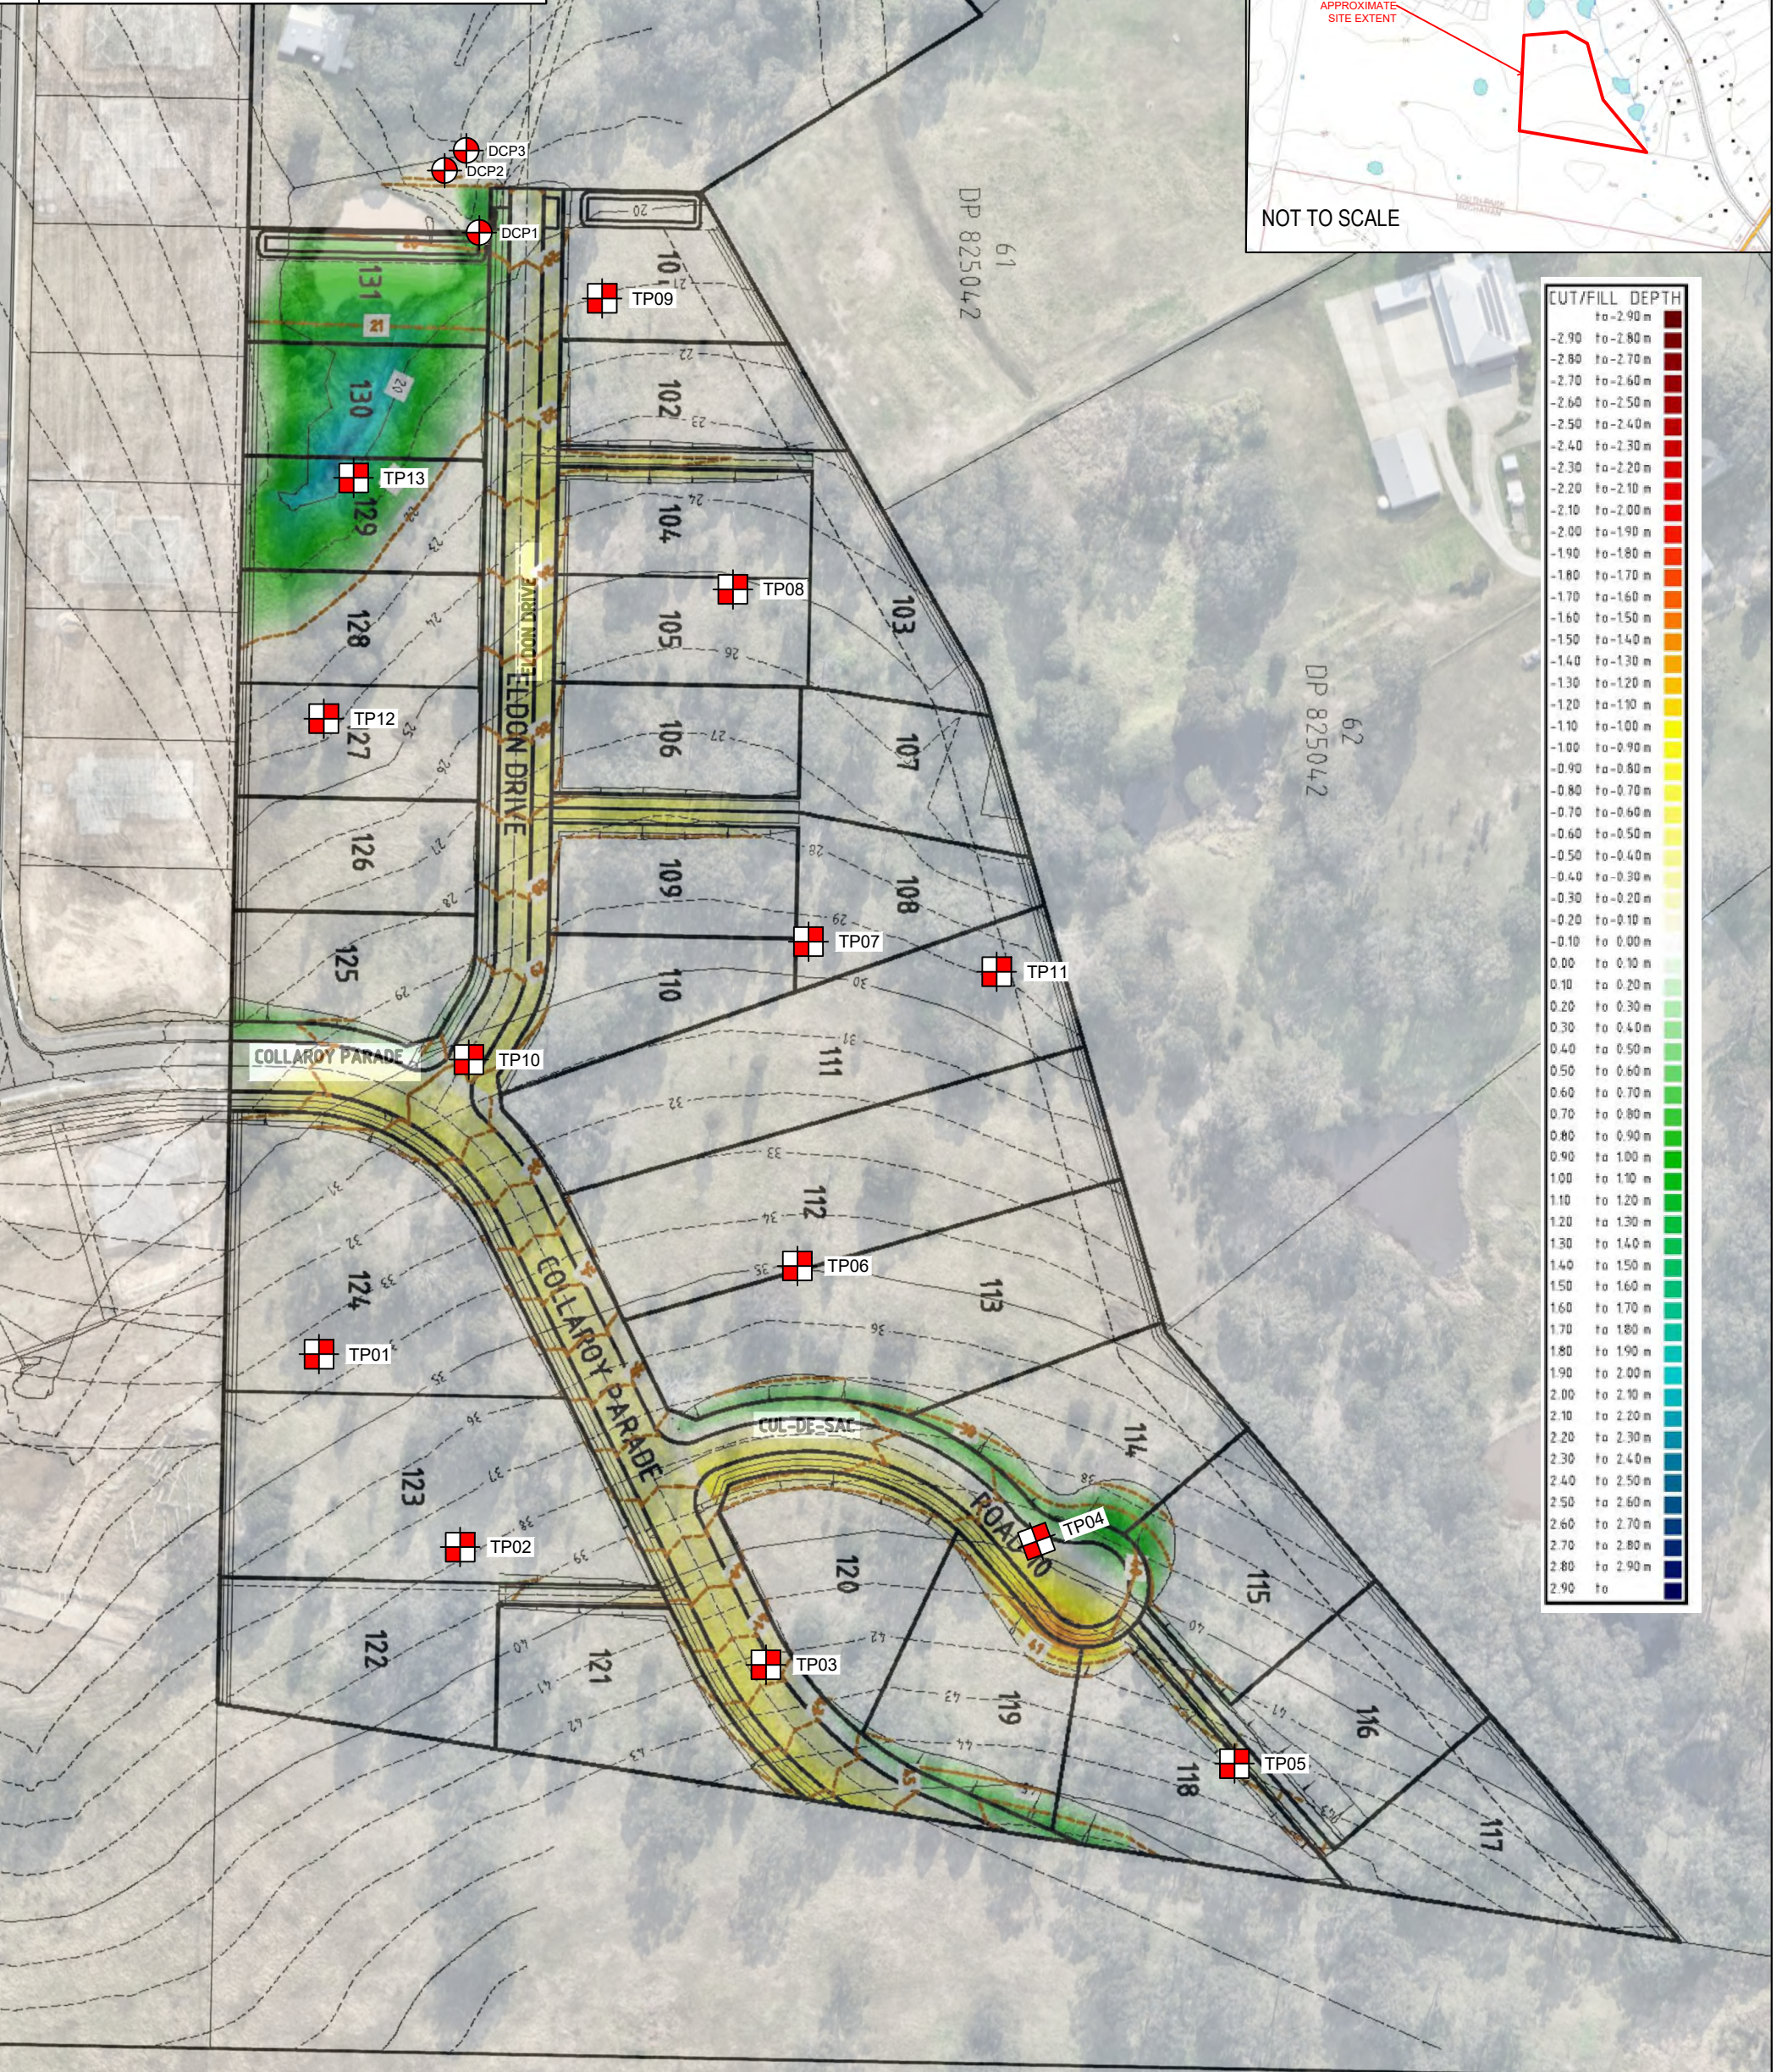
In addition to the test pits, three (3) additional DCP (DCP1-DCP3) test were conducted downstream of the existing farm dam (depicted on Drawing 1 and Drawing 2). The DCPs were undertaken in the overflow path to assess the presence of moisture impacted material and aid in assessing additional stripping depth that may be required beyond topsoils. No DCPs were undertaken within the dam impoundment due to access and safety issues.
