Proposed Subdivision -  
Preliminary Geotechnical  
Assessment

898 New England Highway, and  
Wyndella Road, Lochinvar

NEW22P-0012-AB  
4 March 2022

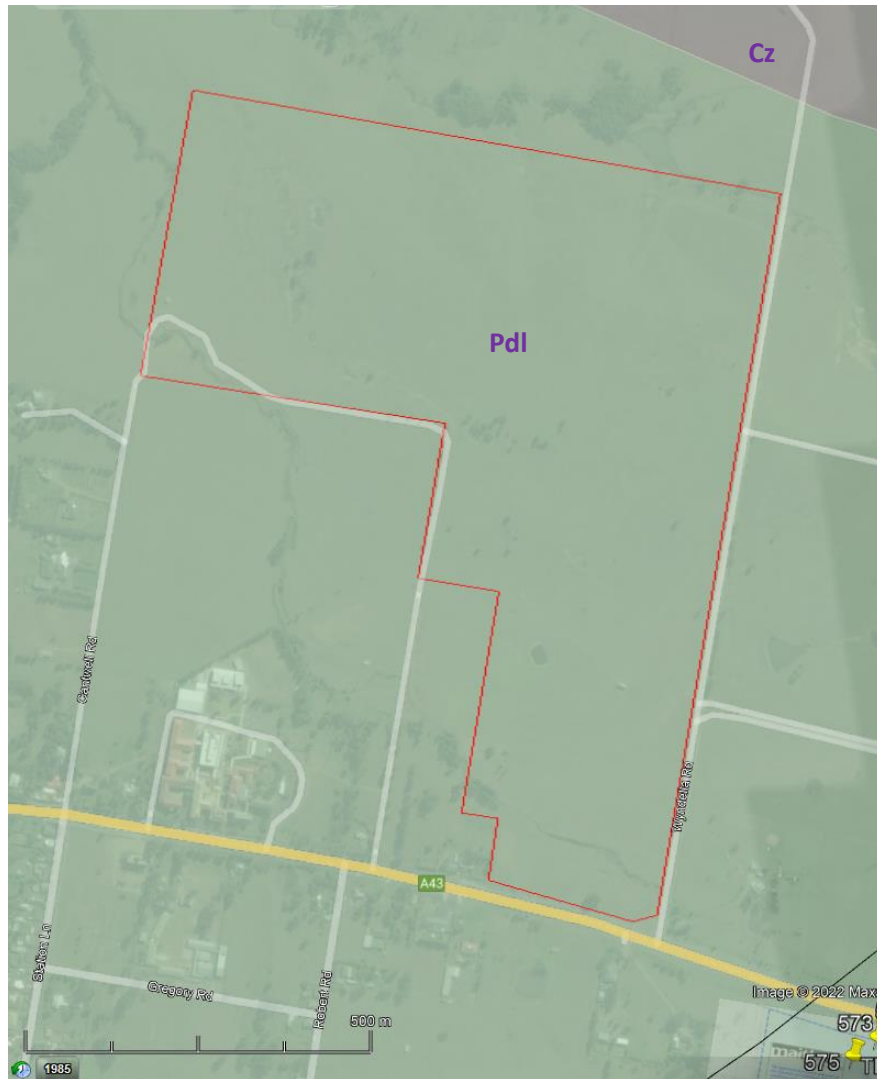
Reference to the 1:100,000 Newcastle Coalfield Regional Geology Sheet 9231 indicates the site to be underlain by the “Lochinvar” Formation (PdI) of the “Dalwood” Group, which is characterised by basalt, siltstone and sandstone rock types.

**Figure 1: Newcastle Geology Map Overlay:** Geological units are labelled in purple text. Approximate site boundary shown in red.

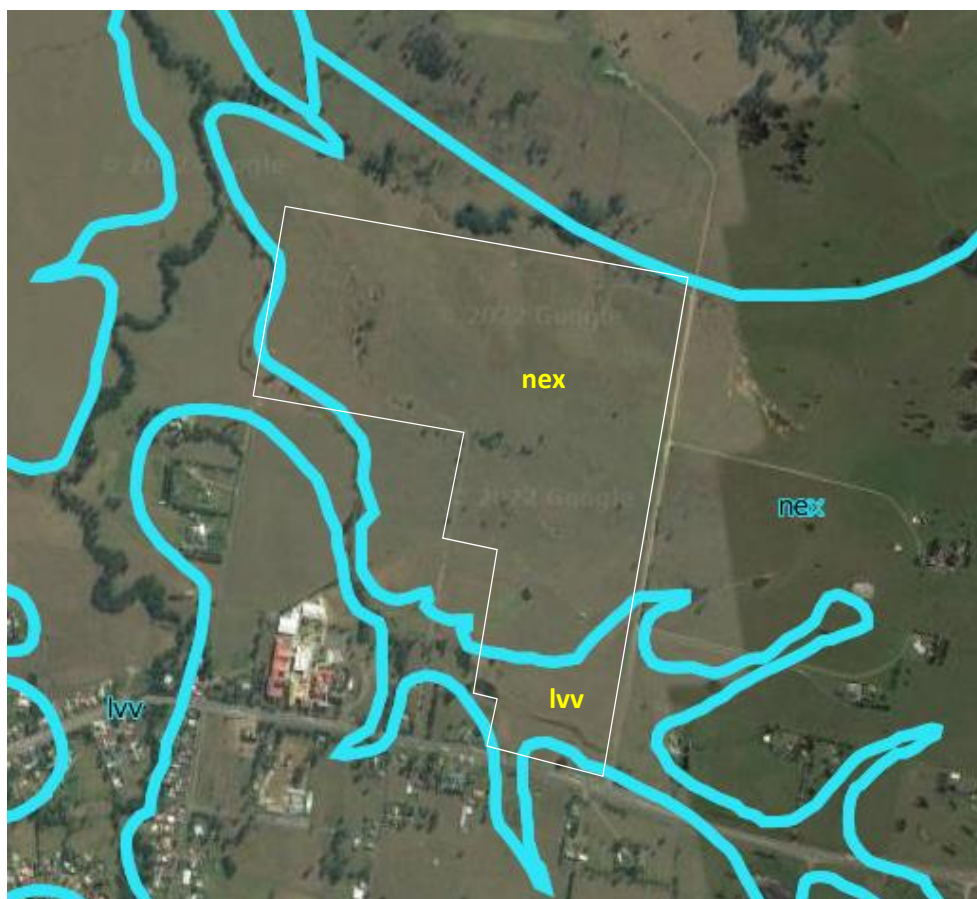
**Figure 2: Soil Landscape Map Overlay:** Soil landscape units are labelled in yellow text. Approximate site boundary shown in white.

The northern area is mostly mapped as the North Eelah Landscape (nex), and typical qualities and limitations include the following: localised shallow soils, localised rock outcrop hazard, widespread foundation hazard, widespread productive arable land, widespread recharge zone, localised gully erosion hazard, widespread sheet erosion hazard, localised high run-on, localised seasonal waterlogging.

The southern area is mapped as the Lovedale Landscape (lvv), and typical qualities and limitations include the following: localised non-cohesive soils, widespread foundation hazard, localised discharge zone, localised salinity hazard, localised gully erosion hazard, widespread sheet erosion hazard, localised streambank erosion hazard, widespread high run-on, widespread poor drainage, localised permanent waterlogging, localised seasonal waterlogging, localised flood hazard.

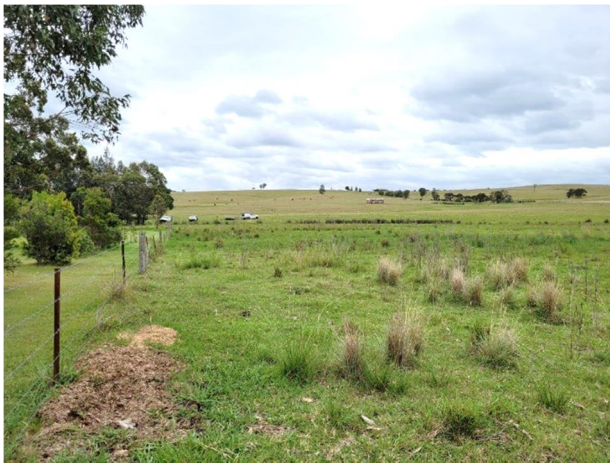
**Photograph 9:** From south-western corner of site facing north. Area of wet / boggy ground visible.

- The presence of wet/boggy areas in lower lying parts of the site, as well as watercourses, drainage depressions, farm dams and ponds. These may include areas or layers of inadequate bearing capacity for support of footings / earthworks and construction plant. There is also potential for abnormal moisture conditions associated with prolonged wet conditions. It is recommended that these potential issues are investigated prior to development in the vicinity of these areas, and addressed during earthworks prior to filling and footing construction. Measures such as drainage improvements, over-excavation, deepened footings, subgrade treatment or bridging layers may be required.

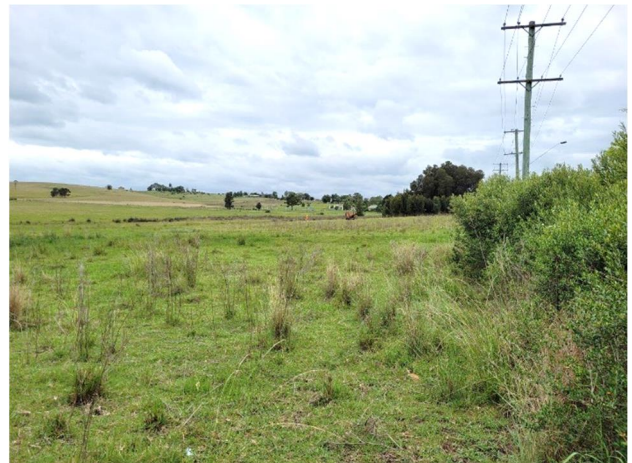
During the site investigation which was carried out following significant rainfall, the majority of the site appeared well drained primarily by way of surface runoff towards drainage depressions and creek tributaries. A relatively broad area of boggy ground and/or surface water was observed in the south to south-western areas. This included low lying areas alongside the primary watercourse, and the area in the south-western corner of the site receiving runoff from drains passing under the adjacent New England Highway formation.

**Photograph 10:** From south-western corner of site facing northeast. Area of wet / boggy ground receiving runoff from NEH visible.

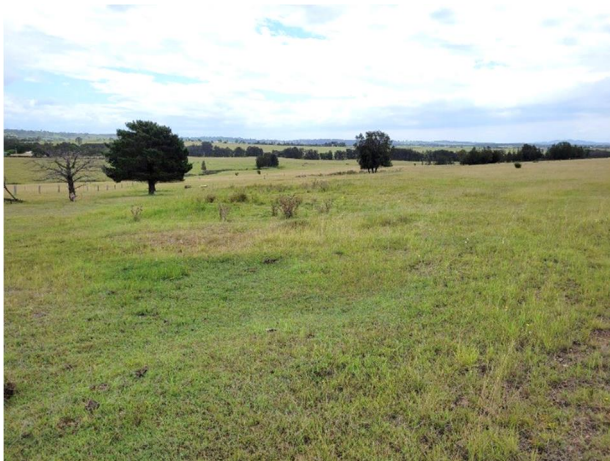
**Photograph 27:** From near north-western corner of R1 zoned area, on Lot 1 DP 65706 facing west towards area of buried fill.

- The presence or inferred presence of localised areas of uncontrolled fill. Residential footings and pavements should be founded in suitable material beneath all uncontrolled fill, or the fill should be removed and replaced under engineering supervision.

Footings should not be founded within any existing uncontrolled fill. If uncontrolled fill is encountered, this will require piered foundations founded beneath the fill, removal of the fill, or removal and replacement of the fill to engineering specification.

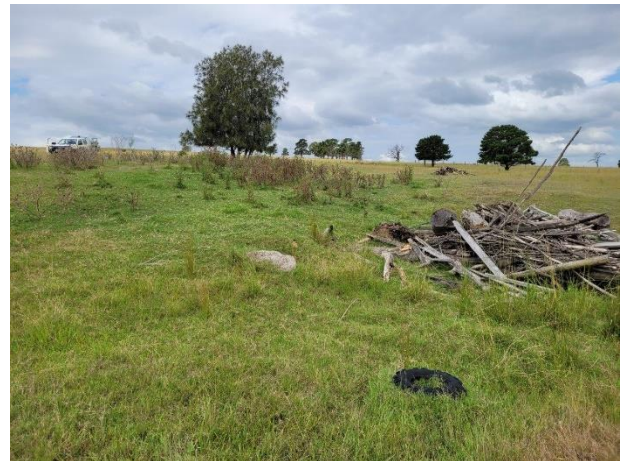
**Photograph 28:** From southern part of Lot 1 DP 65706 facing northeast towards area of buried fill.

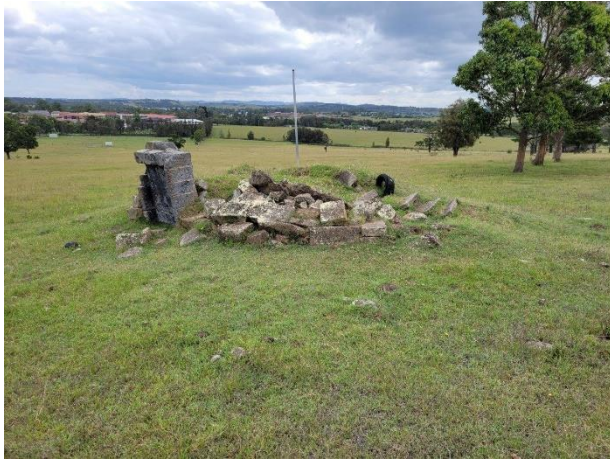
**Photograph 37:** Facing southwest towards fill mound near boundary of Lot 1 DP 65706 and R1 zoned area.

It is recommended that existing fill on site in any areas of proposed settlement sensitive development be removed and replaced with approved clean materials. The placement of such fill should be witnessed and documented by a geotechnical authority, carried out to 'Level 1' criteria as defined in Clause 8.2 – Section 8, of AS3798-2007.

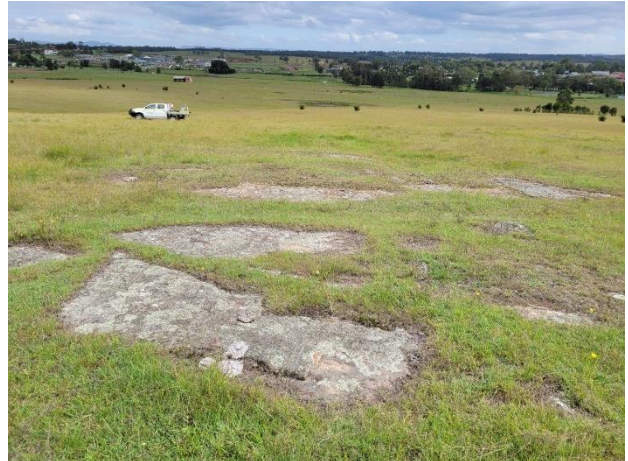
Rock outcrops were observed in the northern part of the R1 zoned area and in the southern part of Lot 1 DP 65706. The rock appeared to include Conglomerate and Pebbly Sandstone of estimated very high strength based upon limited surface observations. Some areas of uneven ground potentially indicative of past surface disturbance, minor erosion and possibly surface slumping or creep movement were observed in the vicinity of the outcrops near the southern boundary of Lot 1 DP 65706.

**Photograph 38:** Outcropping rock near southern boundary of Lot 1 DP 65706.

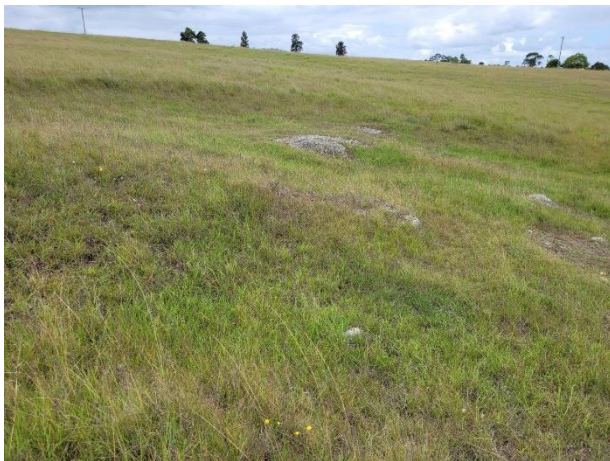
**Photograph 39:** Outcropping rock near northern boundary of R1 zoned area.

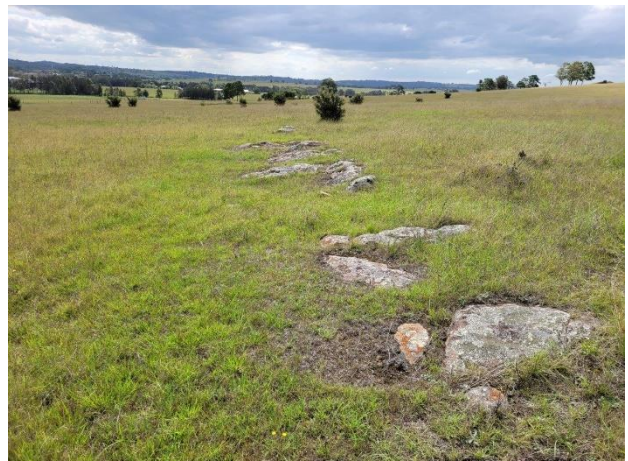
**Photograph 40:** Outcropping rock in north-eastern part of R1 zoned area.
