RGS33442.1 – AJ

13 February 2023

**RE: Proposed Housing Projects – 10a Park Street, Maitland NSW
Geotechnical Site Classification**

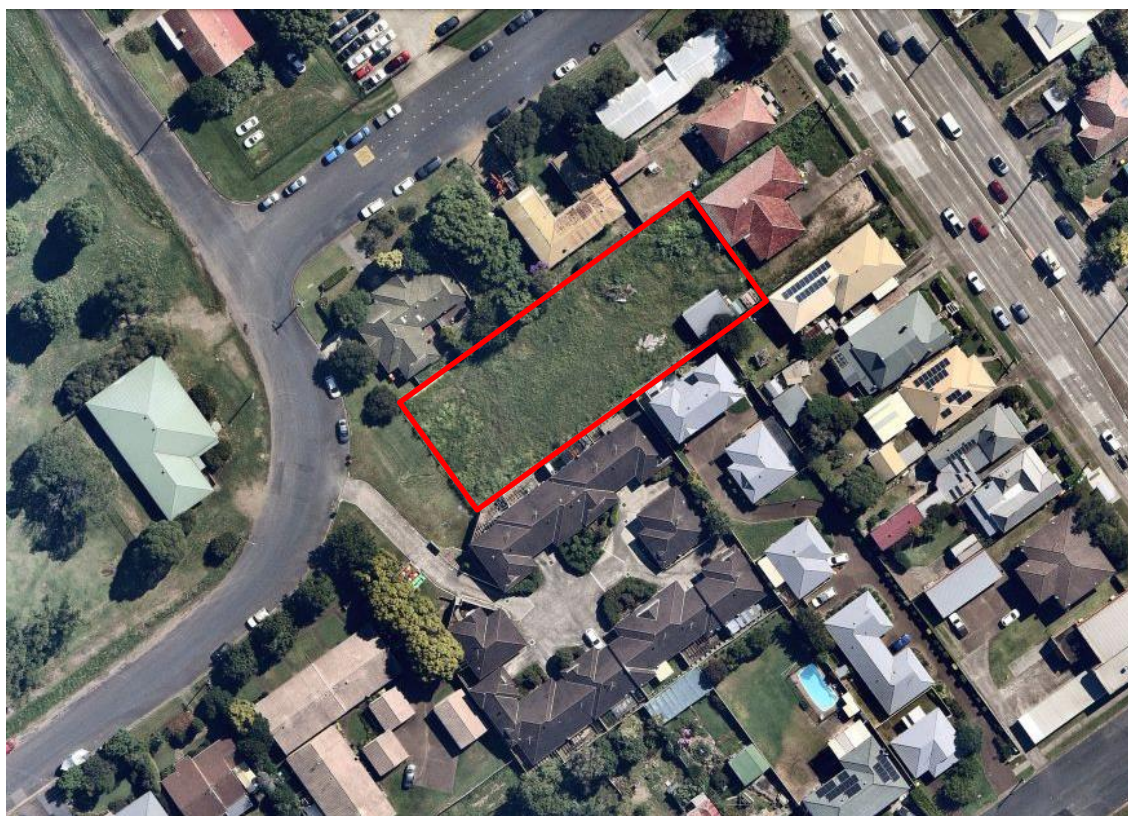
Diagram 1: Site Location and Setting

The site is situated within undulating residual terrain. The site itself slopes southwest at varying grades in the order of 2-6°. At the time of the fieldwork the site was predominantly cleared with a small shed in the south east corner. The lots to the south are retained above the subject site with timber and concrete block retaining walls up to approximately 1.6m.

Neighbouring properties to the north, south and east consist of residential lots with single and double storey brick buildings. The west is bound by Park Street.

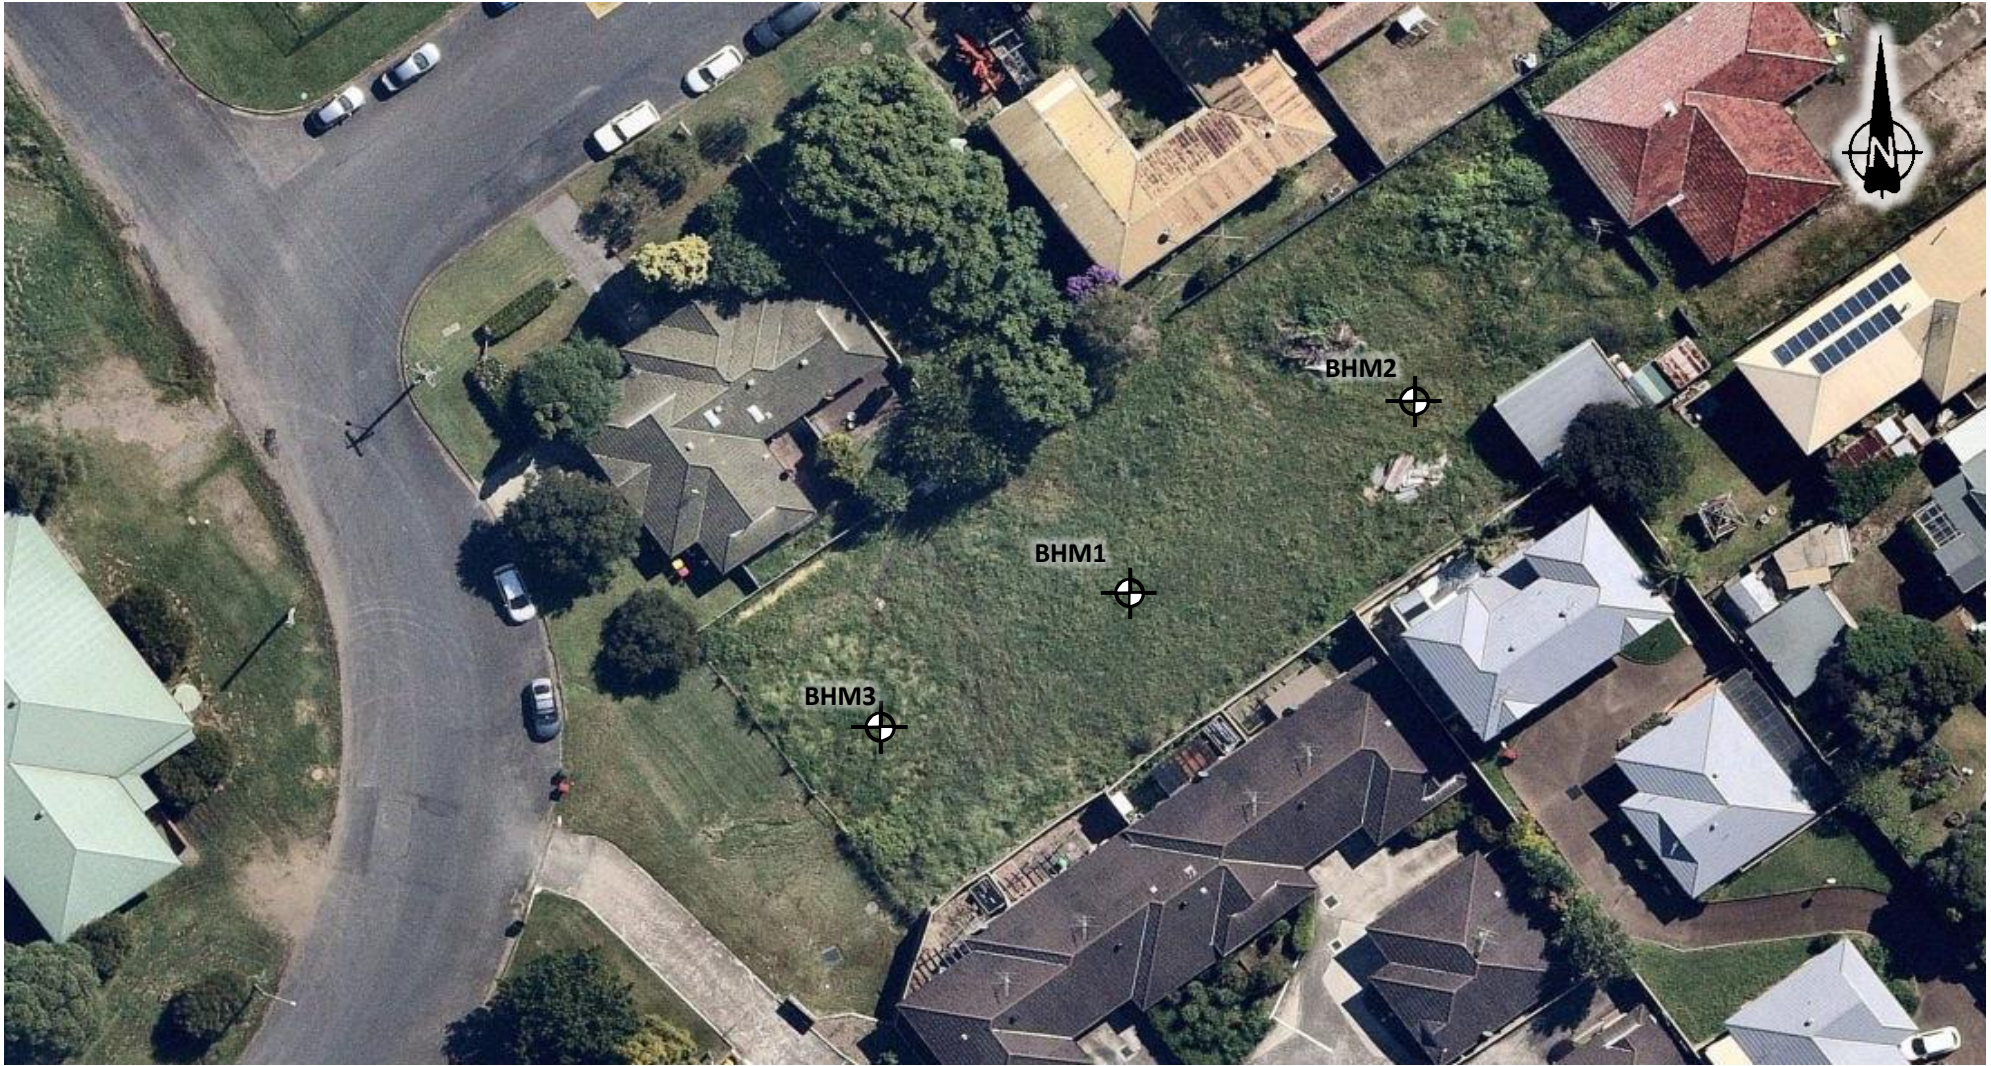
Client:	Housing Plus	Job No.:	RGS33442.1
Project:	Proposed Residential Development	Drawn By:	JB
	10a Park Street, Matiland	Scale:	NTS
Title:	Test Location Plan	Date:	13-Feb-23
		Drawing No.:	Figure 1

Engineering logs of the boreholes and laboratory test sheets are attached. Test locations are shown on the attached Figure 1 and were obtained by measurements to prominent site features.
