Riparian Assessment Report

To Inform Potential Residential Subdivision at New England Hwy & Wyndella Rd, Lochinvar, NSW

Prepared for: Lochinvar Developments

AEP Ref: 2699

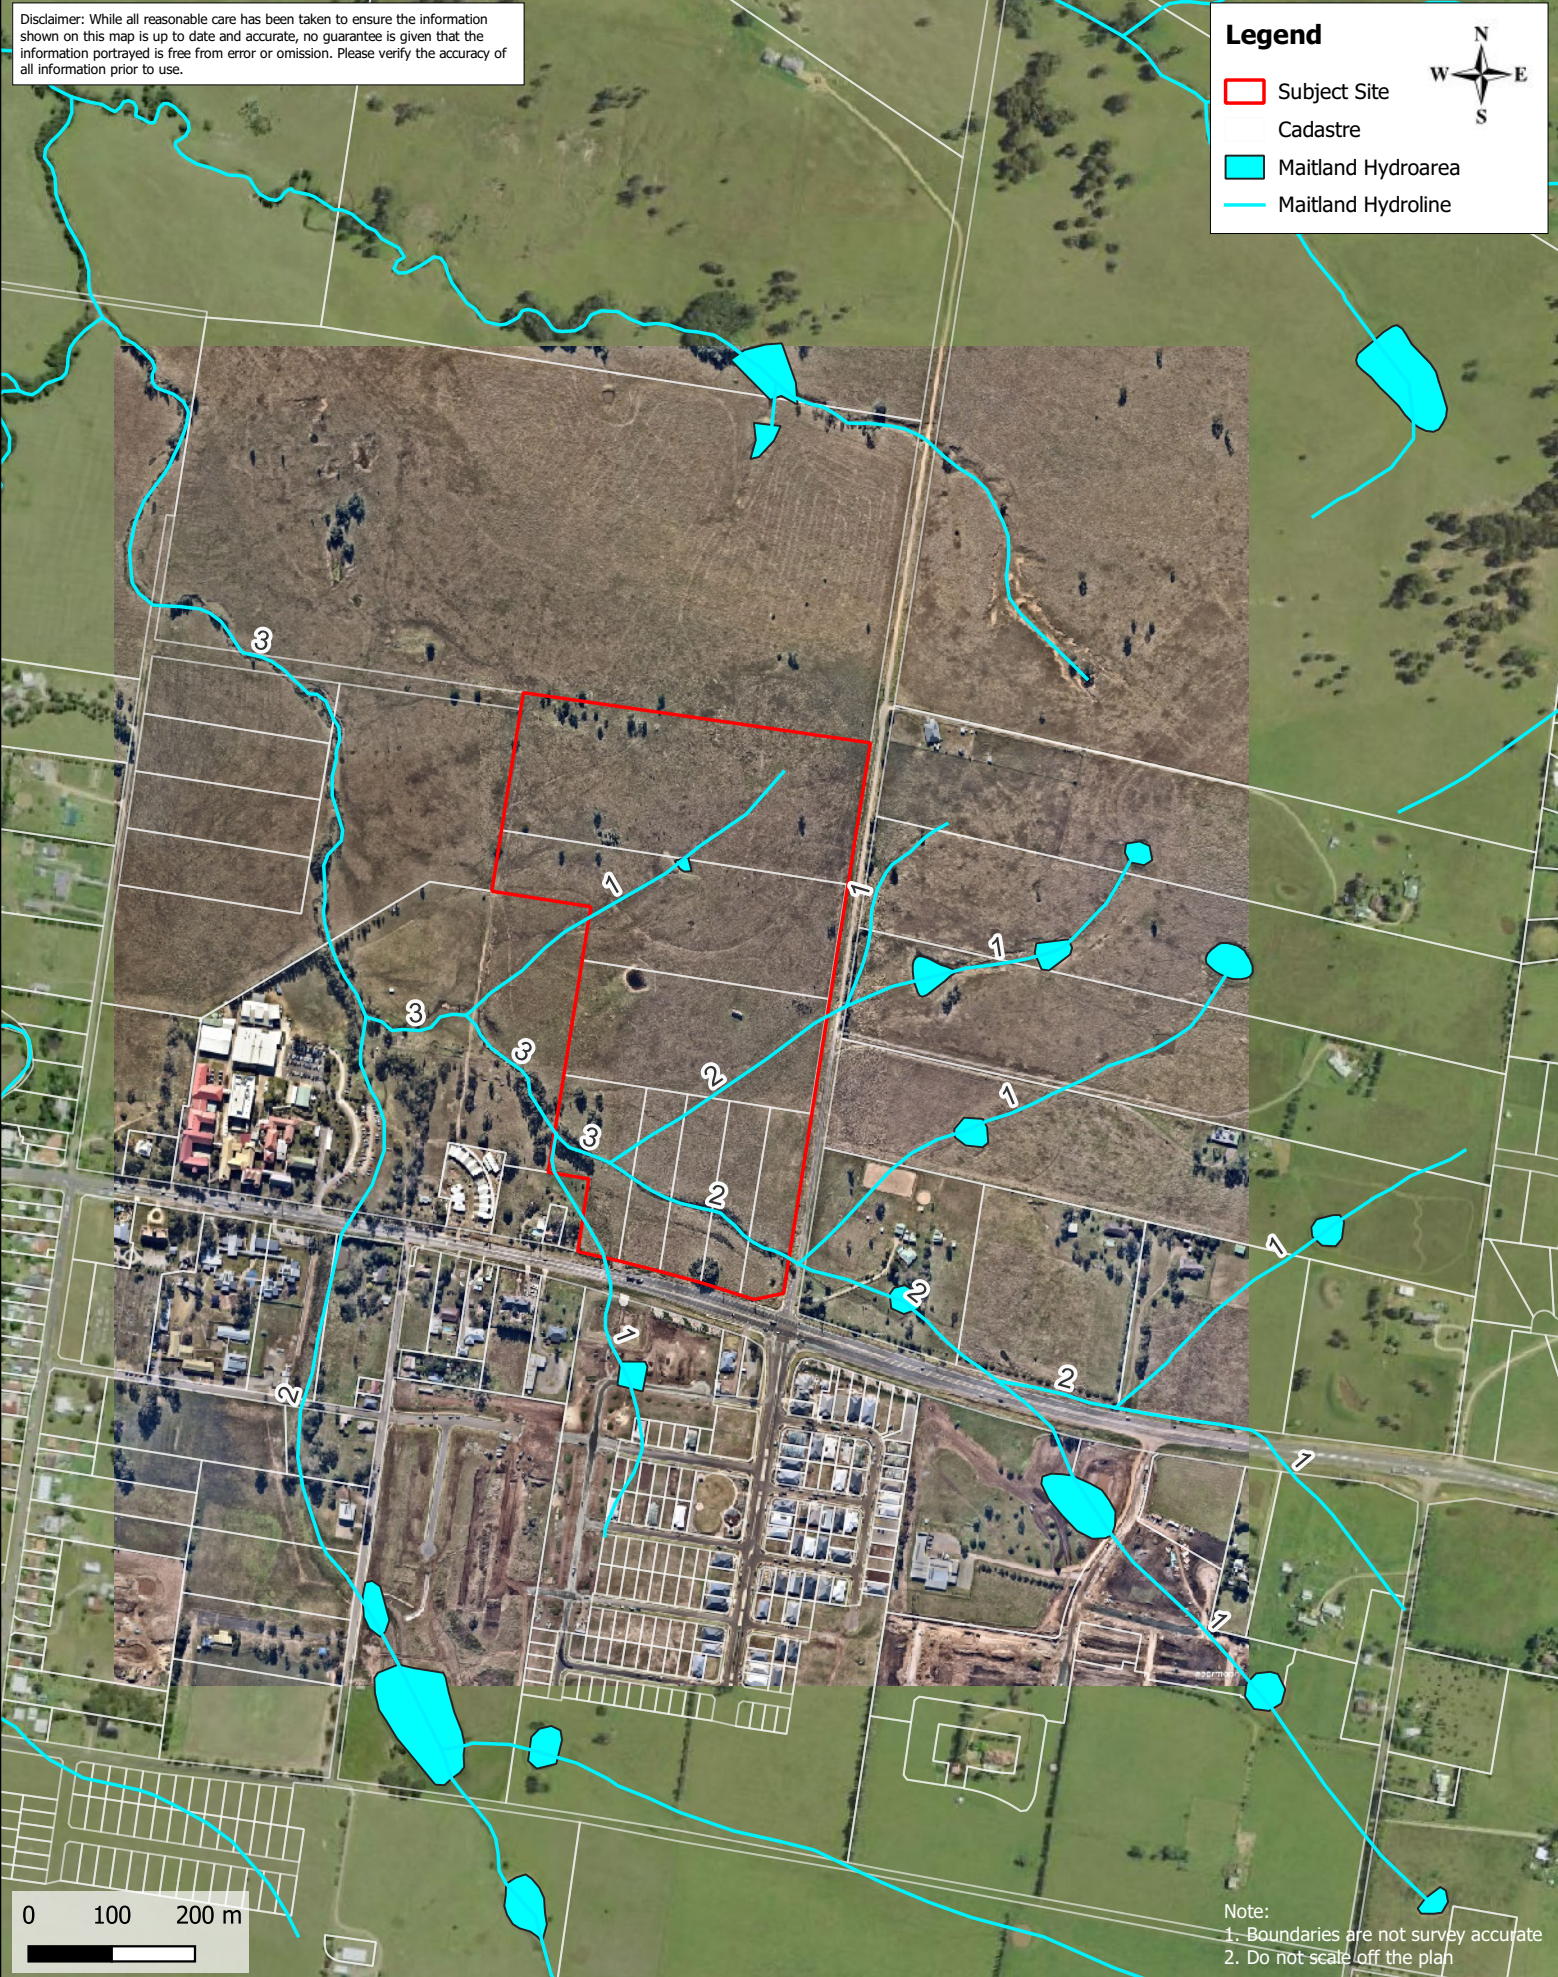
Figure 3 - Desktop Stream Order

- Stream orders were determined using the Strahler Order system via both API and *Water Management (General) Regulation 2018 Hydroline spatial data 1.0*;
- State vegetation mapping, *Maitland, 2022*, was utilised to identify vegetation communities occurring within the Subject Site (**Figure 2**).
- Literature review of stream ordering assessment and field assessment criteria to determine accuracy of mapped hydrolines.
- Assignment of survey identification numbers to potential watercourses (Survey ID) (**Figure 4**).
- Investigations for streams outside of the Subject Site will consist of roadside visual inspections and further desktop analysis.

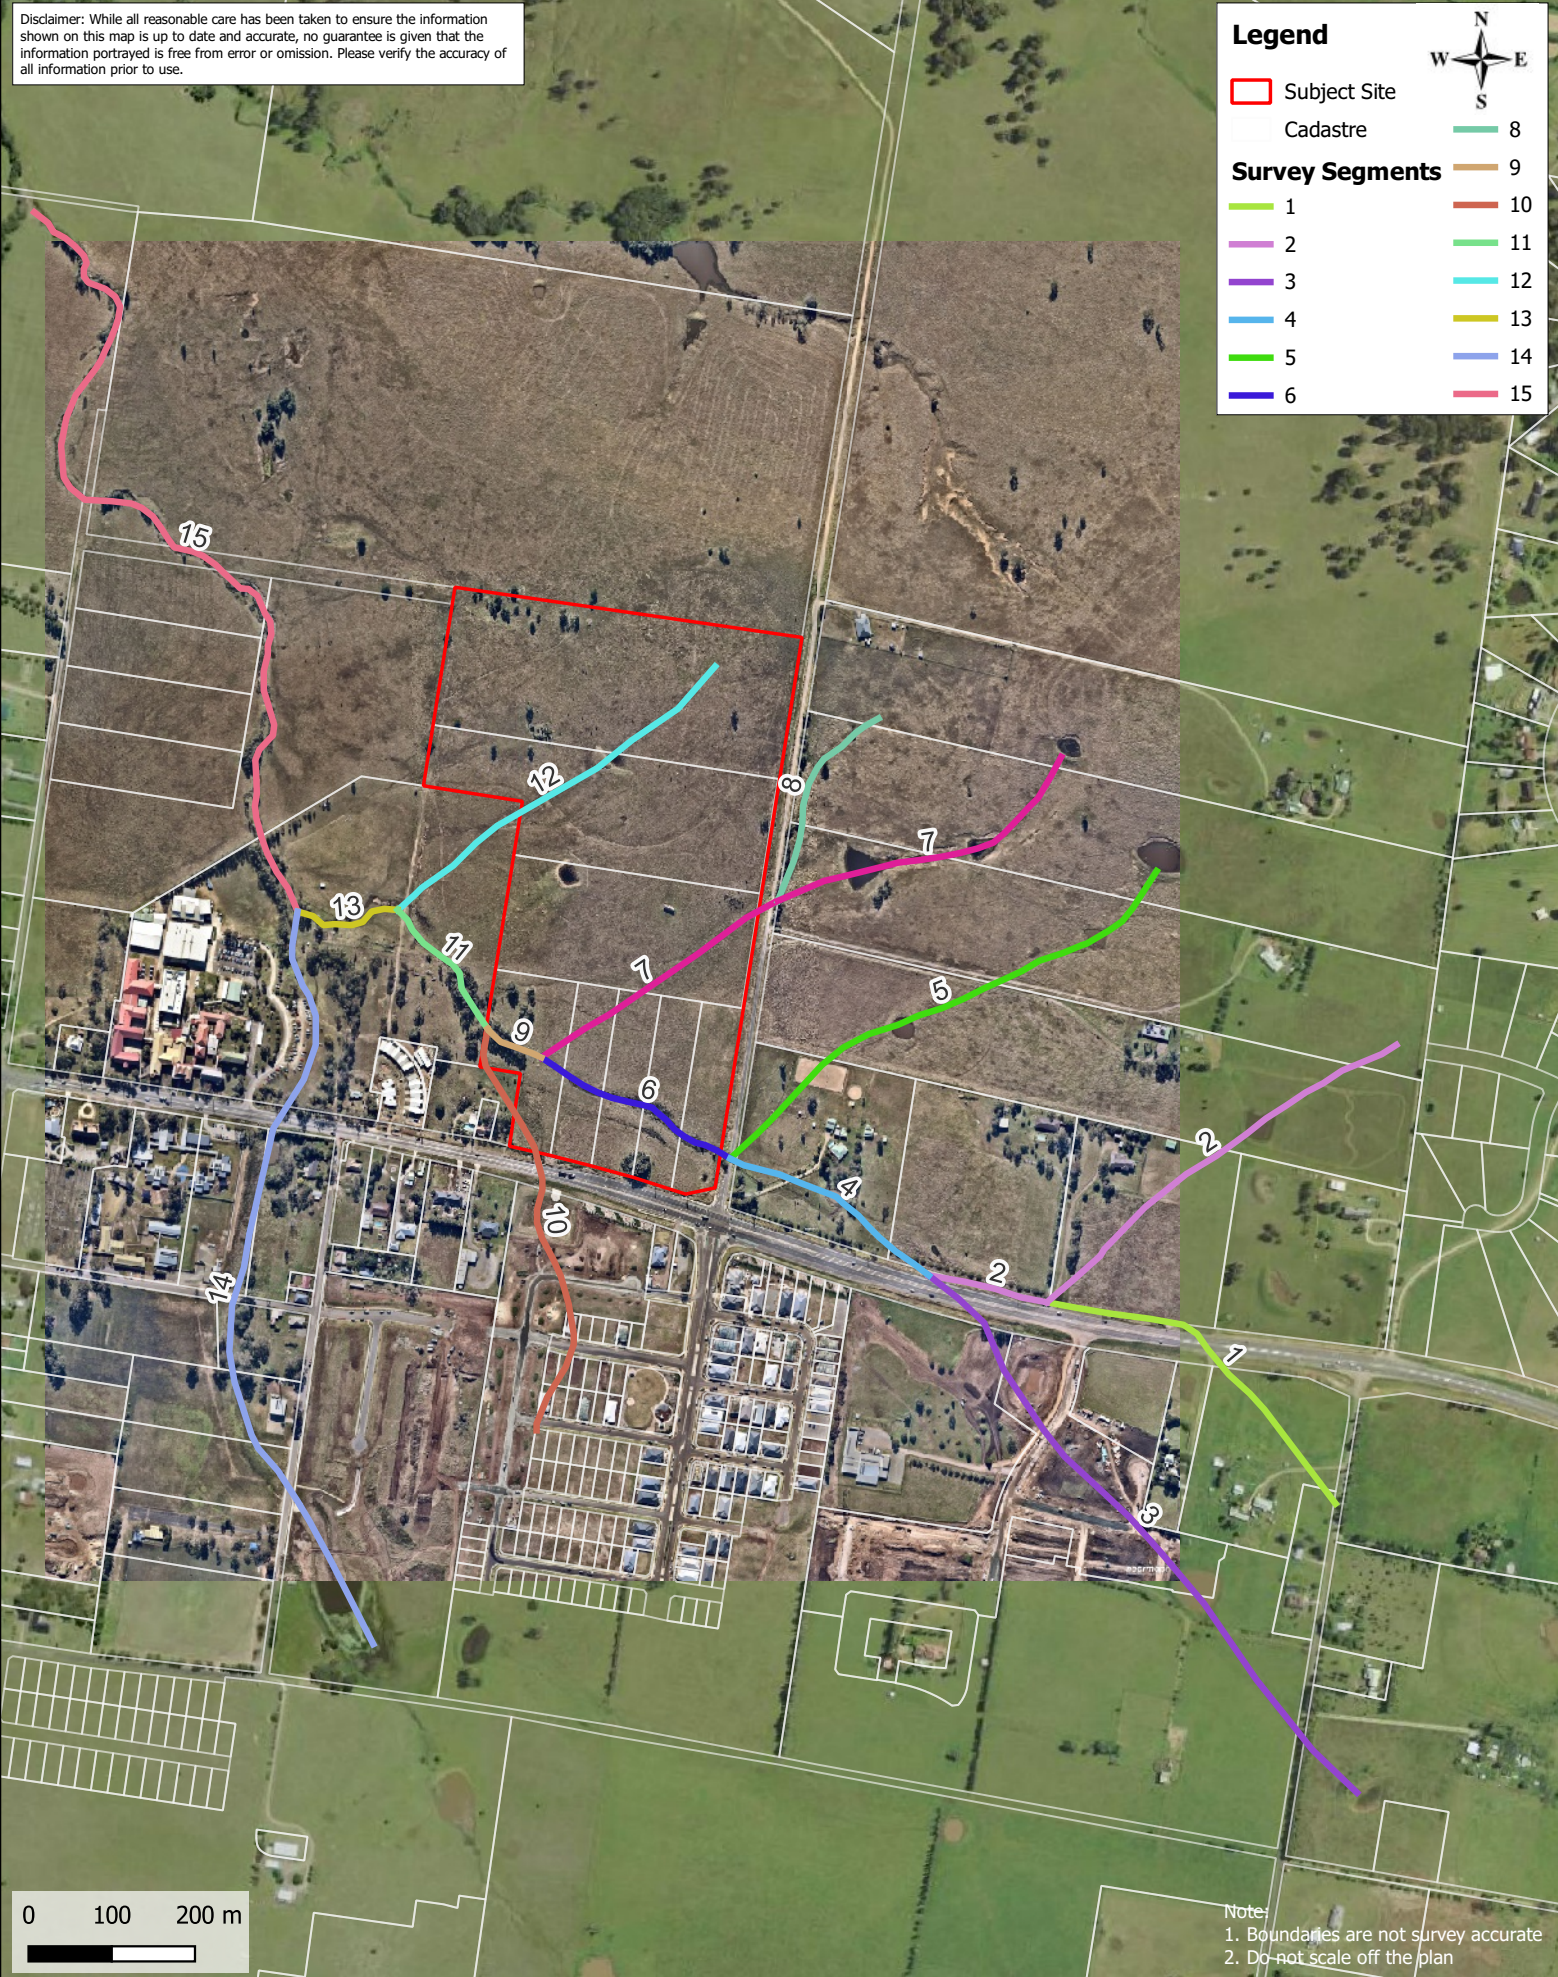
Figure 4 - Survey Identification Number

Task – Waterland Tool (2020)	Assessment	Comments (provide evidence)	Figures
Preparation			
Prepare map allocating survey identification numbers	Yes	A desktop assessment indicated that several segments of the mapped hydrolines may have varying features representative of watercourses. Therefore, 15 segments were identified for individual targeted assessments.	4

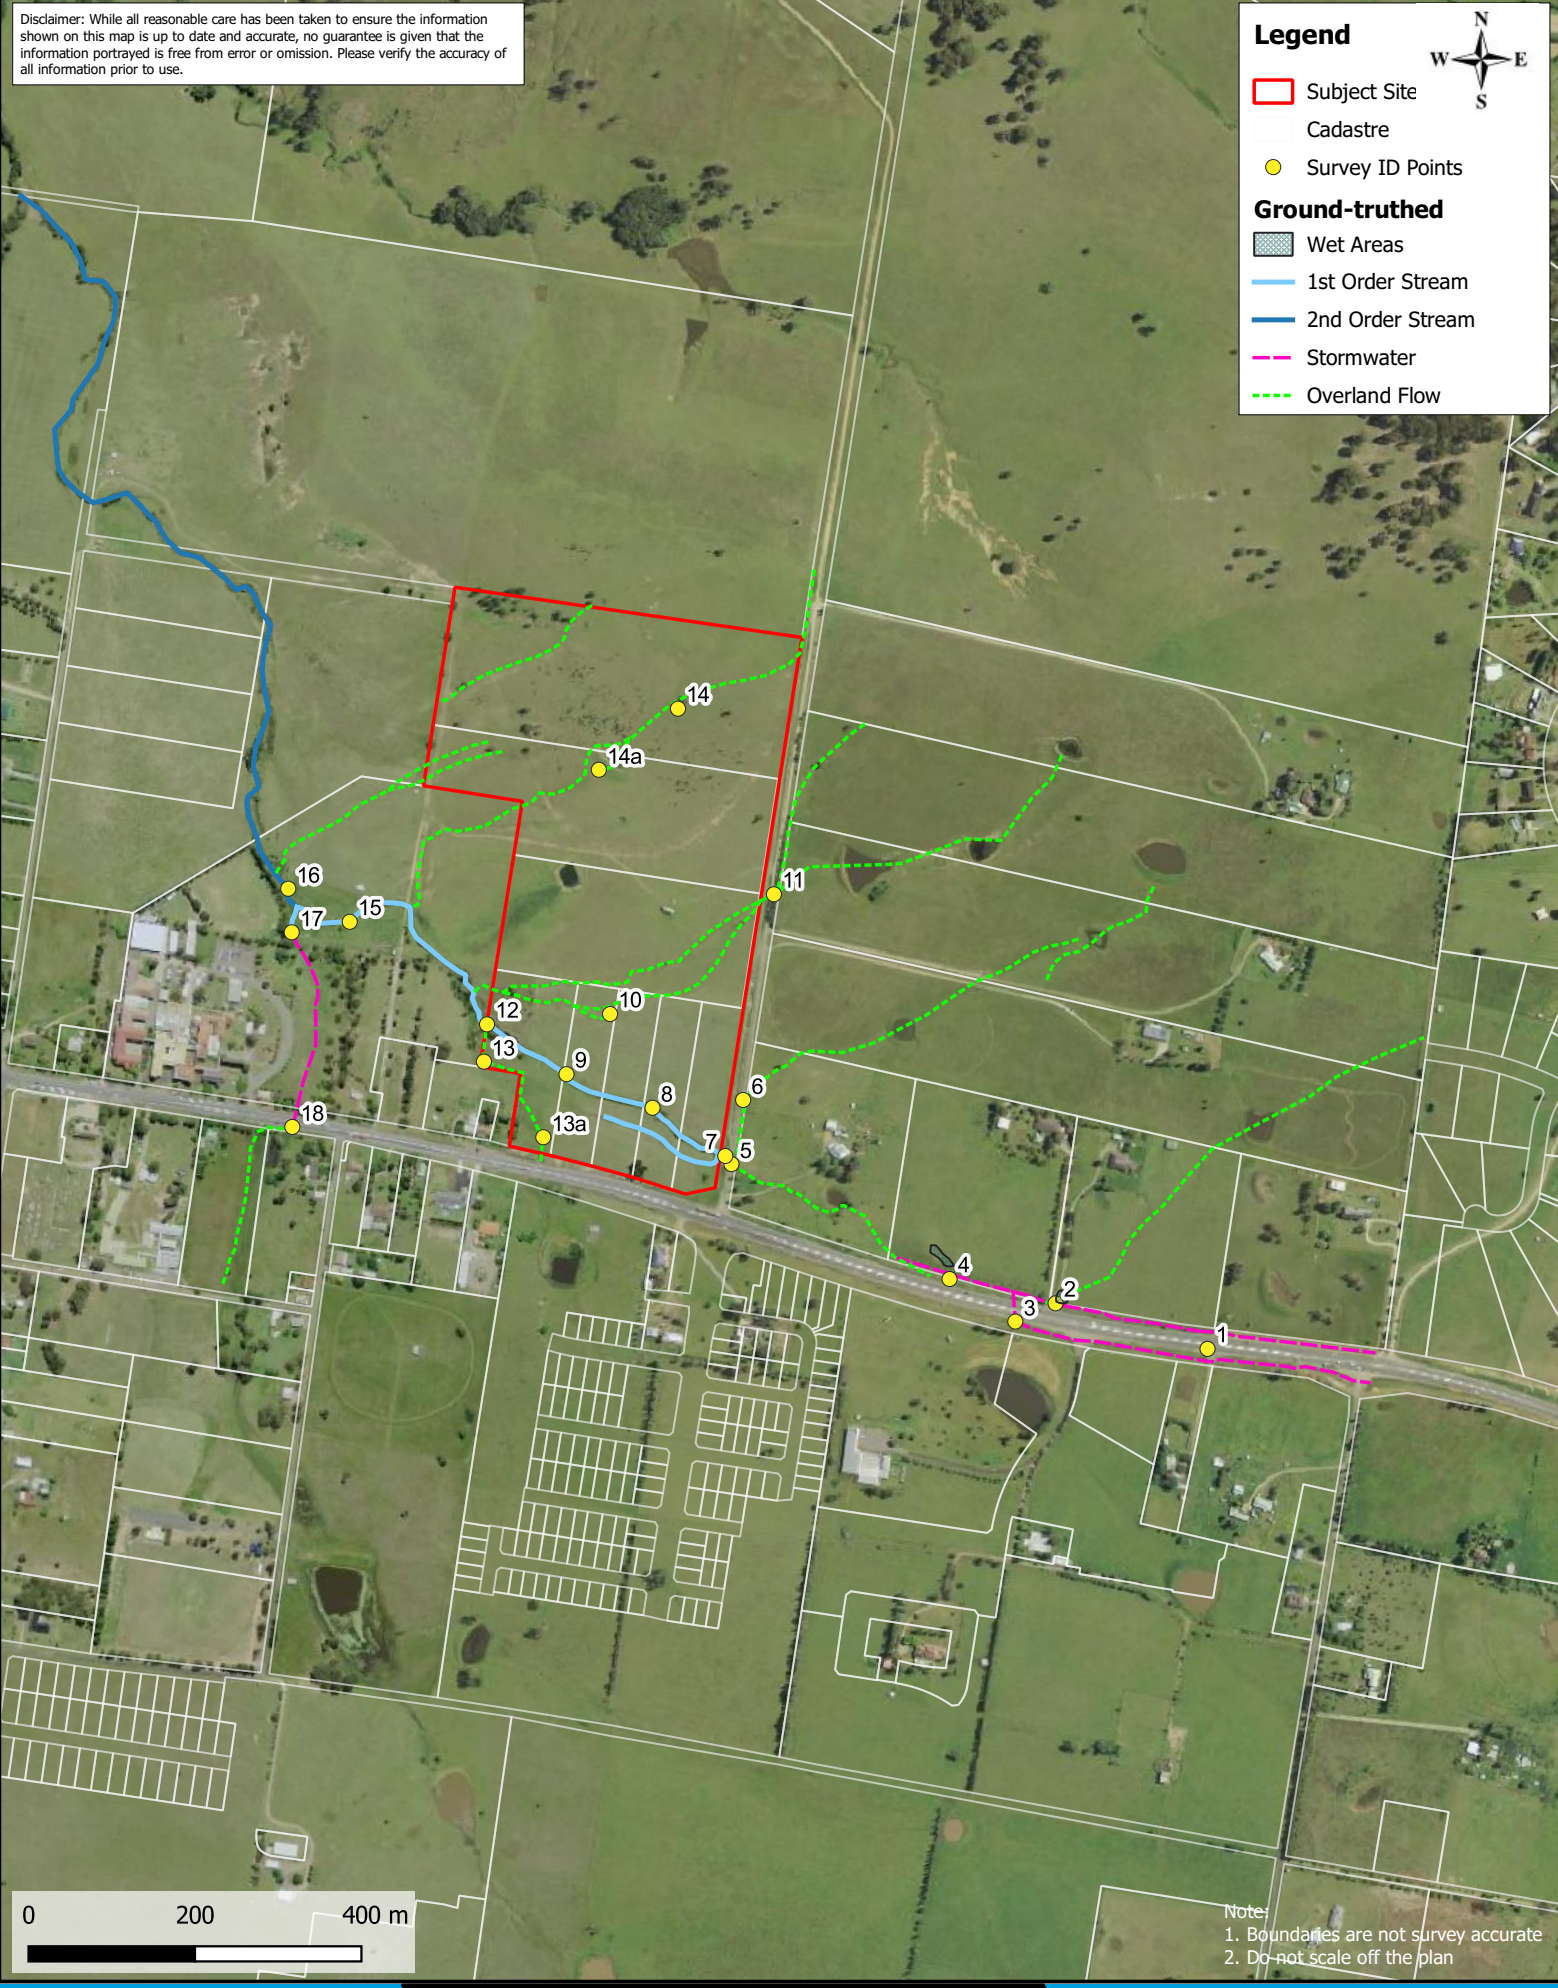
Figure 5 - Survey Efforts
Date: September 2022
Location: New England Hwy and Wyndella Rd, Lochinvar
Client: ADW Johnson
AEP ref: 2699

General observations along New England Highway and Wyndella Road were undertaken to assess the broader locality where access to lots was not available (refer **Figure 5** for survey effort).

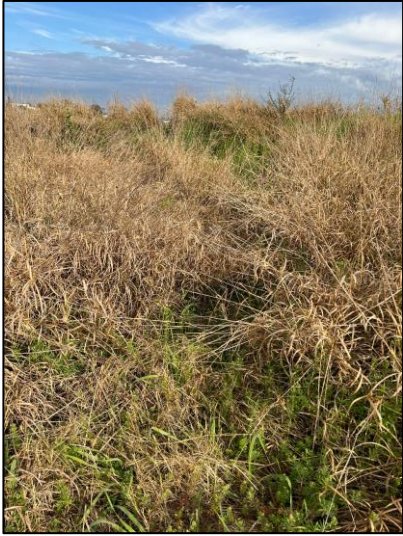
Field Assessment – Survey Id - 1			
Defined Bed and Banks (Yes / No)	No	No watercourse. Drain on south side of road running along parallel.	-
Type of Watercourse: Type 1, Type 2, Type 3a, Type 3b, Type 3c, Type 4, Type 5, Type 6, Type 7, None (Refer Appendix 5 - NRAR Guidelines, 2020)	None		-
Watercourse Feature Present (Pool, Riffle, Erosion and Disposition, None)	None		-
Lakes or Wetlands (Appendix 3 - NRAR Guidelines, 2020)	None		-
Vegetation Present to Indicate Wetlands (Appendix 7 - NRAR Guidelines, 2020)	None		-
High Bank (Appendix 8 - NRAR Guidelines, 2020)	No		-
Ground-truthed Survey Results			5
Controlled Activity Approval Required (Y / N)	No		-
Vegetated Riparian Zone Required (m)	None		-
Comments	Overgrown drain alongside of road		
Ground-truthed Stream Order	0		6

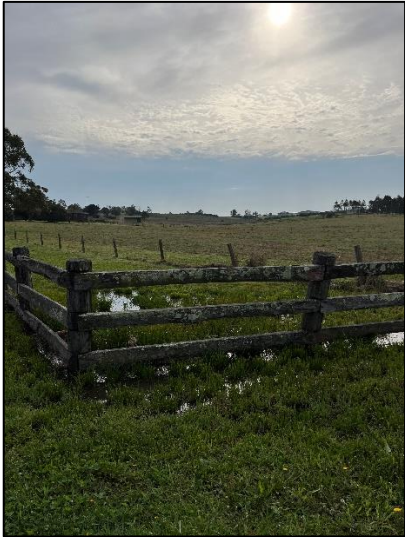
Task – Waterland Tool (2020)	Assessment	Comments (provide evidence)	Figures
Vegetation Present to Indicate Wetlands (Appendix 7 - NRAR Guidelines, 2020)	None		-
High Bank (Appendix 8 - NRAR Guidelines, 2020)	No		-
Ground-truthed Survey Results			5
Controlled Activity Approval required (Y / N)	No		-
Vegetated Riparian Zone Required (m)	None		-
Comments	Survey ID point 2 the site inspection showed a depression at the entrance to the property running into roadside drainage. Drainage runs along north side of road connecting to segment 3 via a drain under the road. In dry times this area would not hold water.		
Ground-truthed Stream Order	0		5

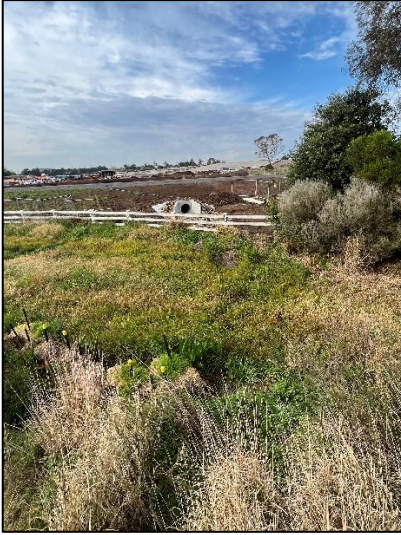
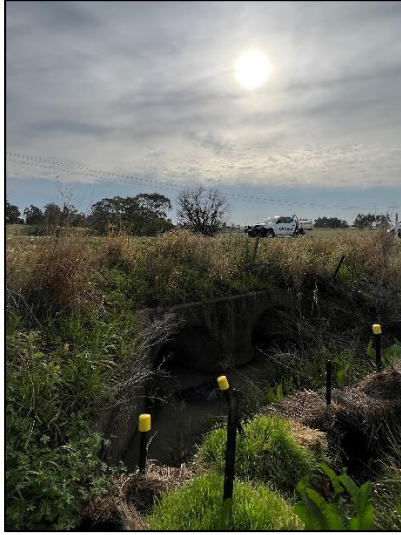
<p>Plate 4: Survey ID 3 from south of New England Highway facing North</p>

High Bank (Appendix 8 - NRAR Guidelines, 2020)	No		-
Ground-truthed Survey Results			5
Controlled Activity Approval required (Y / N)	No		-
Vegetated Riparian Zone Required (m)	None		-
Comments	Surveys determined to be a combination of constructed dry Retention Basin and roadside swales.		
Ground-truthed Stream Order	0		5

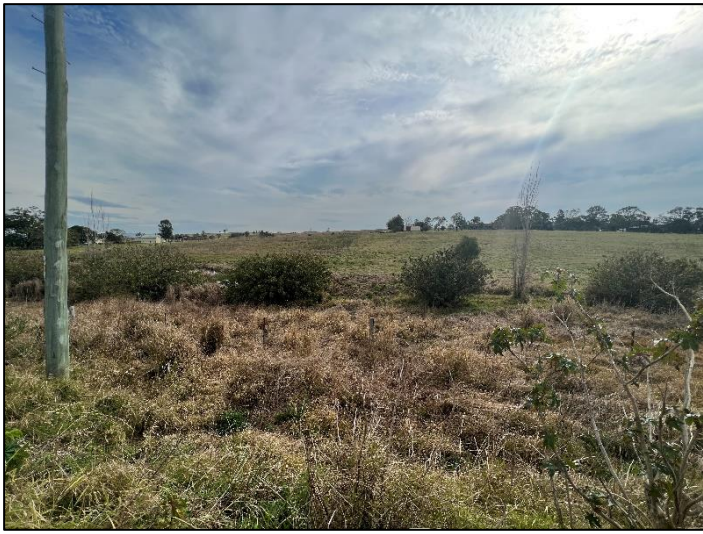
Field Assessment – Survey Id - 4			
Define Bed and Banks (Yes / No)	Yes	The area been surveyed and determined to be a combination of overland flow to the north, stormwater swales along the road and a depression within the private agricultural land to the north of the New England Highway.	-
Type of Watercourse: Type 1, Type 2, Type 3a, Type 3b, Type 3c, Type 4, Type 5, Type 6, Type 7, None (Appendix 5 - NRAR Guidelines, 2020)	4		-
Watercourse Feature Present (Pool, Riffle, Erosion and Disposition, None)	Pool		-
Lakes or Wetlands (Appendix 3 - NRAR Guidelines, 2020)	None		-
Vegetation Present to indicate Wetlands (Appendix 7 - NRAR Guidelines, 2020)	None		-
High Bank (Appendix 8 - NRAR Guidelines, 2020)	No as private land where watercourse commences, no access to the site.		7
Ground-truthed Survey Results			6
Controlled Activity Approval required (Y / N)	No		-
Vegetated Riparian Zone Required (m)	0		-

Comments	The area been surveyed and determined to be a combination of overland flow to the north, stormwater swales along the road and a depression within the private agricultural land to the north of the New England Highway		
Ground-truthed Stream Order	0		5

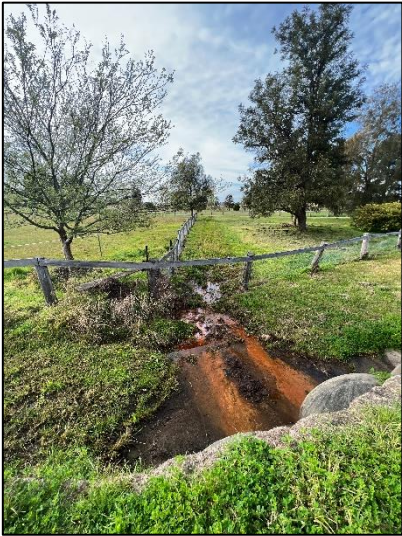
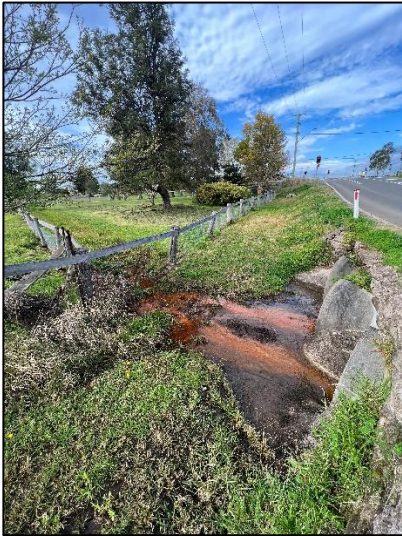
<p>Plate 7: Survey ID 5</p>

Field Assessment – Survey Id - 5			
Define Bed and Banks (Yes / No)	No	The site inspection showed that the mapped hydroline was overland flowing across lawn and paddocks, with no defined bed or bank obvious, however a path is visible.	-
Type of Watercourse: Type 1, Type 2, Type 3a, Type 3b, Type 3c, Type 4, Type 5, Type 6, Type 7, None (Appendix 5 - NRAR Guidelines, 2020)	-		-
Watercourse Feature Present (Pool, Riffle, Erosion and Disposition, None)	No		-
Lakes or Wetlands (Appendix 3 - NRAR Guidelines, 2020)	None		-
Vegetation Present to indicate Wetlands (Appendix 7 - NRAR Guidelines, 2020)	None		-

Task – Waterland Tool (2020)	Assessment	Comments (provide evidence)	Figures
High Bank (Appendix 8 - NRAR Guidelines, 2020)	-		-
Ground-truthed Survey Results			5
Controlled Activity Approval required (Y / N)	No		-
Vegetated Riparian Zone Required (m)	0		-
Comments	Survey ID point 5 is consist of a stormwater drainage system. Therefore, the desktop assessment classifying the hydroline as a Stream Order 2 is inaccurate having been confirmed by ground-truthing.		
Ground-truthed Stream Order	0		5

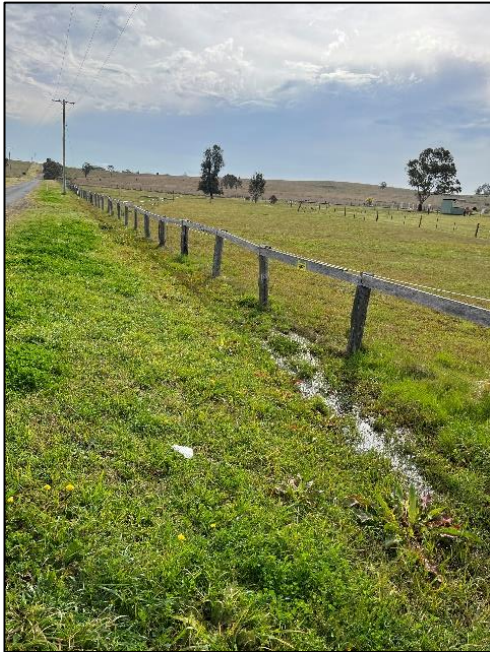
Plate 9: Survey ID 6			
Desktop Assessment – Survey Id - 7			
Is your property located on a watercourse, lake or estuary within the shaded area in any of the NRAR waterfront land maps? (Appendix 1 - NRAR Guidelines)	No		-

Task – Waterland Tool (2020)	Assessment	Comments (provide evidence)	Figures
Field Assessment – Survey Id - 6			
Define Bed and Banks (Yes / No)	No	The site inspection showed that the mapped hydroline was overland flowing across paddocks and then alongside road.	-
Type of Watercourse: Type 1, Type 2, Type 3a, Type 3b, Type 3c, Type 4, Type 5, Type 6, Type 7, None (Appendix 5 - NRAR Guidelines, 2020)	None		-
Watercourse Feature Present (Pool, Riffle, Erosion and Disposition, None)	None		-
Lakes or Wetlands (Appendix 3 – NRAR Guidelines)	None		-
Vegetation Present to Indicate Wetlands (Appendix 7 - NRAR Guidelines)	None		-
High Bank (Appendix 8 - NRAR Guidelines)	None		-
Ground-truthed Survey Results			5
Controlled Activity Approval required (Y / N)	No		-
Vegetated Riparian Zone Required (m)	0		-
Comments	Survey ID point 6 was determined to be overland flow. Therefore, desktop assessment indicating the presence of a Stream Order 1 hydroline is inaccurate having been confirmed by ground-truthing.

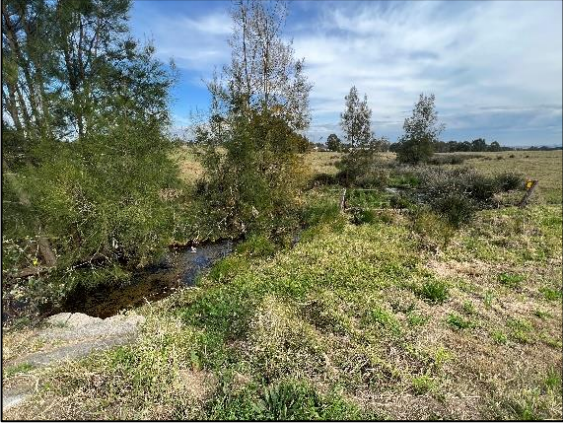
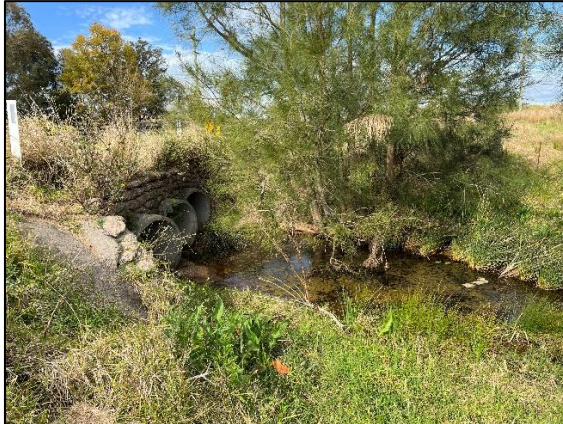
<p style="text-align: center;">Plate 10: Survey ID 7</p>

Field Assessment – Survey Id - 7			
Define Bed and Banks (Yes / No)	Yes	Refer to Plate 10 .	-
Type of Watercourse: Type 1, Type 2, Type 3a, Type 3b, Type 3c, Type 4, Type 5, Type 6, Type 7, None (Appendix 5 - NRAR Guidelines)	Type 4	The stream bed is wider than the main channel in which water flows providing a wide floodplain.	-
Watercourse Feature Present (Pool, Riffle, Erosion and Disposition, None)	None		-
Lakes or Wetlands (Appendix 3 – NRAR Guidelines)	None		-
Vegetation Present to Indicate Wetlands (Appendix 7 - NRAR Guidelines)	None		-
High Bank (Appendix 8 - NRAR Guidelines)	Yes		7
Ground-truthed Survey Results			5
Controlled Activity Approval required (Y / N)	Yes		-
Vegetated Riparian Zone Required (m)	10m (either side of the watercourse)		8
Comments	<p>A defined natural bed, present riparian vegetation and marginal flow of water indicate a watercourse. Highly degraded with <i>Juncus acutus</i> present at the top of bank. It is noted that there is a small tributary with a depression in the south of this arm, as shown in Figure 5. It appears that this area is the overflow from the culvert in times of heavy rainfall. There are aquatic flora species present, mostly weed species, however in times of lower rainfall this area would not have these characteristics and would be a depression within the landscape, hence AEP has determined the area is not a wetland.</p> <p>If wet conditions continue, MCC may question this assessment and request a 40m buffer around the depression, which would need to be justified.</p>

Ground-truthed Stream Order	1		6

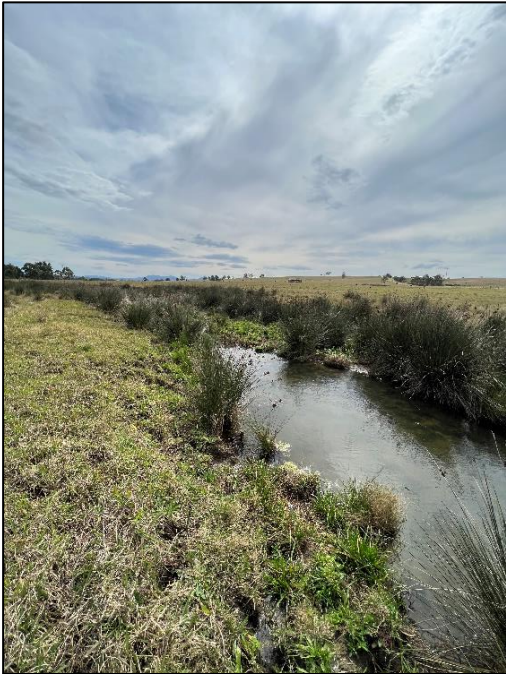
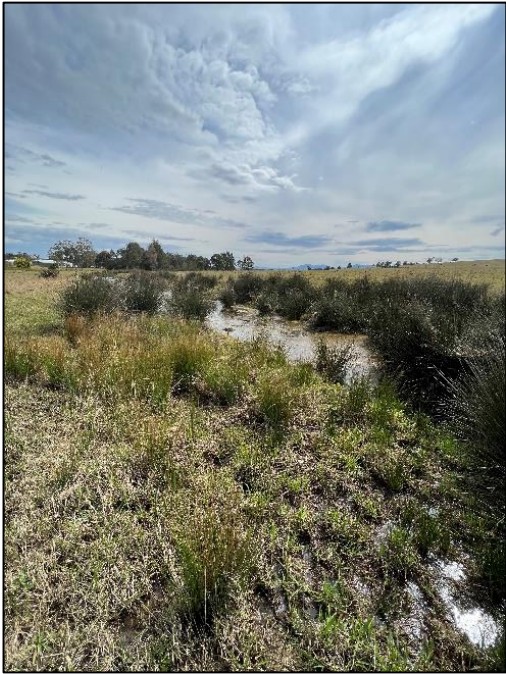
<p>Plate 12: Survey ID 8</p>

Task – Waterland Tool (2020)	Assessment	Comments (provide evidence)	Figures
High Bank (Appendix 8 - NRAR Guidelines)	Yes	No	7
Ground-truthed Survey Results		No	5
Controlled Activity Approval required (Y / N)	Yes	No	-
Vegetated Riparian Zone Required (m)	10m (either side of the watercourse)	No	8
Comments	<p>A defined natural creek bed, present riparian vegetation and marginal flow of water indicate a watercourse.</p> <p>Continuation of the 1st order stream identified at Survey ID 7. At this stage no additional hydrolines join this creek.</p>		
Ground-truthed Stream Order	1		6

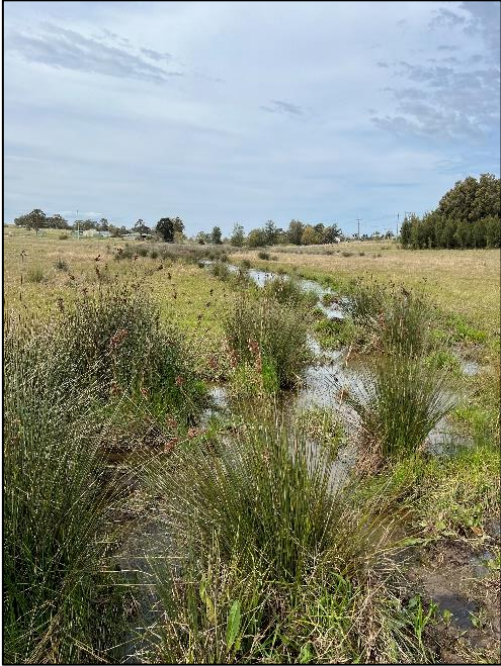
Vegetation Present to indicate Wetlands (Appendix 7 – NRAR Guidelines, 2020)	No	No	-
High Bank (Appendix 8 - NRAR Guidelines, 2020)	Yes	No	7
Ground-truthed Survey Results		Banks are sloped and defined providing flow of water. The river bed is a natural channel and riparian vegetation is present.	5
Controlled Activity Approval required (Y / N)	Yes	No	-
Vegetated Riparian Zone Required (m)	10m (either side of the watercourse)		8
Comments	A defined natural creek bed, riparian vegetation present, and marginal flow of water indicate a watercourse. This is a continuation of the 1 st order stream identified at Survey ID 8. At this stage no additional hydrolines join this creek. Due to the lack of stream at Survey ID 11 and 10 the desktop assessment indicating the presence of a Stream Order 3 hydroline is inaccurate having been confirmed by ground-truthing.		
Ground-truthed Stream Order	1		6

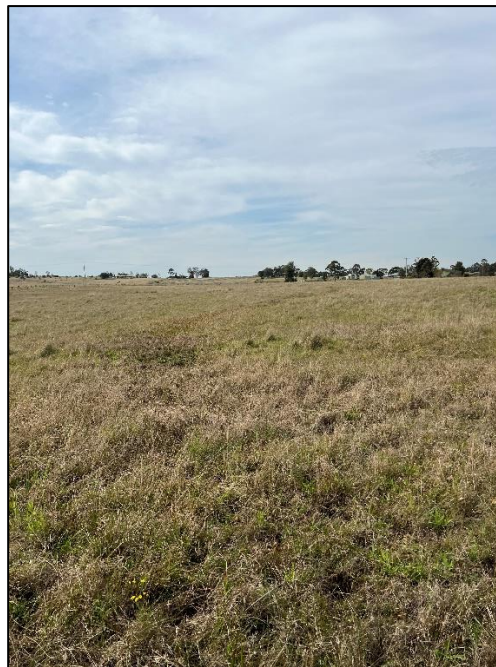
Plate 15: Survey ID 10

Field Assessment – Survey Id - 10			
Define Bed and Banks (Yes / No)	No		-
Type of Watercourse: Type 1, Type 2, Type 3a, Type 3b, Type 3c, Type 4, Type 5, Type 6, Type 7, None (Appendix 5 - NRAR Guidelines, 2020)	None	No	-

Task – Waterland Tool (2020)	Assessment	Comments (provide evidence)	Figures
Watercourse Feature Present (Pool, Riffle, Erosion and Disposition, None)	Erosion	Overland flow erosion	-
Lakes or Wetlands (Appendix 3 – NRAR Guidelines, 2020)	No	No	-
Vegetation Present to indicate Wetlands (Appendix 7 - NRAR Guidelines, 2020)	No	No	-
High Bank (Appendix 8 - NRAR Guidelines, 2020)	No	No	-
Ground-truthed Survey Results		No	5
Controlled Activity Approval required (Y / N)	No	No	-
Vegetated Riparian Zone Required (m)	0	No	-
Comments	No watercourse was confirmed, overland flow with water erosion.		
Ground-truthed Stream Order	0		5

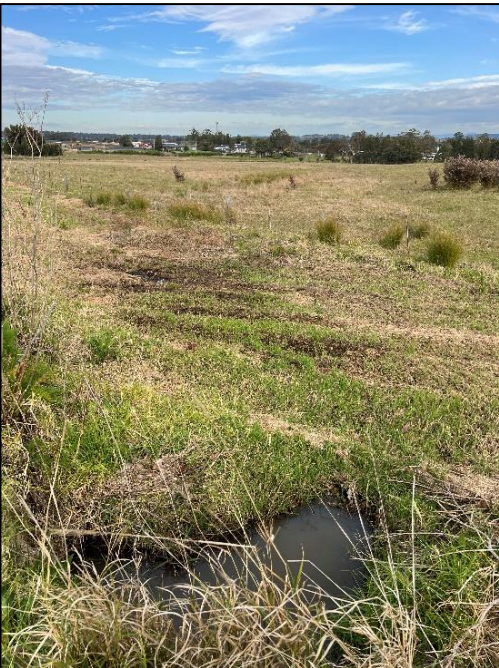
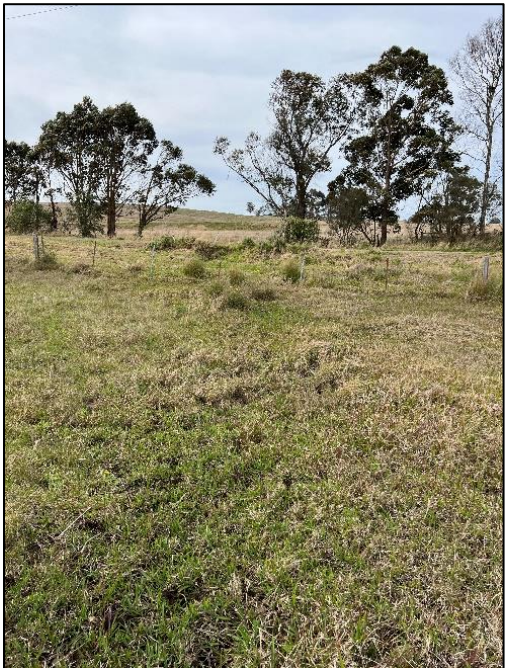
<p style="text-align: center;">Plate 16: Survey ID 11</p>

Lakes or Wetlands (Appendix 3 – NRAR Guidelines, 2020)	No		-
Vegetation Present to indicate Wetlands (Appendix 7 - NRAR Guidelines, 2020)	No		-
High Bank (Appendix 8 - NRAR Guidelines, 2020)	No		-
Ground-truthed Survey Results			5
Controlled Activity Approval required (Y / N)	No		-
Vegetated Riparian Zone Required (m)	0		-
Comments	Survey ID point 11 determined the hydroline across the property to be overland flow. Therefore, the desktop assessment classifying the hydroline as 1 st Stream Order is inaccurate having been confirmed by ground-truthing.		
Ground-truthed Stream Order	0		5

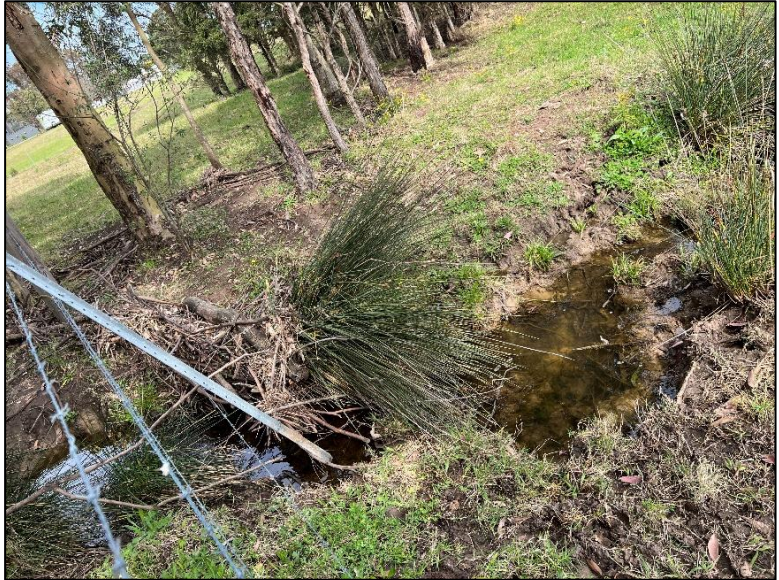
Field Assessment – Survey Id - 12			
Define Bed and Banks (Yes / No)	Yes	Refer to Plate 18 .	-
Type of Watercourse: Type 1, Type 2, Type 3a, Type 3b, Type 3c, Type 4, Type 5, Type 6, Type 7, None (Appendix 5 - NRAR Guidelines, 2020)	Type 4		-
Watercourse Feature Present (Pool, Riffle, Erosion and Disposition, None)	Deposition, erosion	Erosion around banks. Refer to Plate 18 .	-
Lakes or Wetlands (Appendix 3 – NRAR Guidelines, 2020)	None		-
Vegetation Present to indicate Wetlands (Appendix 7 - NRAR Guidelines, 2020)	None		-
High Bank (Appendix 8 - NRAR Guidelines, 2020)	Yes		7
Ground-truthed Survey Results		Continuation of the 1st order stream identified at Survey ID 8.	5
Controlled Activity Approval required (Y / N)	Yes		-
Vegetated Riparian Zone Required (m)	10m (either side of the watercourse)		8
Comments	<p>A defined natural creek bed, present riparian vegetation and marginal flow of water indicate a watercourse.</p> <p>Continuation of the 1st order stream identified at Survey ID 8. The stream continues to flow off property onto neighbouring land.</p>

Task – Waterland Tool (2020)	Assessment	Comments (provide evidence)	Figures
		Therefore, desktop assessment indicating the presence of a Stream Order 3 hydroline is inaccurate having been confirmed by ground-truthing.	
Ground-truthed Stream Order	1		6

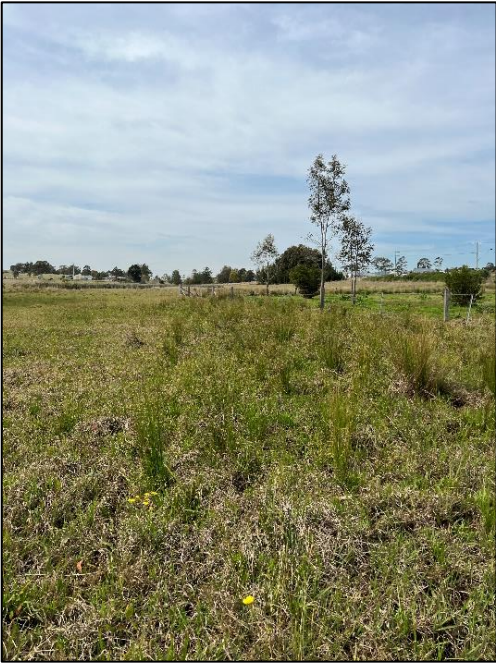
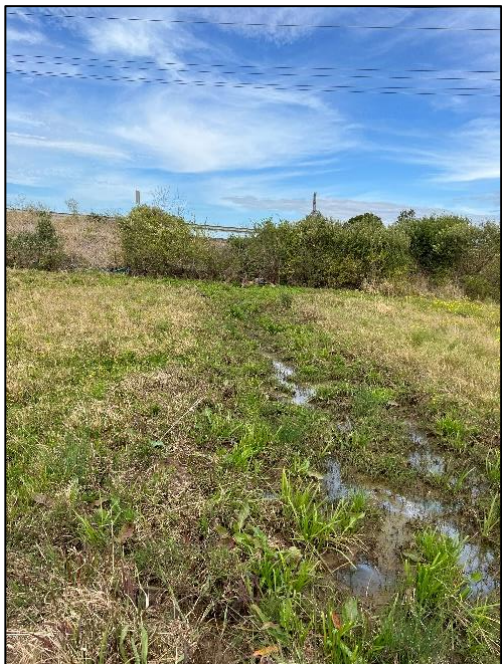
<p>Plate 19: Survey ID 13</p>

Task – Waterland Tool (2020)	Assessment	Comments (provide evidence)	Figures
Watercourse Feature Present (Pool, Riffle, Erosion and Disposition, None)	None		-
Lakes or Wetlands (Appendix 3 – NRAR Guidelines, 2020)	No		-
Vegetation Present to indicate Wetlands (Appendix 7 - NRAR Guidelines, 2020)	No		-
High Bank (Appendix 8 - NRAR Guidelines, 2020)	No		-
Ground-truthed Survey Results			5
Controlled Activity Approval required (Y / N)	No		-
Vegetated Riparian Zone Required (m)	No		-
Comments	Overland flow from the development south of the New England Highway. Given the topography and the scattered occurrence of species associated with wetter areas it is likely that the area (identified in Figure 9) will become a wetland if the current drainage remains.		
Ground-truthed Stream Order	0		5

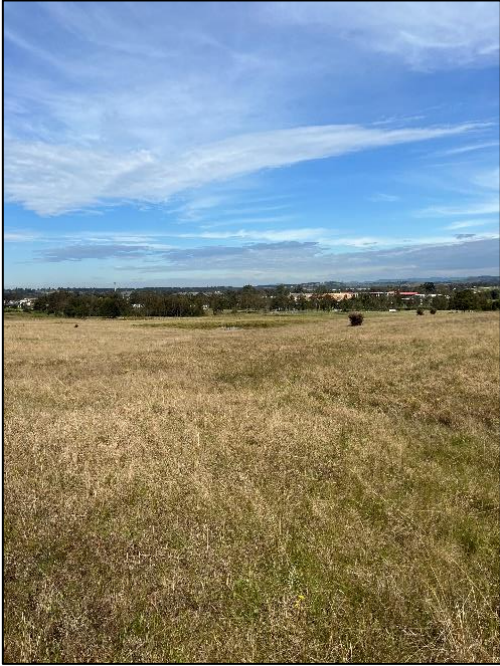
Task – Waterland Tool (2020)	Assessment	Comments (provide evidence)	Figures
		Aerial imagery does not reveal any watercourses.	
Is there a lake or wetland on your property or within 40 metres of the proposed work? (Appendix 3 - NRAR Guidelines, 2020 — Lakes and Wetlands)	No	No	-
Using the <i>Determining Stream Order</i> fact sheet (Appendix 4 – NRAR Guidelines, 2020) and the <i>NSW Hydro Line Spatial Data Map</i> , what is the stream order of your watercourse?	1	Based on the desktop assessment, Hydroline ID 14 is mapped as Stream order 1 via the Strahler Stream order classification.	3
Field Assessment – Survey Id – 14			
Define Bed and Banks (Yes / No)	No	No	-
Type of Watercourse: Type 1, Type 2, Type 3a, Type 3b, Type 3c, Type 4, Type 5, Type 6, Type 7, None (Appendix 5 - NRAR Guidelines, 2020)	None	No	-
Watercourse Feature Present (Pool, Riffle, Erosion and Disposition, None)	Erosion and Disposition	Drainage depression is evident	-

Lakes or Wetlands (Appendix 3 – NRAR Guidelines, 2020)	No	No	-
Vegetation Present to indicate Wetlands (Appendix 7 - NRAR Guidelines, 2020)	No	No	-
High Bank (Appendix 8 - NRAR Guidelines, 2020)	No	No	-
Ground-truthed Survey Results		The site inspection showed that the mapped hydroline was overland flowing across paddocks.	5
Controlled Activity Approval required (Y / N)	No	No	-
Vegetated Riparian Zone Required (m)	0	No	-
Comments	Survey ID point 14 is likely to consist of over land flow that turns into a pond and then runs under a dirt road before becoming a piped drain on school grounds. Therefore, the desktop assessment classifying the hydroline as a Stream Order 1 is inaccurate having been confirmed by ground-truthing.		
Ground-truthed Stream Order	0		5

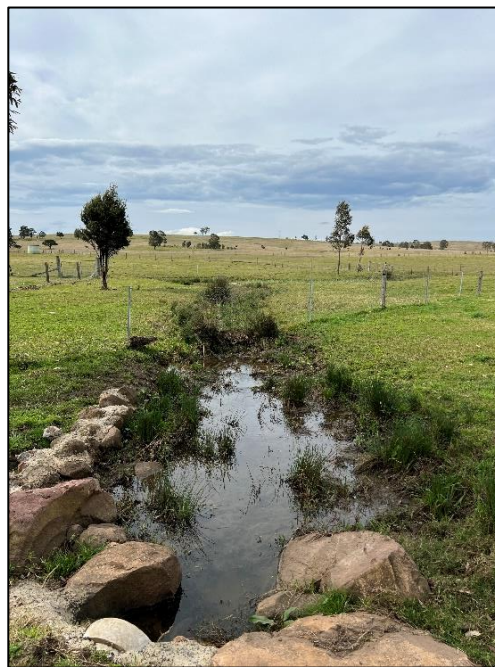
Plate 22: Survey ID 15

Field Assessment – Survey Id – 15			
Define Bed and Banks (Yes / No)	Yes	Defined bed or bank obvious, however a path is visible. Highly degraded with <i>Juncus acutus</i> . Runs through Agricultural School farm and risk being exposed to animal waste. The school has modified the creek by inserting a crossing path.	-
Type of Watercourse: Type 1, Type 2, Type 3a, Type 3b, Type 3c, Type 4, Type 5, Type 6, Type 7, None (Appendix 5 - NRAR Guidelines, 2020)	Type 4		-
Watercourse Feature Present (Pool, Riffle, Erosion and Disposition, None)	Erosion and Disposition		-
Lakes or Wetlands (Appendix 3 – NRAR Guidelines, 2020)	No		-

Task – Waterland Tool (2020)	Assessment	Comments (provide evidence)	Figures
Vegetation Present to indicate Wetlands (Appendix 7 - NRAR Guidelines, 2020)	None		-
High Bank (Appendix 8 - NRAR Guidelines, 2020)	Yes		7
Ground-truthed Survey Results			5
Controlled Activity Approval required (Y / N)	Yes		-
Vegetated Riparian Zone Required (m)	10m (either side of the watercourse)		8
Comments	Survey ID point 15 is has defined bed and erosion and deposition.		
Ground-truthed Stream Order	1		6

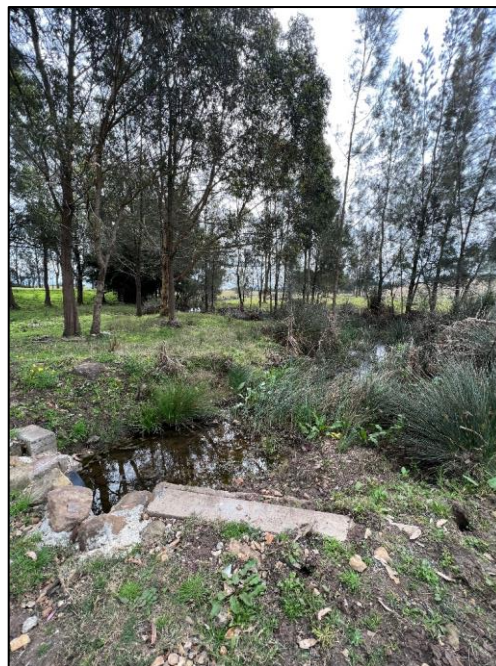
Plate 23: Survey ID 16

Controlled Activity Approval required (Y / N)	No		-
Vegetated Riparian Zone Required (m)	20m (either side of the watercourse)		8
Comments	Survey ID point 16 is has defined bed. However, due to the ground-truthing of the upper tributaries, the desktop assessment classifying the hydroline as a Stream Order 3 is inaccurate having been confirmed by ground-truthing.		
Ground-truthed Stream Order	2		6

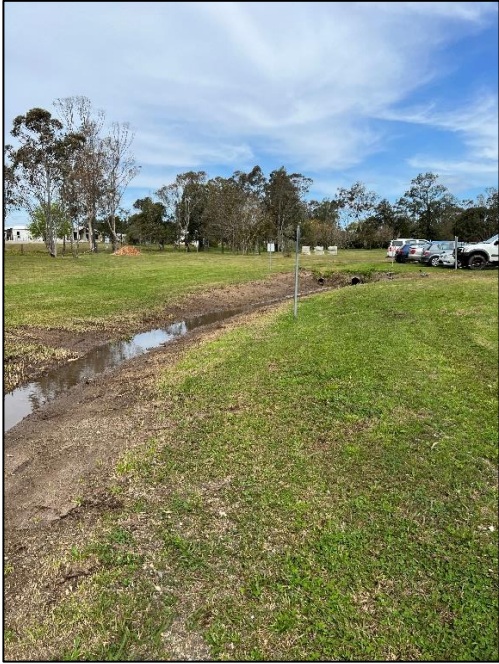
Ground-truthed Stream Order	1		6

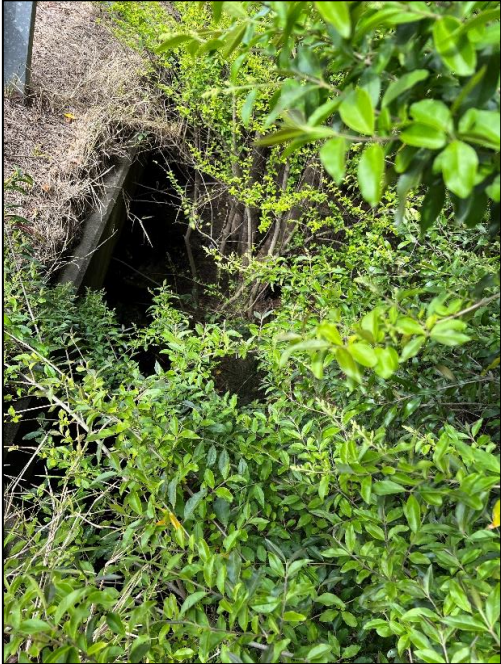
Plate 25: Survey ID 18

Task – Waterland Tool (2020)	Assessment	Comments (provide evidence)	Figures
Vegetation Present to indicate Wetlands (Appendix 7 - NRAR Guidelines, 2020)	None		-
High Bank (Appendix 8 - NRAR Guidelines, 2020)	No		-
Ground-truthed Survey Results			5
Controlled Activity Approval required (Y / N)	No		-
Vegetated Riparian Zone Required (m)	None		-
Comments	Survey ID point 18 is likely to consist of a continuing stormwater drainage system connected to detention basins or underground drains. Therefore, the desktop assessment classifying the hydroline as a Stream Order 2 is inaccurate having been confirmed by ground-truthing.		
Ground-truthed Stream Order	0		5
