Report on Earthworks Strategy

457-527 Cessnock Road, Gillieston
Heights

304100964-002

Prepared for
Walker Gillieston Heights Pty Ltd

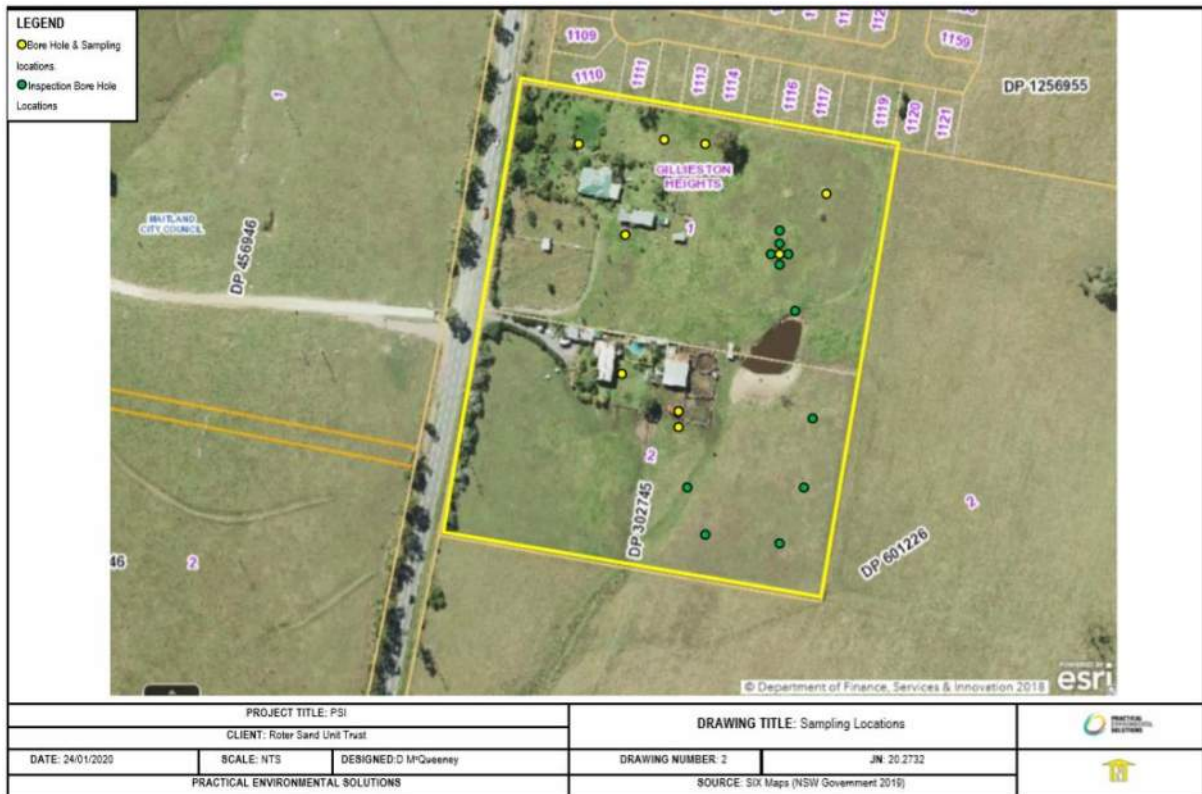
Figure 4: Site locations (Lot 1 & 2, DP 302745) identified in PES (2020)

A Preliminary Site Investigation (PES PSI) at a property located at 457-463 Cessnock Road (adjoining Lots 1 & 2, DP 302745, respectively) Gillieston Heights, New South Wales, as shown on Figure 4 below, was conducted by Practical Environmental Solutions Pty Ltd (PES) in February 2020. The investigation was undertaken to develop an understanding of the current and historical activities that either have been or are being conducted on the land and its surrounds. This included assessing areas of environmental concern (AECs) and *potential contaminants of concern (PCOCs) and reporting on the potential for contamination on the site, if any, to impact on the planned, future residential use of the land. At the time the proposed development of the area was a manufactured home estate.

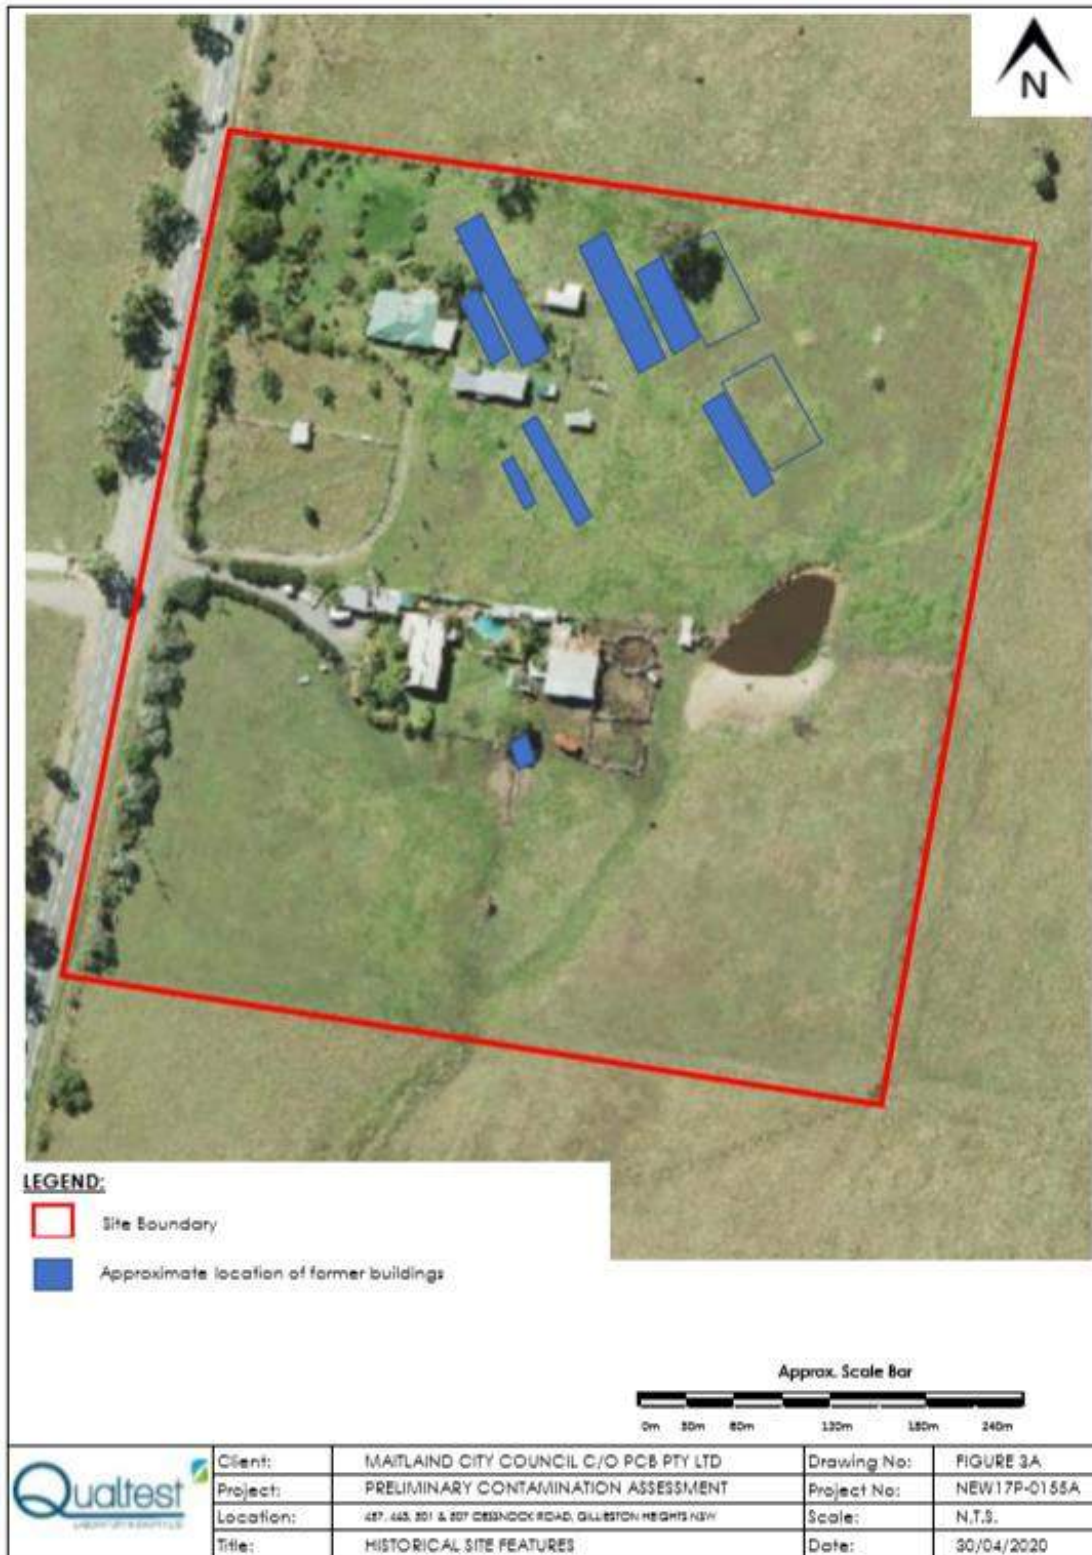
Figure 6: Locations of former structures on site (Lot 1 & 2 DP 302745) identified by Qualtest Laboratory (NSW) Pty Ltd (2020)

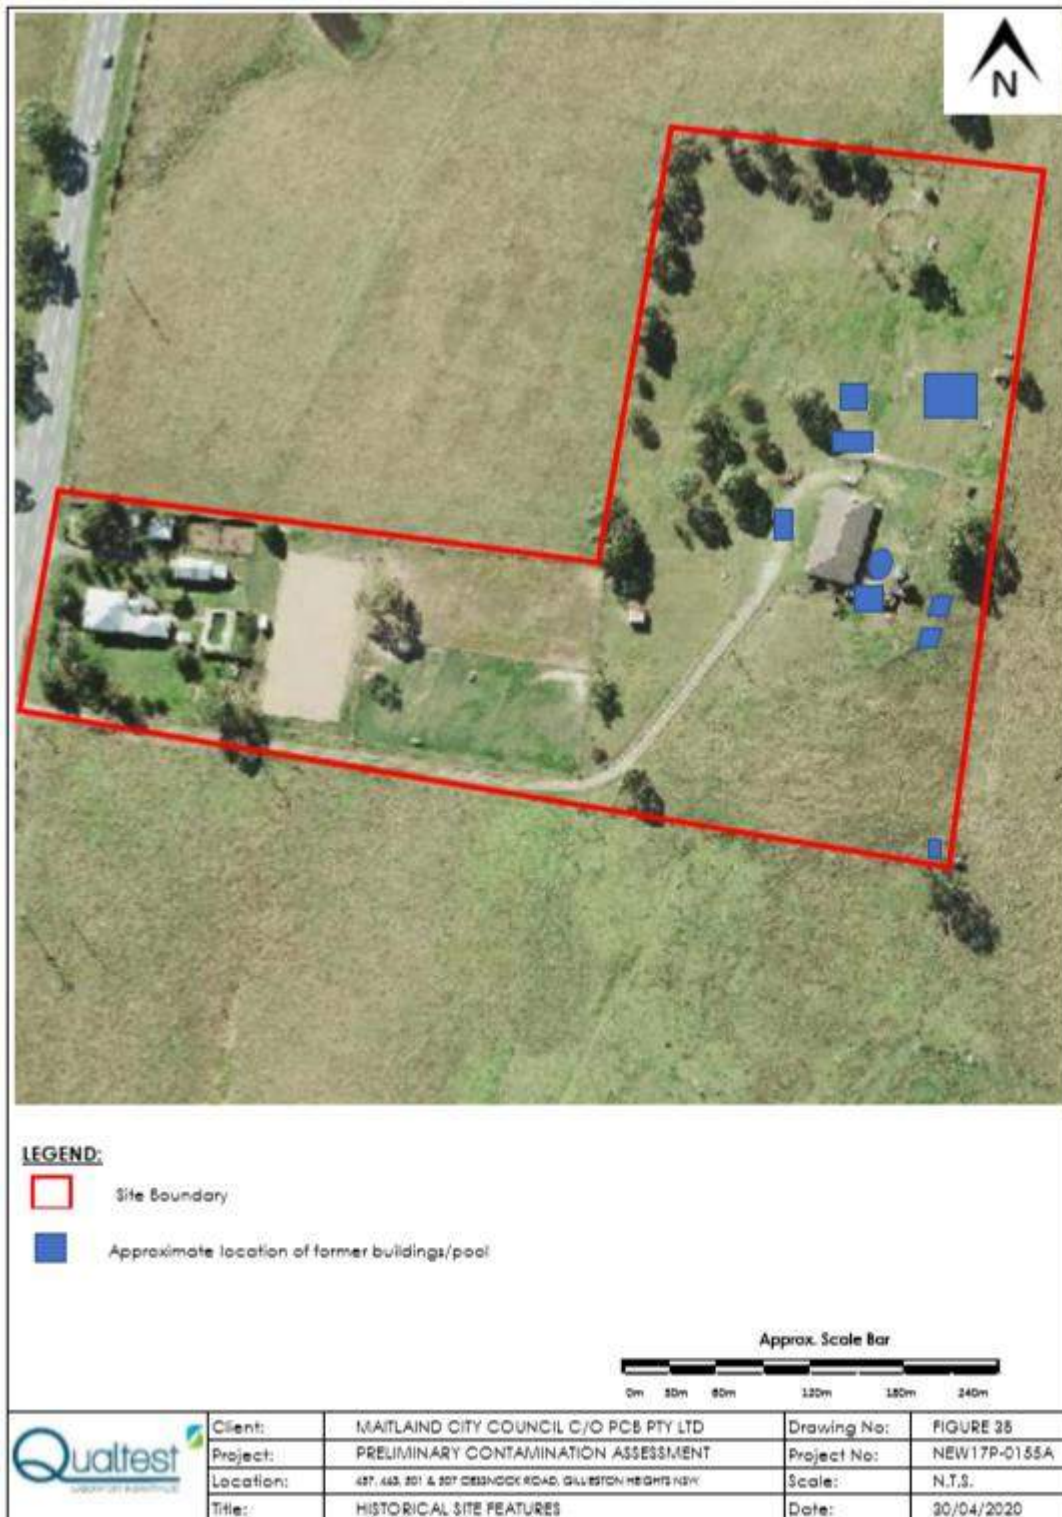
Figure 7: Locations of former structures on site (Lot 1 DP 311179 and Lot 1 DP 601226) identified by Qualtest Laboratory (NSW) Pty Ltd (2020)

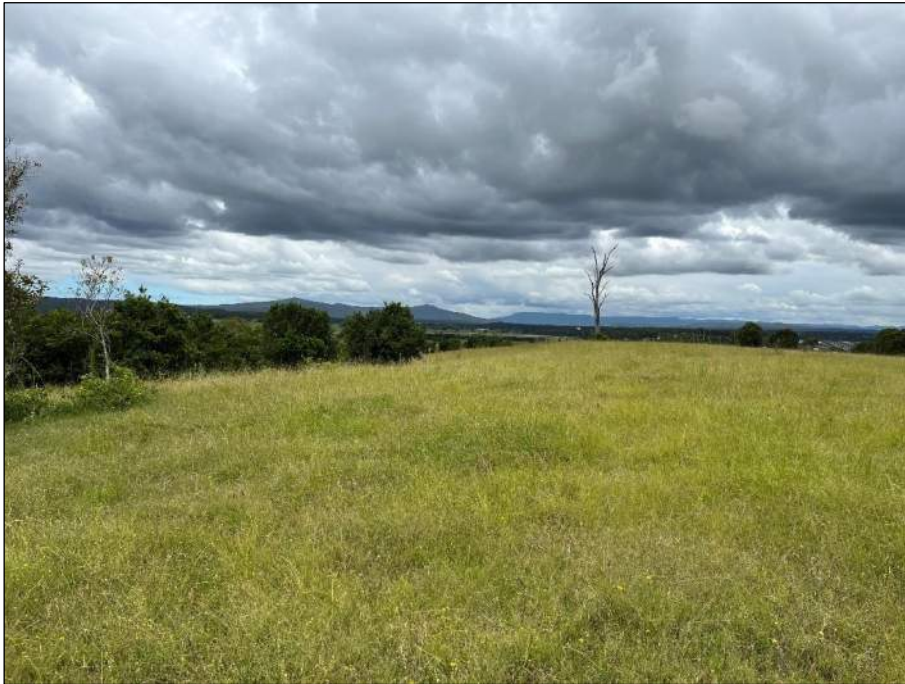
Figure 8: Grassed paddock and ridge in the northern portion of the site, looking south

- The majority of the site surface generally comprised grassed paddocks, including a ridge in the northern portion of the site (Figure 8), with the remainder of the site generally falling to the south and east towards Testers Hollow and Wallis Creek respectively. Figure 9 shows the elevated paddocks in the central portion of the site, with Figure 10 illustrating the low-lying areas of the southern portion of the site;

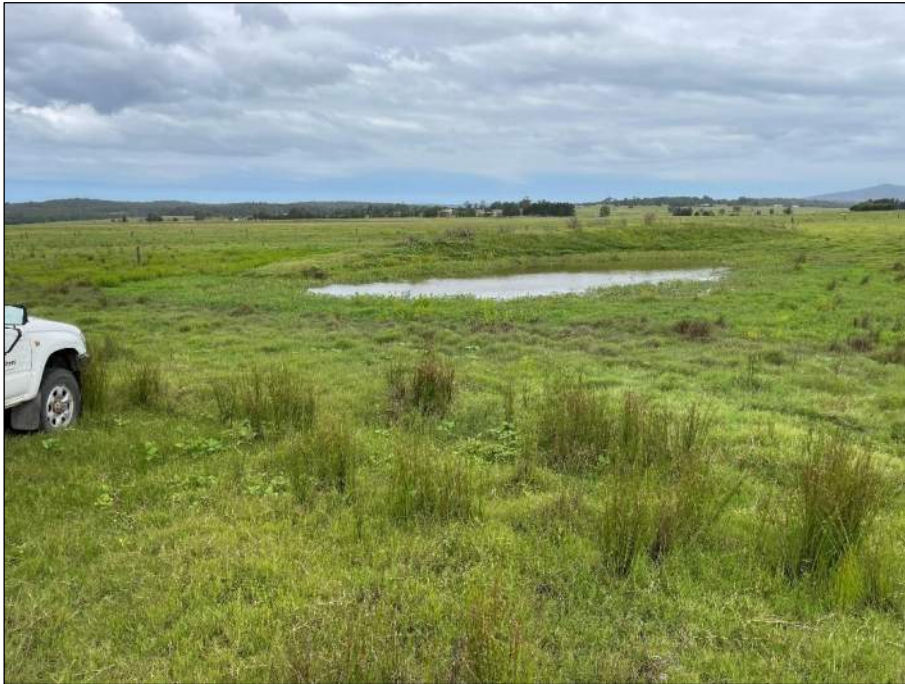
Figure 10: Grassed paddock and dam in the southern portion of the site, looking south

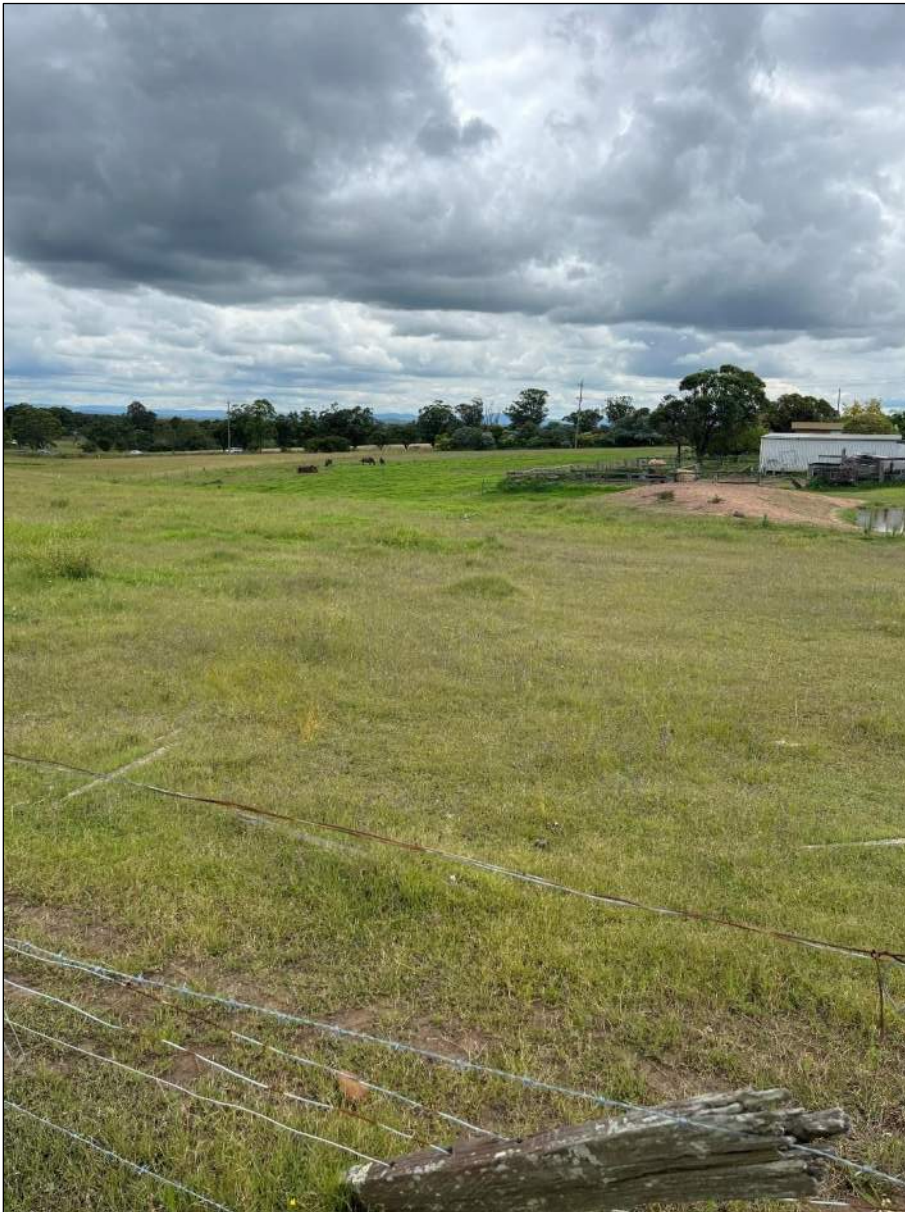
Figure 11: Residential and hobby farm structures and paddocks immediately north-west of the subject site, looking south-west

- Residential and hobby farm properties in the lots immediately north-west of the subject site (Figure 11). It was noted that surface water drainage from these lots flow onto the subject site (Figure 12). Several structures, enclosures and a dam were observed within the adjacent sites;

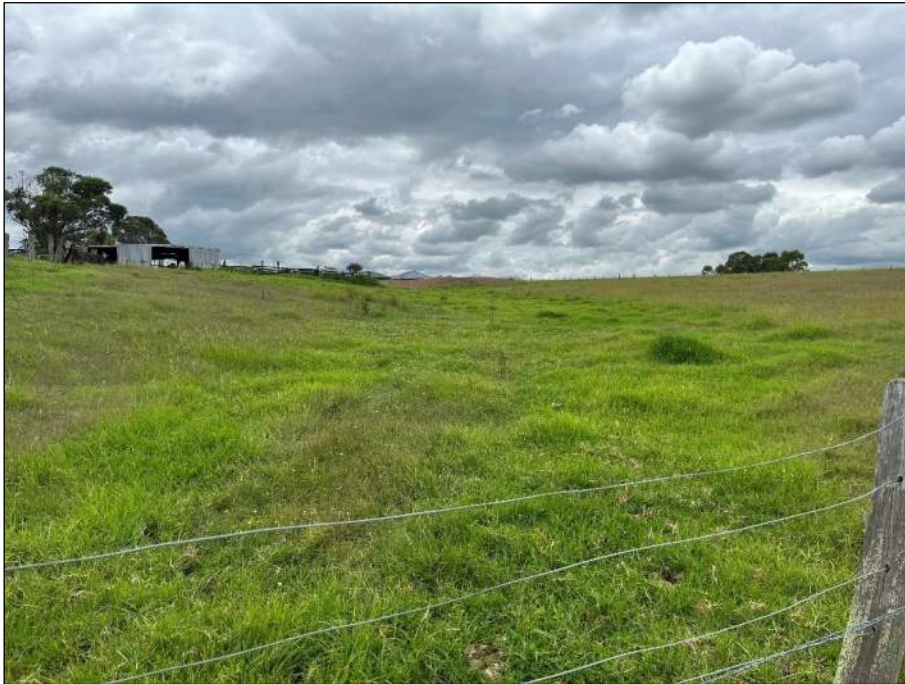
Figure 12: Drainage line flowing from the adjacent site to the north-west onto the subject site, looking north-east

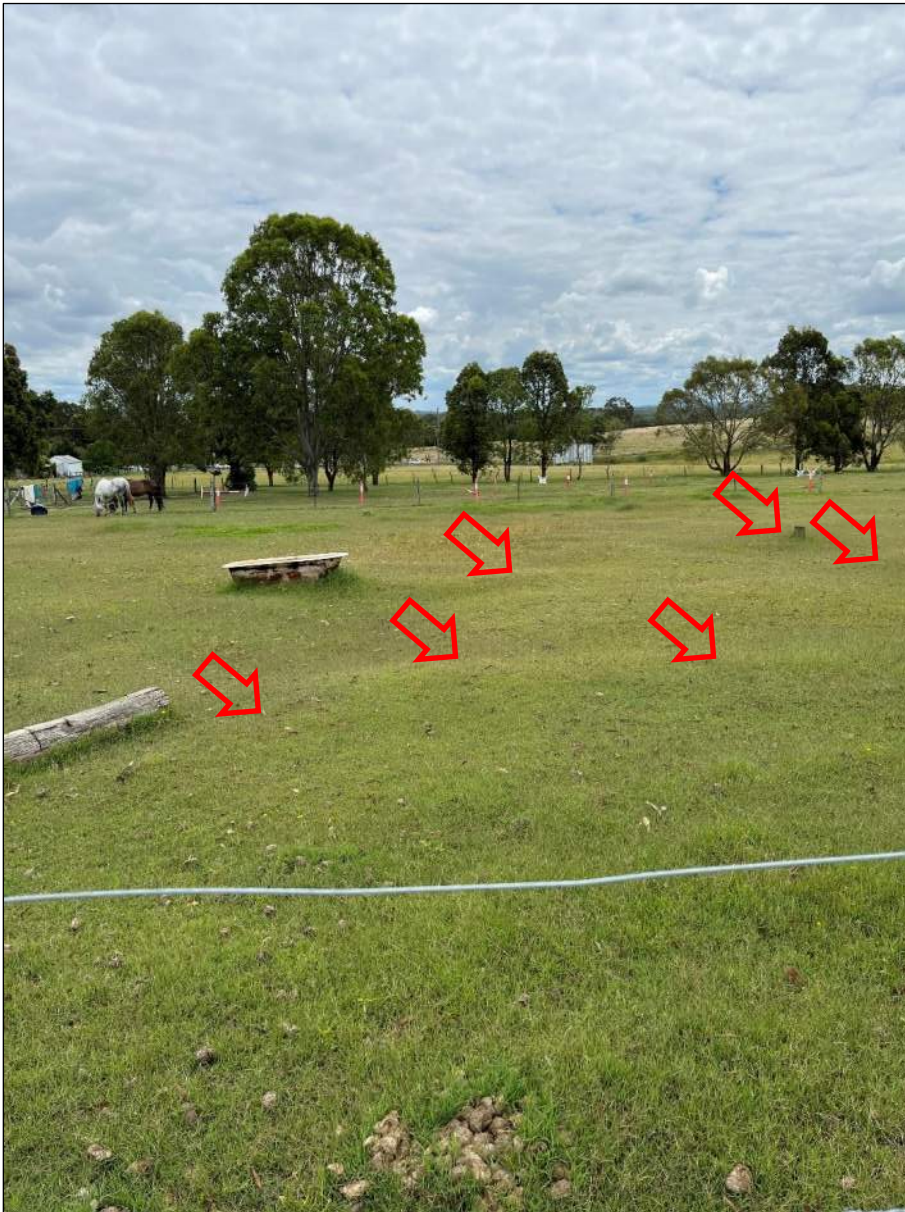
Figure 13: Possible ground disturbance within Lot 1 DP 601226. Arrows show locations of raised/disturbed ground

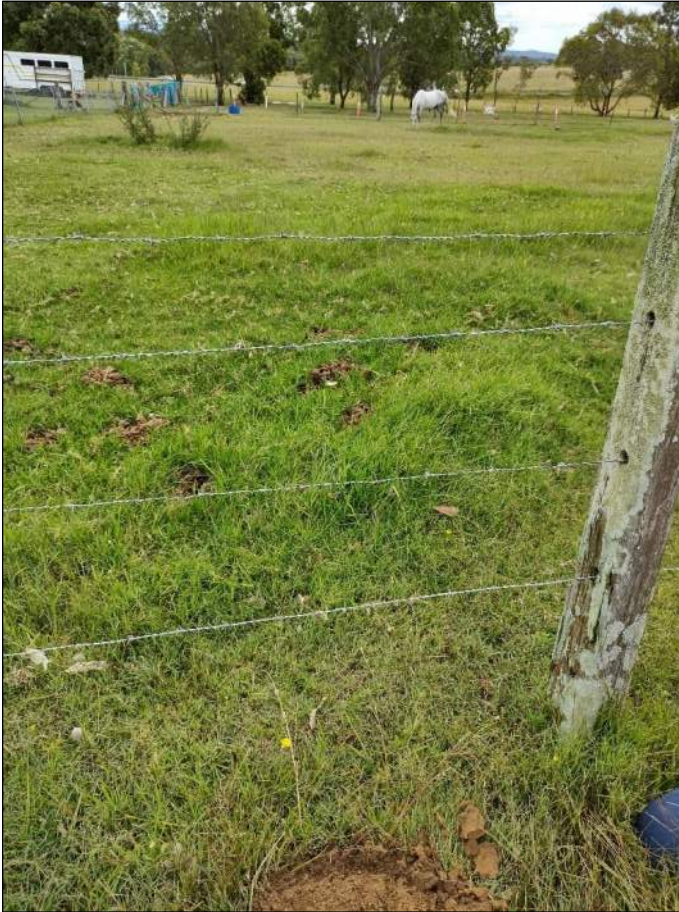
Figure 14: Possible ground disturbance within Lot 1 DP 601226.

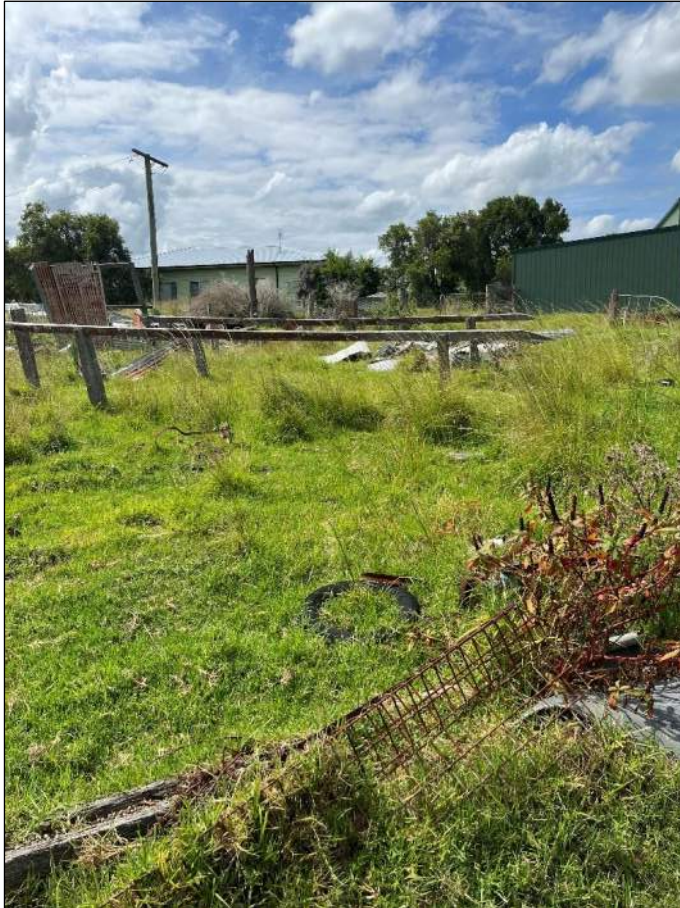
Figure 15: Residential dwelling, metal clad and framed shed structure and evidence of former animal holding area, central-southern portion of the site, looking north

- A residential structure and associated agricultural shed structures were observed in the central-southern portion of the site, within Lot 2 DP 601226 (Figures 15 and 16);

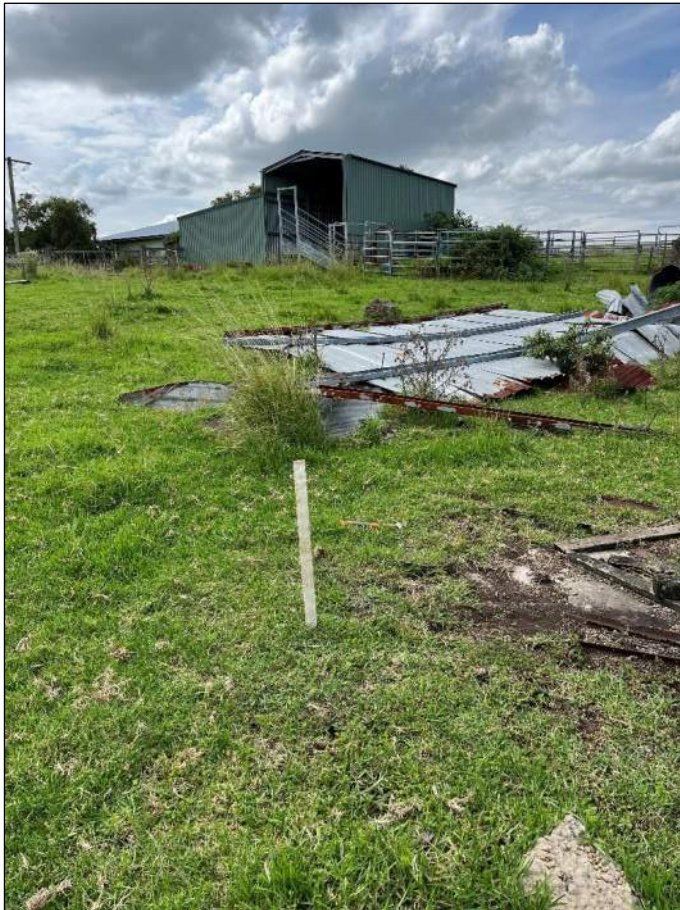
Figure 16: Residential dwelling, metal clad and framed shed structure and evidence of former animal holding area, central-southern portion of the site, looking north-east

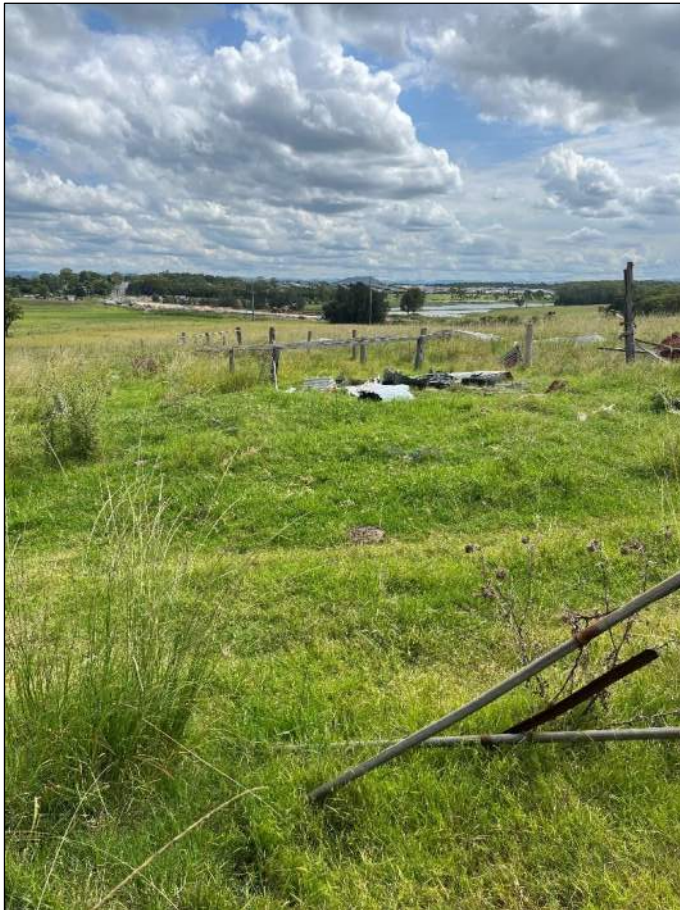
Figure 17: Building materials and uneven ground in the central-southern portion of the site, looking south-west

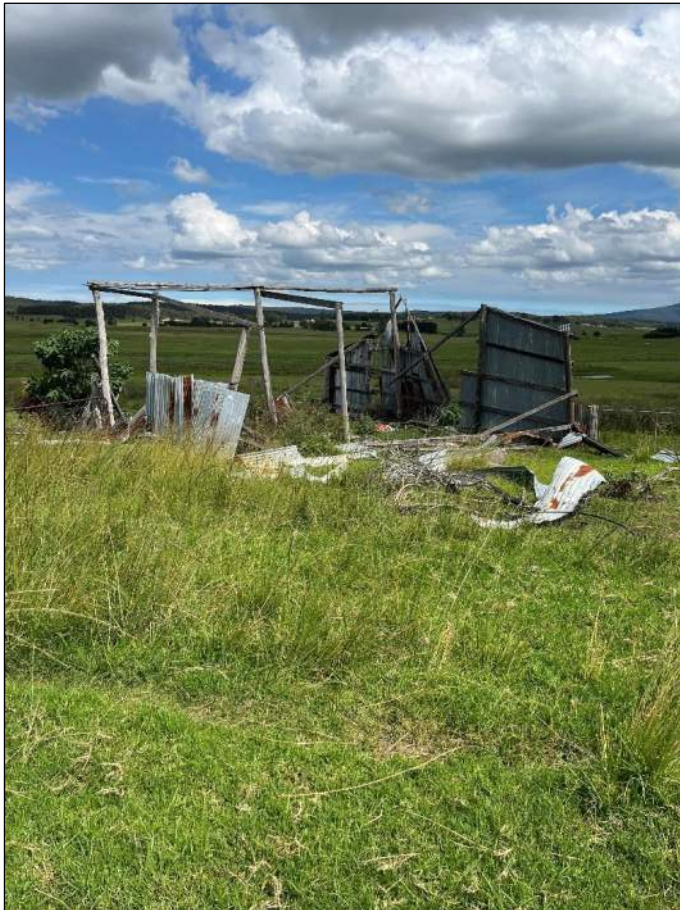
Figure 18: Building materials, remnant structure and uneven ground in the central-southern portion of the site, looking south-east

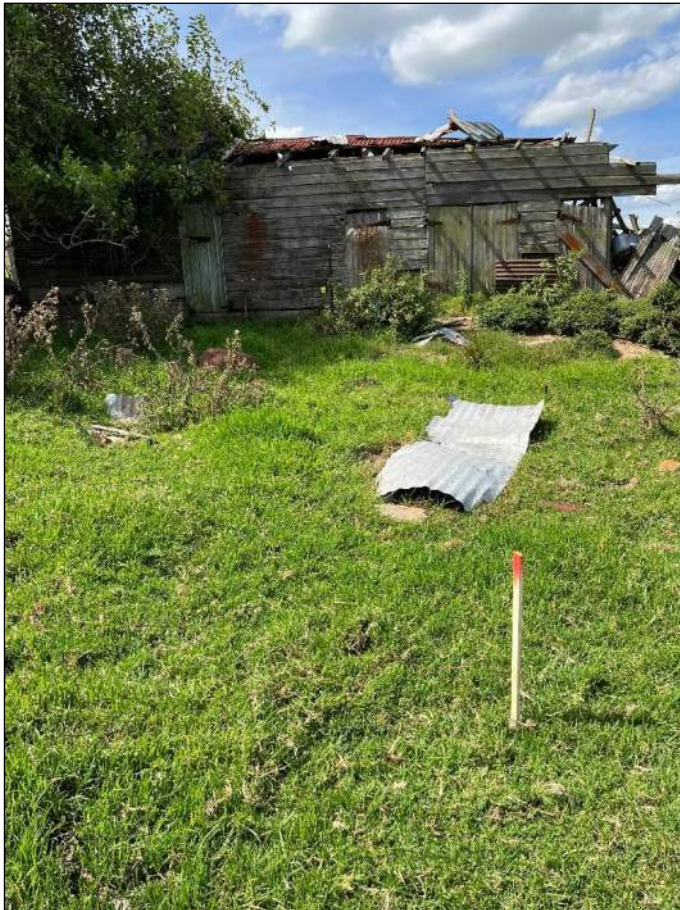
Figure 19: Former dairy structure, of timber and metal construction, in the central-southern portion of the site, looking north

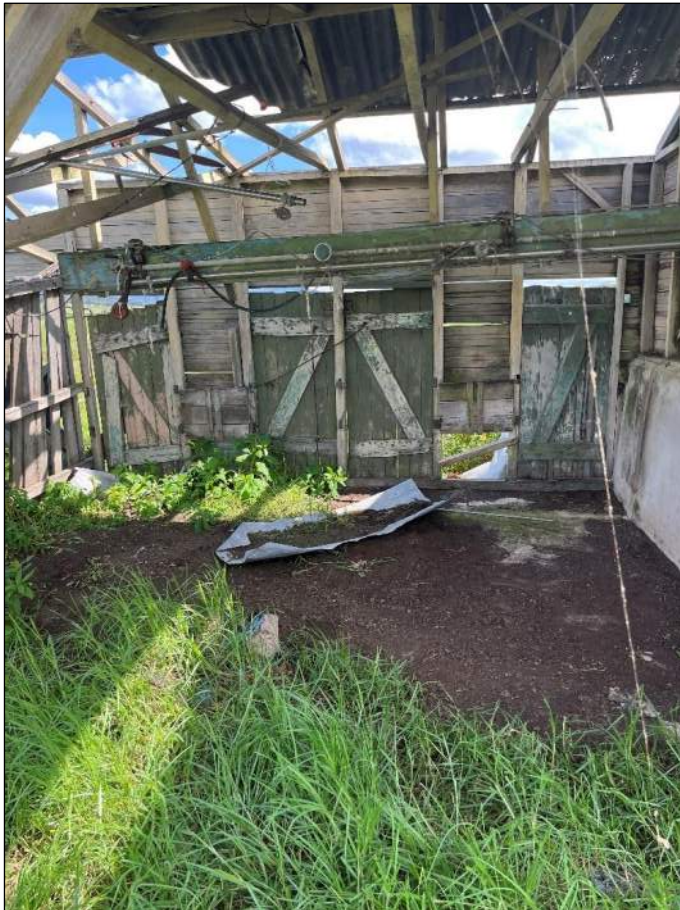
Figure 20: Former dairy structure, of timber and metal construction, in the central-southern portion of the site, looking south

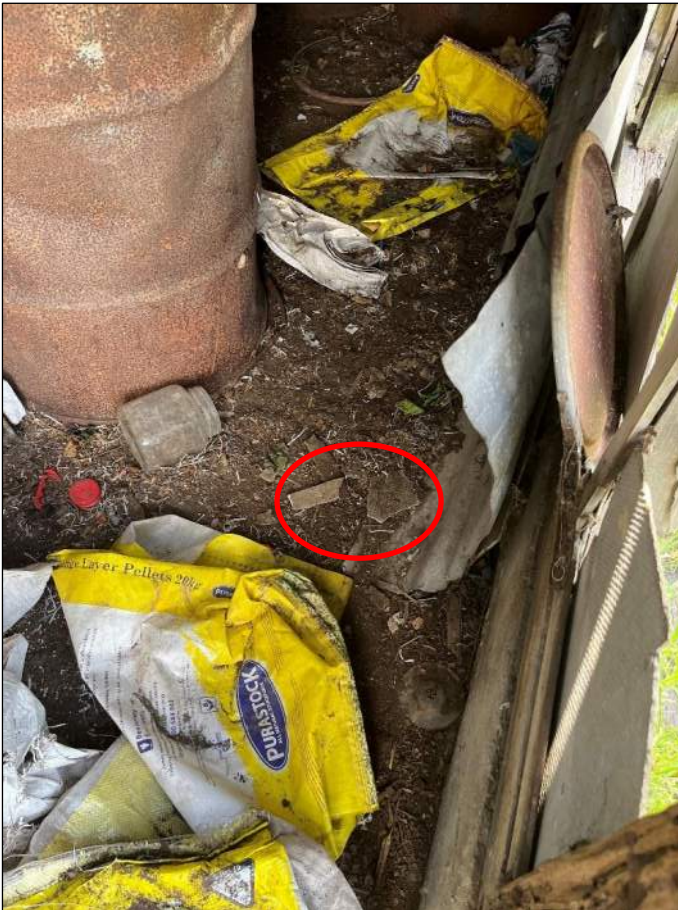
Figure 21: Cement sheeting/cladding on the walls of a portion of the former dairy, with some broken sheeting on the exposed soil (in red circle) in the central-southern portion of the site.

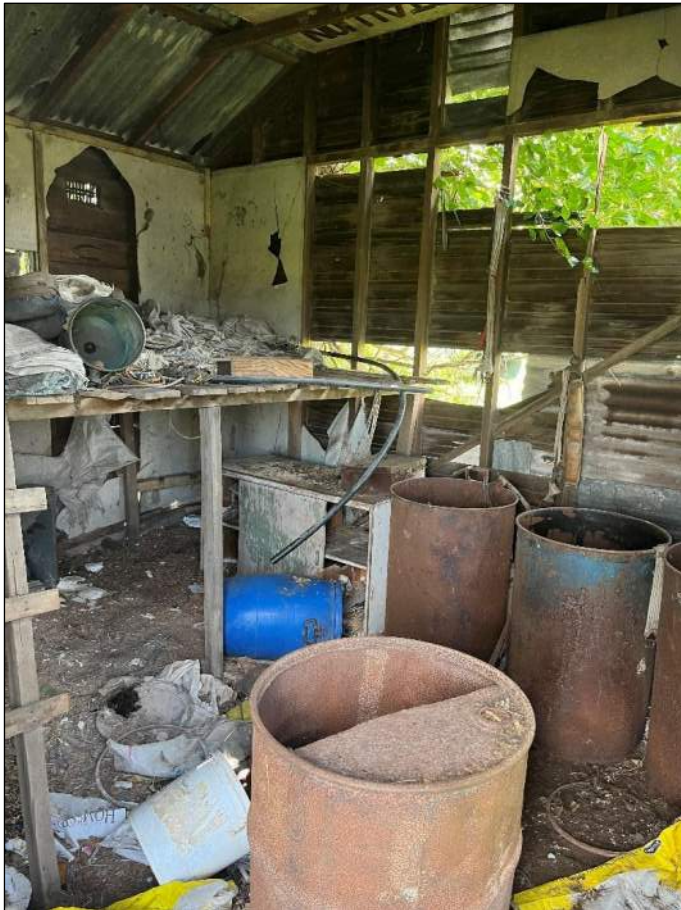
Figure 22: Oil/fuel barrels within the former dairy structure in the central-southern portion of the site

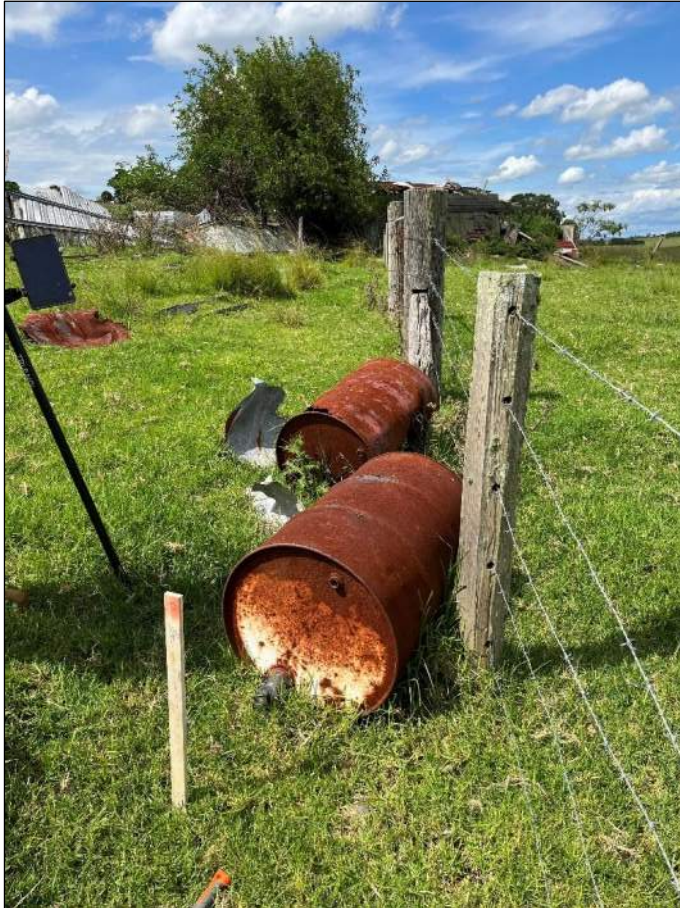
Figure 23: Oil/fuel barrels in the central-southern portion of the site

- Some evidence of possible fuel/oil storage was also observed in the former dairy farm area and surrounds (Figures 22 and 23);
- Storage of cement pipes (possible asbestos containing materials) in the central-southern portion of the site (Figure 24); and

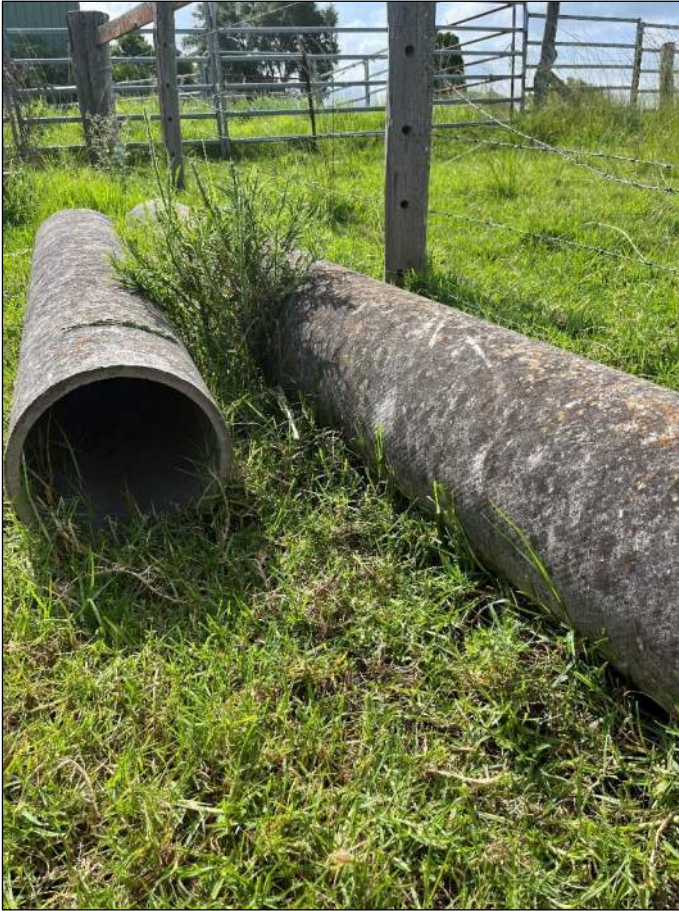
Figure 24: Cement pipes (possible asbestos containing materials) in the central-southern portion of the site (i.e. former dairy area)

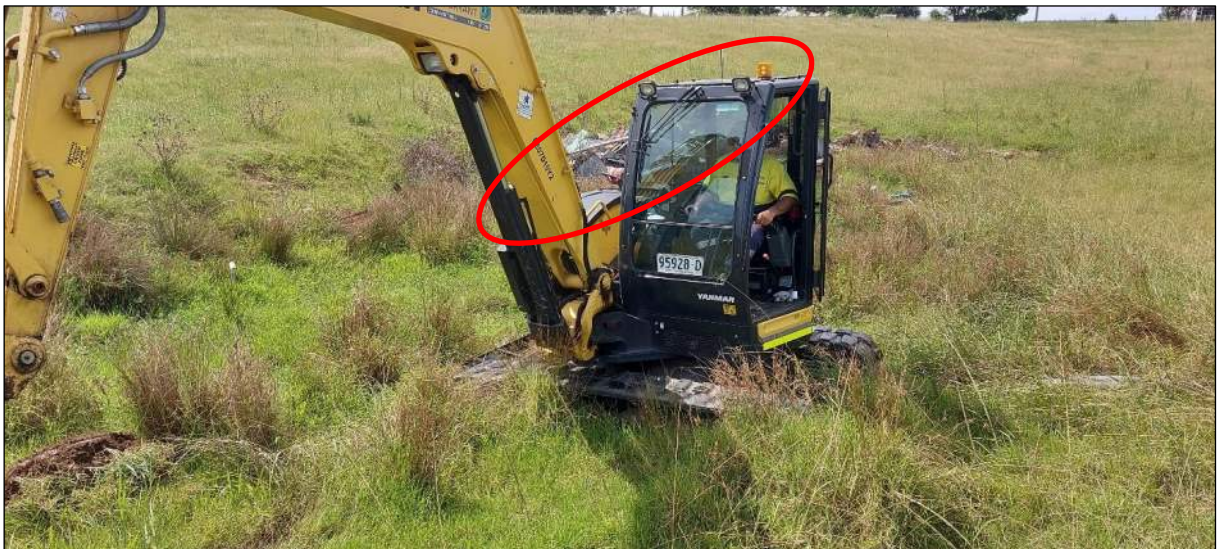
Figure 25: Infilled dam (red circle) in the central-southern portion of the site, looking north

- Infilled drainage channel/dam in the central-southern portion of the site. The dumped material included metal sheeting and timber (Figure 25).

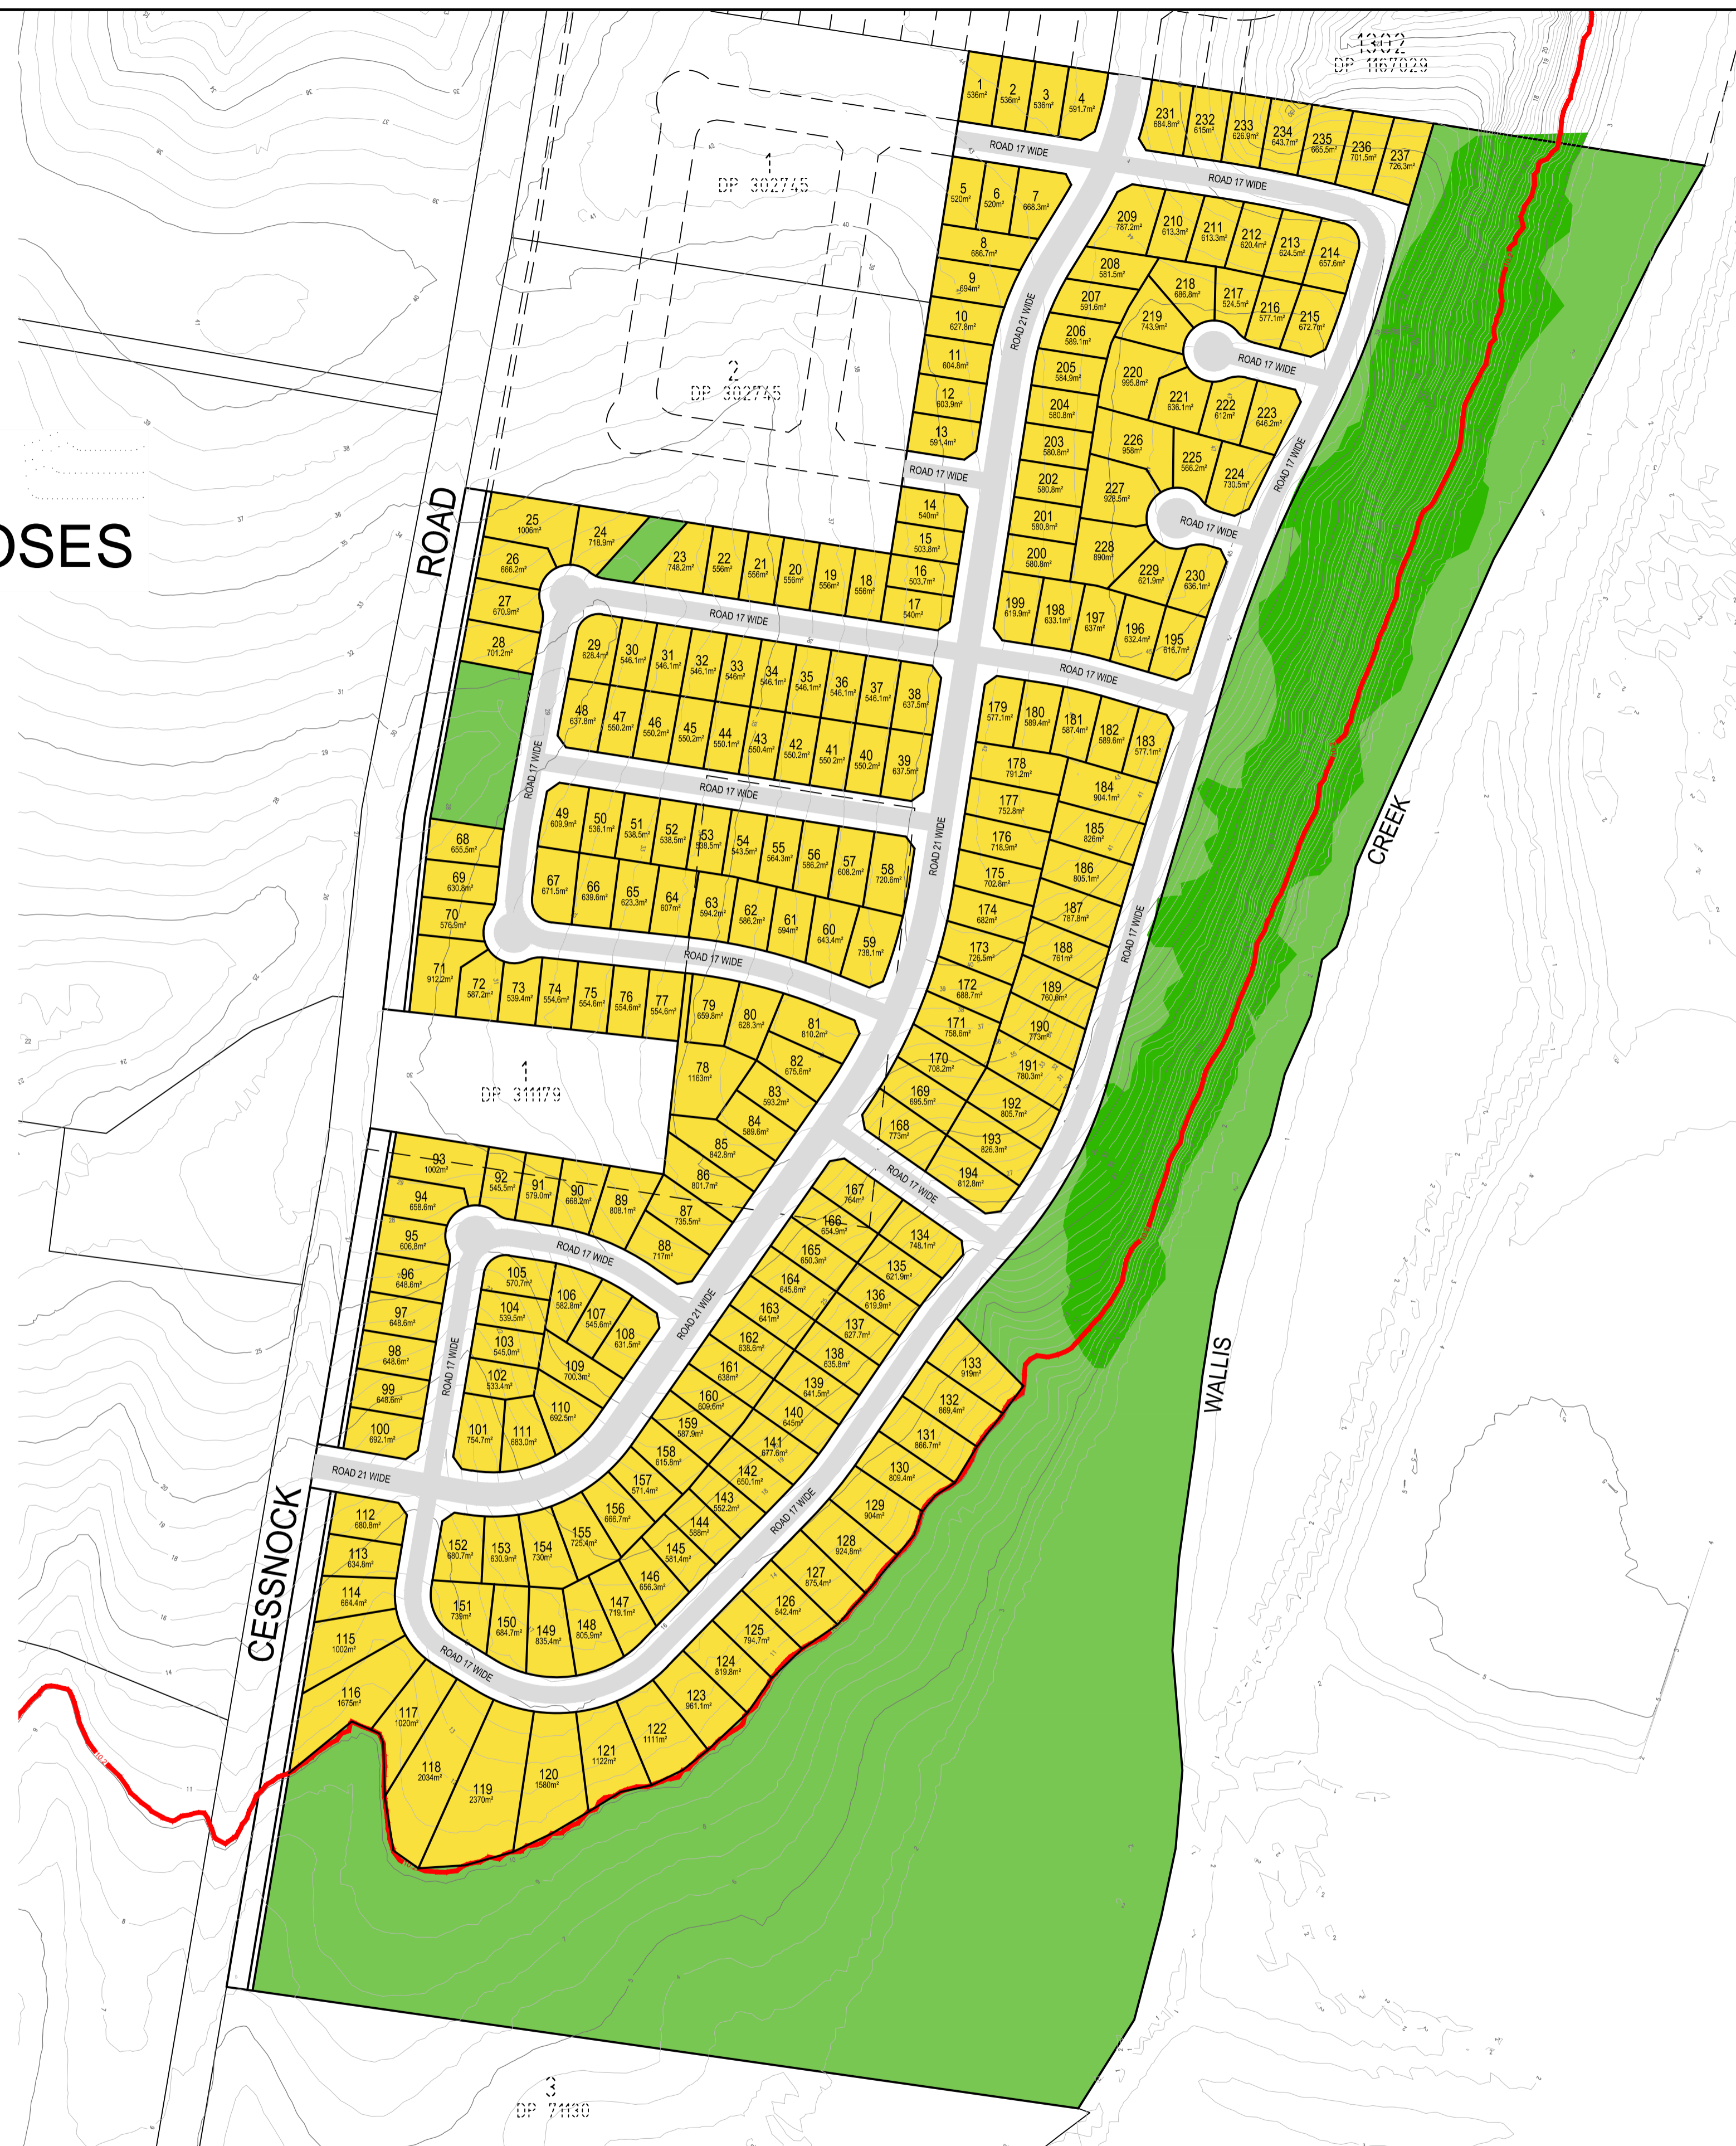
237 LOTS

LAYOUT A DESKTOP EXERCISE ONLY
NO SURVEY OR PRELIMINARY ENGINEERING
DESIGN UNDERTAKEN

CONTOURS - FROM LIDAR INFORMATION
FLOOD LEVEL RL 10.2m (ADOPTED)
(CURRENT FLOOD LEVEL 9.73m AHD
- MCC UNDER REVIEW)
