Report on Earthworks Strategy

457-527 Cessnock Road, Gillieston
Heights

304100964-002

Prepared for
Walker Gillieston Heights Pty Ltd

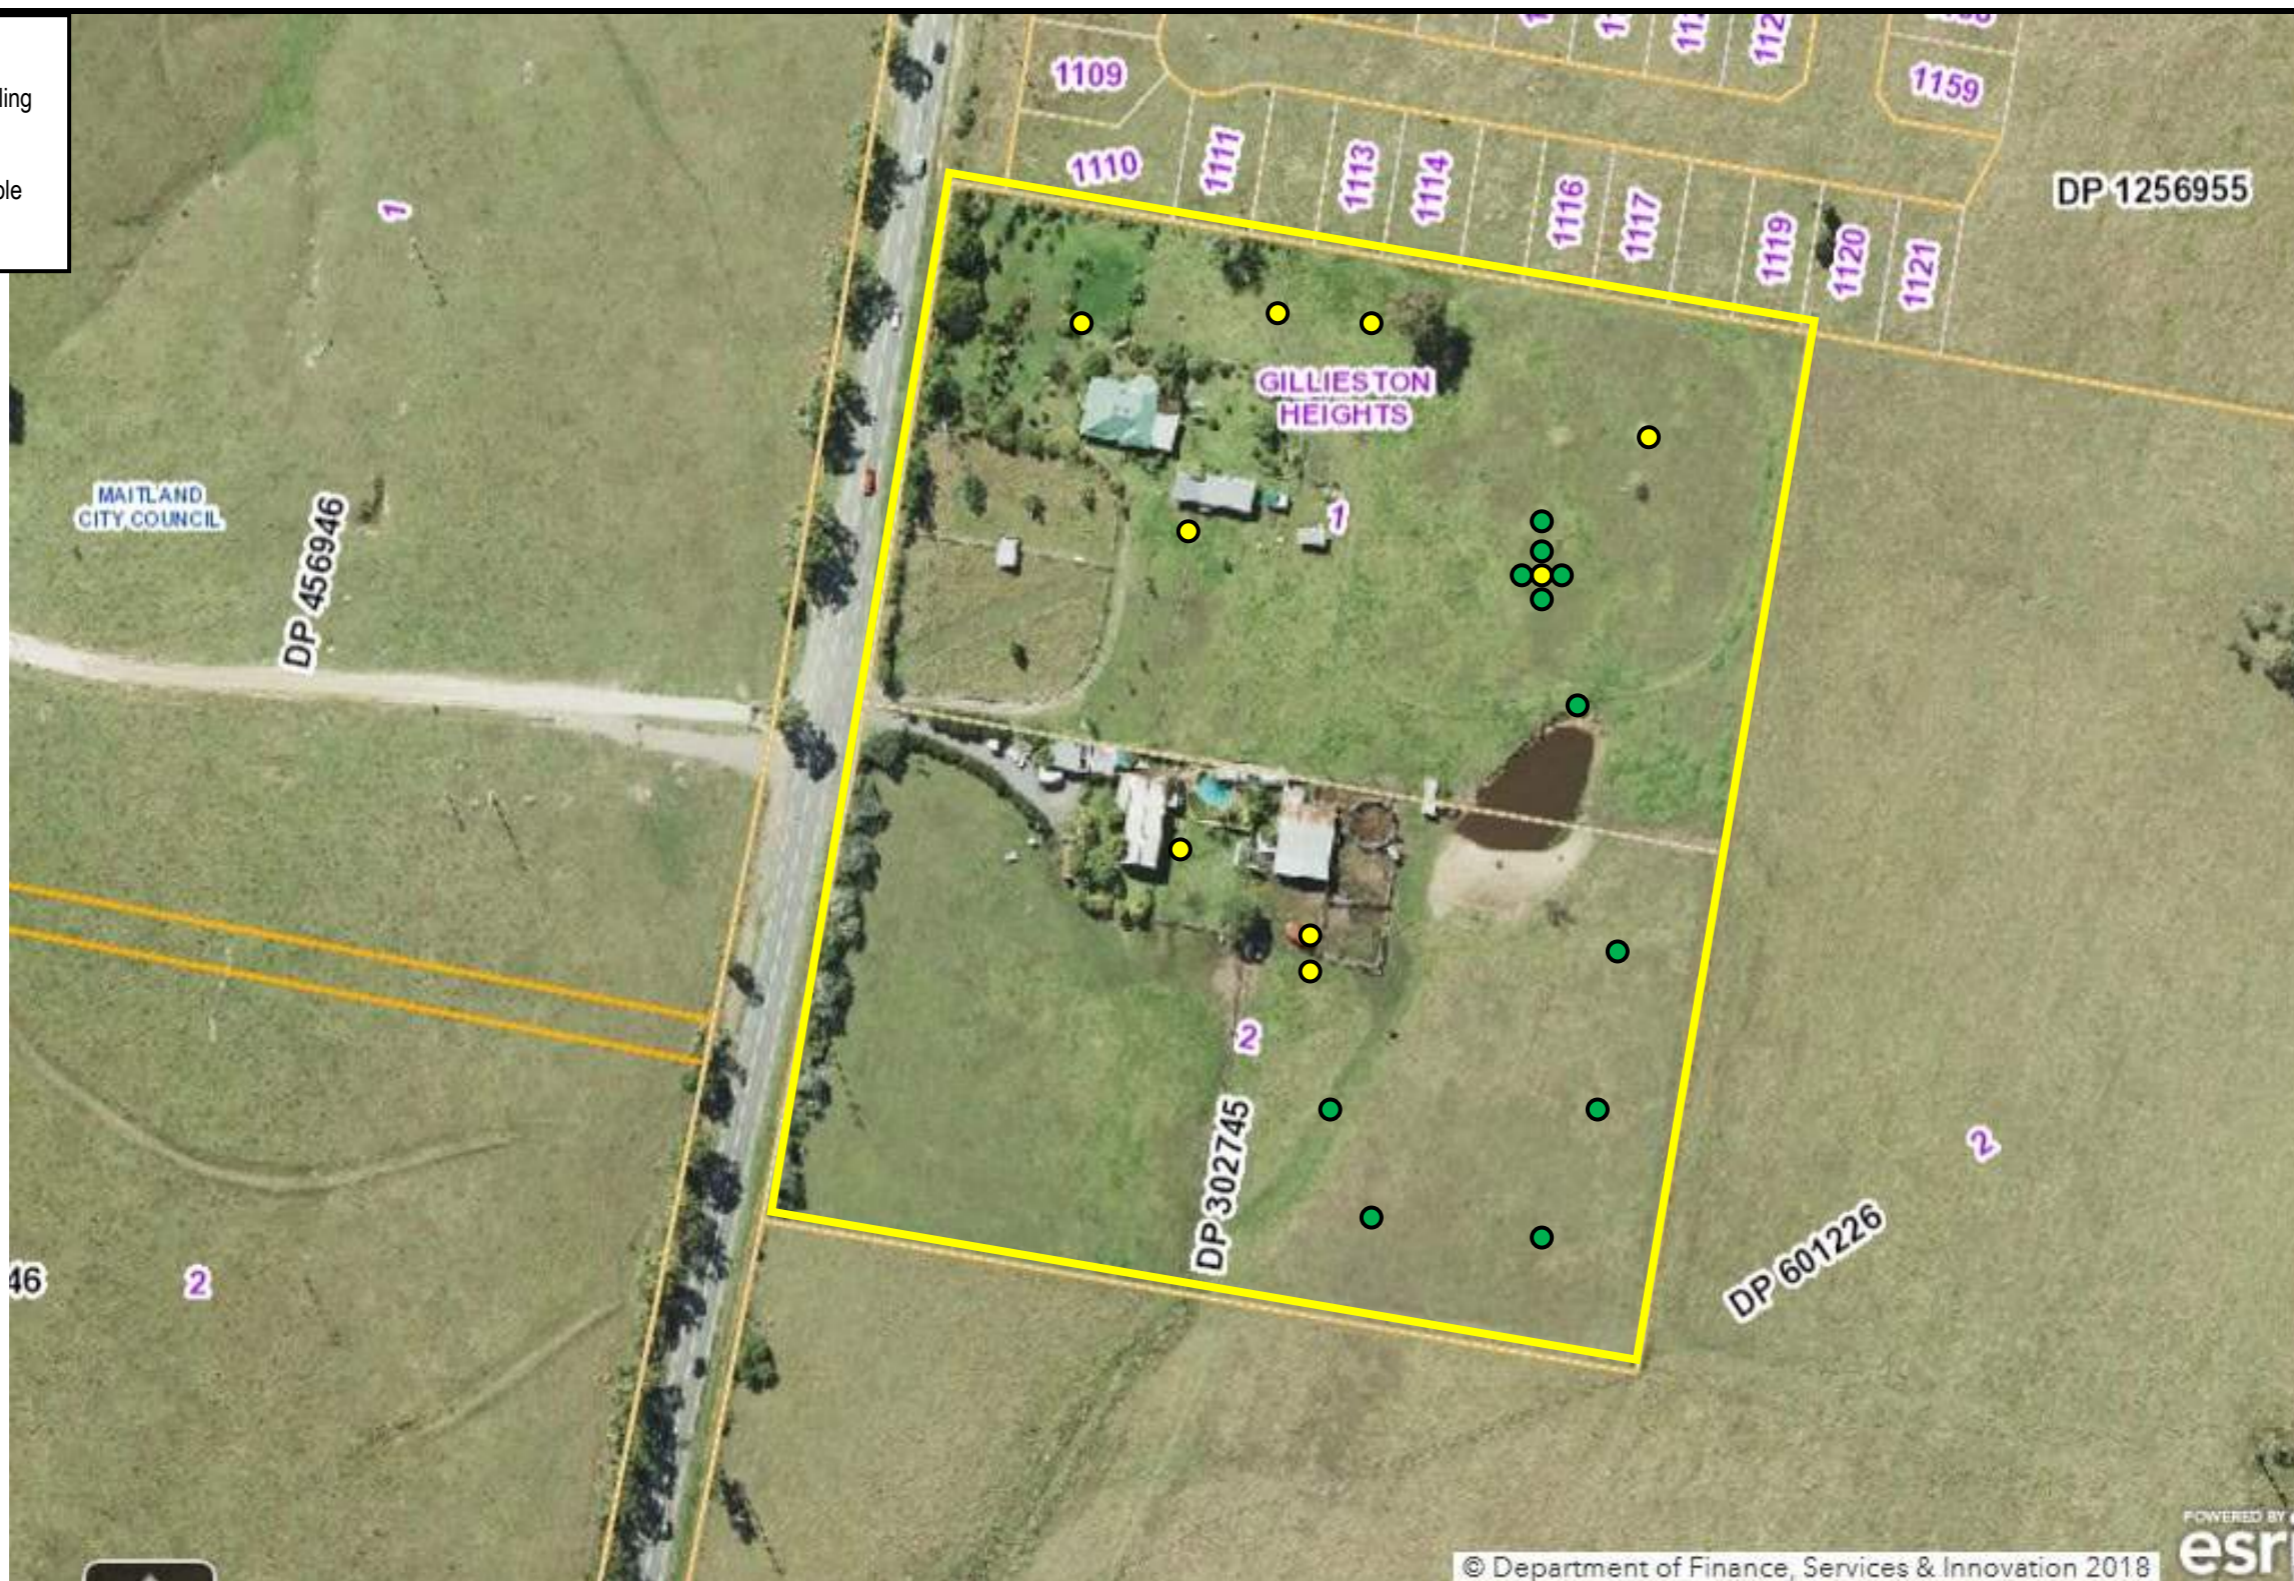
PROJECT TITLE: PSI			DRAWING TITLE: Sampling Locations		
CLIENT: Roter Sand Unit Trust					
DATE: 24/01/2020	SCALE: NTS	DESIGNED: D McQueeney	DRAWING NUMBER: 2	JN: 20.2732	
PRACTICAL ENVIRONMENTAL SOLUTIONS			SOURCE: SIX Maps (NSW Government 2019)

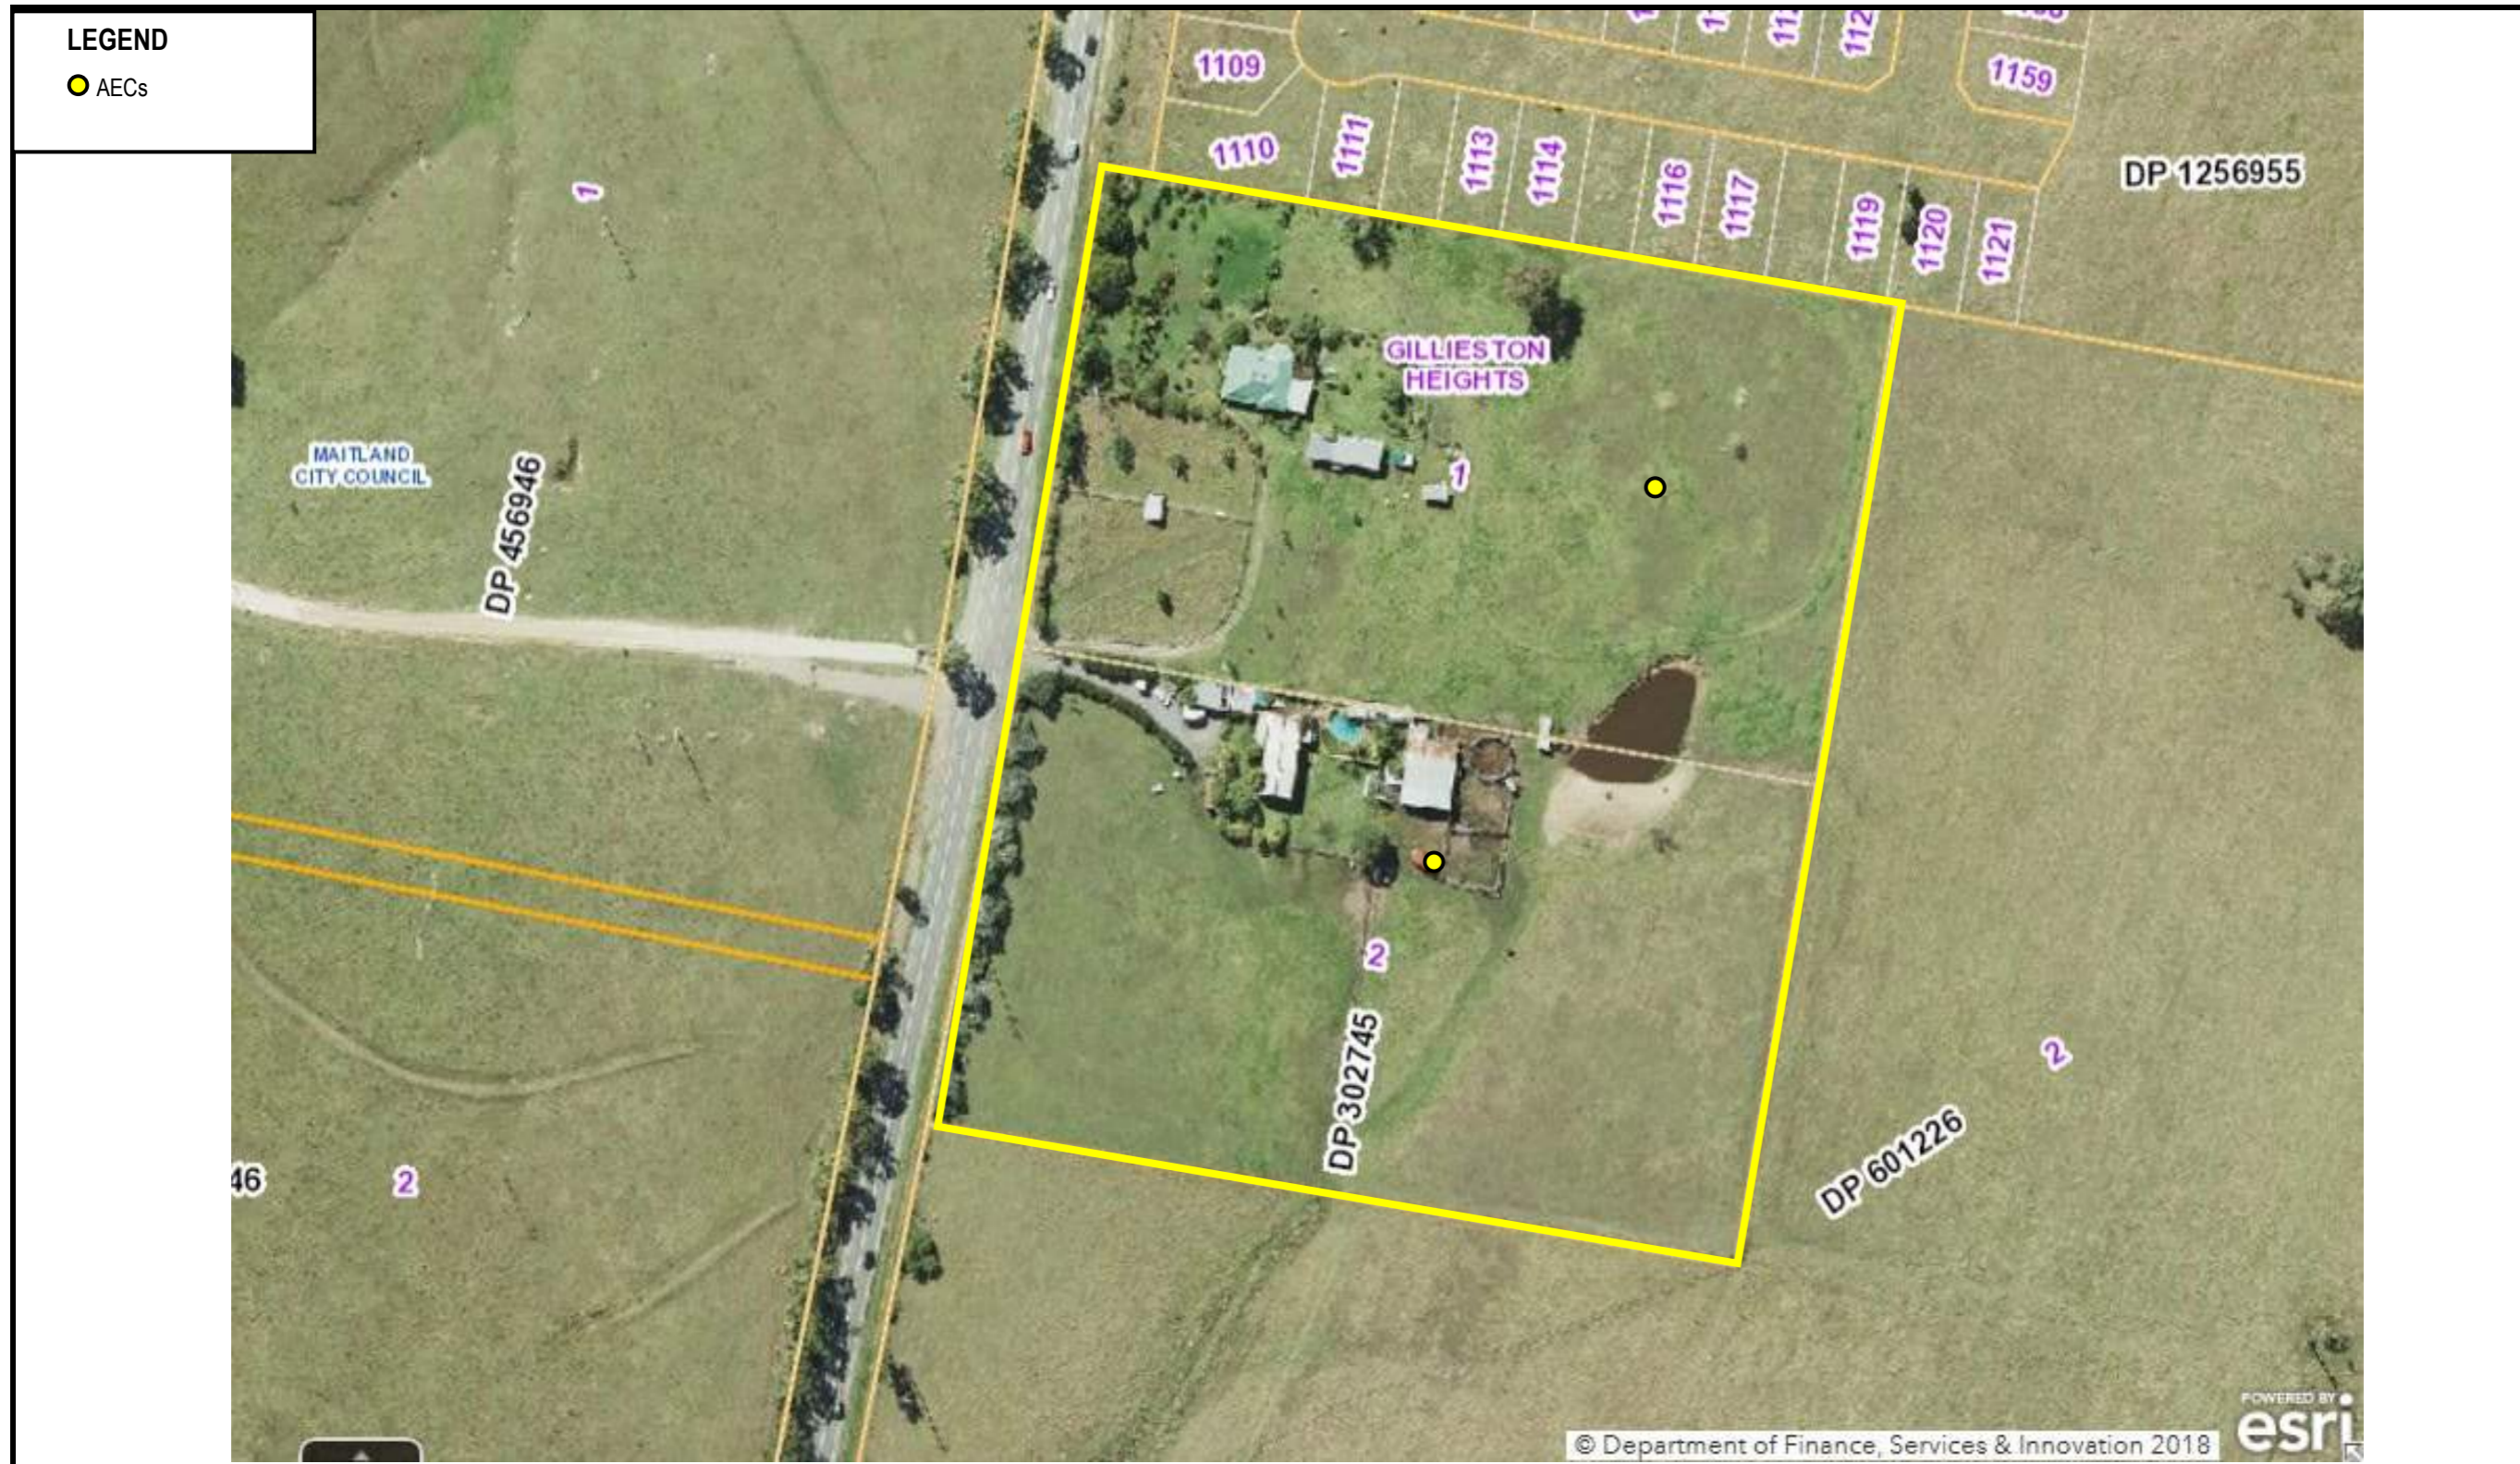
PROJECT TITLE: PSI			DRAWING TITLE: AECs		
CLIENT: Roter Sand Unit Trust					
DATE: 24/01/2020	SCALE: NTS	DESIGNED: D McQueeney	DRAWING NUMBER: 3	JN: 20.2732	
PRACTICAL ENVIRONMENTAL SOLUTIONS			SOURCE: SIX Maps (NSW Government 2019)

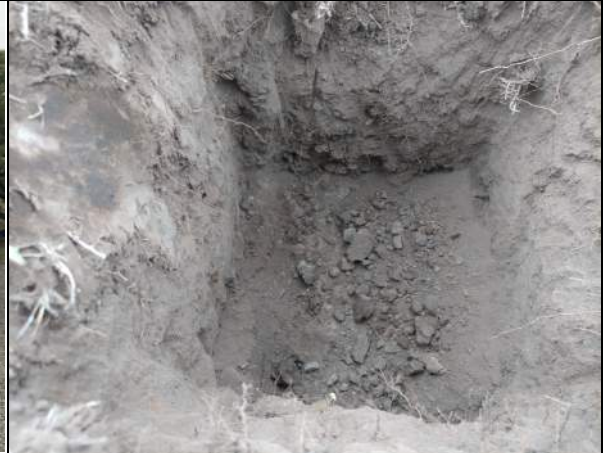
Photograph 2: Example Test Pit

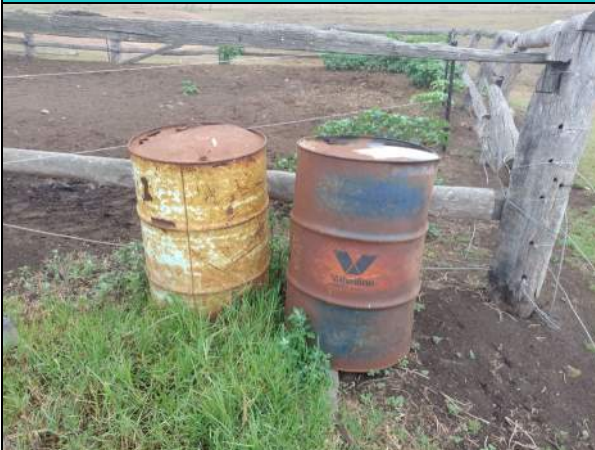
Photograph 5: 44 Gallon (205 lt.) Drums

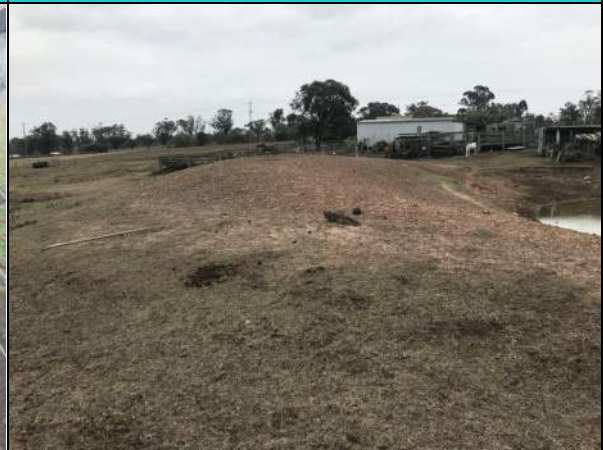
Photograph 6: Dam Wall

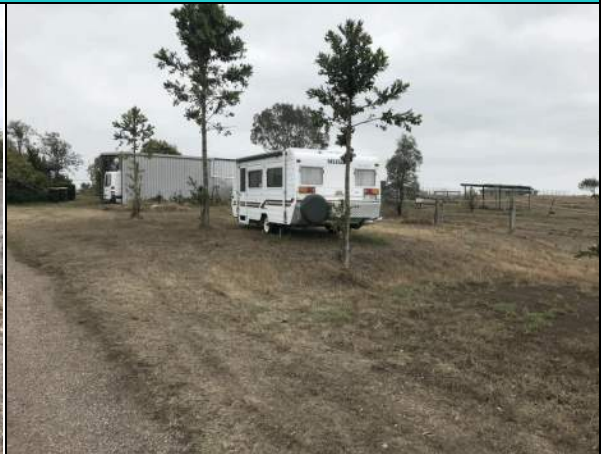
Photograph 8: Cut / Fill Area

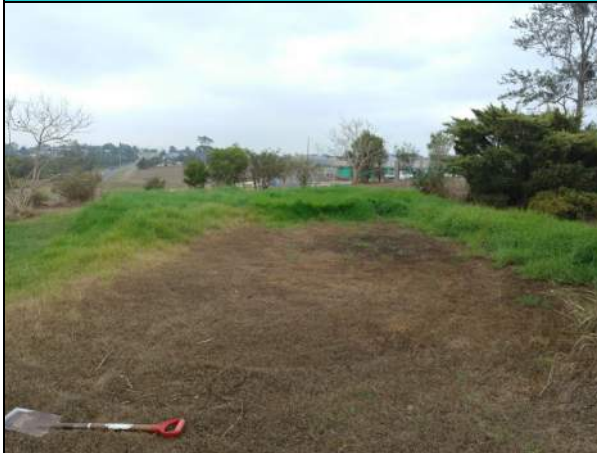
Photograph 9: Sewage Transpiration Bed

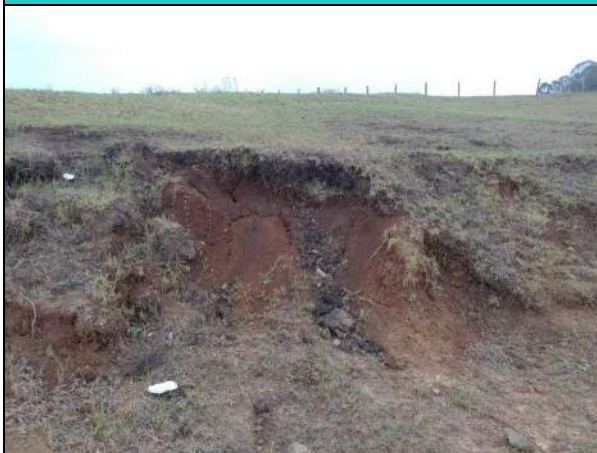
Photograph 11: Dam wall (North Elevation)

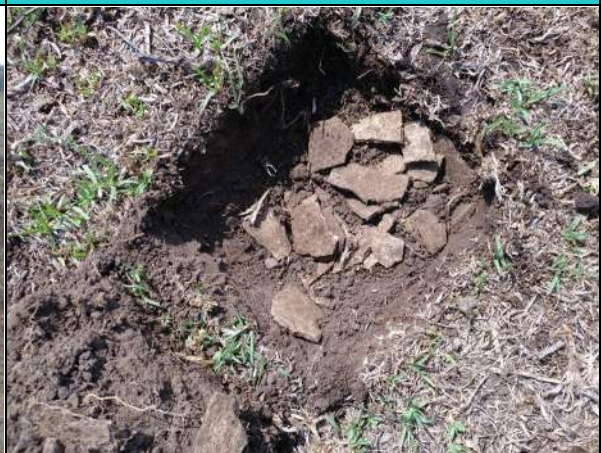
Photograph 12: ACM 'Find'

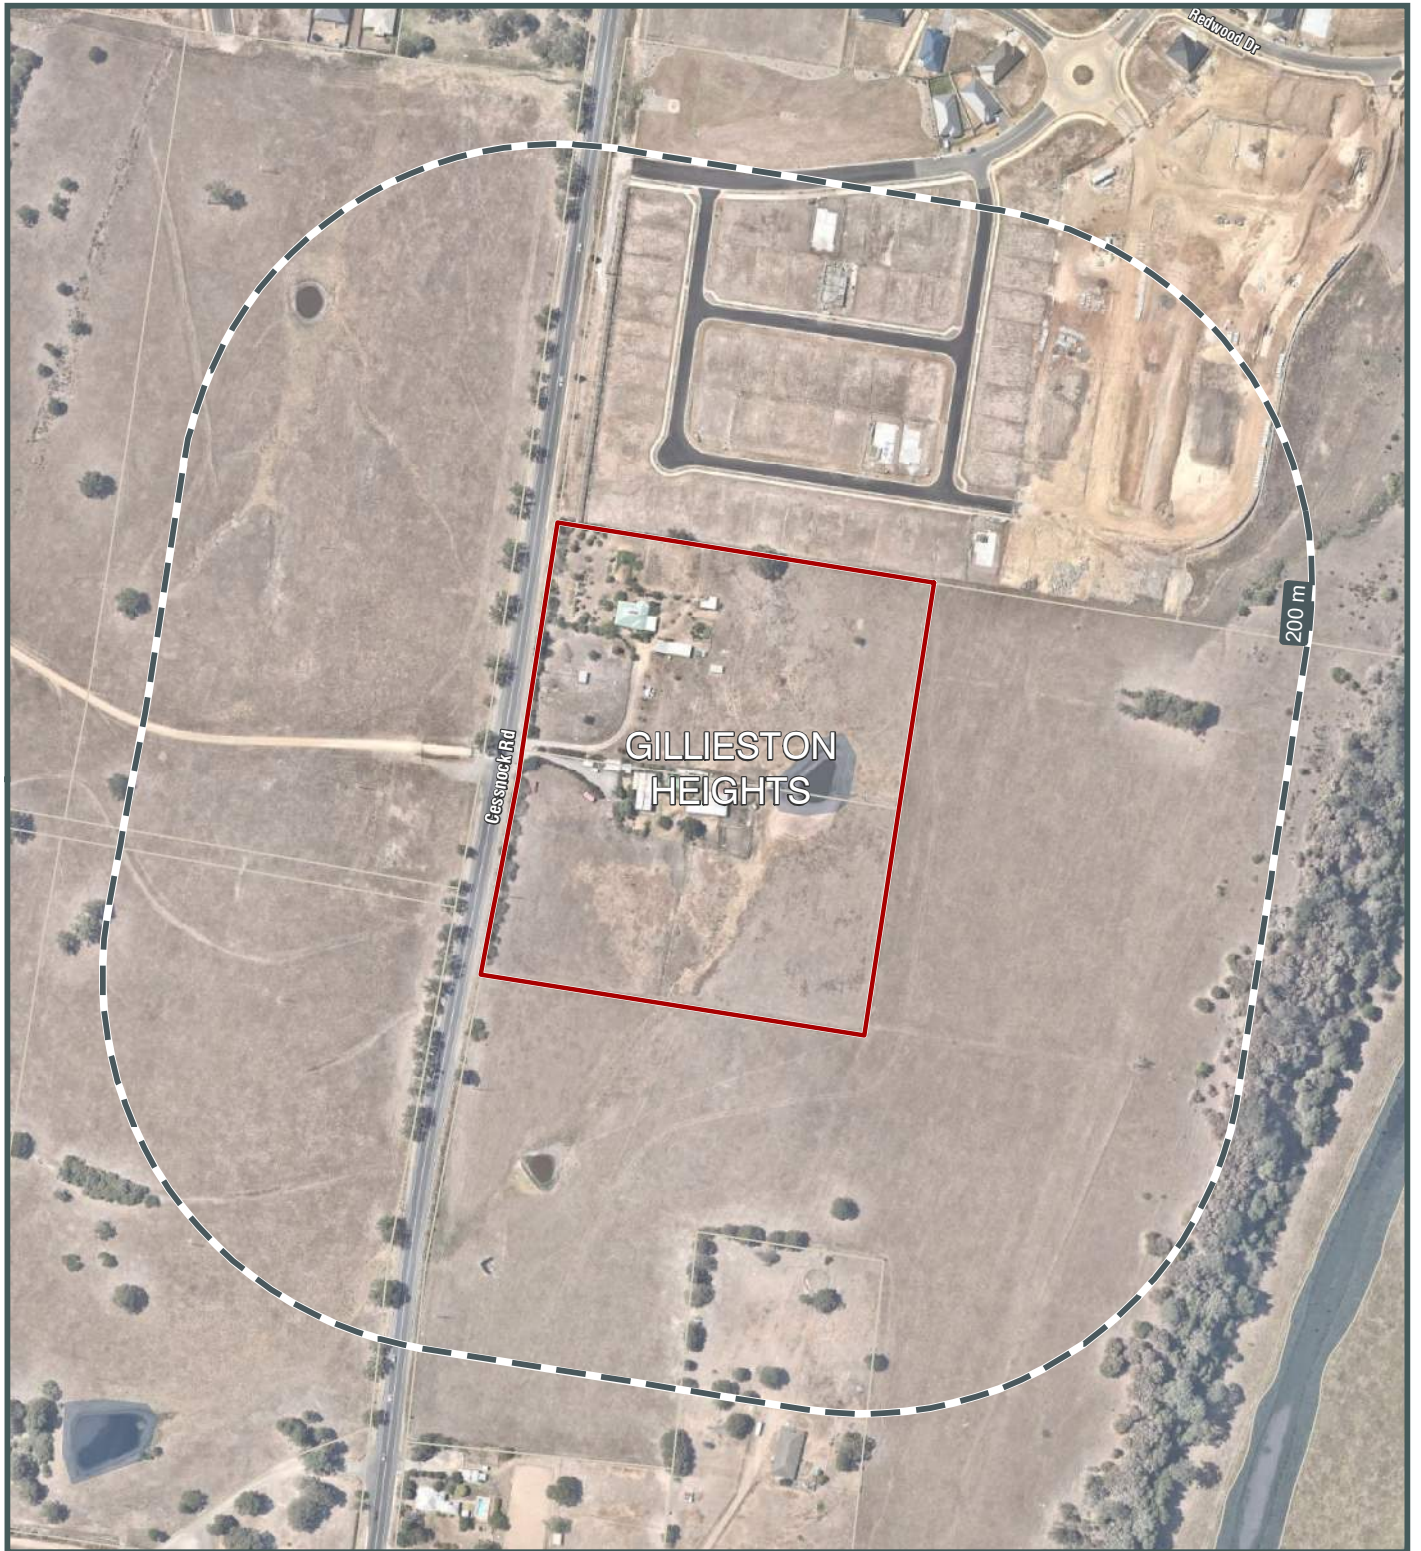
- Subject area
- Cadastral boundary
- Transmission Line
- Stormwater channel
- Sewer Main
- Water Main
- Pipeline

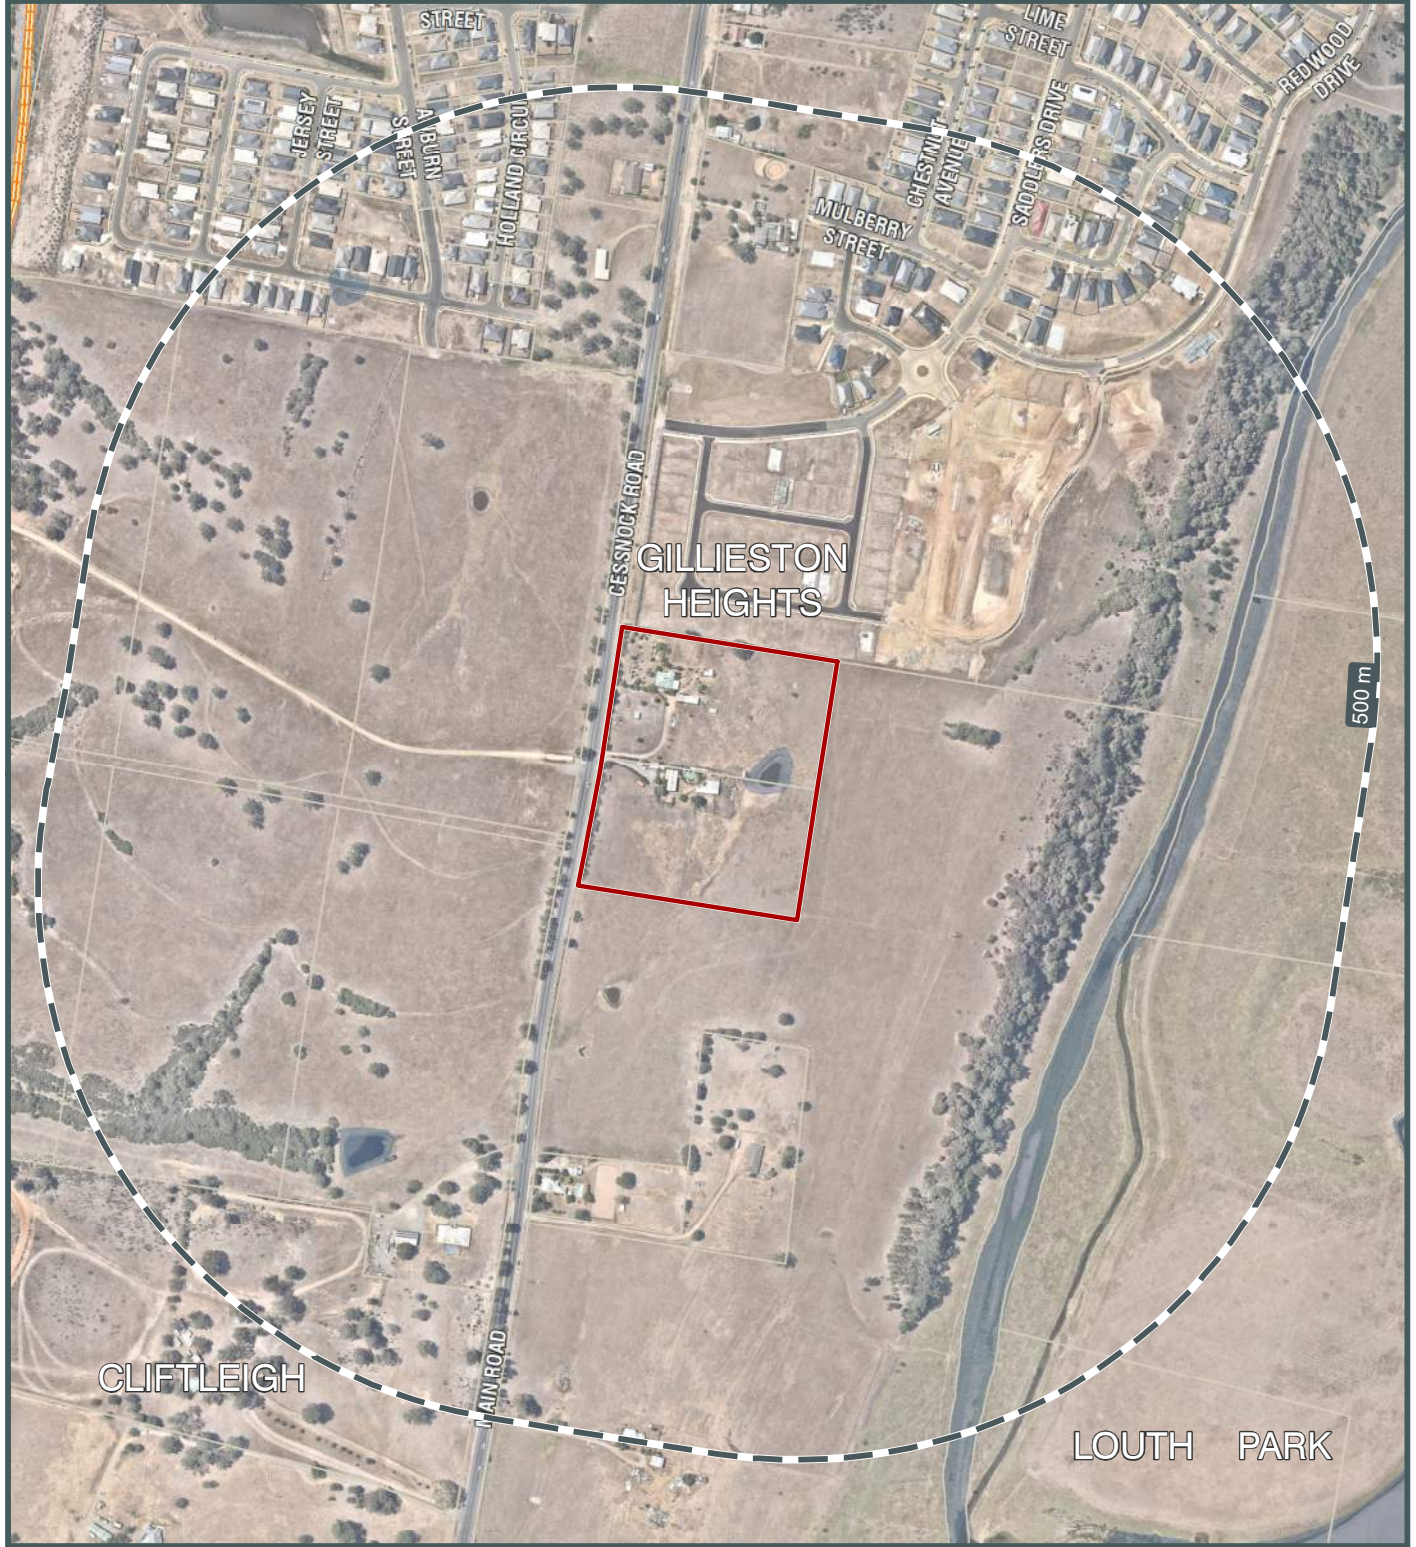
- Subject area
- Licensing Under The POEO Act**
- POEO Licences
- Surrendered Licences still Regulated by EPA
- Clean Up and Penalty Notices
- NPI Facilities

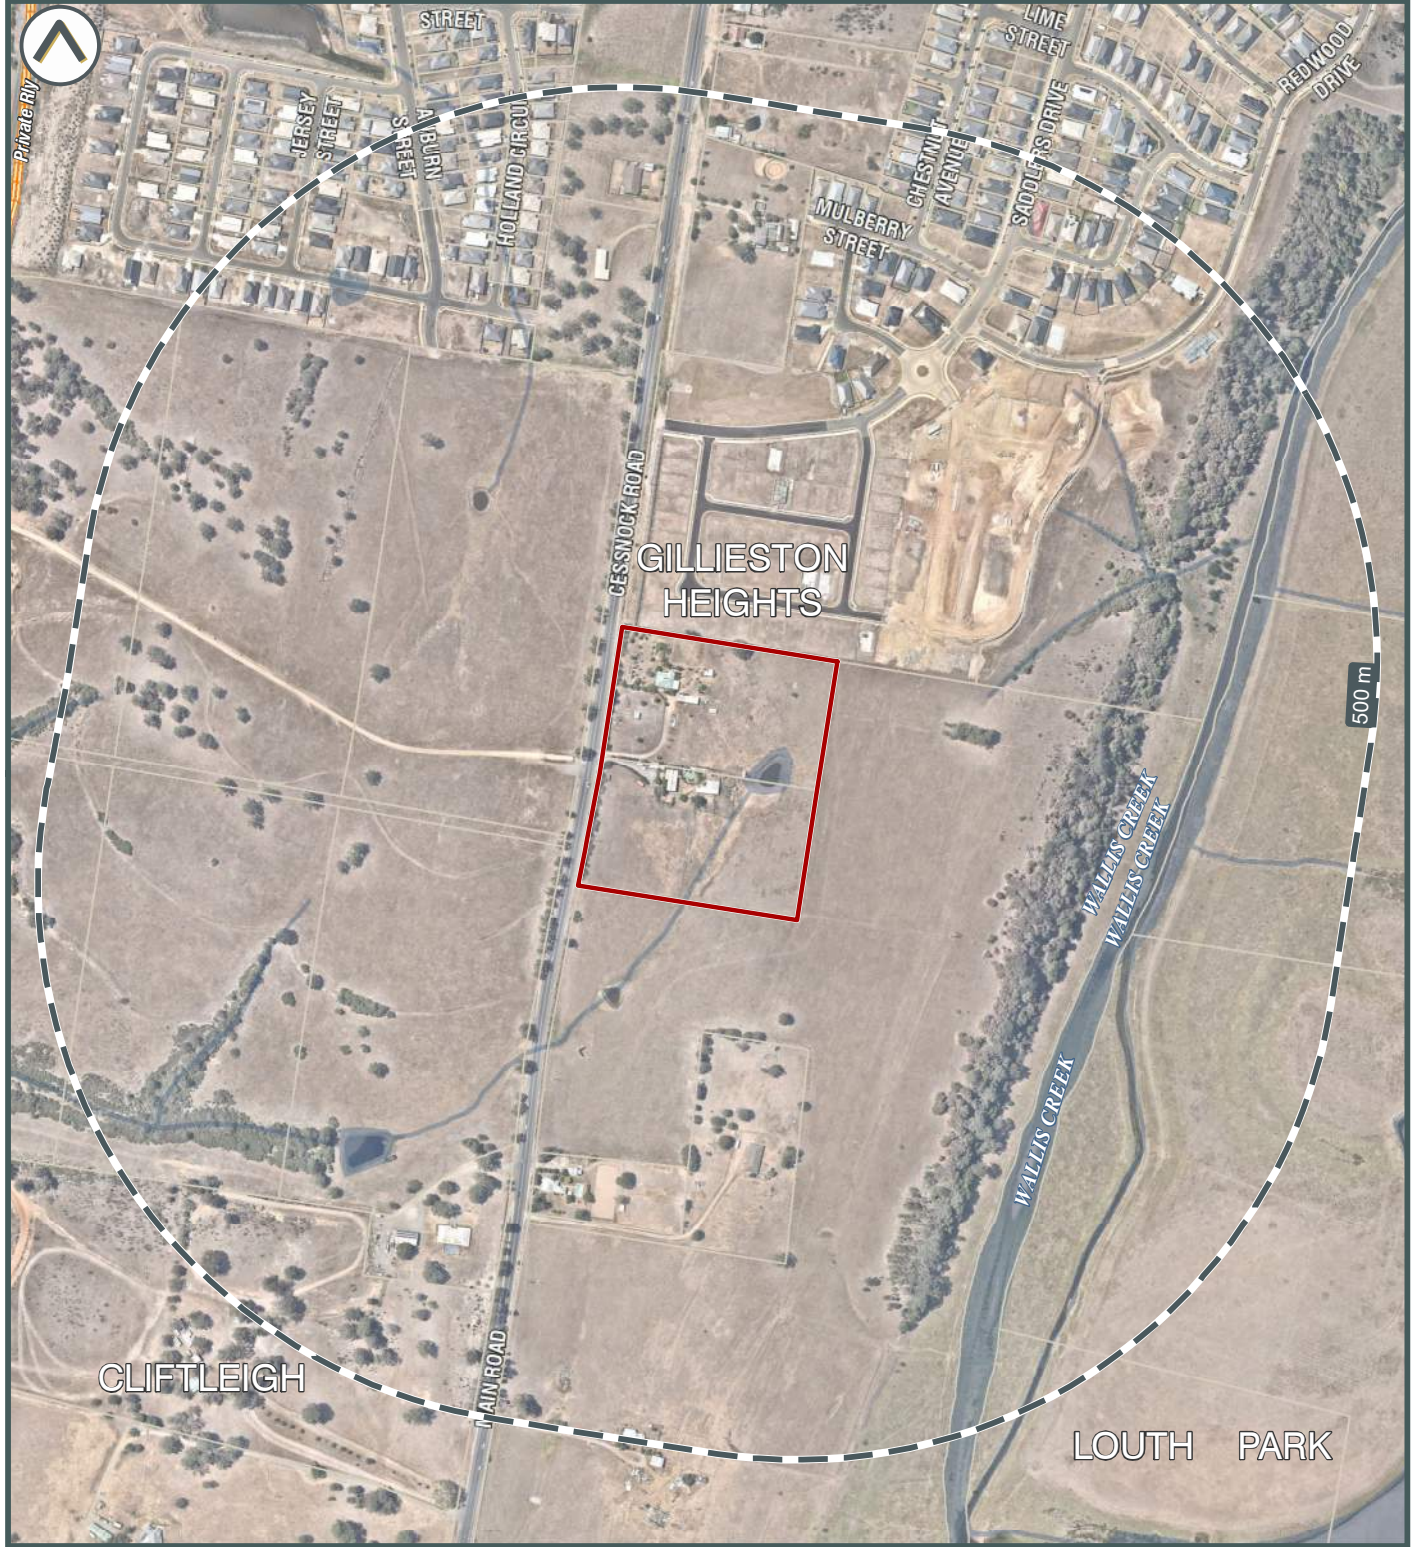
- Subject area
- Aviation fuel depots
- Cattle dip
- Dry cleaners
- Fire Rescue sites
- Liquid fuel depots / terminals
- Mine/quarry
- Power stations
- Service stations
- Substation locations
- Telephone exchanges
- Waste management facilities
- Wastewater Treatment Facility

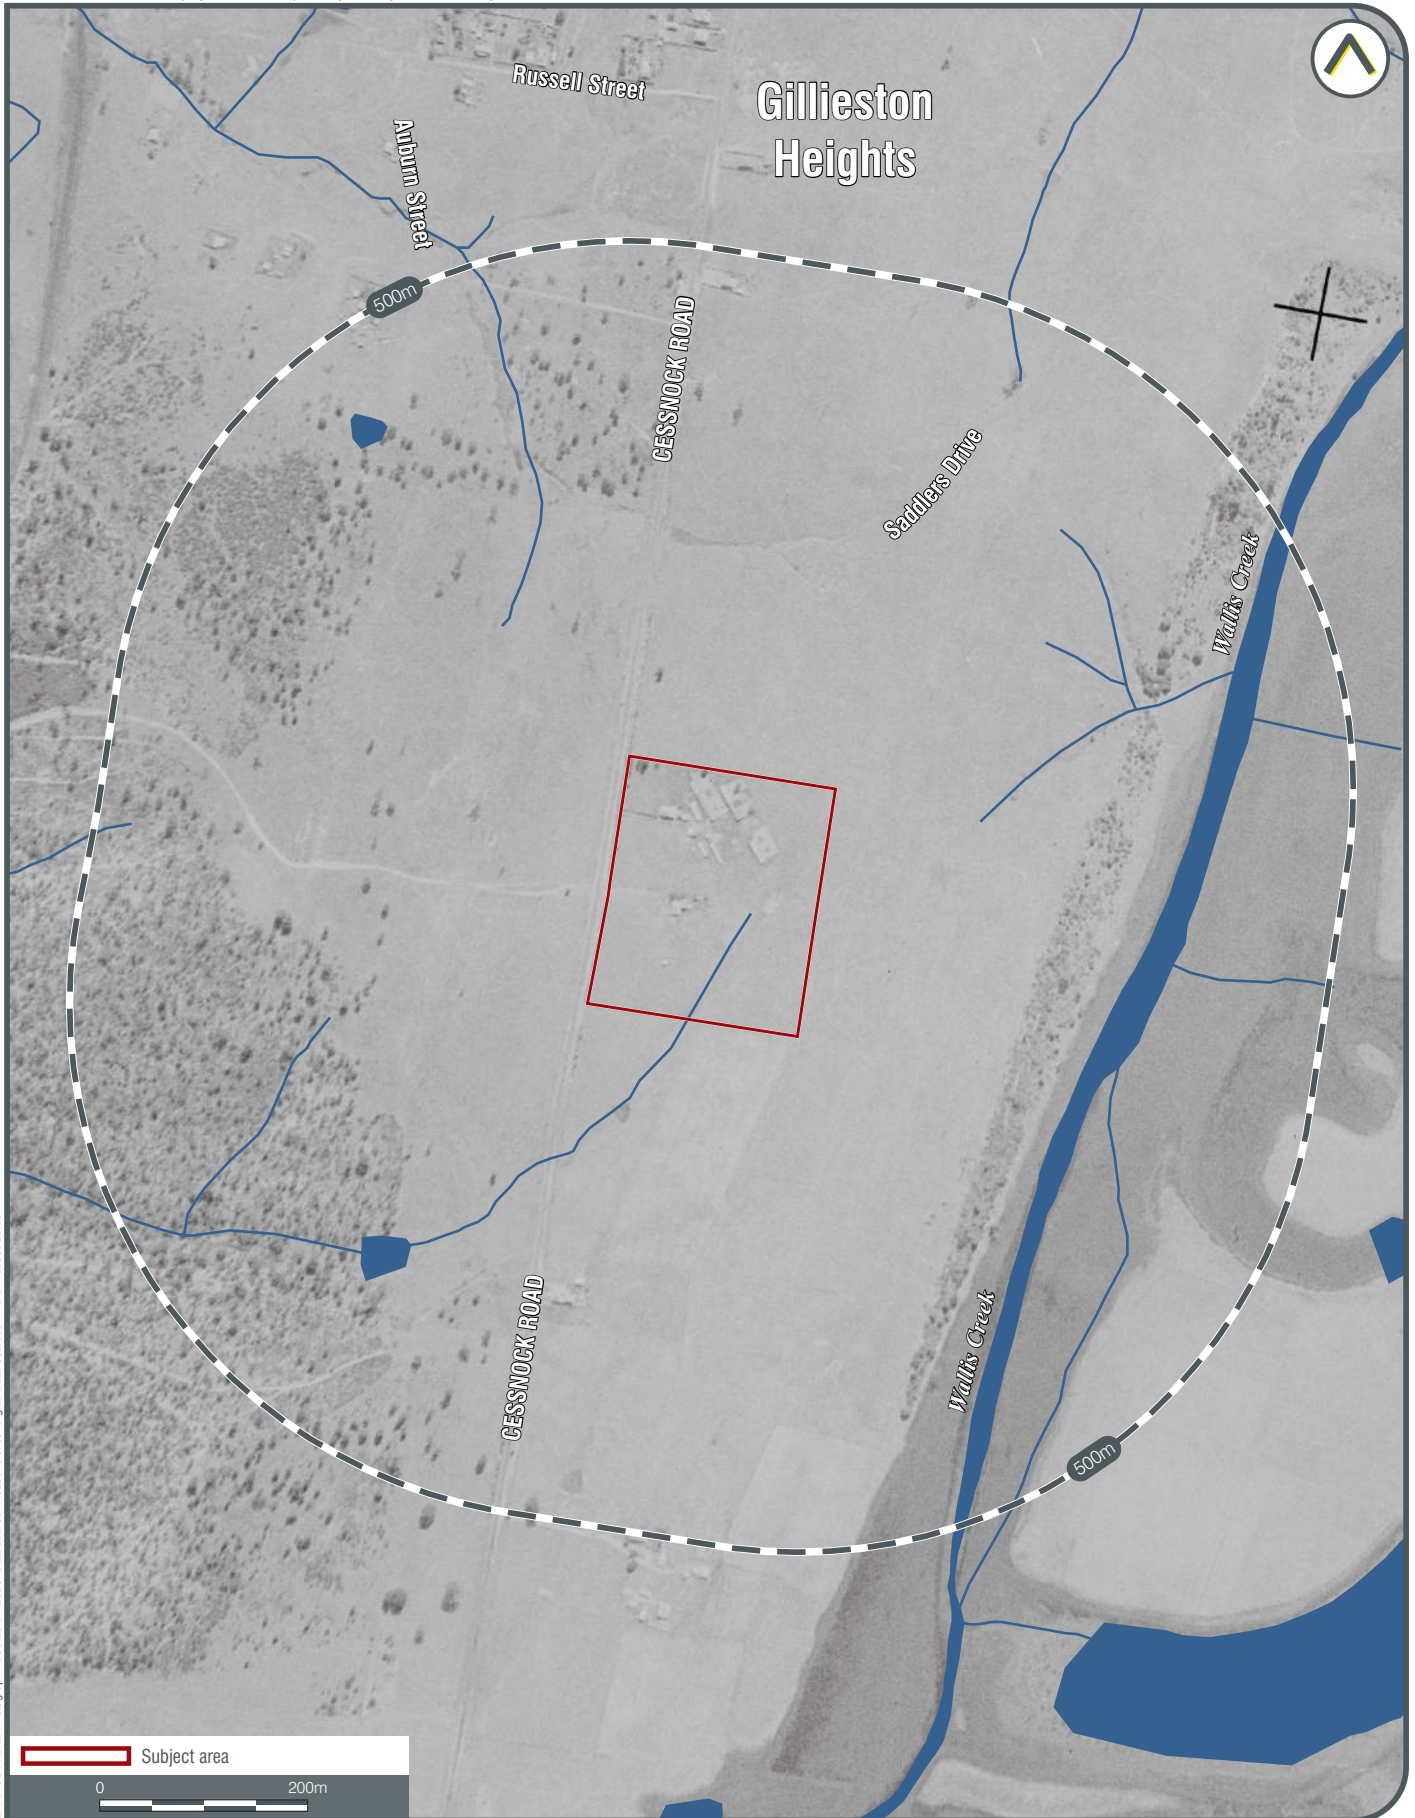
HISTORIC AERIAL PHOTOGRAPH - 1958

LIR-01094 Aerial Photograph, 1958, 23.01.2020. Data source: Please refer to "Digital Data Sources" in the Product Guide.

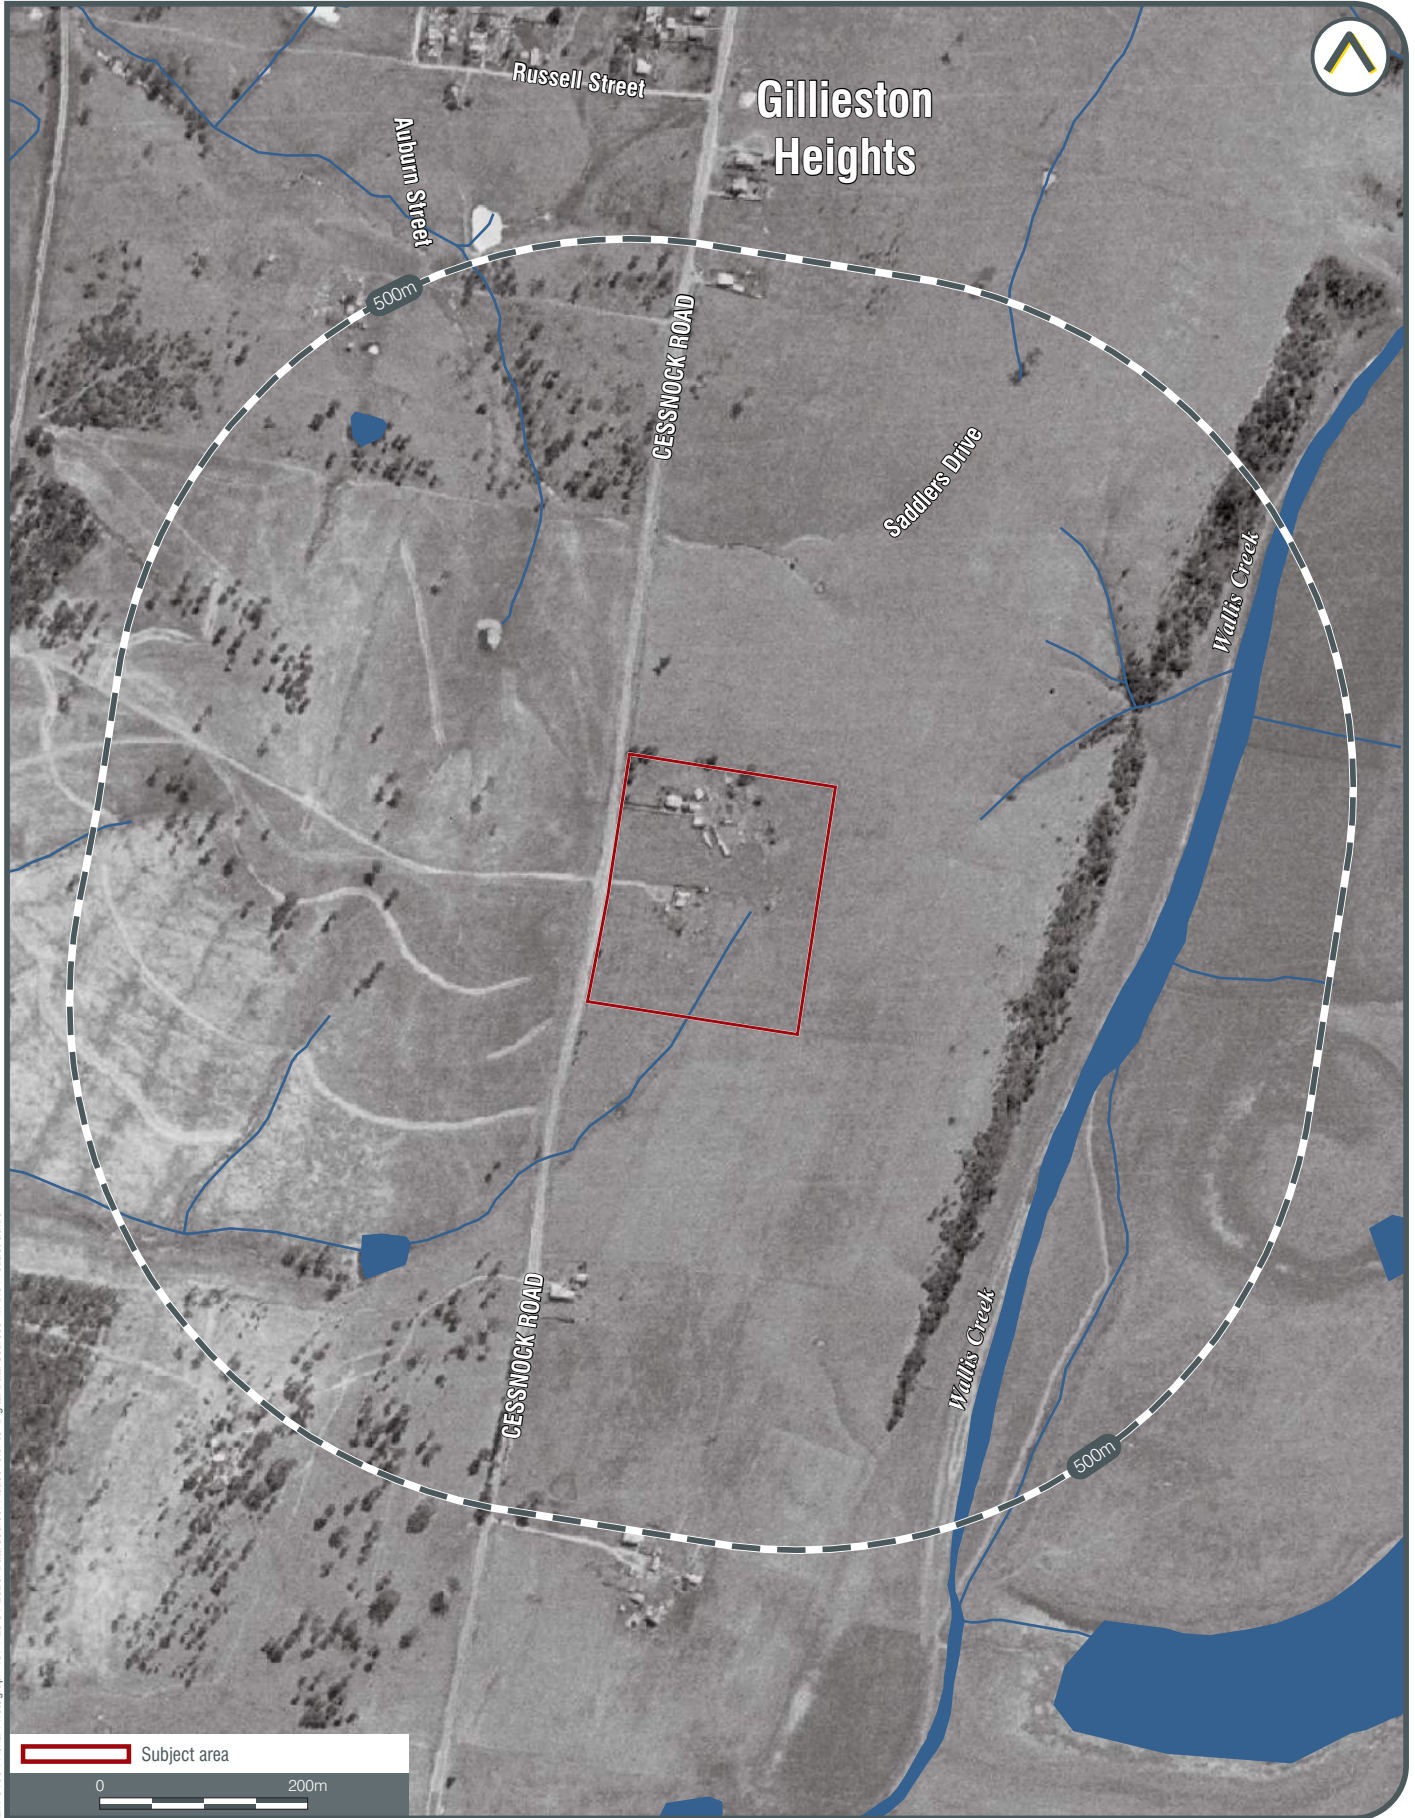
HISTORIC AERIAL PHOTOGRAPH - 1971

LIR-01094 Aerial Photograph 1971 23 01 2020. Data sources: Please refer to "Digital Data Sources" in the Product Guide
