Report on Earthworks Strategy

457-527 Cessnock Road, Gillieston
Heights

304100964-002

Prepared for
Walker Gillieston Heights Pty Ltd

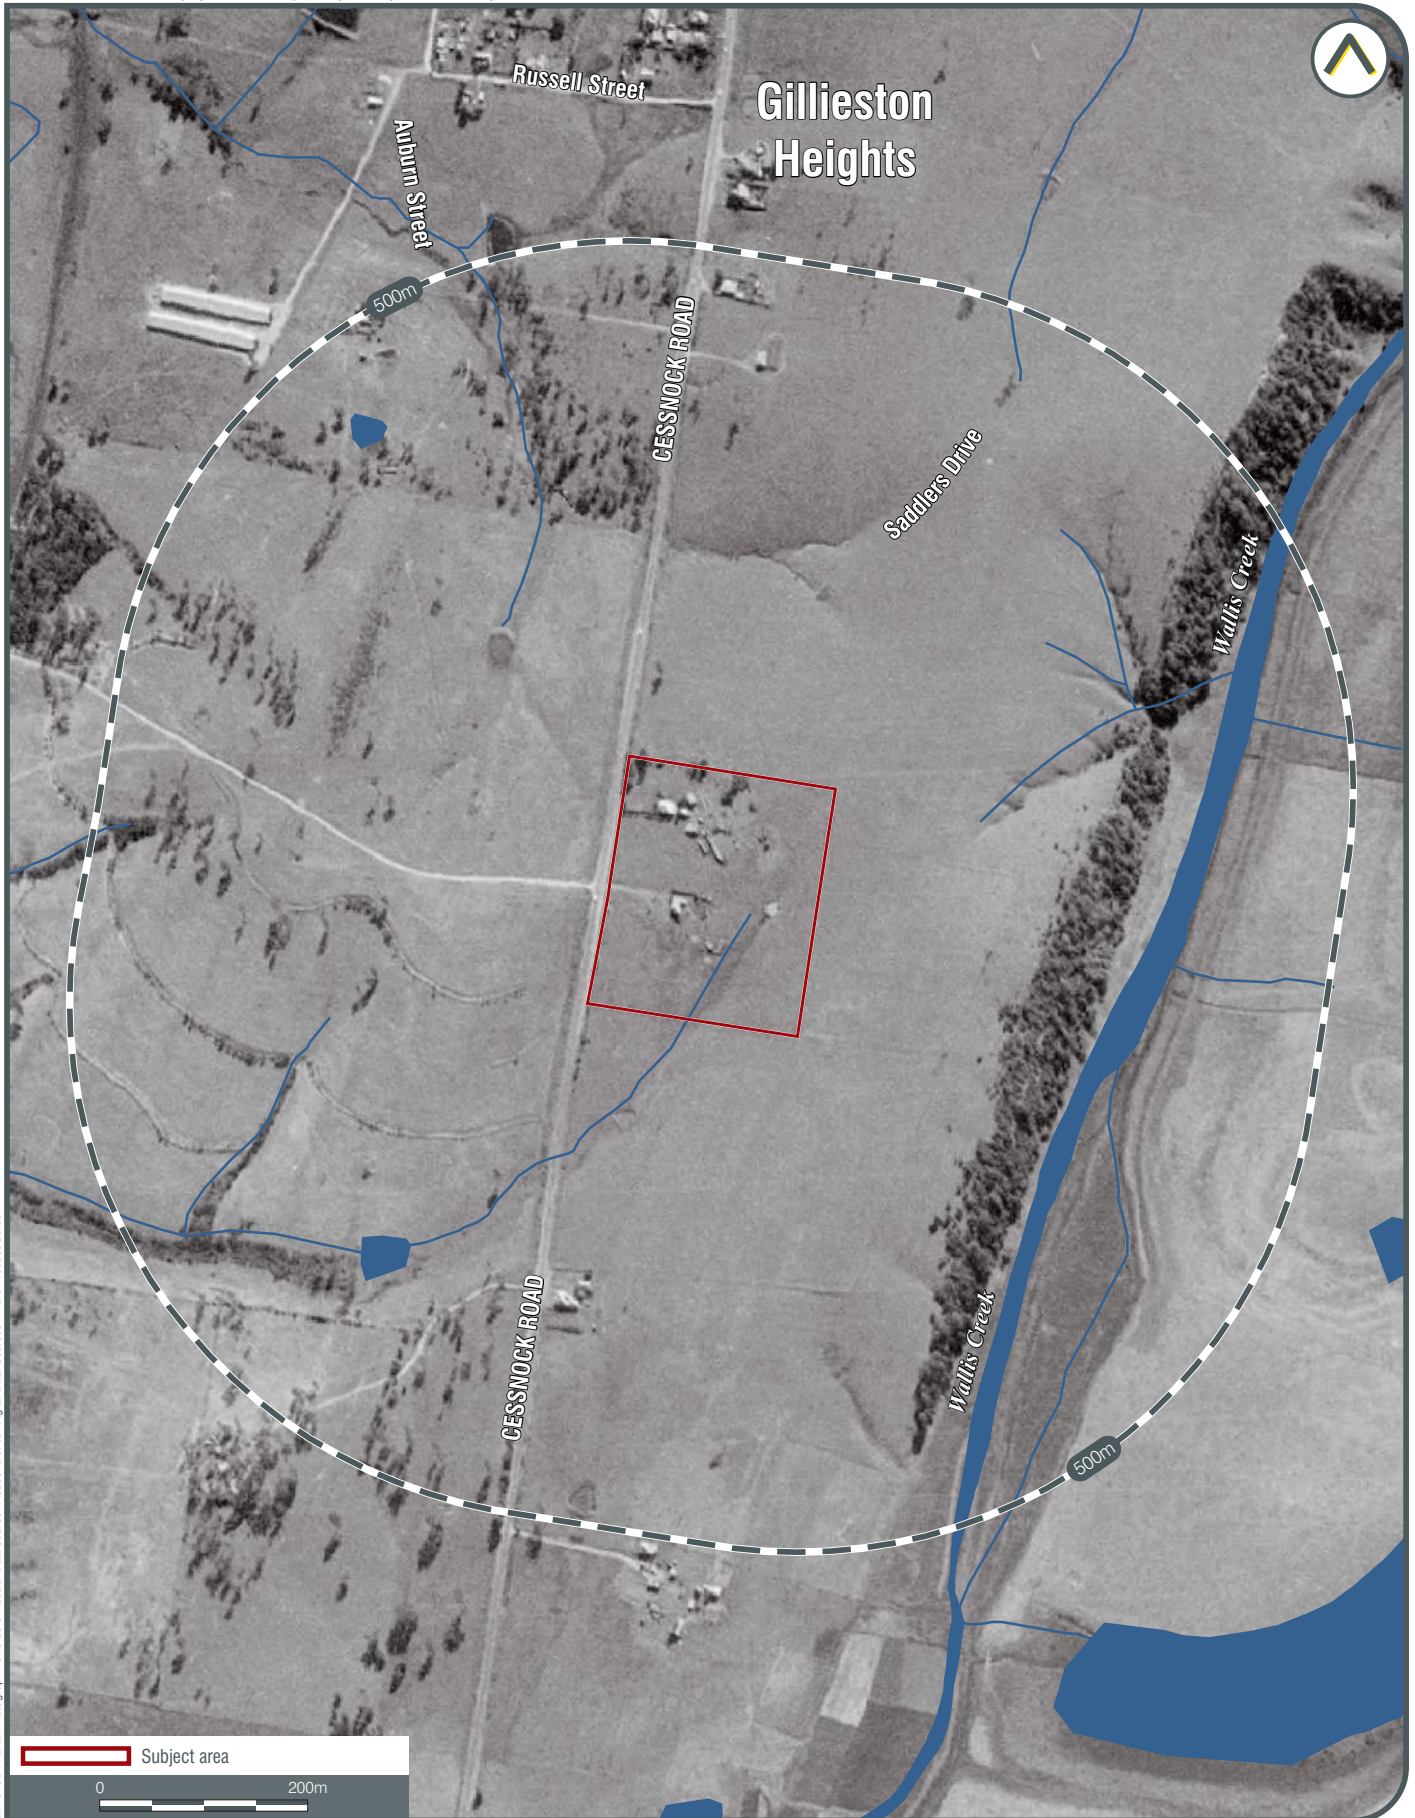
HISTORIC AERIAL PHOTOGRAPH - 1975

LIR-01094 Aerial Photograph: 1975 23 01 2020. Data sources: Please refer to "Digital Data Sources" in the Product Guide

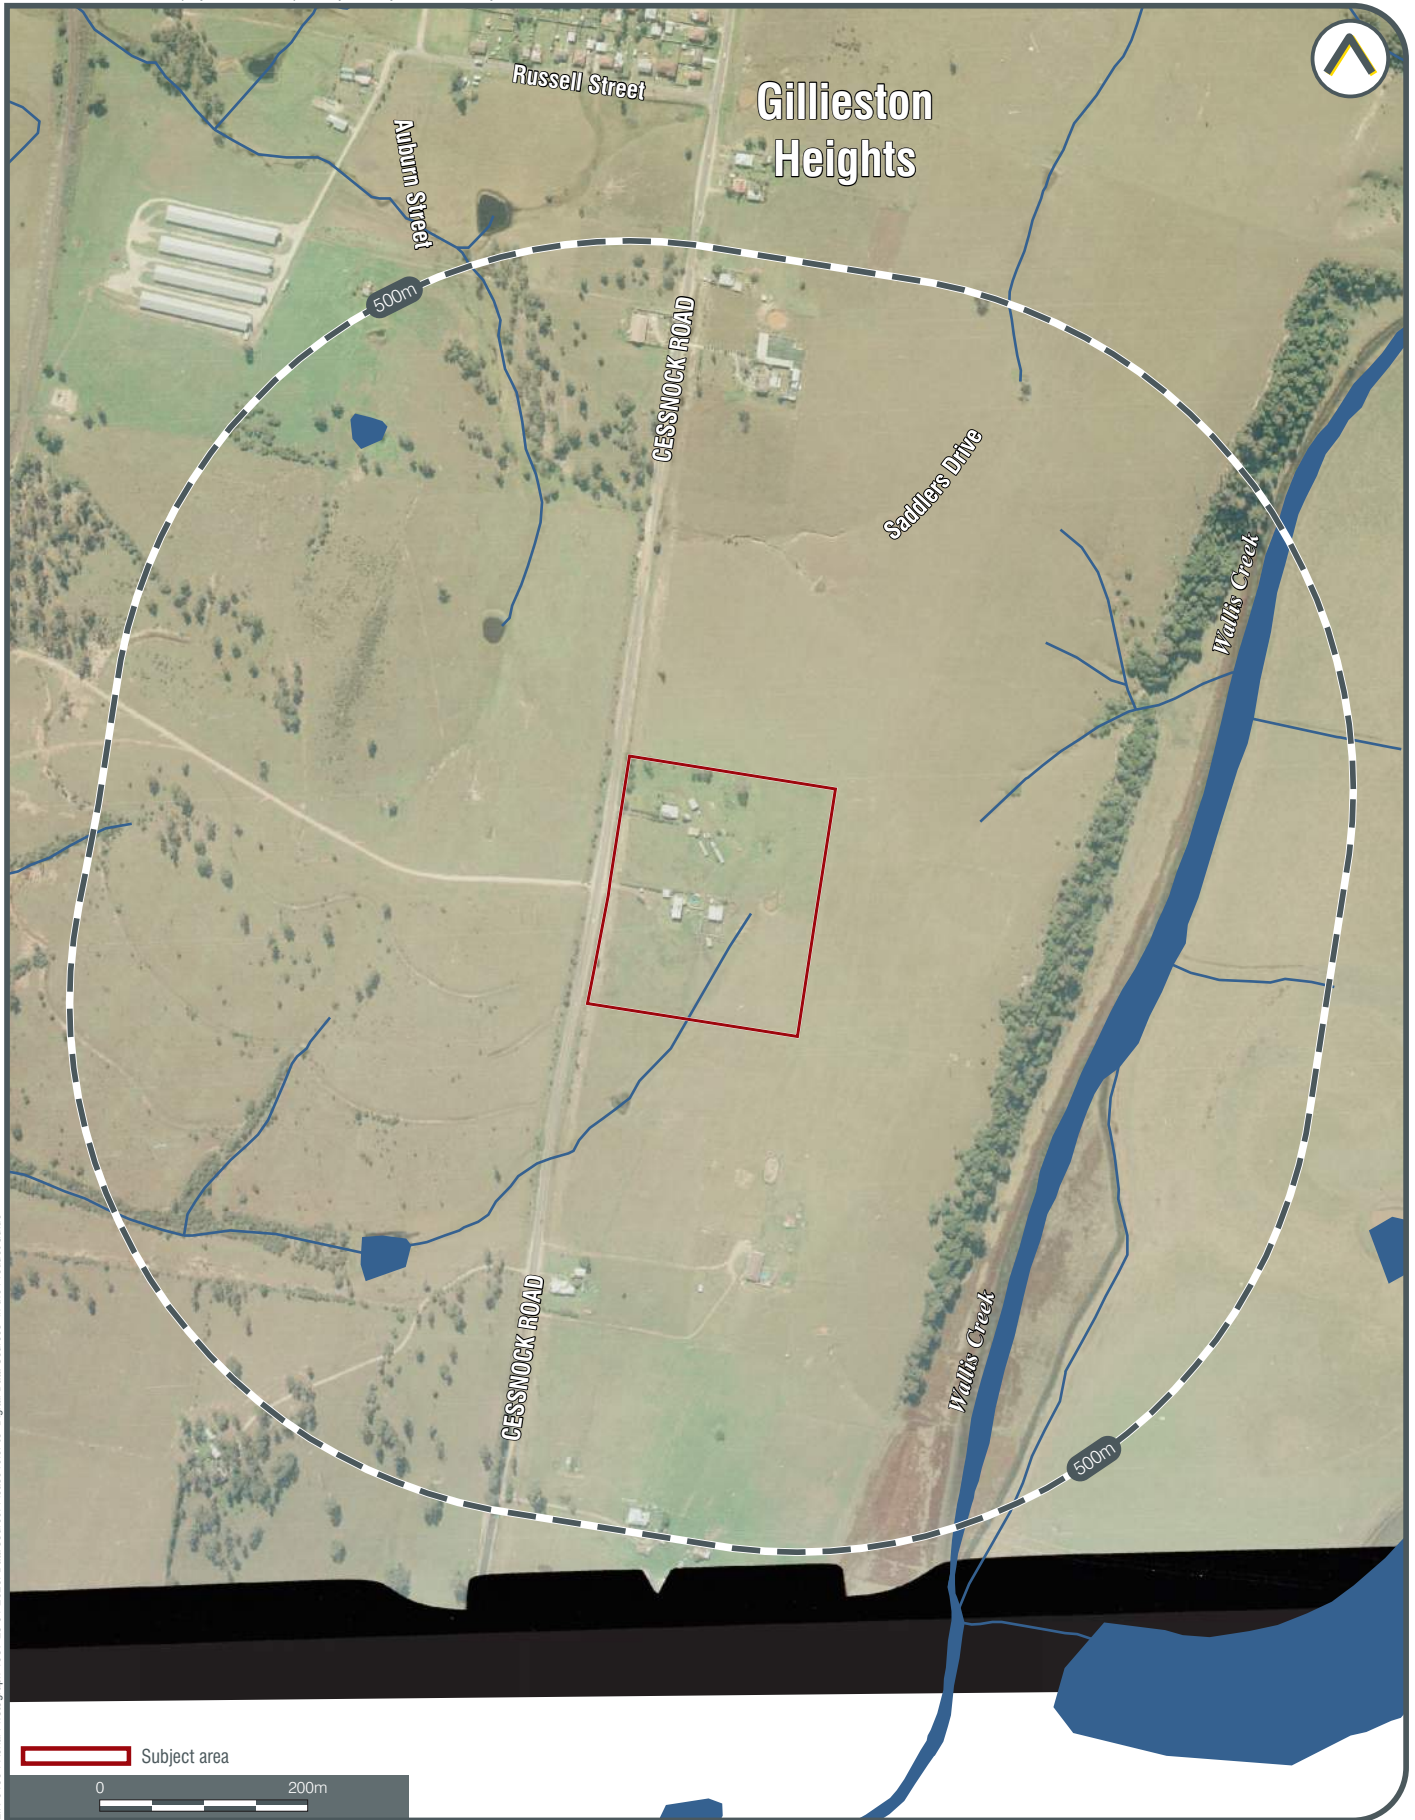
HISTORIC AERIAL PHOTOGRAPH - 1987

LIR-01094 Aerial Photograph 1987 23.01.2020. Data source: Please refer to "Digital Data Sources" in the Product Guide.

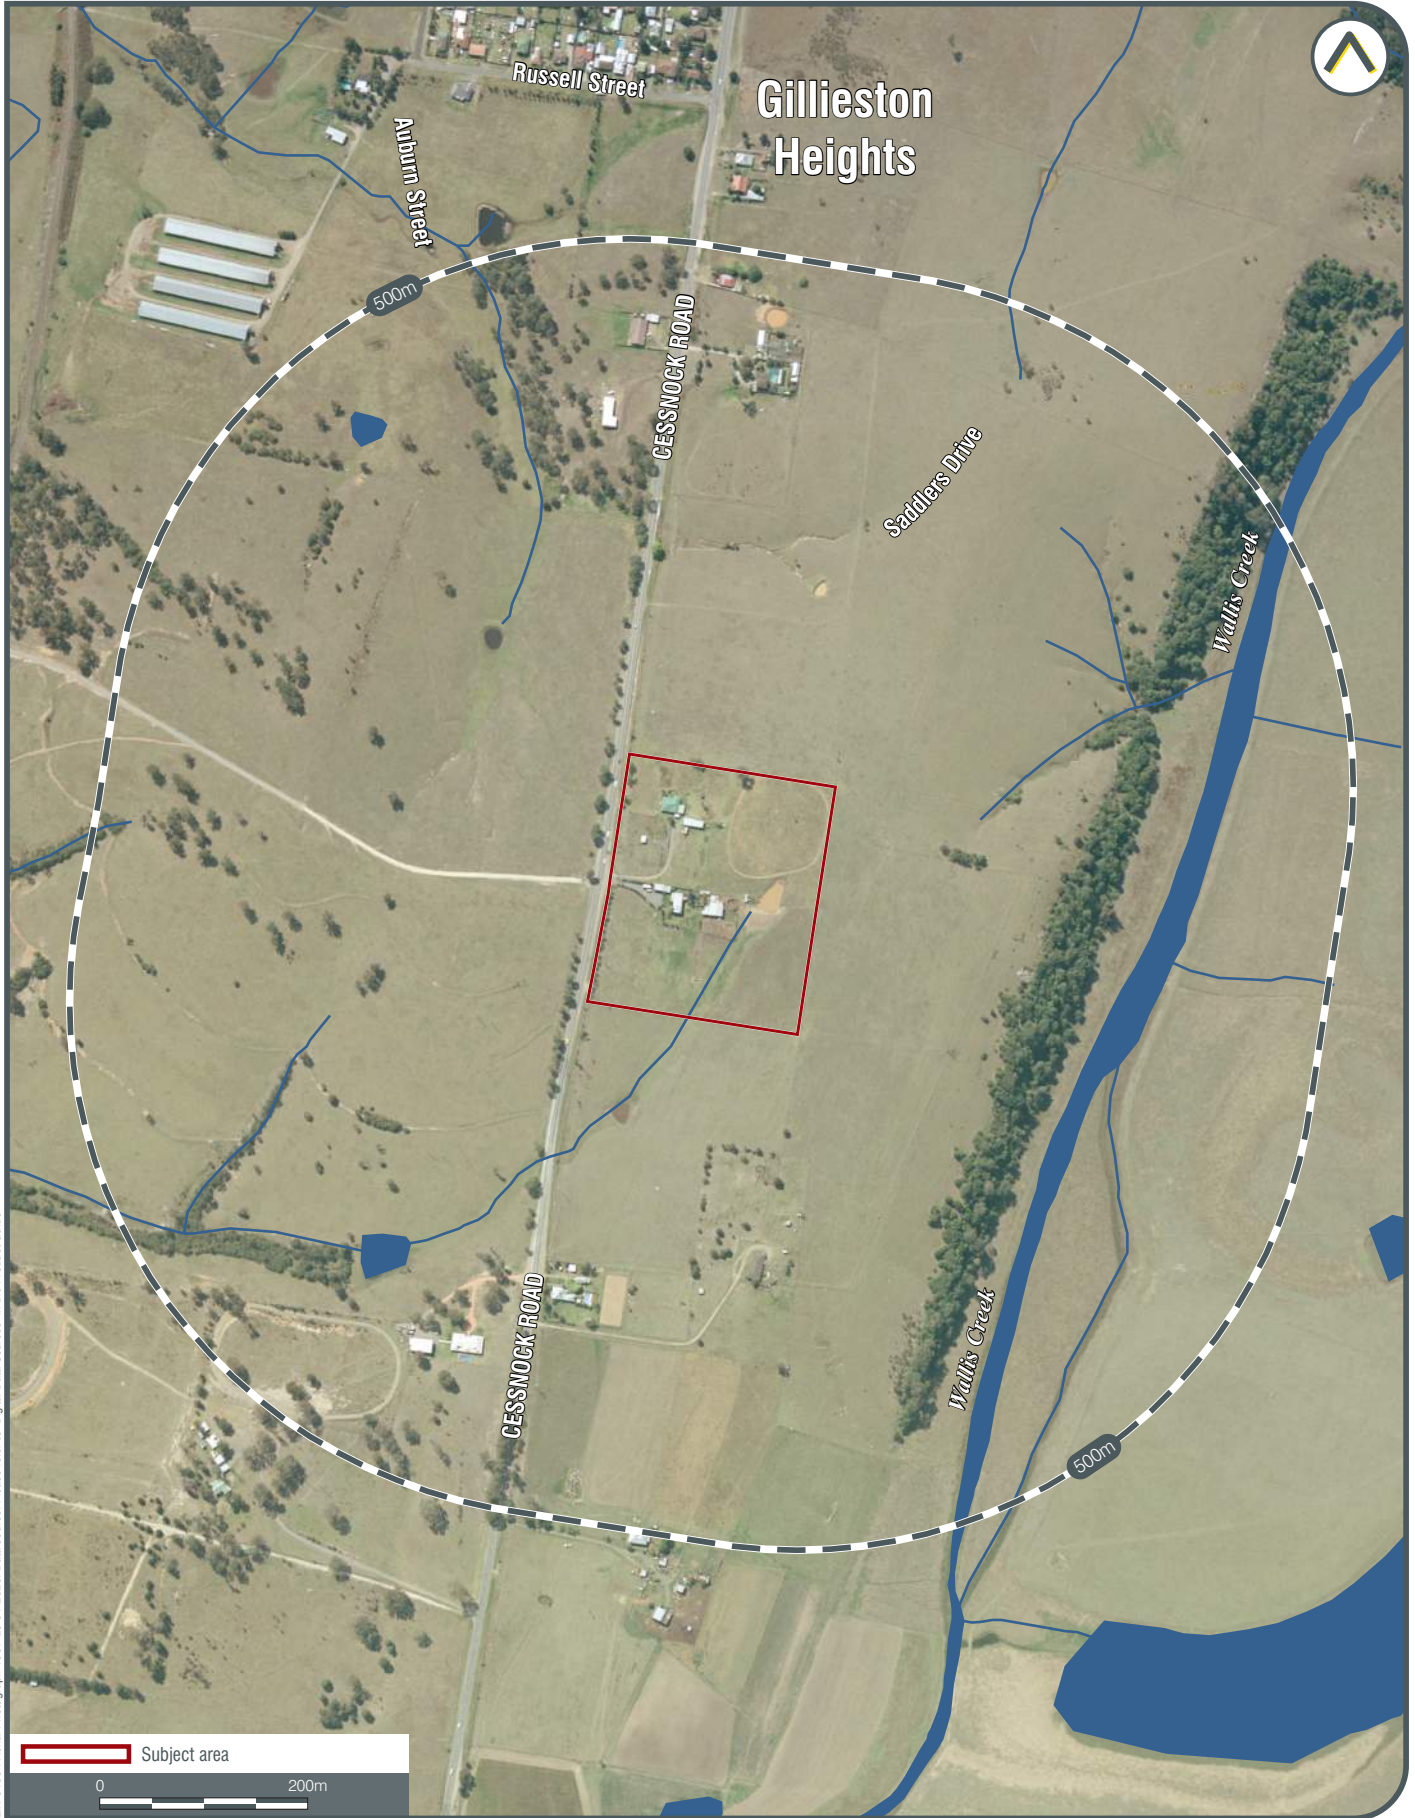
HISTORIC AERIAL PHOTOGRAPH - 2004

LIR-01094 Aerial Photograph 1987 23 01 2020. Data sources: Please refer to "Digital Data Sources" in the Product Guide

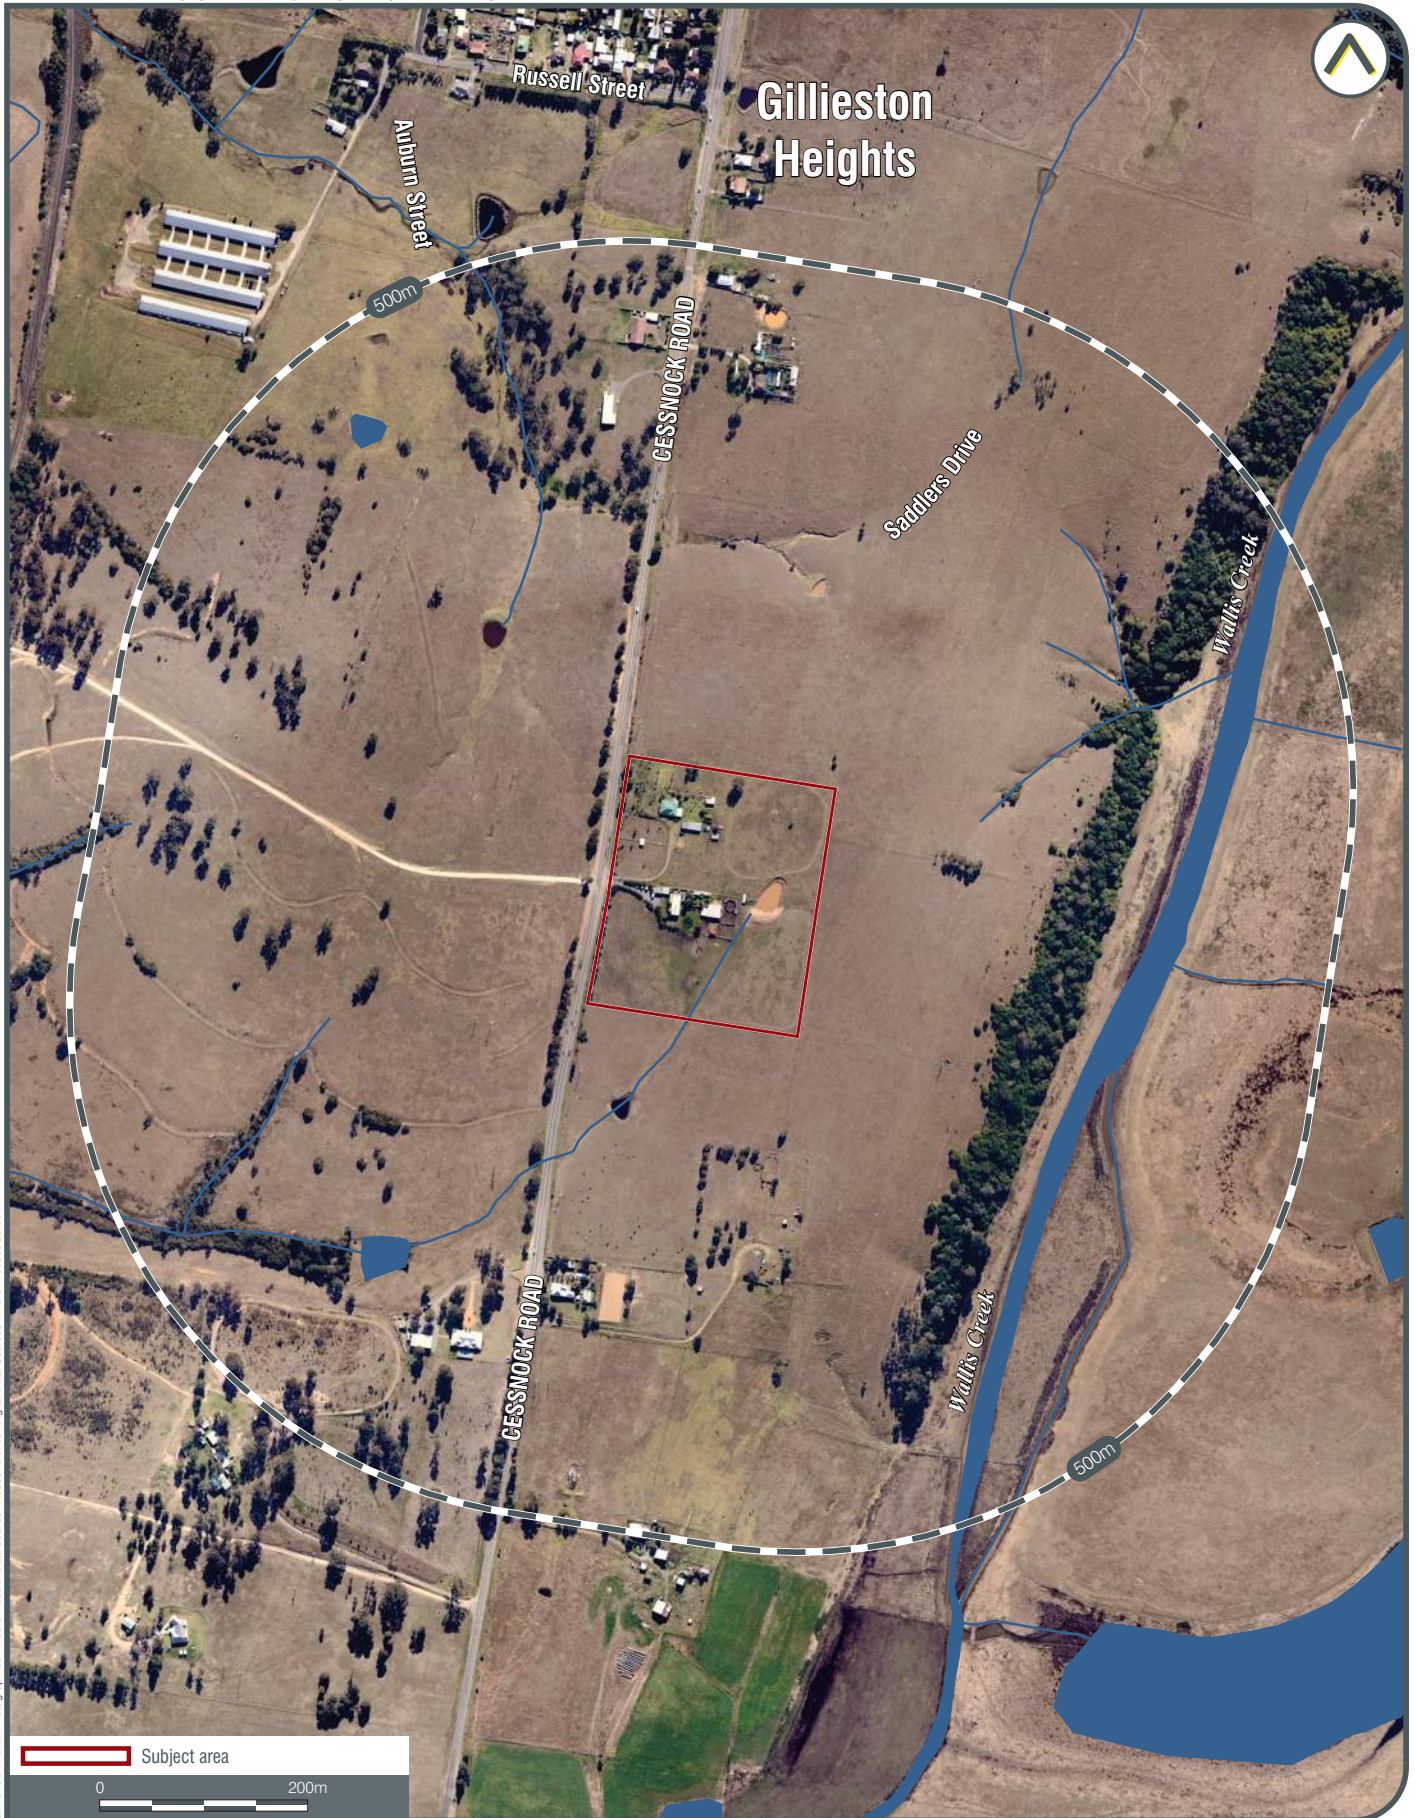
HISTORIC AERIAL PHOTOGRAPH - 2010

LIR-01094 Aerial Photograph, 2014.23.01.2020. Data source: Please refer to "Digital Data Sources" in the Product Guide

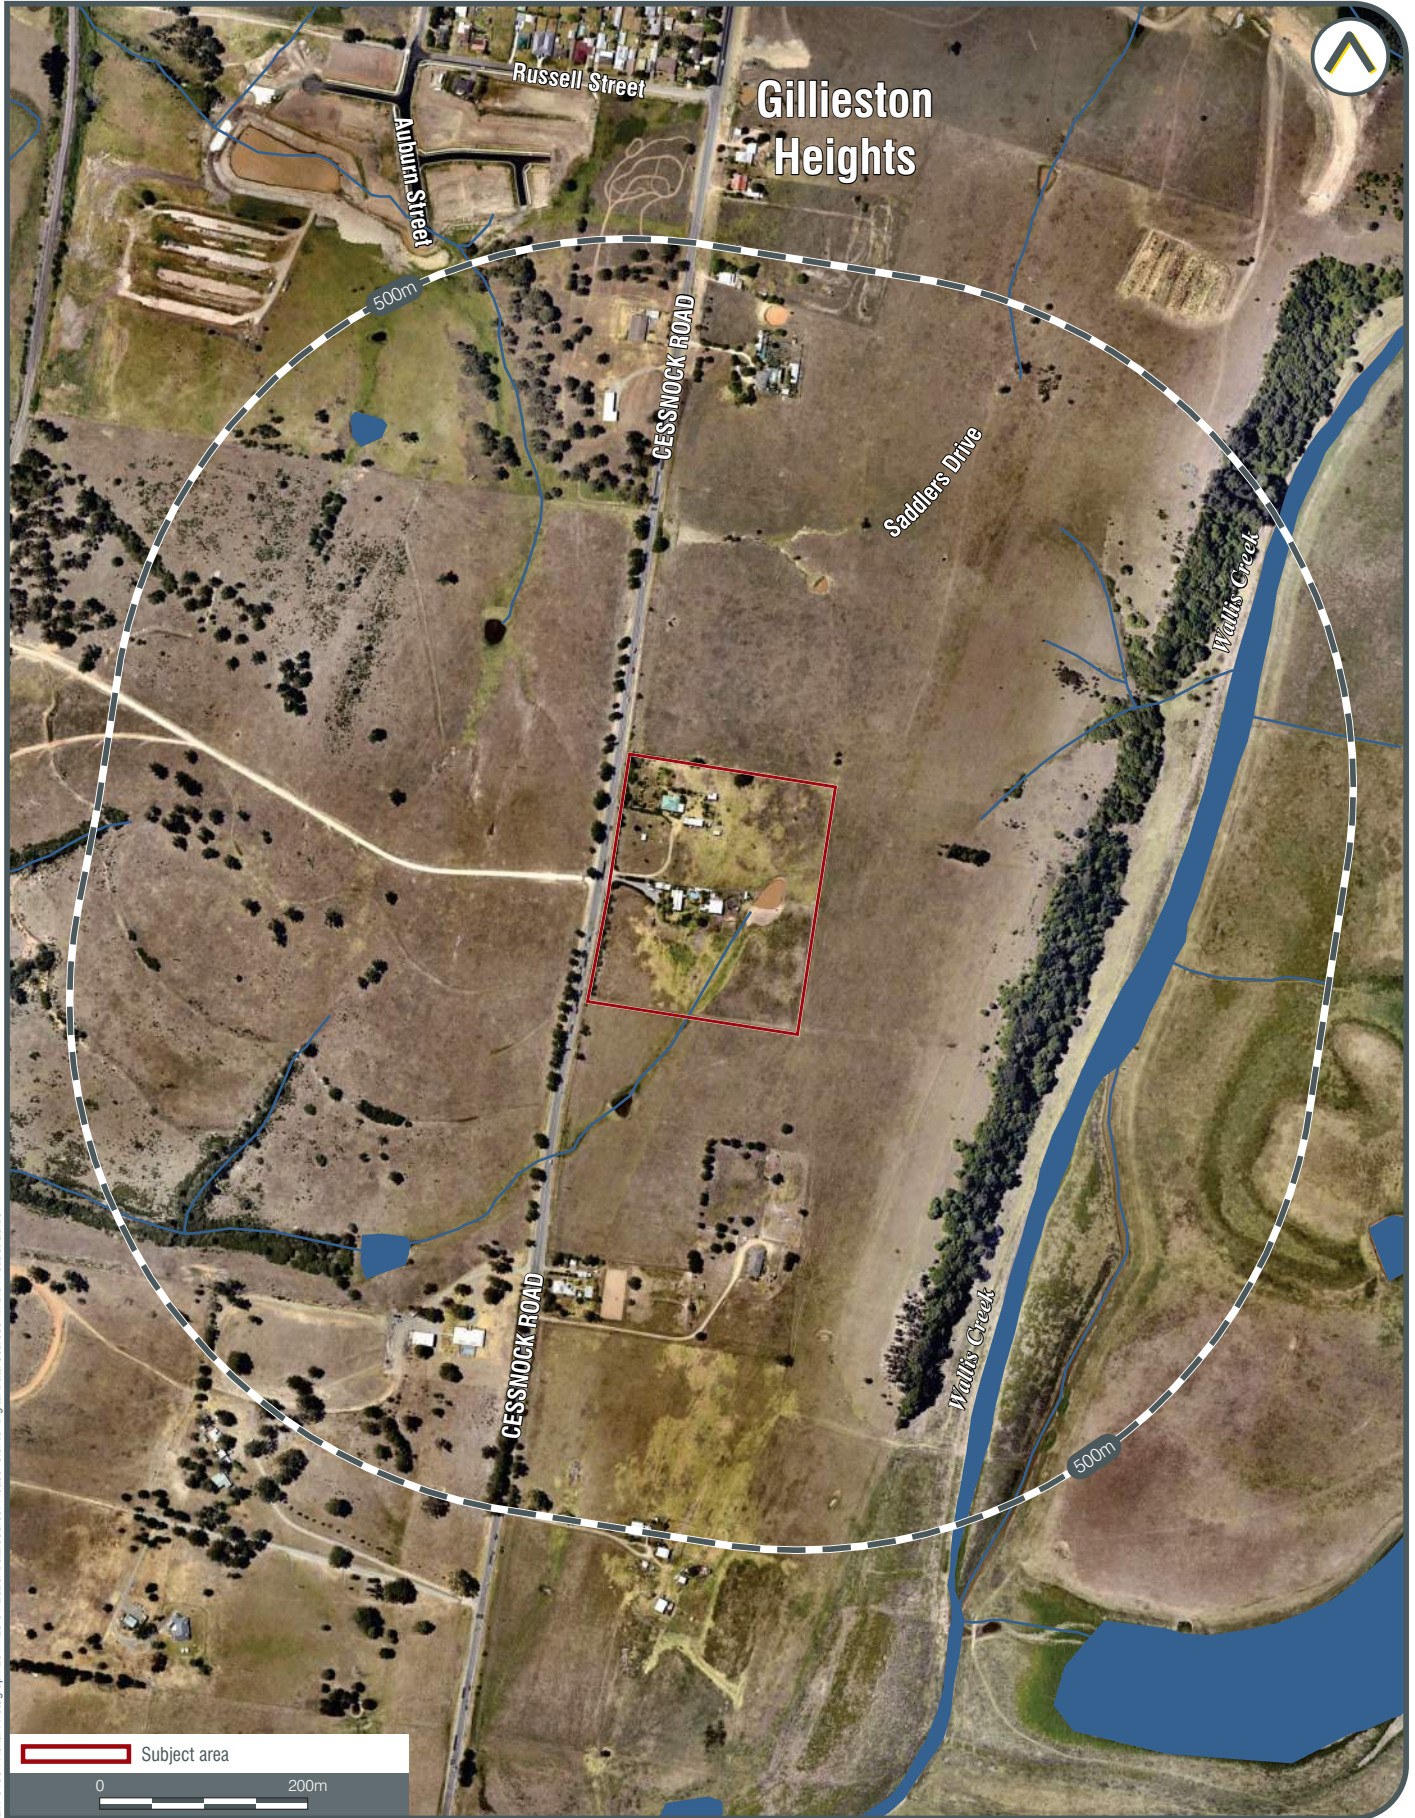
HISTORIC AERIAL PHOTOGRAPH - 2014

LIR-01094 Aerial Photograph 2014 23 01 2020. Data sources: Please refer to "Digital Data Sources" in the Product Guide

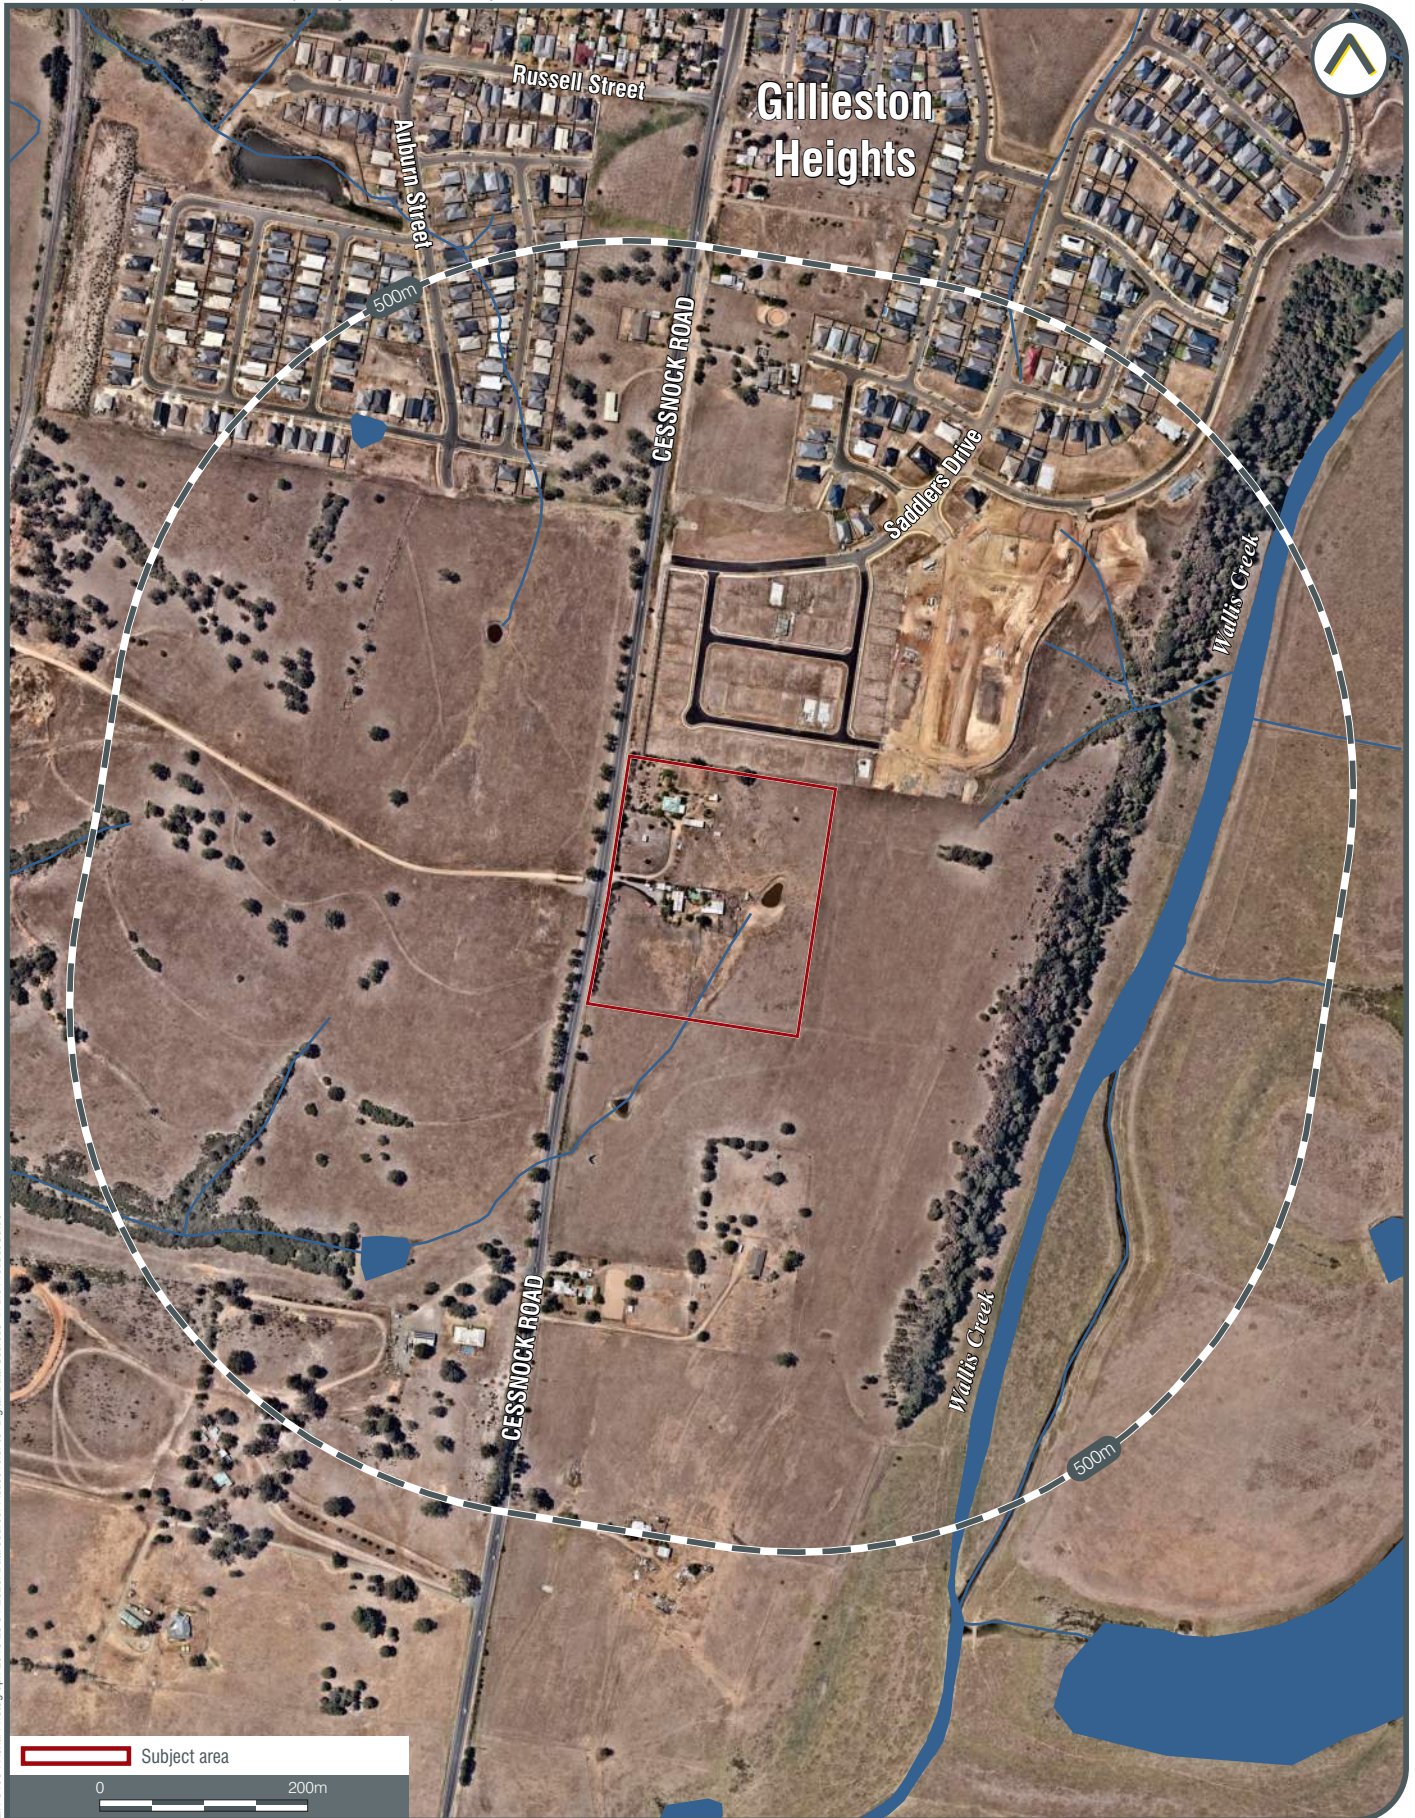
HISTORIC AERIAL PHOTOGRAPH - 2019

LIR-01094 Aerial Photograph 2019 23 01 2020. Data sources: Please refer to "Digital Data Sources" in the Product Guide
