Report on Geotechnical Investigation

457-527 Cessnock Road Gillieston Heights

304100964

16 June 2023

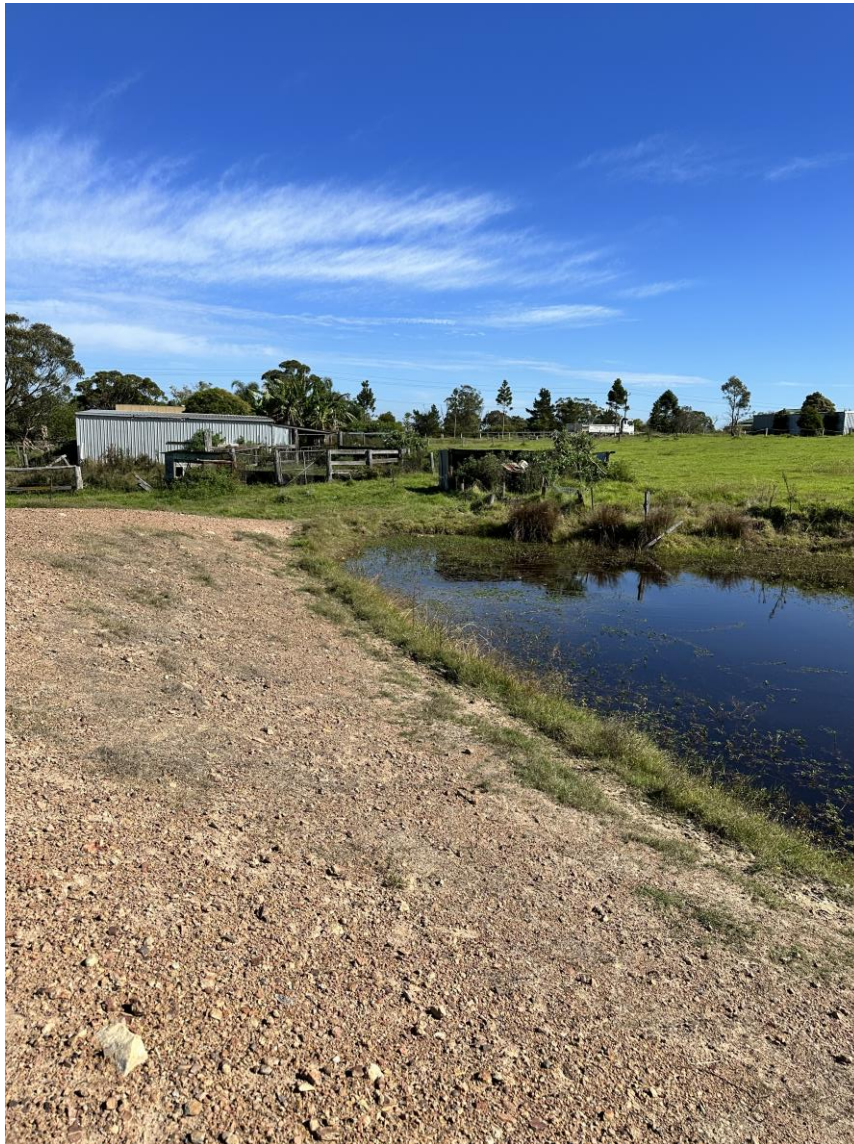
Figure 6-1 Existing Rural Dam

The existing site supported well established vegetation comprising open pasture with isolated mature trees. No indication of saline soils were noted during the inspection. Minor indications of erosion were observed around the existing central eastern farm dam in the form of a head scape on the upstream wall. as shown Figure 6-1.

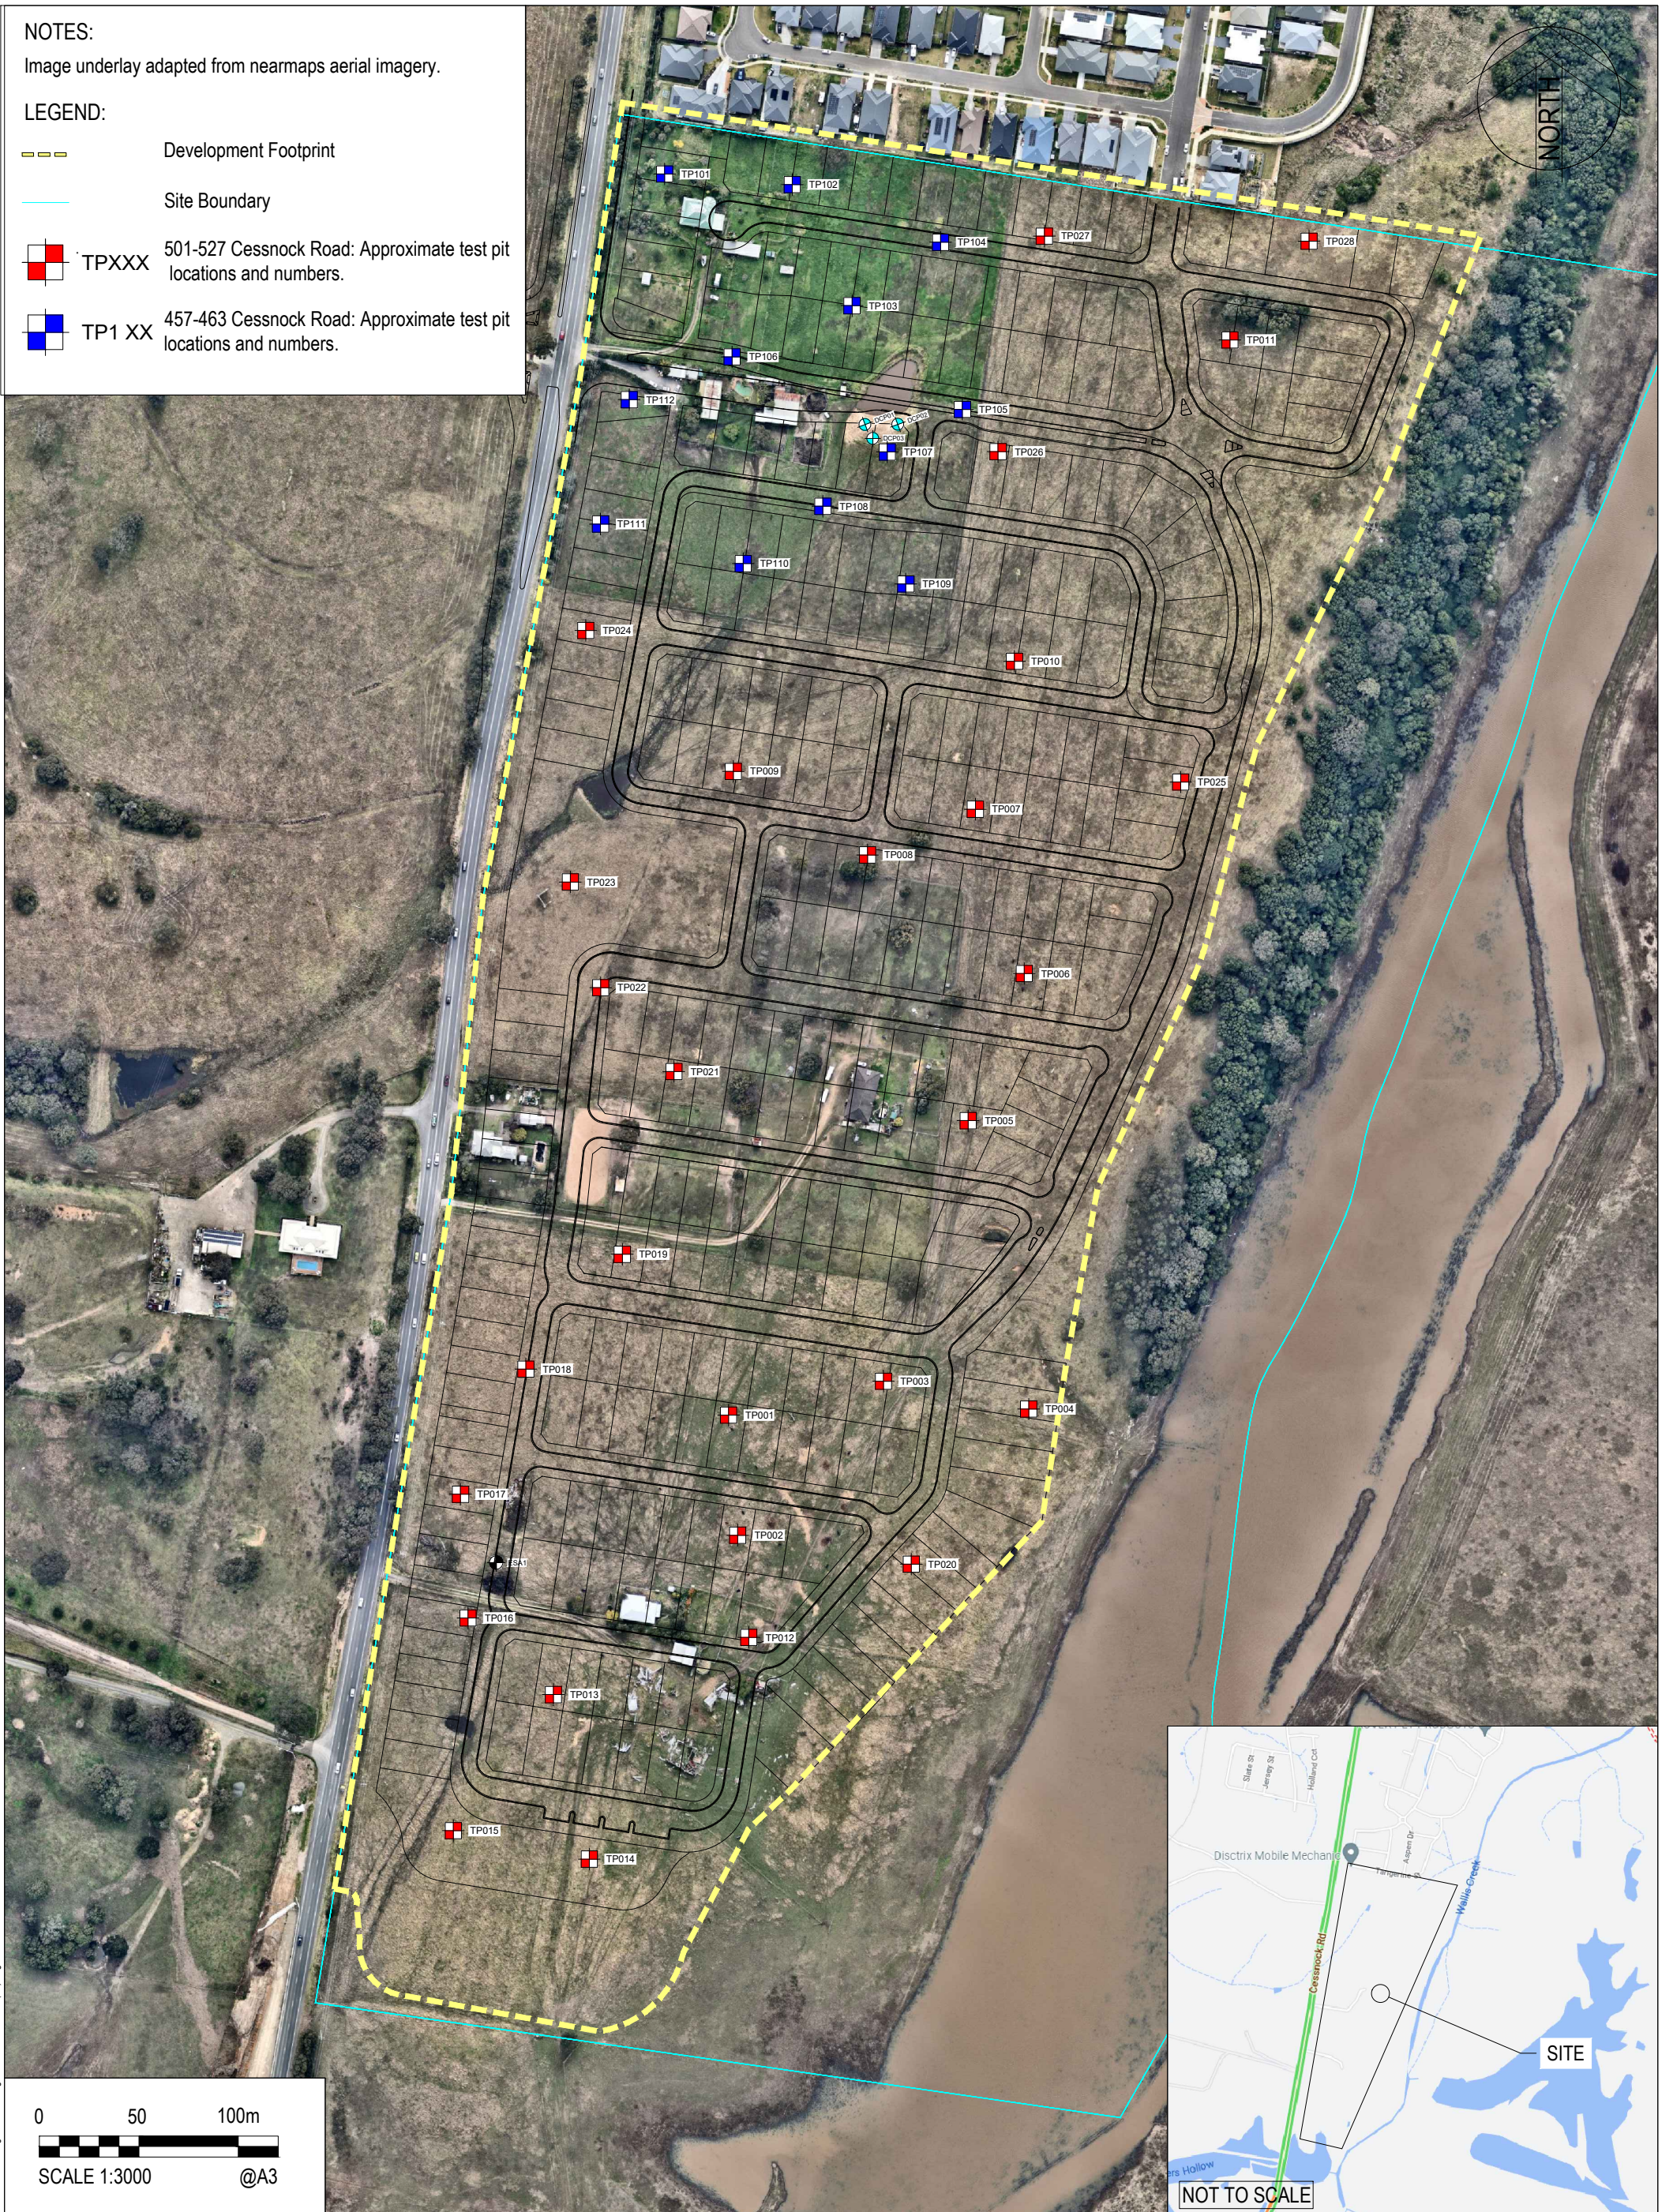
TP1 XX 457-463 Cessnock Road: Approximate test pit locations and numbers.

The location of the test pits is shown on Figures F1-F4, attached in Appendix A. Subsurface conditions are summarised below and detailed in the engineering logs attached in Appendix B with explanatory notes.

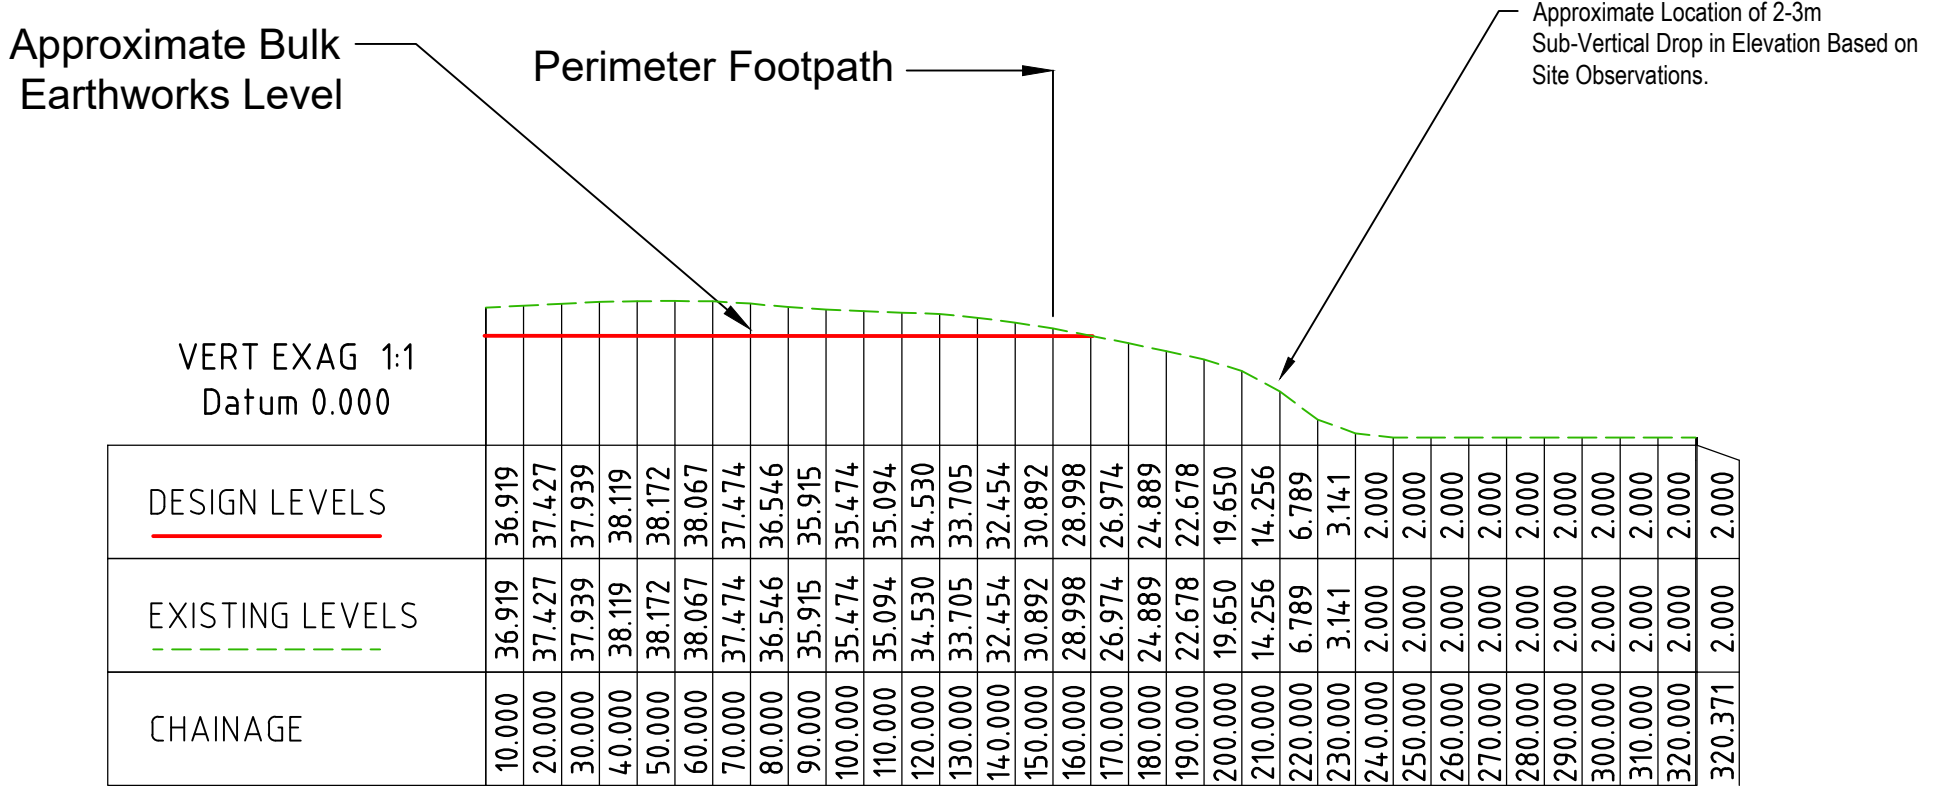
SECTION 3 LONG SECTION

NOTES:
 Sections cut from LiDAR dated 2019. Given limitation of LiDAR due to dense tree coverage on eastern boundary of site, sub-vertical elevation changes have been inferred from site observations and denoted on sections below.
