1.1 Background

This report represents an assessment of heritage impact for the proposed partial demolition and conservation works at St Peter's Anglican Church, 47 William Street, East Maitland NSW 2323, related specifically to slate roof replacement.

1.5 Development Proposal

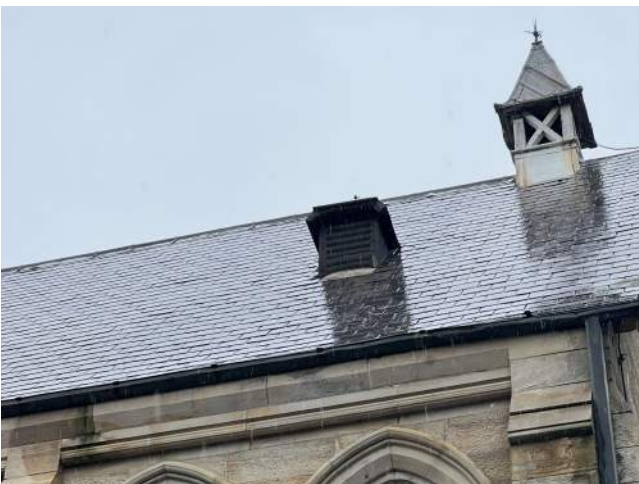
Figure 25
Detailed view of slate roof with timber dormers and bellcote.
source: Heritas, 2022.

The large roof is covered in slate, and has a small bellcote at the north-west end of the nave. This small lead-covered bellcote against the large blank façade of the north western façade confirms The Maitland Mercury's report of October 1886, which observed that 'the building will ever appear woefully incomplete at its western end till the tower is supplied.' This rather bland façade is in contrast to the decorative remaining façades, of local ashlar sandstone dressed smooth at reveals, edges and corbels, with hood moulds, organic-themed labels stops, sandstone tracery, hipped roof vents that break up the steep slate-covered roof, and the clustered moulding of the pointed arch door reveals.

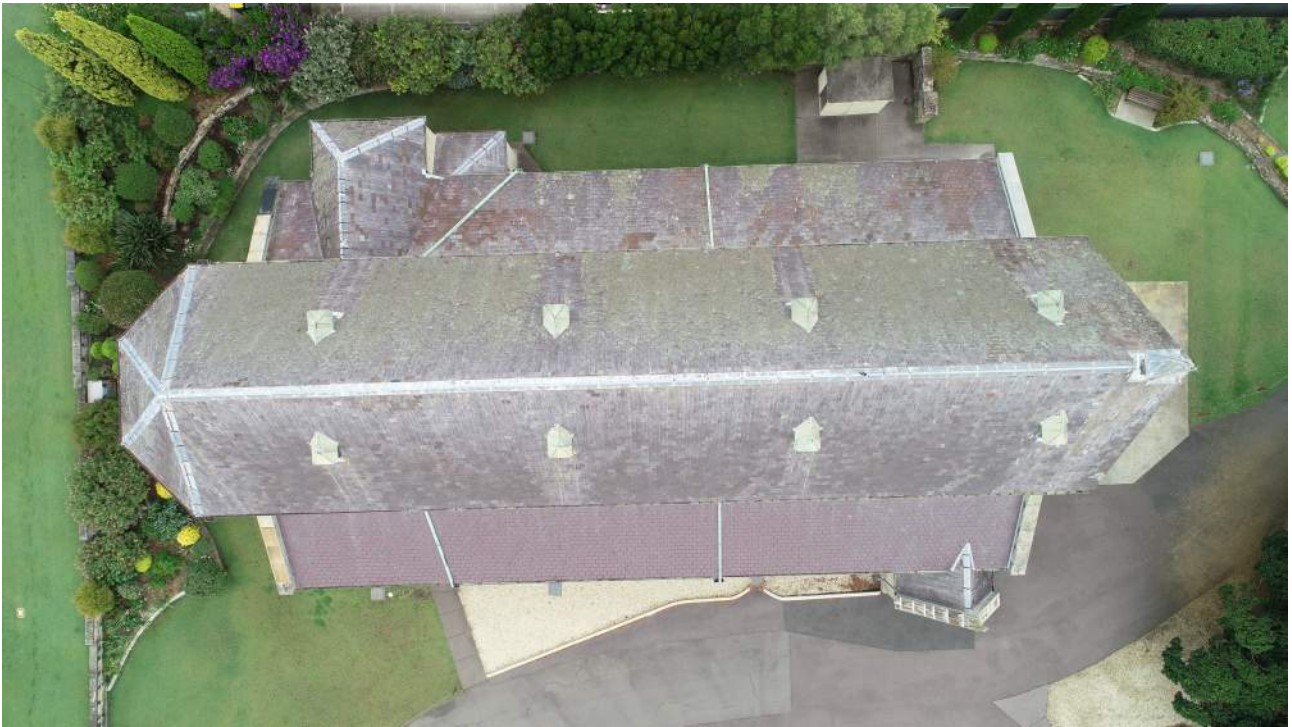
Figure 27
Aerial view of slate roof to church.
source: iScope Consultants, March 2021.

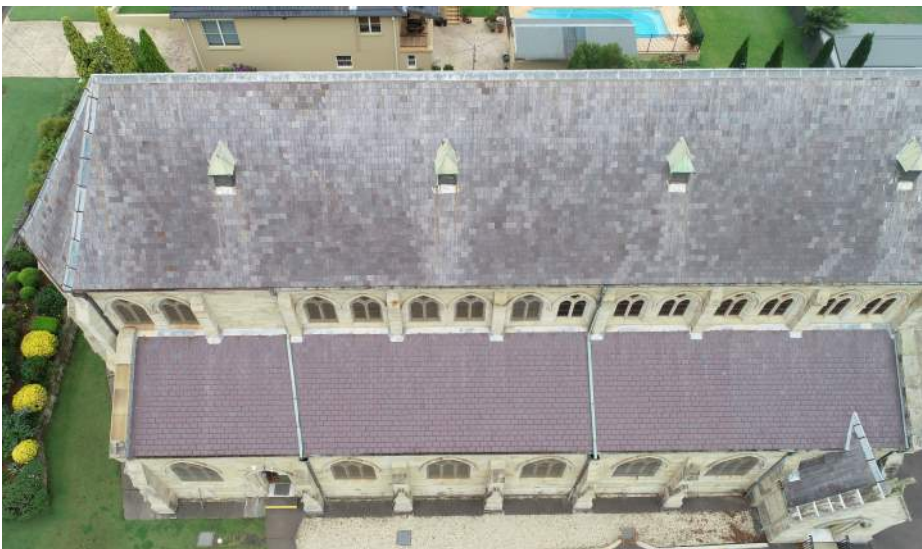
Figure 28
Aerial view of slate roof to church. Slate replaced to north aisle. Note difference in condition of slate.
source: iScope Consultants, March 2021.

The proposal is for removal of existing slate roof, re-slating of the roof, reconstruction of the roof plumbing elements (gutters, downpipes, and rainwater heads), and reconstruction of the roof dormer vents. The slate on the north aisle was replaced in c2010 and does not require renewing.

- The Canadian Glendyne slate tile emulates the existing Welsh slate tile in texture, material and colour, and will not have a detrimental impact on the significance of the church. The north aisle slate was replaced in c2010 using Canadian Glendyne slate therefore the current proposal will match this.

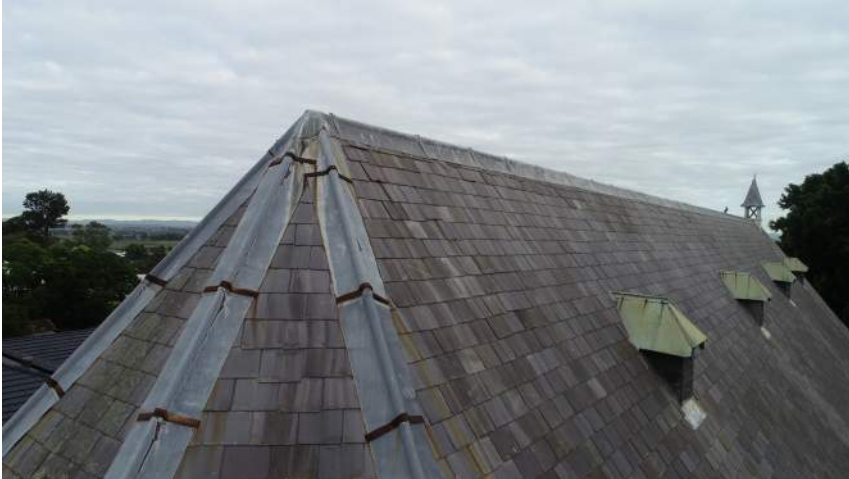
Figure 29
Aerial view of metal ridge capping impacted by hail damage. Note also the condition of the dormer cladding.
source: iScope Consultants, March 2021.

Metal roof cladding to all roof dormers and guttering on the western roof plane have been impacted by hail damage. Many of the louvres to the roof ventilators have become dislodged, with protective mesh screening also in a state of disrepair. A selection of the slate roof tiles present in poor condition with recent breakages evident warranting replacement. This collective destruction has caused for water ingress and subsequent damage to the internal masonry walls.

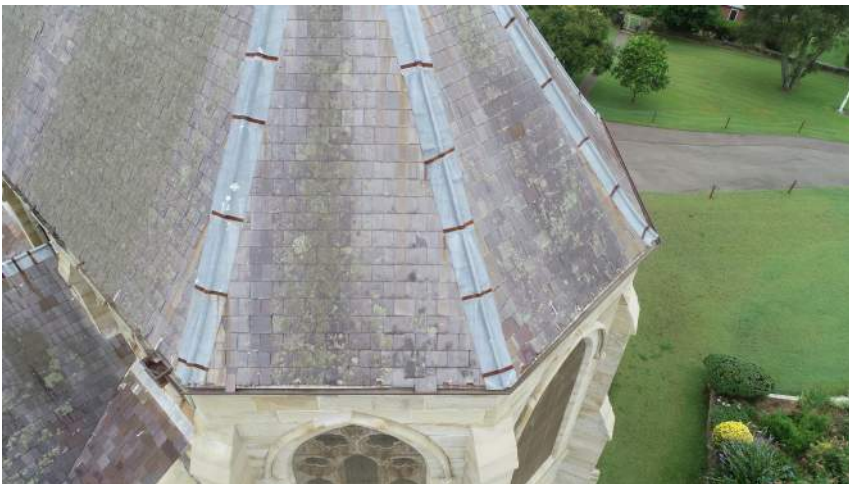
Figure 30
Aerial view of metal ridge capping and guttering impacted by hail damage.
source: iScope Consultants, March 2021.

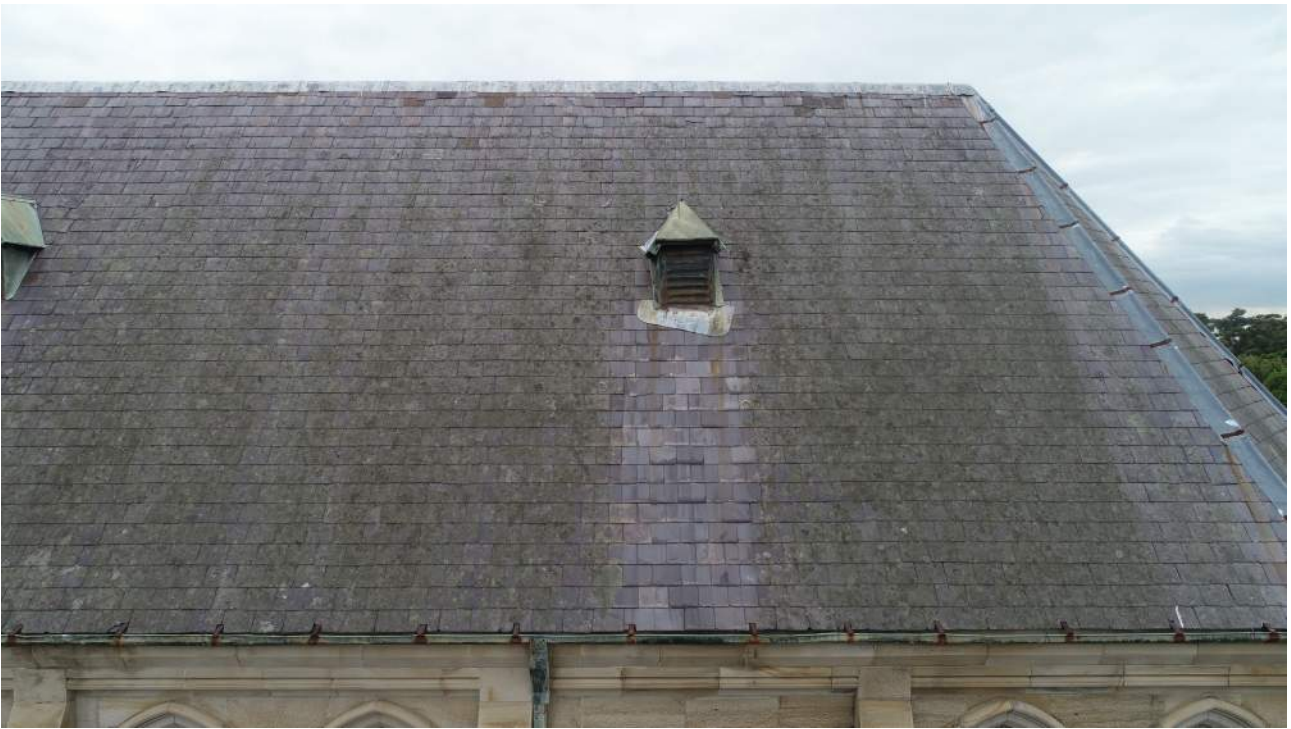
Figure 32
View of damaged dormer with metal cladding, metal louvres and flashing in poor condition.
source: iScope Consultants, March 2021.

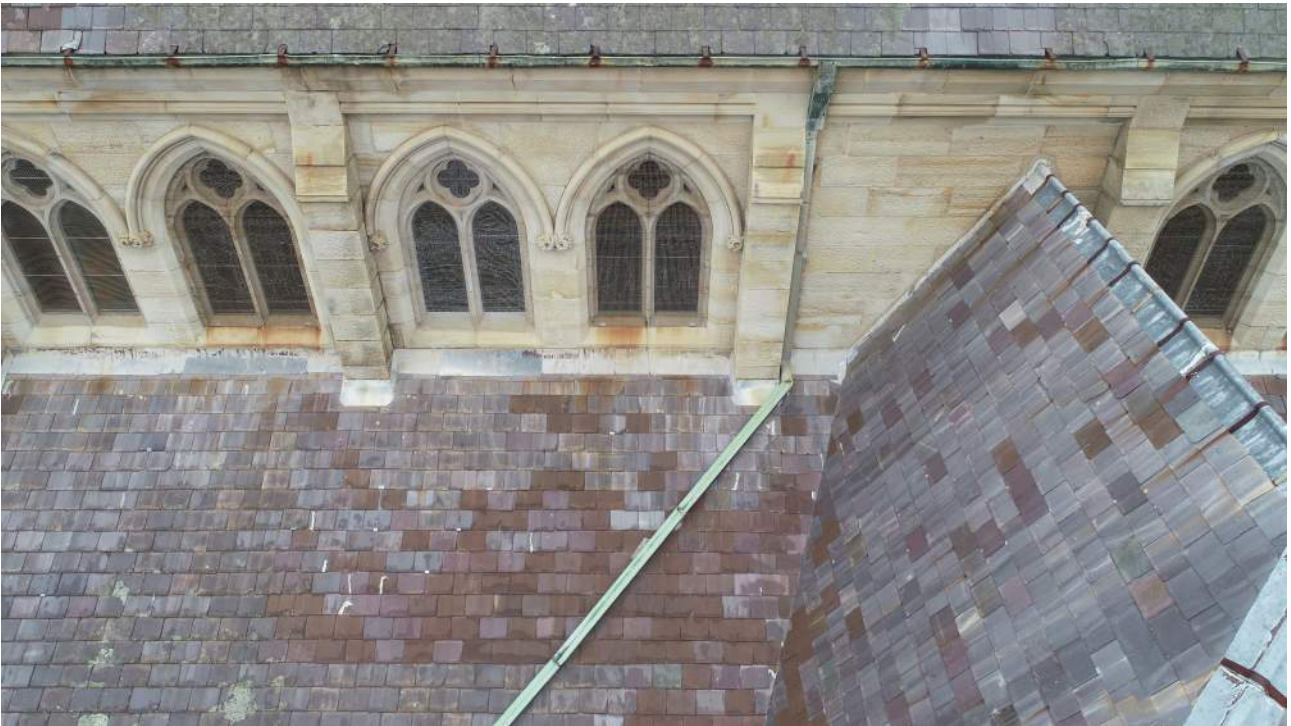
Figure 33
View of metal gutter in poor condition with new slate tile repairs evident to lower roof plane.
source: iScope Consultants, March 2021.

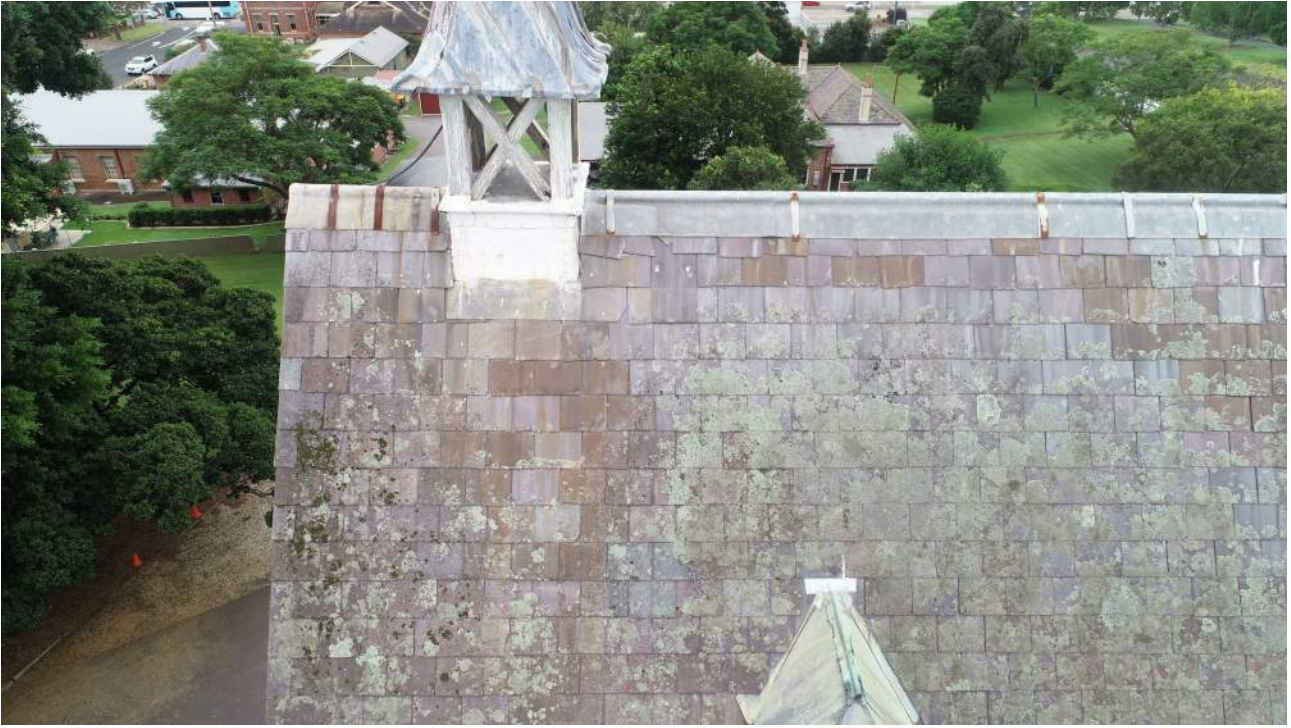
Figure 34
View of bellcote to west end of roof apex. Masonry plinth with metal flashing and painted timber framing. Rolled lead roof sheeting.
source: iScope Consultants, March 2021.

Reconstruction of the bellcote is proposed. Damage to the existing bellcote is documented in a 2019 report by horologist Tim Tracey (Tower Clock Services Australia).

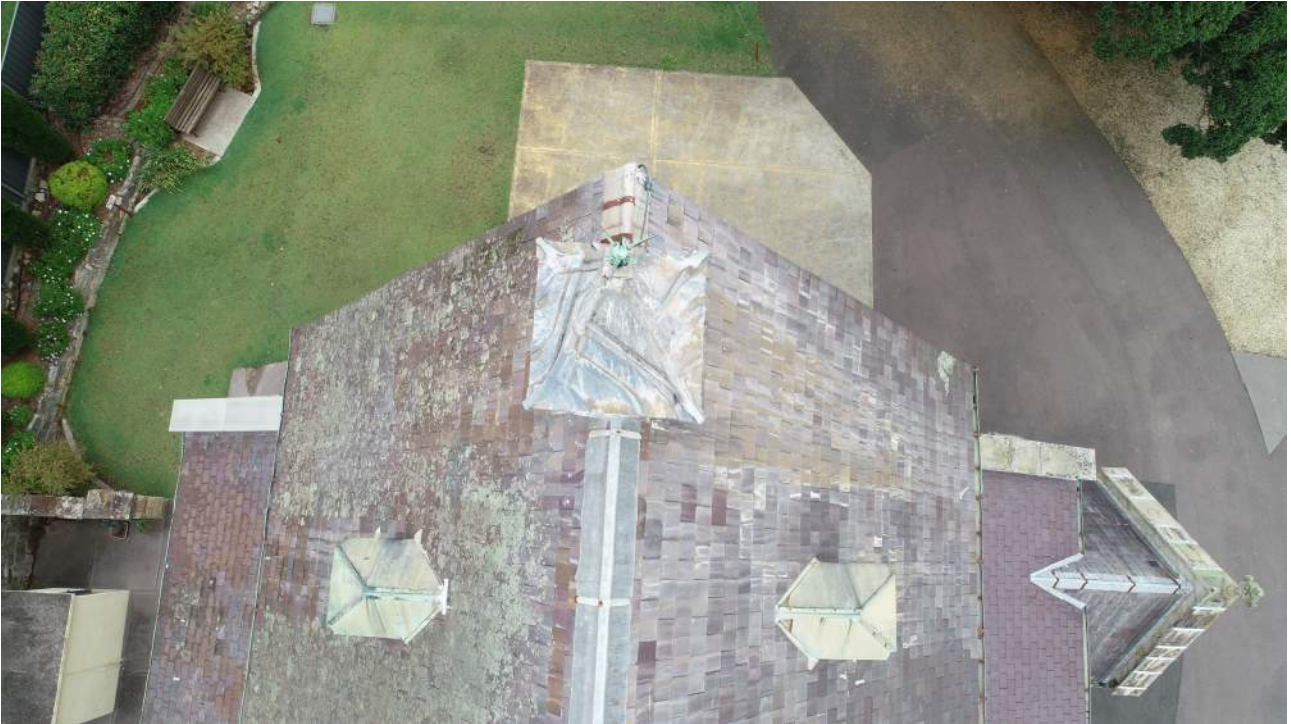
Figure 35
Aerial view of bellcote to western apex with rolled lead sheeting and copper lightning rod.
source: iScope Consultants, March 2021.

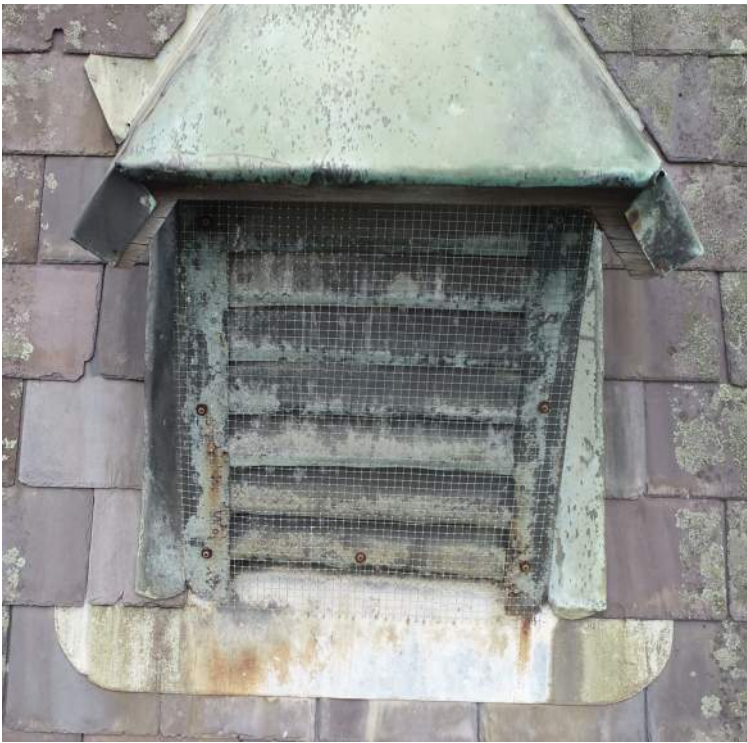
Figure 36
View of timber framed dormer with copper roof cladding and flashing. Copper louvres in poor condition.
source: iScope Consultants, March 2021.

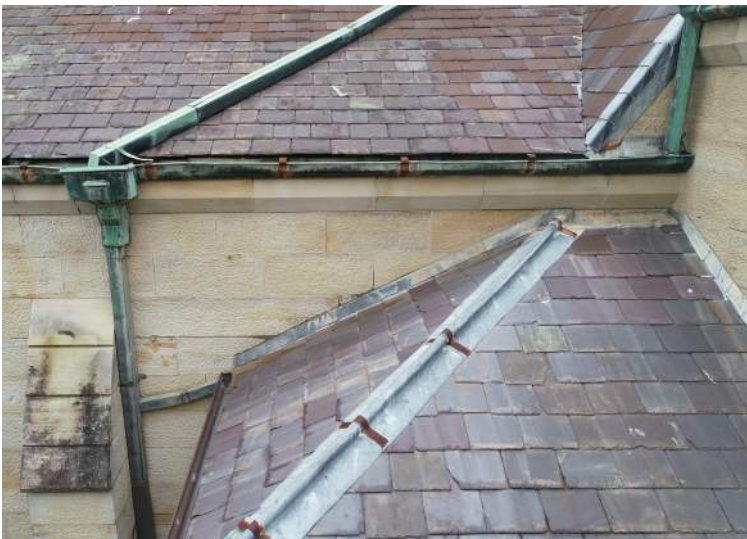
Figure 37
Detailed view of copper rainwater heads and metal guttering in poor condition.
source: iScope Consultants, March 2021.

- Re-roofing will allow for the protection of internal fabric.
- The proposed materials for reconstruction are based on existing details, including guttering and rainwater heads. This will ensure the character of the original church is maintained. There are two different profiles existing on the church, confirming previous works at some stage. One of these profiles is ogee. The original gutter profile is not known however, ogee, half-round and quadrant profiles were in use by the late 1800s. It is considered acceptable therefore to use an ogee profile for the replacement gutter.

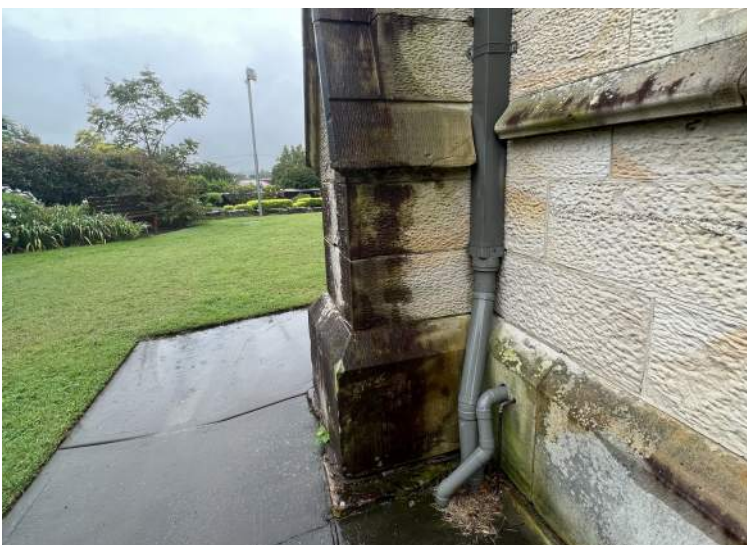
Figure 38
New rectangular metal downpipe with painted PVC outlet.
source: Heritas, 2022.

- Although the document set indicates the gutters and downpipes will be replaced with copper, the client has verbally indicated their desire to use Colorbond due to the threat of theft. The use of copper at height, and Colorbond at lower levels, is discounted due to incompatibility. While the use of copper is preferred from a historical perspective, it must be acknowledged that protecting gutters and downpipes at lower levels of the church in areas that are readily accessible by the public is significantly challenging. As an alternative option, Colorbond roof plumbing can be considered acceptable where cross-section profiles match the original and the colour is sympathetic. It should be noted that Colorbond may be subject to accelerated corrosion due to the use of copper for slate nails and dormer cladding.
