# Riparian Assessment Report

Proposed residential subdivision at 527, 507, 501, 463 and 457  
Cessnock Road, Gillieston Heights NSW 2321

**AEP Ref: 2665.02**

**16 June 2023**

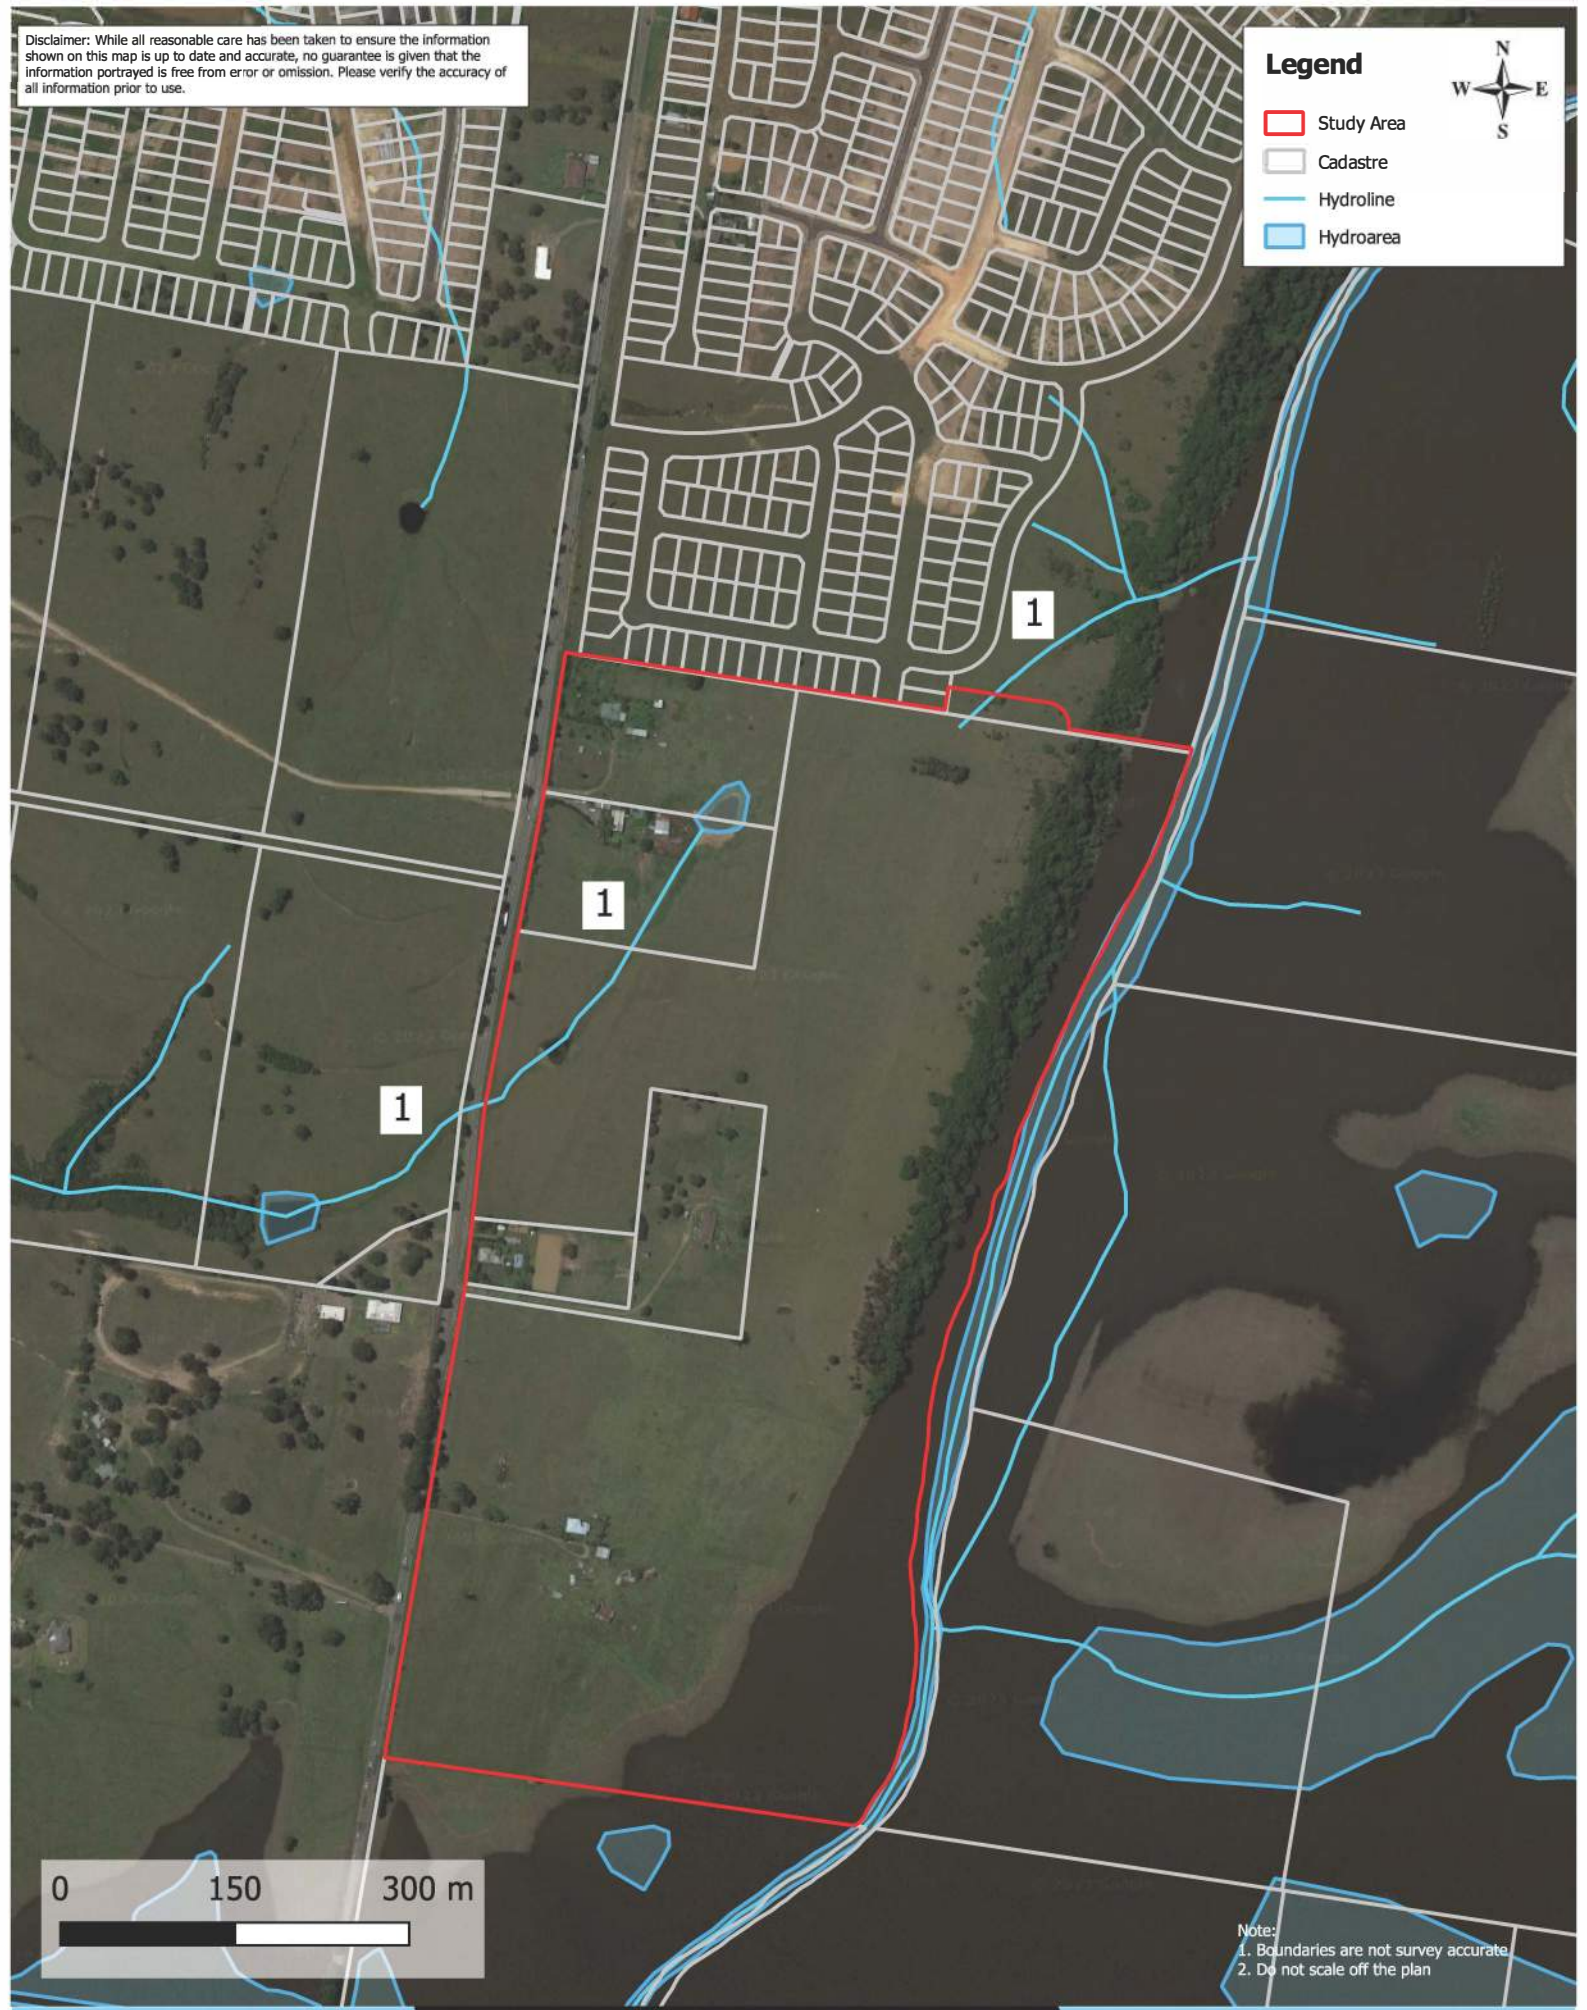
Title: Figure 3 - Desktop Stream Order  
Location: 527 Cessnock Rd, Gilleston Heights NSW 2321  
Client: Walker Gilleston Heights Pty Ltd  
Date: June 2023  
AEP ref: 2665.02

- Stream orders were determined using the Strahler Order system via both API and *Water Management (General) Regulation 2018 Hydroline spatial data 1.0* refer **Figure 3** Desktop Stream Order;
- Regional Vegetation Mapping assessed utilising Lower Hunter Vegetation mapping 2013 was utilised to identify vegetation communities occurring within the Subject Site (refer **Figure 2**);
- Literature review of stream ordering assessment and field assessment criteria to determine accuracy of mapped hydrolines;
- Assignment of segment identification numbers to potential watercourses (Segment ID) (refer **Figure 4**); and
- Investigations for streams outside of the Subject Site will consist of roadside visual inspections and further desktop analysis.

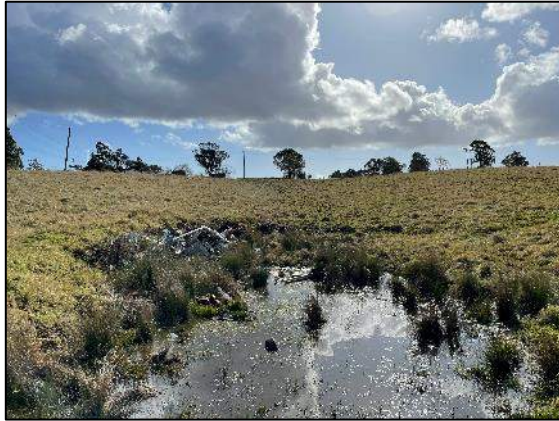
Ground-truthed Numbering to Determine VRZ	N/A	-	6
Controlled Activity Approval Required (Y / N)	No	-	-
Vegetated Riparian Zone Required (m)	N/A	-	-
Comments	No bed and banks were observed at field survey segment 1.1.

late 1: Segment ID 1.1 Showing dam facing north.

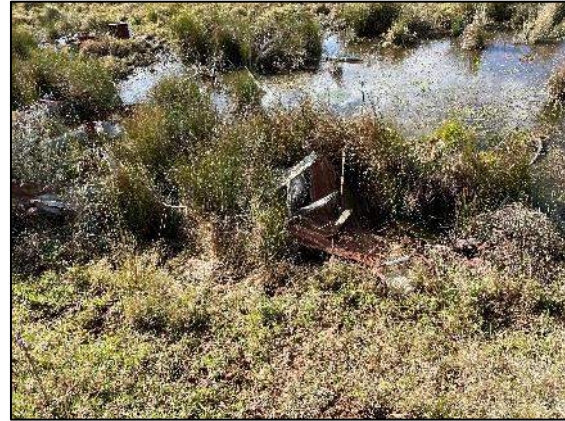
Plate 2: Segment ID 1.1 Facing east across dam.

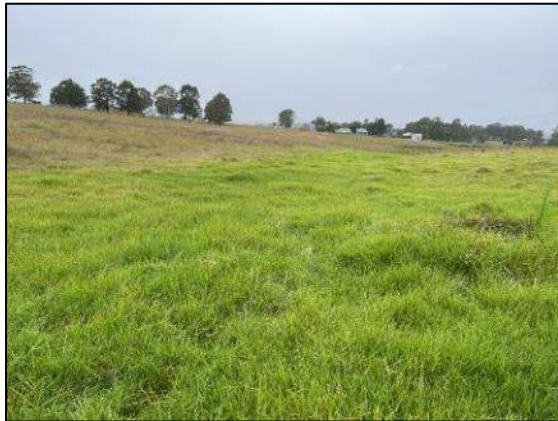
Ground-truthed Numbering to Determine VRZ	N/A	-	6
Controlled Activity Approval Required (Y / N)	No	-	-
Vegetated Riparian Zone Required (m)	N/A-	-	-
Comments	Field survey segment 1.2 is located downhill (south-west) of segment 1.1 just below the farm dam. This wet area does not meet the criteria for a 1st order stream due to the lack of defined bed

Task – Waterfront Land Tool (2020)	Assessment	Comments (provide evidence)	Figures
		<p>and banks, lack of riparian/ aquatic vegetation and no visible high bank. The vegetation is greener due to the convergence of overland flow in between landscape undulations.</p> <p>Watercourse features as defined by Appendix 6 of the Waterfront Land Tool were not identified.</p> <p>The mapped 1st order stream is not present within the Subject Site.</p>

**Plate 3 Segment ID 1.2 (left) facing SW**

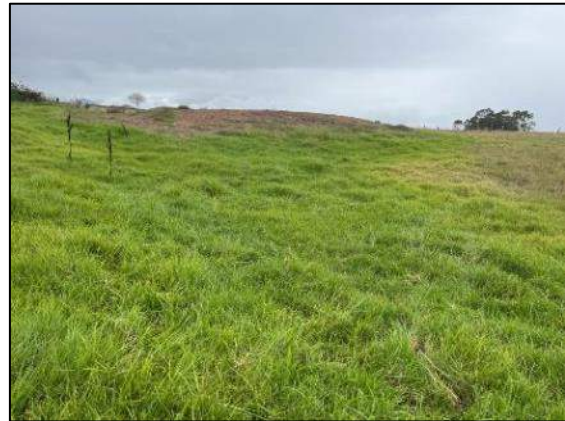
**Plate 4: Segment ID 1.2 (right) facing NE. The dam wall can be seen.**

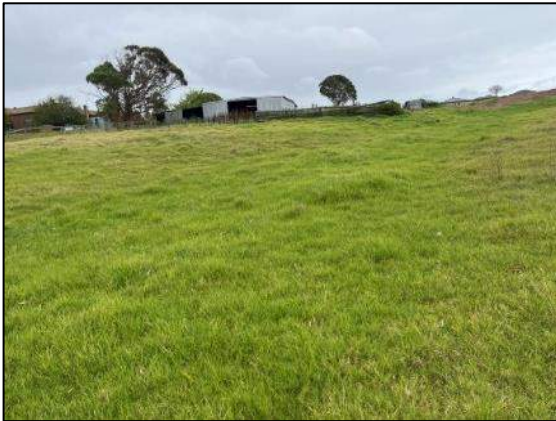
Ground-truthed Numbering to Determine VRZ	N/A	-	-
Controlled Activity Approval Required (Y / N)	No	-	-
Vegetated Riparian Zone Required (m)	No	-	-
Comments	Field survey segment 1.3 is located further downhill (south-west) along field survey segment 1. This wet area does not meet the

Task – Waterfront Land Tool (2020)	Assessment	Comments (provide evidence)	Figures
		<p>criteria for a 1st order stream due to the lack of defined bed and banks, lack of riparian/ aquatic vegetation and lack of water.</p> <p>Watercourse features as defined by Appendix 6 of the Waterfront Land Tool were not identified.</p> <p>The mapped 1st order stream is not present within the Subject Site.</p>

**Plate 5: Segment ID 1.3 facing NE.**

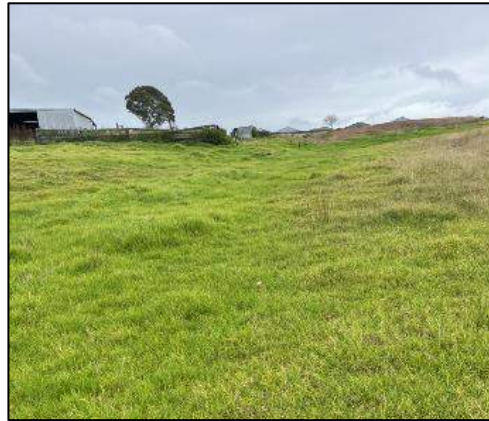
**Plate 6: Segment ID 1.3 facing NE.**

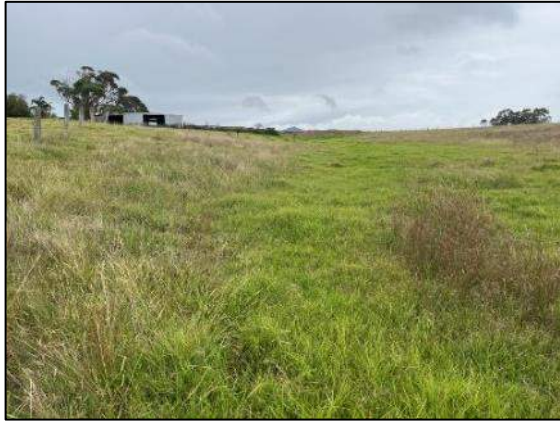
Ground-truthed Numbering to Determine VRZ	N/A	-	-
Controlled Activity Approval Required (Y / N)	No	-	-
Vegetated Riparian Zone Required (m)	No	-	-
Comments	Field survey segment 1.4, does not meet the criteria for a 1 <sup>st</sup> order stream due to the lack of defined bed and banks, lack of

<p>riparian vegetation and no water present in spite of recent rain before time of survey.</p> <p>Watercourse features as defined by Appendix 6 of the Waterfront Land Tool were not identified.</p> <p>The mapped 1st order stream is not present within the Subject Site.</p>
--	---

**Plate 7: Segment ID 1.4 facing NE.**

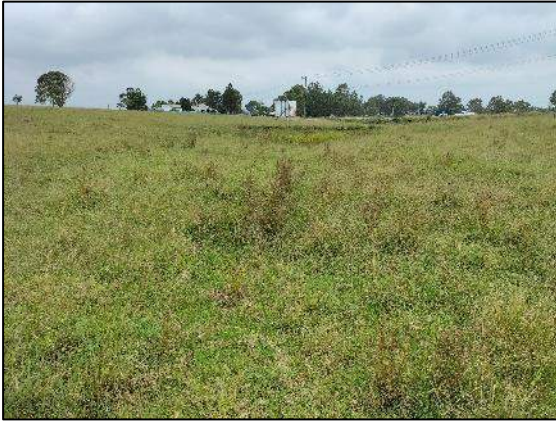
Ground-truthed Numbering to Determine VRZ	N/A	-	-
Controlled Activity Approval Required (Y / N)	No	-	-
Vegetated Riparian Zone Required (m)	No	-	-
Comments	<p>Field survey segment 1.5, does not meet the criteria for a 1<sup>st</sup> order stream due to the lack of defined bed and banks, lack of riparian/ aquatic vegetation and lack of water.</p> <p>Watercourse features as defined by Appendix 6 of the Waterfront Land Tool were not identified.</p> <p>The mapped 1st order stream is not present within the Subject Site.</p>

**Plate 9: Segment ID 1.5 facing NE, the lower dam can be seen.**

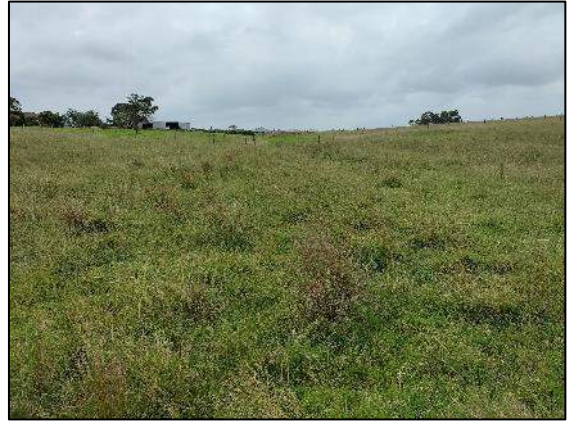
**Plate 10: Segment ID 1.5 facing SE.**

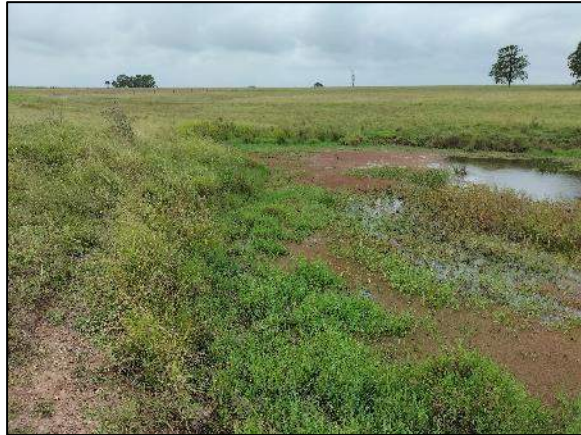
Ground-truthed Numbering to Determine VRZ	N/A	-	-
Controlled Activity Approval Required (Y / N)	No	-	-
Vegetated Riparian Zone Required (m)	No	-	-
Comments	A farm dam is located at field survey segment 1.6. A gully to the south east channels overland flow during heavy rainfall into the dam, however, no defined bad and banks are visible, or any

<p>watercourse features as defined by Appendix 6 of the Waterfront Land Tool.</p> <p>Watercourse features as defined by Appendix 6 of the Waterfront Land Tool were not identified.</p> <p>The mapped 1st order stream is not present within the Subject Site.</p>
--	--

**Plate 11: Segment ID 1.6 facing NE**

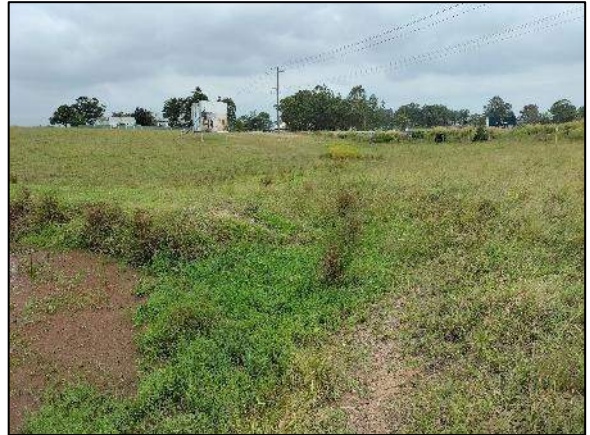
**Plate 12: Segment ID 1.6 facing SE**

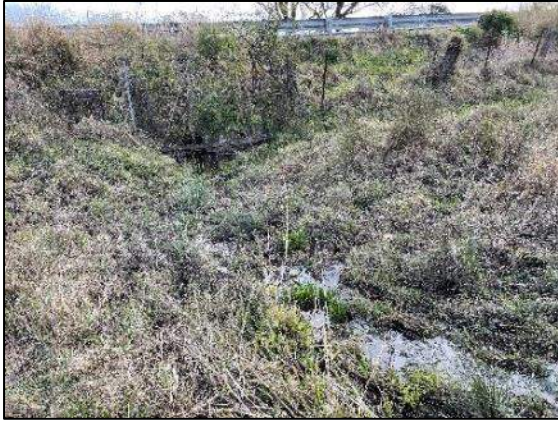
<p>Comments</p>	<p>Field survey segment 1.7, does not meet the criteria for a 1<sup>st</sup> order stream due to the lack of defined bed and banks, lack of riparian/aquatic vegetation. At the time of survey there was water present from recent rain but it was clear that it would diminish within a relatively short time frame.</p> <p>Watercourse features as defined by Appendix 6 of the Waterfront Land Tool were not identified.</p> <p>The mapped 1st order stream is not present within the Subject Site.</p>
-----------------	--

**Plate 13: Left Segment ID 1.7 Culvert showing no defined bed or bank along eastern side of Cessnock Rd facing west.**

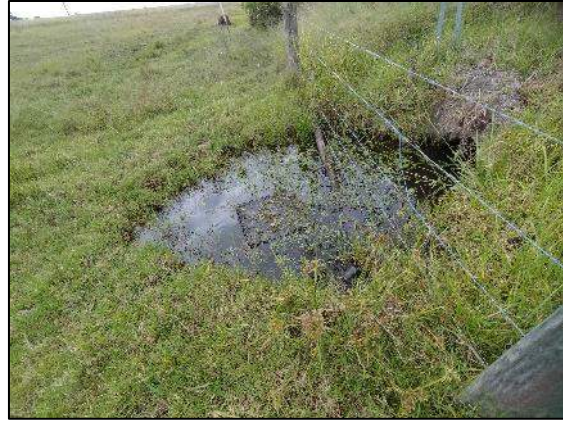
**Plate 14: Right Segment ID 1.7 (right) Culvert on western downstream side of Cessnock Rd.**

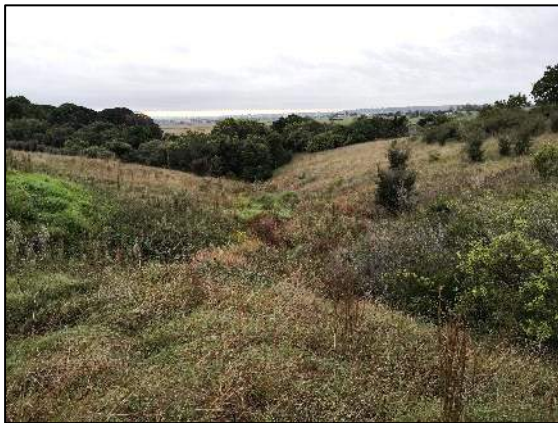
Ground-truthed Numbering to Determine VRZ	1	As per Appendix 4 of the Waterfront Land Tool, Segment ID 2 has been determined to be commensurate with a 1 <sup>st</sup> order stream for the purposes of defining the associated VRZ.	6
Controlled Activity Approval Required (Y / N)	Yes	The watercourse begins approx. 15m to the north of the boundary of Lot 2 DP 601226 and within Lot 2 DP1230739 and the proposed development will encroach and require a CAA.	-
Vegetated Riparian Zone Required (m)	Yes	10m from top of bank.	-

Task – Waterfront Land Tool (2020)	Assessment	Comments (provide evidence)	Figures
Comments		<p>Field survey segment 2.1 is located on the northern boundary of the Subject Site. From the south overland flow converges down steep paddock grassland transitioning to a thick patch of non-native shrubs. A defined bed and bank are visible within the vegetation approximately 15m to the north of the boundary of Lot 2 DP601226 and within Lot 2 DP1230739. Additionally, an outlet pipe discharges water at the boundary, artificially contributing to the watercourse.</p> <p>Watercourse features as defined by Appendix 6 of the Waterfront Land Tool were identified in this location.</p> <p>Ground-truthing of the NSW Hydroline spatial data identified the mapped 1<sup>st</sup> order stream is present within the Subject Site within Lot 2 DP1230739. The proposed VRZ for this first order stream is 10m and as works will occur within 40m of waterfront land, a Controlled Activity Approval will be required to accompany this development application.</p>

**Plate 15: Segment ID 2.1 downstream**

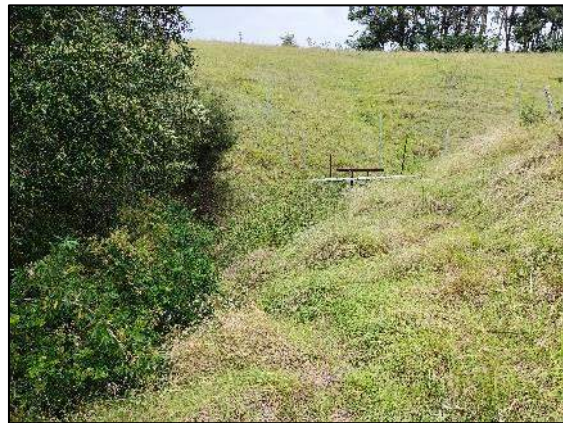
**Plate 16: Segment ID 2.1 upstream**

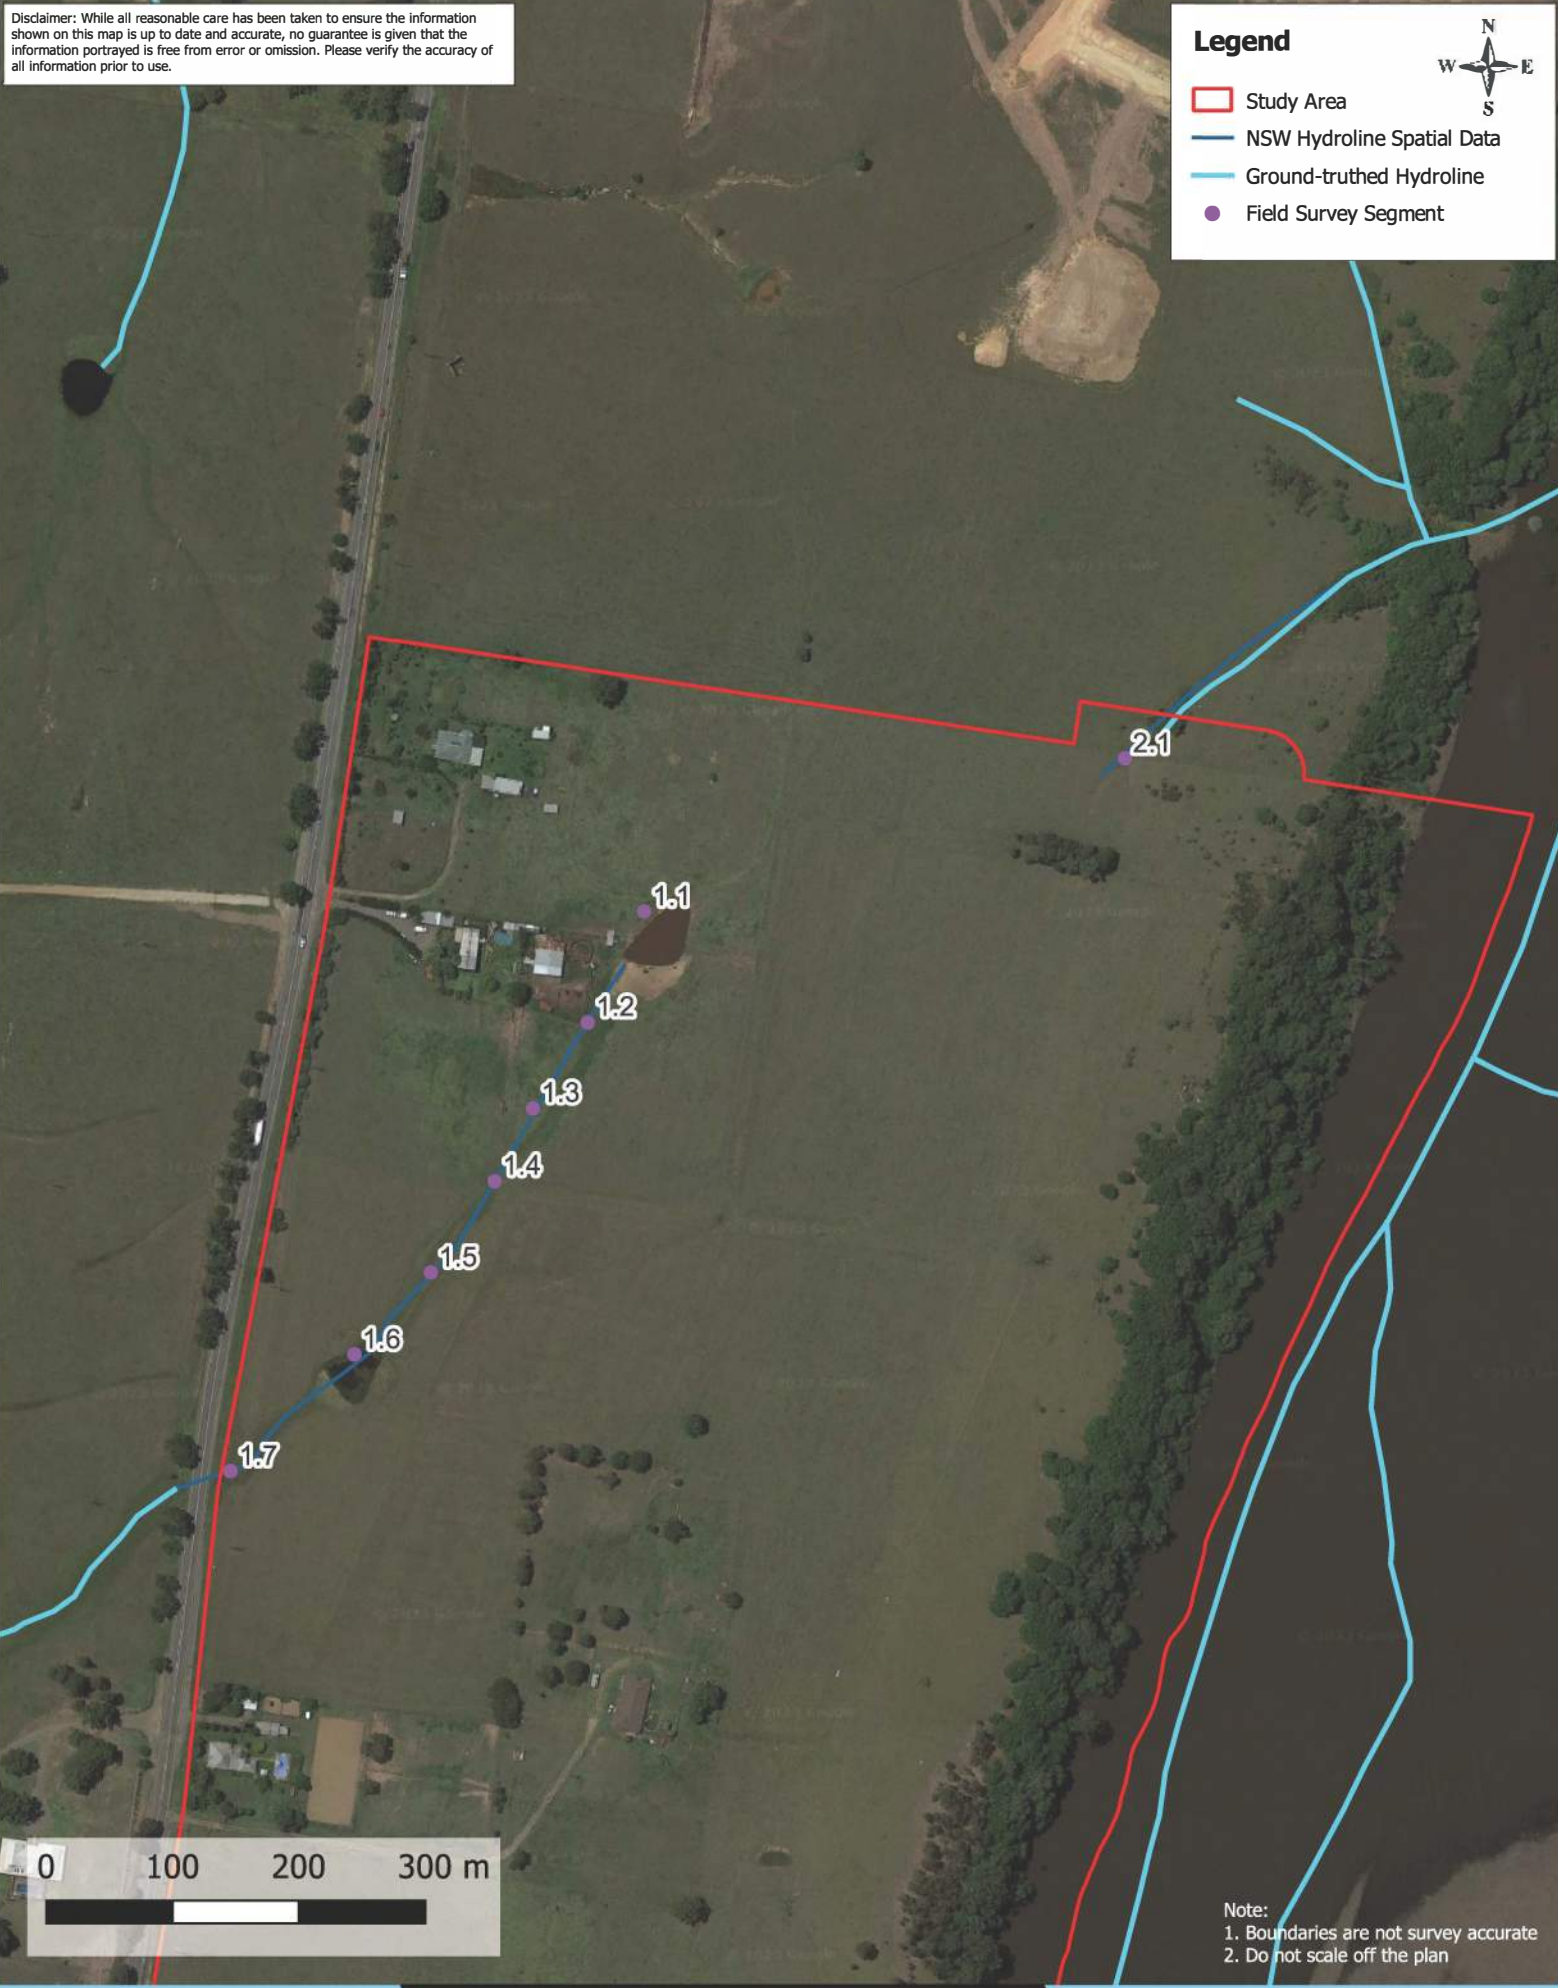
Figure 5 - Survey Effort Date: June 2023  
Location: 527 Cessnock Rd, Gilleston Heights NSW 2321  
Client: Walker Gilleston Heights Pty Ltd AEP ref: 2665.02

General observations outside of the Subject Site were undertaken to assess the hydrolines in the broader locality (refer **Figure 5** for survey effort).

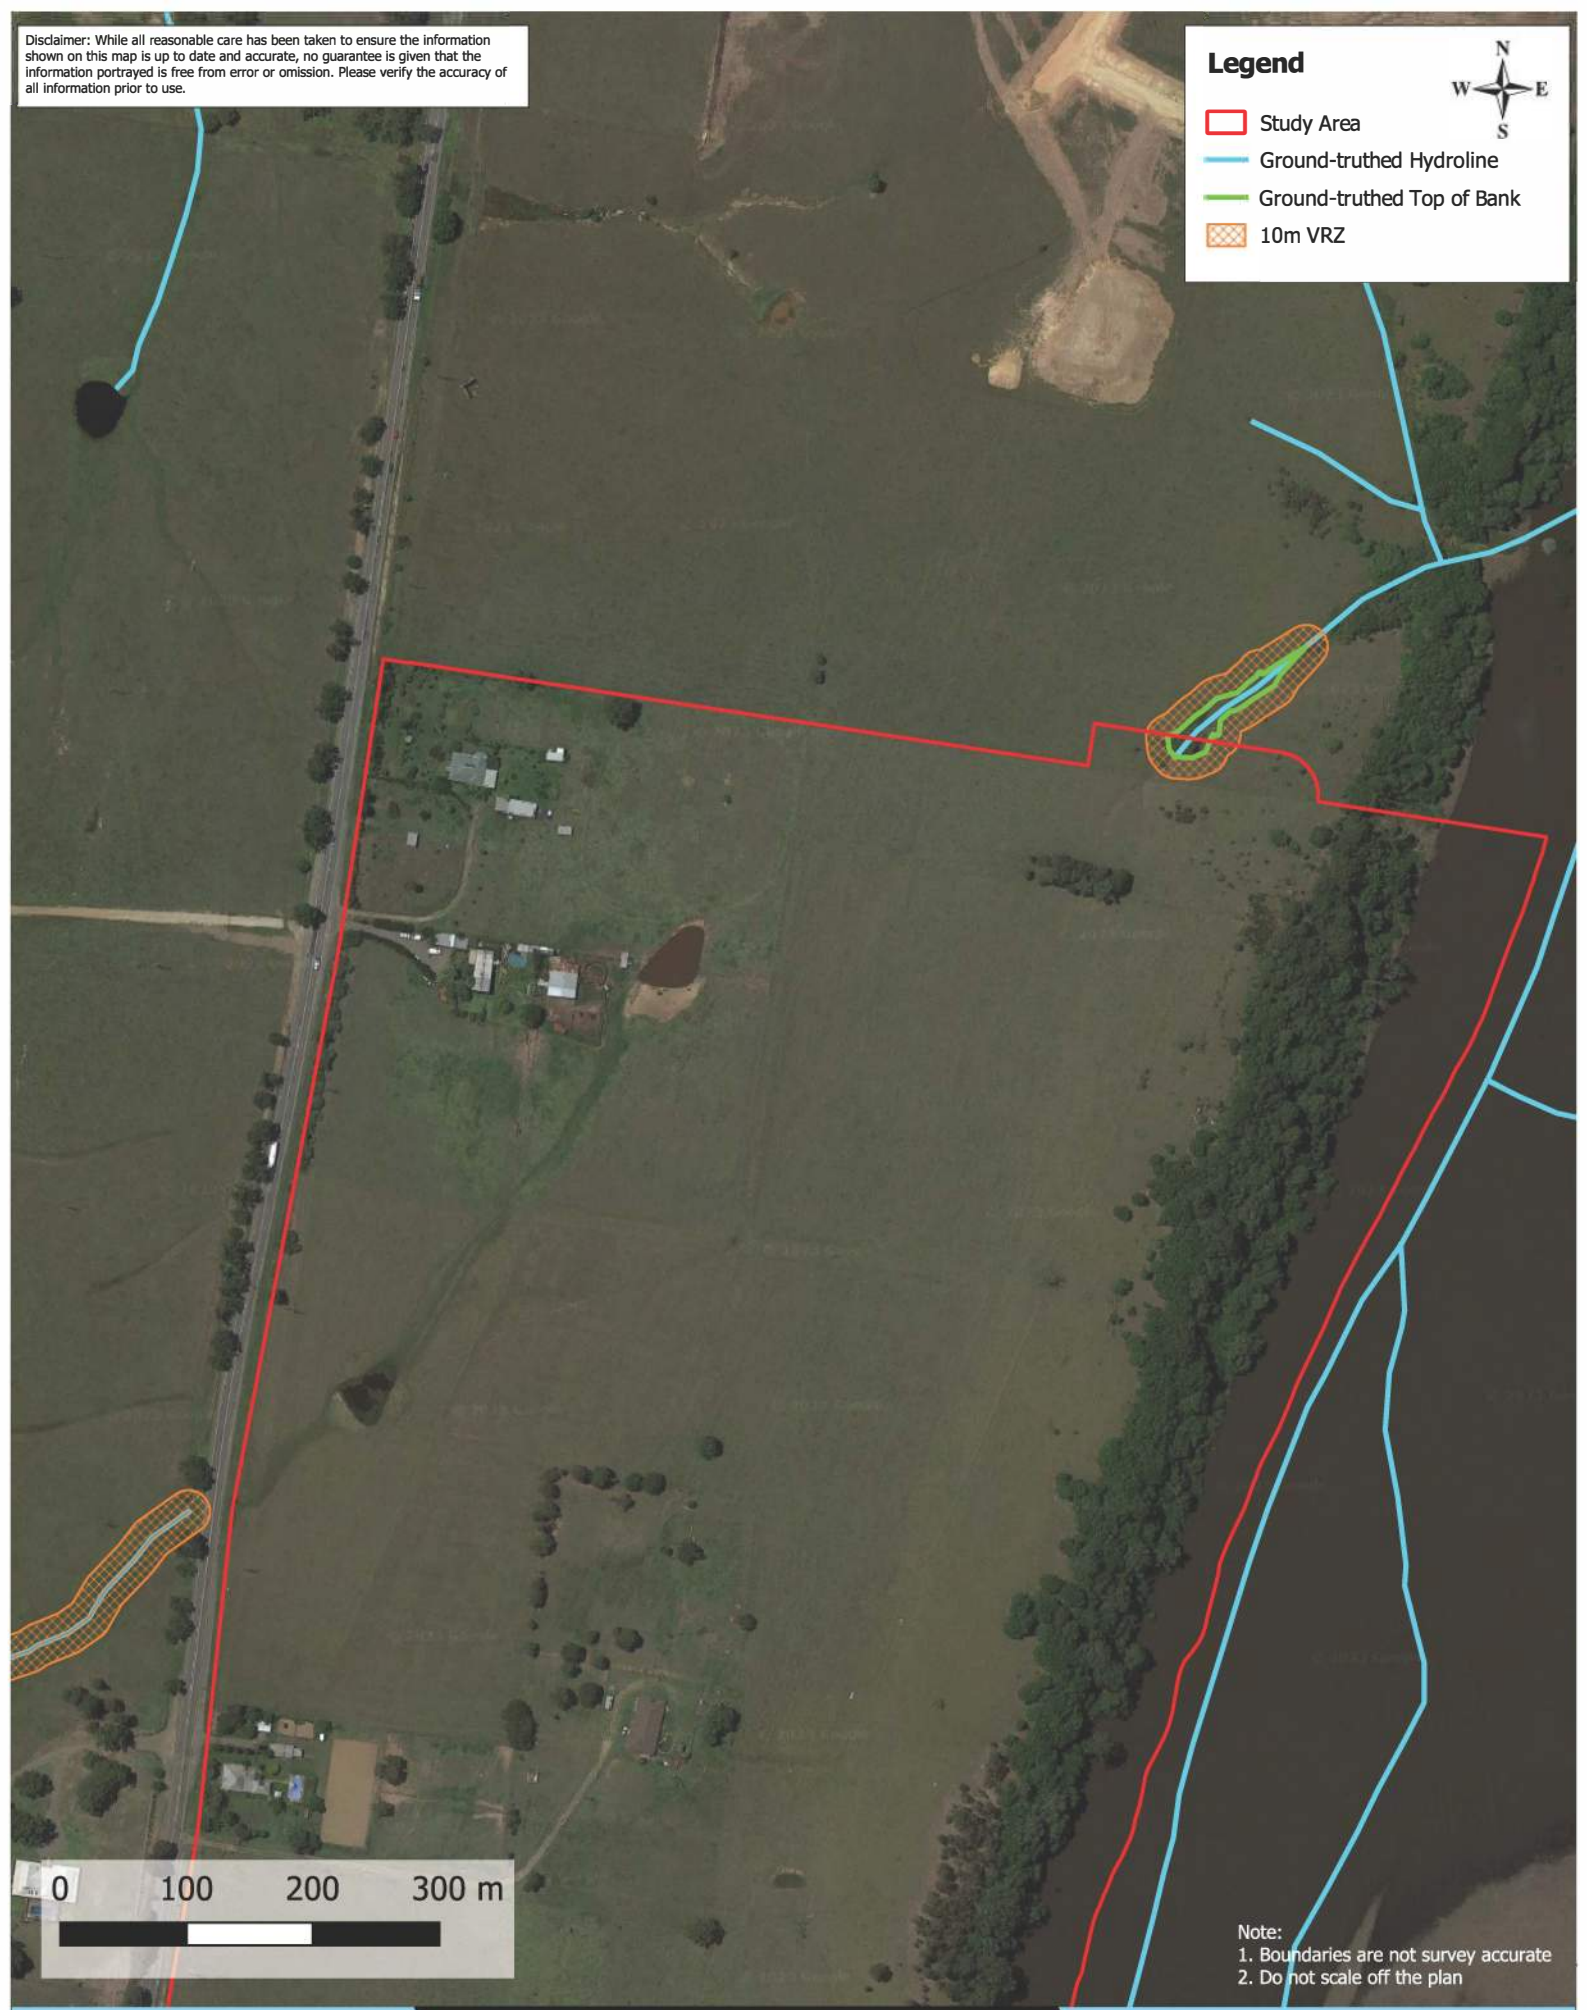
Title: Figure 5 - Ground-Truthed VRZ  
Date: June 2023  
Location: 527 Cessnock Rd, Gilleston Heights NSW 2321  
Client: Walker Gilleston Heights Pty Ltd  
AEP ref: 2665.02

The desktop and field surveys have shown that Segment ID 2 constitutes a Type 1 – Confined Valley Headwater. At the time of field surveys no additional tributaries were identified connected to this segment. Therefore this segment was assigned ground-truthed numbering 1 for the purposes of defining the Vegetation Riparian Zone (VRZ). Segment ID 2 requires a VRZ of 10m either side of the ground truthed high banks, as defined in **Table 11**.

One (1) unnamed first order mapped hydroline is located within the Subject Site. Site investigations indicate that the closest top of bank stream measurement is **within 10m** of the Subject Site and as such a VRZ encroachment is applicable with offsets required that can be included within the BMP Lands within the Study Area. A Controlled Activity Approval (CAA) will be required to be submitted with the Development Application as works will occur within 40m of Waterfront Land.

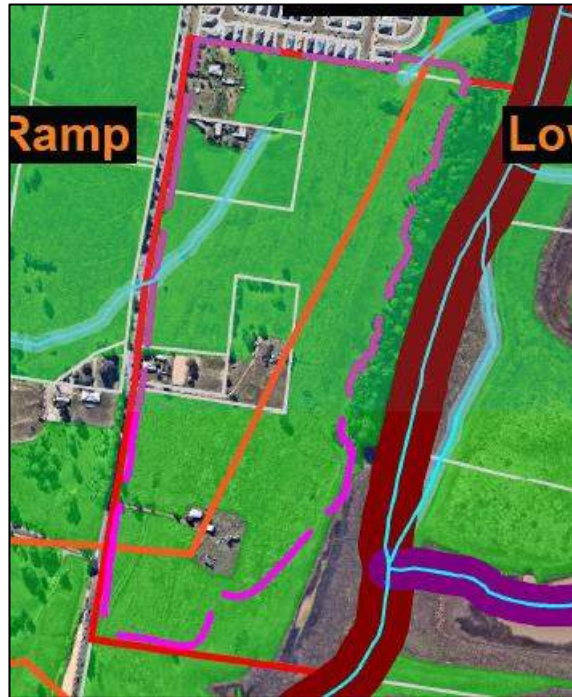
**Table 12 - VRZ Wallace Creek**

It should be noted that the applicable 40m VRZ for Wallace Creek that is a 5<sup>th</sup> order stream encroaches the BMP Lands (refer **Table 12**), however as this area is not being impacted by the development no further consideration is required.

40m VRZ that encroaches BMP lands (indicated in brown) that lies outside of the Subject Site.
