Streamlined Biodiversity Development Assessment Report (Small Area and Planted Native Vegetation)

Proposed residential subdivision at 527, 507, 501, 463 and
457 Cessnock Road, Gillieston Heights NSW 2321

AEP Ref: 2665.02

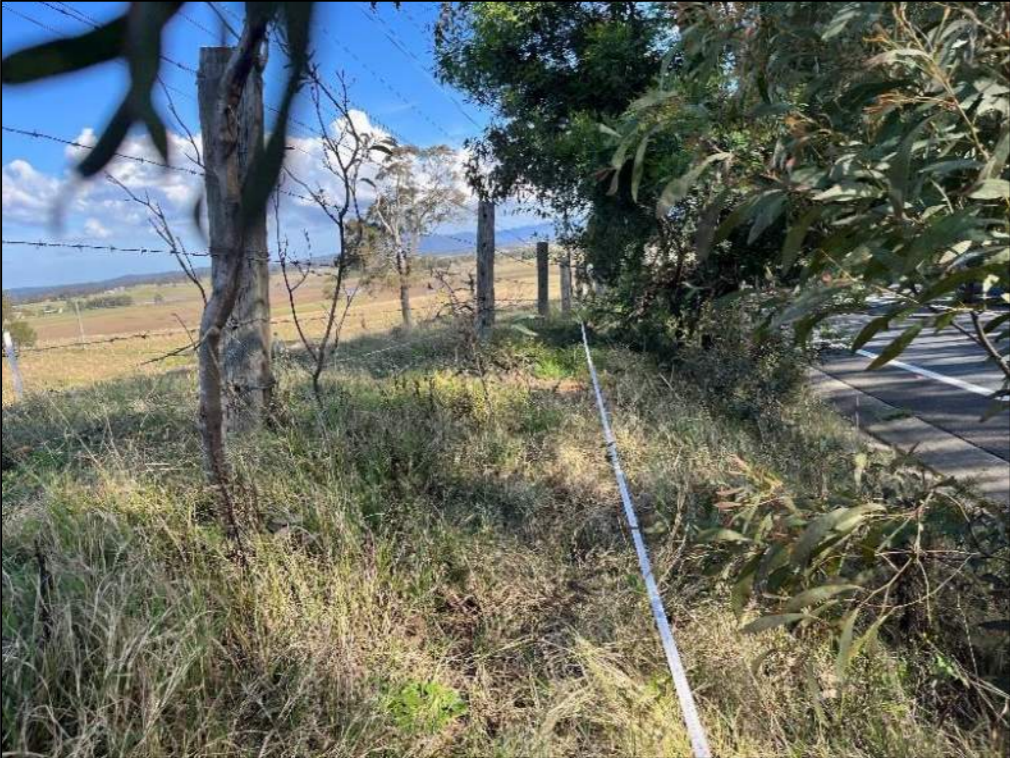
<p data-bbox="507 1864 1154 1896">Plate 1 - PCT 1600 BAM Plot 7 in a degraded condition</p>

Vegetation Zones	
Vegetation Zones of this PCT within Subject Site	The Vegetation Integrity Score (VIS) was calculated at 28.5 which is in the 'degraded' category/condition with the one vegetation community present.
Degraded Condition	
Description of Vegetation Zone	<p>This vegetation zone occurs as scattered remnant vegetation across the site, intermixed with planted vegetation for windbreaks and aesthetic gardens. The mid stratum was sparse, and contained various acacia species. The understorey was predominantly disturbed with a low native cover. This community is consistent with the regionally mapped PCT 1600.</p> <p>Canopy: <i>Corymbia maculata</i>, <i>Eucalyptus fibrosa</i>, <i>Eucalyptus siderophloia</i> and <i>Eucalyptus paniculata</i>.</p> <p>Mid stratum: <i>Acacia falcata</i>, <i>Ozothamnus diosmifolius</i>, <i>Breynia oblongifolia</i>, <i>Acacia ulicifolia</i>, <i>Bursaria spinosa</i>, <i>Pultenaea spinosa</i> and <i>Acacia parvipinnula</i>.</p> <p>Understorey: Native grasses, <i>Themeda triandra</i>, <i>Microlaena stipoides</i>, the forb, <i>Dichondra repens</i> and fern, <i>Cheilanthes sieberi</i>.</p> <p>Exotic species: This vegetation zone consists of a predominantly disturbed understorey, containing high threat exotics, <i>Cenchrus clandestinum</i> (Kikuyu), <i>Senecio madagascariensis</i> (Fireweed), <i>Paspalum dilatatum</i>, <i>Chloris gayana</i> (Rhodes Grass), <i>Ehrharta erecta</i> (Panic Veldtgrass), and other exotic pasture species. Most plots across the entire Subject Site consist of cosmopolitan species <i>Cynodon dactylon</i>.</p> <p>Plates 1 & 2 show examples of PCT 1600 (Degraded condition).</p>

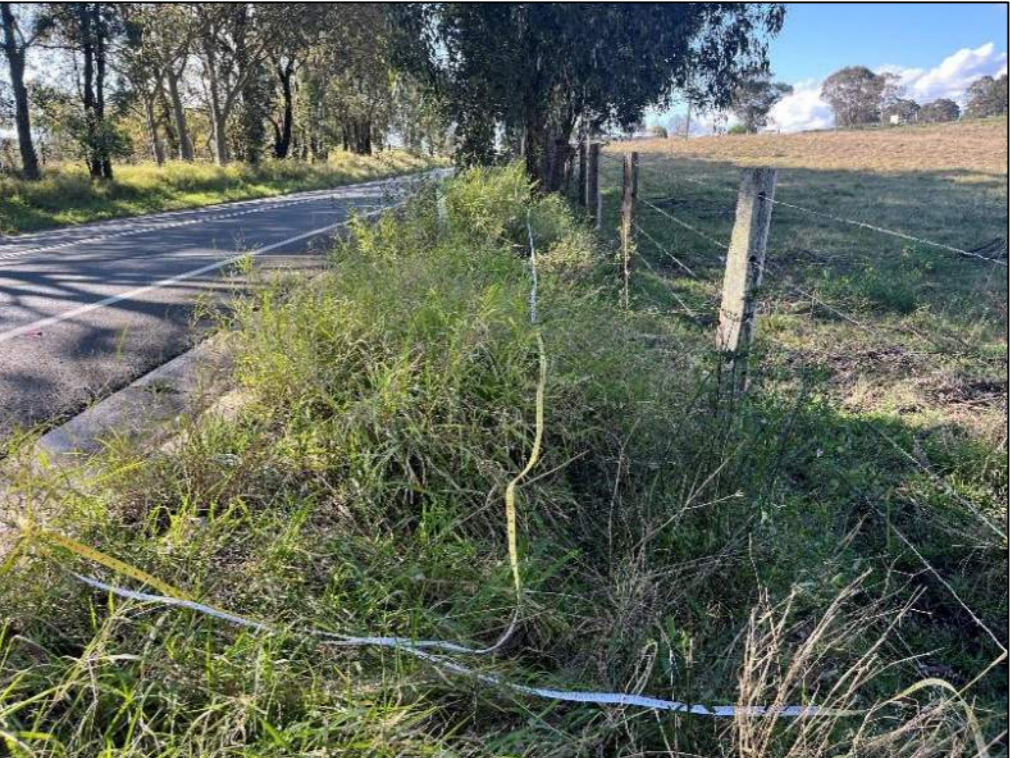
<p data-bbox="1798 1864 2475 1896">Plate 2 - PCT 1600 BAM Plot 7 linear due to road reserve</p>

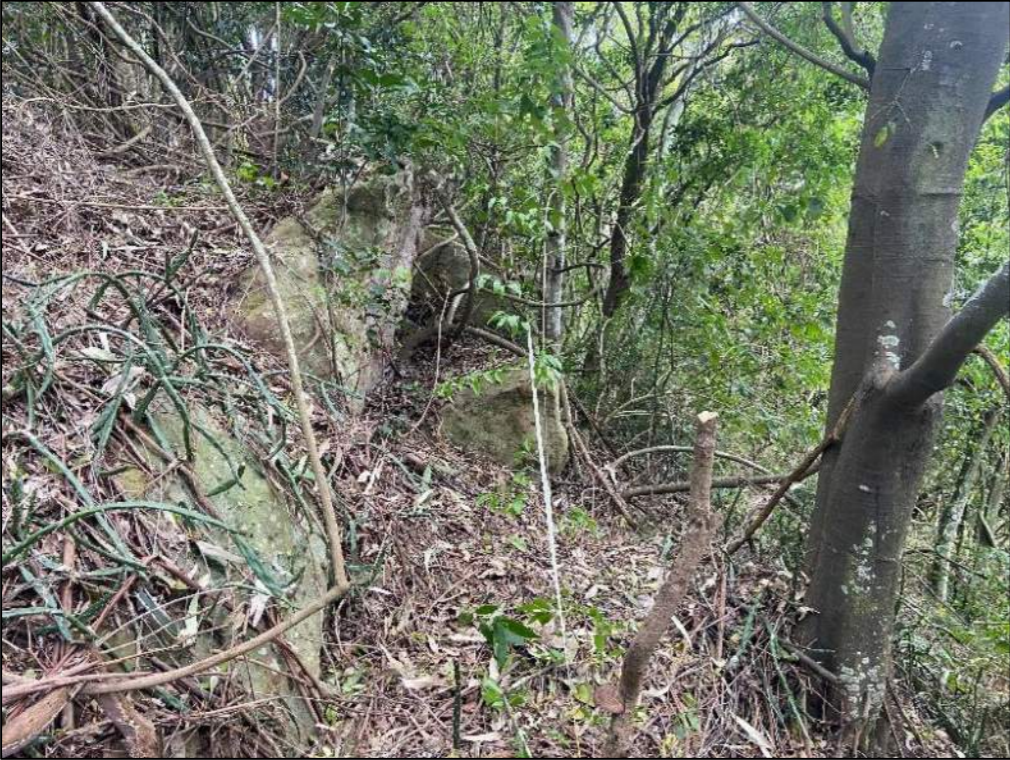
<p data-bbox="507 1675 1151 1705">Plate 3 - PCT 1525 BAM Plot 9 start, in poor condition</p>

Vegetation Zones	
Vegetation Zones of this PCT within Subject Site	The Vegetation Integrity Score (VIS) was calculated at 45.6 which is in the 'poor' category with the one vegetation community present.
Poor Condition	
Description of Vegetation Zone	<p>The vegetation within this community occurs residually in the eastern portion of the Study Area as isolated trees including <i>Cupaniopsis anacardioides</i> (Tuckeroo), <i>Notelaea longifolia</i>, <i>Backhousia myrtifolia</i> and <i>Ficus sp.</i> With a disturbed understorey and midstratum (if present), containing <i>Lantana camara</i>, and predominantly exotic grass species. A plot was carried out in the adjacent, intact Rainforest community to the east to determine the residual vegetation community on site as a BAM plot within the Subject Site was unable to be undertaken. The VIS score in the retained vegetation was still utilised for this area.</p> <p>Plates 3 & 4 show examples of the broader patch of PCT 1525 where BAM plots were undertaken (Poor condition).</p>

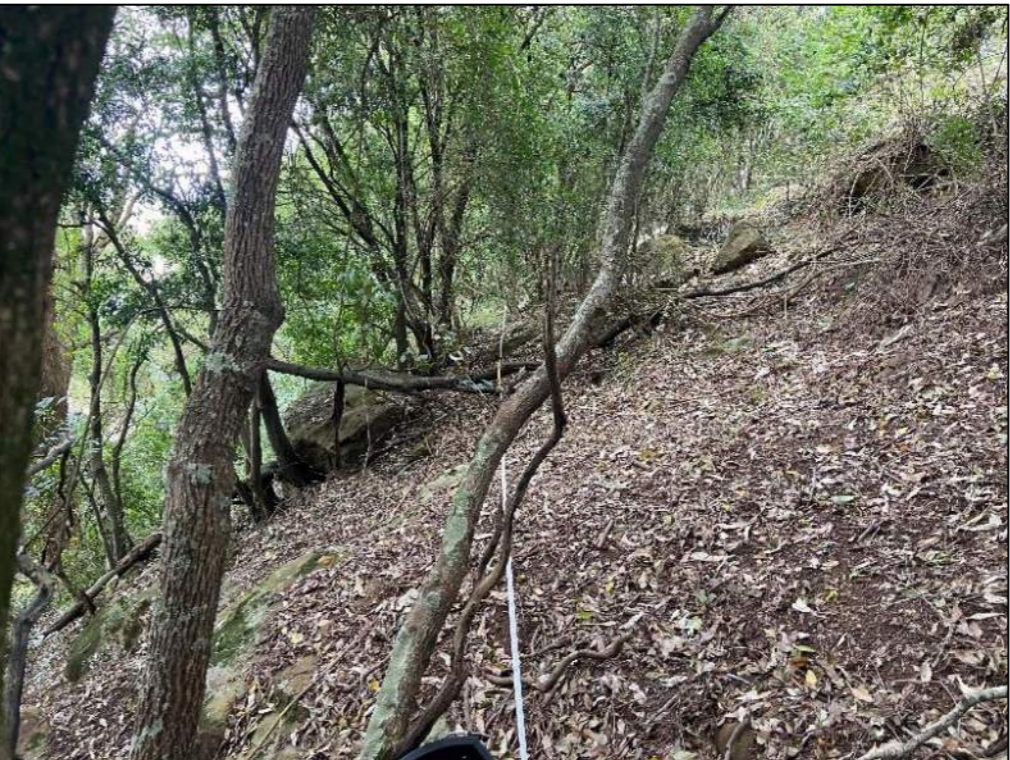
<p data-bbox="1923 1675 2338 1705">Plate 4 - PCT 1525 BAM Plot 9 end</p>

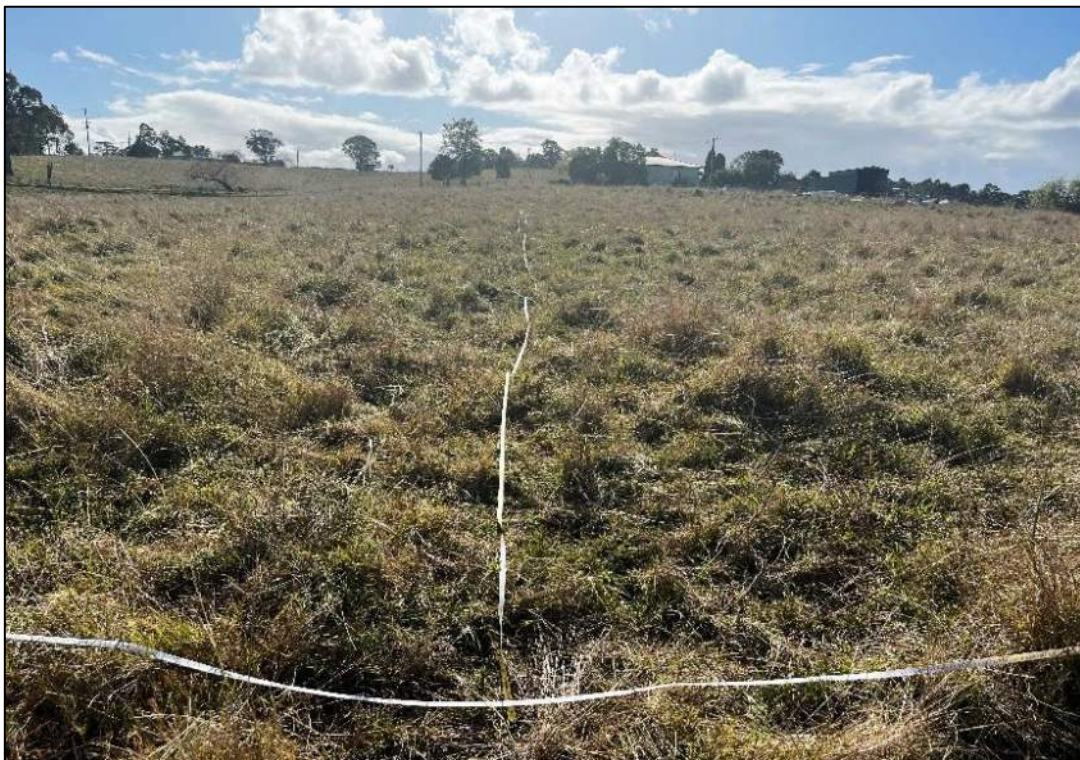
Plate 5 – Exotic pasture BAM Plot 1

Refer to **Plates 5 - 15** for representative photos of the site including BAM plots and vegetation assessed as planted native vegetation. Additional site photographs are included in **Appendix G**.

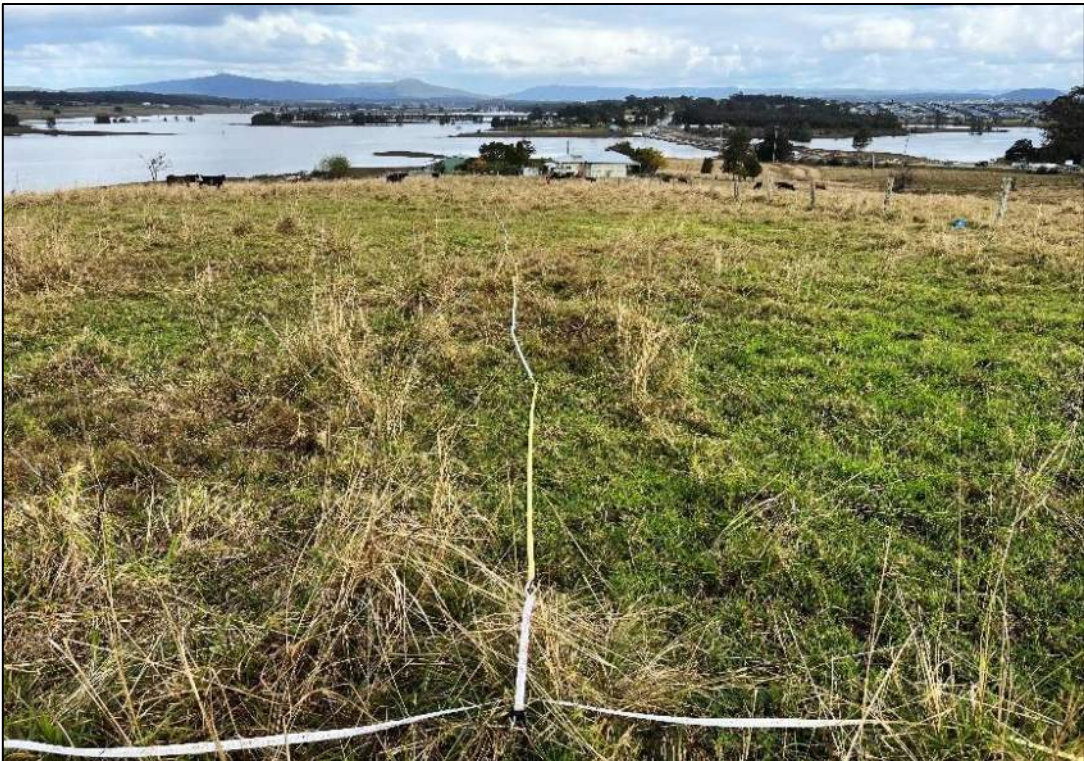
Plate 6 – Exotic pasture BAM Plot 2

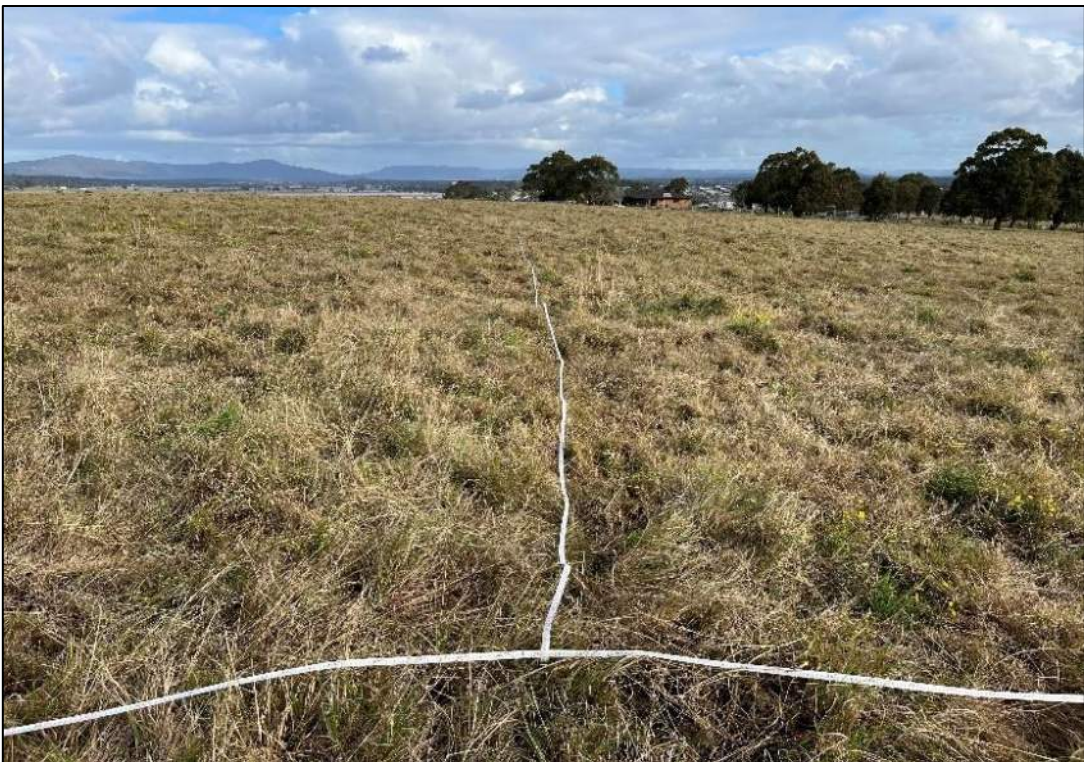
Plate 7 – Exotic pasture BAM Plot 4

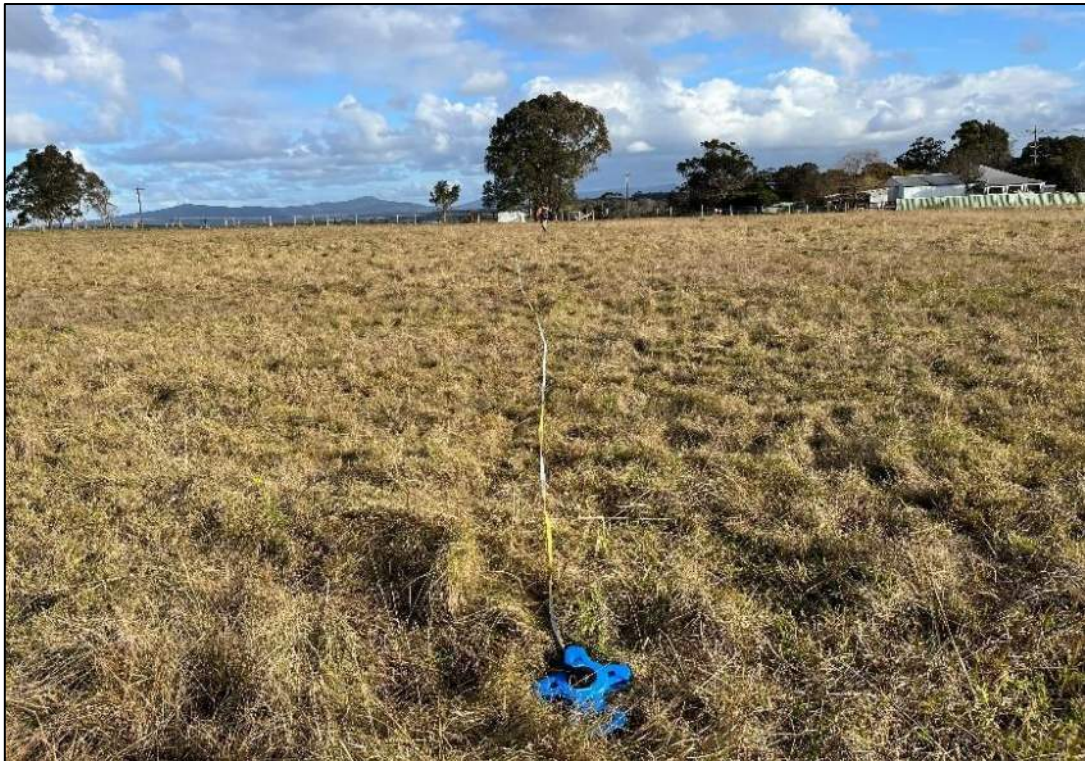
Plate 8 – Exotic pasture BAM Plot 5

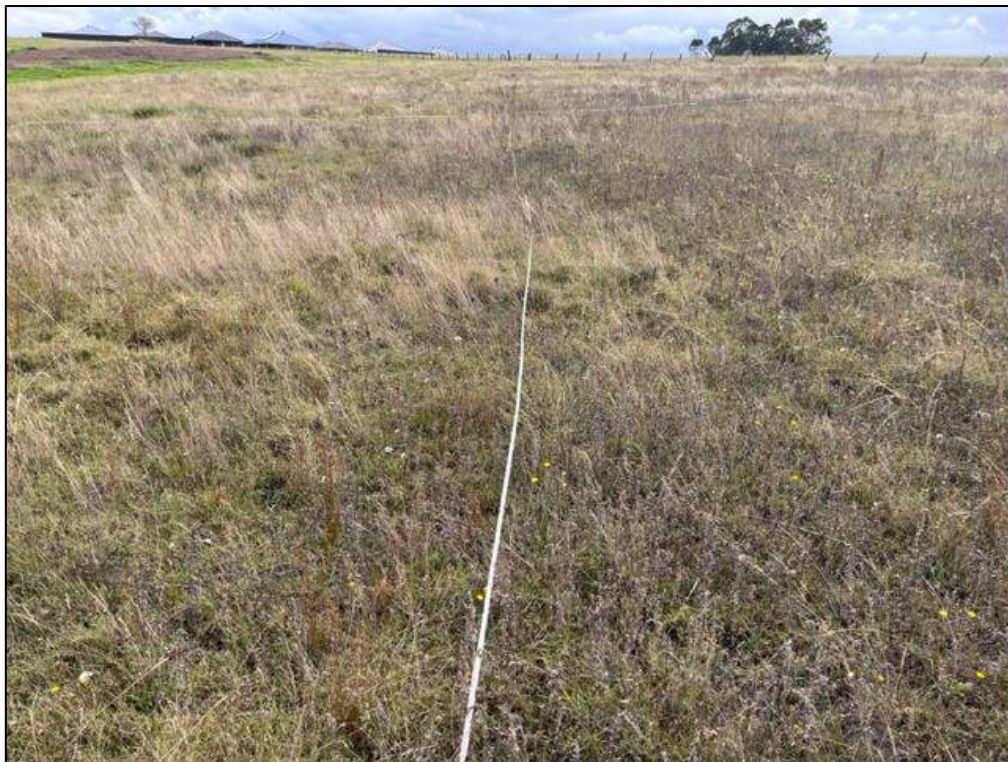
Plate 9– Exotic pasture BAM Plot 11

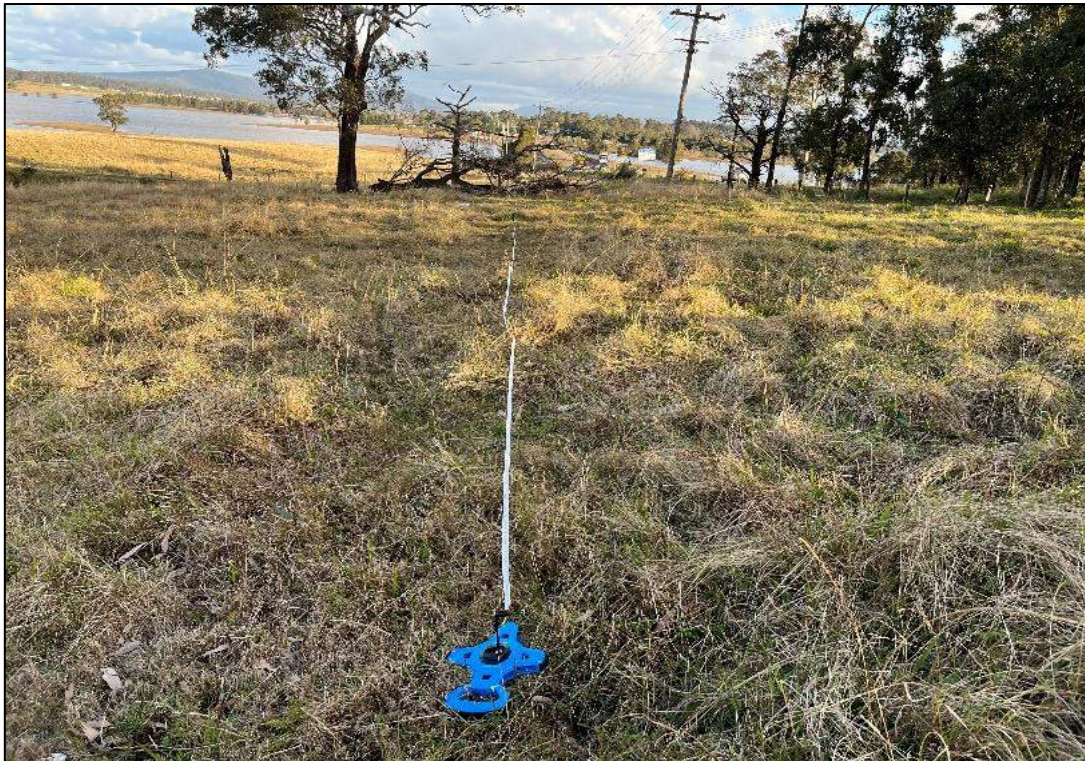
Plate 10 – Ecotone plot that was discarded - BAM Plot 6

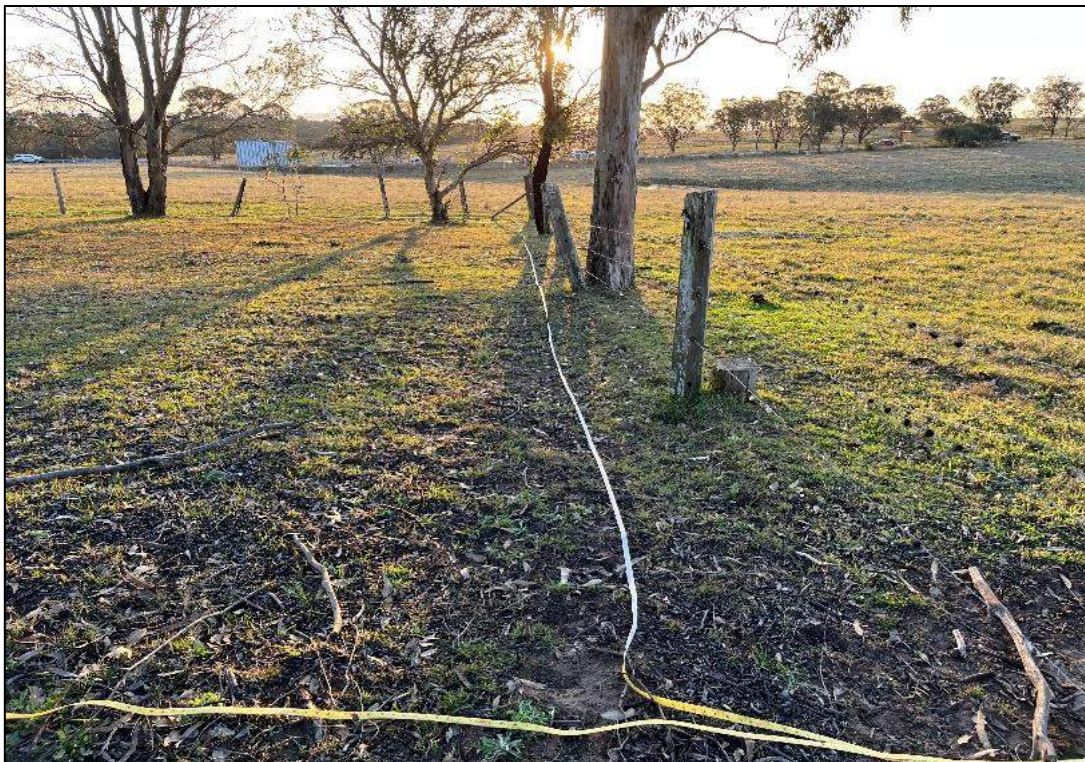
Plate 11 – BAM Plot 8 – Planted *Eucalyptus spp* in the south of the site.

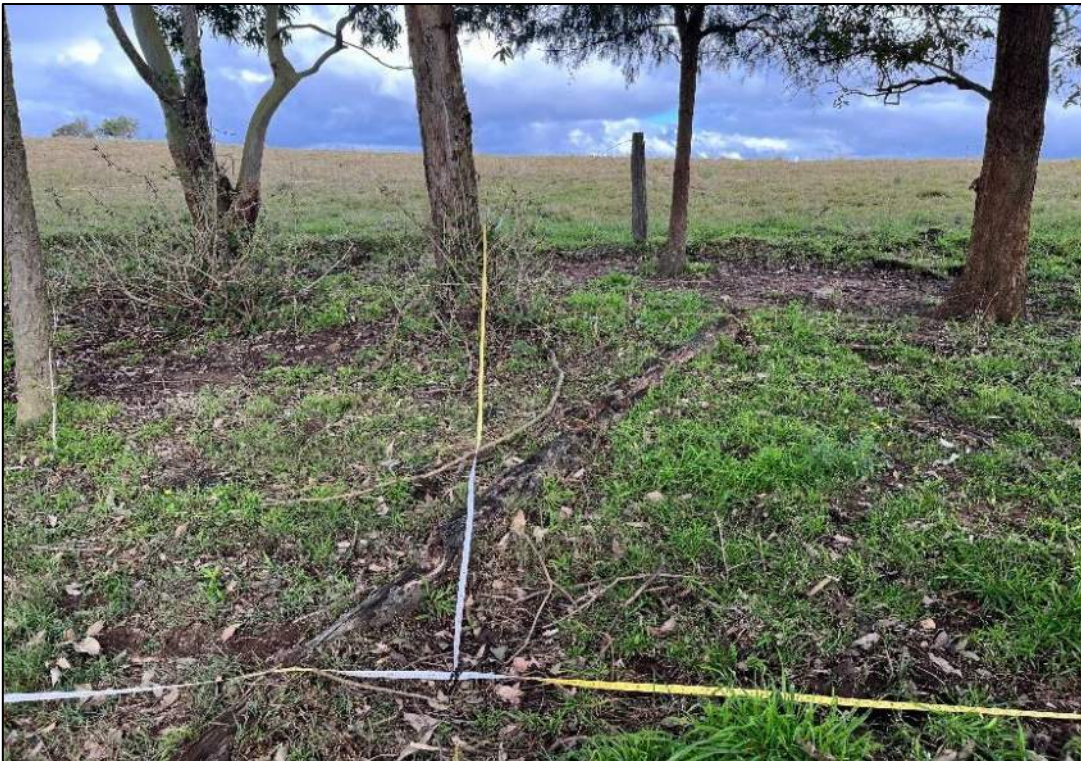
Plate 12 – BAM Plot 3 – Planted rows of *Eucalyptus spp* in the north of the site.

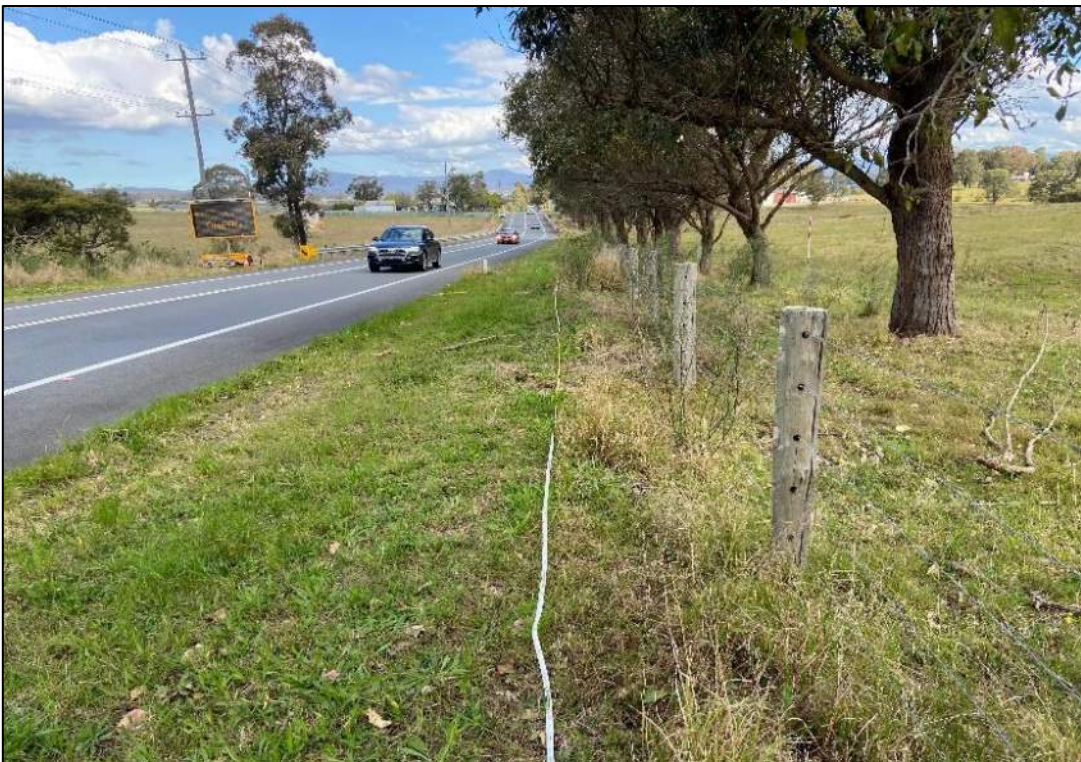
Plate 13 – BAM Plot 10 - Planted native vegetation

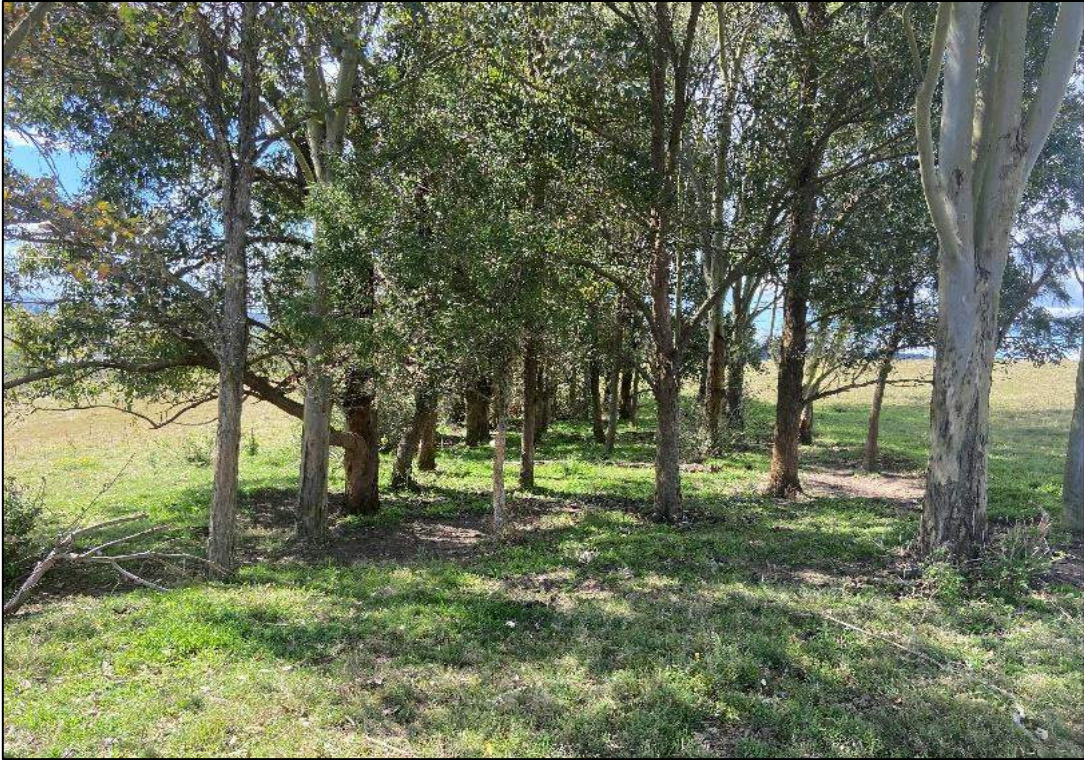
Plate 14 – Planted native vegetation in north (Where BAM Plot 3 was undertaken), note rows and spacing and consistent size of trees

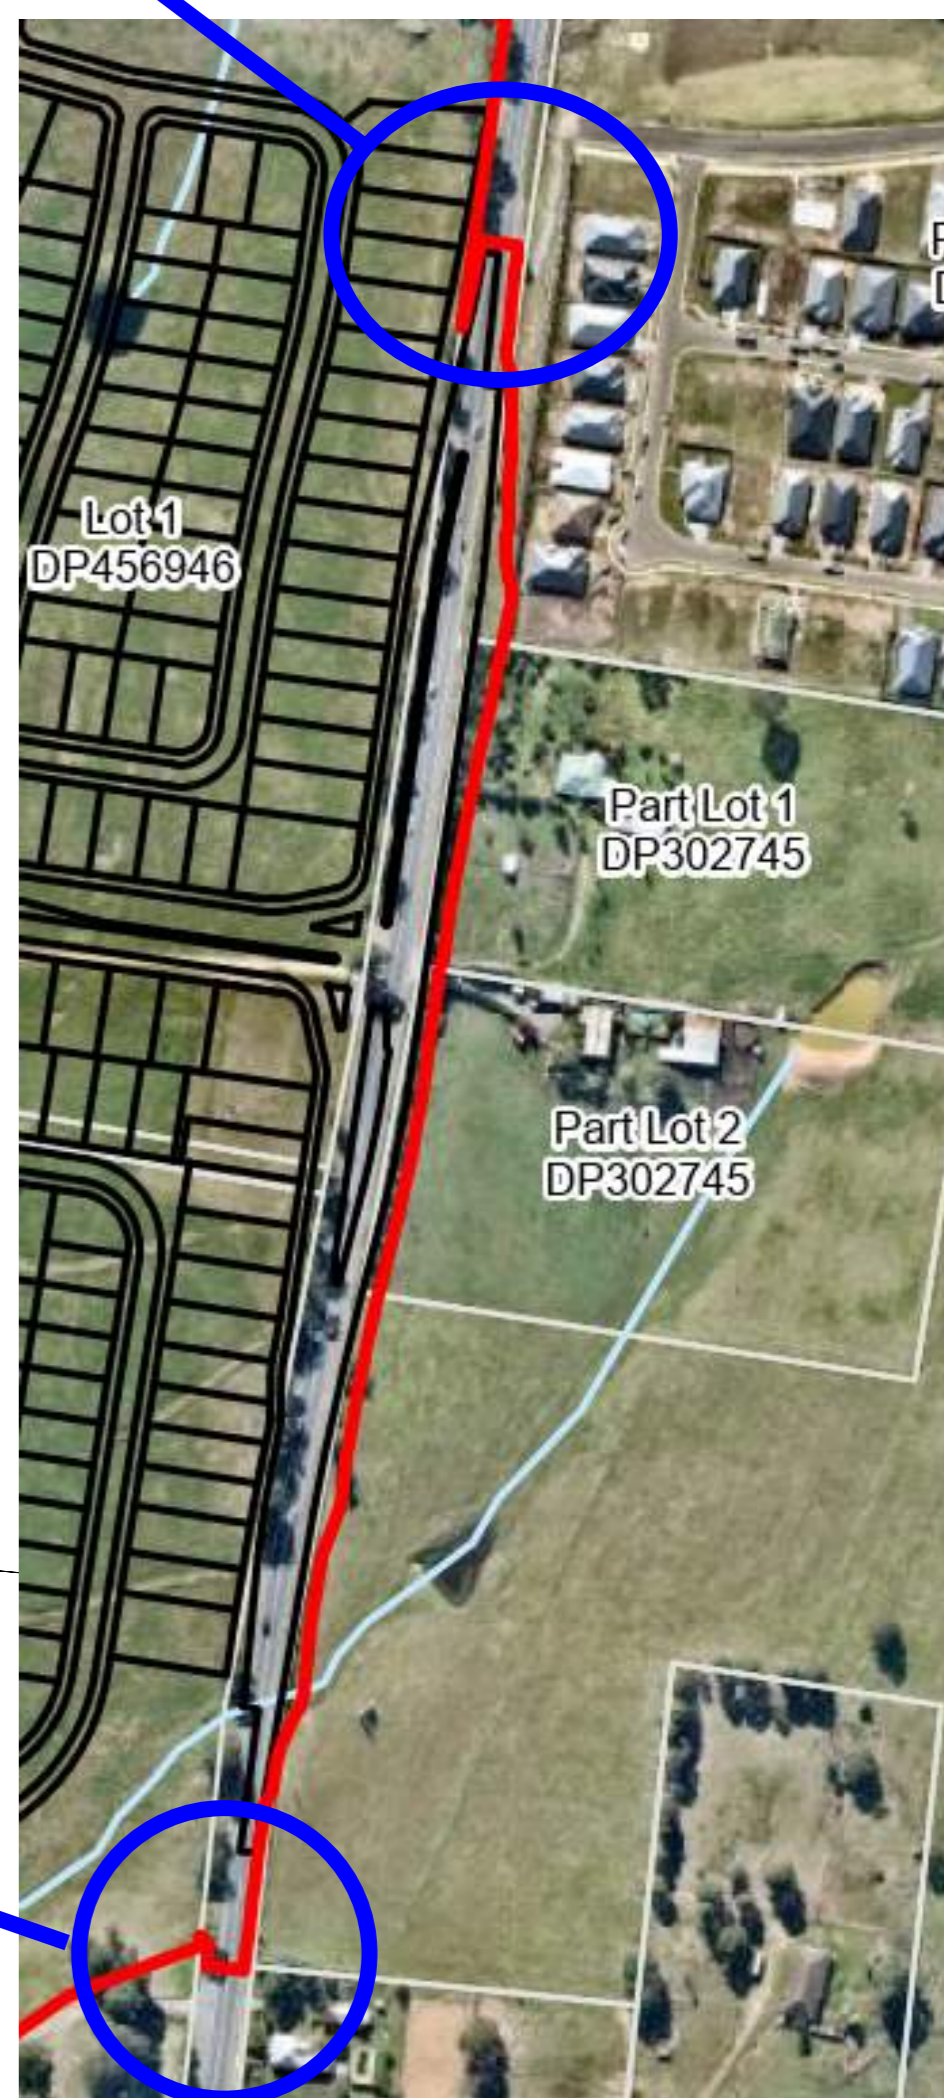
Date:	30/05/2023	Project No:	210039
Project:	SOUTH GILLIESTON	Page:	1
Title:	APZ OVERLAY	Revision:	1
Drawing No:	SKET052	Scale:	1:1500
Drawn:	ML

Extract from 'Regrowth - Kurri Kurri - Precinct 1 BDAR - Revision 0 - Dated 2nd February 2022'

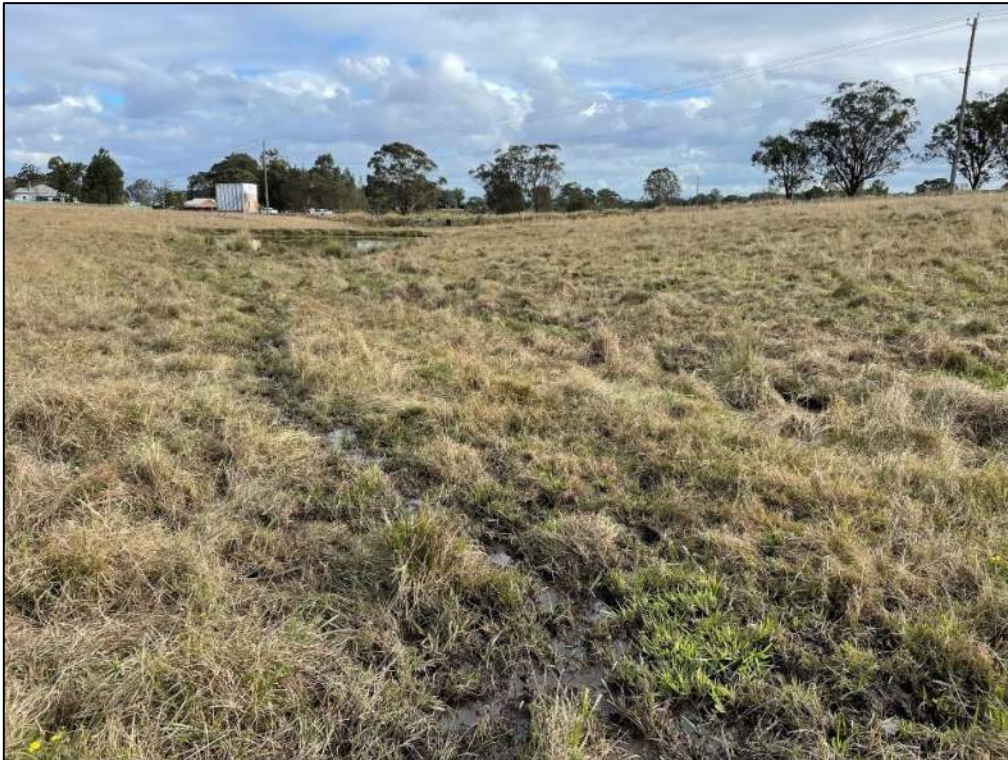
Above: Mapped hydroline – degraded with no defined bed or bank
Below: Overland water flow across Subject Site

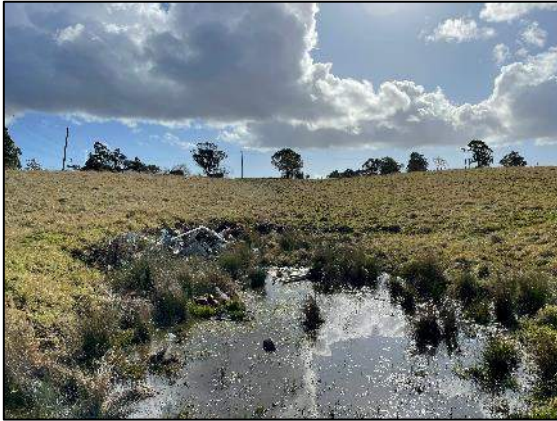
Ground-truthed Numbering to Determine VRZ	N/A	-	6
Controlled Activity Approval Required (Y / N)	No	-	-
Vegetated Riparian Zone Required (m)	N/A	-	-
Comments	No bed and banks were observed at field survey segment 1.1.

Task – Waterfront Land Tool (2020)	Assessment	Comments (provide evidence)	Figures
		<p>Watercourse features as defined by Appendix 6 of the Waterfront Land Tool were not identified.</p> <p>It is likely this Survey Point represents an area of dam over flow during periods of heavy rain, and does not meet the definition for waterfront land.</p> <p>The mapped 1st order stream is not present within the Subject Site</p>

late 1: Segment ID 1.1 Showing dam facing north.

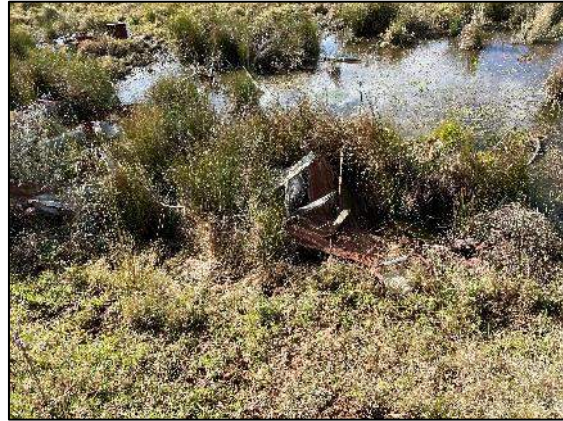
Plate 2: Segment ID 1.1 Facing east across dam.

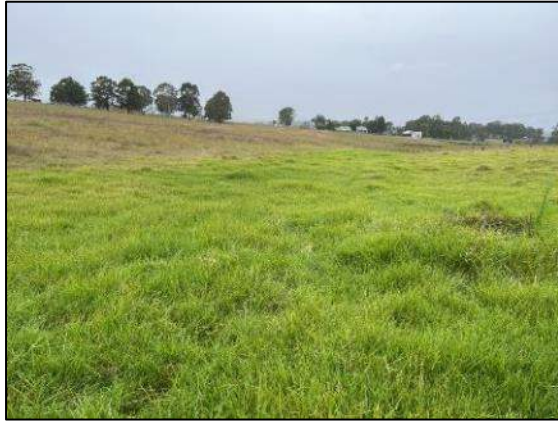
Ground-truthed Numbering to Determine VRZ	N/A	-	6
Controlled Activity Approval Required (Y / N)	No	-	-
Vegetated Riparian Zone Required (m)	N/A-	-	-
Comments	Field survey segment 1.2 is located downhill (south-west) of segment 1.1 just below the farm dam. This wet area does not meet the criteria for a 1st order stream due to the lack of defined bed

Task – Waterfront Land Tool (2020)	Assessment	Comments (provide evidence)	Figures
		<p>and banks, lack of riparian/ aquatic vegetation and no visible high bank. The vegetation is greener due to the convergence of overland flow in between landscape undulations.</p> <p>Watercourse features as defined by Appendix 6 of the Waterfront Land Tool were not identified.</p> <p>The mapped 1st order stream is not present within the Subject Site.</p>

Plate 3 Segment ID 1.2 (left) facing SW

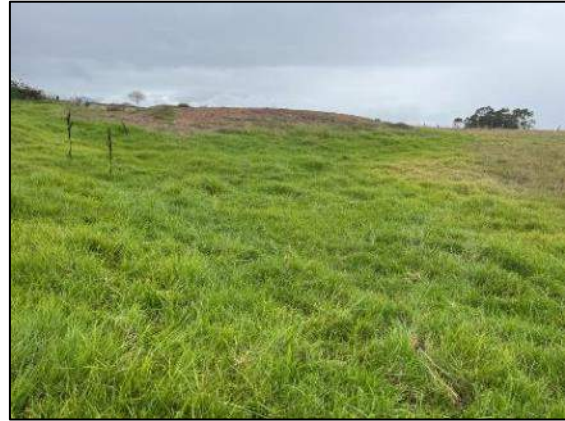
Plate 4: Segment ID 1.2 (right) facing NE. The dam wall can be seen.

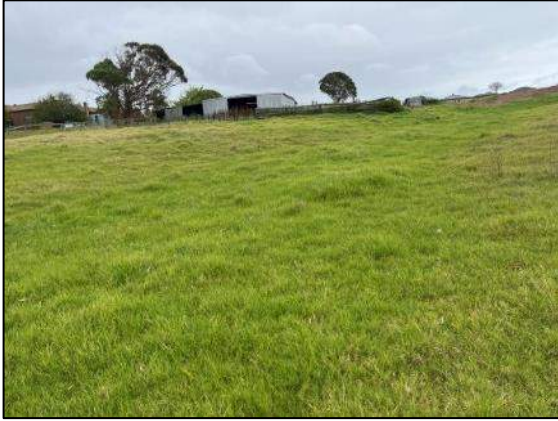
Ground-truthed Numbering to Determine VRZ	N/A	-	-
Controlled Activity Approval Required (Y / N)	No	-	-
Vegetated Riparian Zone Required (m)	No	-	-
Comments	Field survey segment 1.3 is located further downhill (south-west) along field survey segment 1. This wet area does not meet the

Task – Waterfront Land Tool (2020)	Assessment	Comments (provide evidence)	Figures
		<p>criteria for a 1st order stream due to the lack of defined bed and banks, lack of riparian/ aquatic vegetation and lack of water.</p> <p>Watercourse features as defined by Appendix 6 of the Waterfront Land Tool were not identified.</p> <p>The mapped 1st order stream is not present within the Subject Site.</p>	
<div style="display: flex; justify-content: space-around;"> <div style="text-align: center;">

<p>Plate 5: Segment ID 1.3 facing NE.</p> </div> <div style="text-align: center;">

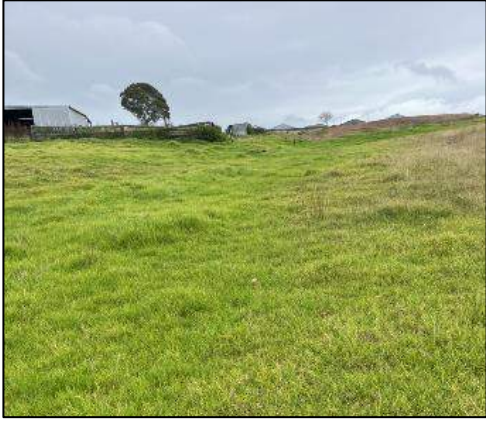
<p>Plate 6: Segment ID 1.3 facing NE.</p> </div> </div>

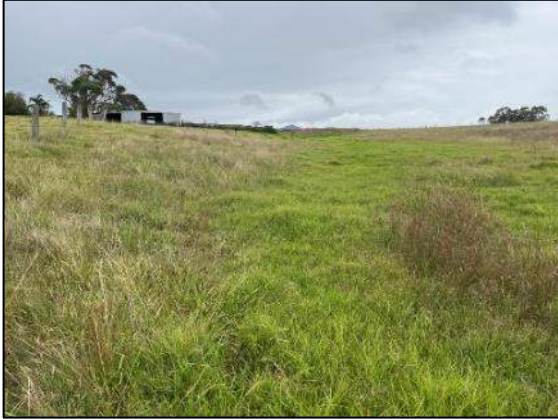
Plate 7: Segment ID 1.4 facing NE.

Ground-truthed Numbering to Determine VRZ	N/A	-	-
Controlled Activity Approval Required (Y / N)	No	-	-
Vegetated Riparian Zone Required (m)	No	-	-
Comments	Field survey segment 1.4, does not meet the criteria for a 1 st order stream due to the lack of defined bed and banks, lack of

<p>riparian vegetation and no water present in spite of recent rain before time of survey.</p> <p>Watercourse features as defined by Appendix 6 of the Waterfront Land Tool were not identified.</p> <p>The mapped 1st order stream is not present within the Subject Site.</p>
--	---

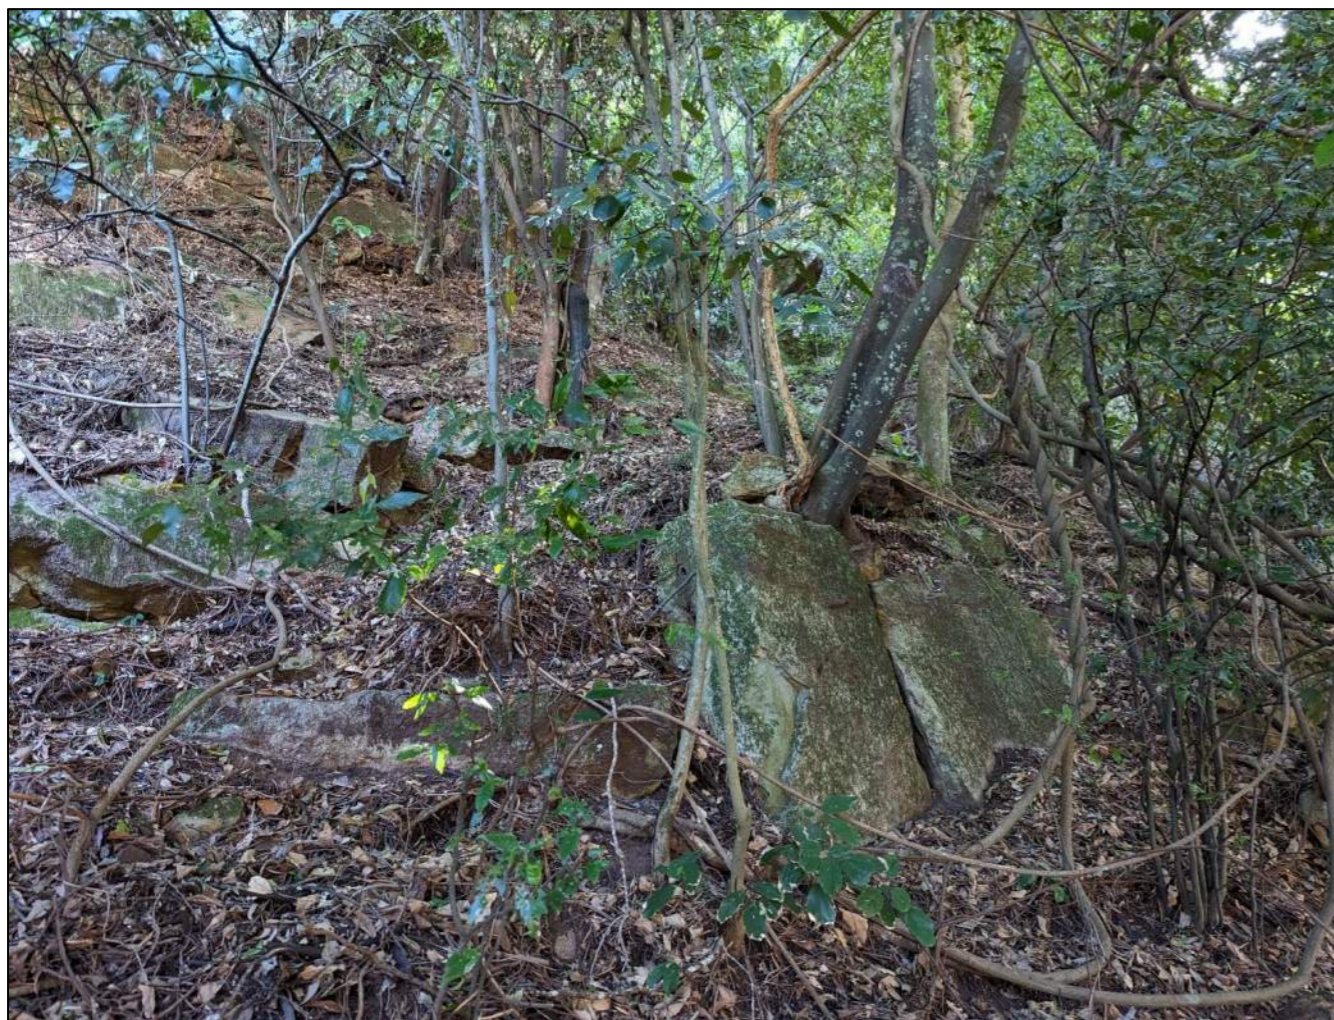
Plate 1 - Lower Hunter Valley Dry Rainforest present onsite in good condition

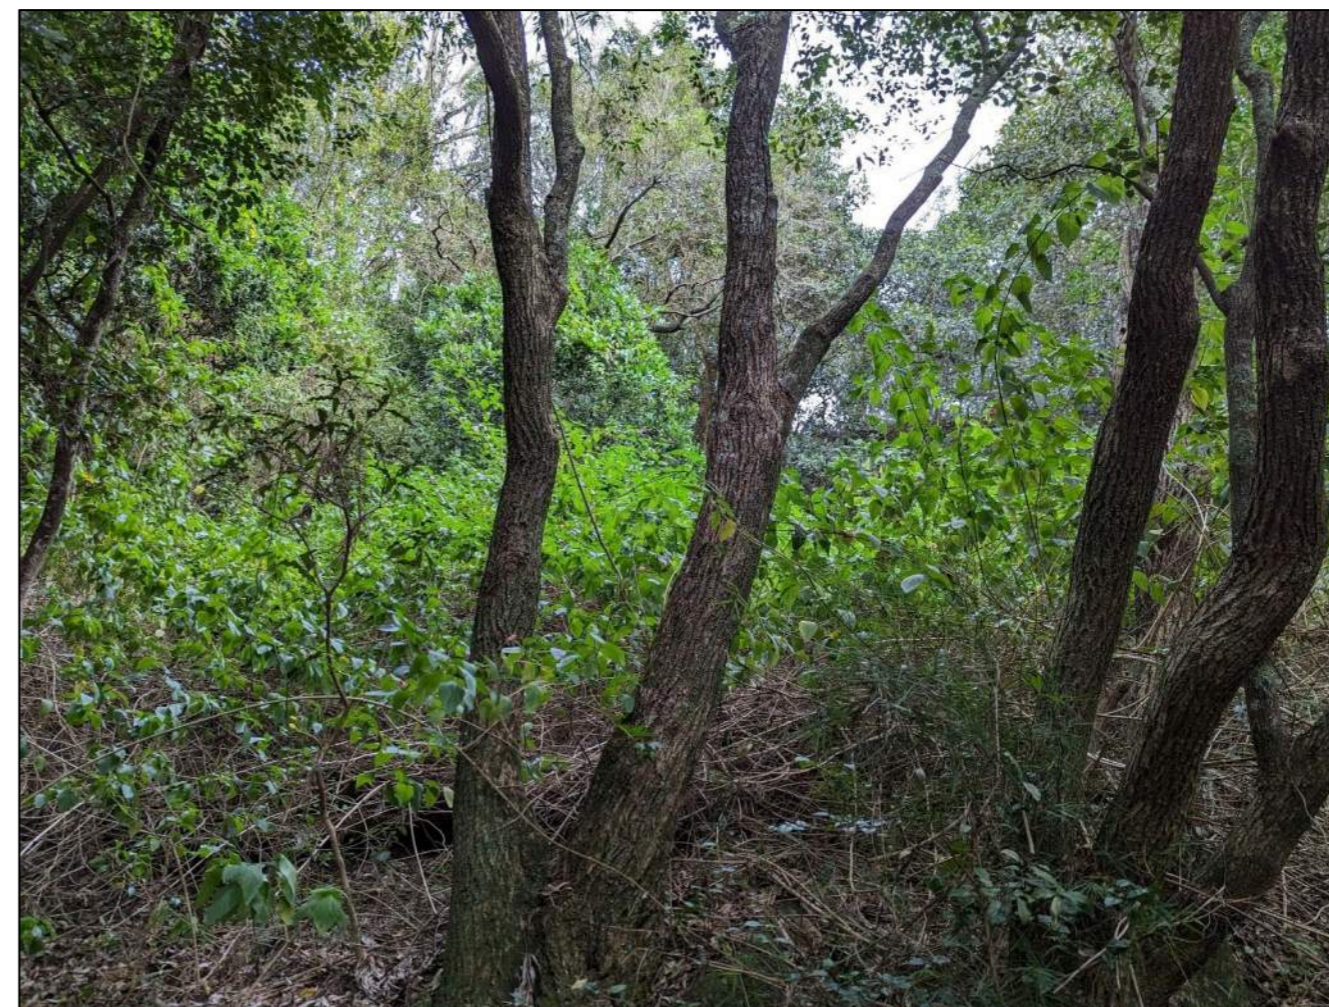
Plate 2 - Lower Hunter Valley Dry Rainforest present onsite in disturbed condition

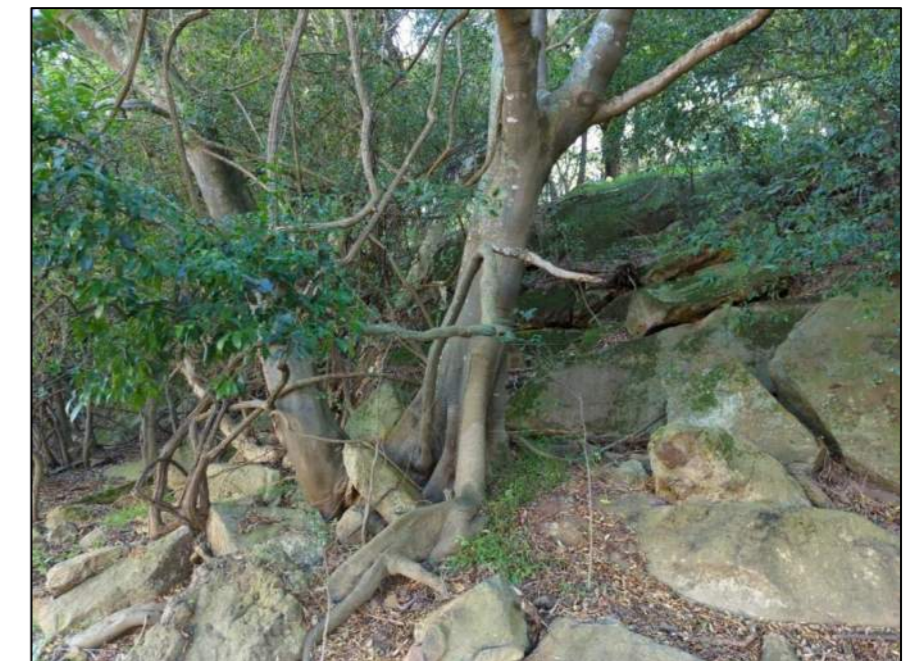
Plate 3 - Parts of the site are in good condition with low incidence of exotic species

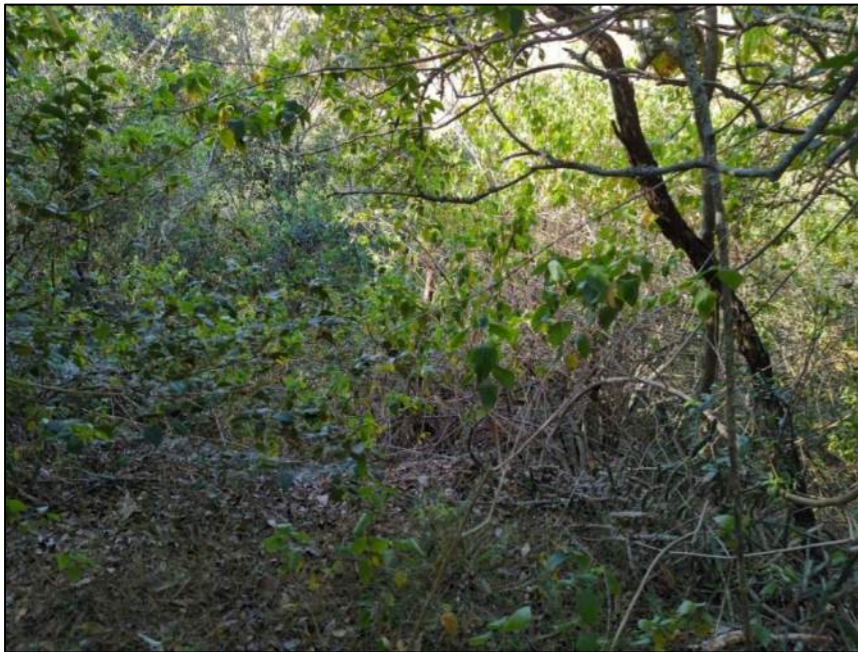
Plate 4 - Thickets of Lantana are scattered throughout the site

Note that some rainforest trees and shrubs are regenerating within thickets of Lantana including pioneer species such as *Alphitonia excelsa* (Red Ash). As such, care should be taken during weed control activities. This is discussed further in **Section 3**.

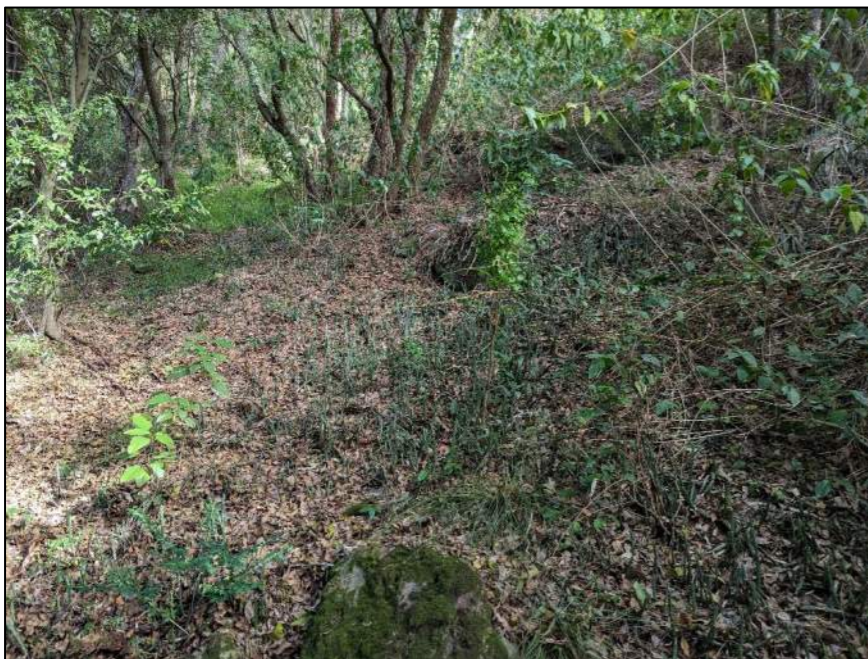
Plate 5 - large areas of the ground layer have been colonized by Tiger Pear

The understory and ground layer fluctuates from good condition areas dominated by native ferns and forbs including *Pellaea falcata* (Sickle Fern), *Adiantum hispidulum* (Rough Maidenhair), *Peperomia blanda* and *Oplismenus aemulus* (Basket Grass) to highly disturbed areas including thickets of *Lantana camara* and large areas colonized by *Ehrharta erecta* and *Opuntia spp.*

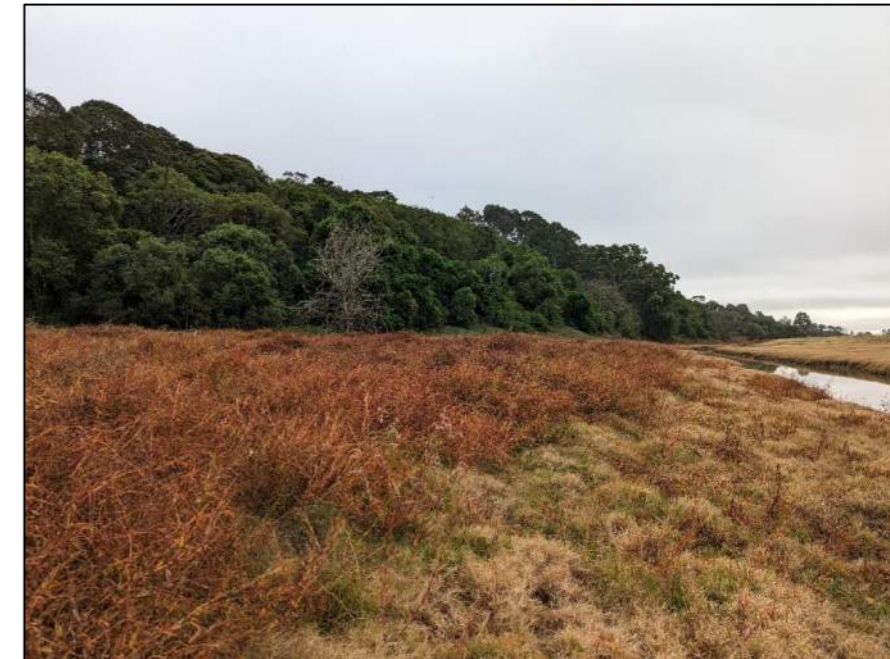
Plate 7 - Exotic Grassland along Wallis Creek (not subject of BMP)

The alluvial flat of Wallis Creek at the bottom of the escarpment consists of an exotic grassland currently being grazed by cattle. This area is not proposed to be managed as part of this BMP.
