Streamlined Biodiversity Development Assessment Report (Small Area and Planted Native Vegetation)

Proposed residential subdivision at 527, 507, 501, 463 and
457 Cessnock Road, Gillieston Heights NSW 2321

AEP Ref: 2665.02

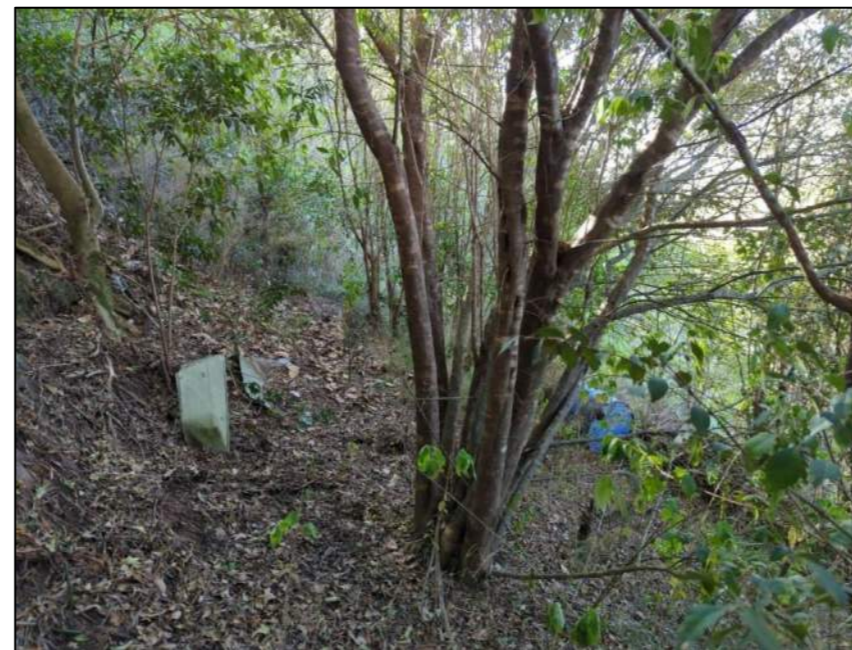
Plate 8 - Rubbish within the BMP Lands

All extant of rubbish/waste is to be removed from BMP lands including farm fencing and structures. The need to remove such material should be assessed on a case-by-case basis as in some instances the material is inert, such as concrete, rocks and timber posts, etc. Such material may inadvertently provide geomorphic stability and suitable shelter and habitat for native fauna.

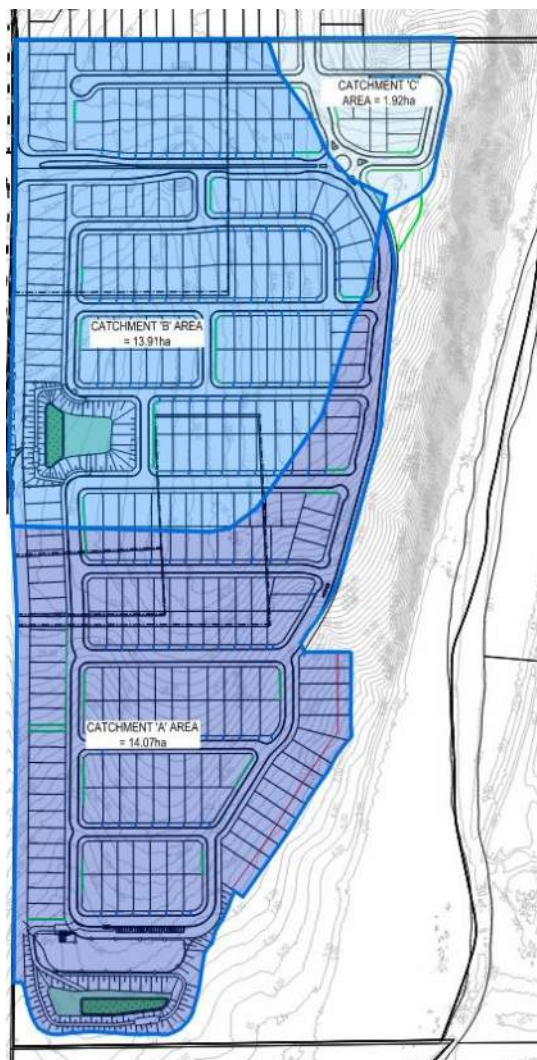
Under existing conditions, the catchments and impervious areas have been determined based on aerial photography and ground survey of the site, refer to **Figure 3** for existing catchment plan.

Figure 3 - Existing Catchments

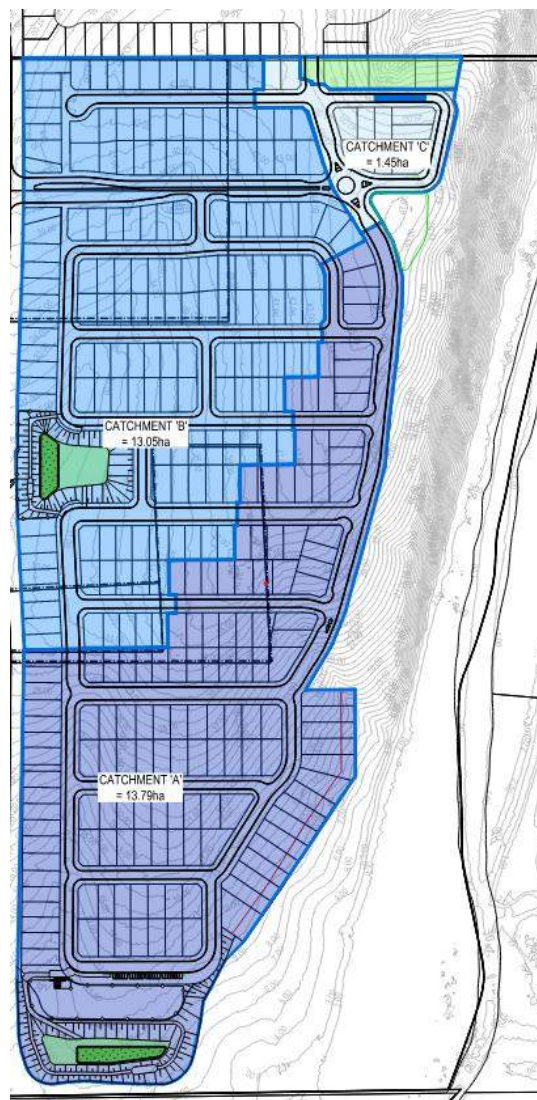
The post development catchments for the development are shown in **Figure 4**.

Figure 4 - Proposed Catchments

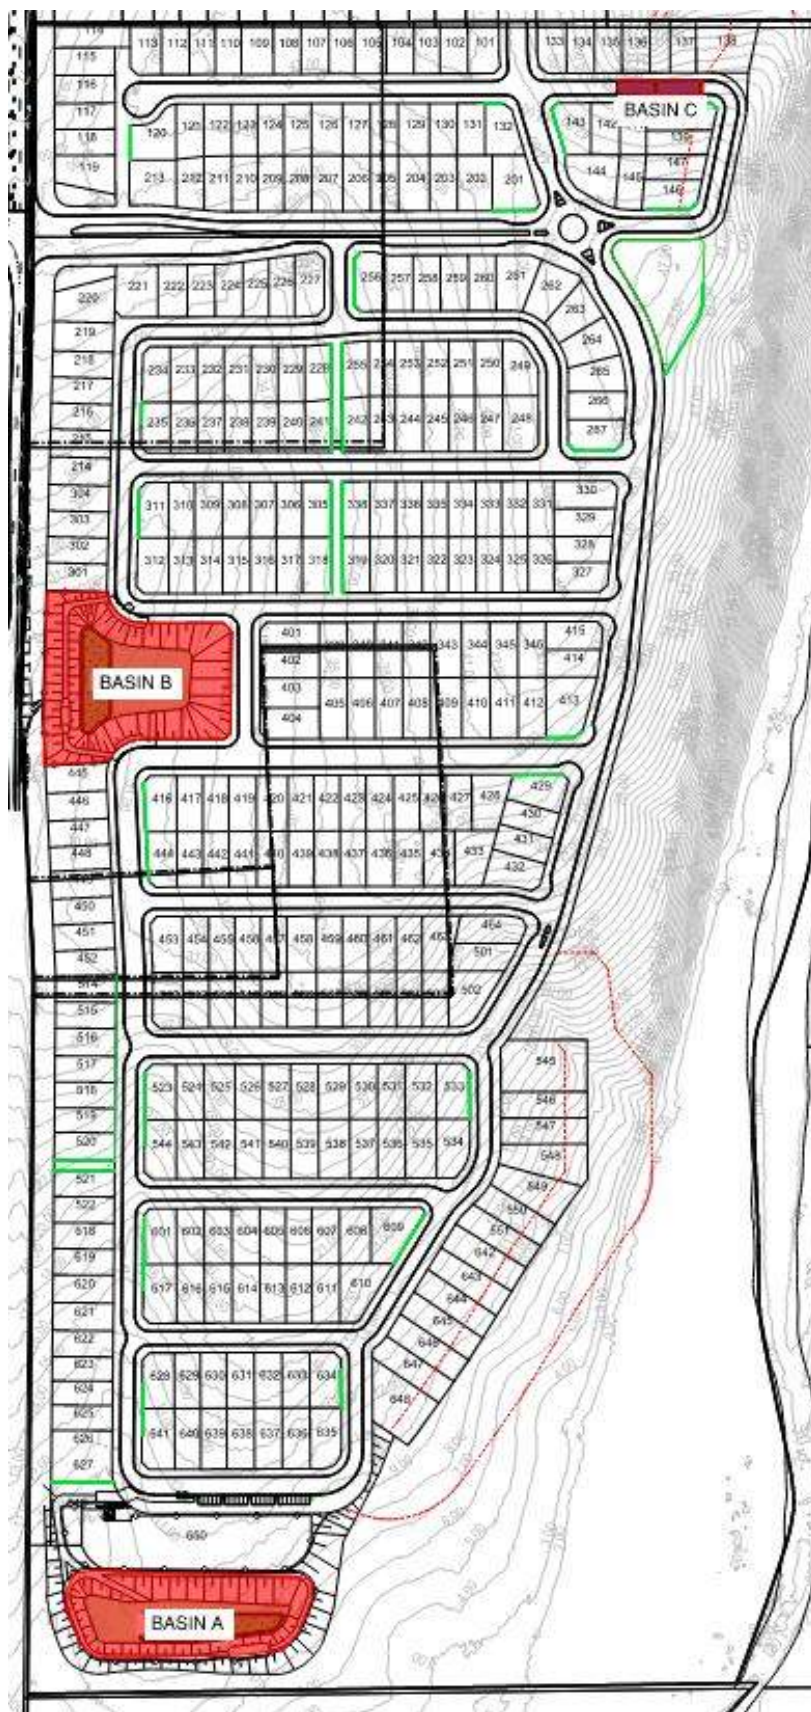
Catchment 'C' – Discharges to the north via a below ground OSD culvert system. The flow is then conveyed to Wallis Creek through the existing low point.

Figure 5 – Basin Locations

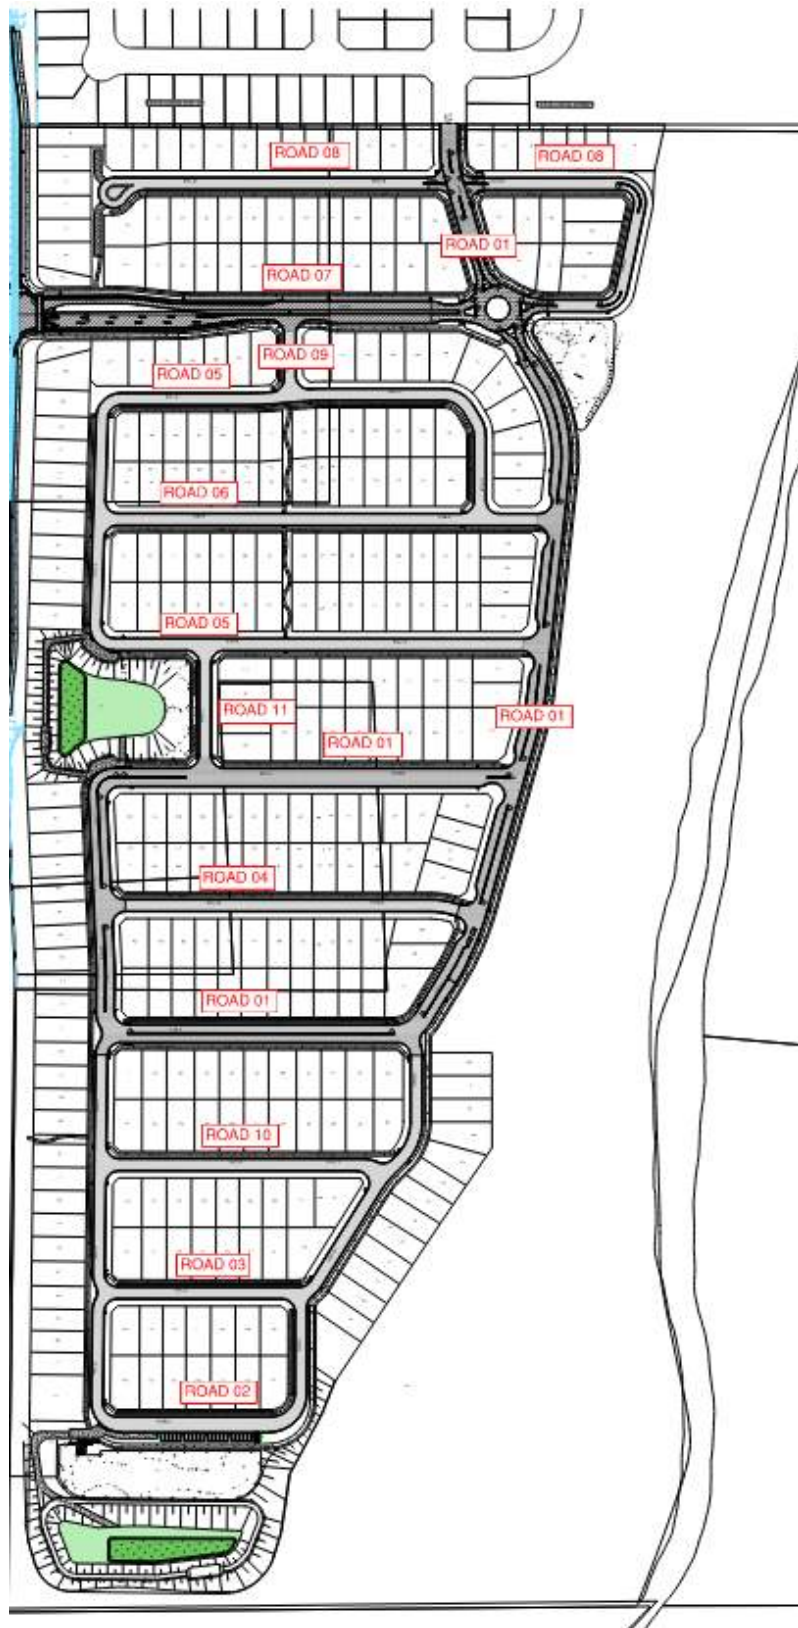
Figure 9 – Proposed Road Layout

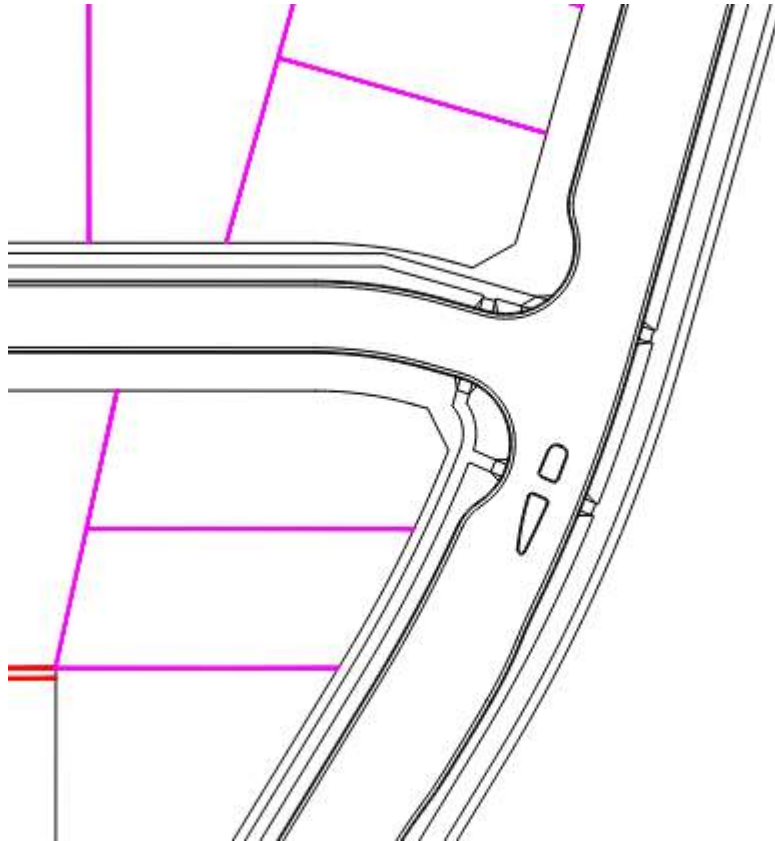
standards. Bus stops have been implemented on Road 01 as to ensure that no resident is generally located within a 400m walk from the nearest bus stop. Kerb blisters are also proposed along the perimeter portion of Road 01 to provide traffic calming and safe crossing locations for pedestrians. The kerb blister located behind the bus stop can be seen in **Figure 10** Below.

Figure 10 - Kerb Blisters
