Walka Water Works

Remedial Action Plan

Maitland City Council

19 November 2022

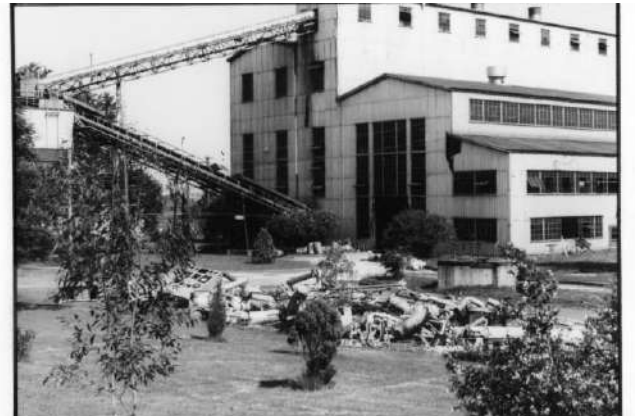
Apparent friable lagging, January 1978

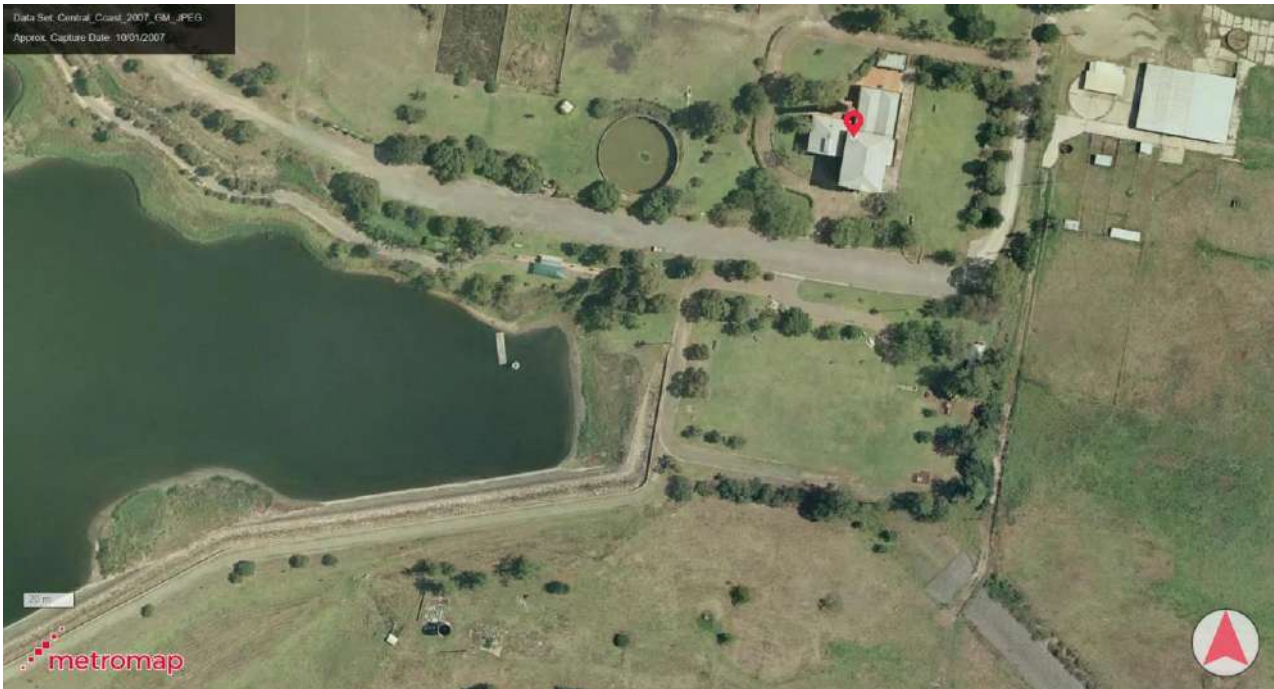
Figure 4.2 Aerial photograph from MetroMap 10 January 2007 showing lower water level

Contaminated soil and sediments could be removed from the beach area and disposed off-site or contained elsewhere on the site, however the heritage constraints and difficulty in excavating sediments suggest that in-situ capping may be a more effective remediation strategy for this area.
